Advanced Oxygen Generation Assembly for Exploration Missions

Future Exploration missions will require an Oxygen Generation Assembly (OGA) to electrolyze water to supply oxygen for crew metabolic consumption. The system design will be based on the International Space Station (ISS) OGA but with added improvements based on lessons learned during ISS operations and technological advances since the original OGA was designed and built. These improvements will reduce system weight, crew maintenance time and spares mass while increasing reliability. Currently, the design team is investigating the feasibility of the upgrades by performing ground tests and analyses. Upgrades being considered include: redesign of the electrolysis cell stack, deletion of the hydrogen dome, replacement of the hydrogen sensors, deletion of the wastewater interface, redesign of the recirculation loop deionizing bed and redesign of the cell stack Power Supply Module. The upgrades will be first demonstrated on the ISS OGA.

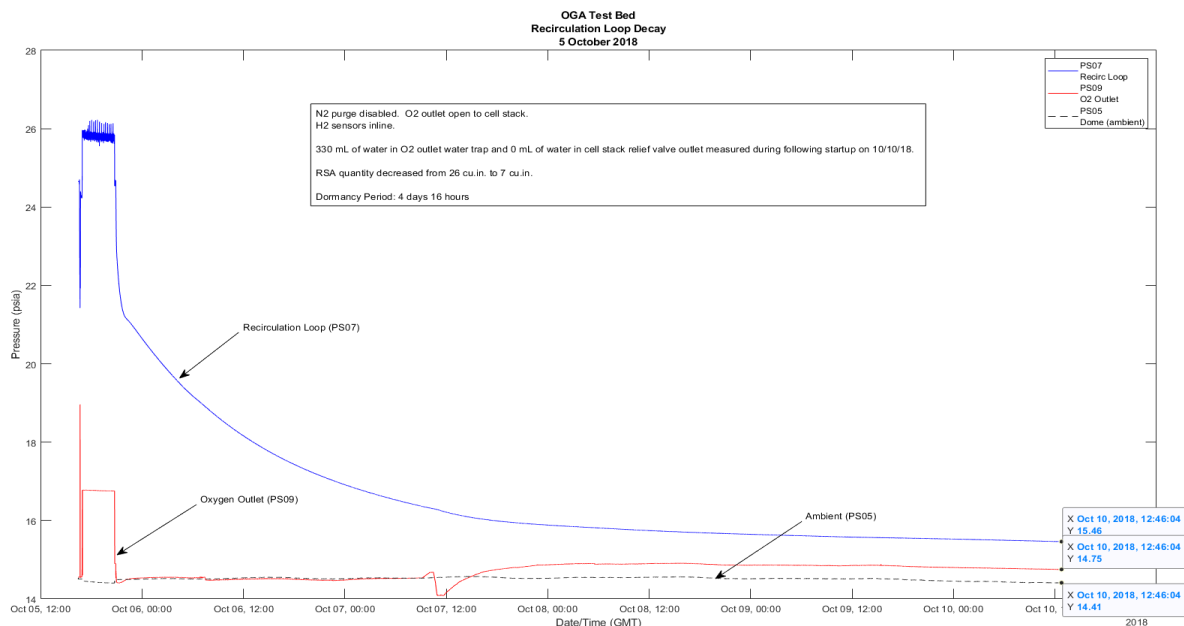
The major operational concerns with disabling nitrogen purging are: water in the oxygen outlet, low RSA quantity on subsequent startup, and low recirc loop pressure on subsequent startup. When nitrogen purging is disabled in the OGA testbed, a large amount of water (up to 330 mL) is observed in the oxygen outlet line upon every subsequent startup. This amount of water at every startup is undesirable, since it would damage the hydrogen sensors in the oxygen outlet line. In addition, liquid water is not allowed to exit the oxygen outlet port into the cabin. This additional water would have to be captured by the oxygen outlet line water absorber, and a method for drying the absorber would need to be developed. Without nitrogen purging, the cathode pressure is higher than the anode pressure. The pressure gradient pushes water across the membrane from the cathode to the anode. The second related issue is the low RSA quantity upon subsequent startup when nitrogen purging is disabled. Testing has shown that a significant reduction of RSA water quantity occurs when nitrogen purging is disabled, from a nominal 25 – 30 cu-in to as low as 0 cu-in. This reduction in RSA water quantity during shutdown with nitrogen purging disabled can make the subsequent startup more difficult. There is an Independent Shutdown Monitor (ISM) interlock which prevents the system from starting up if the RSA quantity is too low. The related third issue is the low recirculation loop pressure on subsequent startup when nitrogen purging is disabled. When nitrogen purging is enabled, the cell stack anode compartments are pressurized with nitrogen upon shutdown. The nitrogen in the anode compartments permeates across the cell stack membranes to the cathode compartments and helps keep the recirculation loop pressure at a desirable level for the

Figure 9. Recirculation Loop Pressure and Cell Stack Anode Pressure During Shutdown, No N2 Purge

next startup. When nitrogen purging is disabled during shutdown of the OGA testbed, the anode pressure is at ambient pressure, and the recirculation loop pressure drops close to ambient pressure within two days after the system is unpowered, as shown in Figure 9. When the system is in Process, the recirculation loop pressure (blue line) is at about 26 psia. Once the system is unpowered, the recirculation loop pressure decreases to approximately 15.5 psia within 3 days. This pressure decrease makes the subsequent startup more difficult, as this is below the low shutdown limit for the recirculation loop pressure of 20.5 psia during Standby. Given these operational issues, the design team will need to decide whether these issues can be managed if nitrogen purging were to be deleted.

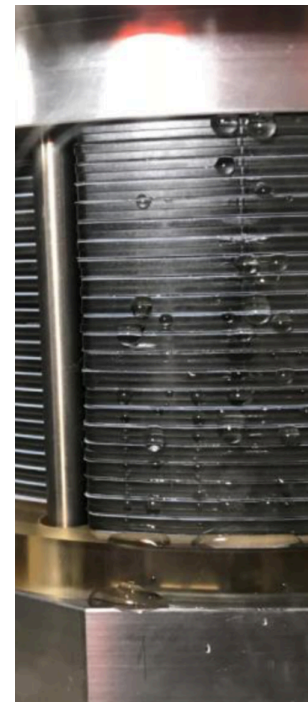
The cell stack burst test was completed in 2018. A development cell stack of the proposed AOGA 22-cell design was built. All components which would affect external leakage were flight like, including the end plates and cell frames. Internal components which would not affect external leakage were substituted for lower cost equivalents, including the cathode and anode screens and membrane catalyst. The test plan called for hydraulically pressurizing the cell stack until leakage or burst occurred. The test stand had the capability to pressurize the cell stack up to 3,000 psig. High speed video cameras were in place to capture any destructive burst of the cell stack. In addition, calipers were in place to measure the growth in height of the cell stack as it was pressurized. During the test, the stack pressure was increased in 50 psig increments. As the cell stack was pressurized, it grew in height. No leakage or deformation was observed until the cell stack was pressurized to 1,000 psig. At this pressure, water droplets were observed on the outer edges of the cell stack hydrogen manifold, as shown in Figure 13. In addition, it was observed that the cell stack grew in height by approximately 0.018 inch, which allowed some loss of compression between the cell frames, and paths for external leakage to form. When the pressure was removed, the cell stack returned to its original height and no permanent deformation was observed. Normal operating pressure of the cell stack is approximately 10 psig. The expected MDP (worst case pressure due to a failure of internal components) of the AOGA cell stack is expected to be under 500 psig. Although

Figure 13. Water Leakage of the Cell Stack at 1,000 psig

this test is a single data point, it provides confidence that the cell stack does not require redesign. Future analysis will be required to corroborate the test results.
