# Upgrades to the International Space Station Urine Processor Assembly

Jill P. Williamson<sup>1</sup>, Layne Carter<sup>2</sup>, Jimmy Hill<sup>3</sup>, Davey Jones<sup>4</sup>, Danielle Morris<sup>5</sup>, Rex Graves<sup>6</sup>  
*NASA George C. Marshall Space Flight Center, Huntsville, Alabama 35812, USA*

The ISS Urine Processor Assembly (UPA) began operations in November 2008. Though the UPA has successfully generated distillate from crew urine, several modifications and upgrades have been implemented to improve overall system performance throughout the years. Current and future upgrades to the UPA will continue to focus on improved system performance and reliability, focusing primarily on the Distillation Assembly and upgrades to the UPA vacuum pump. Work towards a flight demonstration experiment of a vacuum pump utilizing scroll pump technologies has also continued forward. The following paper discusses progress on these various concepts, including the implementation of a more reliable drive belt, improved methods for managing condensate in the stationary bowl of the Distillation Assembly, installation of improved centrifuge bearings, implementation of a liquid level sensor

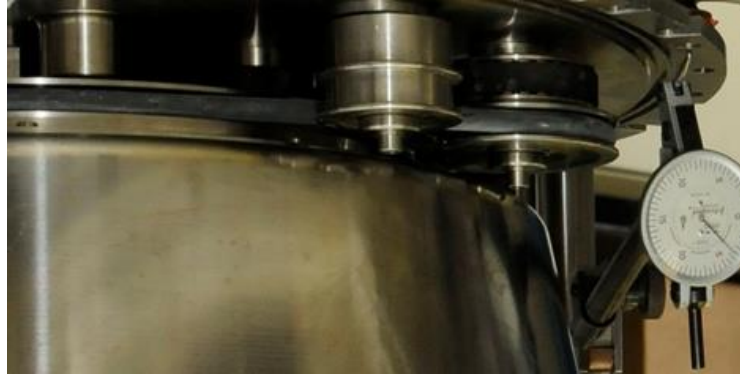
**Figure 2. The DA O-ring drive belt.**

Rotation of the DA is currently driven by an O-ring belt (Figure 2). However, this belt frequently slips during operation due to the steam environment in the DA. The risk is greatest at the beginning of a process run, since the steam has time to condense as the DA cools between processing cycles. Belt slippage at startup has been consistently observed in UPA operations on ISS. In February 2016, DA SN002 experienced a failure when the belt was unable to maintain sufficient centrifuge speed. This occurred after several months of off-nominal UPA performance in which the DA was consistently challenged with excess condensate in the stationary bowl<sup>2,3</sup>. The current DA SN005, installed April 2017, has also experienced belt slip during startup; however, centrifuge speeds have continued to recover upon restart. These events coupled with the consistent slips on startup led to the objective of replacing the O-ring drive belt with a more robust design.

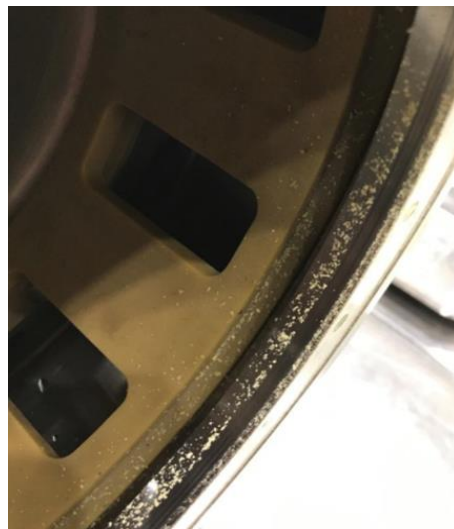
**Figure 7: VariSeal shedding in centrifuge assembly after 200 hours of runtime.**

Initial testing of a VariSeal lip seal design within the DA with O-ring drive belts took place at MSFC in late 2018. After 100 hours of nominal operation with the VariSeal, approximately 65 mL of fluid was collected in the stationary bowl. In previous test operations over similar run time without the seal, over 1700 mL of fluid was reported. This confirms a significant improvement to minimizing water vapor from entering the stationary bowl by reducing the gap. Further parametric testing continued, only now, with the installation of the toothed synchronous belt drive system. It is believed the remaining 65mL found was due to another known leak path on the aft end of the centrifuge. A custom design solution has been determined with support from Trelleborg. The seals are currently being manufactured by Trelleborg as well as necessary MSFC design changes to support initial testing on the development DA unit. Disassembly of the DA after a subsequent parametric testing revealed shedding of the VariSeal material due to contact between the centrifuge and compressor aft. Figure 7 shows the flaking nature of this shedding within the DA. It is believed the material make-up of this particular VariSeal was the cause for this shedding. An alternate material (T40) has been chosen and procured for later testing. It is hopeful shedding will be reduced, if not minimized, and fluid reduction in the stationary bowl performance is maintained. Despite the shedding issue, the VariSeal has shown promise in mitigating the amount of fluid in the stationary bowl. Overall, 95% reduction of fluid in the stationary bowl was observed compared to a baseline performance without the seal and no heaters. Moreover, MSFC Engineering will consider a break-in procedure of these VariSeals to address observed drag during parametric testing.

Further efforts to decrease this leak path incorporates a Teflon seal instead of the VariSeal at the same location. Acting as a spacer, a thin Teflon ring design can be a compromise to reduction of water vapor into the stationary bowl while avoiding the potential for material shedding. Similar Teflon seal design is already incorporated on the hub end of the DA, which proves a viable sealing option within this dynamic environment. These Teflon seal designs reduce in gap size at the interface, which should reduce the amount of water vapor. Because there is no material touching the moving surfaces, there is no concern for shedding or increased drag onto the system. Ground testing installed a Teflon seal achieving a 75% reduction in gap, which has shown similar reductions of fluid found during the VariSeal testing. Ongoing testing with the Teflon seal, with respect to thicknesses and runtime, will provide better comparisons to previous VariSeal testing.
