Restore-L Satellite Servicing Internship Final Report

An experiment was conducted to determine whether a sample of shorter flexible metal hoses could sustain tensile loads of up to 200 lbf and continue to meet the minimum mission requirements. The purpose of this experiment was to determine if tension loads during the processing of the hoses compromise performance. With this information, it will be decided whether the flight flex-hose manufacturer should proceed with the testing of the full-scale flex-hoses. To reduce the time and funding required for this test, a test fixture was designed and assembled in the Engineering Development & Operations (EDO) test facility. In this test fixture, two Engineering Development Unit (EDU) flex-hoses were loaded with free floating weights up to 350 lbf. A load of 200 lbf equates to the maximum expected loading with a margin of safety, thus all data recorded after 200 lbf was purely for reference. Measurements were taken using a tape measure and a custom datum measurement system to record the loaded and unloaded length of each flex-hose at various loads. Any permanent stretching beyond a 1/8th of an inch was indicative of inelastic yielding. Th

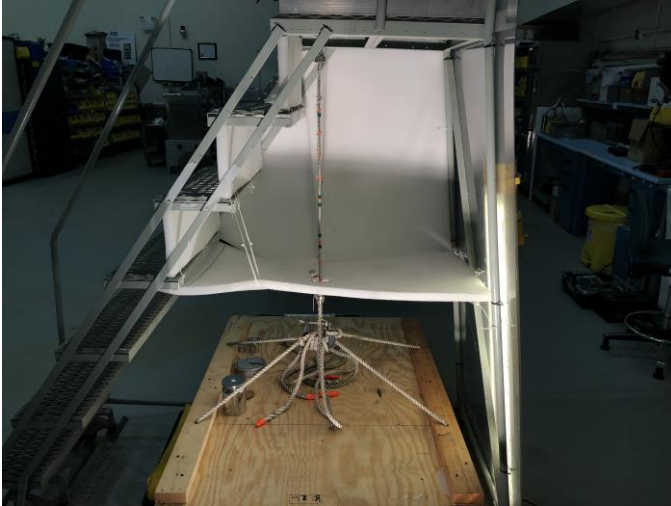
A testing fixture was designed and built in the Engineering Development & Operations (EDO) test facility to vertically hang each EDU flex-hose with weights. To reduce the time and funding required for this test, a testing fixture was assembled out of miscellaneous items (stepladder, foam insulation, and wood) in the EDO. A wooden platform made from plywood was built as a means of transferring the weight of the platform itself and the weights to the EDU flex-hose. The platform was threaded with rope and wrapped around a c-clamp to support the load. In addition, the c-clamp was pinned through a Kellum that was attached to the lower collar of the EDU flex-hose, as seen in Fig. 2. As a result, the total weight of the platform and weights is distributed to the flex-hose in the form of a total hanging load, as shown in Fig. 3. In addition to the wooden platform, a metal bar is used to support the top Kellum, and effectively the flex-hose from the top of the stepladder.

Figure 2. Tension Test Setup. Image credit: Brian Nufer, NIFS mentor.

Furthermore, when the EDU flex-hose is loaded in tension, the hose could plastically yield until the strands fracture and cause the hose to fail by splitting in half. During this failure, the hose could recoil and whip people in the surrounding area. Due to this possibility, foam panels were installed on the stairs of the step ladder and on one side for safety during the test. Another safety precaution consisted of a horizontal guard for the hose to be fed through, such that if the hose failed during loading of the wooden platform, the person loading the platform would be safe. In addition, the back of the step ladder was covered with a thin sheet of polymethyl methacrylate (PMMA) for protection. Therefore, only one exterior side would be exposed for video recording purposes.

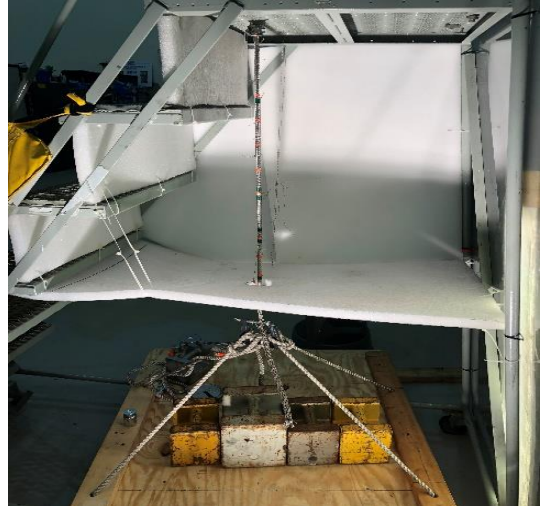
Figure 3. Maximum load configuration. Image credit: Brian Nufer, NIFS mentor.

The goal of the test was to verify no significant stretching of the hose indicative of inelastic yielding at a weight of 200 lbf or less. A benchmark of 200 lbf was determined to simulate maximum operating conditions with a factor of safety margin. All other data for tests at above 200 lbf are for reference only. For a given EDU flex-hose, the applied load was initially set at 80 lbf by hanging the weight of the platform itself (62.2 lbf) and placing several weights on this platform. Next, the loading of the flex-hose was increased by 20 lbf for a total weight of 100 lbf. Once a weight of 100 lbf was achieved, the loading was increased by 50 lbf thereafter to a maximum load of 350 lbf. The maximum loading configuration can be seen in Fig. 3.

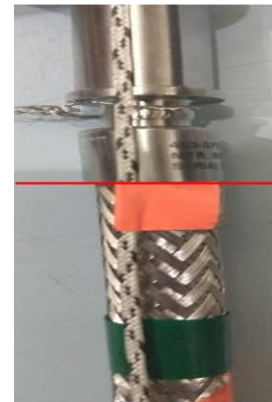
At each loading, the length of the hose was measured using two different methods before the load was removed. One of the methods involved using a tape measure to measure the distance from collar to collar of the flex-hoses to the nearest 1/16th inch. The second method involved using tape as a datum attached to a string parallel to the hose, to measure its length with a ruler to the nearest 1/32nd inch. The tape around the string is initially level with the collar before loading as seen in Fig. 4. The datum string is fastened with similar string tied around the flex-hose for the full length of the hose with the bottom being free. A knot and loop of a separate string is tied every 2 inches down the length of the flex-hose to ensure the string remains parallel to the hose. Once the hose is loaded, the static string attached parallel to the flex-hose will remain stationary as the hose elongates. The displacement between the tape and the collar of the flex-hose can then be used to measure the elongation of the hose during the test.

Figure 4. Datum reference. Image credit: Joseph Dziekan, NIFS intern.

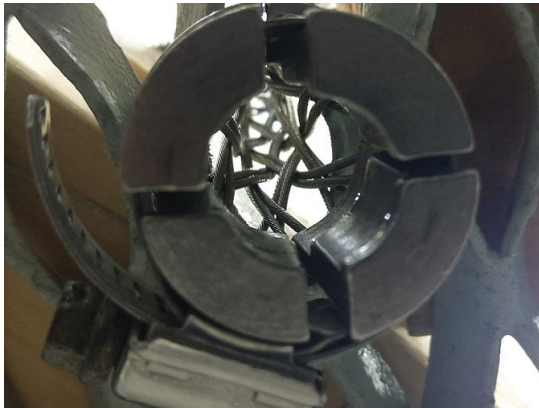
In addition, the shock loading of the flex-hose due to slippage in the Kellem collet was analyzed for future prevention. Each steel Kellem used to grip the collar of the flex-hose works by having four identical quarter-round pieces that can be secured around a shaft or collar with a hose clamp in the manner shown in Fig. 5. As seen in Fig. 6, the individual quarter-round pieces have three different radii going along the length of the piece. During testing, the collar of the flex-hose was resting near the fillet at location 1 of Fig. 6. Once a loading of 150 lbf was applied, the collar of the flex-hose made contact with the fillet. The radius of the collar was smaller than the cut Kellem piece both at locations 1 and 2 of Fig. 6, resulting in the collar slipping down to make contact with the edge at location 2.

Figure 5. Installed configuration of Kellem.
Image credit: Joseph Dziekan, NIFS intern.

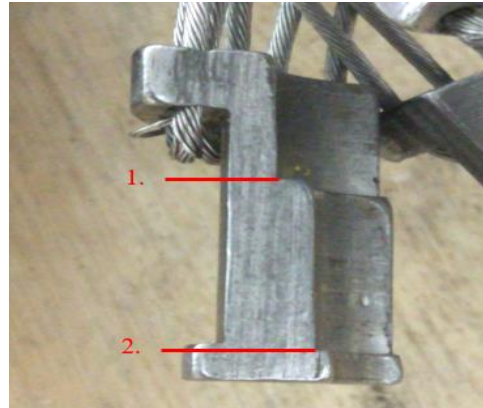
Figure 6. Individual section of Kellem.
Image credit: Joseph Dziekan, NIFS intern.

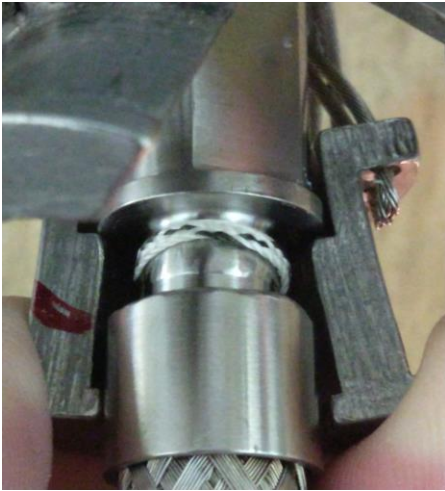
Furthermore, the initial placement of the flex-hose’s collar in the Kellem can be seen in Fig. 7. This orientation of the collar in the Kellem is at the largest of the three radii of each quarter-round piece. As previously mentioned, the collar then slipped from the location shown in Fig. 7, to the location shown in Fig. 8. The radius below the collar of the hose in Fig. 8 is the smallest radius of each quarter-round piece. Therefore, the Kellem slipped and was caught by the ledge formed due to the reduction in the radius. As a result, the flex-hose was shock loaded and it was decided to terminate the test early.

Figure 7. Position of collar in Kellem initially. Image credit: Joseph Dziekan, NIFS intern.

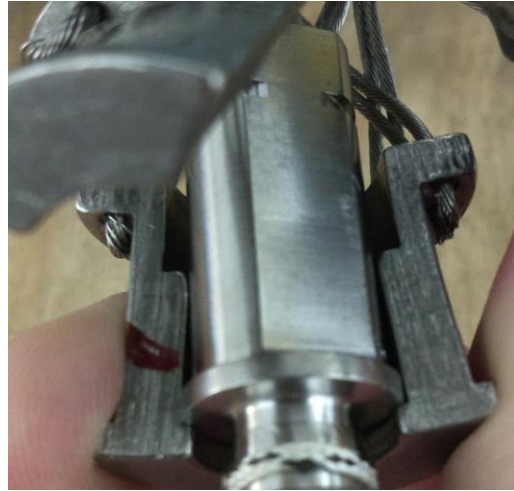
Figure 8. Position of collar in Kellem after slippage. Image credit: Joseph Dziekan, NIFS intern.

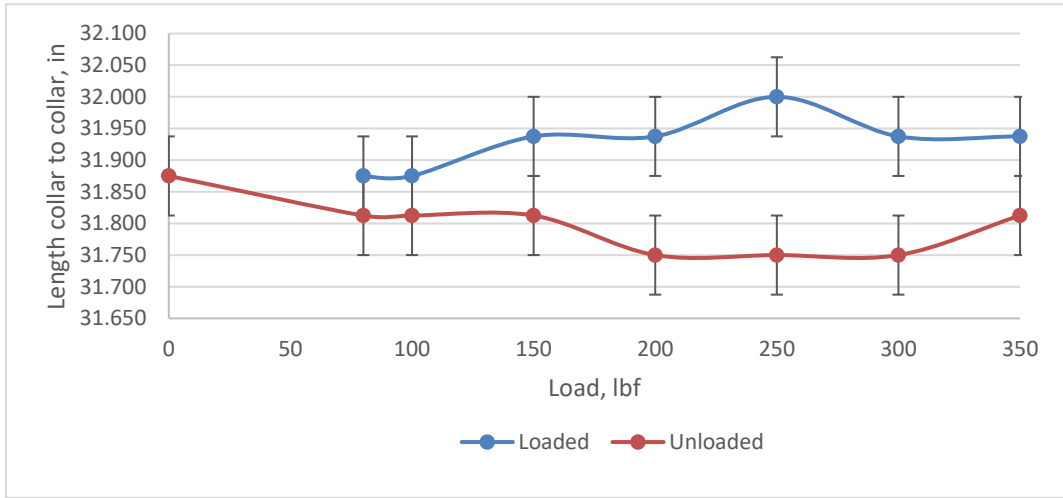
After the loading reached 250 lbf, the bottom Kellem attached to the EDU flex-hose slipped and shock loaded the hose. The bottom Kellem was misaligned causing the collet to slip relative to the bottom collar of the hose. As a result, the graph using the datum measurements was omitted because the slippage at both 150 lbf and 250 lbf loads invalidated the datum test data. In addition, the correct alignment of these Kellems was carefully verified for future loadings. The data collected using the tape measure method can be seen in Fig. 9. The maximum loaded length of 32 inches occurred at a load of 250 lbf while the maximum unloaded length of 31.875 inches occurred at no load. However, the 32 inch maximum loaded length is within the margin of error of the tape measure, as seen by the close proximity of the error bars in Fig. 9.

Figure 9. Length of first flex-hose during run 2 using tape measure

The length of the hose unloaded at the beginning of the test fluctuated within a 1/8th of an inch throughout the test. Although the beginning length of the hose is the maximum recorded unloaded length, this variation is negligible due to the accuracy of the tape measure. On the other hand, the flex-hose experienced measurable changes in the loaded length measurements throughout the test. For example, the loaded length of the hose increased from 31.875 inches to 31.9375 inches. This slight elongation of the hose could possibly be explained by the shock loading experienced by the hose at 150 when lbf load. A shock loading at this weight caused the hose to stretch slightly, and this is supported by the consistency of the hose’s length for the remaining portion of the test. In omitting the measurement of the hose at 250 lbf due to shock loading, the loaded length of the flex-hose remained at 31.9375 inches consistently within a 1/8th of an inch. Similarly, the unloaded length of the flex-hose remained consistently 31.8125 inches within a 1/16th of an inch margin of error as seen in Fig. 9. As a result of the negligible variation in the unloaded length, the flex-hose can be said to have not experienced inelastic yielding from both the static and shock loadings applied.

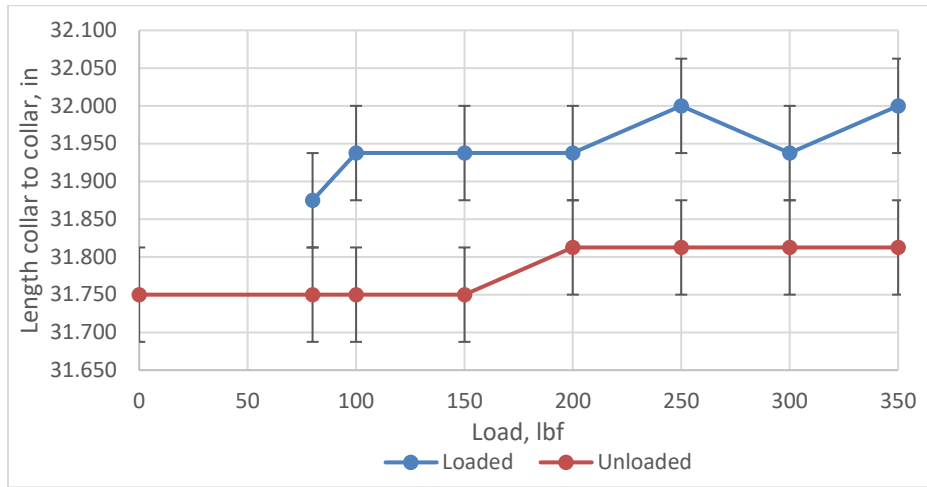
Two hoses have been successfully tested at the time of this report and one more test will be conducted once the third and final hose is received. The second EDU flex-hose was loaded according to the previously mentioned revised procedure and no relative slippage occurred at any stage of the test. Throughout the test, data was collected for both methods of measuring length, including unloaded and loaded lengths. This data is summarized in Table 3 below. Also, the recording of the unloaded and loaded lengths of the hose using the tape measure can be seen in Fig. 10. Using this measurement method, a maximum loaded length of 32 inches occurred both at 250 lbf and 350 lbf. As a result, the maximum elongation of the flex-hose was 0.0625 inches. Therefore, the recorded maximum loaded length of 32 inches is within the margin of error as seen in the 1/16th of an inch error bars in Fig. 10. In addition, the unloaded length of the hose did not change significantly during the test.

Figure 10. Length of second flex-hose using tape measure

The string is not easily adjusted once installed, therefore, the non-zero initial value is used as a baseline comparison. In addition, the fluctuation of the data in Table 3 is within the 1/16th of an inch margin of error for the tape measure method, as seen in the error bars in Fig. 10.

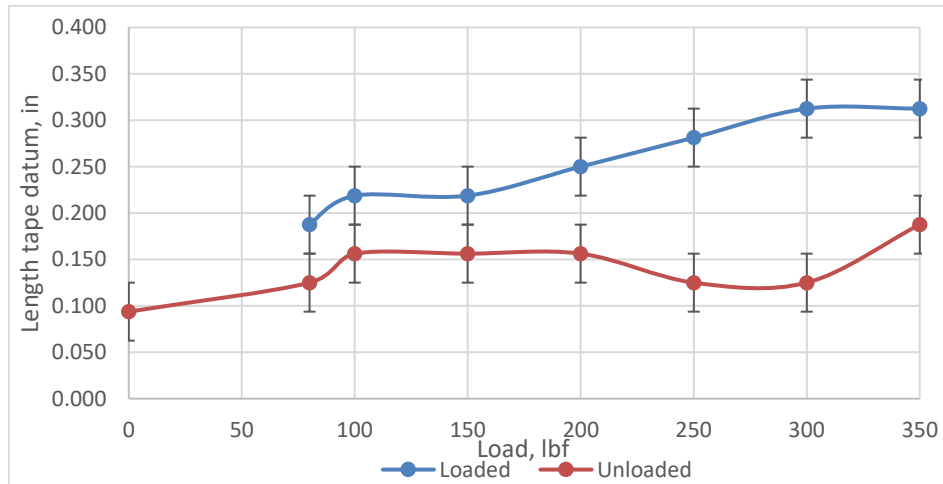
Furthermore, the tape datum measuring method showed a maximum unloaded elongation of 0.094 inches after a loading weight of 350 lbf. In comparison, a maximum loaded elongation of 0.219 inches was achieved with a load of 300 lbf. A graph of the tape datum measuring method data can be seen in Fig. 11. The margin of error in the tape datum measuring method can be seen in the 1/32nd of an inch error bars in Fig. 11.

Figure 11. Length of flex-hose using tape datum method

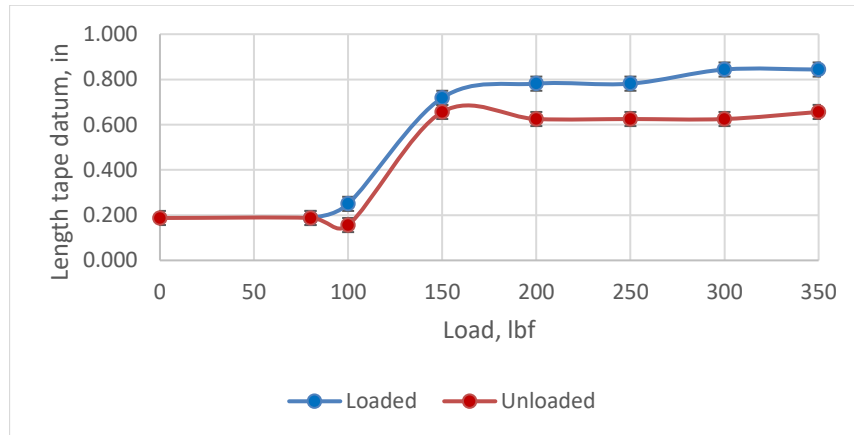
Figure 12. Length of first flex-hose during run 2 using datum measurements. Kellem slippage occurred and invalidated this datum measurement data.
