# Quick-replacement high-temperature superconducting current leads for use in a research cryostat

*NASA Goddard Space Flight Center*

Cryogenic Engineering Conference 2019

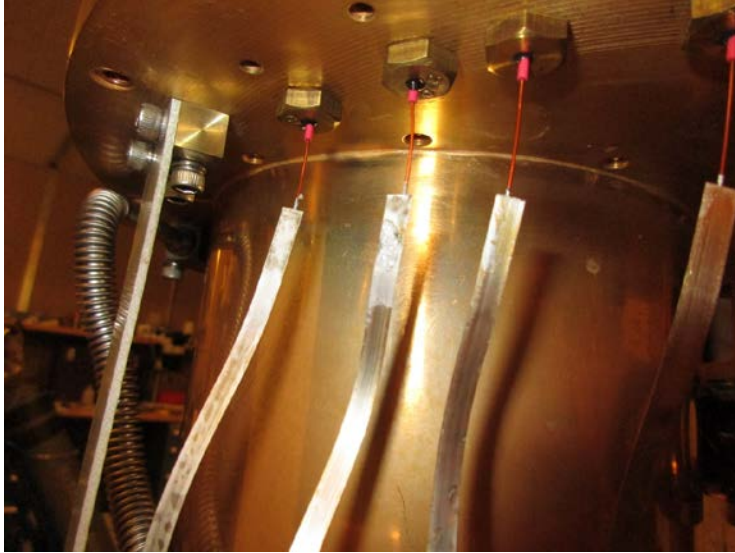
# How to attach HTS Leads?

- Solder directly to the HTS tapes
  - Concern damaging the superconducting layer rendering a section of the tape normal
  - Not simple to replace a tape that is damaged for some reason
- Clamp the tape to conducting blocks
  - Concern damaging the tape via some mechanical strain or cracking the superconducting layer
  - May be easy to replace a tape if needed.

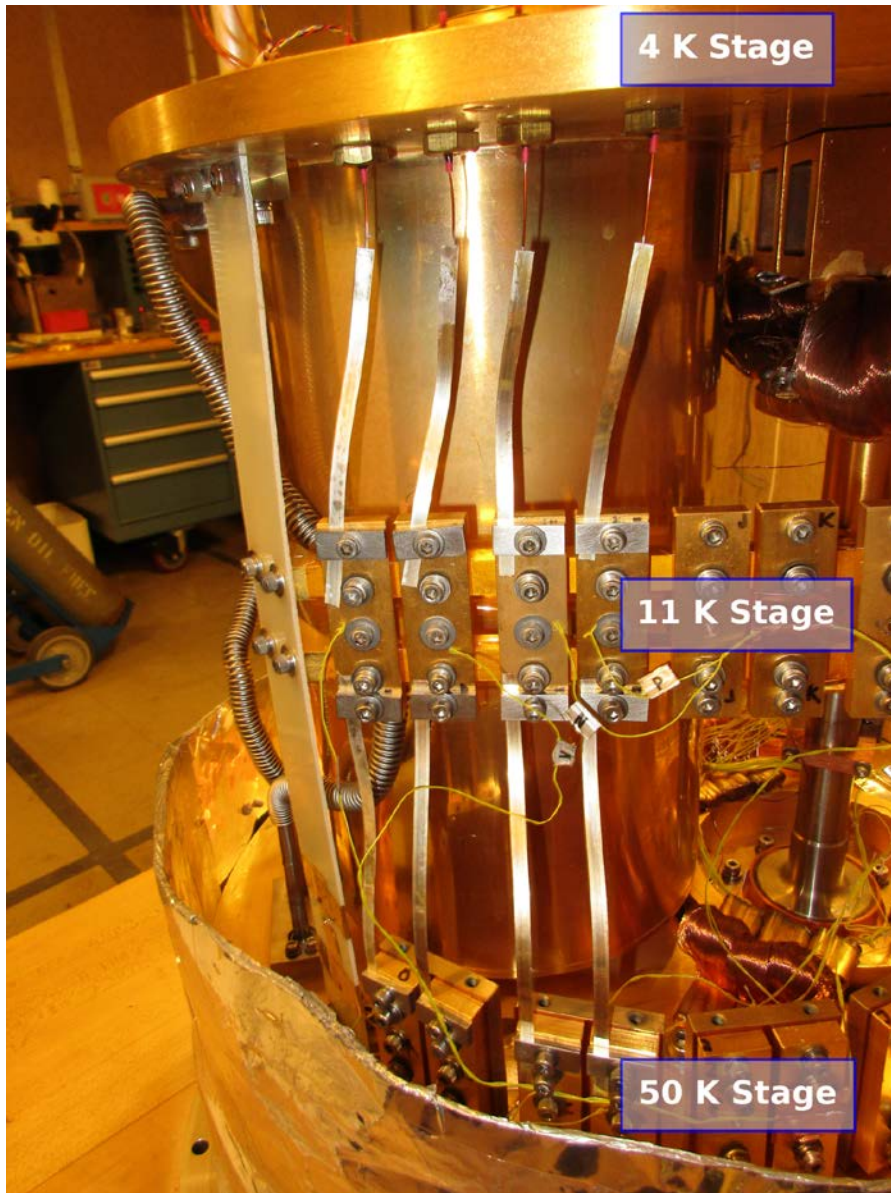
# First Attempt to Generate a Clamp Joint

- Older cryostat used a combination of solder joints and clamp joints
- Near 4 K, HTS tapes were soldered directly to LTS leads.
  - Often worked, sometimes not
- A mid-temperature stage installed so the tapes did not need to traverse a wide range in temperature
  - Required twice as many tapes cut
  - Blocks used to clamp the tapes had a portion relieved ( $\sim 1.5$  mm) to allow the tapes to be sit flush on the gold-coated contact blocks

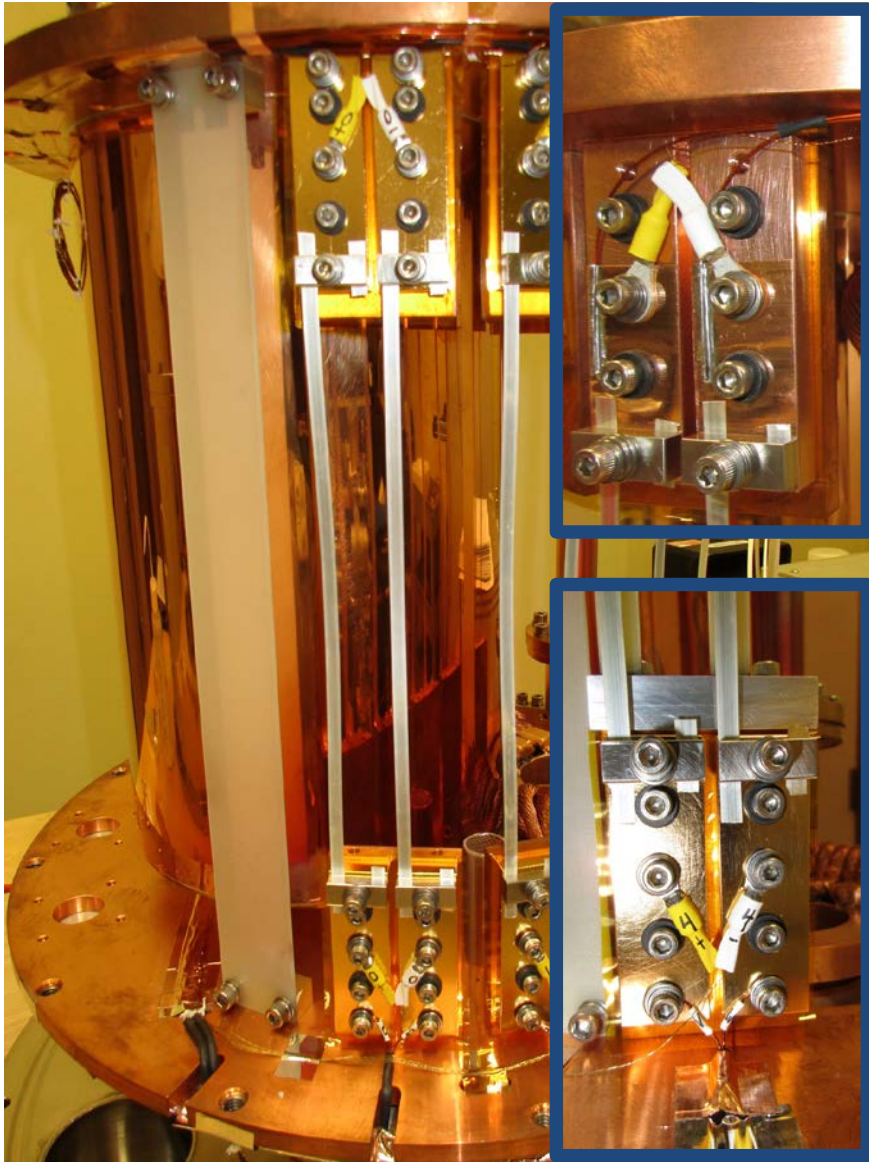
# Implementation in New Cryostat

In the new cryostat, it was decided to try spanning 50 to 3 K using a single tape per circuit leg

- Create clamp blocks with no relief cut
  - Use a short section of tape mirrored about the screw used to clamp block to allow even pressure across tape
- LTS leads attached to the 3 K plate current block via low-resistance solder joint
- Current leads from outside the Dewar terminate on the 50 K current block via a screw
- This worked great... *until it didn't*
  - $10 \mu\Omega$  or less resistance per clamped joint
  - Something caused the tapes to go normal -> no pattern to which tape would remain normal after a cooldown

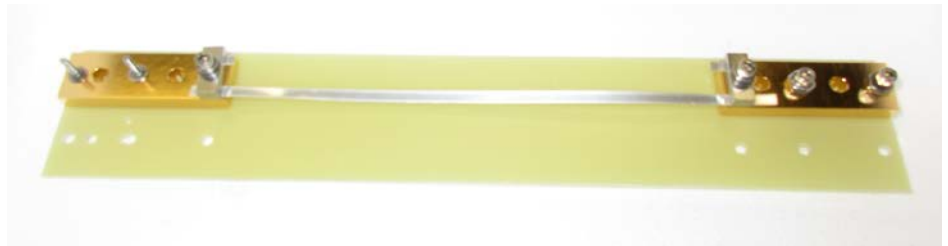
# Test of Individual Tape

There was a fear that a rapid pumpout of the Dewar flexed the HTS tapes and broke the YBCO layer

- Built a simple fixture to mount a HTS tape that appeared normal even though both ends were below 60 K
- Submerging the fixture with tape attached allowed a measurement of resistance
- *Tape proved to be intact and superconducting at 77 K*
  - *Fourth lead not shown in the image to the left. We constructed a probe that could touch the tape in various locations to identify where a break occurs if one exists*

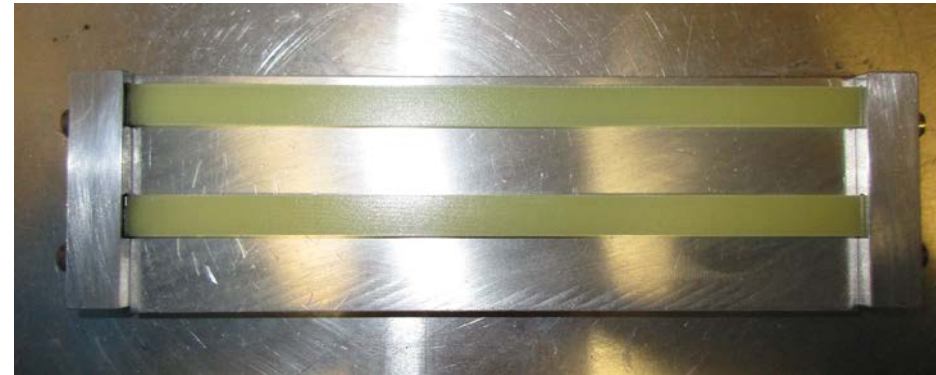
# Install Strongbacks Behind Tapes

Strongbacks made from G10 installed behind each tape

- Provide structural support
- Provide a “black” structure near tapes to absorb some 50 K radiation and higher temp radiation if it exists
- G10 slats epoxied into an aluminum block at the 50 K side and float in a slot on the 4 K side

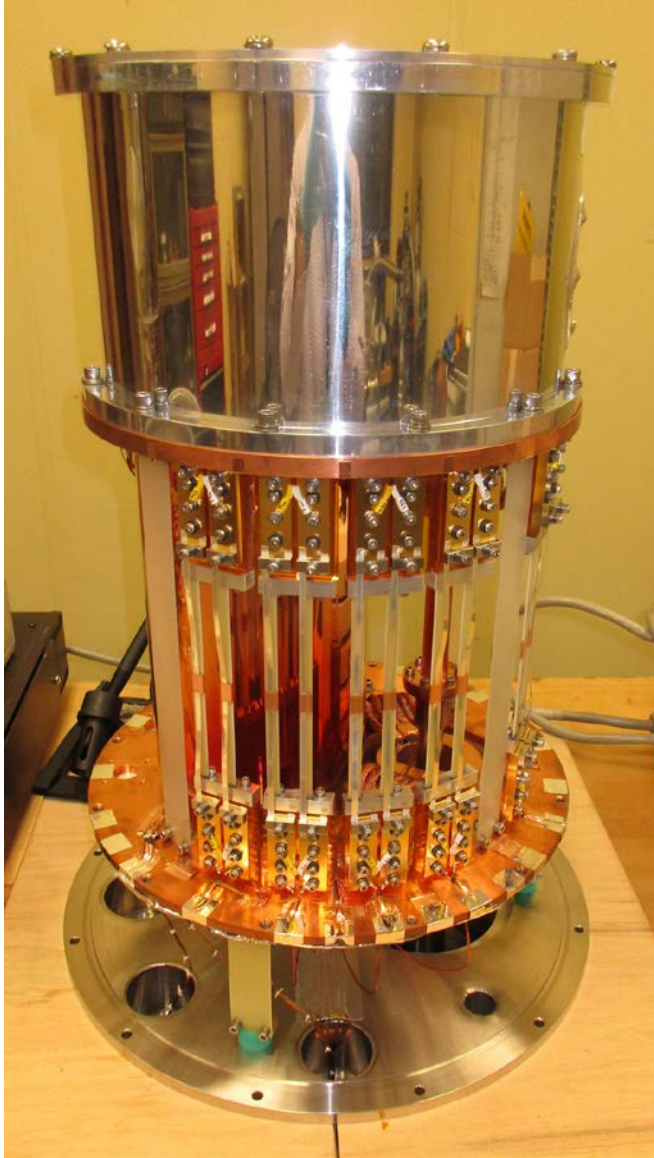
# Final Configuration and Conclusion

- Ten 4 mm-wide YBCO HTS Tapes installed in a Dewar to run a 4-Stage CADR
- Behind each tape is a strongback made form G10
  - Strongbacks epoxied on the 50 K end, allowed to float on the 4 K end
  - Copper tape adheres tapes to strongback half-way down the run; replaced the original idea of using lacing cord to anchor the tapes
- Ten HTS Tapes contribute 1.77 mW to 3 K plate (assumes the G10 does not make contact at 3 K)
- Since installed system run 8 times -> all 10 tapes performed as expected!
