Ultimate shear strength tests of full-sized prestressed concrete beams

Prestressed Concrete Bridge Members
Progress Report No. 28

Fritz Engineering Laboratory Report No. 223.28

December 1965

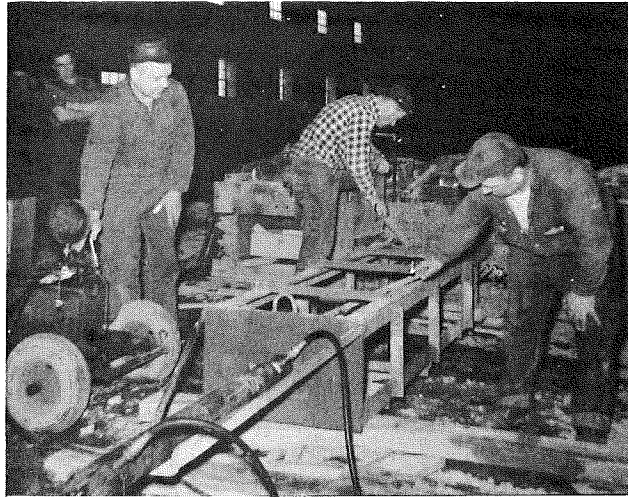
Fig. 8 Stressing of Individual Strands

one end of the bed. Each strand was individually stressed with a hydraulic jack at the opposite end of the bed. Figure 8 shows a general view of the stressing operation. The load was measured during jacking by means of a 50 kip Chatillon strand dynamometer connected in the linkage between the strand and the hydraulic jack.

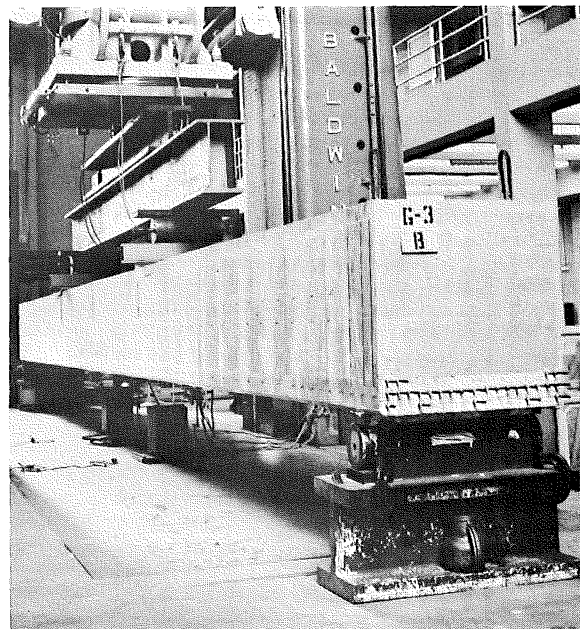
Fig. 13 Views of Beams Prior to Test

a. First Test on G-4

b. First Test on G-3

Figure 13a and b shows views of beams G-4 and G-3, respectively, prior to the first test. Figure 13c shows beam G-1 during the second test. Figure 13d shows beam G-4 during the third test. External reinforcement composed of 1-in. diameter rods and steel plates were used to reinforce the cracked shear span so that a test could be conducted on the other shear span.

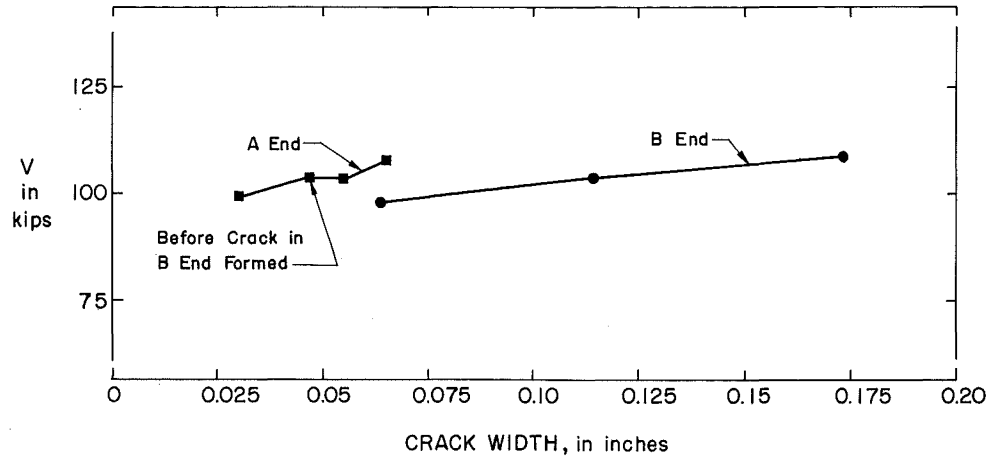
Fig. 17 Inclined Crack Widths in G-2 and G-4

a. First Test on G-2

b. Second Test on G-2

c. Second and Third Tests on G-4

The width of the widest crack in region A after the first test was 0.038-in. Figure 17b shows the increase in width of this crack during the second test. The last measurement of 0.106-in. was obtained at 98.4 percent of the load causing failure.

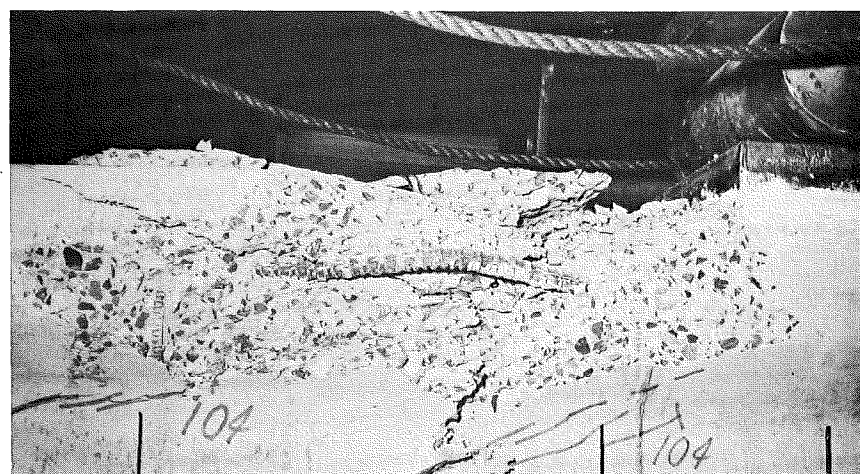
Fig. 19 Second Test on G-2

a. Condition of Region A at Start of Test

b. Region A after Failure

c. View of Failure Region

After the B end had been removed, G-2 was reset under the testing machine and examined. Cracks in the top fibers of region A, shown in Fig. 19, apparently developed concurrently with the failure, since these cracks were not observed during the first test. However, these cracks appeared to be completely closed. Strain readings at the level of the cgs indicated that the flexural cracks were almost completely closed and that the prestress force was fully effective in region A.

The beam held its maximum load for approximately 15 minutes before a slow flexural failure occurred at a shear of 118 kips. The failure was characterized by crushing of the concrete in the compression flange adjacent to the load point, as shown in Fig. 19b and 19c. However, the failure was influenced to some extent by shear, since the failure occurred above the top of an inclined crack in the shear span with the least amount of web reinforcement. Cracks parallel to the direction of the compressive stress were observed in the region in which crushing occurred prior to failure.

The slip measurements at the A end of the beam after the second test gave no indication of any strand slip, despite the extension of an inclined crack to within a few inches of the end of the beam, as shown in Fig. 19b.

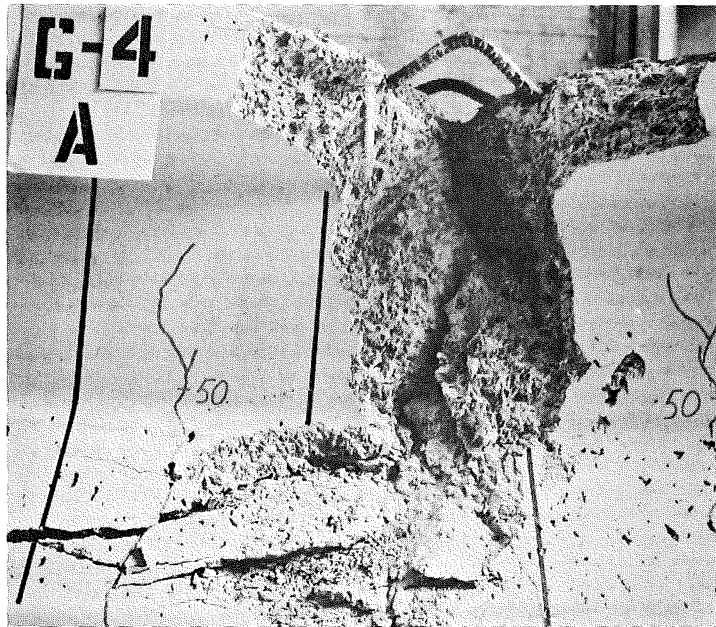
Fig. 20 First Test on G-4

a. During Loading Near Ultimate Capacity

b. View of Flexural Failure Region

c. Region B Near Load Point

d. Region A Near Load Point

Flexural cracking was first observed when the applied load shear was 34 kips and the deflection was 0.72-in. Figure 20a shows the beam when the shear was 62 kips, or 94 percent of the ultimate load. The deflection was approximately $4\frac{1}{2}$ -in. at this time. The beam failed in flexure, as shown in Fig. 20b, after it had held a shear of 66 kips for several minutes.

Inclined flexure shear cracking had developed from flexural cracks in both shear spans prior to failure, as shown in Fig. 20c and d. These flexure shear cracks had formed over distances approximately 1.7d from the load point. At no time did it appear that these cracks would cause failure, and additional cracking would probably have had to form further from the load point before shear would have been critical. Flexure shear crack widths of 0.032-in. and 0.027-in. were measured in regions A and B, respectively, while the load was held at 97 percent of the load causing failure. These widths were obtained using the targets in the web of the beam.

The flexural failure occurred almost exactly in the center of the beam. The two No. 6 bars used as reinforcement in the top flange buckled when the failure occurred, as shown in Fig. 20b. Spalling and cracking parallel to the direction of the compressive stress was observed prior to failure.

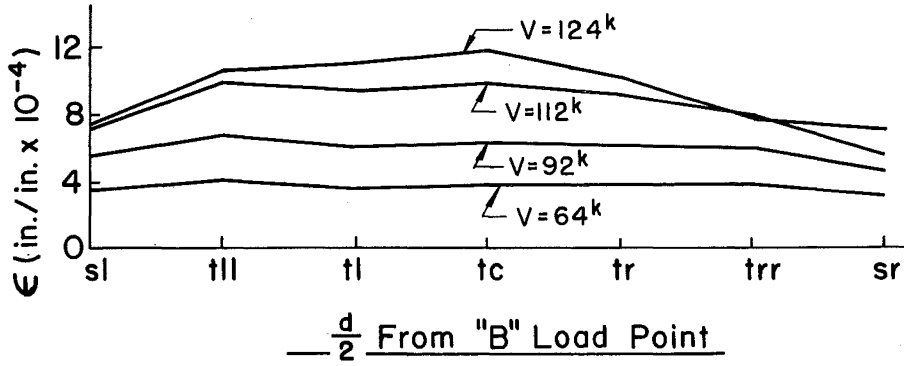
Fig. 24 Strain Measurements during the First Test on G-3

Gages Along Left Side of Top Flange

Gages Along Right Side of Top Flange

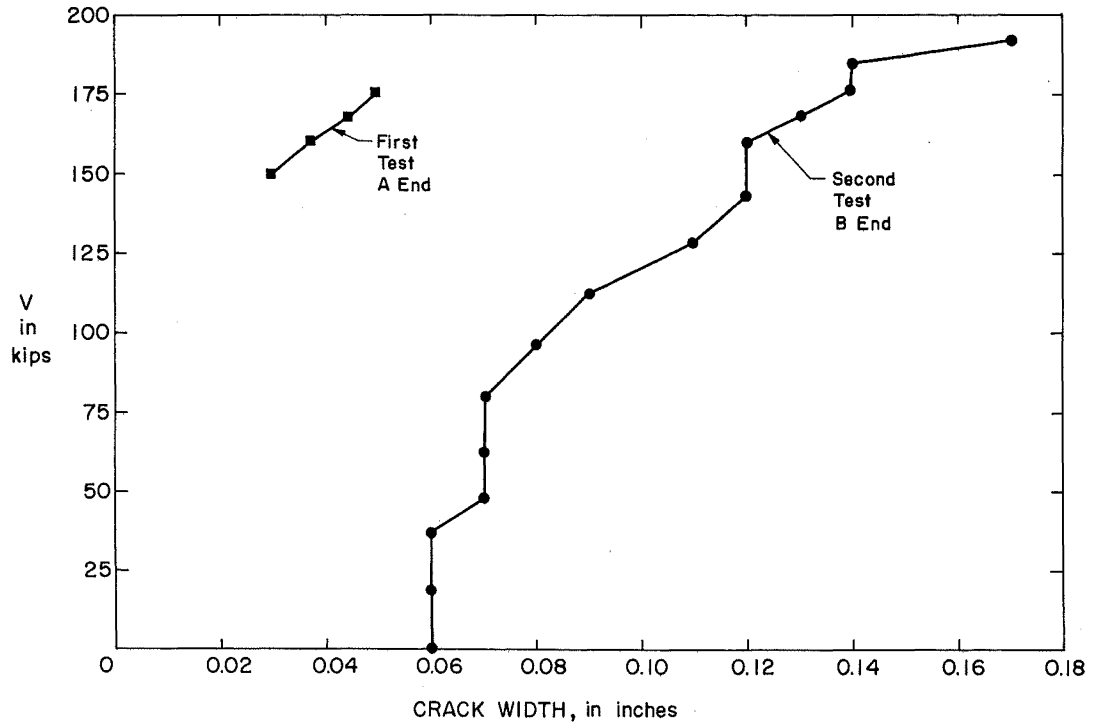
Fig. 25 Inclined Crack Widths in G-1 and G-3

a. First and Second Test on G-1

b. First Test on G-3
