TESTS OF LONG A440 STEEL BOLTED BUTT JOINTS

Fritz Engineering Laboratory Report No. 288.26

February 1965

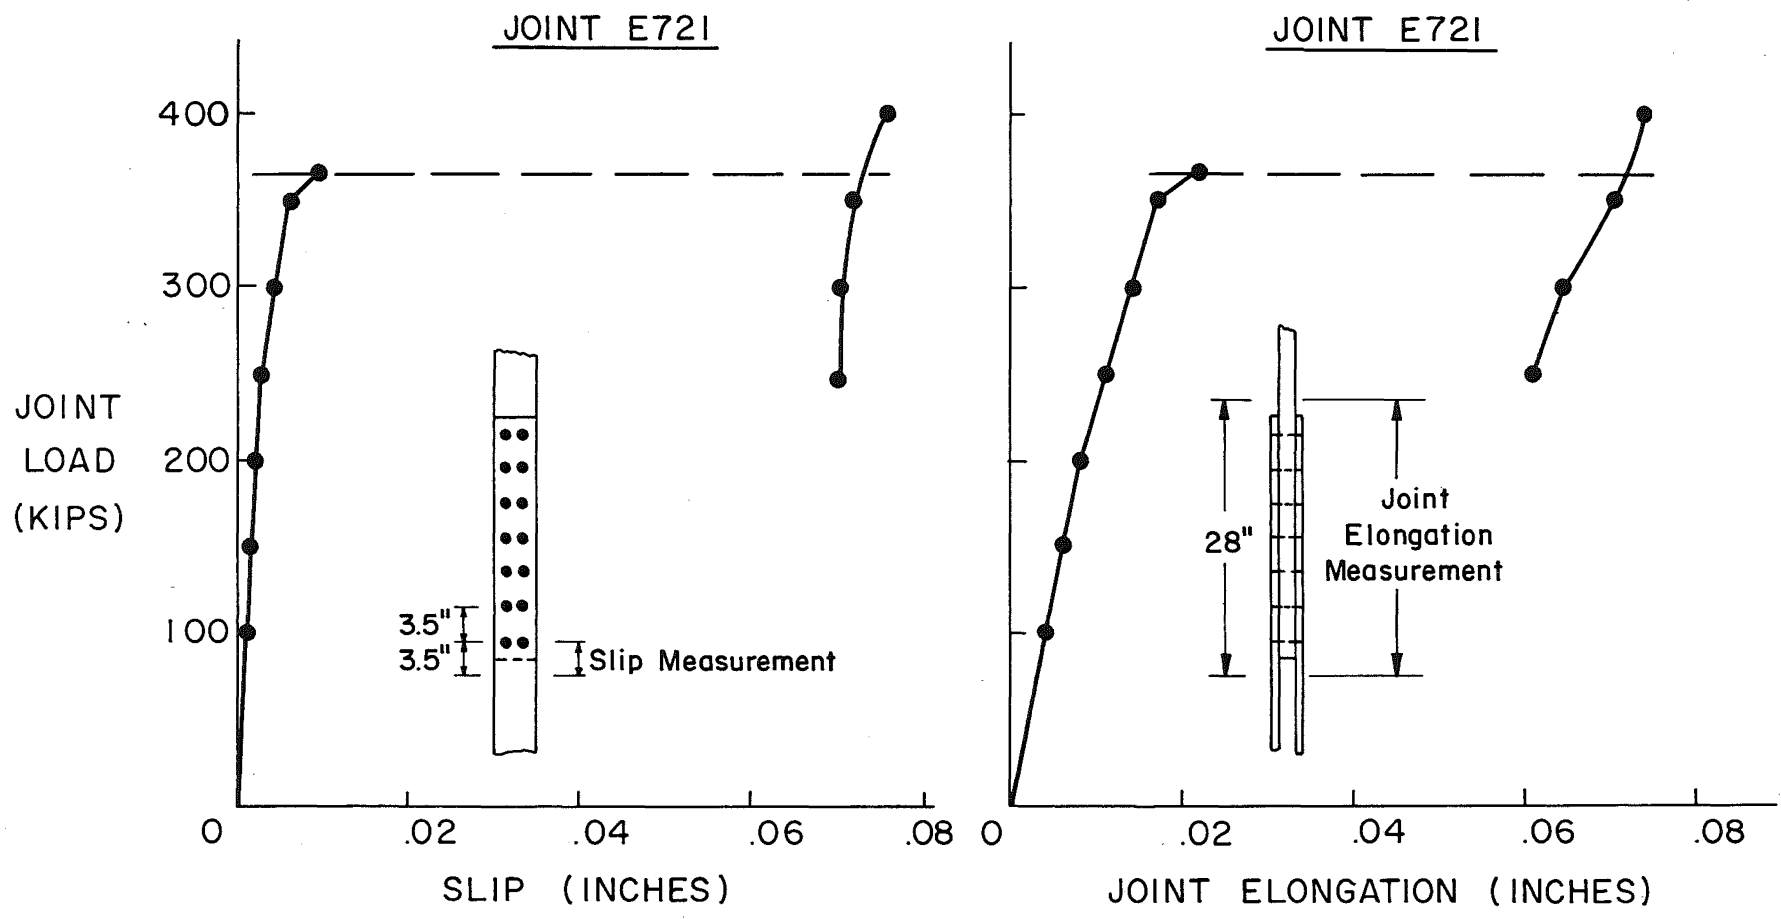
Figure 4. Pre-Slip Behavior of Joint E721

Joint E721, with an A_n/A_s ratio of 0.8, slipped into complete bearing under a load of 366 kips as is shown in Figures 1 and 4. This load corresponded to a slip coefficient of 0.28, and an average "bolt shear stress" at slip of 21.7 ksi. This joint reached an ultimate load of 1070 kips, which was 8 kips below the predicted load, and failed by unbuttoning of a bolt at the main plate end, as is shown in Figure 3a.

Figures 4, 6, and 7 show that the slip dials recorded deformations as soon as load was applied to the member. Part of this deformation was caused by elastic elongations in the 3.5 inch gage measurement length. It is apparent from these plots that the measured slip deformations deviated from linearity long before major slip was reached. That is, there was differential movement between the main and lap plate at the joint ends under relatively low loads. Analytical and experimental studies⁽⁵⁾ have shown that relative displacements of contact surfaces at the ends of a butt joint should occur before major slip. As the joint load is increased from zero this displacement between discrete contact points proceeds inward from the joint ends as the shear stress on the faying surface exceeds the slip resistance. When the maximum static frictional resistance is reached over the entire faying surface major slip occurs.

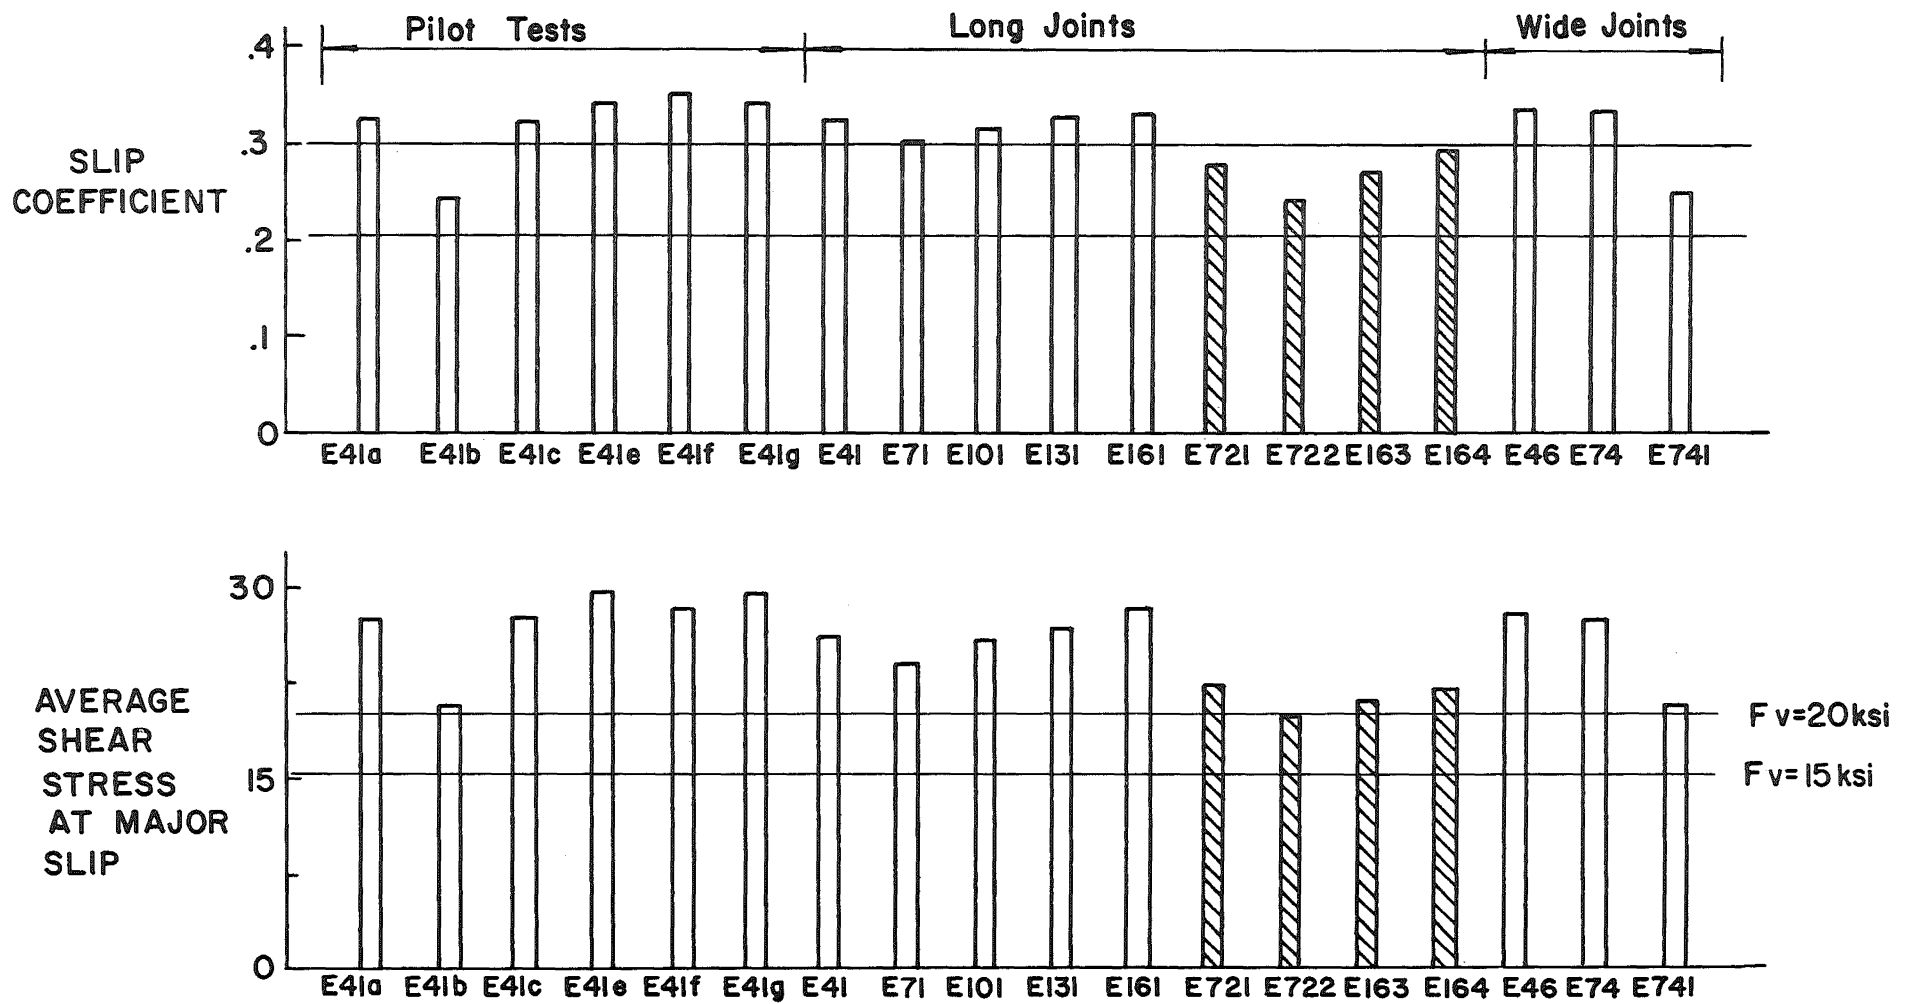
Figure 10. Slip Resistance of Bolted Joints

Figure 10 shows a bar graph of the slip coefficients attained in these four tests and in the previous tests of similar joints⁽¹⁾. The slip coefficients ranged from 0.24 to 0.29 for the four tests under discussion. This was slightly below the average value attained in the previous work⁽¹⁾.

Also shown is the average "bolt shear stress" at the major slip load for these four joints. All of these tests indicated a slip resistance above the currently specified value of 15 ksi for static loading. Most of the tests gave a slip resistance above the 20 ksi specified⁽⁷⁾ for static and wind loading.
