Paper presented to the 47th Annual
Meeting of the Highway Research Board,
National Research Council,
Washington, D. C.

FATIGUE BEHAVIOR
OF CONTINUOUS COMPOSITE BEAMS

J. Hartley Daniels, Assistant Professor of Civil Engineering,
and John W. Fisher, Associate Professor of Civil Engineering,
Fritz Engineering Laboratory, Lehigh University, Bethlehem,
Pennsylvania

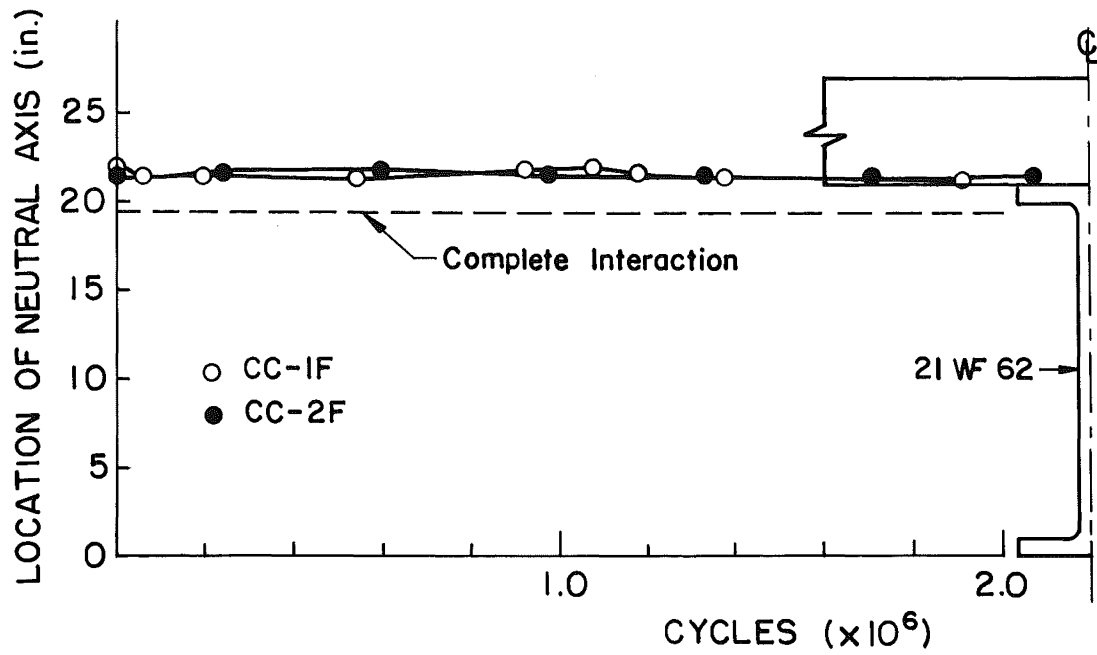
Fig. 9 Location of the Neutral Axis in the Positive Moment Regions

Figure 9a compares the location of the neutral axis as a function of applied cycles for typical sections in the positive moment regions of beams CC-1F and CC-2F. Figure 9b makes a similar comparison for beams CC-3S and CC-4S. It can be observed that the number of applications of load had only a small effect on the flexural behavior in the positive moment regions of all four beams.

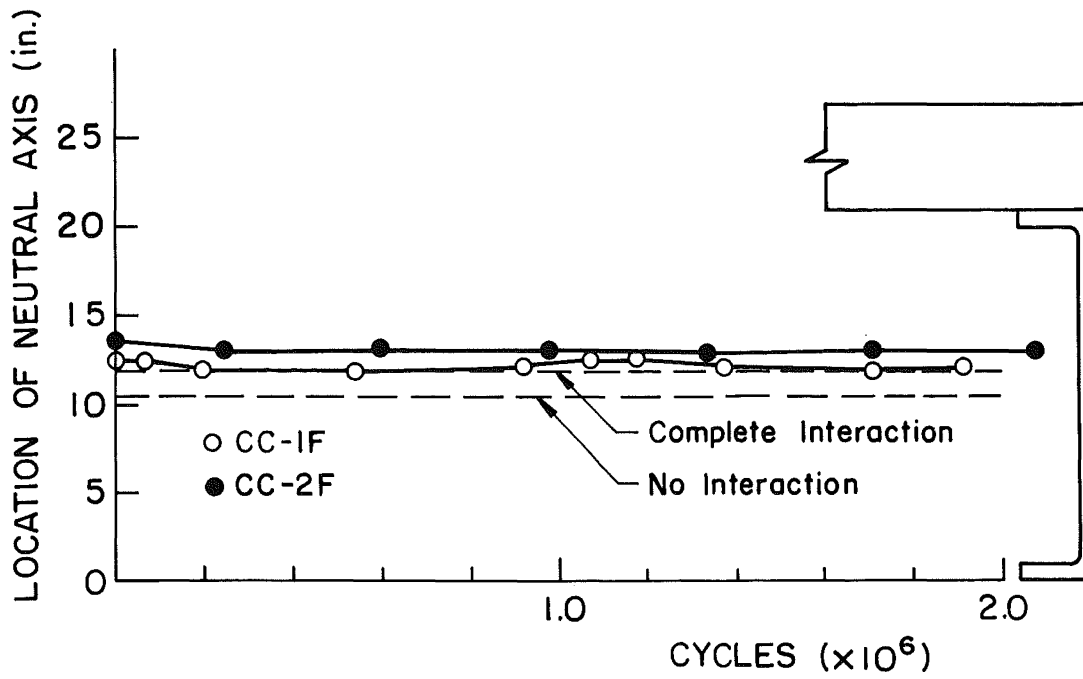
Fig. 10 Location of the Neutral Axis in the Negative Moment Regions

Figure 10 shows the location of the neutral axis as a function of the applied cycles for typical sections in the negative moment regions. It is apparent from the figure that the slab had cracked in all four beams under the initial application of load and that additional applications of load had only a small effect on the stresses in the steel beams.

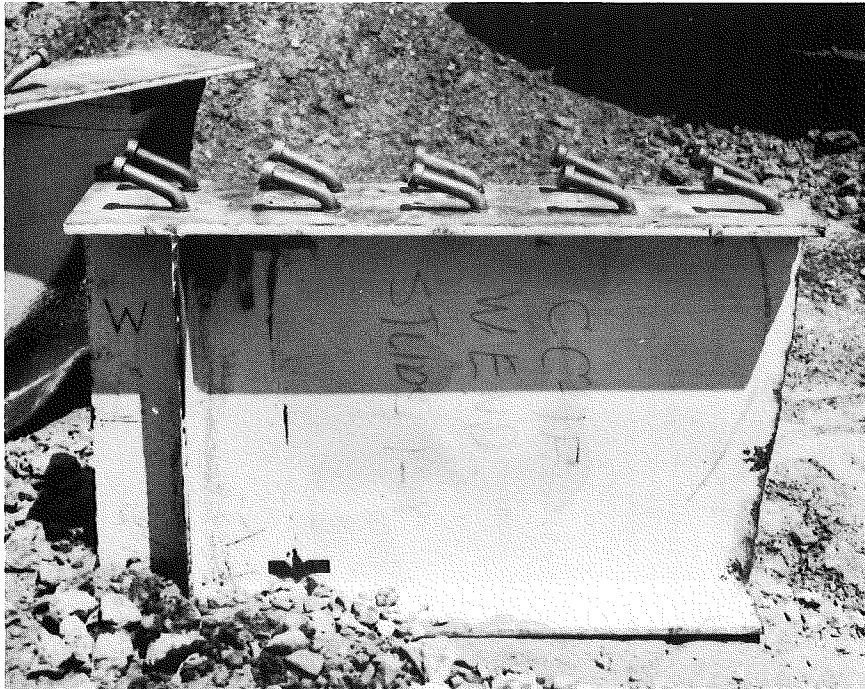
Fig. 13 Studs at the End of Beam CC-1F After Fatigue Testing

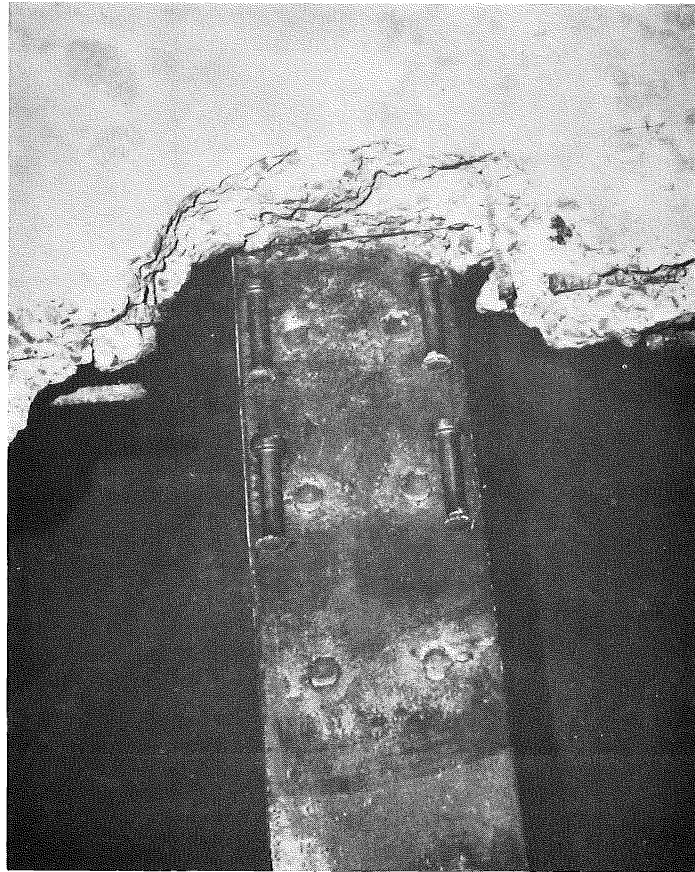
Fig. 15 Studs at the East Inflection Point of Beam CC-1F
After Fatigue Testing

point passes through the two circular craters at the bottom of the photo which were left by the failure of studs 15 (left) and 16 (right). These studs remained imbedded in the portion of concrete slab which was removed. Studs 17 and 19 (left) and 18 and 20 (right) are shown beside their former positions after they were removed by hand. Since these studs were nearly completely fractured from the beam after the slab was removed, it is probable that the high strain readings observed at the end of the test were caused by the dowelling of the failed stud in the rather deep crater that was taken from the beam flange. A typical view of the fracture surface of one of these studs is shown in Fig. 16. The fatigue fracture surfaces can easily be seen.
