Manual for inspecting bridges for fatigue damage conditions, January 1990, 174p. (Final report)

Project 85-02: State-of-the-Art for Inspecting
Bridges for Fatigue Damage Condition

Manual For Inspecting Bridges For Fatigue Damage Conditions

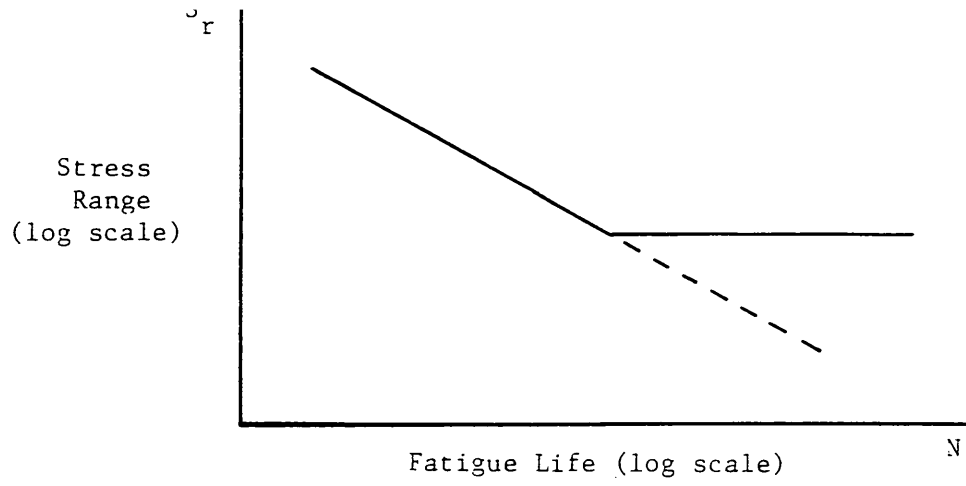
Fig. 1.1 Typical Fatigue Strength Curve

The fatigue characteristic of a structural detail is most commonly represented by an S-N curve, which depicts the relationship between the magnitude of stress range, S_R , and the number, N , of applications of this stress range causing fatigue failure (Fig. 1.1). Except for very low magnitudes of stress range, the fatigue life is inversely related to the stress range. Stress cycles of very low magnitude may be repeated indefinitely without causing fatigue. The limiting stress range which does not cause fatigue cracking is called the fatigue limit.

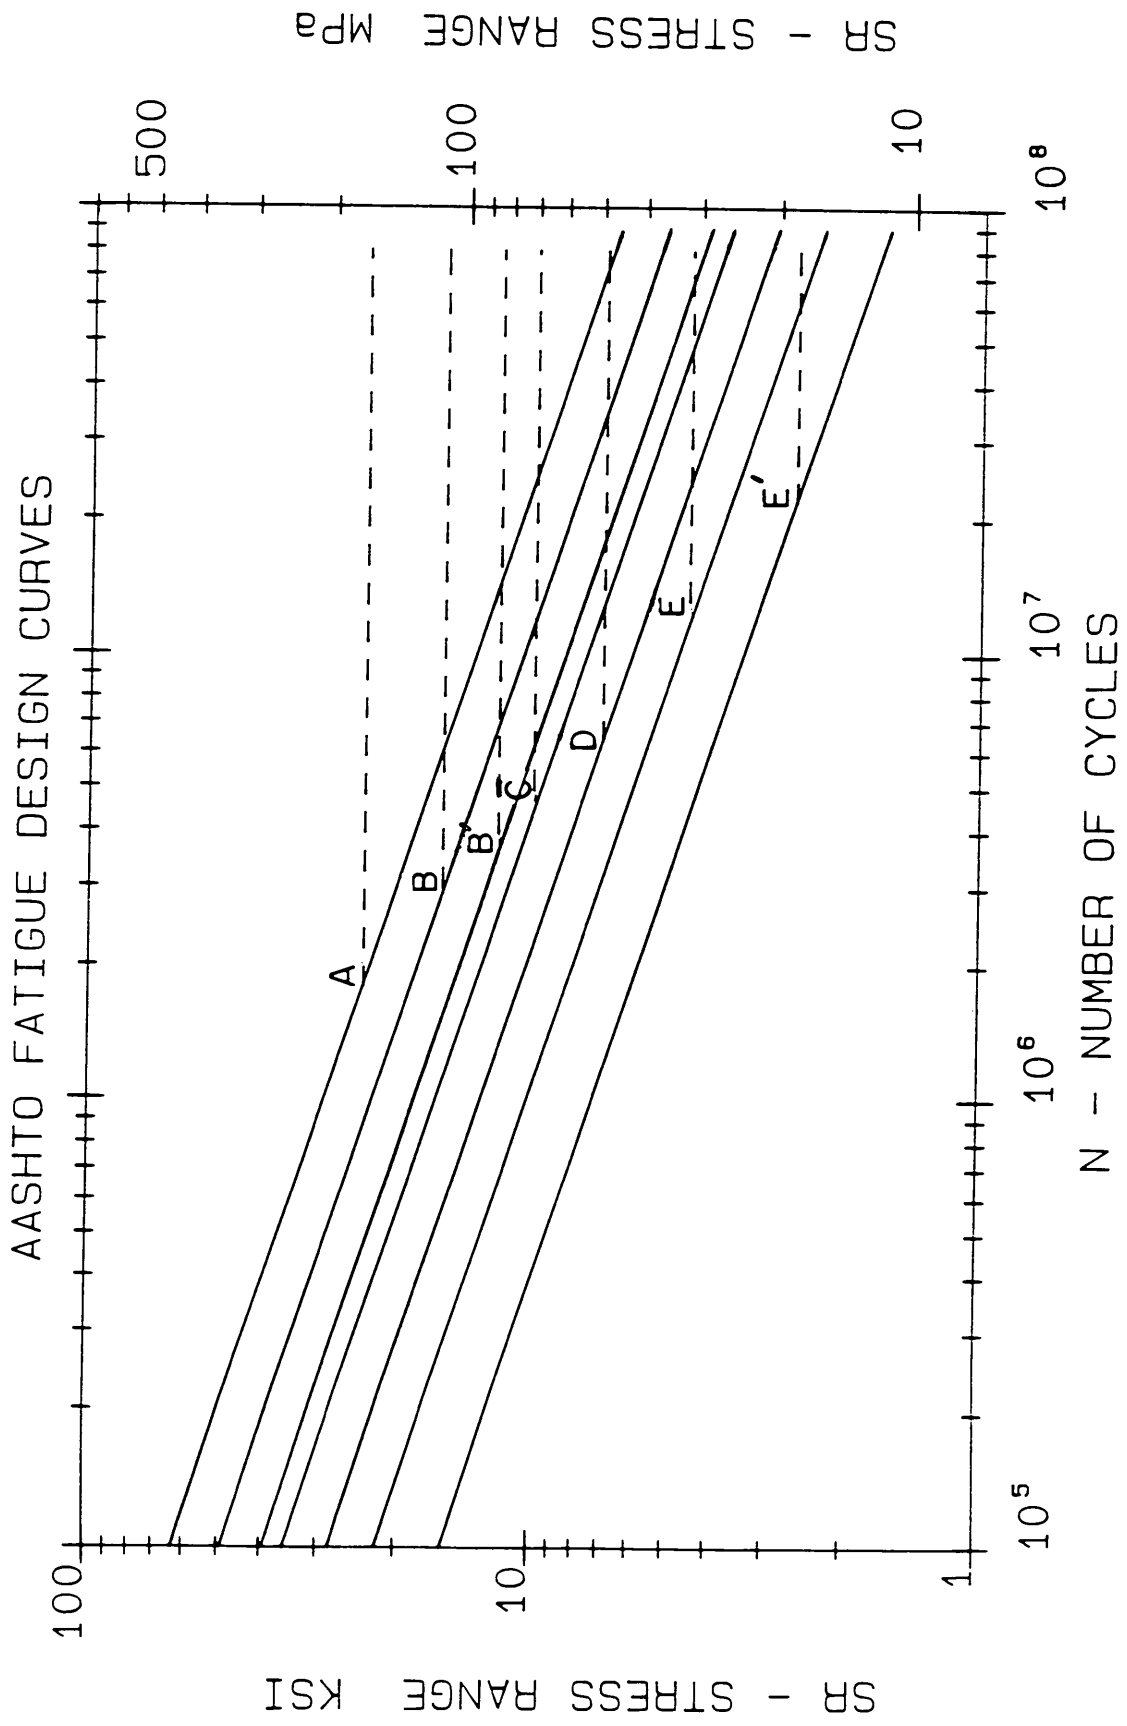
Fig. 2.1 AASHTO Allowable Fatigue Stress Ranges - Redundant Load Path

Schematics of bridge and structural details and the fatigue strength categories are sketched in Figs. 2.2 to 2.45. These details are presented in descending order of the fatigue strength, from Category A to categories E and E'. In all sketches, the locations of potential fatigue cracks are indicated by the positions of the arrows, which show the direction of the controlling tensile stresses. Fatigue cracks generally propagate perpendicular to the stress arrows.

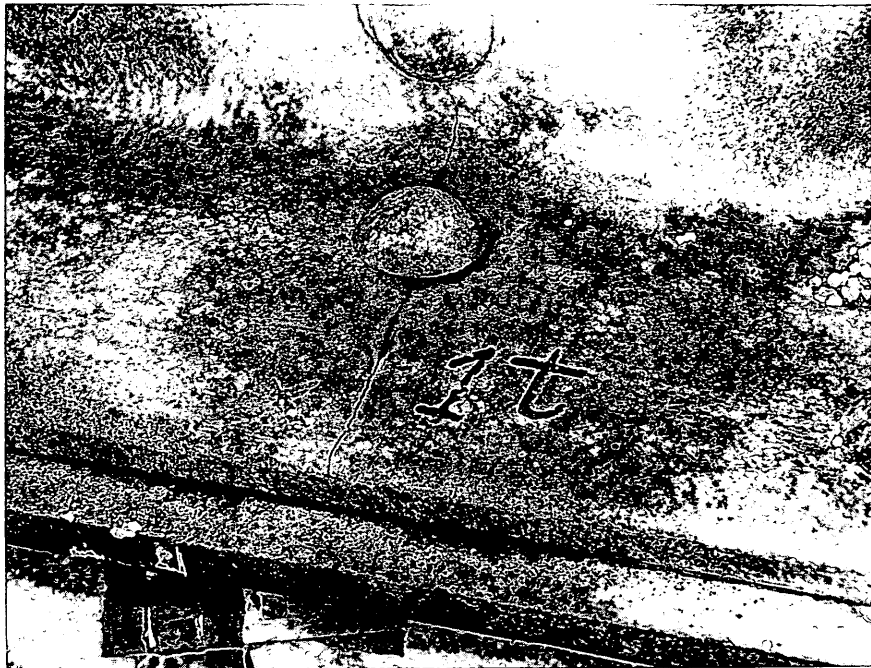
Fig. 3.4. Oxide Particles at Rivet

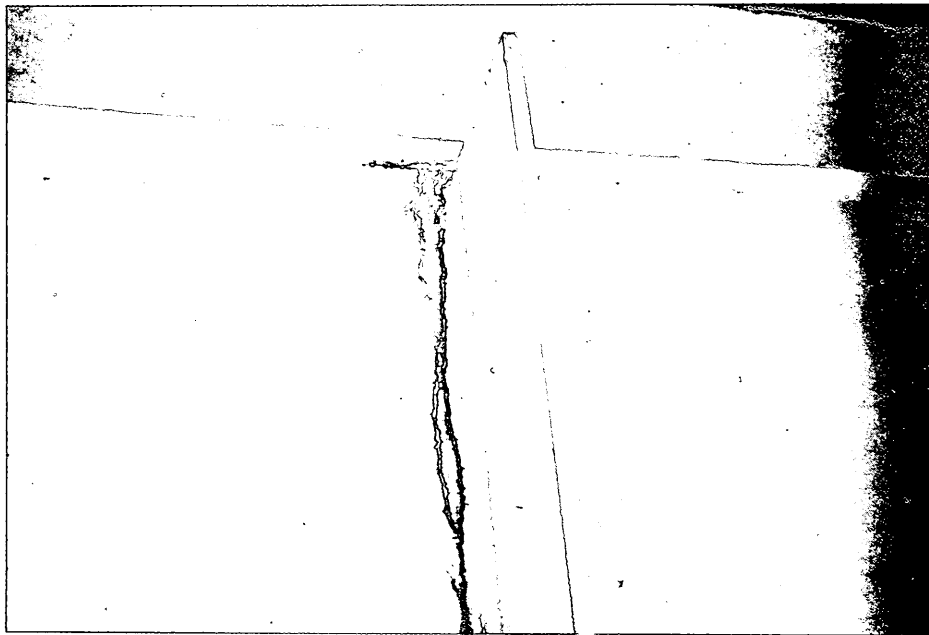
Fig. 3.5. "Bleeding" at Crack

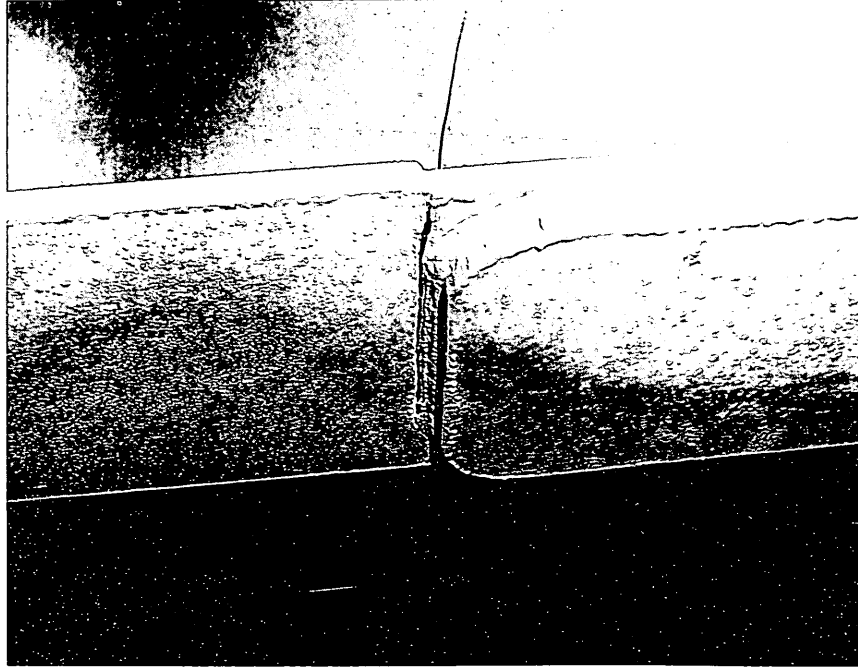
Fig. 4.1 Cracked Flange at Cover Plate

At the ends of cover plates without an end weld, the fatigue crack will develop in the flange plate at the ends of the longitudinal fillet welds. This and other cracks at various end conditions of welded cover plates are shown schematically in Fig. 4.4. Results of studies have shown that the differences of fatigue strength among these end conditions are minor⁽³⁾⁽¹⁸⁾ unless the cover plate is wider than the flange and has no end weld (Category E'). Another important influencing factor is the flange thickness: flange plates thicker than 0.8 in. have category E' fatigue strength.

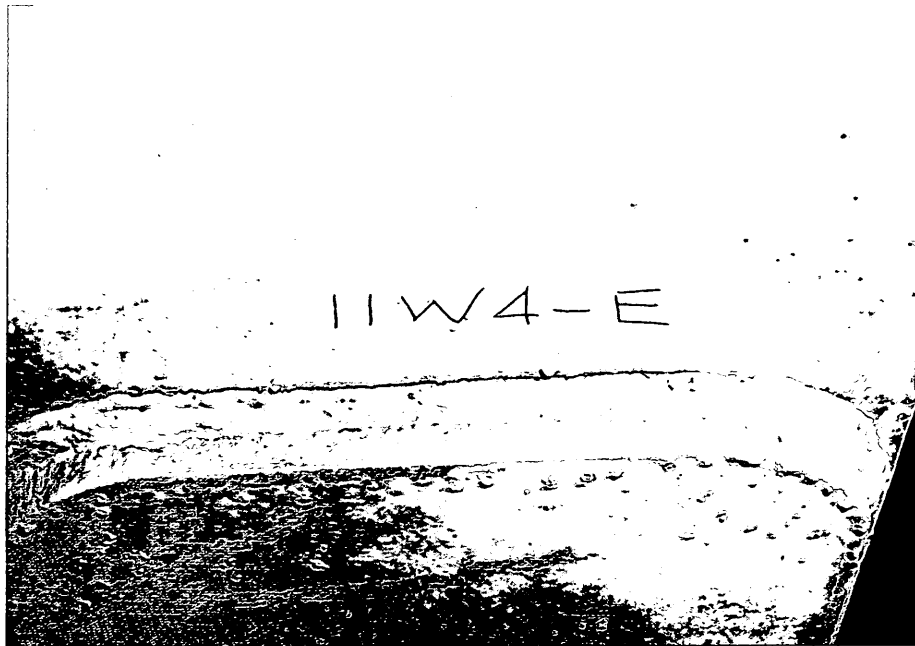
Fig. 4.3 Crack at Welded end of Cover Plate

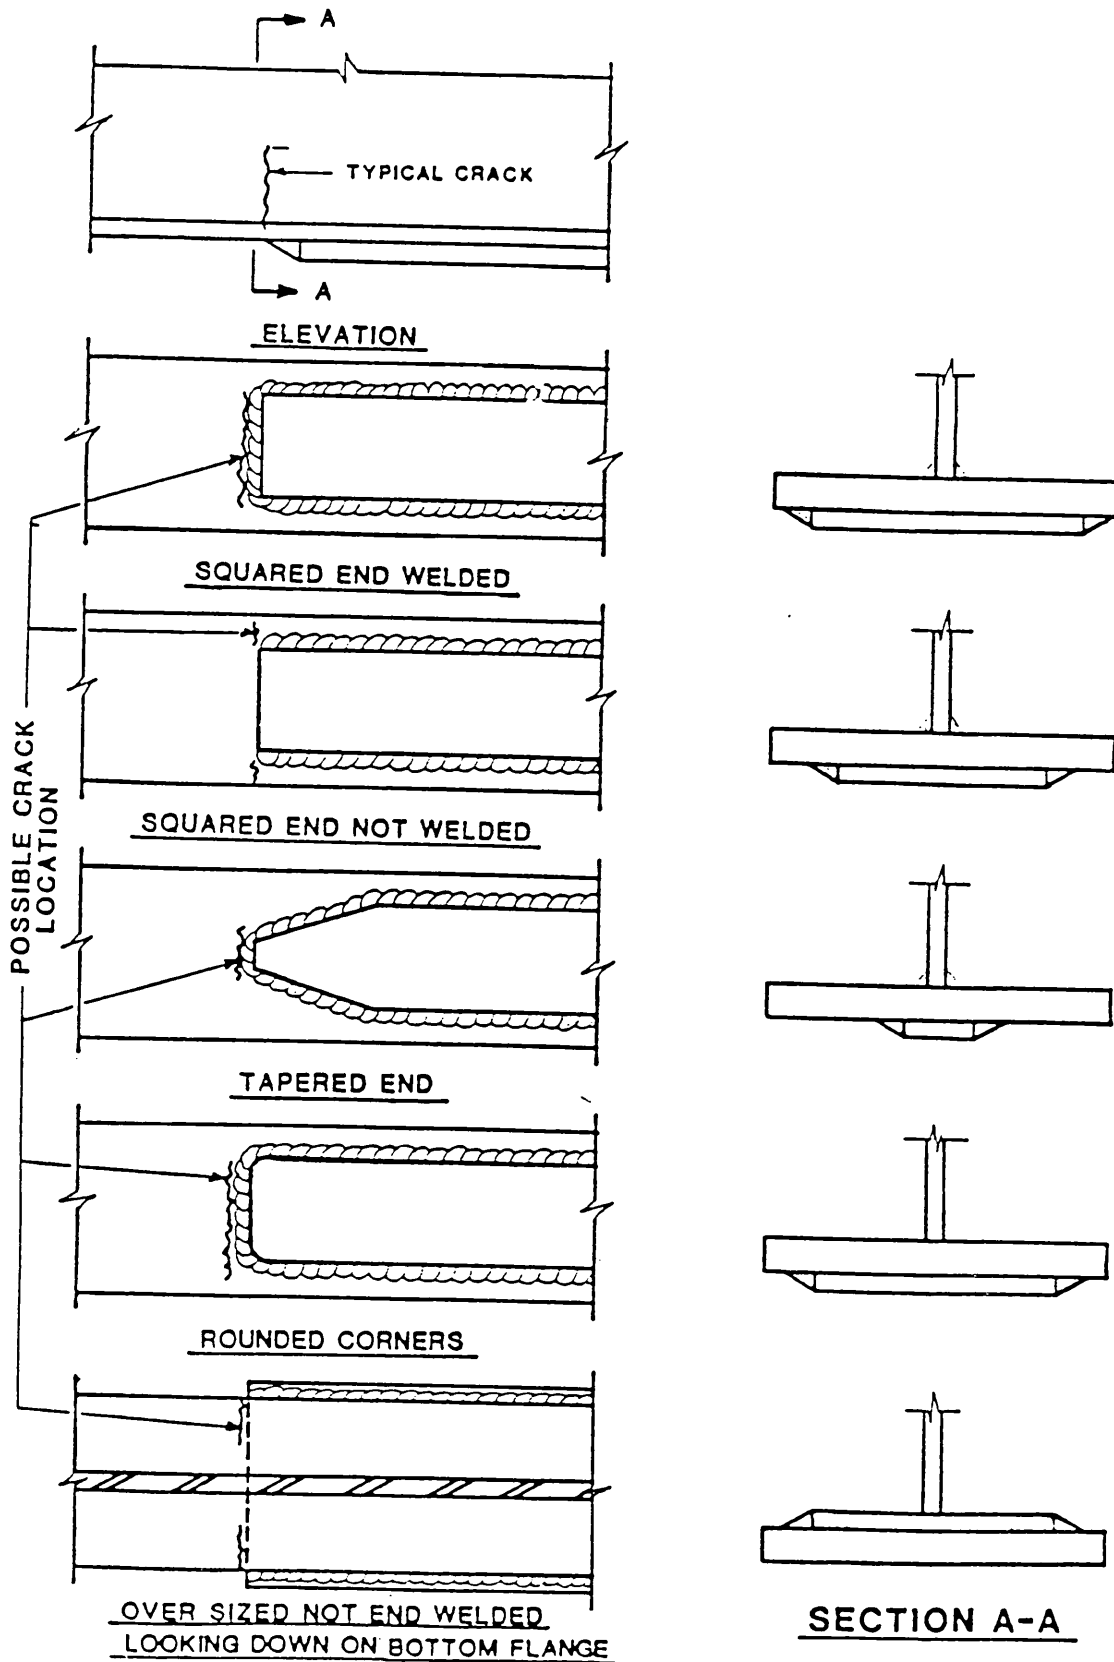
Fig. 4.4 Crack at Ends of Welded Cover Plates - Schematic

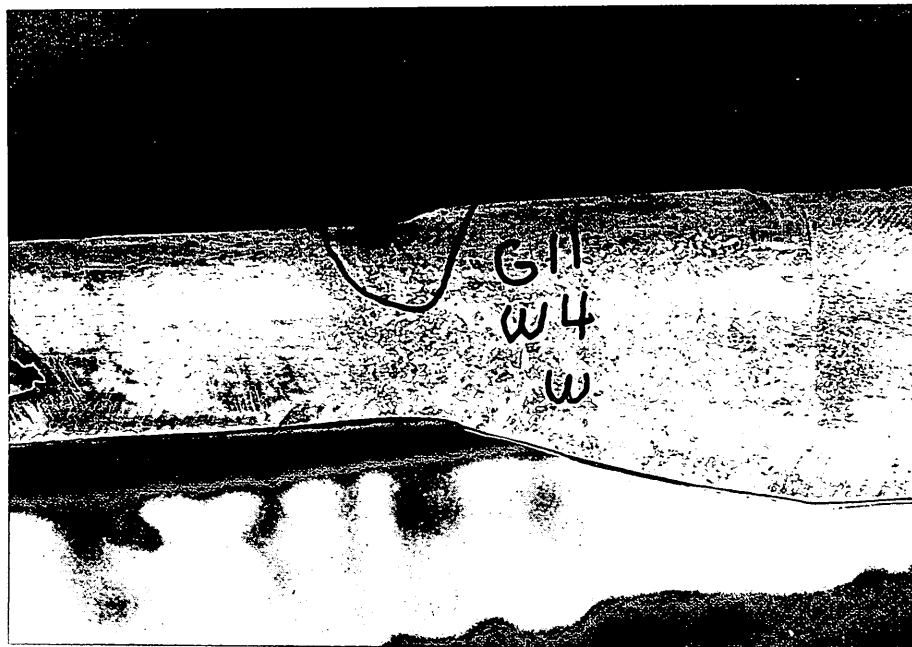
Fig. 4.5 Crack at Electroslag Groove Weld of Flange

Groove welded splices in tension flanges made prior to the early 1970's or by the electroslag weld procedure should be inspected very carefully. The consequence of fatigue crack growth and fracture of a tension flange could be serious, and dictates careful inspection.

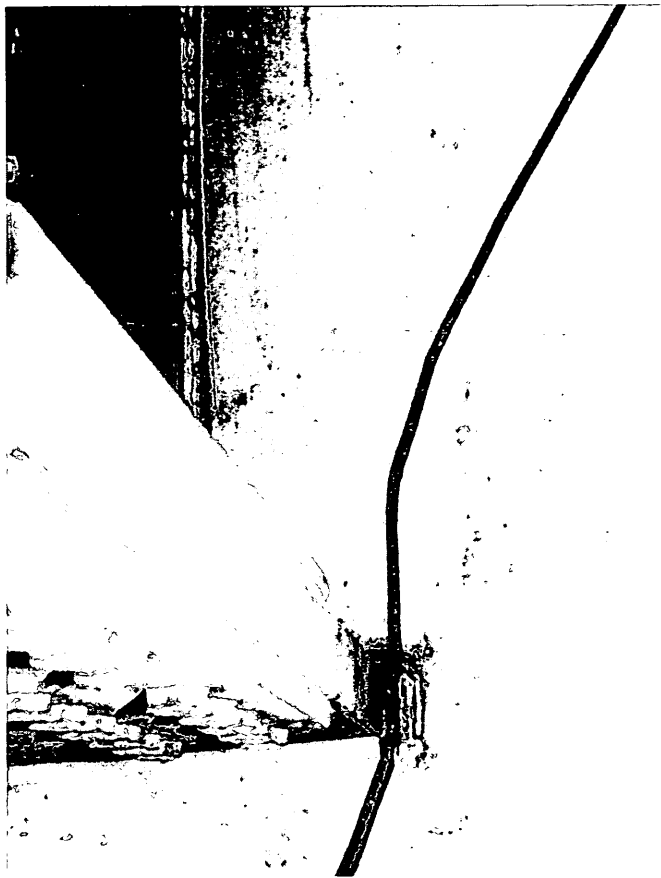
Fig. 4.8 Crack in Box Girder Web at Penetrating Flange Splice Plate

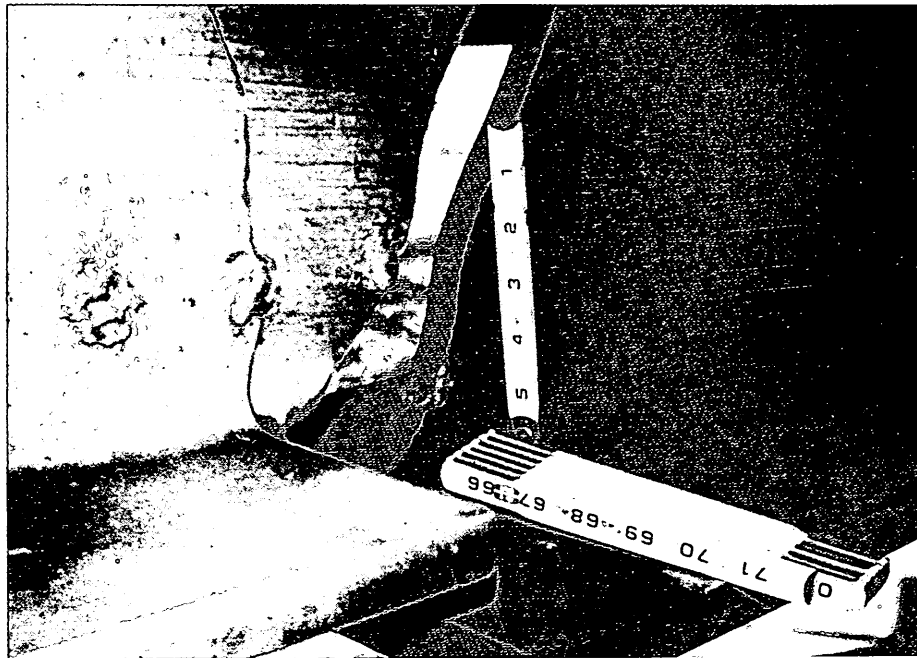
(a) Schematic showing location of misplaced holes.

Fig. 4.13 Crack forming at Weld-Filled Holes

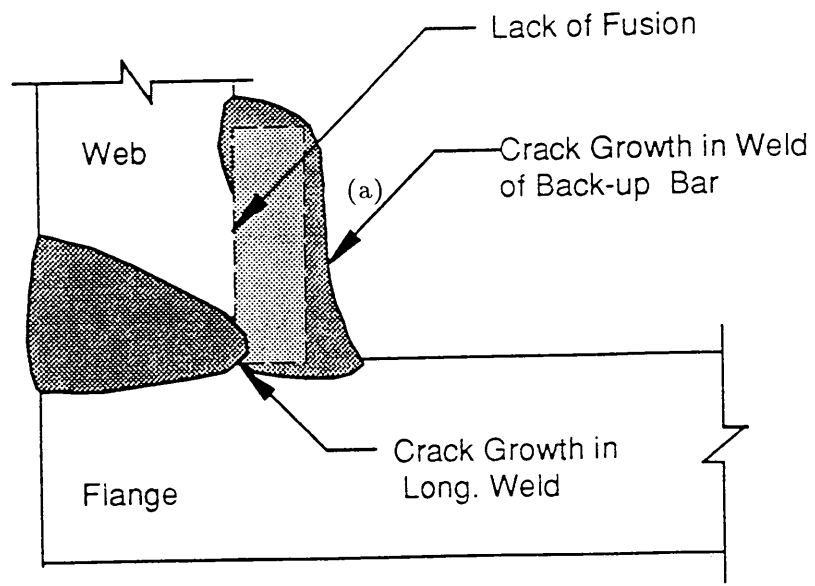
Fig. 4.14 Cracks Originating from Back-Up Bars

Backup bars for full penetration welds between webs and flanges of box girders are usually left in place after fabrication. These backup bars are continuous in the direction of the box girder and sustain the same magnitude of strain as the web to flange junction. Figure 4.14a shows a schematic of the arrangement.

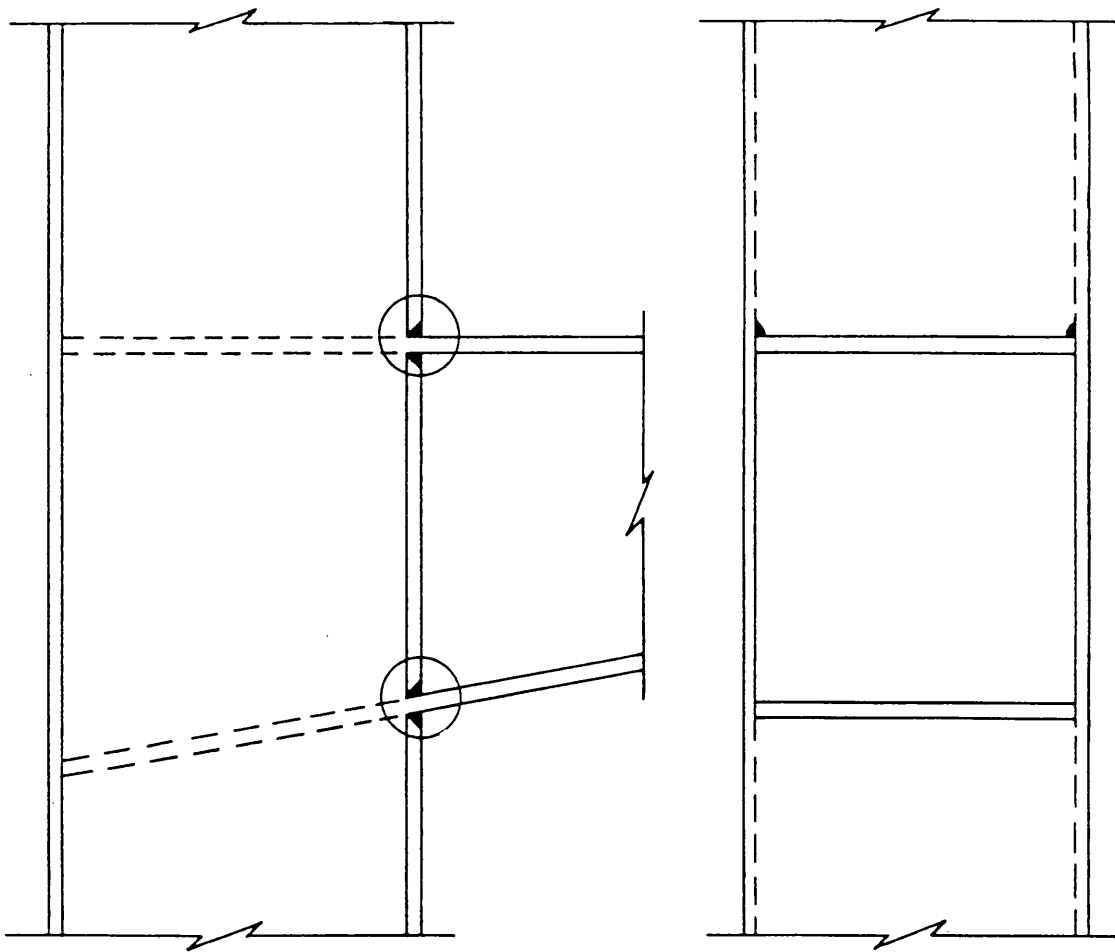
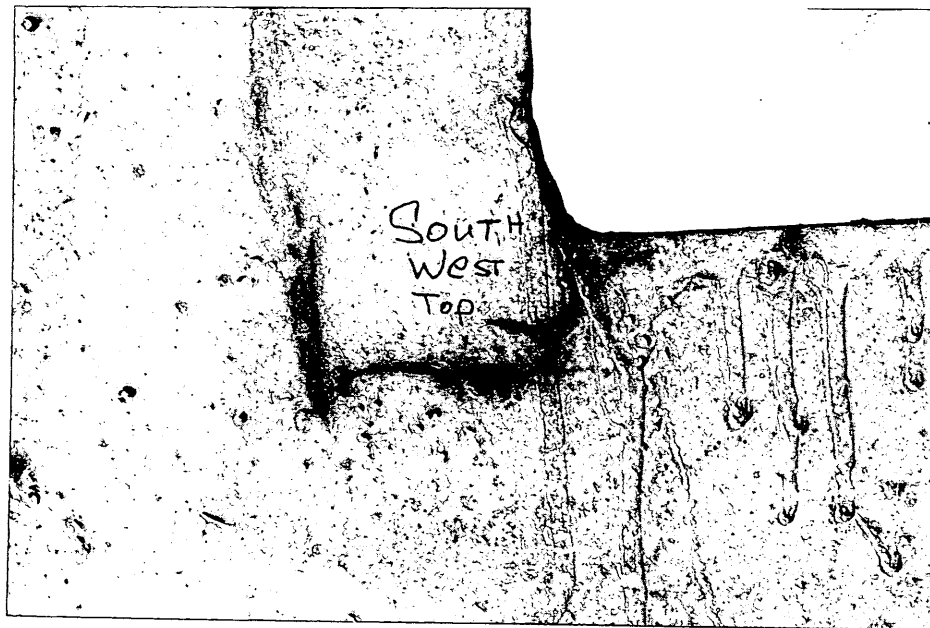
Fig. 4.18 Cracking at Cross Beam to Column Connections

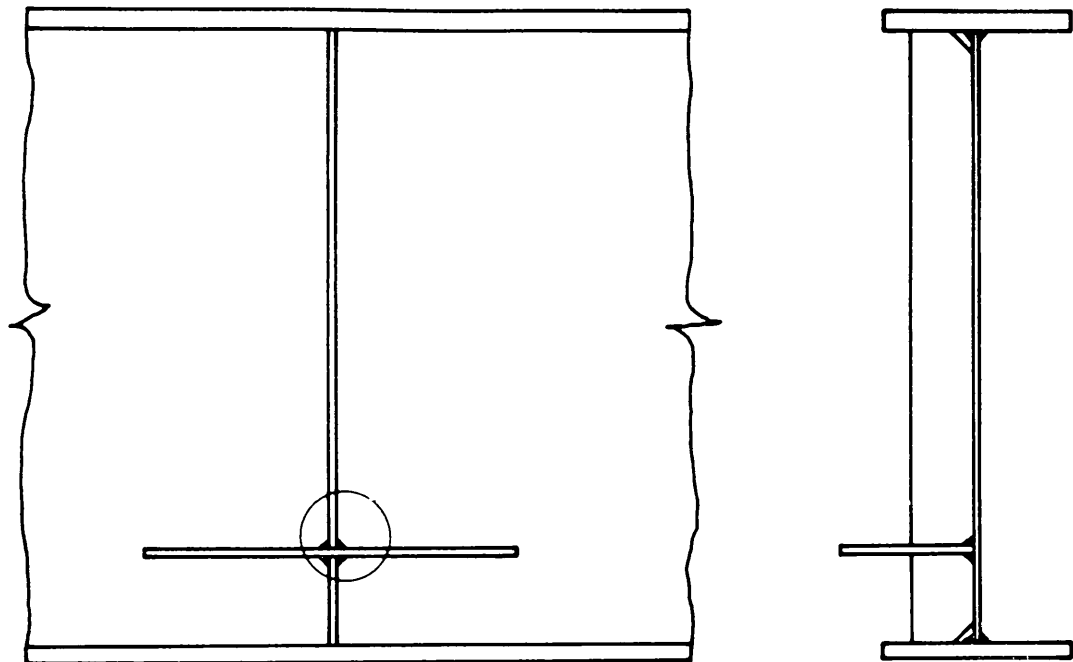
Fig. 4.21 Intersecting Welds at Gusset-Stiffener-Web Intersection-Schematic

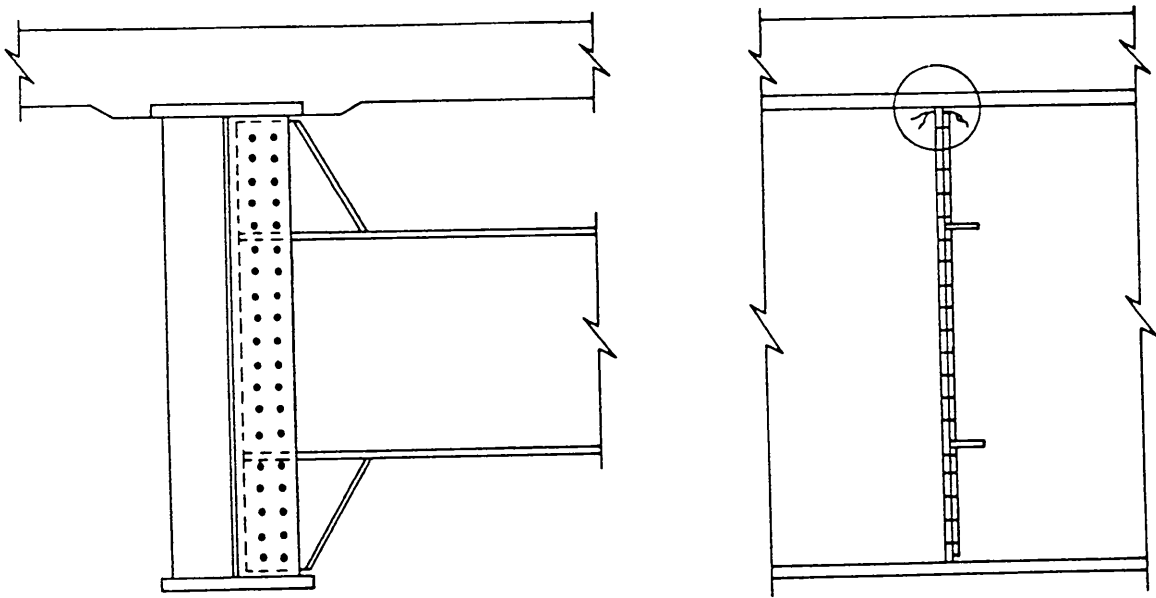
Fig. 4.23 Crack in Girder Web at Floor Beam Bracket
Connection-Schematic

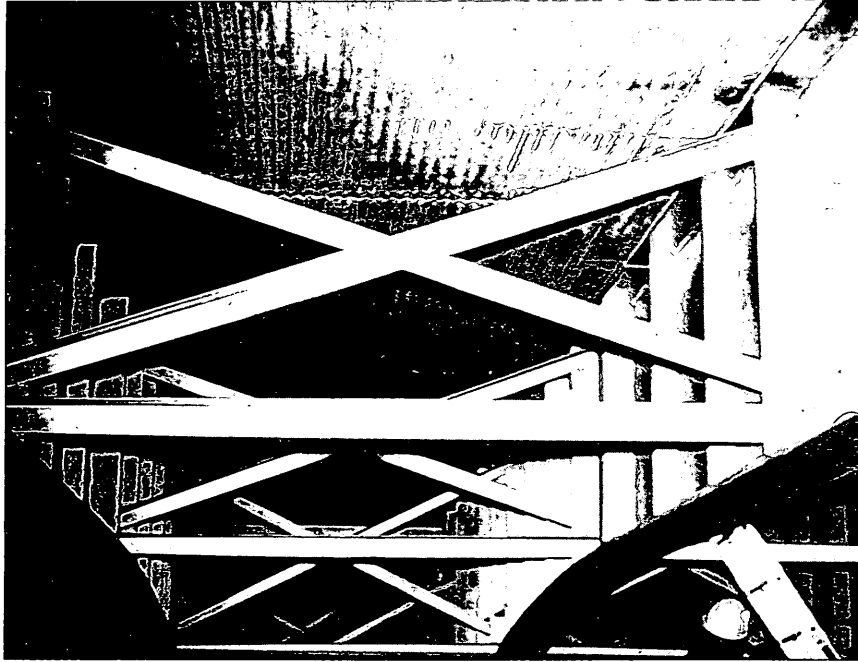
Fig. 4.25 Crack in Girder Web at K-Diaphragm Connection

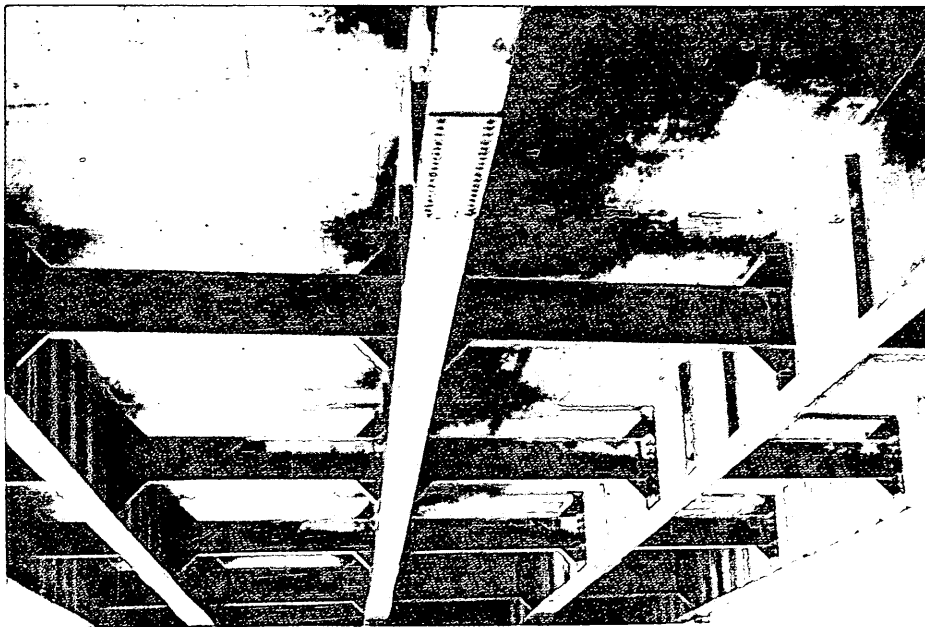
Fig. 4.26 Crack in Girder Web at Beam Type Diaphragm

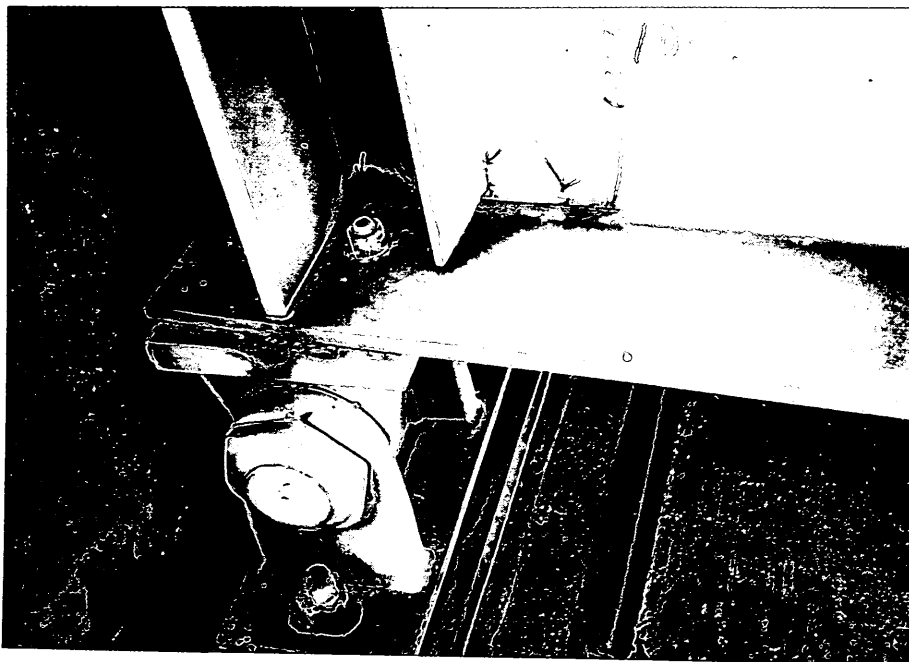
Fig. 4.27 Crack in Web near Support

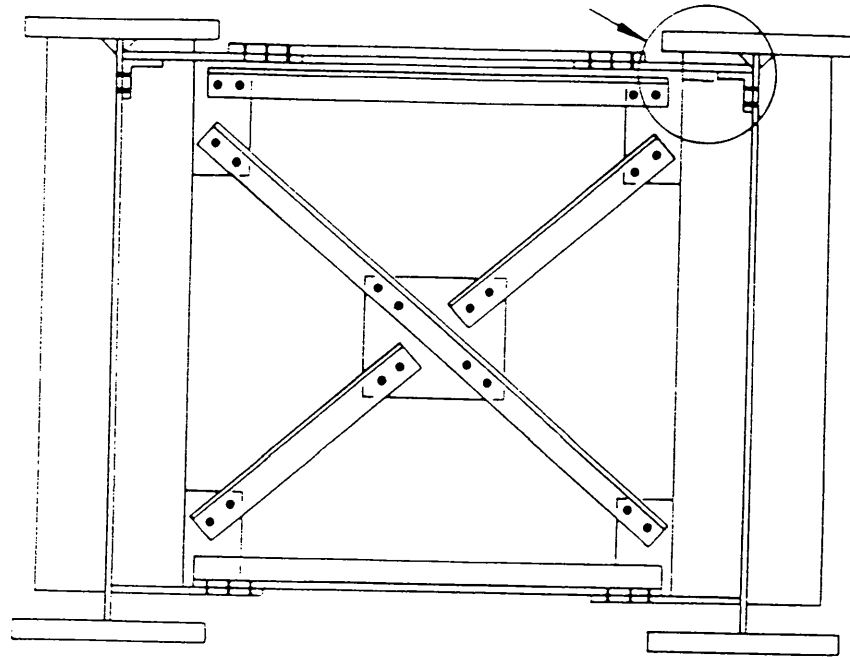
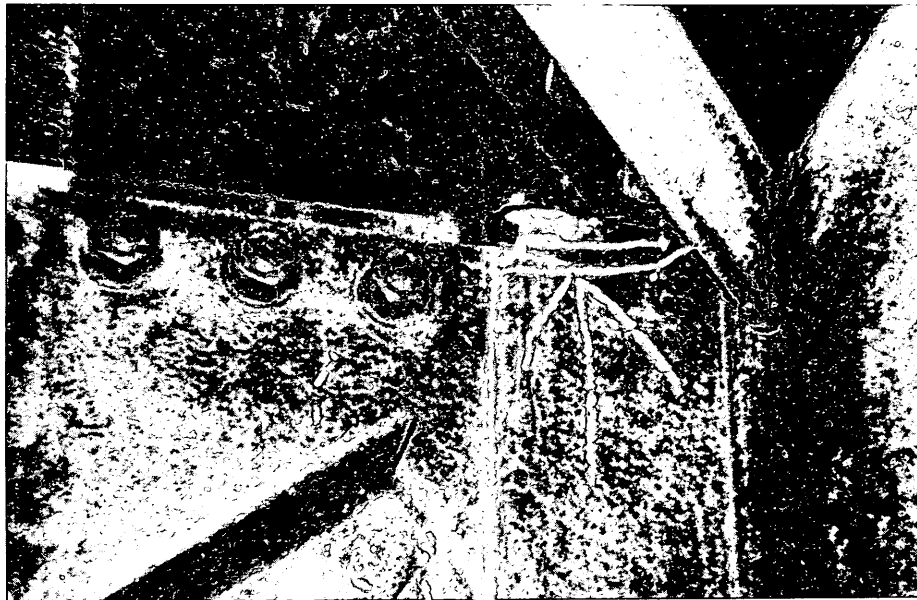
Fig. 4.31 Crack in Diaphragm Connection Plate at Gusset

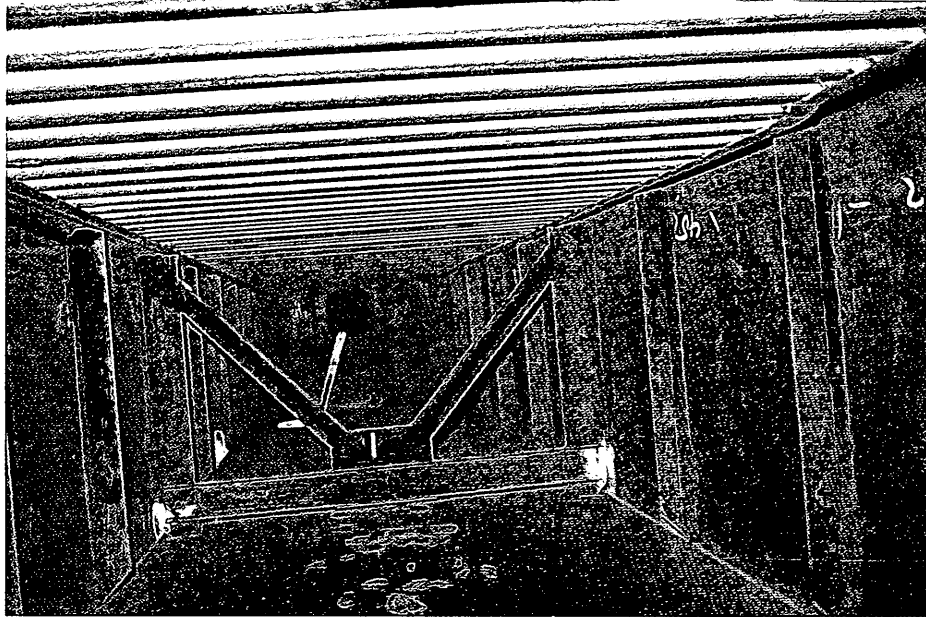
Fig. 4.32 K-Diaphragm in Box Girder

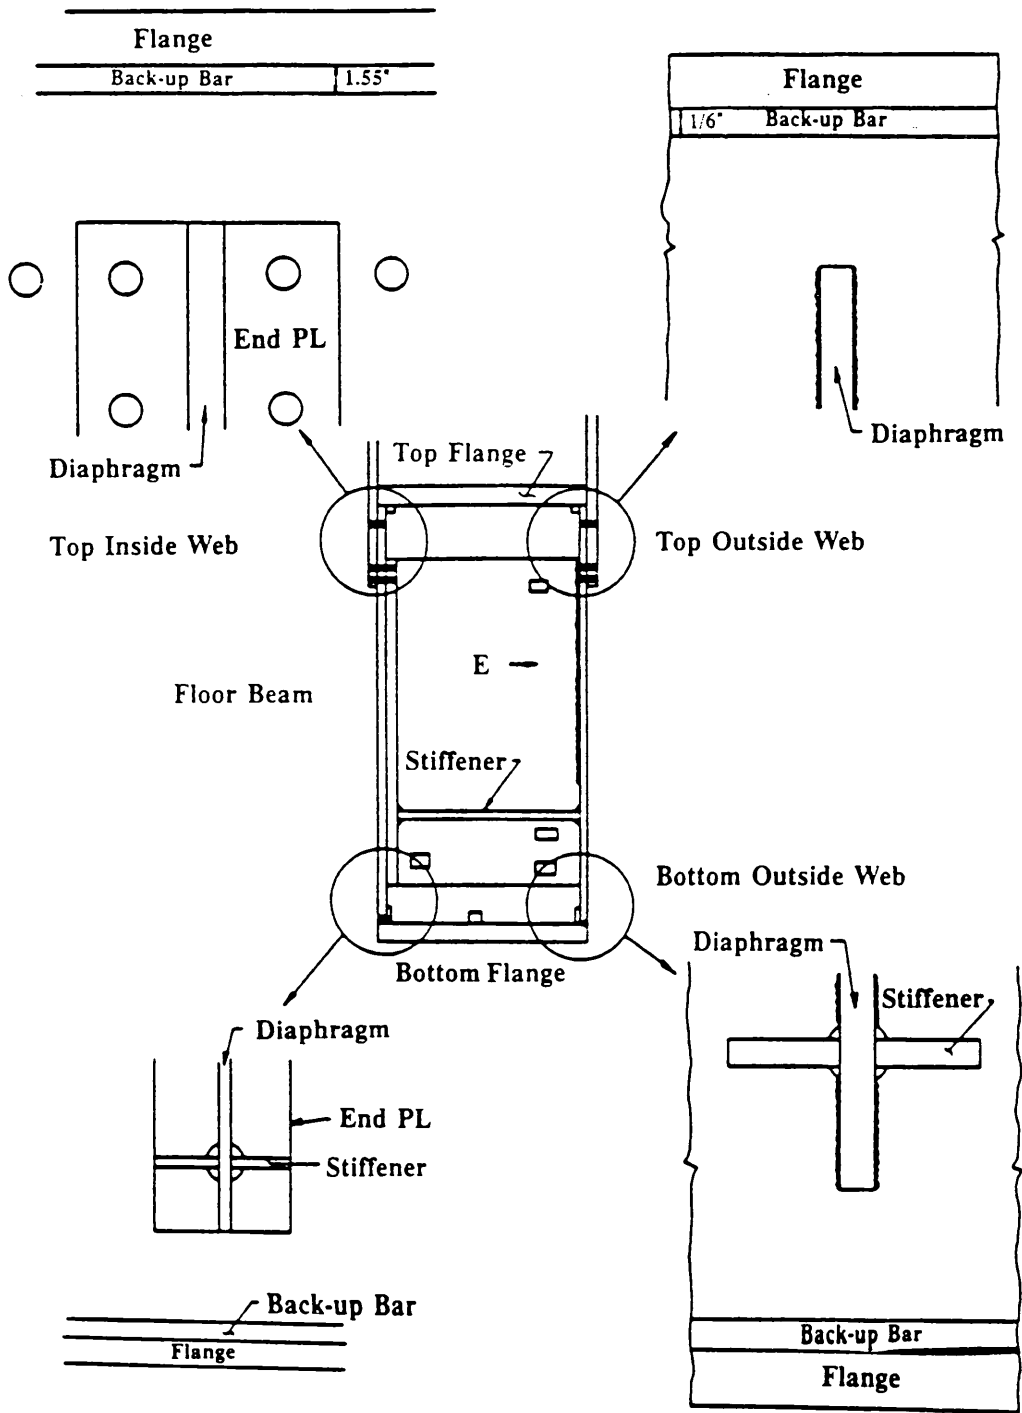
Fig. 4.34 Partial Depth Diaphragm inside Tie Girders

Another region of web-diaphragm junction in box girders which has incurred displacement induced fatigue cracks is at partial depth diaphragms inside tie girder of tie arch bridges. A schematic is shown in Fig. 4.34. The diaphragms are usually in alignment with the floor beams, and the primary function is to resist deformation of the box section. However, the small, unstiffened regions of the webs do not have sufficient rigidity against lateral, out-of-plane deflection. The situation is analogous to that of webs at unattached ends of floor beam or diaphragm connection plates. Fatigue cracks can develop at the ends of the diaphragm plates. An example is shown in Fig. 4.35. The crack initiated from the weld between the diaphragm and the web. In this instance, the weld was undersized and the crack propagated upward along the weld toe on the diaphragm side. The crack which is shown in Fig. 4.36 grew through the weld and into the web, following the typical pattern. Also shown in Fig. 4.36 is a horizontal crack in the flange to web weld, exposed after removal of the backup bar. This

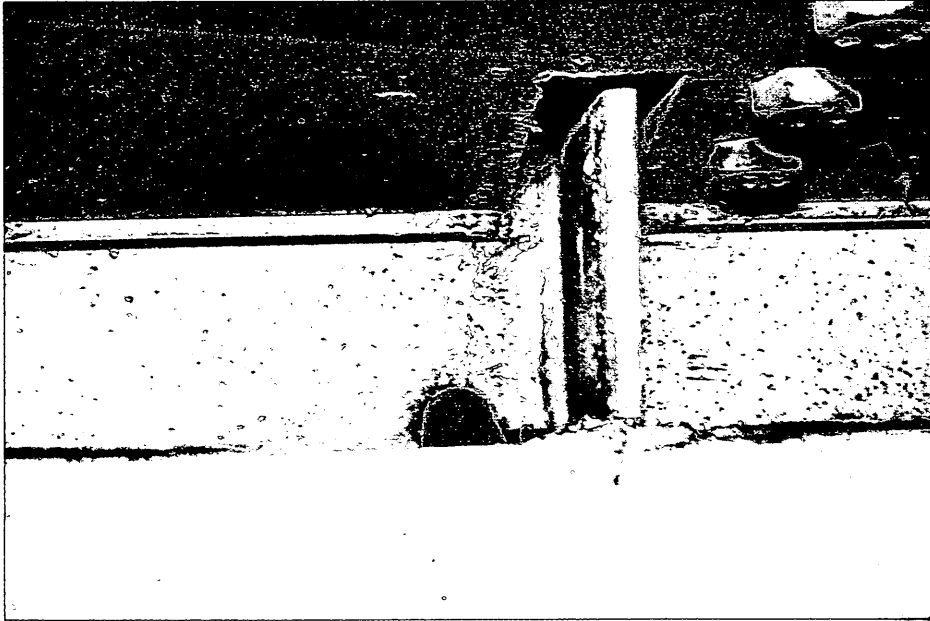
Fig. 4.38 Fatigue Crack at Lateral Bracing Gusset Plate Gap

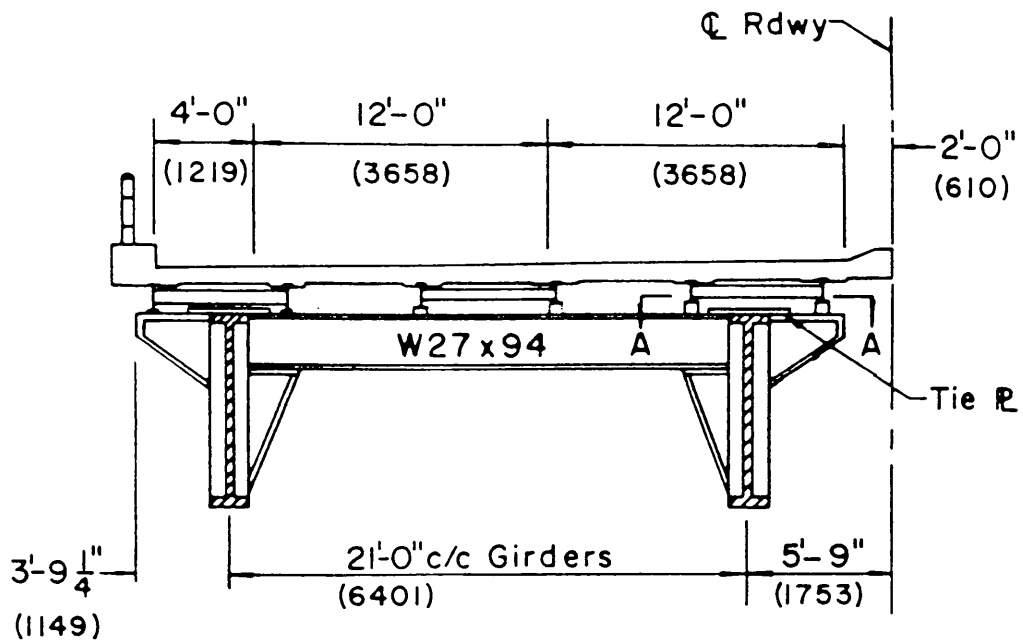
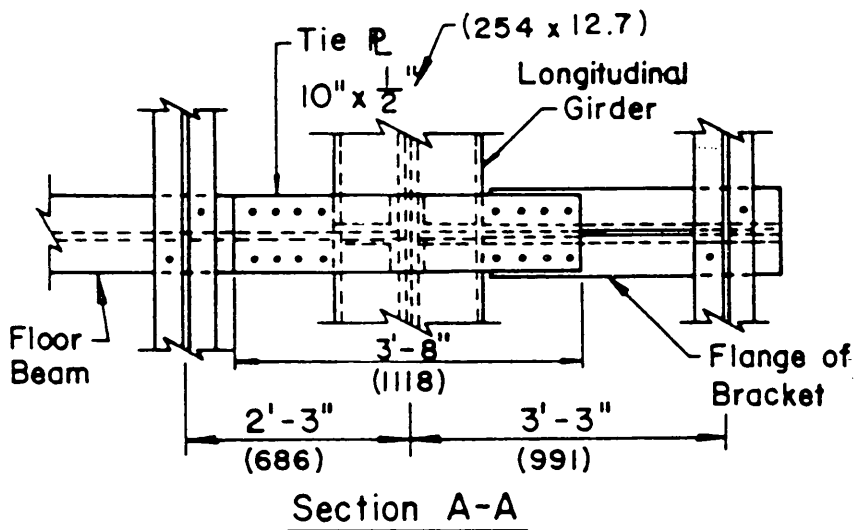
Fig. 4.41 Floor Beam-Cantilever Bracket Tie Plate not Connected to Girder Top -- Flange

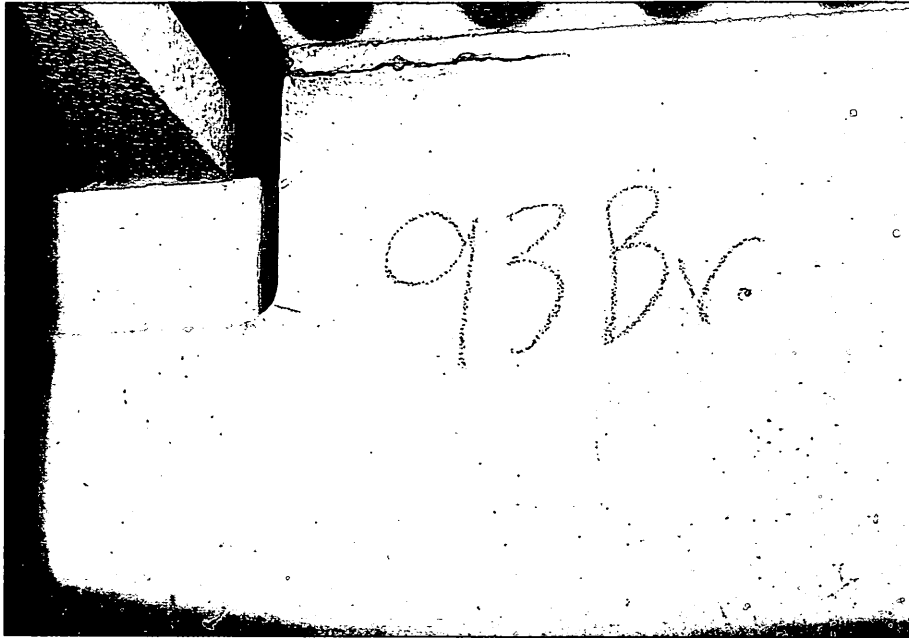
Fig. 4.42 Fatigue Cracks in Floor Beam Web at Connection to Girder

A fatigue crack in the web of a welded floor beam in a continuous girder bridge is shown in Fig. 4.42. The tie plate connecting the top flanges of the floor beam and the cantilever bracket is not attached to the top flange of the girder. The relative movement between the girder and floor beam-cantilever bracket flanges induced out-of-plane deflection of the floor beam web and caused the fatigue crack. Similar cracks were detected at a number of similar locations, both in the floor beam web and in the web of the cantilever bracket of this bridge. In another bridge which has rolled floor beams and built-up cantilever brackets, the same kind of out-of-plane deflections caused fatigue cracks in the web plate of both the floor beams and the cantilever brackets. Examples are shown in Figs. 4.43 and 4.44. In Fig. 4.43, the oxide and bleeding are clear signs of cracking; along the flange of the rolled beam of Fig. 4.44, the

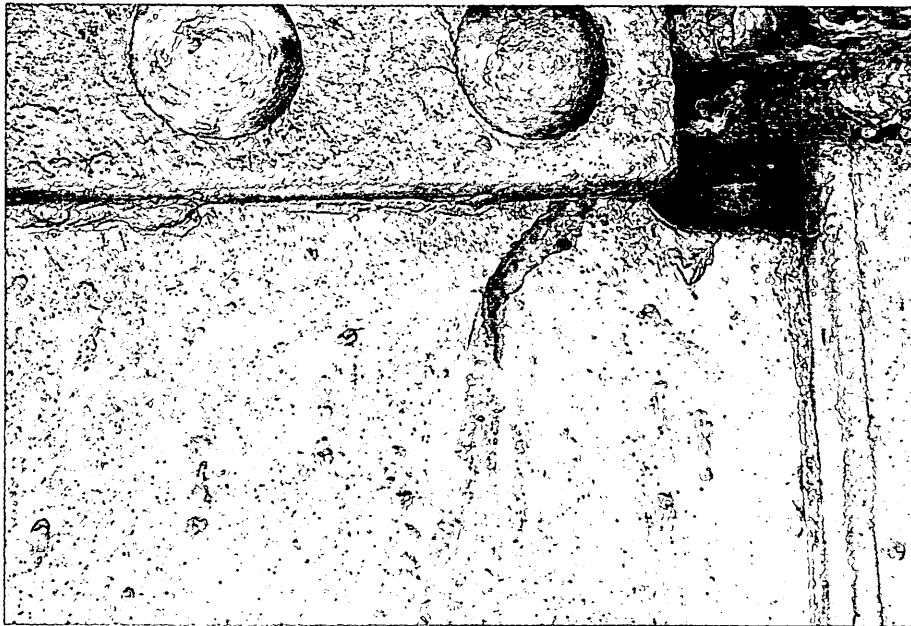
Fig. 4.43 Crack in Web of Cantilever Bracket

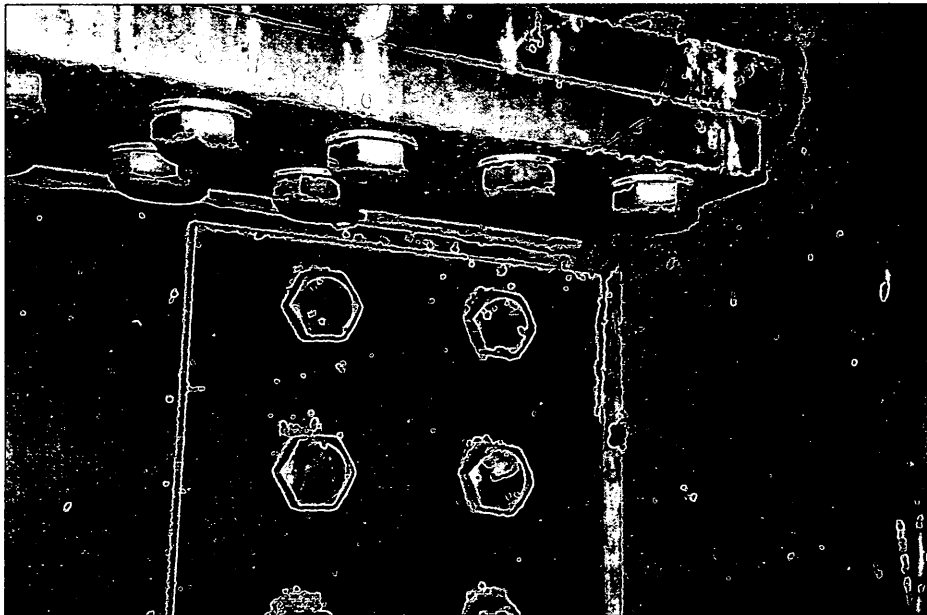
Fig. 4.45 Crack in Web of Floor Beam and in Floor Beam Connection Plate

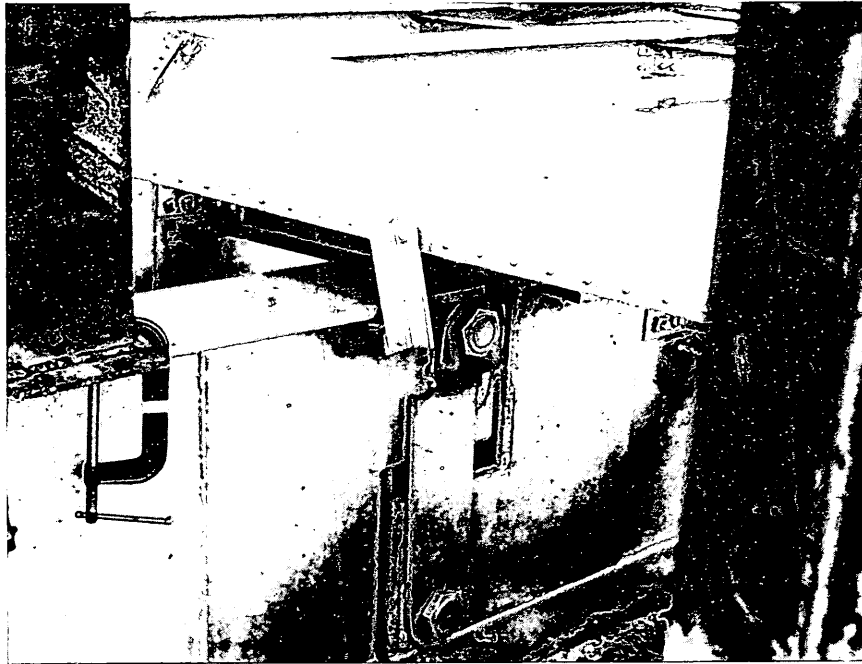
Fig. 4.47 Broken Hanger Plate

Fatigue cracks in hanger plates can be detected by oxide decoloring and cracking of paint film. Inspection of fatigue cracks in a pin assemblage is very difficult without removal of the pin cap. The existence of corrosion products would suggest that cleaning and inspection should be conducted.
