Manual for inspecting bridges for fatigue damage conditions, January 1990, 174p. (Final report)

Project 85-02: State-of-the-Art for Inspecting
Bridges for Fatigue Damage Condition

Manual For Inspecting Bridges For Fatigue Damage Conditions

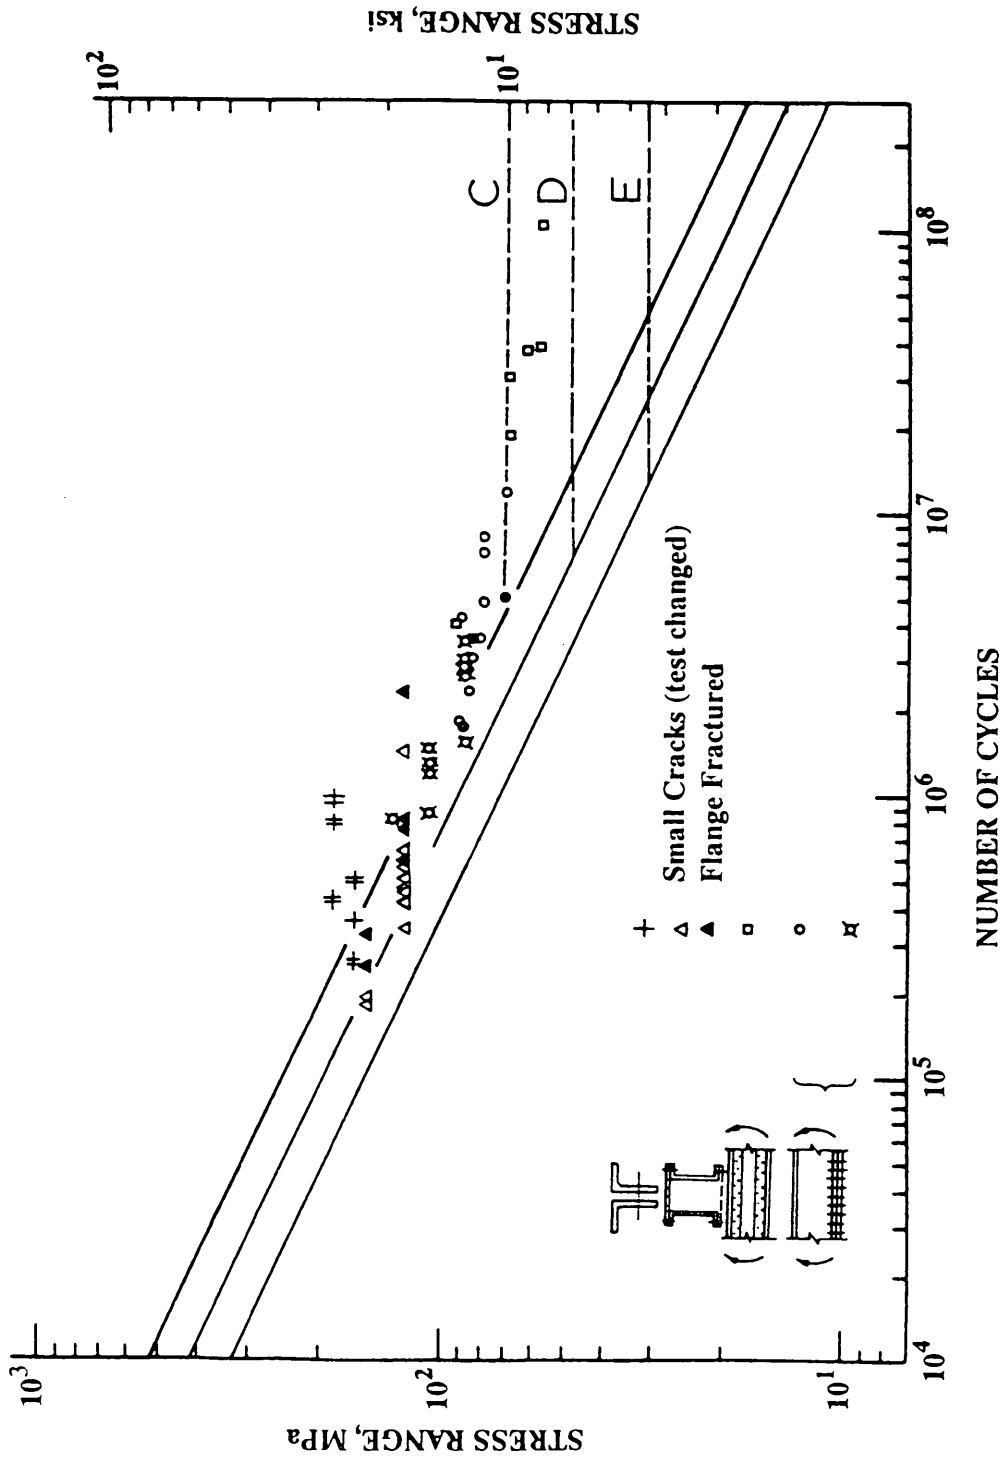
Fig. 5.1 Fatigue Test Date for Full Scale Riveted Bridge Members

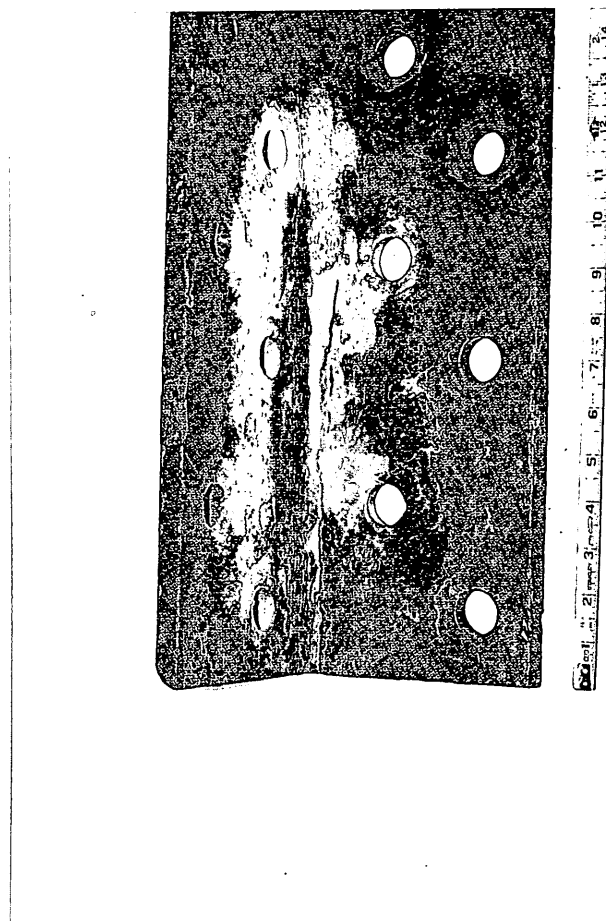
Fig. 5.4 Fatigue Crack at End of Connection Angle

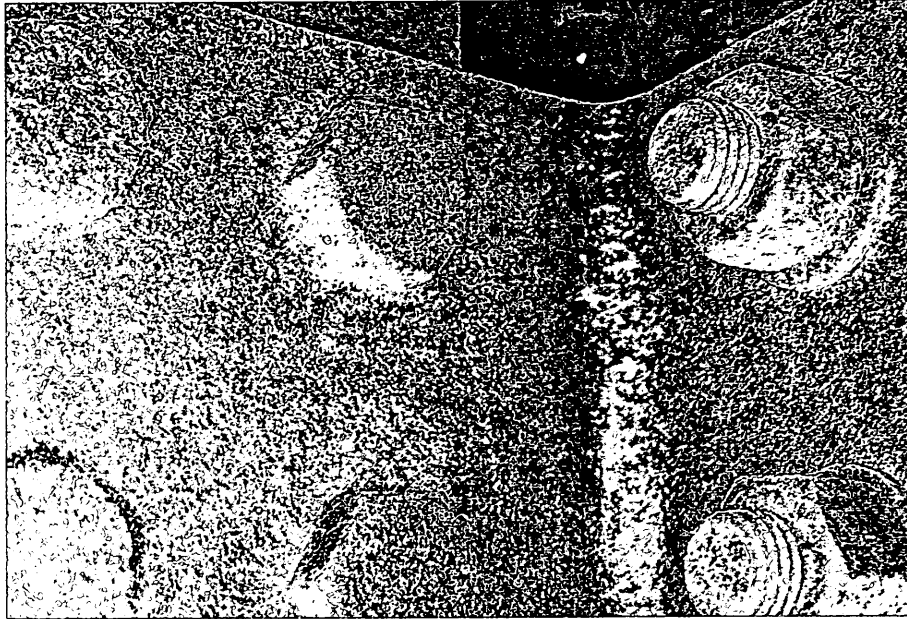
Fig. 5.5 Crack in Longitudinal Girder-Cross Girder Connection Angle

The cracking of connection angles can also develop in the leg parallel to the end of the beam. Figure 5.5 is a close-up view of the lower end of a connection angle between a main girder and the cross girder of a bent. The crack developed along the bolt heads in the leg on the girder web. A similar crack existed in the companion connection angle on the opposite side of the girder web. Inspection from below the girder at its end confirmed the cracks. A photograph of this view is shown as Fig. 5.6.

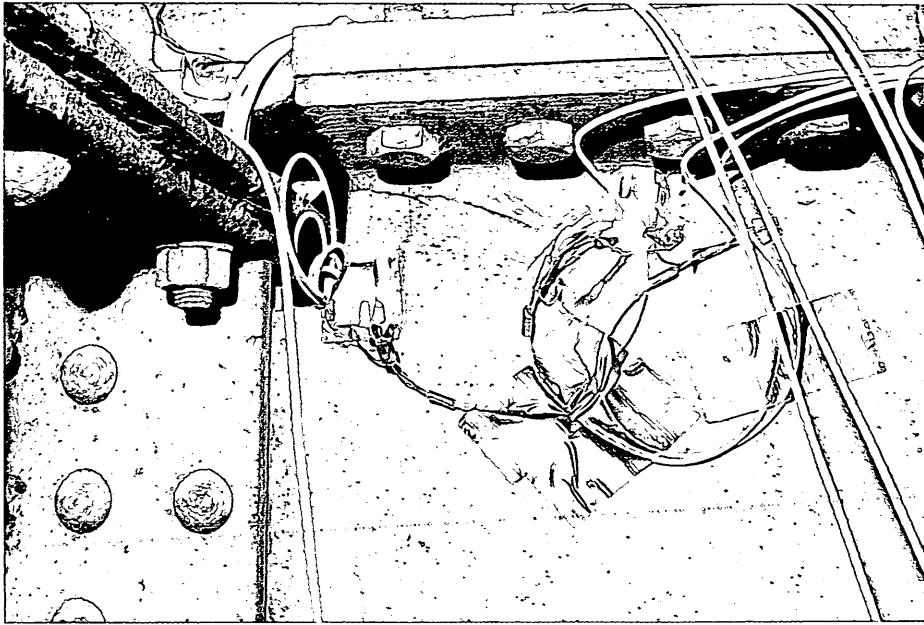
Fig. 5.8 Crack in Floor Beam Web at Riveted Connection to Girder

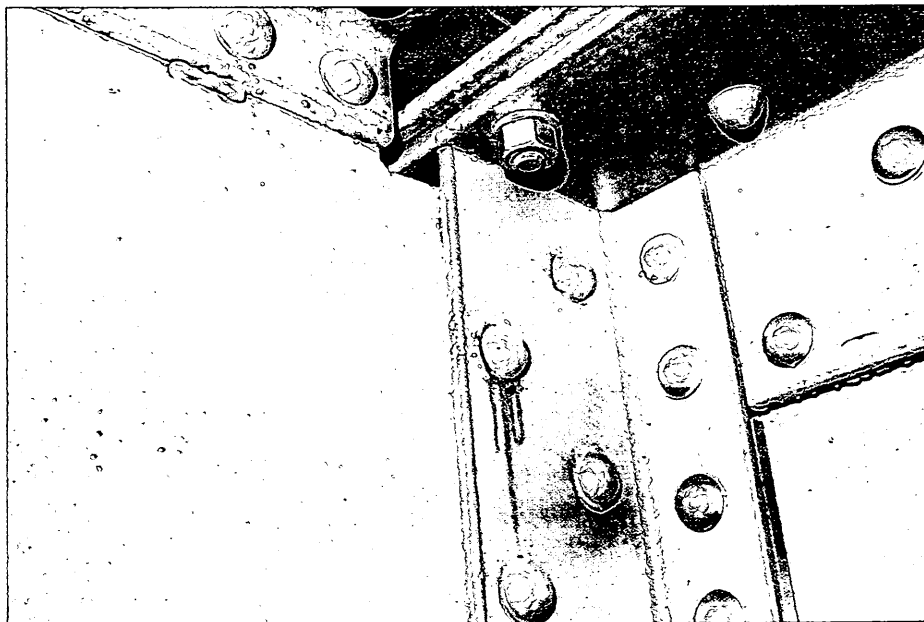
Fig. 5.9 Bleeding from Rivet Suggesting Cracking Underneath Rivet Head

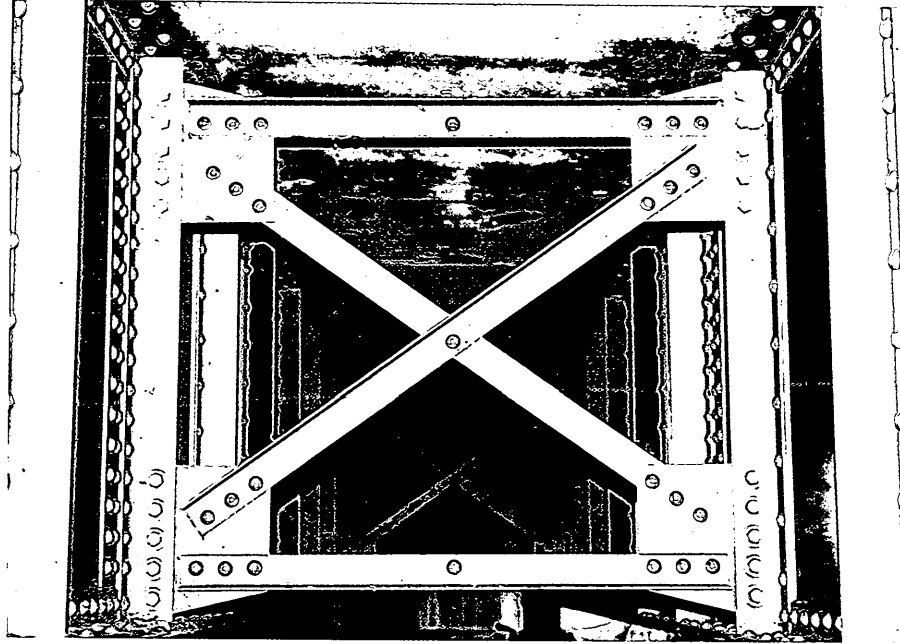
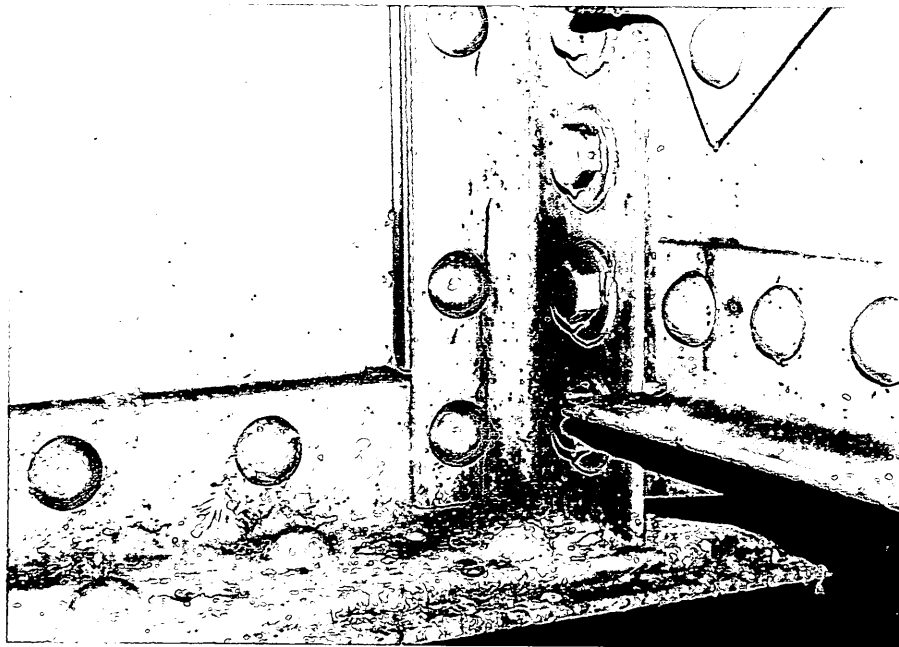
Fig. 5.12 Vertical Crack in Diaphragm Connection Angle

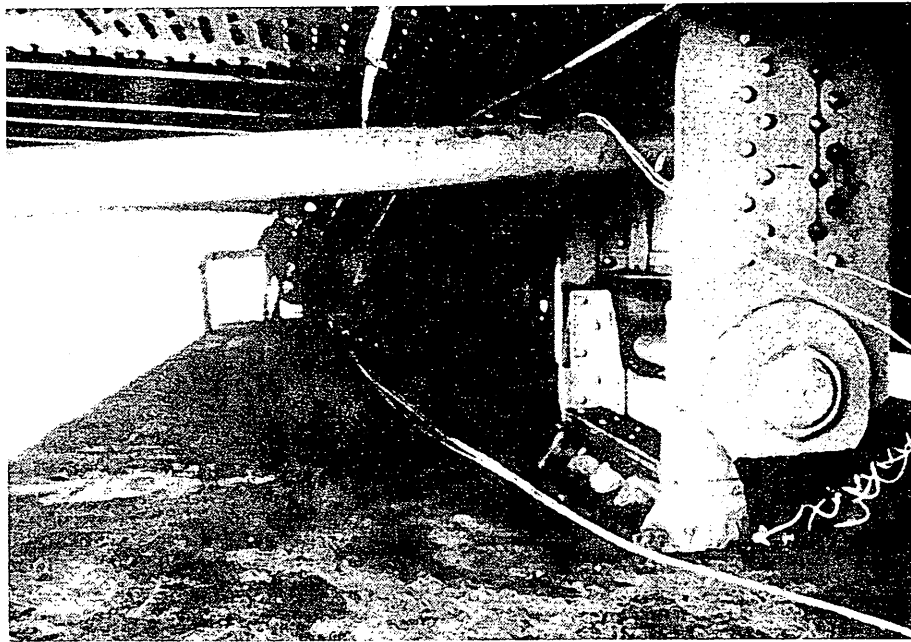
Fig. 5.14 Riveted Link and Anchoring Eyebars at
End of Suspension Bridge

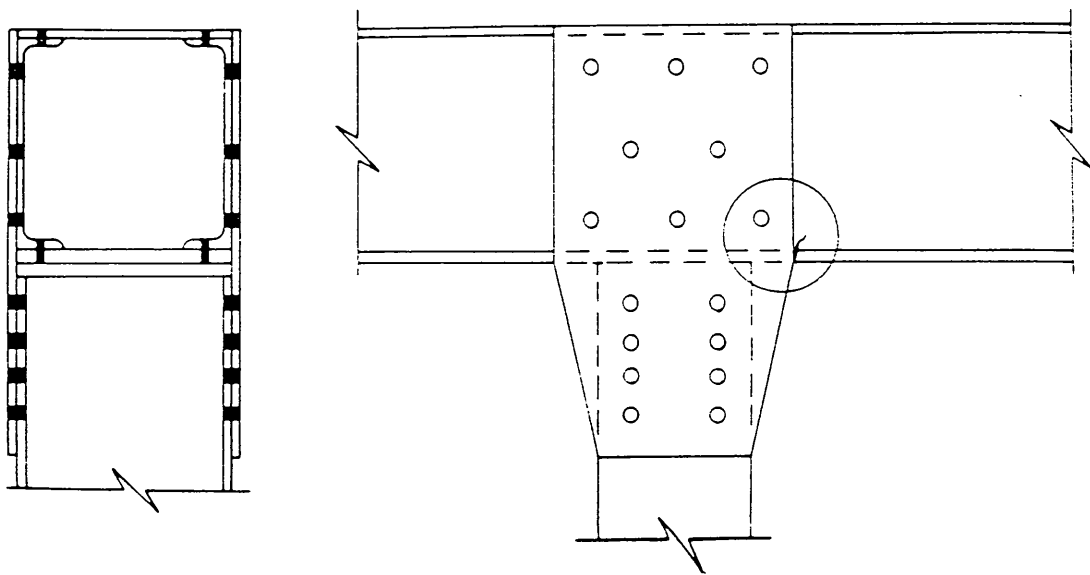
Fig. 5.15 Crack at Tack Weld between Hanger Gusset Plate and Truss Top Chord

While the tack welds may exist in various parts of a riveted structure, it is mostly at joints and connections where the existence of these tack welds and cyclic stresses cause fatigue cracking. All tack welds detected at and near the connection of bridge members should be recorded, the welds inspected, and the results reported. Similarly, all field welded attachments such as posting signs which were added to riveted bridge members should also be inspected and reported.

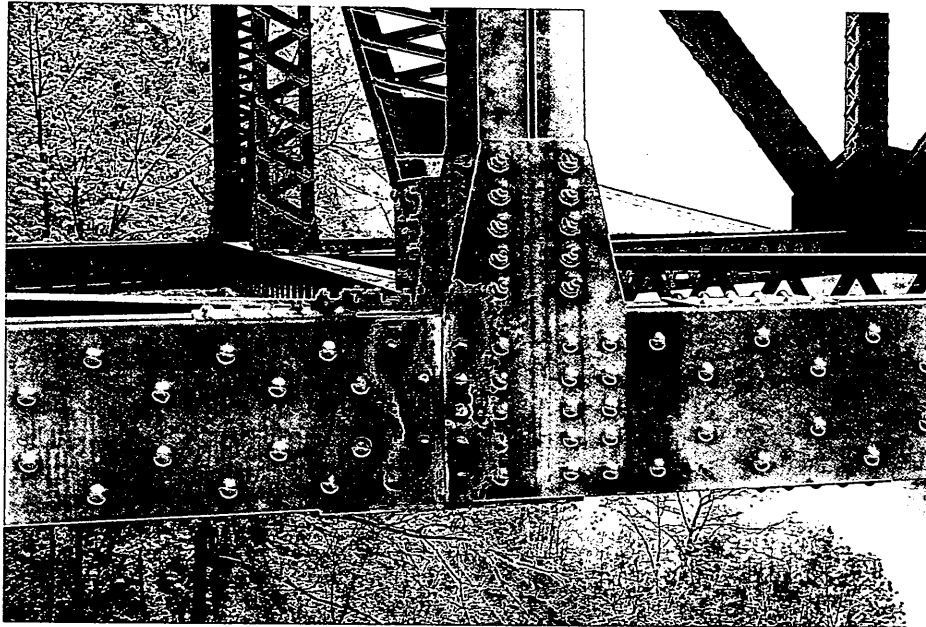
Fig. 5.16 Lower Panel Point of Truss with Crack at Tack Welds

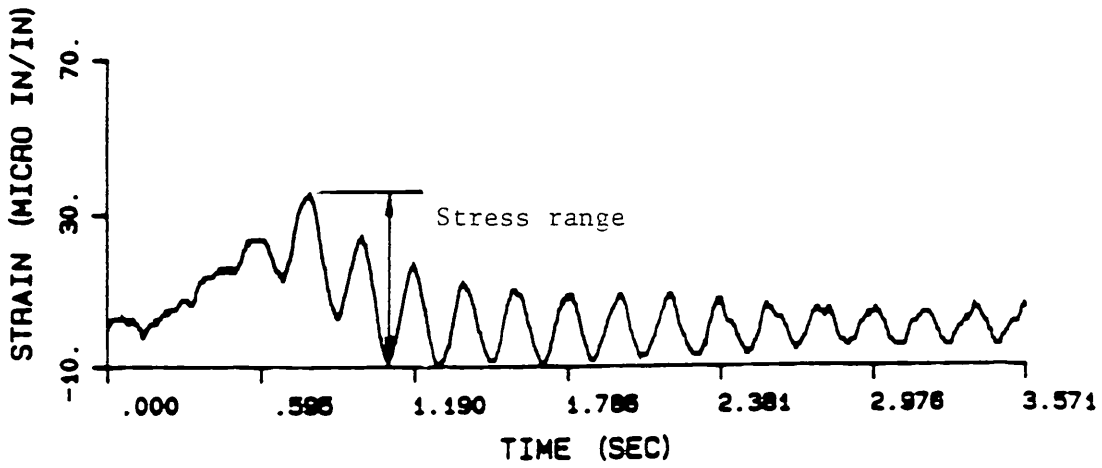
Fig. 7.1 Typical Strain-time Record from a simply supported bridge girder caused by one single truck

The most site-specific and very likely the most costly method requires the field measurement of stresses under actual traffic condition. Strain gages are generally used at the location or detail of interest on the structure, and strains are monitored and recorded over a period of time sufficiently long to provide a realistic representation of the traffic pattern (about two days). Figure 7.1 shows a typical strain-time record caused by the crossing of one single truck over a simple girder bridge. The shape of the curve generally resembles that of an influence line, but with superimposed strain fluctuations reflecting the vibrations of the structure due to the moving loads.

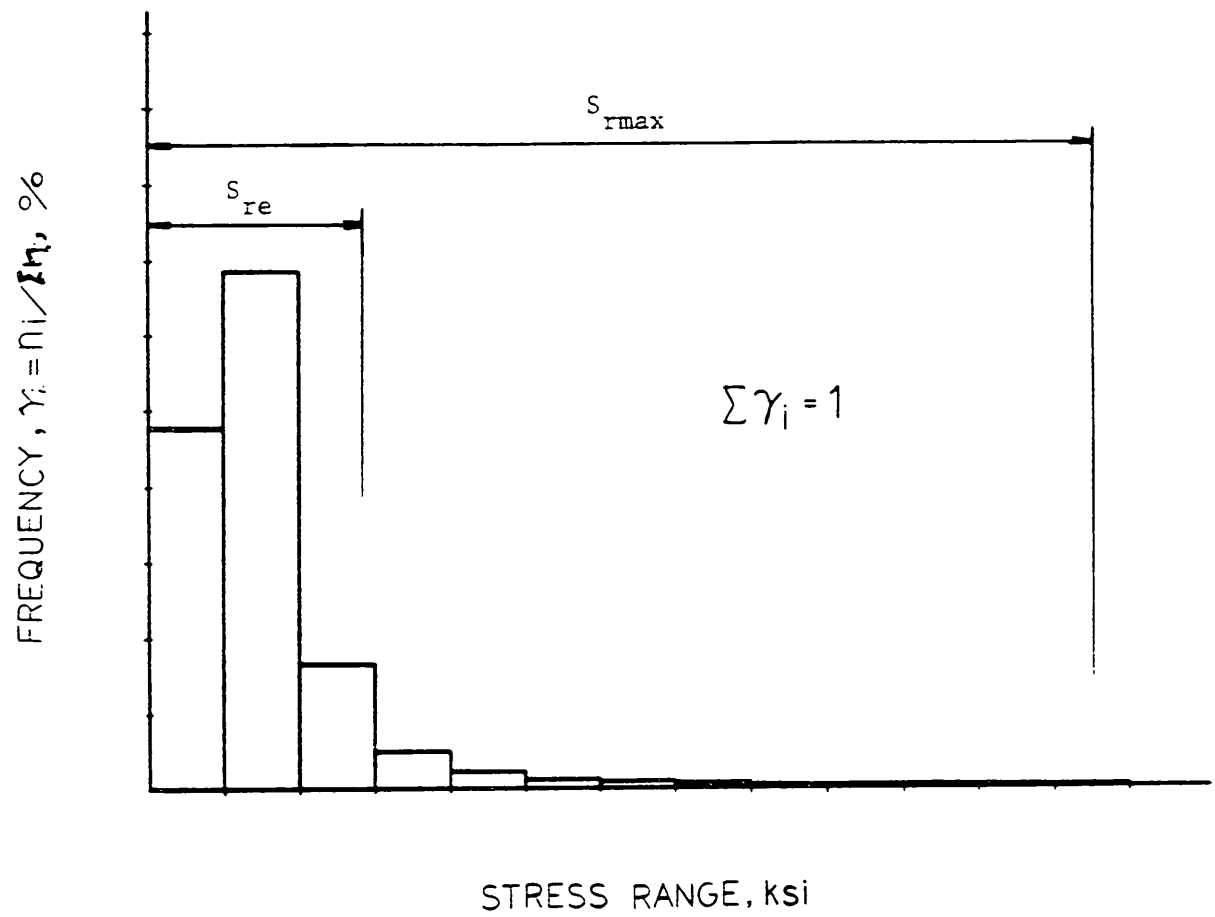
Fig. 7.2 Typical Stress-Range Histogram

$$S_{re} = \left(\sum \gamma_i S_{ri}^3 \right)^{1/3} \quad (7.2)$$
