Tests of riveted and welded steel columns, 1930

TESTS OF RIVETED AND WELDED STEEL COLUMNS
for MCCLINTIC-MARSHALL COMPANY

W. A. Slater and M. O. Fuller

July 1, 1930

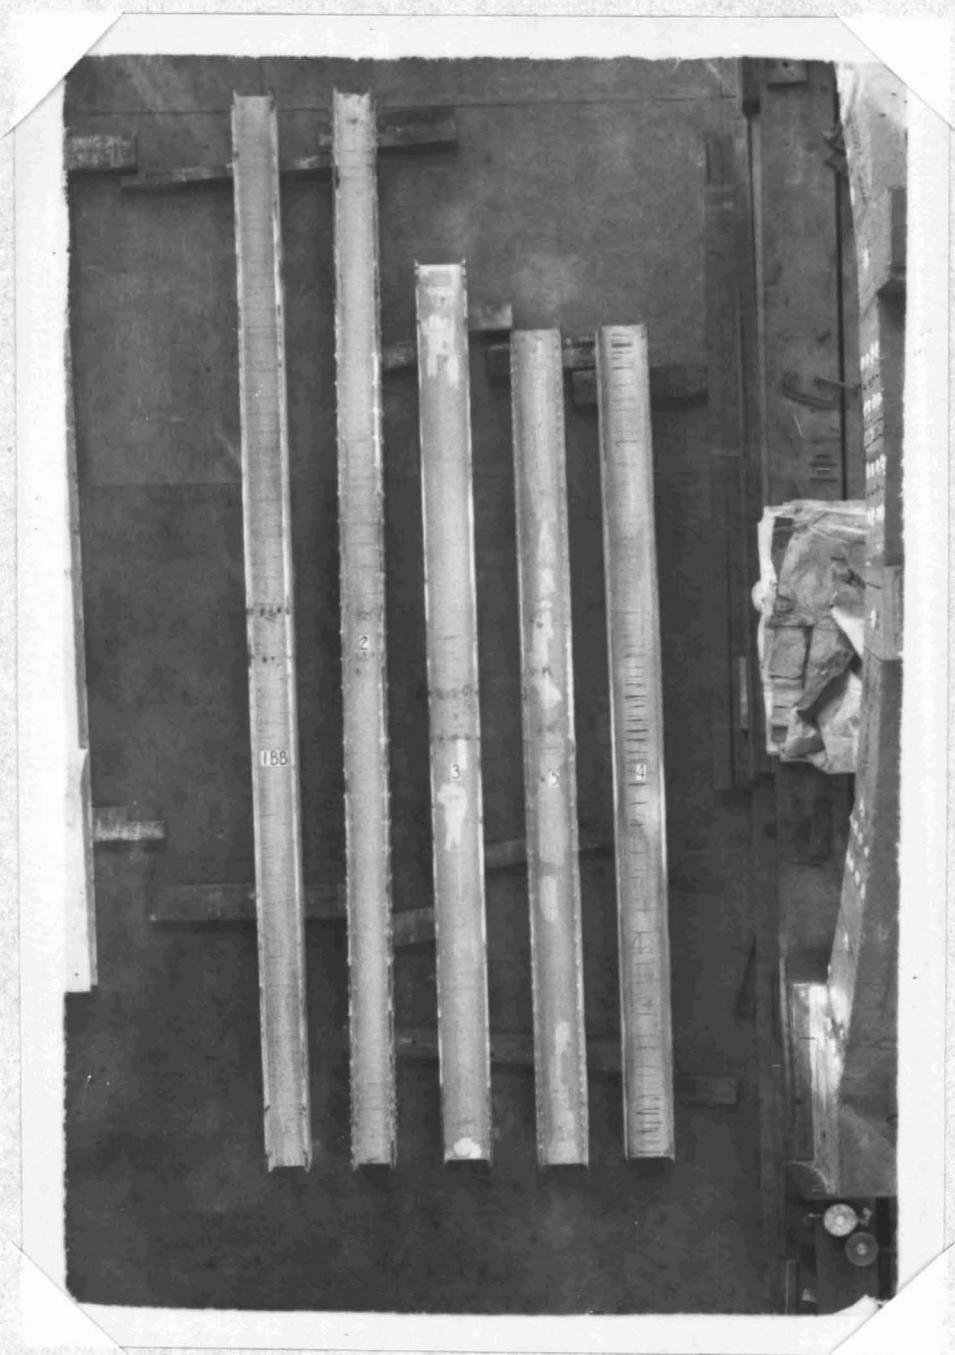
Fig. 4 - Columns 1BB, 2, 3, 4, and 5
After Testing

NOTE: Location of Column Numbers indicate
the portion of the columns shown in
Fig. 32, 34, 35, 38, and 44.

1. The Columns. The program of tests here reported included the testing of eight built-up steel columns furnished for the tests by the McClintic-Marshall Company. Each column consisted of a core, formed by an "I" or an "H" section, and a cover plate attached to each flange of the core. Fig. 1 shows the details of the columns, including the methods of fastening the cover plates to the flanges. As noted, all of the columns were welded except columns 2 and 5, which were riveted. Fig. 2 shows a view of a column in the testing machine. Fig. 3 and 4 show columns 1BB, 2, 3, 4, and 5 after they had been tested.

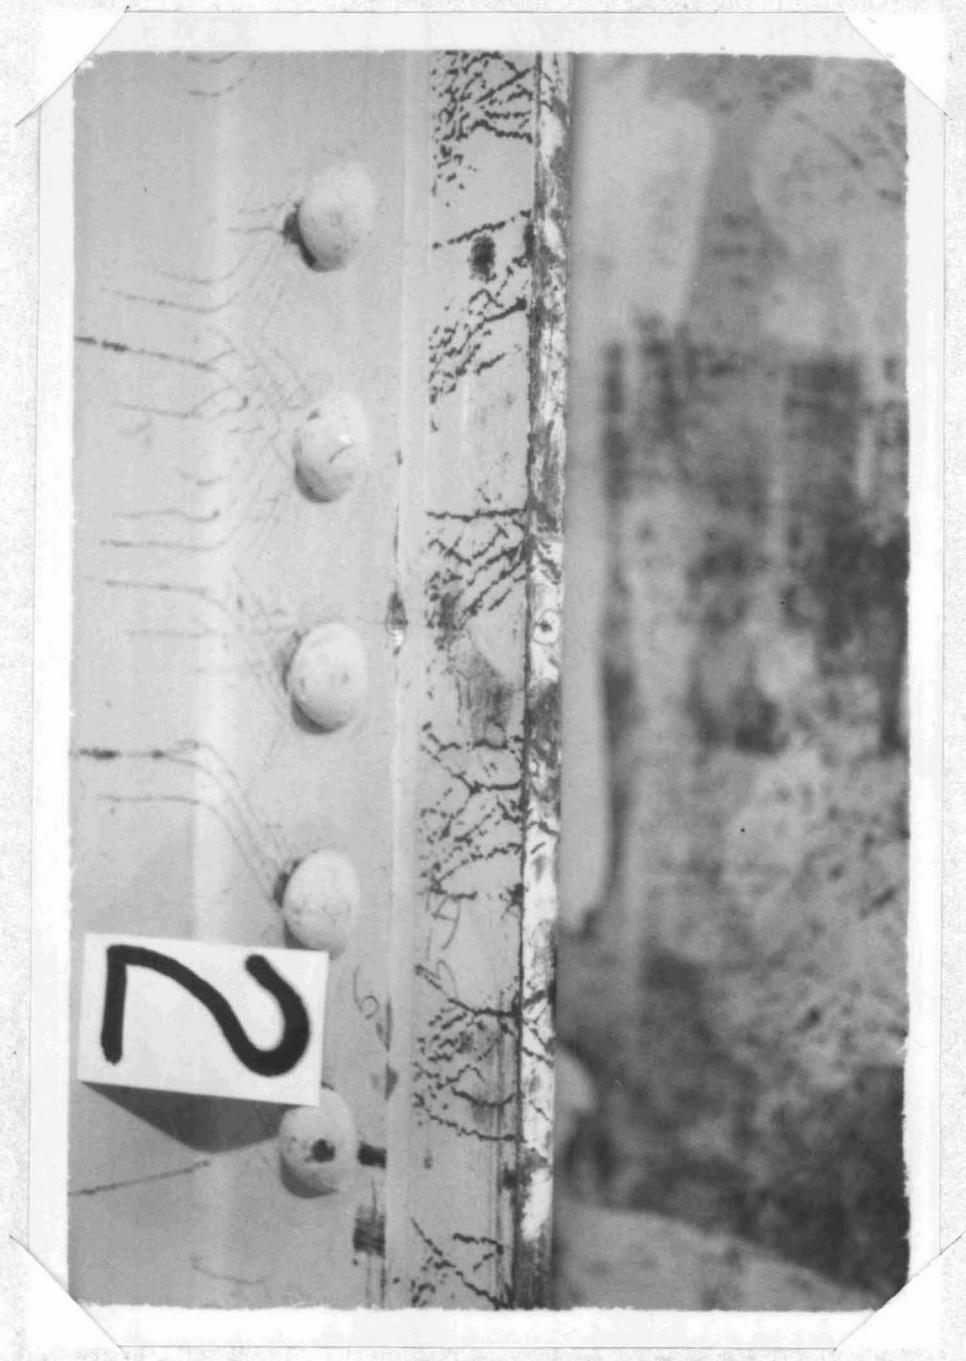
Fig. 36 - Strain Lines on Interior Face of
Cover Plate of Column 2

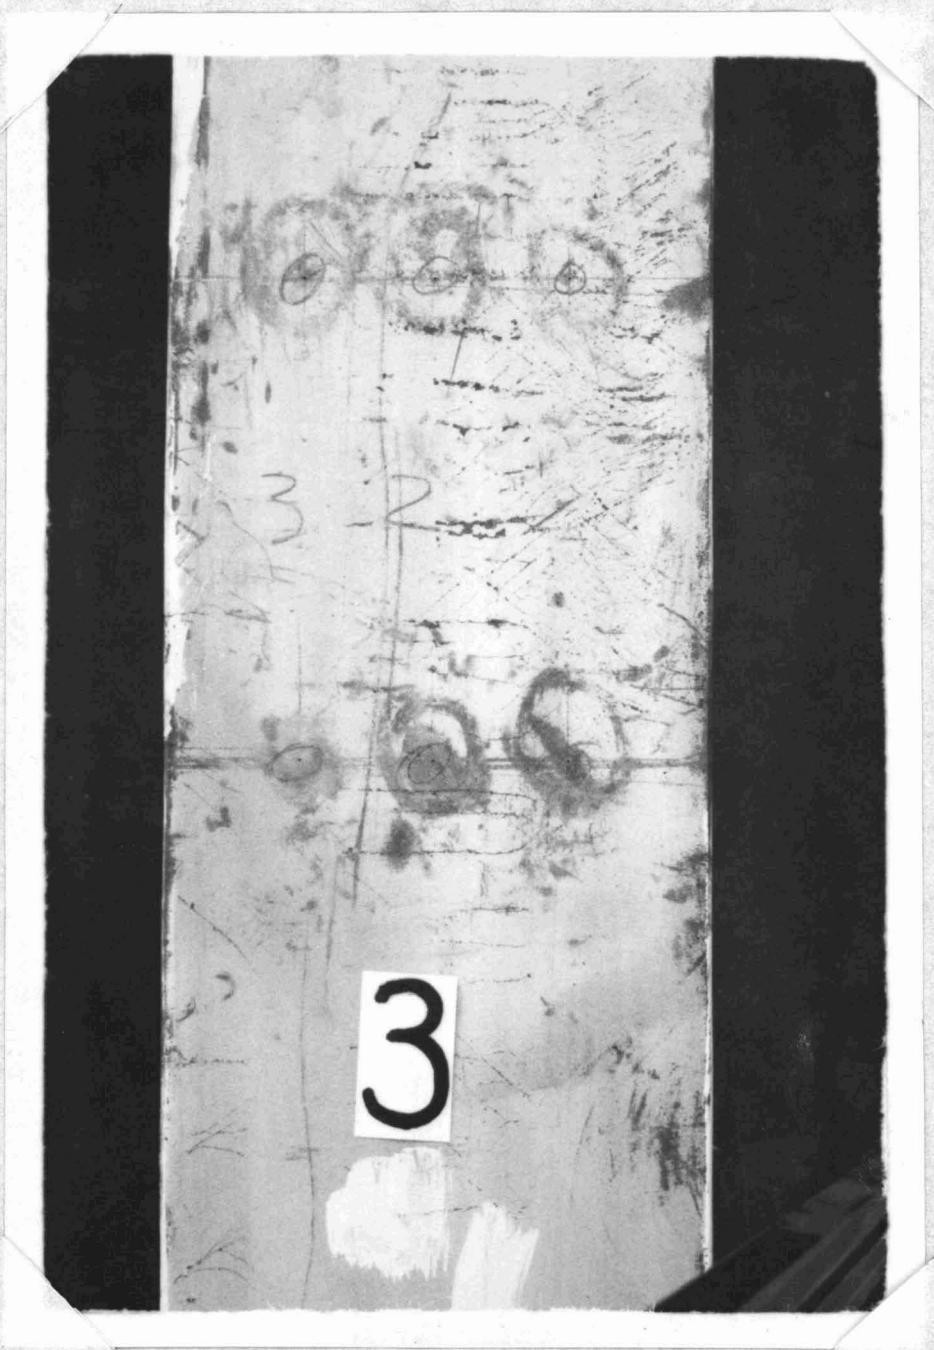
Fig. 37 - Strain Lines on Exterior Face of
Cover Plate of Column 3

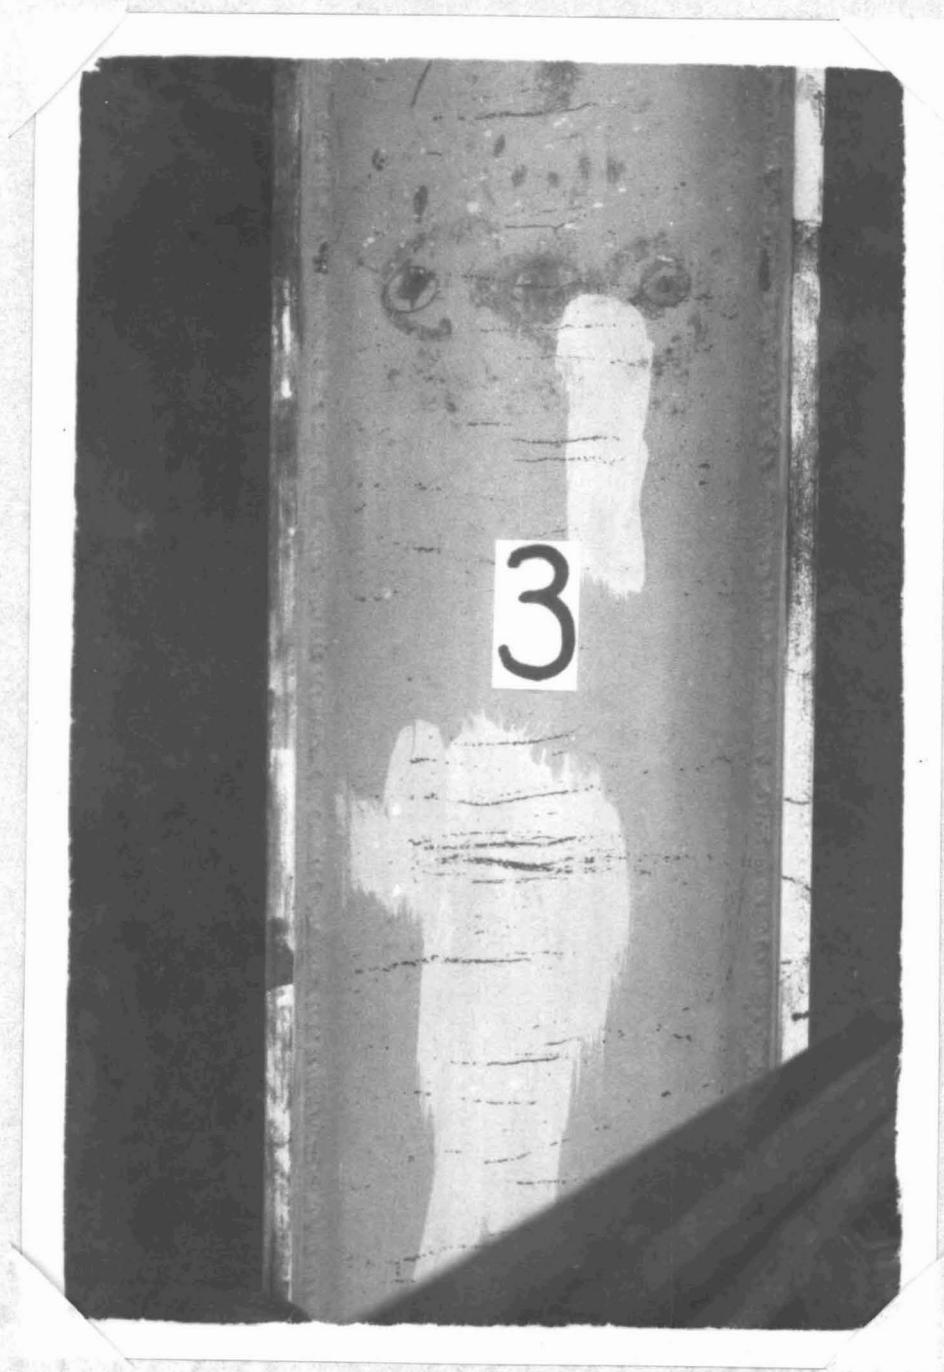
Fig. 38 - Strain Lines on Web of Column 3

In the web of the column at the top and bottom, the lines crossed from flange to flange and continued out into the flanges (Fig. 38). They were more numerous at the center and ends than at intermediate points. Here they were somewhat broken but extended across the fillet into the flange.

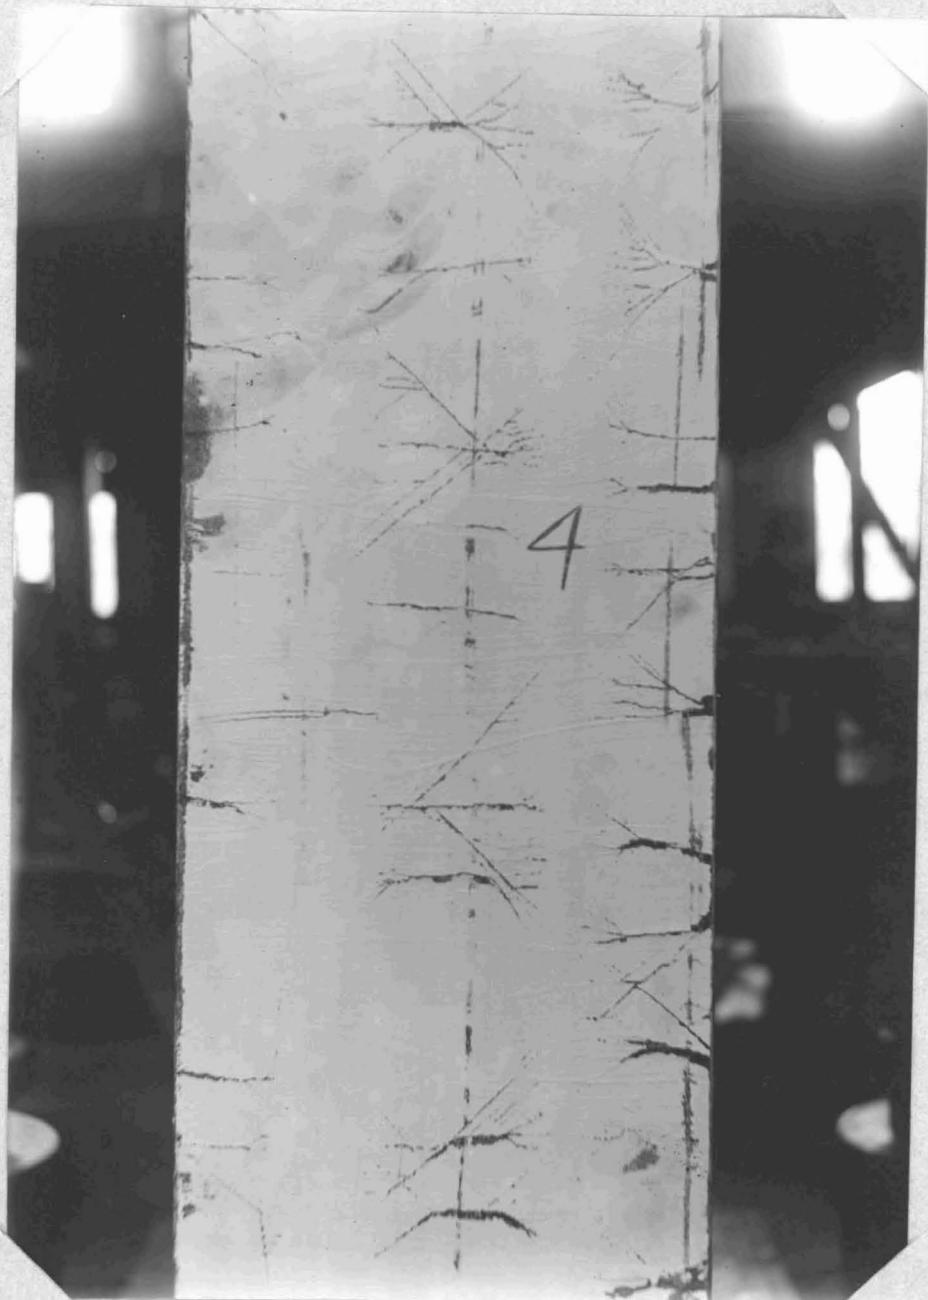
Fig. 40 - Strain Lines on Exterior Face of
Cover Plate of Column 4

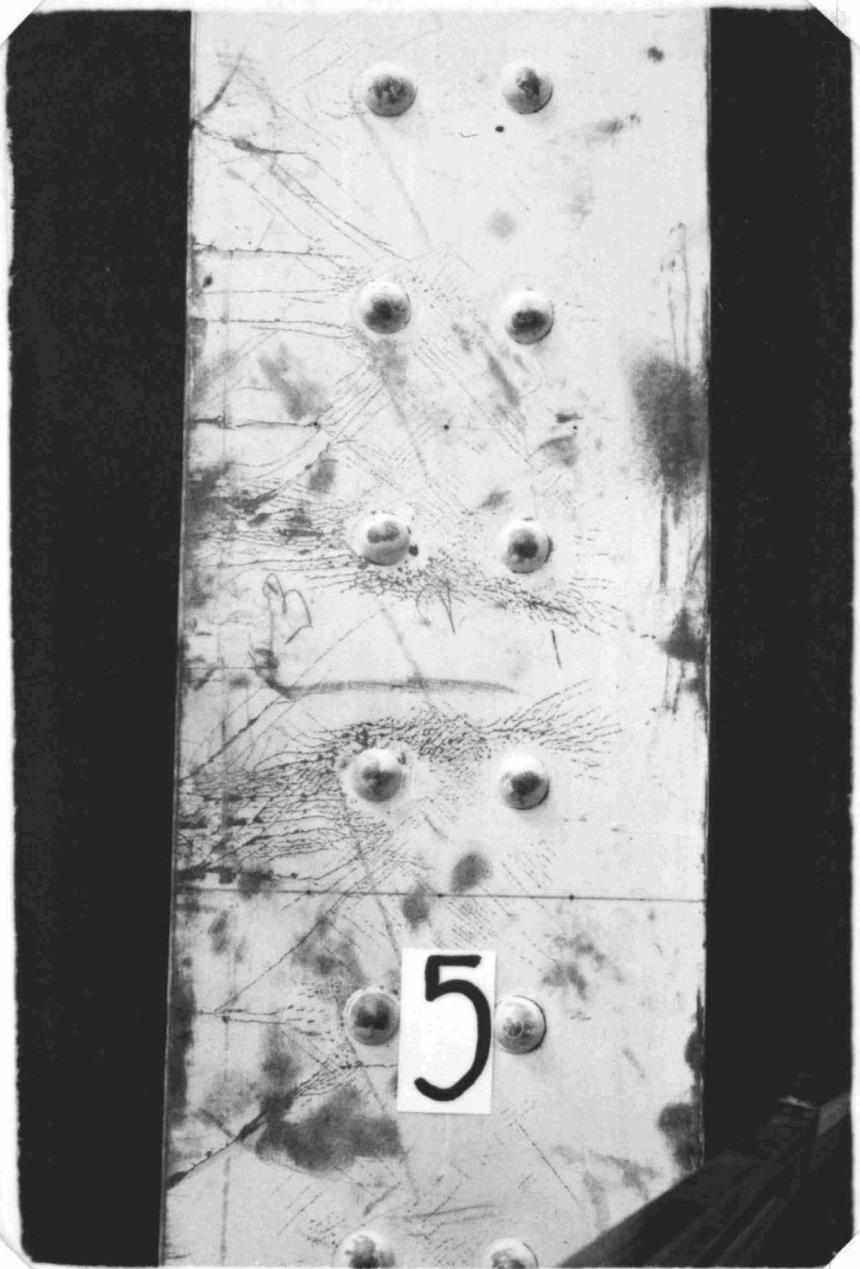
Fig. 43 - Strain Lines on Exterior Face of
Cover Plate of Column 5

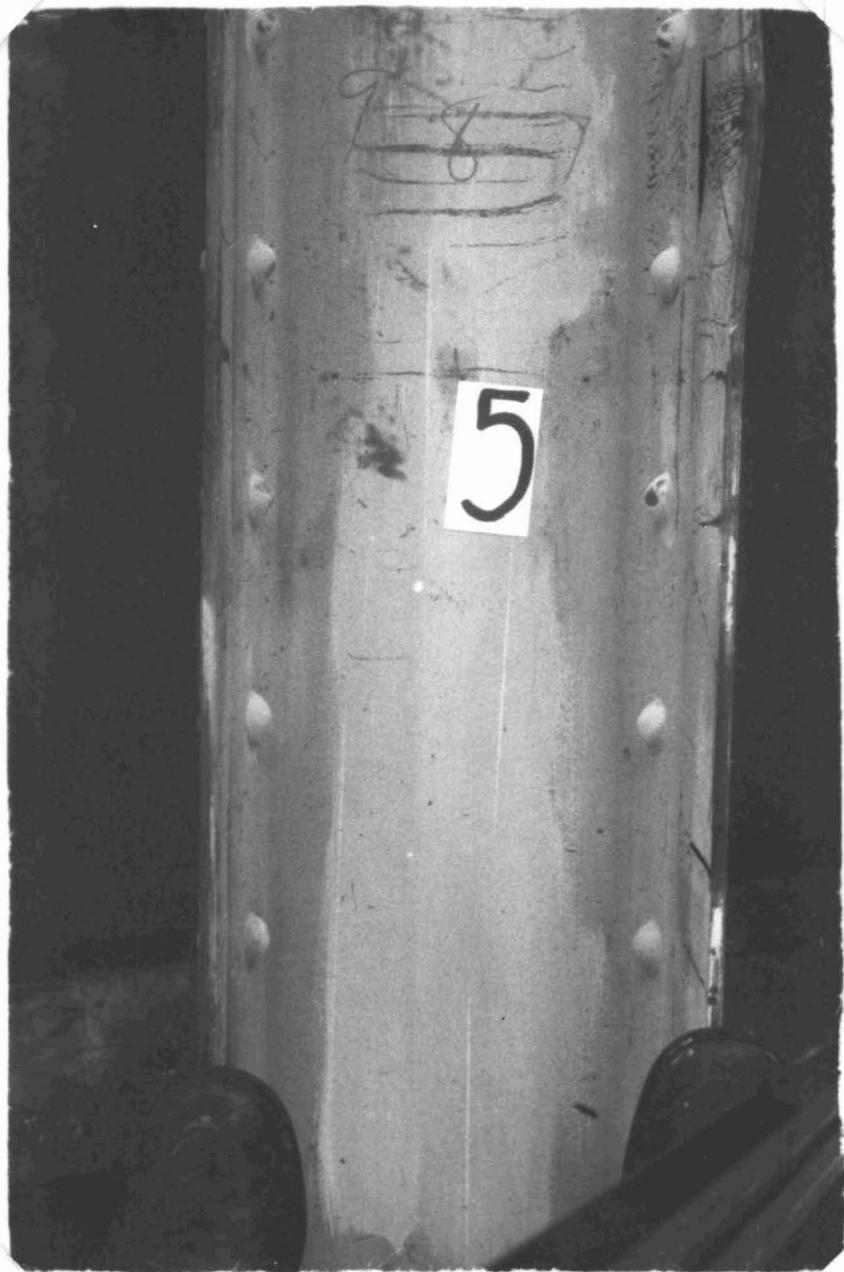
Fig. 44 - Strain Lines on Web of Column 5

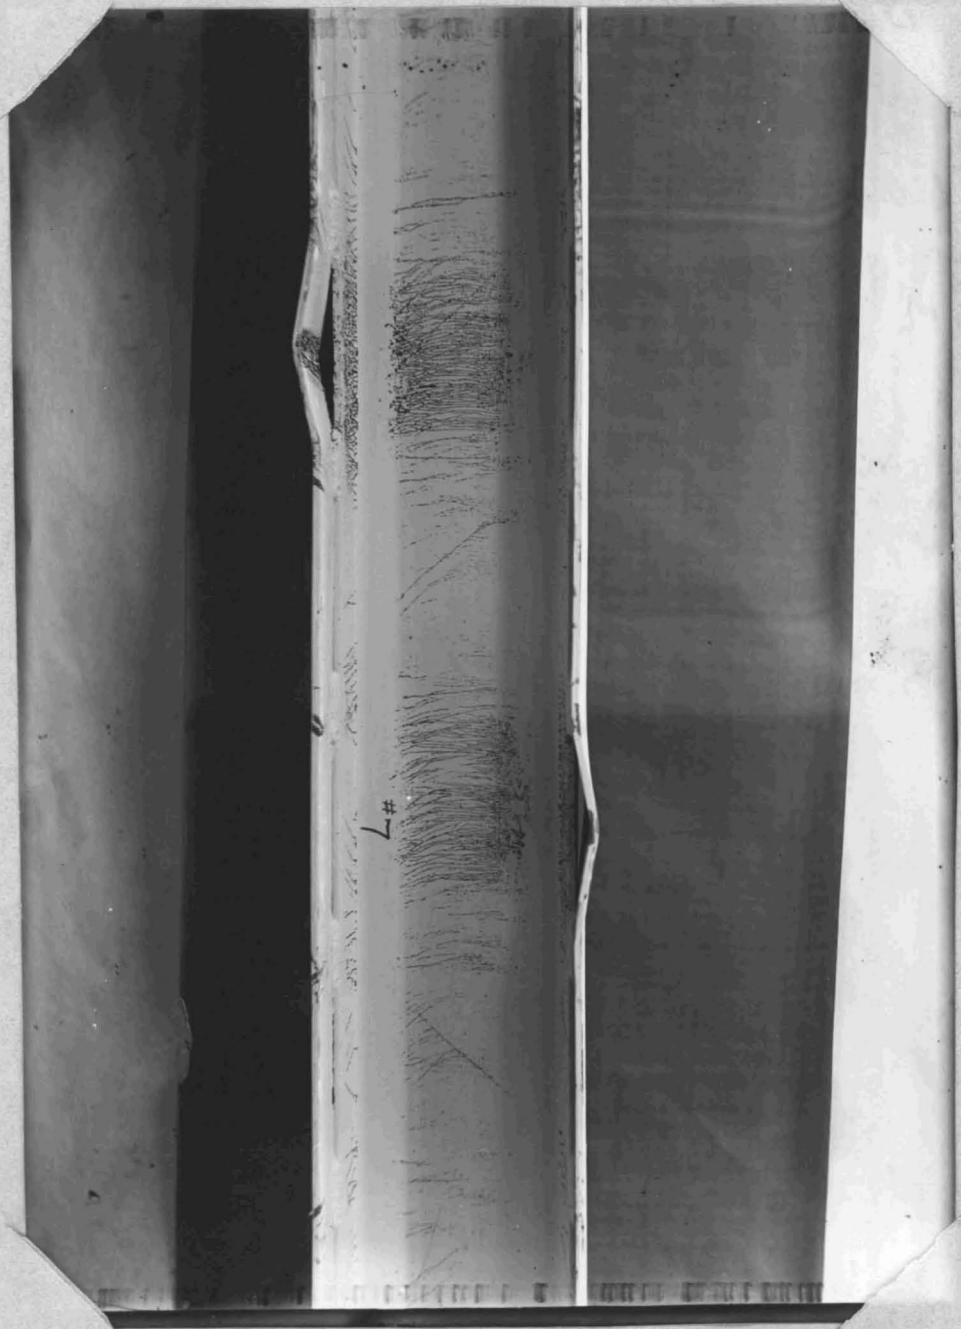
Fig. 46 - Strain Lines on Web of Column 7

The buckling of the cover plates was not due to any observed defect of the welding but probably to too great spacing of the intermittent welds. The ten-inch center to center spacing of the welds proved too great for the 5/16-in. cover plates of Column 7, but was adequate for the 5/8-in. cover plates of Column 6.
