FATIGUE AND STATIC STRENGTH OF STUD SHEAR CONNECTORS

BRUNO THÜRLIMANN

FRITZ ENGINEERING LABORATORY

February 3, 1958

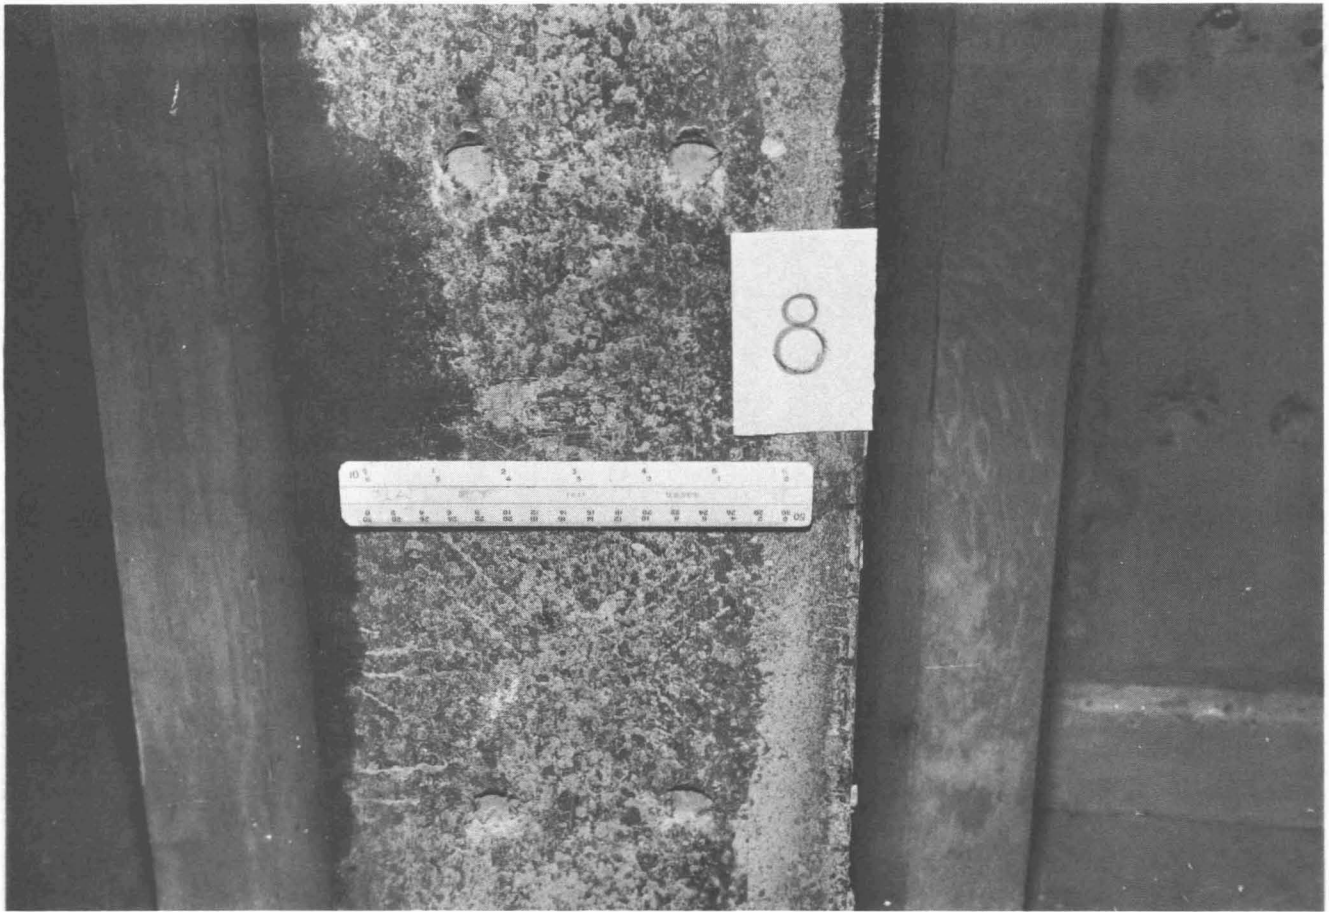
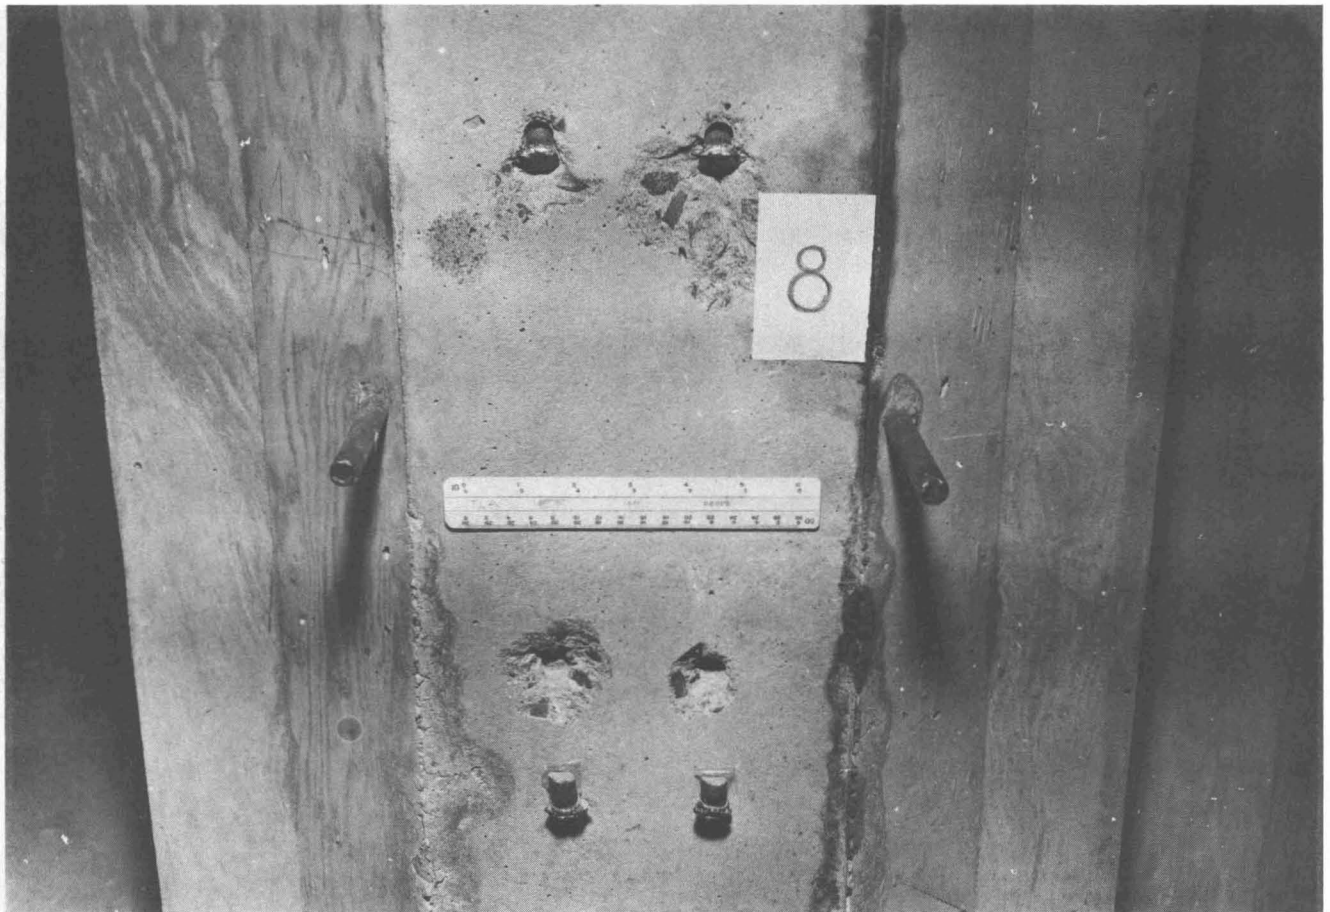
Fig. 13A

Specimens No. 7 and 8 developed not only a fatigue fracture at the base of the studs but also approximately 3/4 inch above the base. Fig. 13 shows a picture of specimen No. 8 after failure. The short pieces broken out of the studs are visible on Fig. 13b. Inspection of the upper studs showed that the second fatigue fracture was progressed through almost the entire section. A possible failure mechanism is sketched in Fig. 14. The first fracture developed at the base of the stud. After considerable cracking the stud was still held in the concavity of the beam material. Under these conditions the bending moment at the base of the stud was greatly reduced and a new maximum developed, as indicated in Fig. 14b, causing ultimately the second fracture. It should be mentioned that both specimens, having L-Connectors, were tested at relatively low stresses, sustained 1.748 and 2.815 million cycles respectively and developed comparatively little slip prior to failure.

(A) FIRST FRACTURE

(B) SECOND FRACTURE

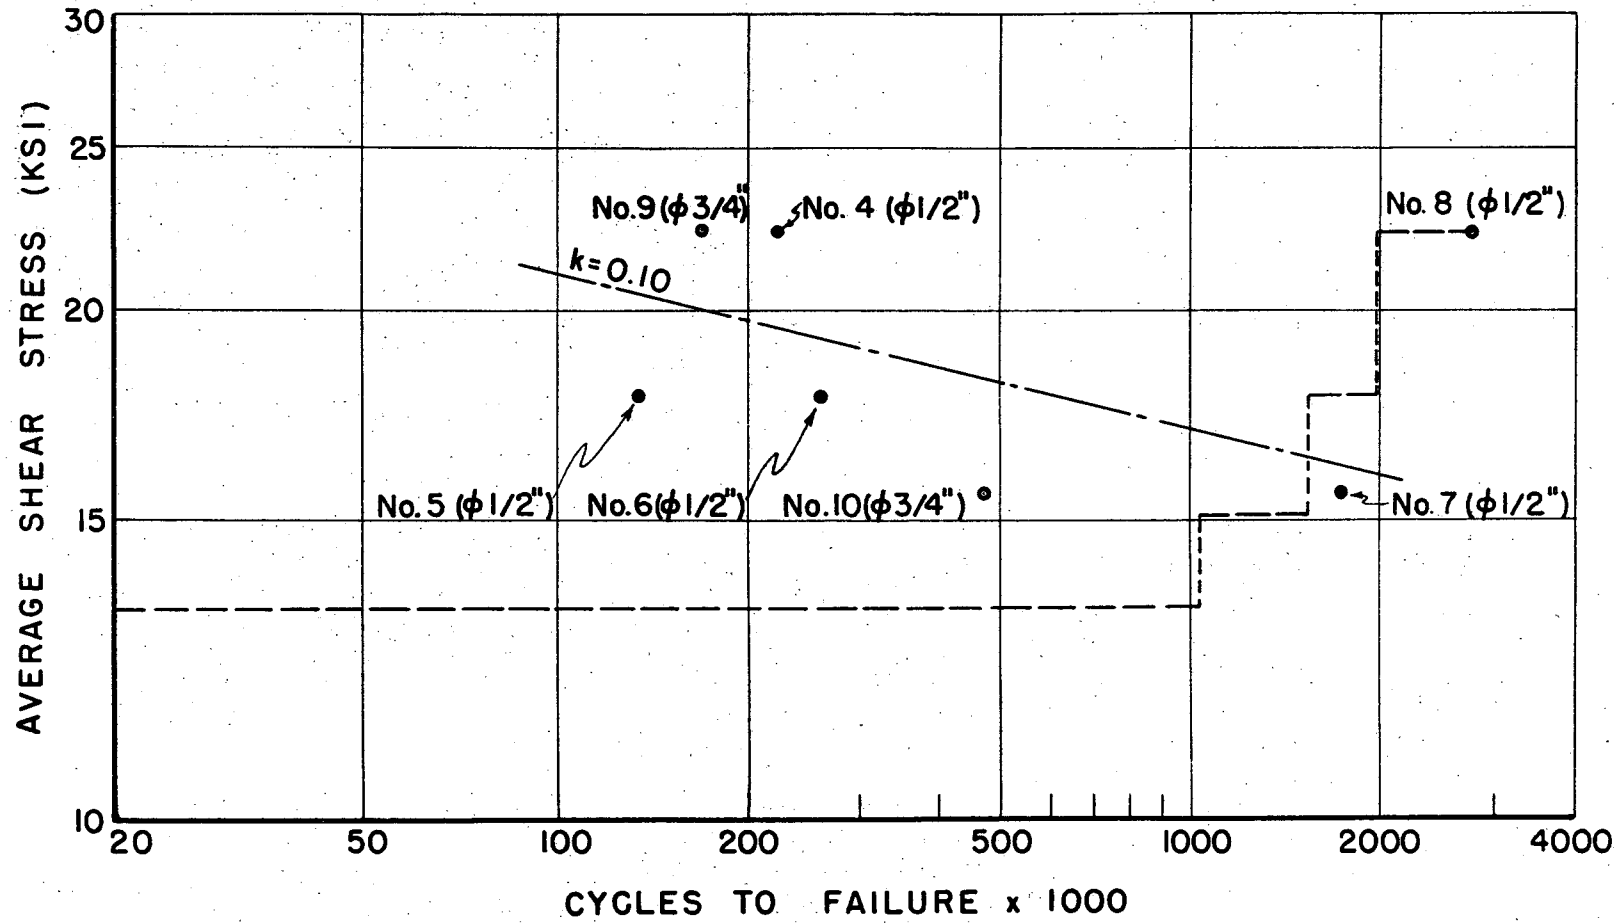
FIG. 15 - FATIGUE TEST RESULTS

All fatigue results are summarized in Table III and Fig. 15. In addition to the test results, Table III lists the fatigue strength of the L-Connectors at 100,000 also 600,000 and 2,000,000 cycles respectively. The derivation of these latter values will be discussed in chapter V. Fig. 15 presents a standard logarithmic plot of the results. The stepped curve for specimen No. 8 indicates that the maximum average shearing stress on the studs was increased in steps as discussed previously.

Comparing the behavior of the haunched specimen, No. 8, with 1/2 inch diameter L-Connectors and the flat specimens carrying the same connectors the first showed at least equal if not superior performance (Fig. 15). It should be remembered that the L-Connectors were only 2-1/4 inch high whereas the haunch was 3 inch deep. Furthermore, no connection between the slab reinforcement and the studs was provided. At the final failure load $P = 35,000$ lbs. the average concrete shearing stress v_c in the haunch at an elevation equal to the height of the studs reached

The fatigue test results obtained on the specimen with L-Connectors as plotted in Fig. 15, establish only specific values of fatigue strength at preselected stress levels. In order to obtain the fatigue strength corresponding to a given number of cycles, recourse to some extrapolation procedure is necessary. Assuming the relationship

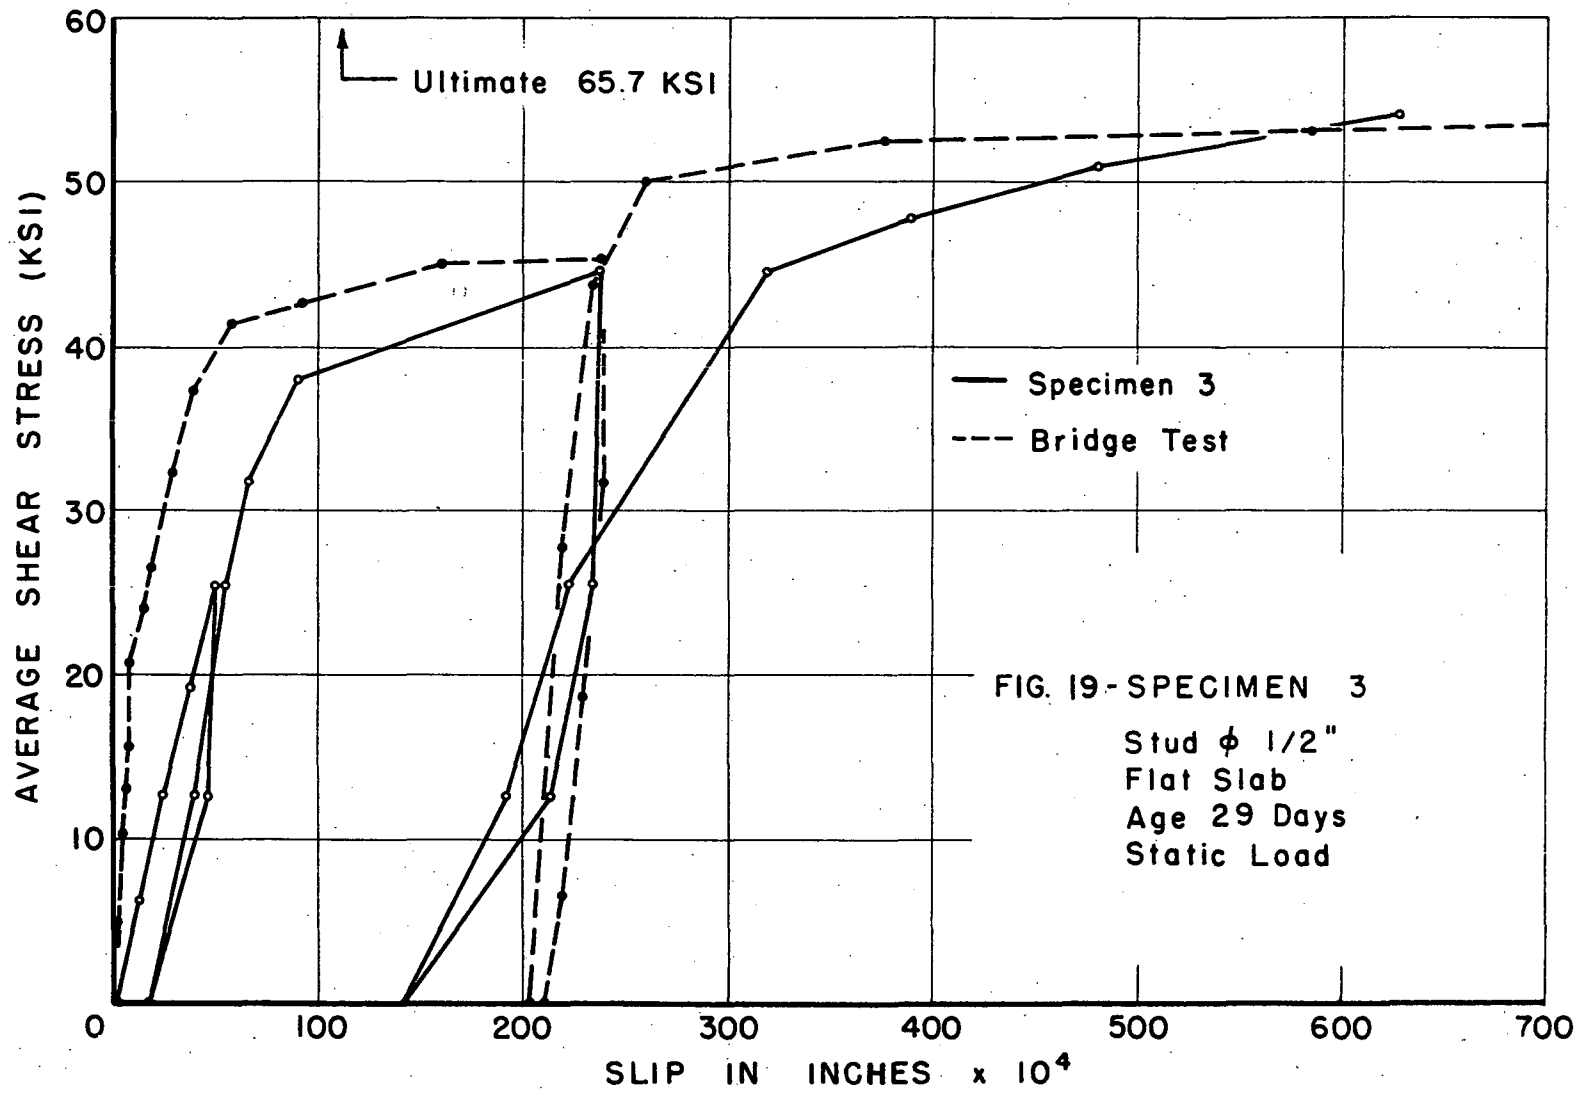
The results of the three tests are plotted in Fig. 17 to 19, showing the average slip recorded by the four dials versus the average nominal shearing stress of the studs, the latter being the load divided by the cross sectional area of all studs. For specimens No. 1 and 2 the difference between the four individual slip readings did not amount to more than $\pm 20\%$. However, for specimen No. 3 it increased over 100% for high loads. It should be therefore recognized that not only under fatigue loading but also under static conditions a considerable spread between individual slip readings must be expected. Approaching ultimate load, a marked influence of the loading speed on the value of the load itself was experienced in all three tests. For that reason not too much significance should be attributed to the recorded ultimate load. Its value does not have any bearing on the design of shear connectors anyhow.

In Fig. 19 the end slip measured on the bridge specimen reported in (1) with 1/2 inch diameter L-Connectors is also shown. The curve presents the average of the slips on the South East and South West end plotted in Fig. 8a and 8b of the mentioned report. The correspondence with the curve obtained from the push-out specimen No. 3 is fair. It therefore may be concluded that the push-out test produced essentially the same conditions as normally existing in actual composite beams.

The relative behavior of 3/4 inch diameter, 4 inch long straight studs and 1/2 inch diameter, 2-1/4 inch high L-Connectors can be judged by comparing Fig. 17 and 19. Specimen No. 3 with the 1/2 inch L-Connectors showed definitely a higher stiffness and less residual slip and hence confirmed similar findings reported in (1). A qualitative explanation can be given using the reasoning previously applied to explain the superior fatigue behavior of these connectors. The smaller stress concentrations, the lower bearing pressures and the wedging action produced by the L-Connectors improve their performance.

No appreciable difference developed between the haunched specimen No. 2 and the flat specimen No. 3 with 1/2 inch L-Connectors up to 0.05 inch slip. The difference in the ultimate load is of no significance as this load does not enter into design considerations. At the failure load $P = 116,000$ lb. of the haunched specimen No. 2 the average concrete shearing stress v_c in the haunch at an elevation equal to the height of the connectors was

Considering the useful static capacity of the L-Connectors the two tests No. 2 and 3 give additional support to the recommendations made in reference (1). At a stress $v_{st} = 38,000$ psi the slip curve for specimen No. 3, Fig. 19, shows a definite break. The corresponding residual slip, as estimated from the figure, reached about 0.003 inches. The slip curve of the haunched specimen No. 2, Fig. 18, exhibits a somewhat less pronounced increase in slip at the same stress level. The increased residual slip of 0.007 inches should have no influence on a satisfactory performance. Multiplying the above stress by the cross sectional area of a L-Connector produces the connector force $Q = 38,000 \cdot 0.196 = 7,450$ lbs. This value corresponds very closely to the value $Q = 7,310$ lbs. determined on the bridge specimen as governing the useful capacity of L-Connectors in accordance with the appropriate criteria of the AASHO Specifications (8).
