TEST OF JUMBO SHAPE
WITH SURFACE SEAMS

Bethlehem Steel Corporation

December 1972

Fritz Engineering Laboratory Report 200.72.13.4

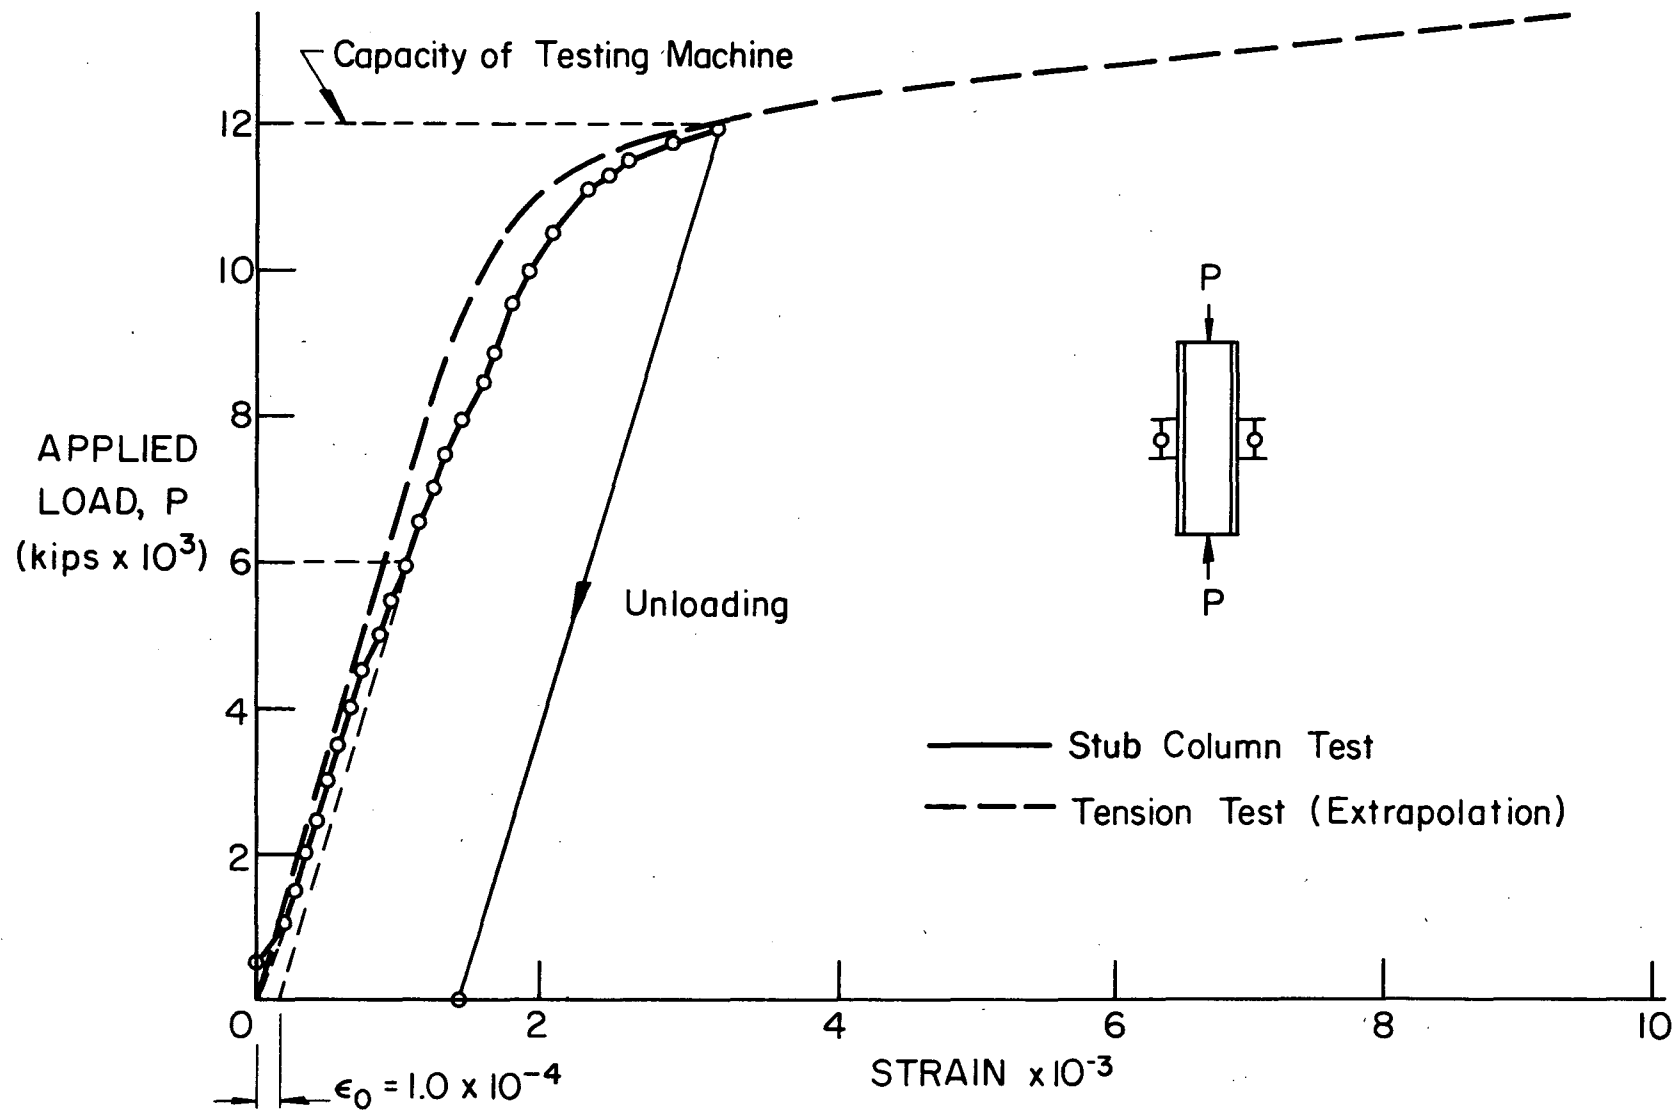
Fig. 6 Stub Column Test Result

Figure 5 shows the stub column set-up and the instrumentation. The test was performed in the 12-million pound capacity testing machine at the National Bureau of Standards, Gaithersburg, Maryland. The average stress-strain curve obtained from this test is shown in Fig. 6. Using an offset of 10 micro in./in. the proportional limit was estimated to be 28.0 ksi for the stub column. The testing was terminated when the specimen was loaded up to the capacity of the testing machine (12 million pounds). At this load, the specimen was beyond the initiation of yield and had exhibited substantial evidence of yielding by the flaking of mill scale. The dashed line in Fig. 6 shows the stub column behavior that was predicted from the tension tests. The weighted yield strength level of the stub column is estimated as 60.4 ksi which is significantly greater than the minimum specified value of 50 ksi.

It is readily apparent in Fig. 6 that the stub column test is in good agreement with the prediction based on coupon tests. The results are directly comparable to other stub column tests where no seams were present.⁽⁵⁾ The deviation from the predicted curve reflects the influence of residual stresses. The maximum compressive residual stress level was estimated from the difference between the proportional limits of the tension coupons and the stub column. This yielded an estimated maximum compressive residual stress for this specimen of 16.5 ksi.

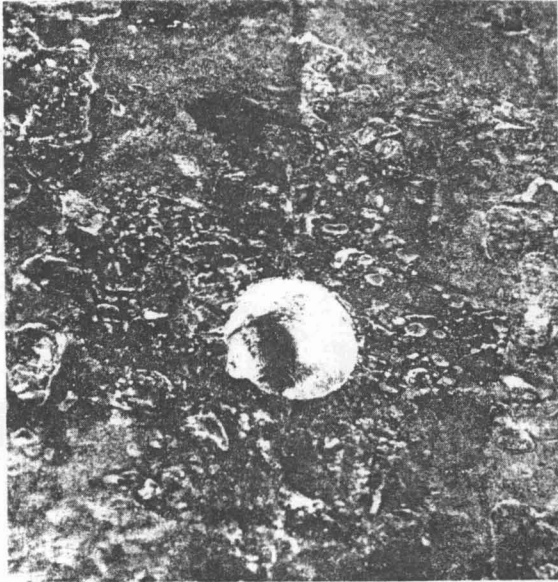
Prior to Loading

At 12,000,000 lb.

Fig. 7 Close-up of Probe Hole A

During the test each probe hole was examined for growth or change in seam size or its shape as the applied load was increased. There was no indication of any change in the size or shape of the seams due to the applied load when observed with a 50x hand microscope. This was true even though loads between 8 million and 12 million pounds were applied to the column for 30 to 45 minutes. A comparison of the conditions of the seam at probe holes A and B is shown in Figs. 7 and 8. The photographs show the specimen at the zero load level and at 12 million pounds. The seams were not changed by the high axial force.

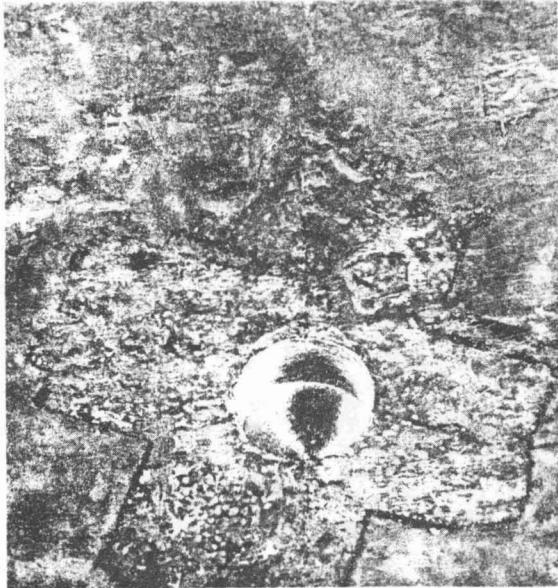
Prior to Loading

At 12,000,000 lb.

Fig. 8 Close-up of Probe Hole C
