Proposal: structural steel investigations (continuous beams, Connections, Frames) to O.N.R.

Progress Report B

PLASTIC BEHAVIOR OF CONTINUOUS BEAMS

May 26, 1949

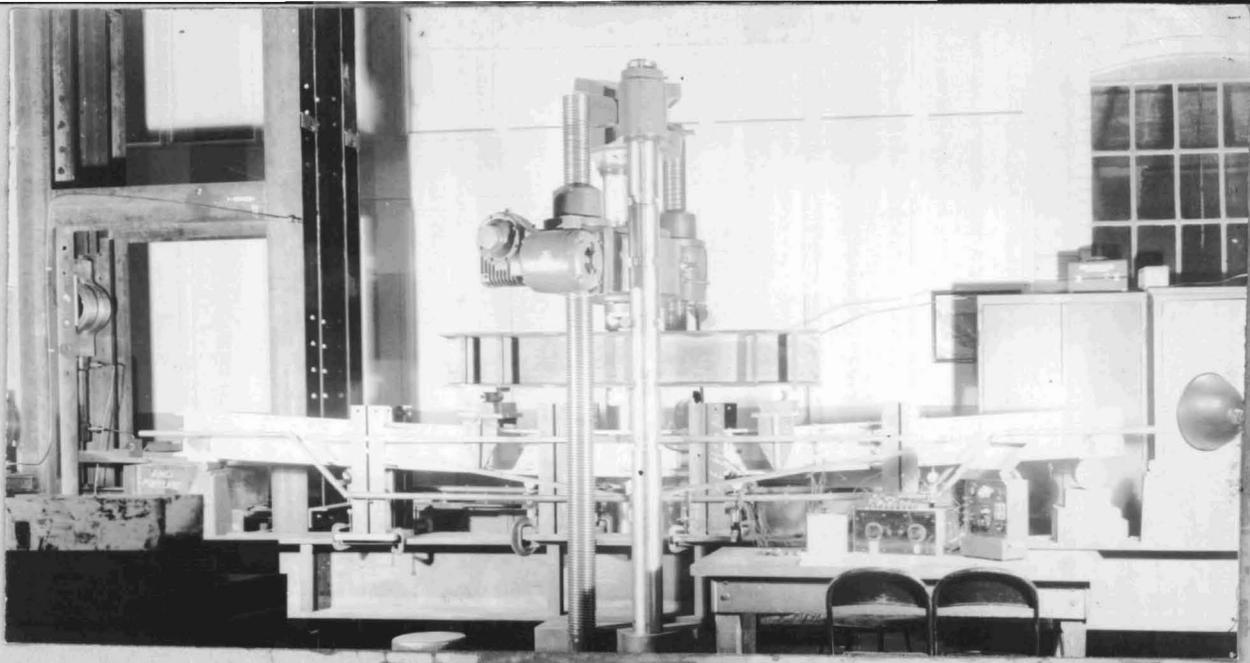
Fig. 1. Set up of simple beam control test.

The same apparatus was adopted in the control test as described in the previous progress report "Plastic Behavior of Wide Flange Beams". Fig. 1 shows the general view of the test set up.

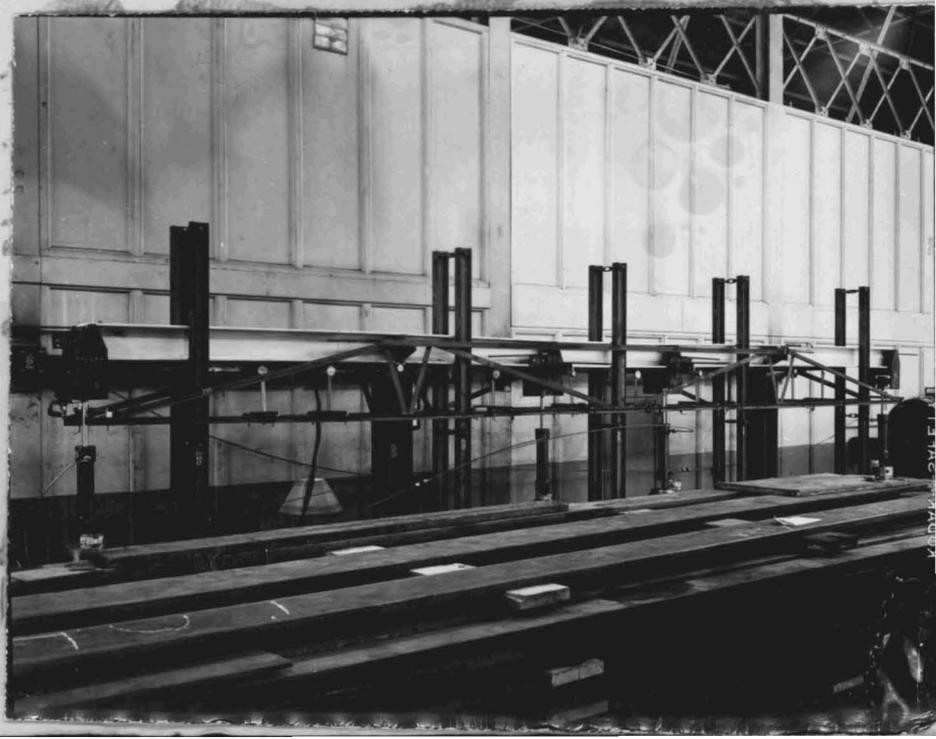
Fig. 2. Set up of continuous beam test.

A new set up was designed for testing continuous beams. The general arrangement of test is shown in Figs. 2 & 6. The specimen was supported on two rollers as shown

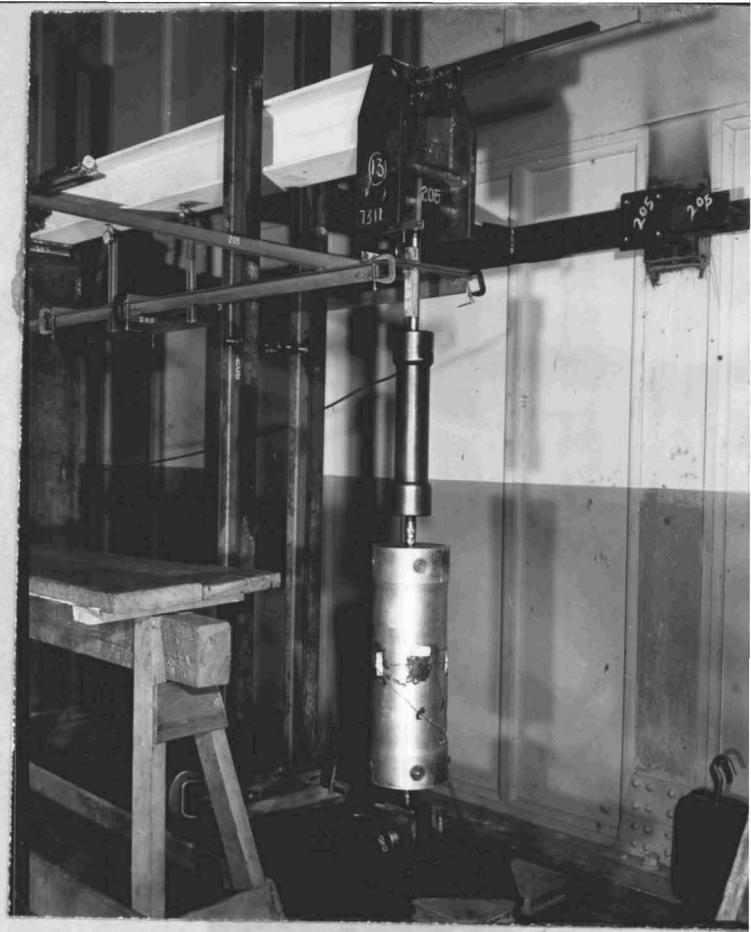
Fig. 3, The dynamometer and hydraulic jack assembly for loading the continuous beam.

Four hydraulic jacks were used for loading. Aluminum tube dynamometers were designed and calibrated for measuring the load. Forces were applied by jacks and dynamometers connected between the loading bracket of the specimens and the base beam as shown in Fig. 3.

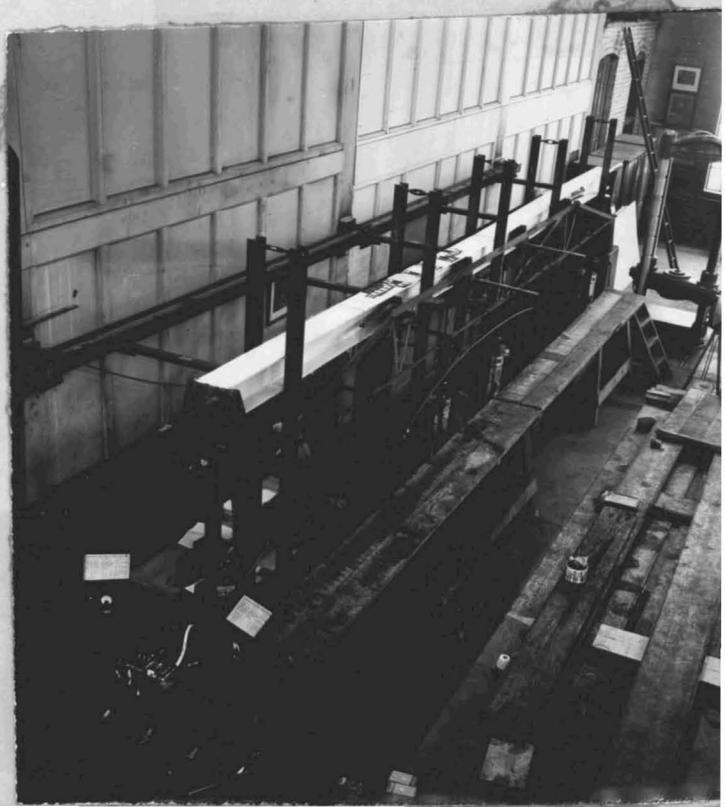
Fig. 4. Lateral support frame for continuous beam tests.

A lateral bracing frame was used for the prevention of lateral deflection as shown in Figs. 4 & 6.

The two continuous beams tested buckled laterally in the plastic range in spite of the lateral support provided (Fig. 4). Two level bars were mounted on continuous beam B3 to measure the lateral rotation of the beam. The load-lateral rotation curve is plotted in Fig. 33. The beam buckled in two half-waves between the three lateral support points in the central span at a load $W = 47$ kips. The beam was twisted after test due to lateral buckling. A picture of the twisted beam is shown in Fig. 34.

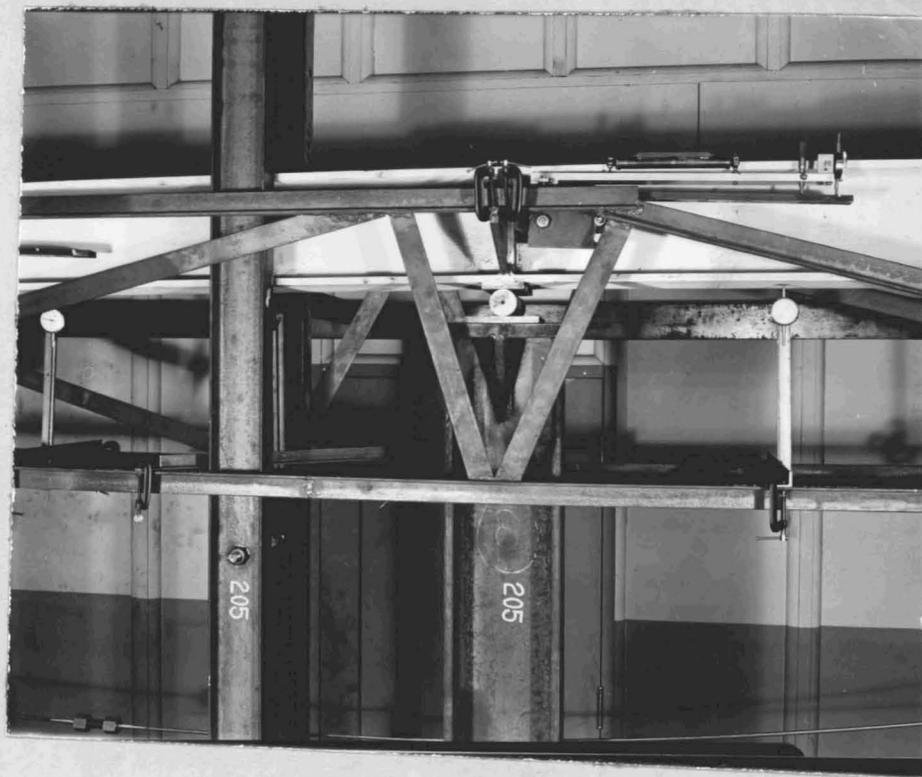
Fig. 5. Detail of vertical support in continuous beam test.

in Fig. 5. A deflection gage rig was attached to plates for mounting of Ames dial gages.

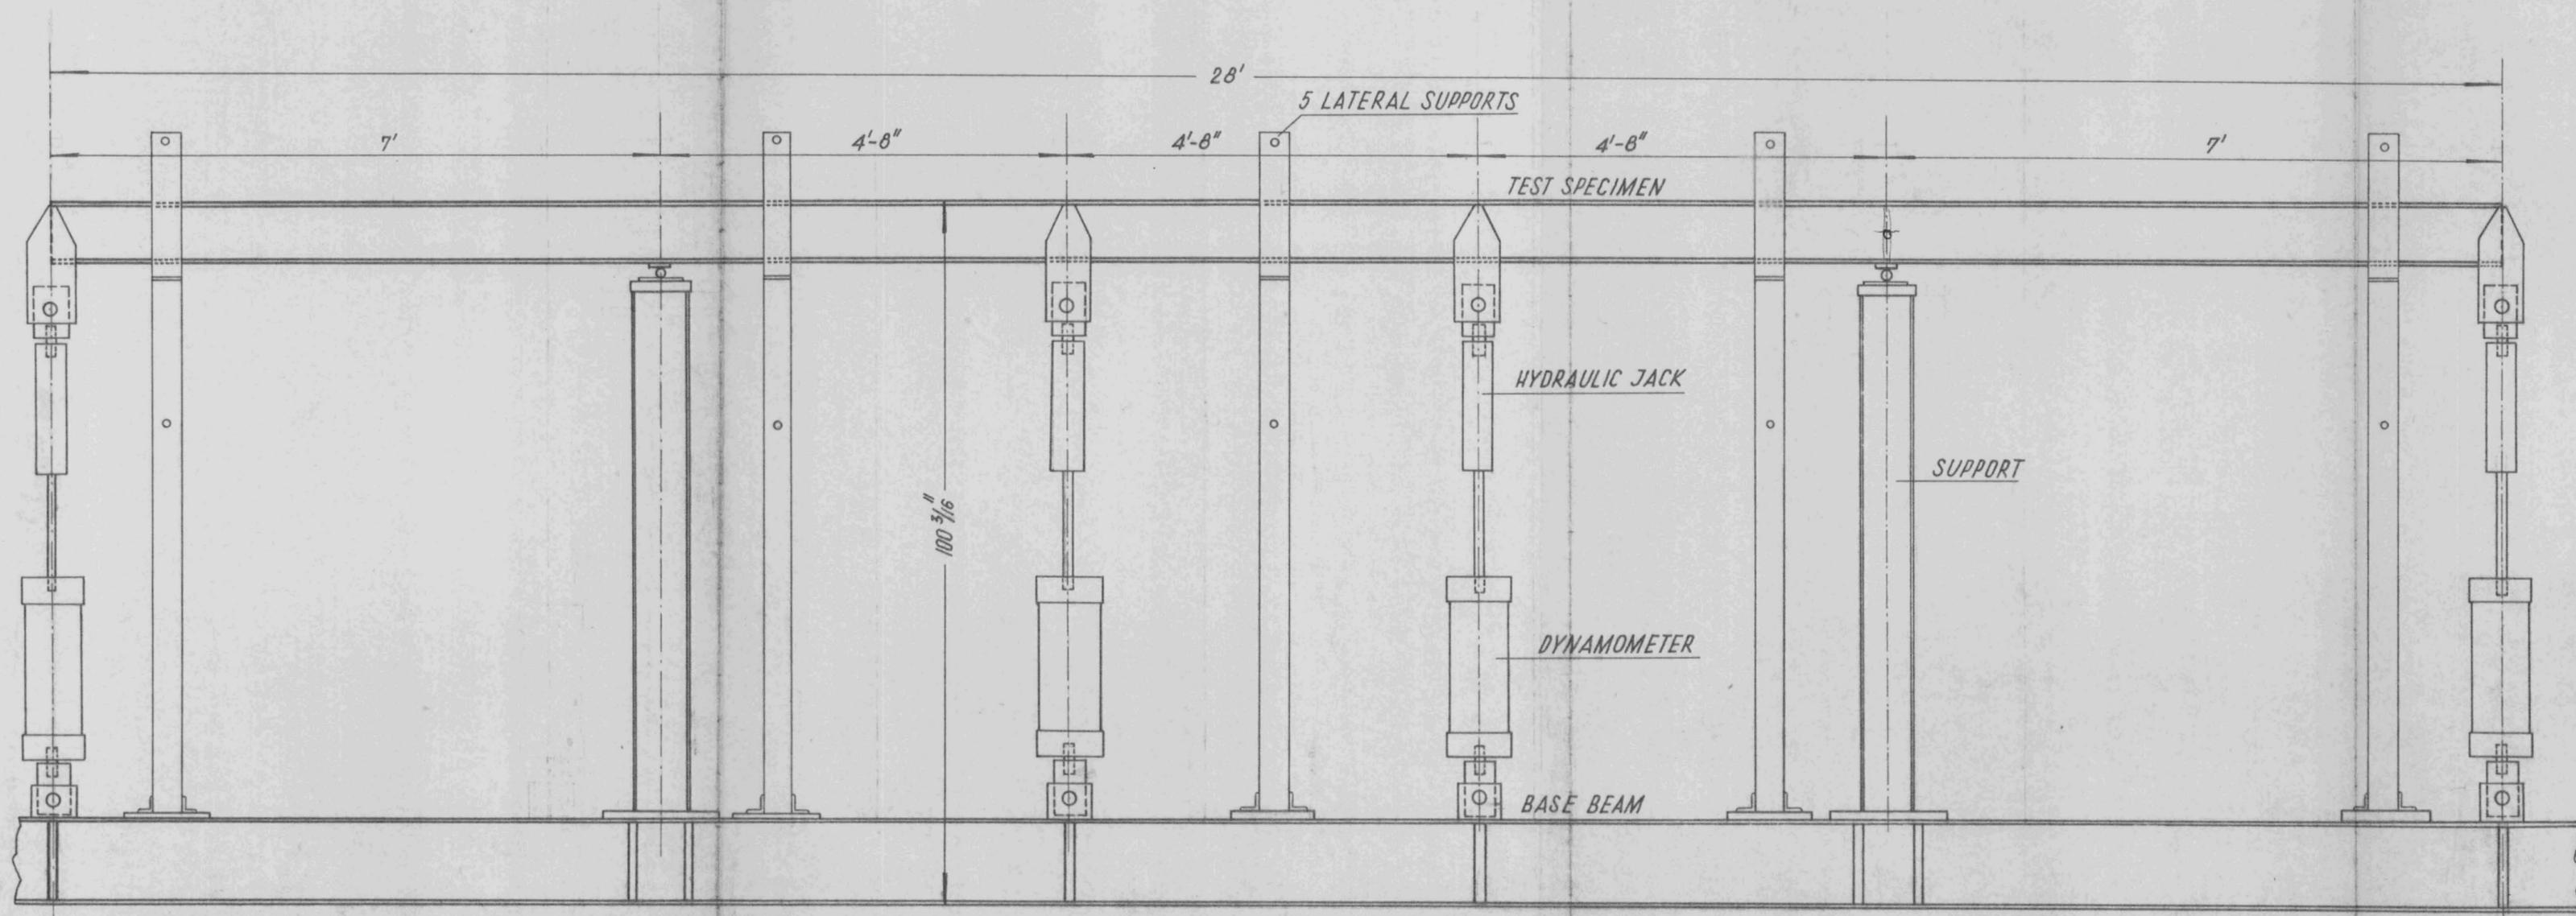
FIG. 6 - CONTINUOUS BEAM TEST SET UP

Deflection, angle rotation and strain were measured by Ames dials, level bars and SR-4 strain gages located as shown in Figs. 6, 7, 8, & 9.

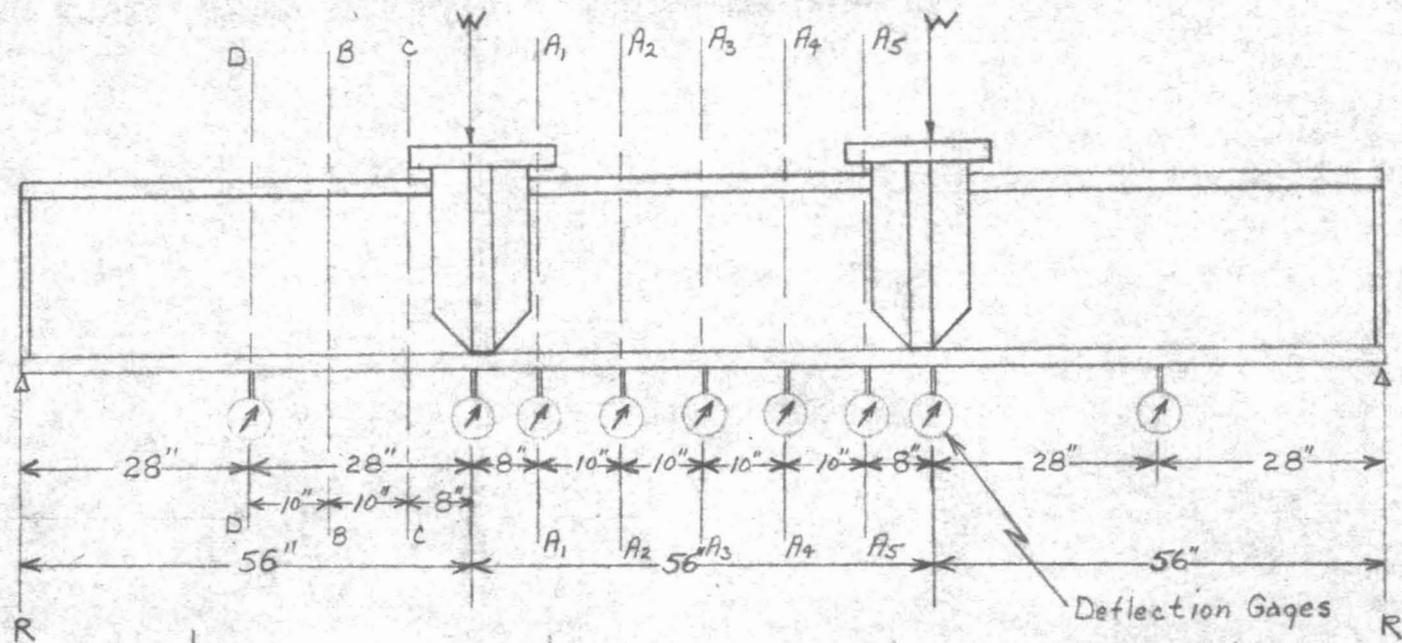
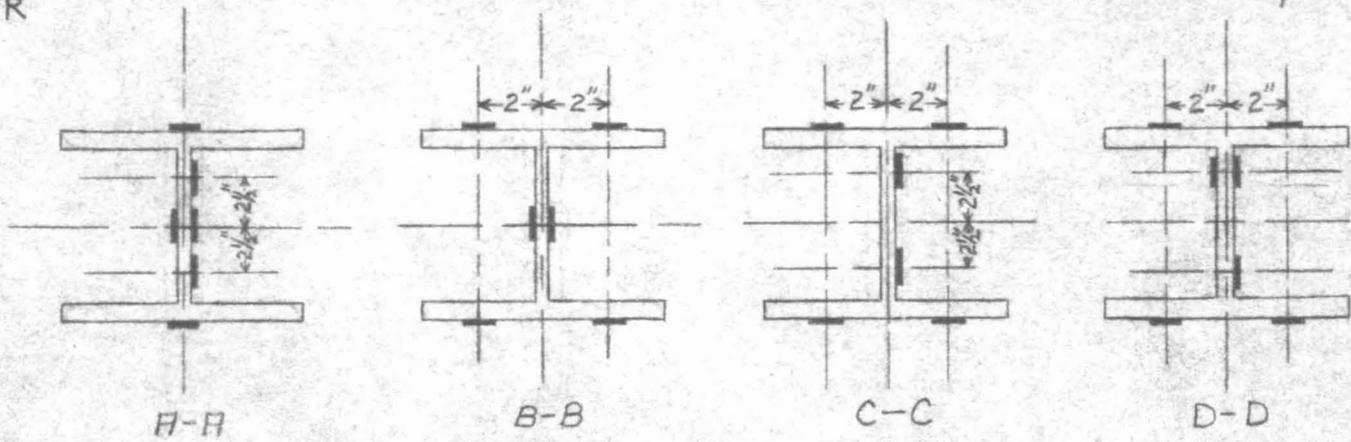
Test No. B-1
 Fig. 7
 Deflection and Strain
 Gage Locations

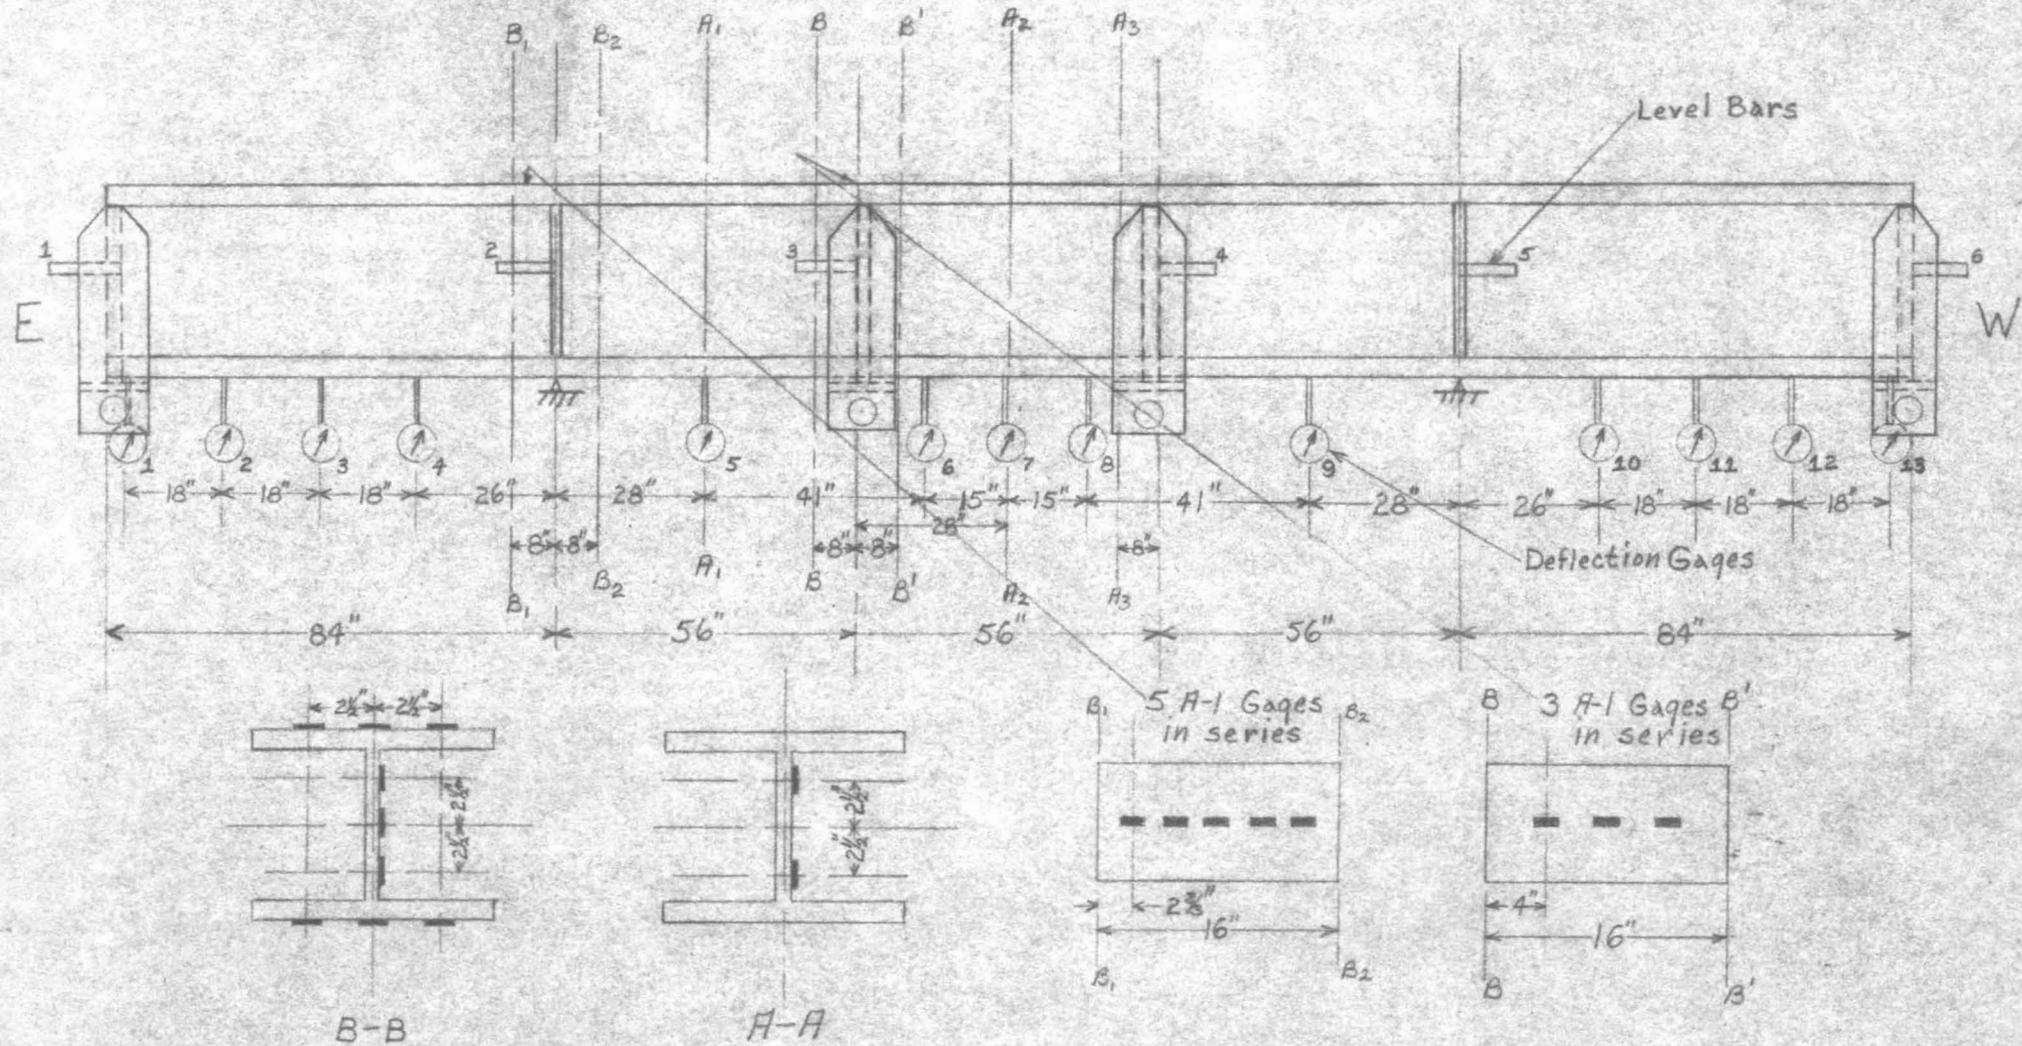
Test B2
 Fig. 8
 Deflection Strain and Level
 Gage Locations

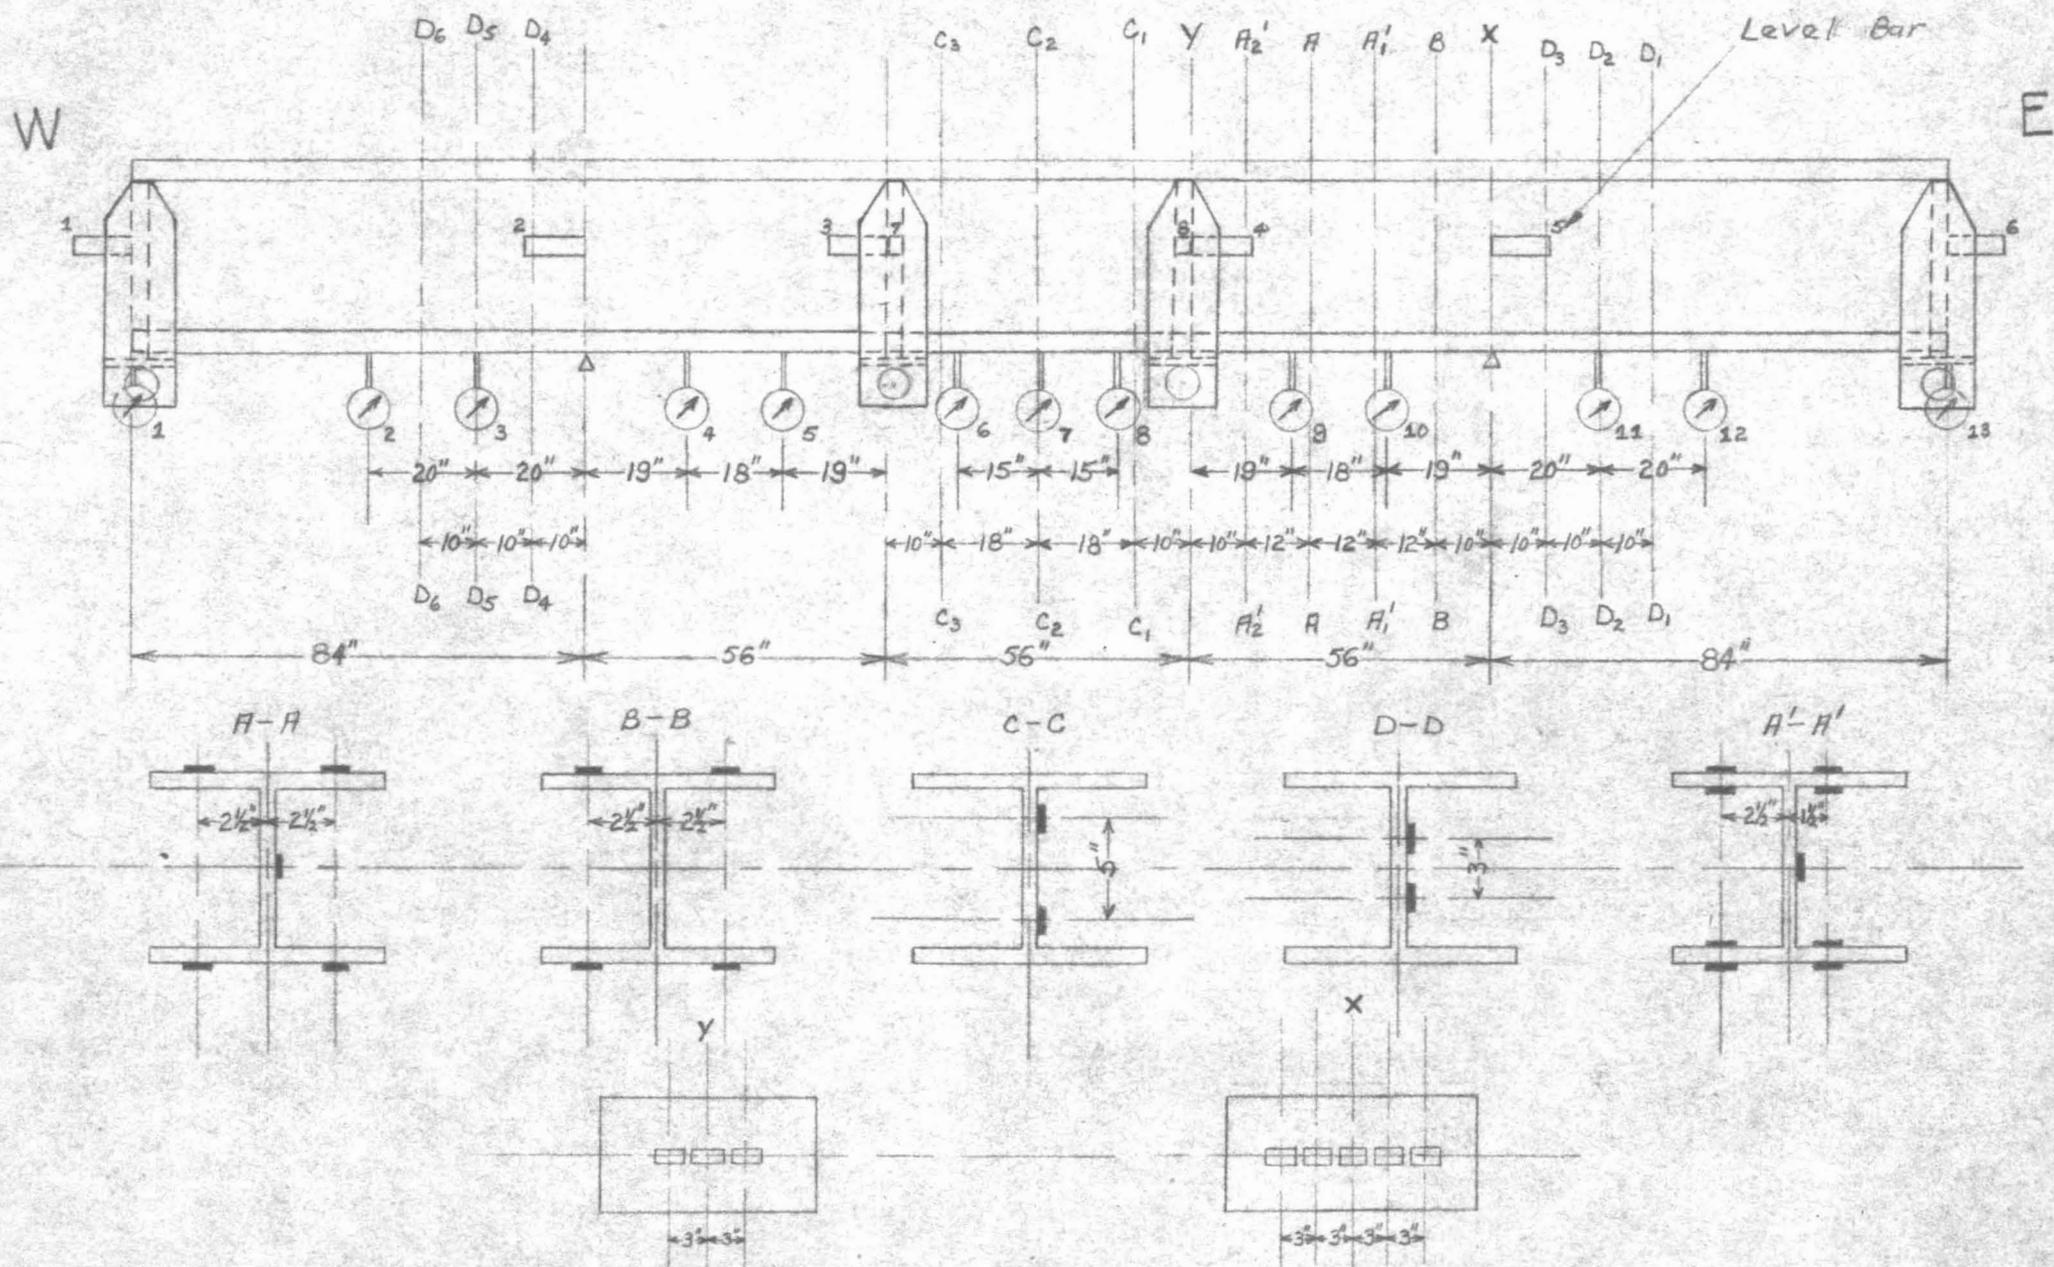
Test B3
 Fig. 9
 Deflection, Strain & Level
 Gage Locations

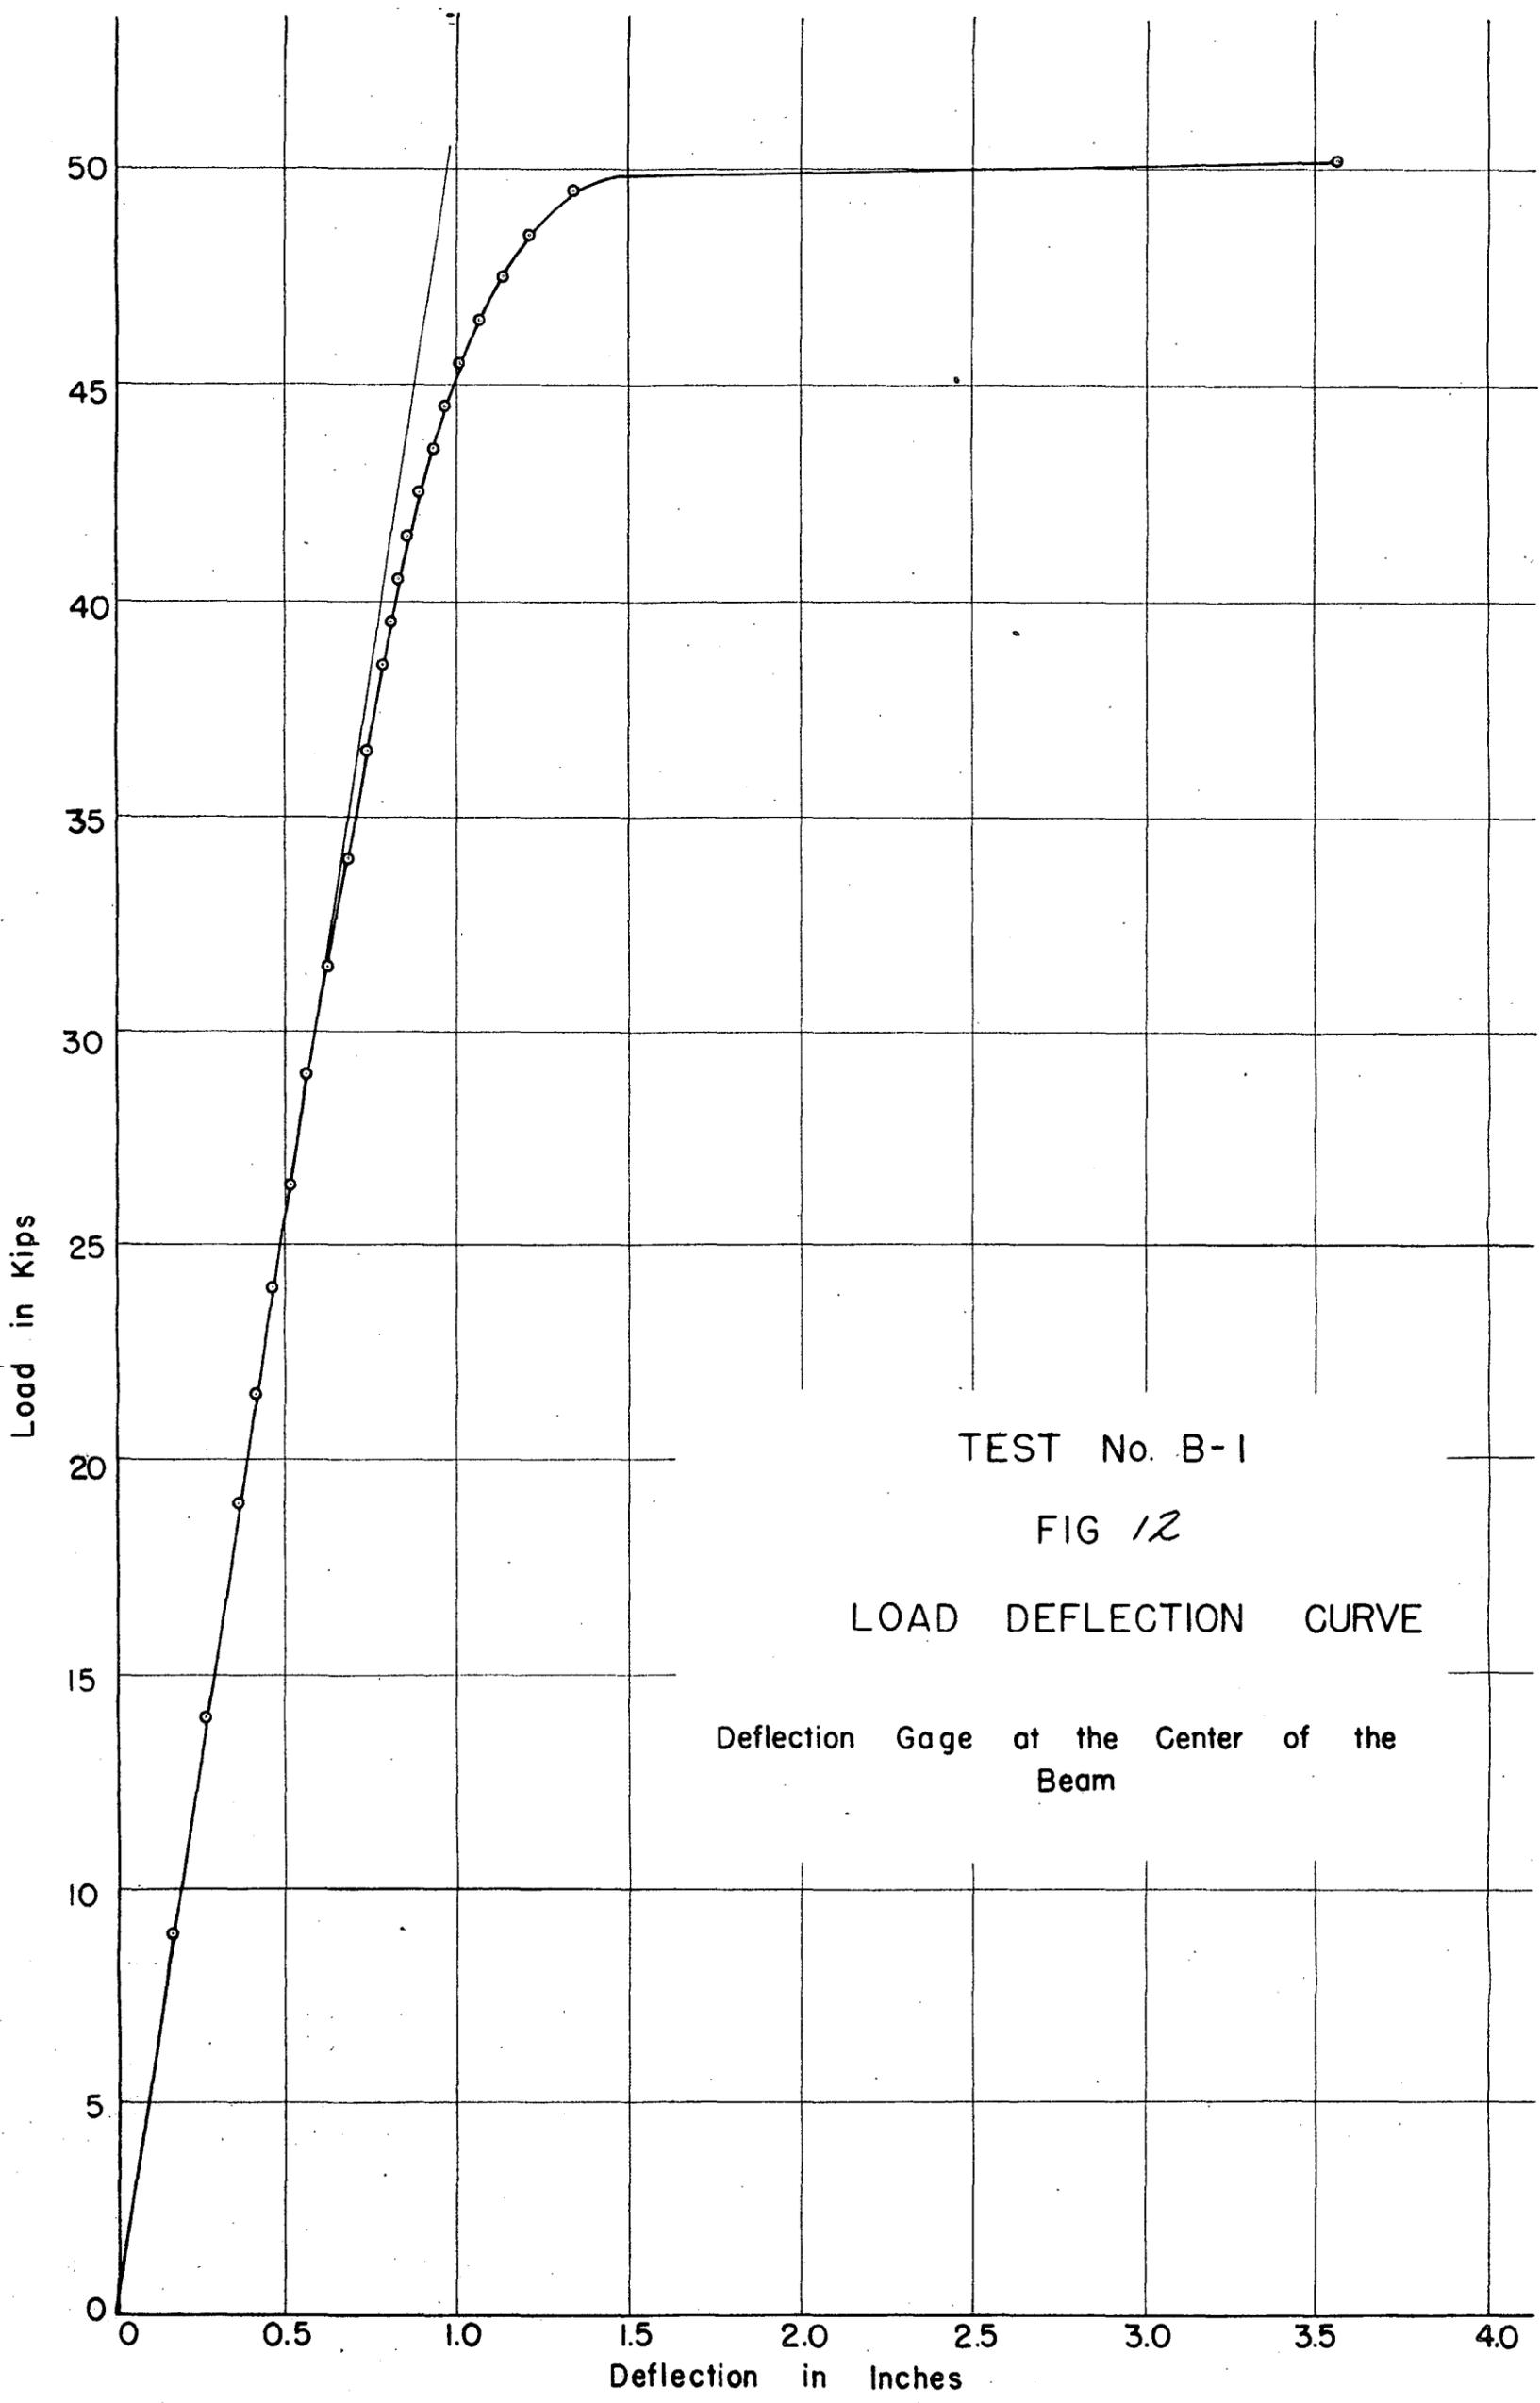
FIG 12

TEST No. B-1

LOAD DEFLECTION CURVE

Deflection Gage at the Center of the Beam

M - ϕ curves of the central section of the beam are plotted in Figs. 10 and 11. The load deflection curve is shown in Fig. 12.

The initial yield strength of the beam as observed from Fig. 12 is about 27.5 kips corresponding to a moment of 770 inch-kips. This load value observed from the load deflection curve is apparently due to local yielding around the loading brackets and is probably induced from welding residual stress and stress concentration. The remaining parts of the beam are still in the elastic range at this load as shown by M - ϕ curves in Figs. 10 and 11.

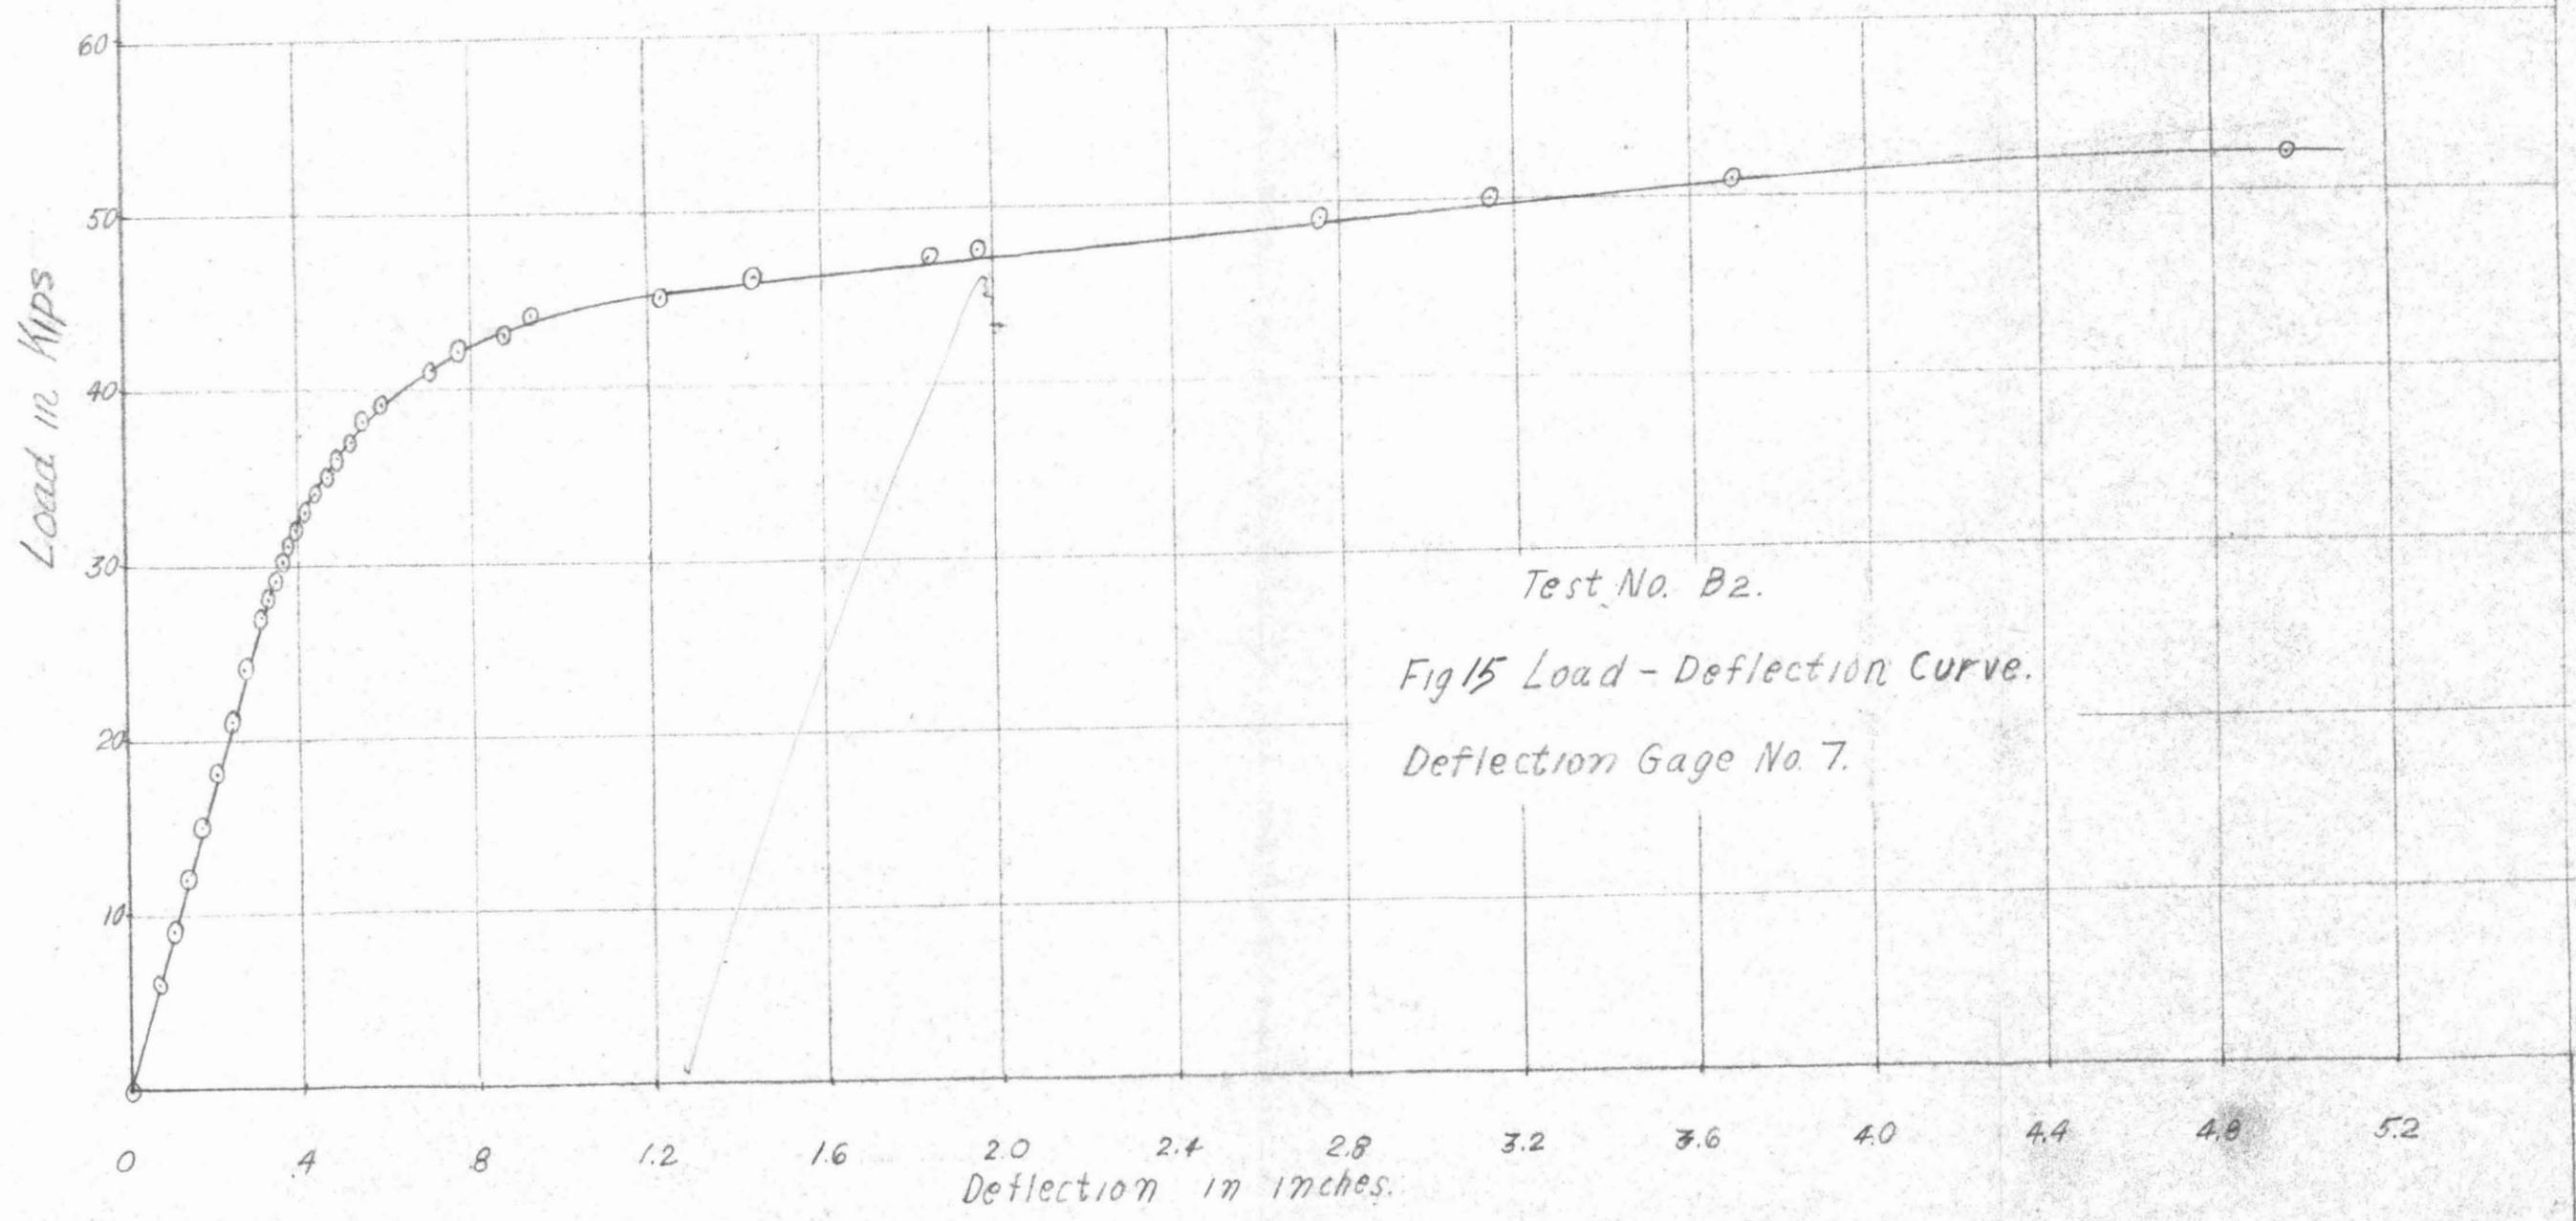
Test No. B2.
Fig 15 Load - Deflection Curve.
Deflection Gage No. 7.

The general behavior of the beam is not significantly affected by such local yielding as can be seen from the load-displacement curves shown in Figs. 15 to 18.

The load-deflection curve plotted in Fig. 15 shows, approximately, two straight lines in the first part of the curves. The first straight line represents the load deflection relation of the restrained beam before the initial yield strength has been reached. The second straight line indicates the behavior after the ends became plastic hinges and prior to yielding at the center.
