Proposal: structural steel investigations (continuous beams, Connections, Frames) to O.N.R.

Progress Report B

PLASTIC BEHAVIOR OF CONTINUOUS BEAMS

May 26, 1949

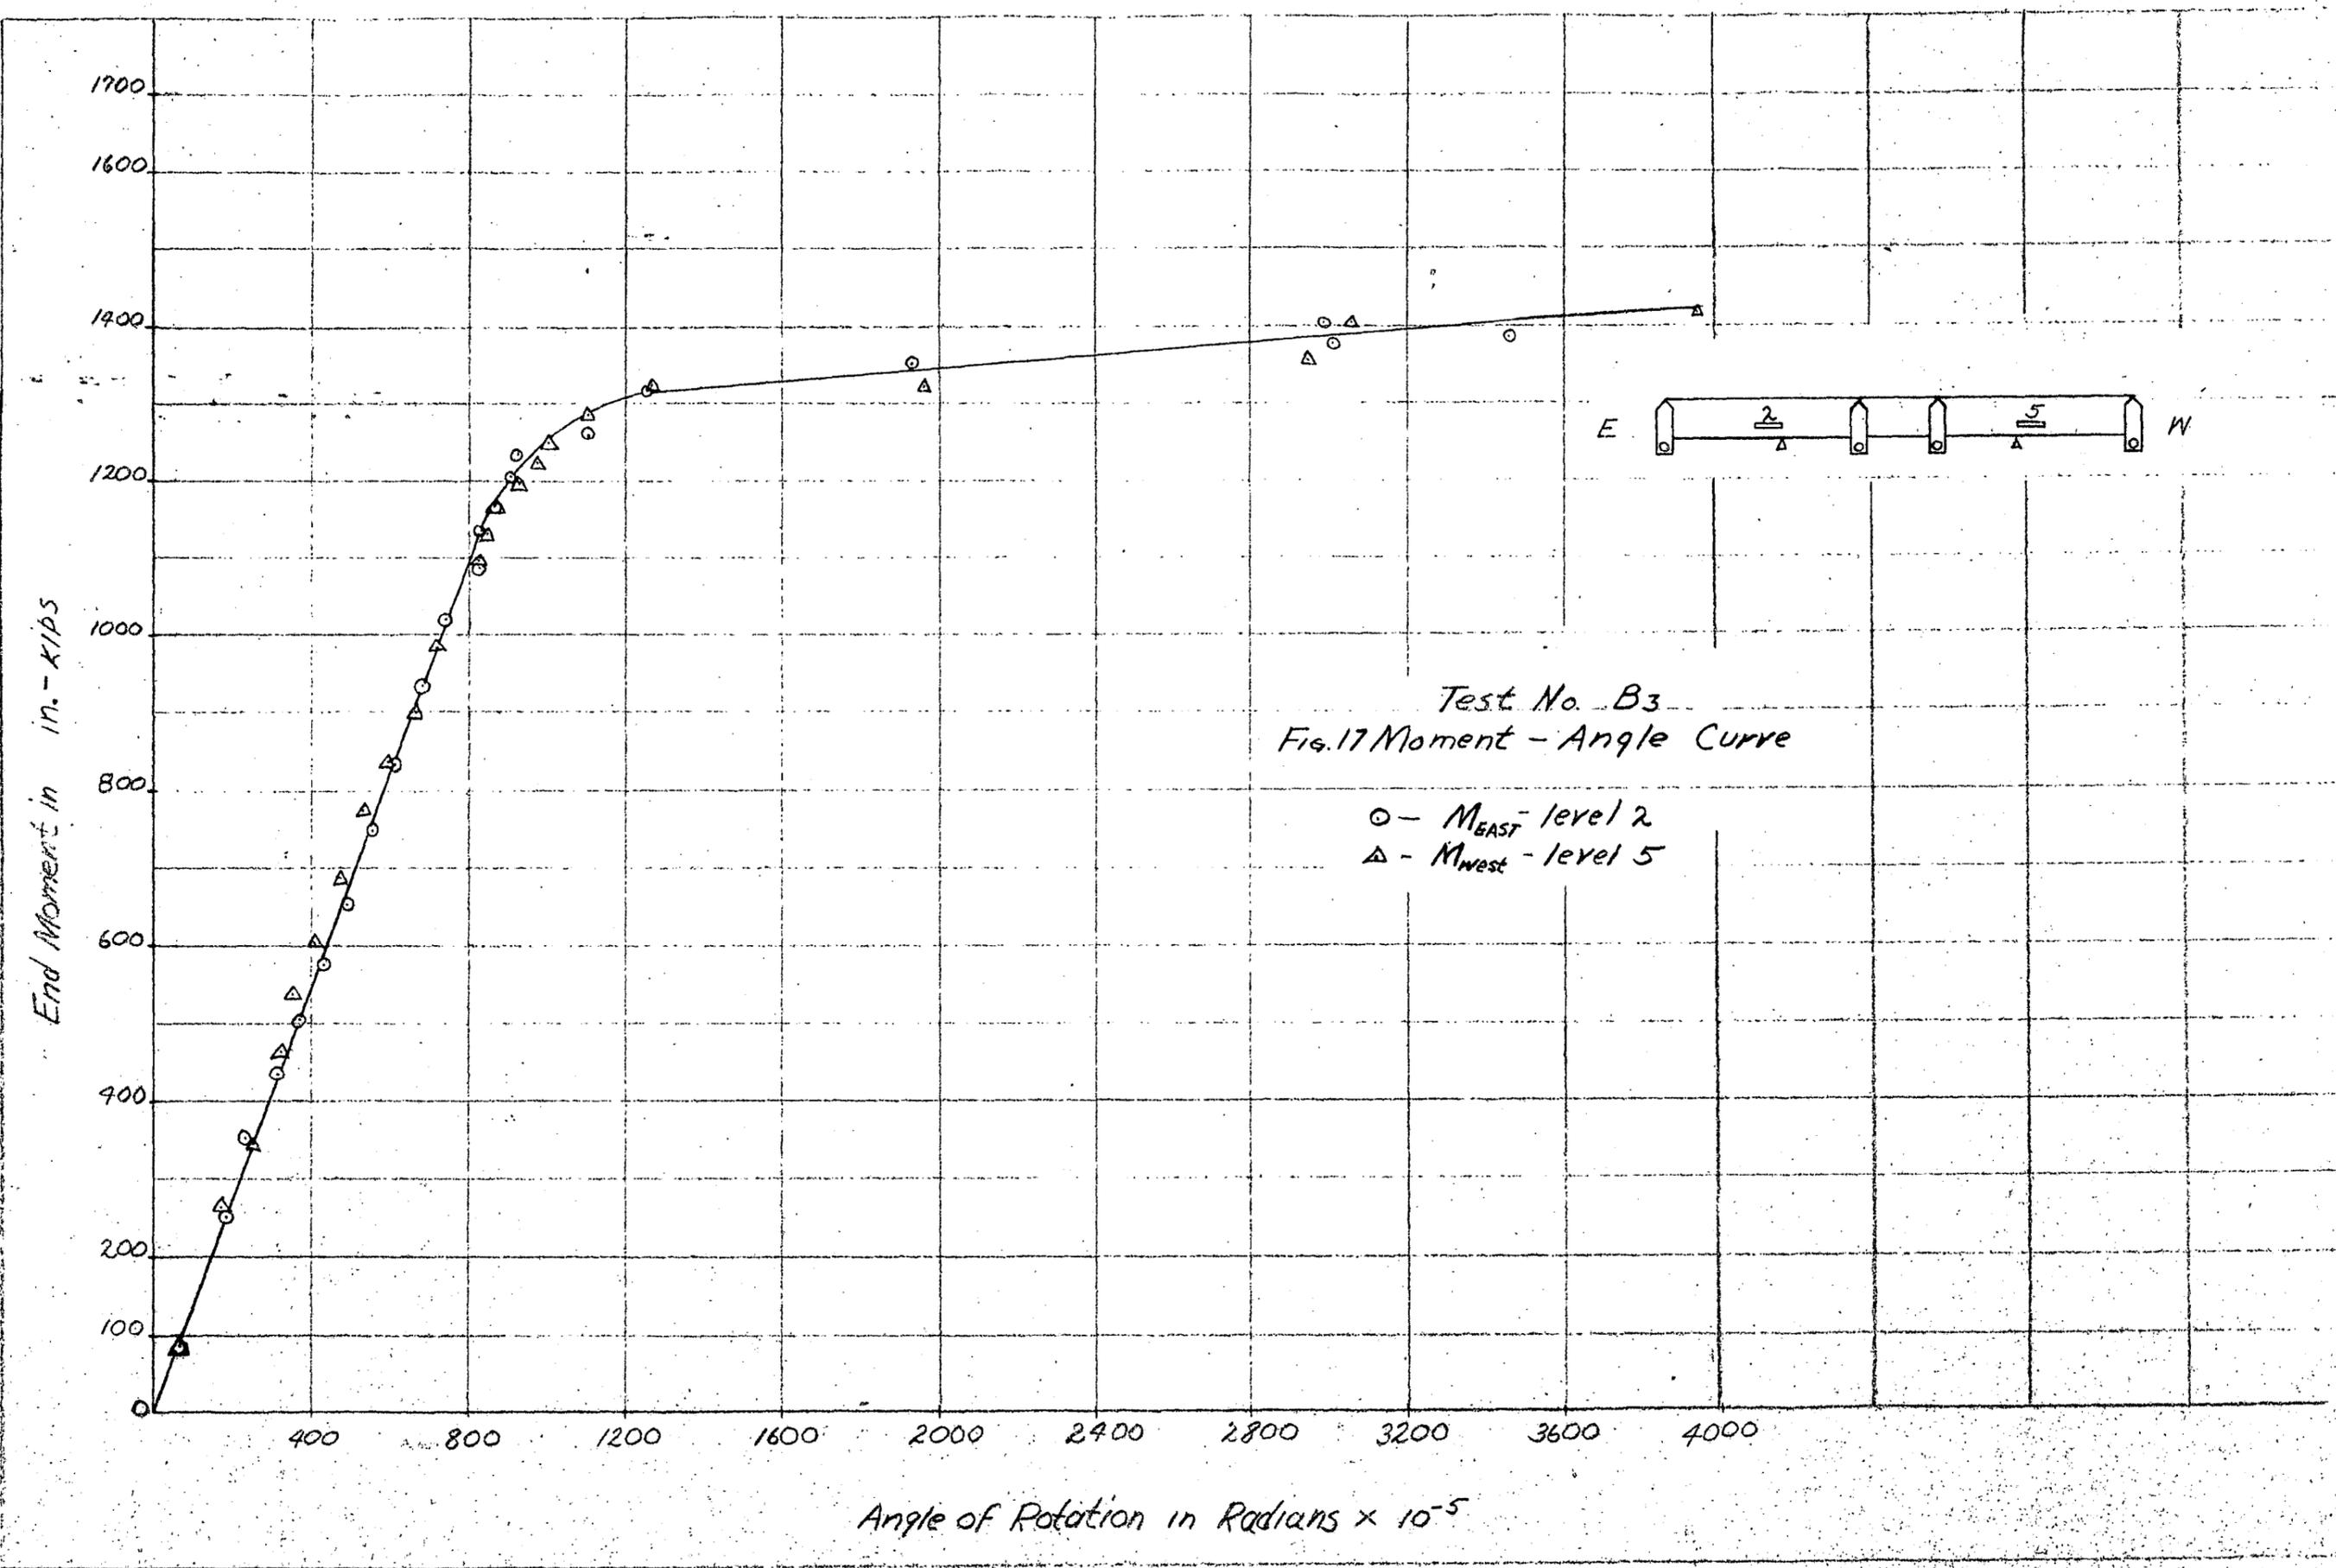
Test No. B3
 Fig. 17 Moment - Angle Curve

○ - M_{EAST} - level 2
 △ - M_{West} - level 5

The general behavior of the beam is not significantly affected by such local yielding as can be seen from the load-displacement curves shown in Figs. 15 to 18.

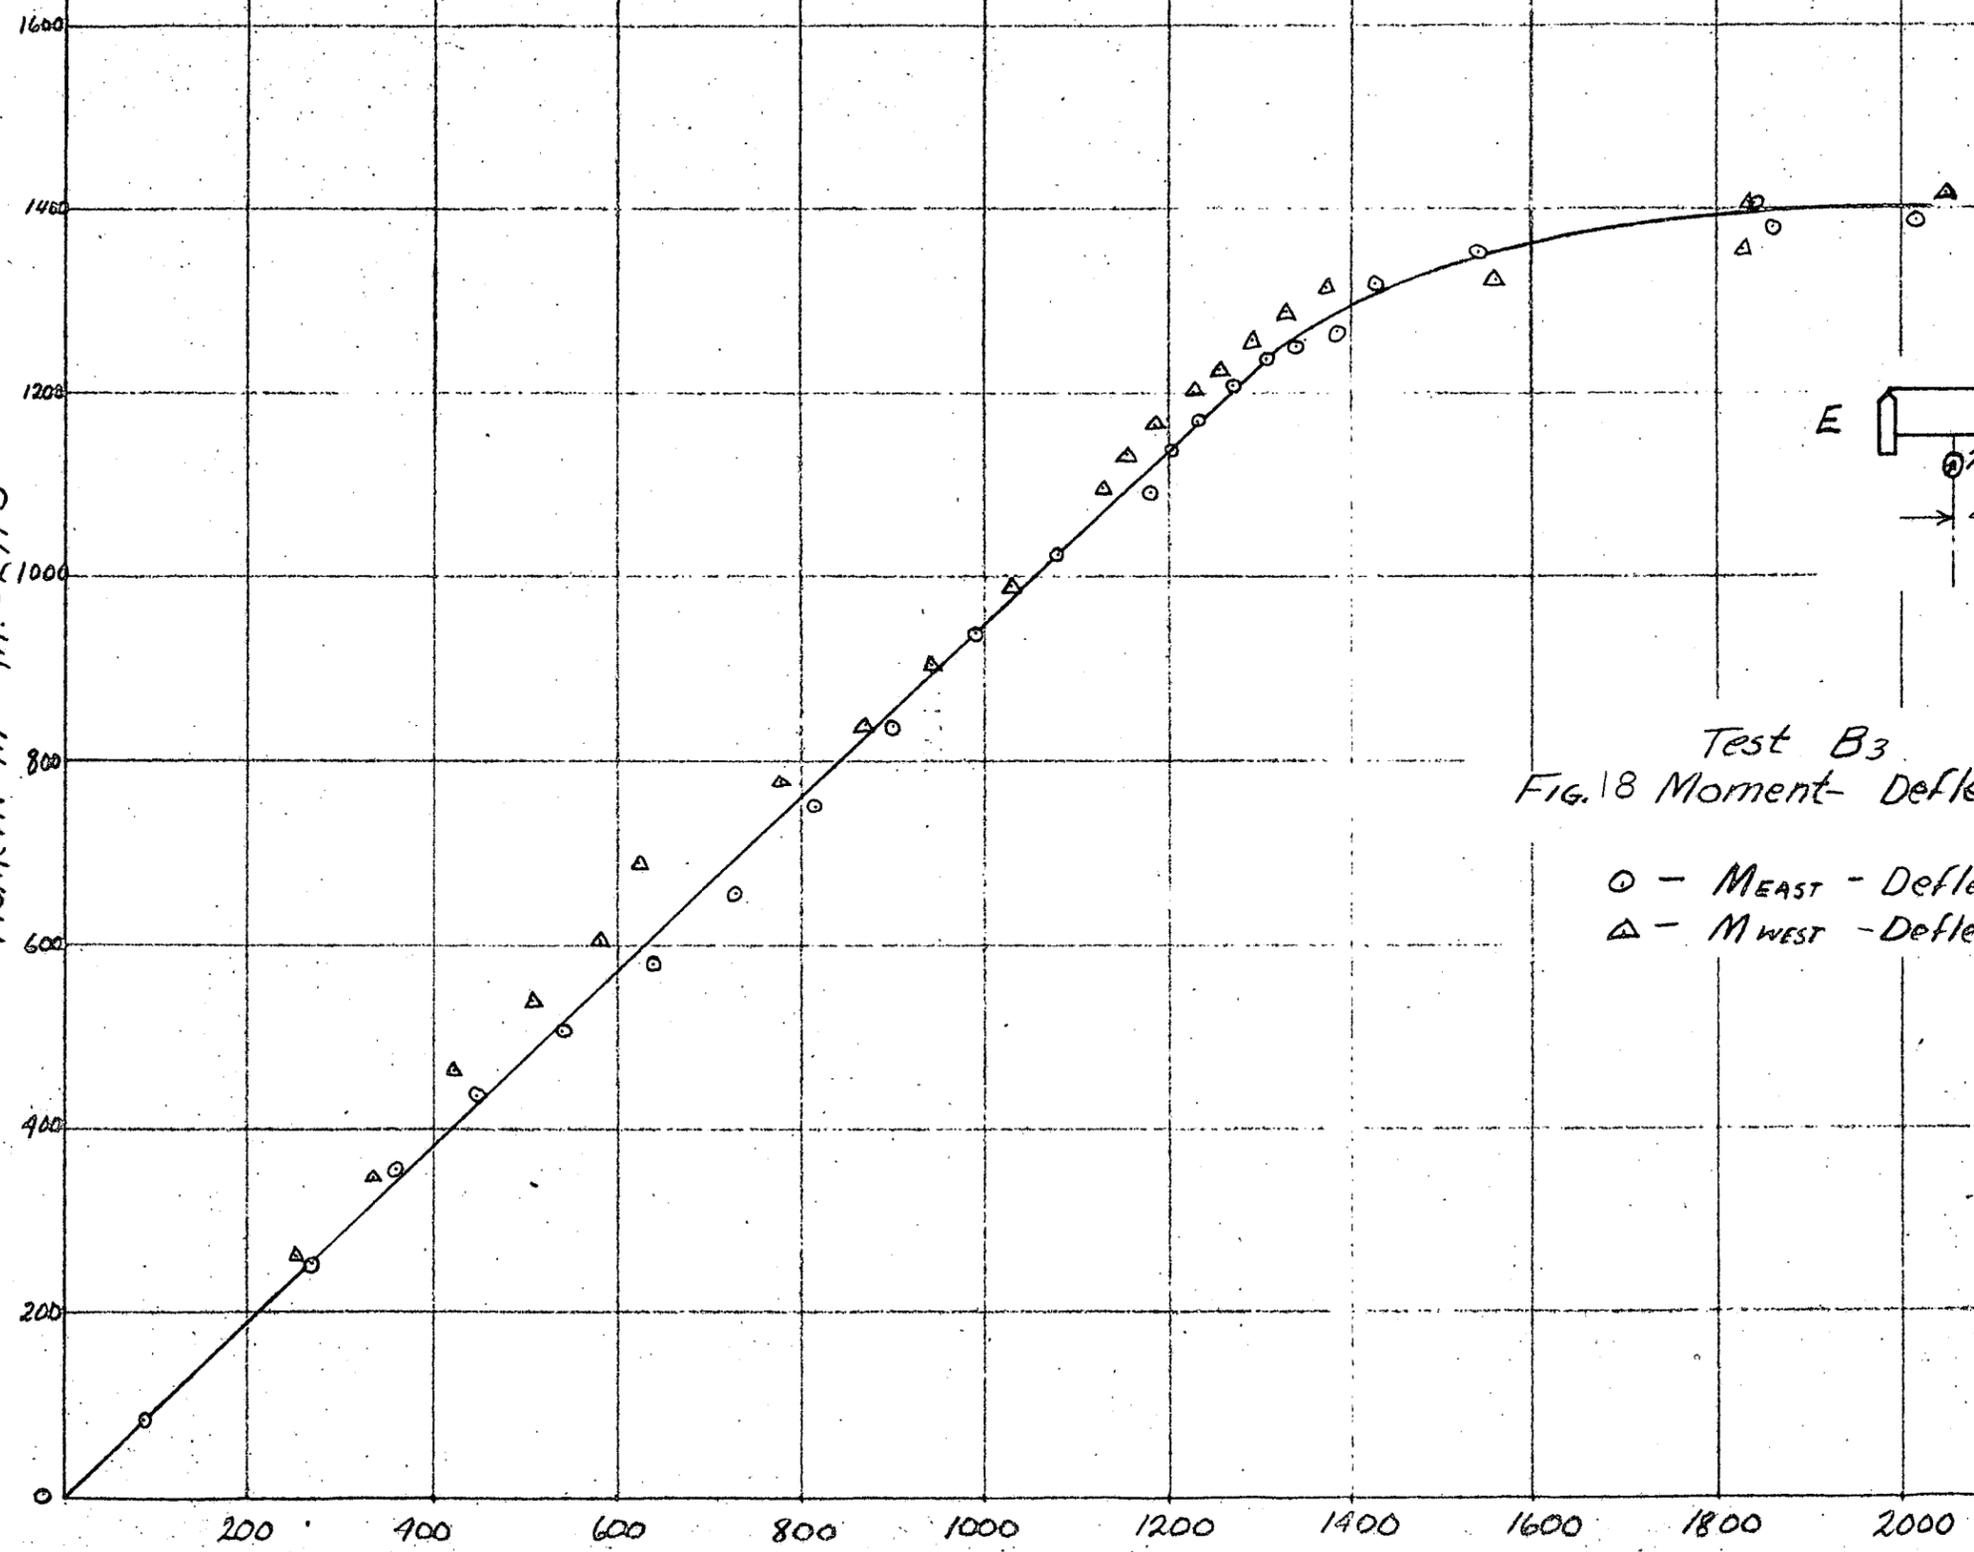
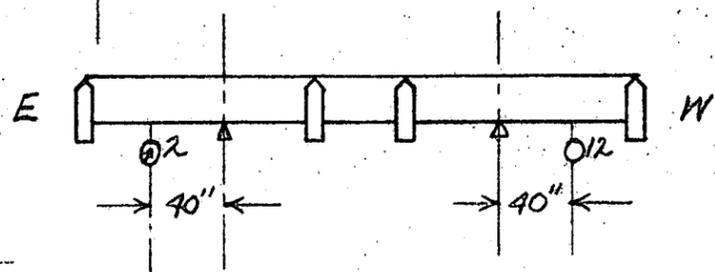
Test B3
FIG. 18 Moment-Deflection Curve

○ - M_{EAST} - Deflection Gage 2
△ - M_{WEST} - Deflection Gage 12

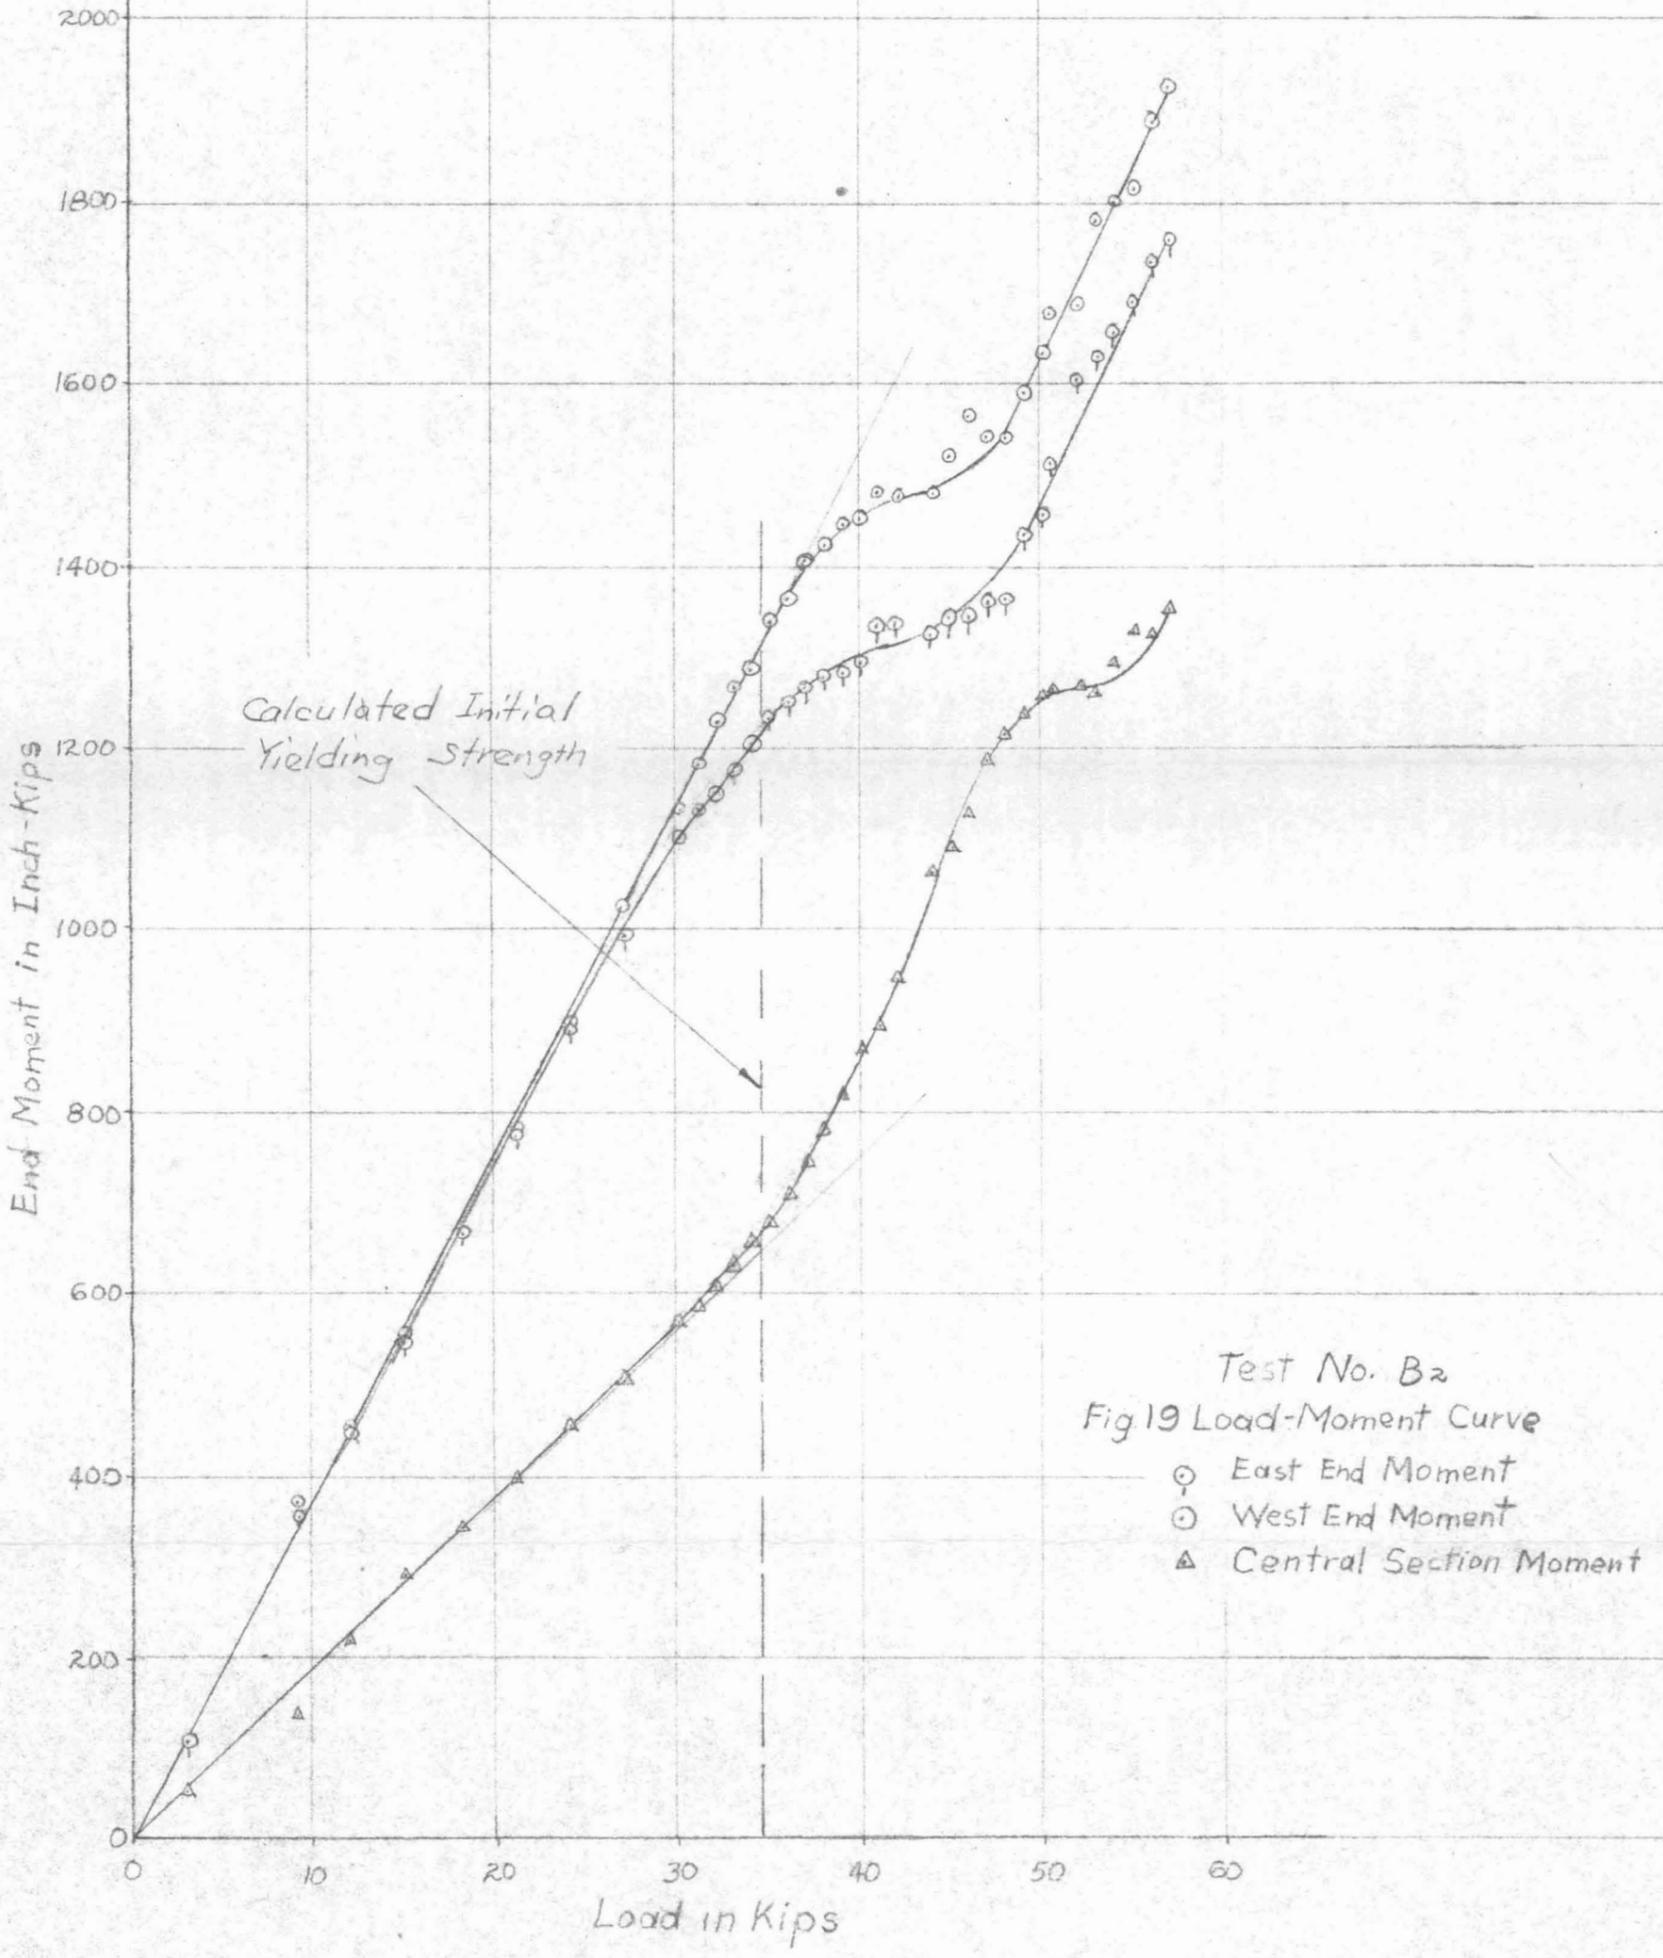
Test No. B₂
 Fig. 19 Load-Moment Curve

- East End Moment
- ⊙ West End Moment
- △ Central Section Moment

Different bending strengths were observed at the two support points of beam B2. End moments are plotted against load in Fig. 19. The east end started to yield at lower load than the west end.

For test B2 the end moments and moment at the central section are plotted in Fig. 19. The tangent straight lines are values calculated in the elastic range.

In Fig. 19 end moments were plotted against load for test B2. Plastic hinges were formed at the supports after the

end moment reached the limiting resisting moment. At a load $W = 46$ kips the central constant moment section started to yield which reduced the rigidity of the beam and this rapidly brought the beams at the supports into the strain hardening range. The end moments increased above M_p before a plastic hinge was fully developed at the central section. The maximum observed load $W = 56$ kips on the structure is, thus, higher than predicted (50.0 kips) because of strain hardening at the two supports of the beam.

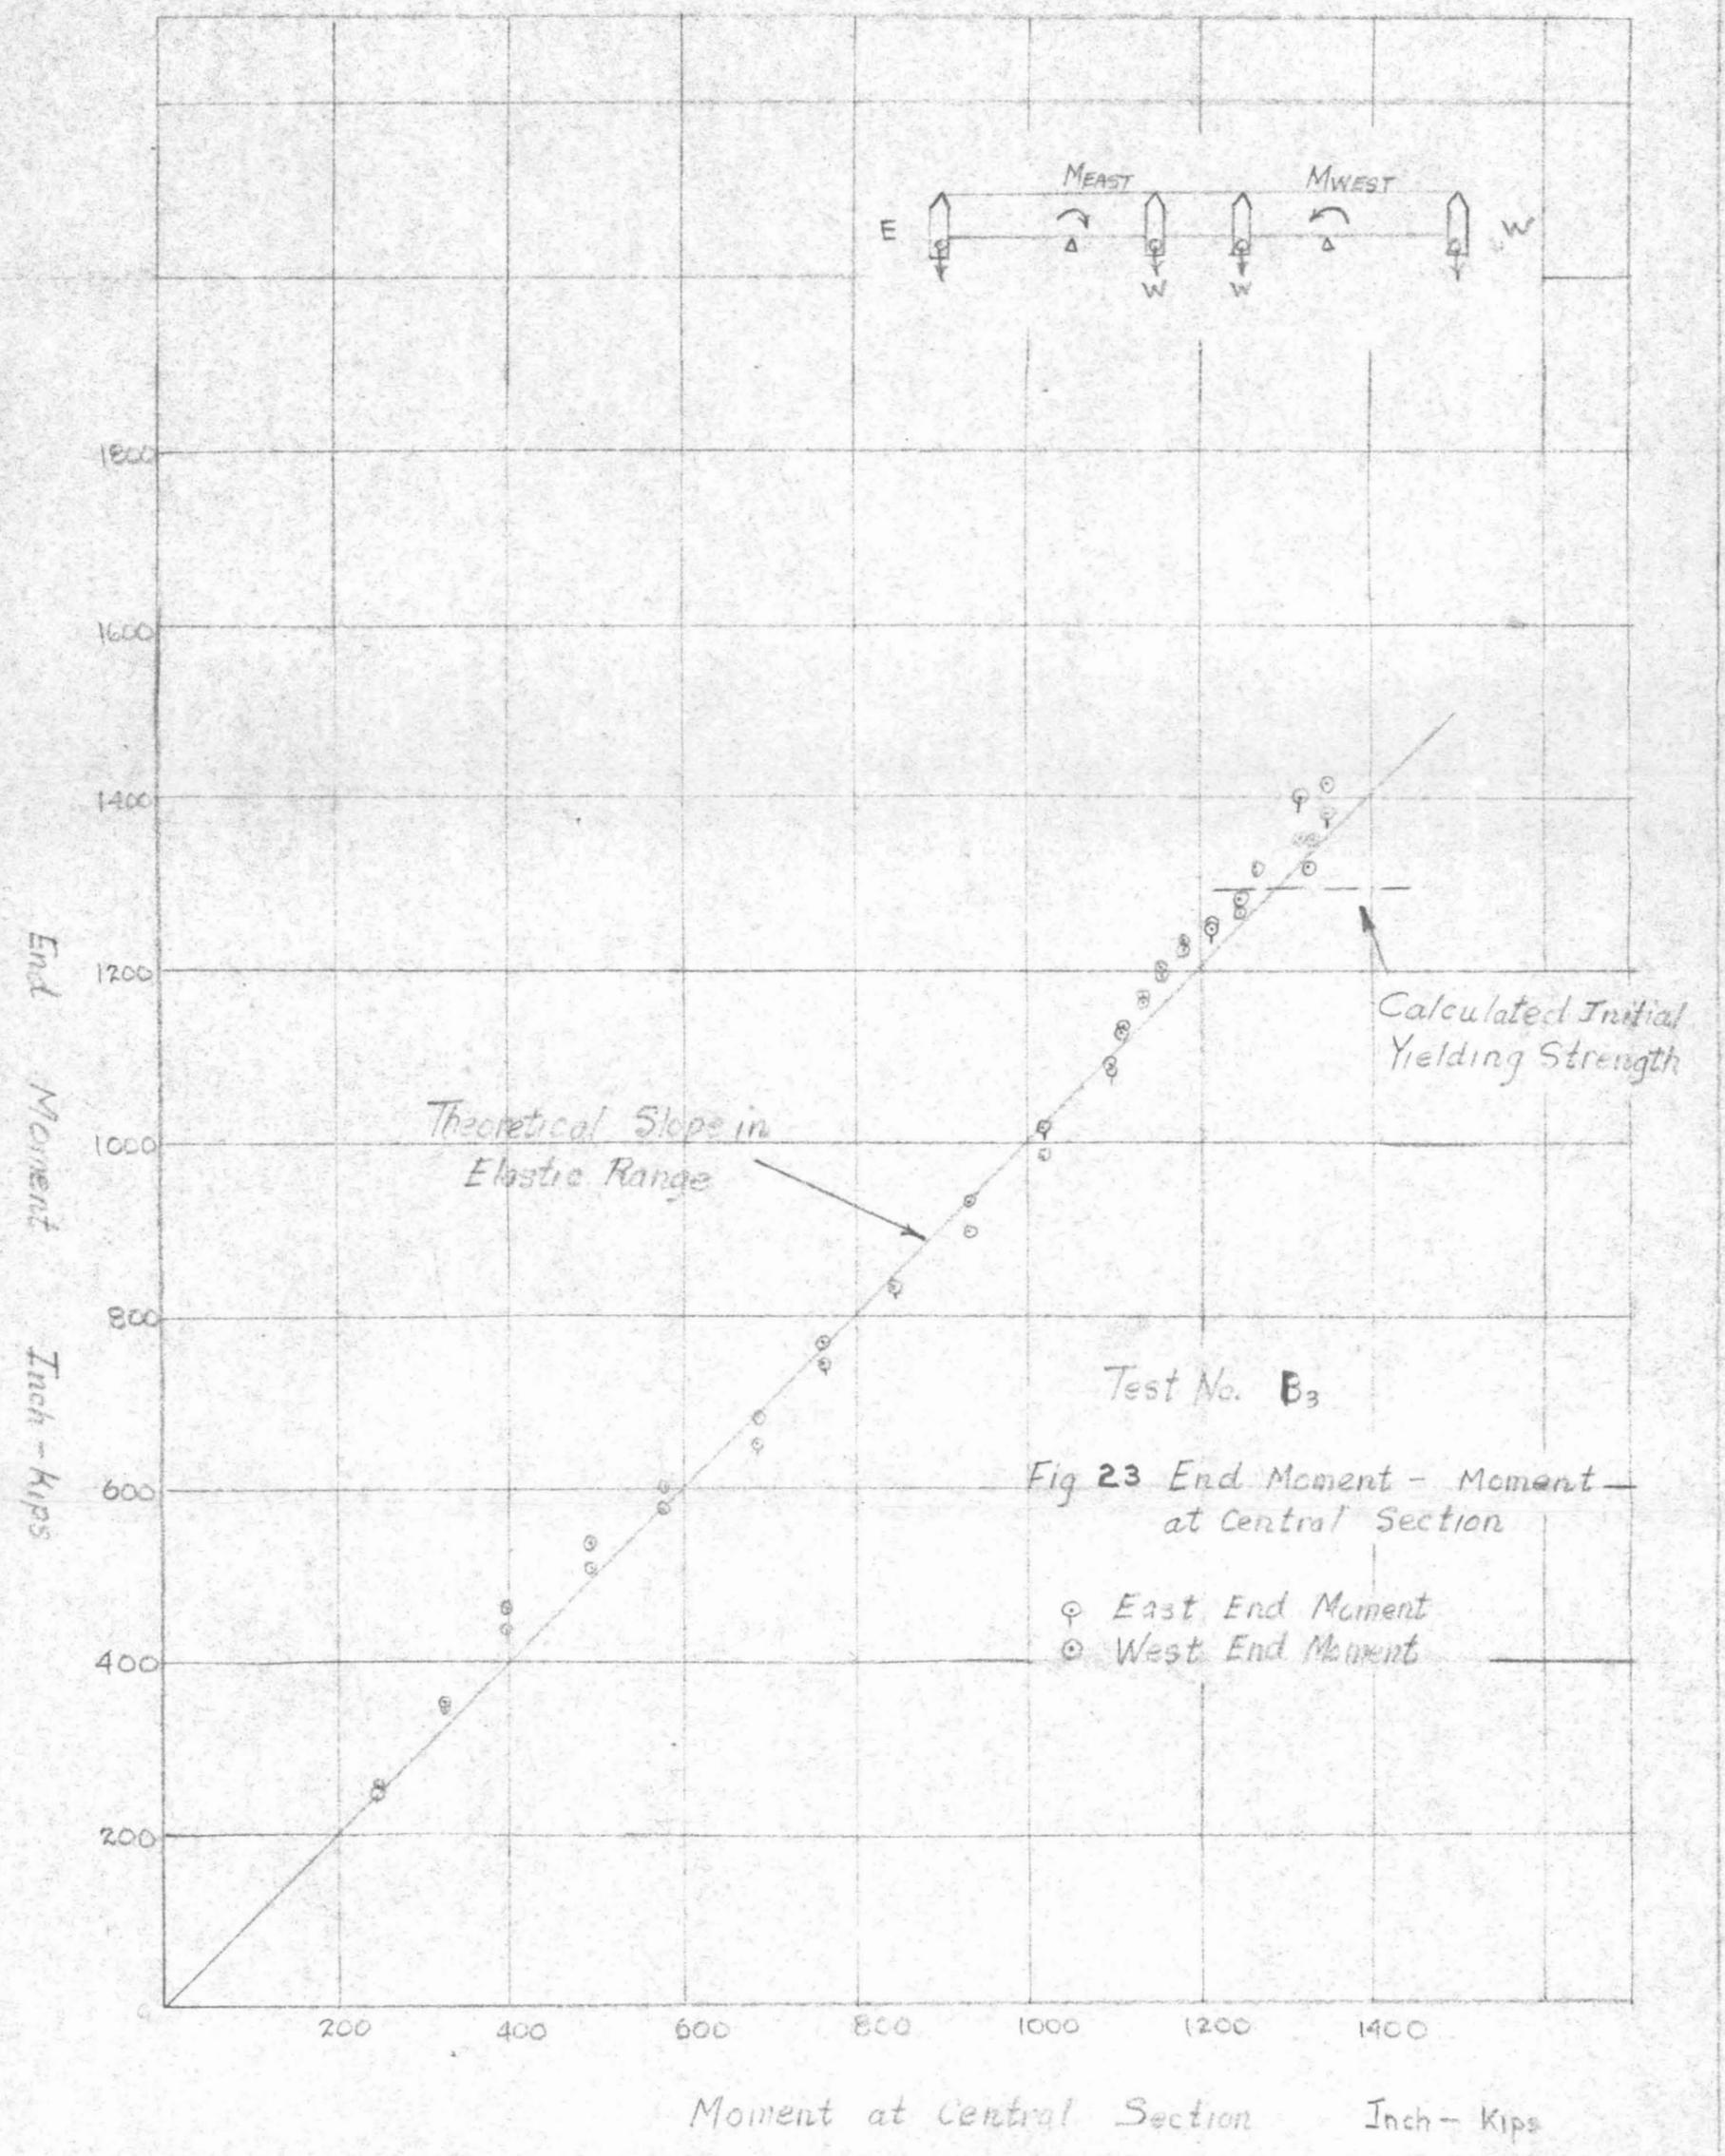
Test No. B₃
Fig 23 End Moment - Moment at Central Section
○ East End Moment
⊙ West End Moment

In test B3 and moments are plotted against the moment of the central section in Fig. 23. The curve closely follows a straight line up to the plastic range.

End moments are plotted against the moment at the central section for test No. B3 in Fig. 23 showing that the two end moments were only slightly raised by strain hardening. The observed maximum load applied to the beam was 49 kips which is very close to the predicted value. Whereas in B2 there were two straight lines in the load deflection curve, in B3 there was only one (Fig. 16). This is because in the latter case the supports and the central section (under constant moment) reached the initial yield strength at the same time.

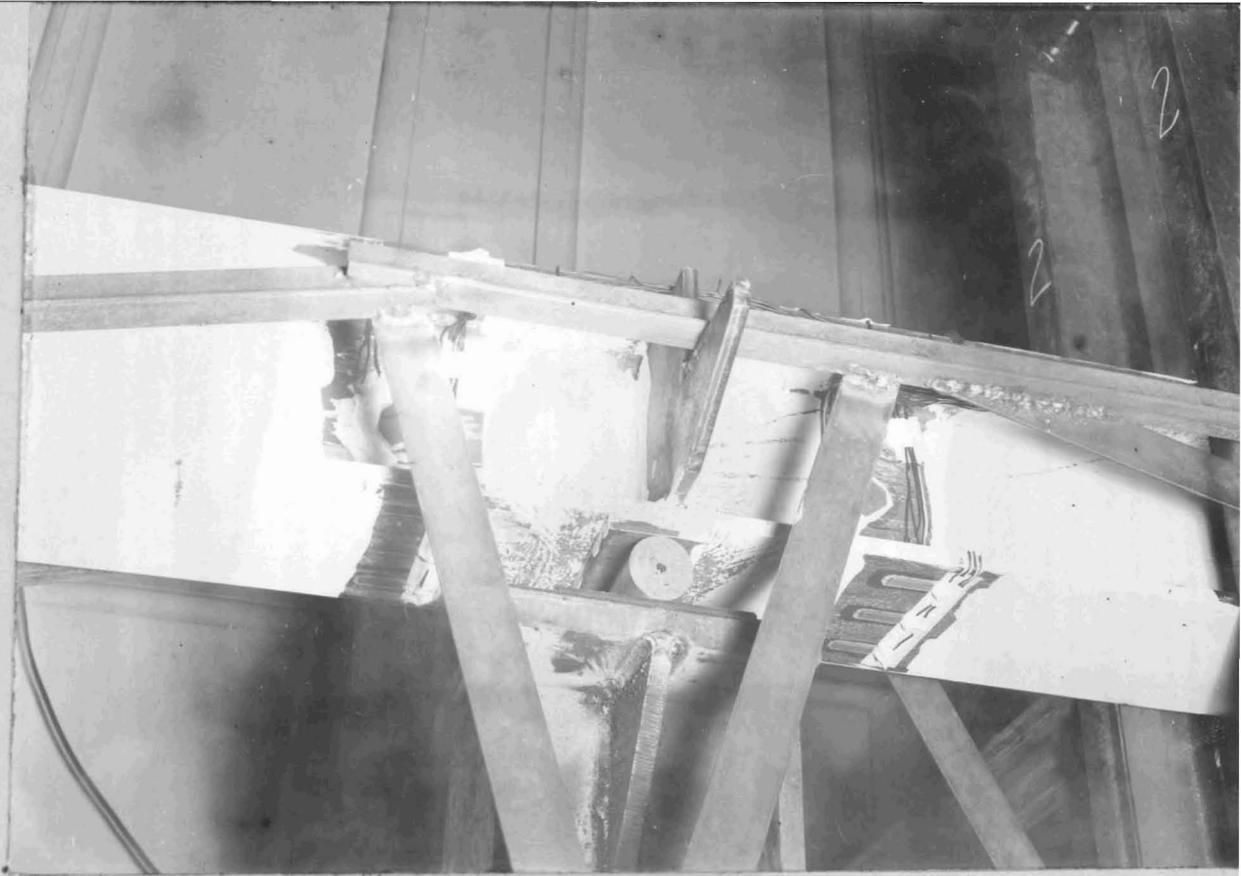
Fig. 24. Lueder lines developed around the support of continuous beam B2 at a load $W = 44$ kips.

kips. This may be due to the combined effects of a slightly higher tensile strength observed in coupon tests (see appendix) and the rolling residual stress distribution. The compressive residual strains observed along flange edges are higher than tensile strains. This was described in Progress Report No. 1. A set of pictures are shown in Figs. 25 to 29 to show the development of Lueder lines on both flanges in test B2. } ①

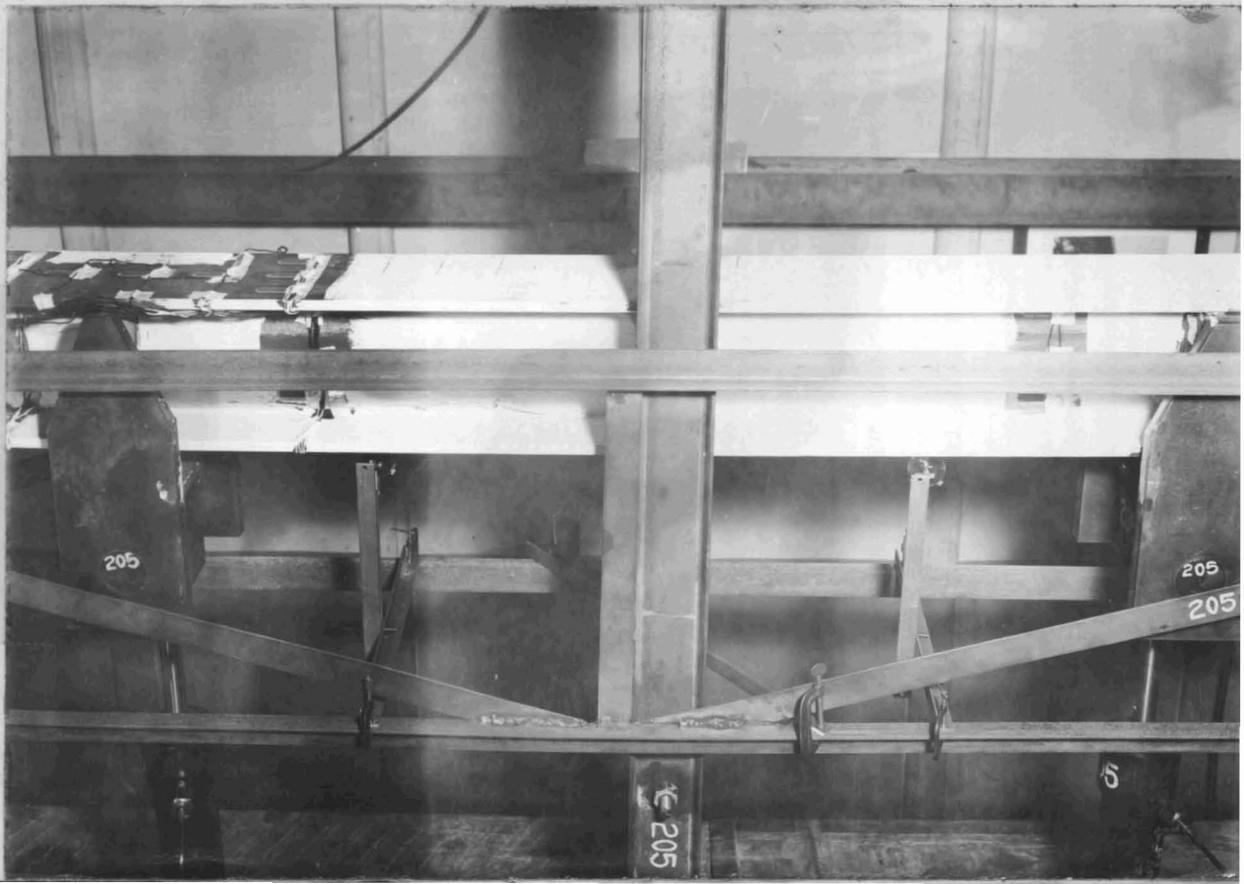
Fig. 25. Flow lines commencing on the top flange of the central span at a load $W = 46$ kips in continuous beam B2.

Lueder lines were first observed in the upper flange in the central span in continuous beam B2 at a load $W = 46$ kips. The lines appeared in lower flanges at a higher load, $W = 50.5$

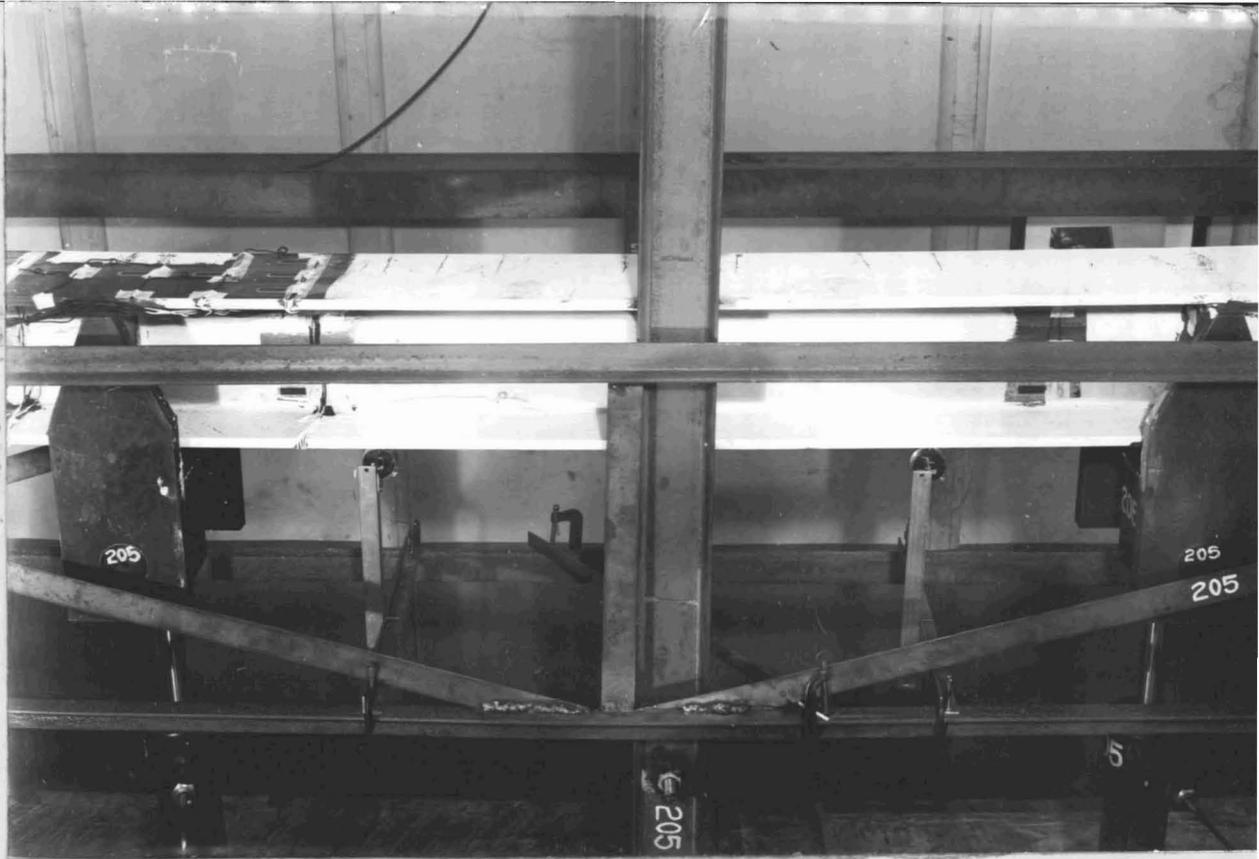
Fig. 26 . The progression of Lueder lines on the top flange of the central span at a load $W = 47$ kips in continuous beam test B2.

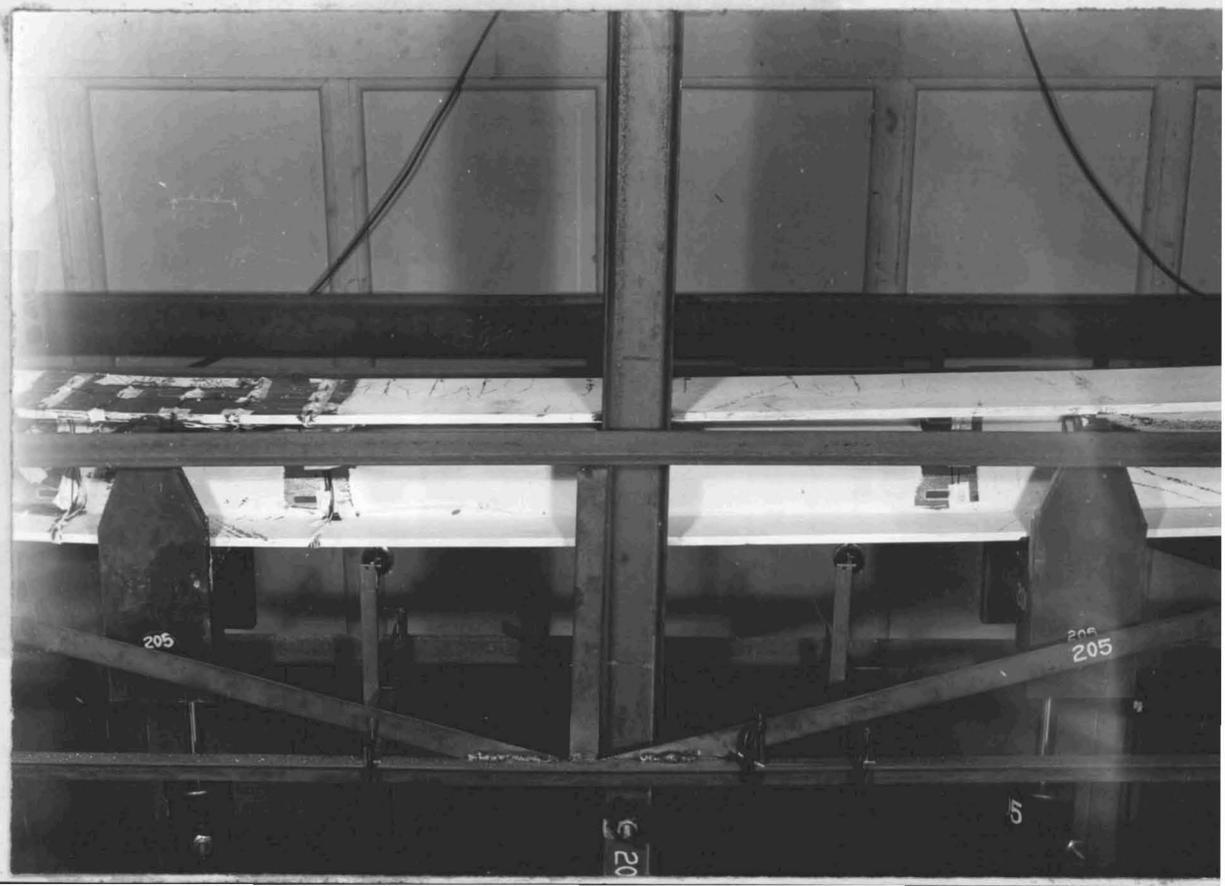
Fig. 27. Lueder lines appearing on the lower flange of the central span at a load $W = 50.5$ kips, test B2.

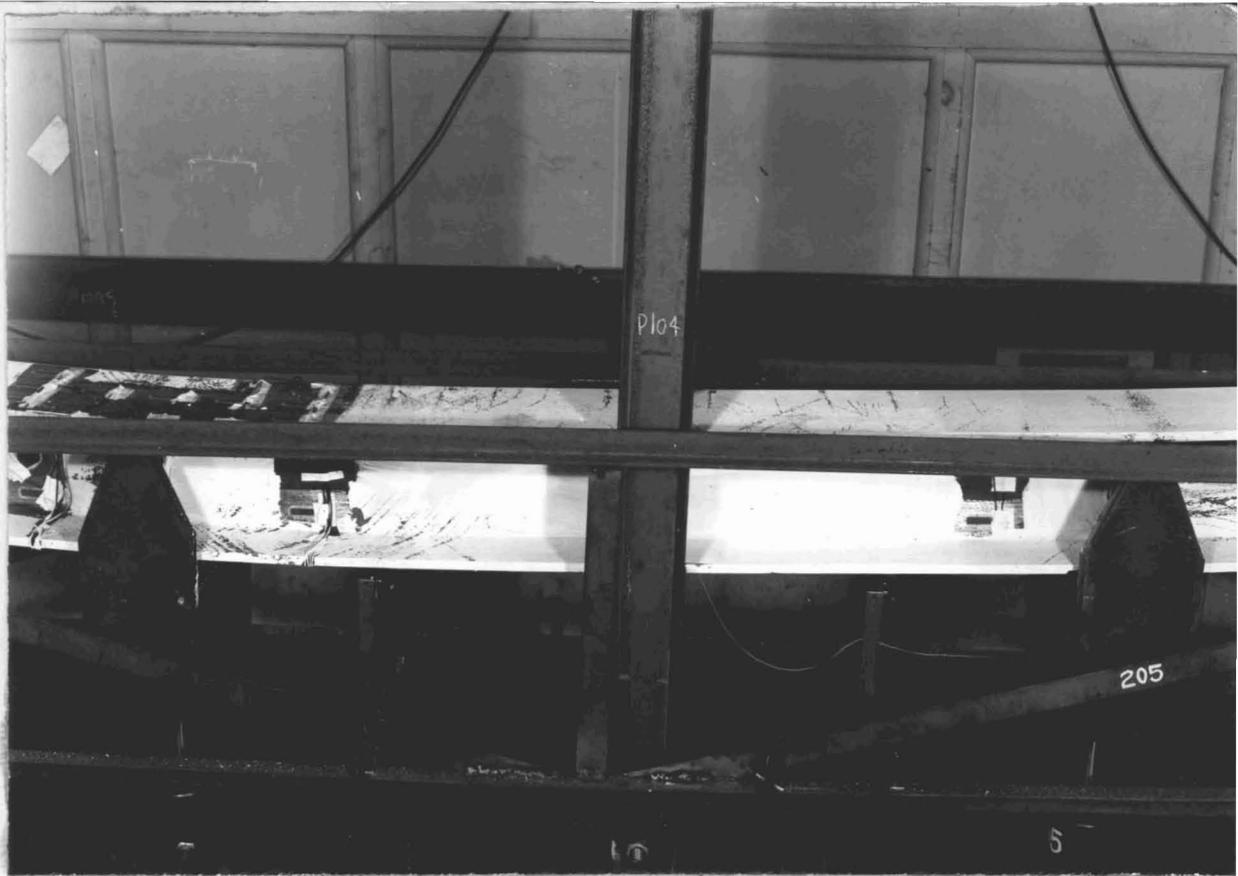
Fig. 28 . The progression of Lueder lines in the lower flange of the central span at a load $W = 54$ kips in continuous beam test B2.

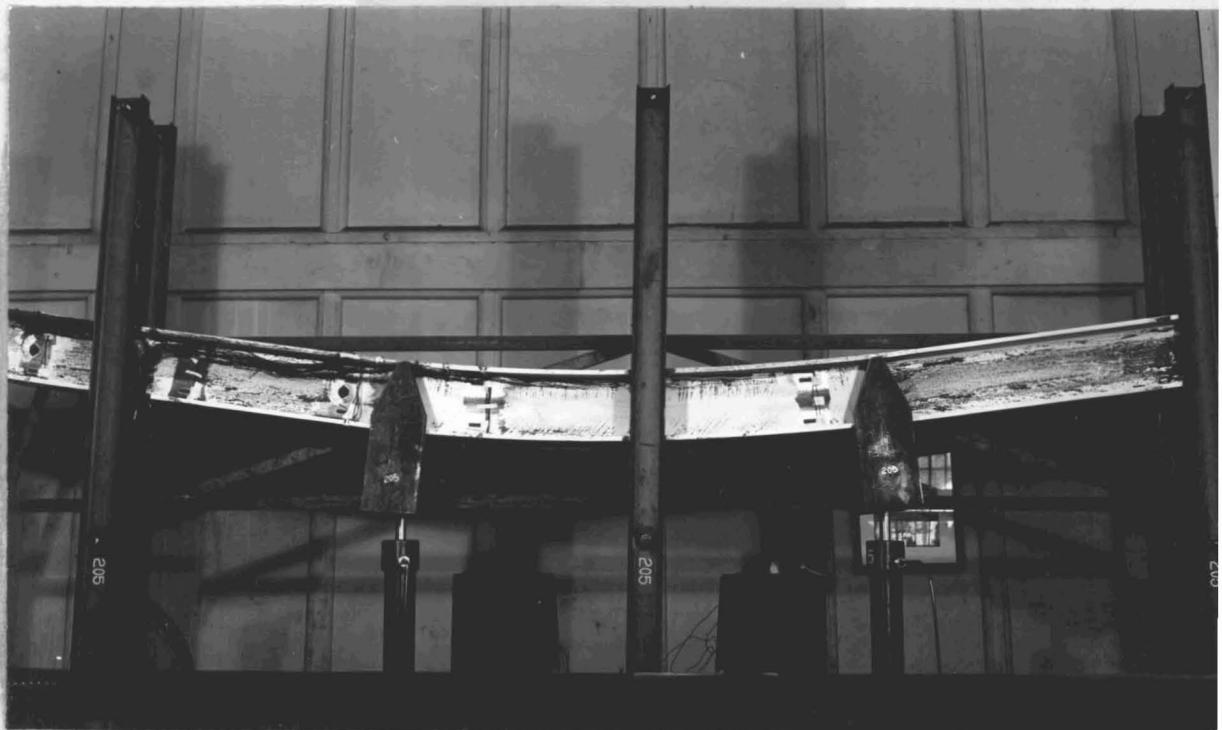
Fig. 29 . Side view of central span, continuous beam B2 after test.

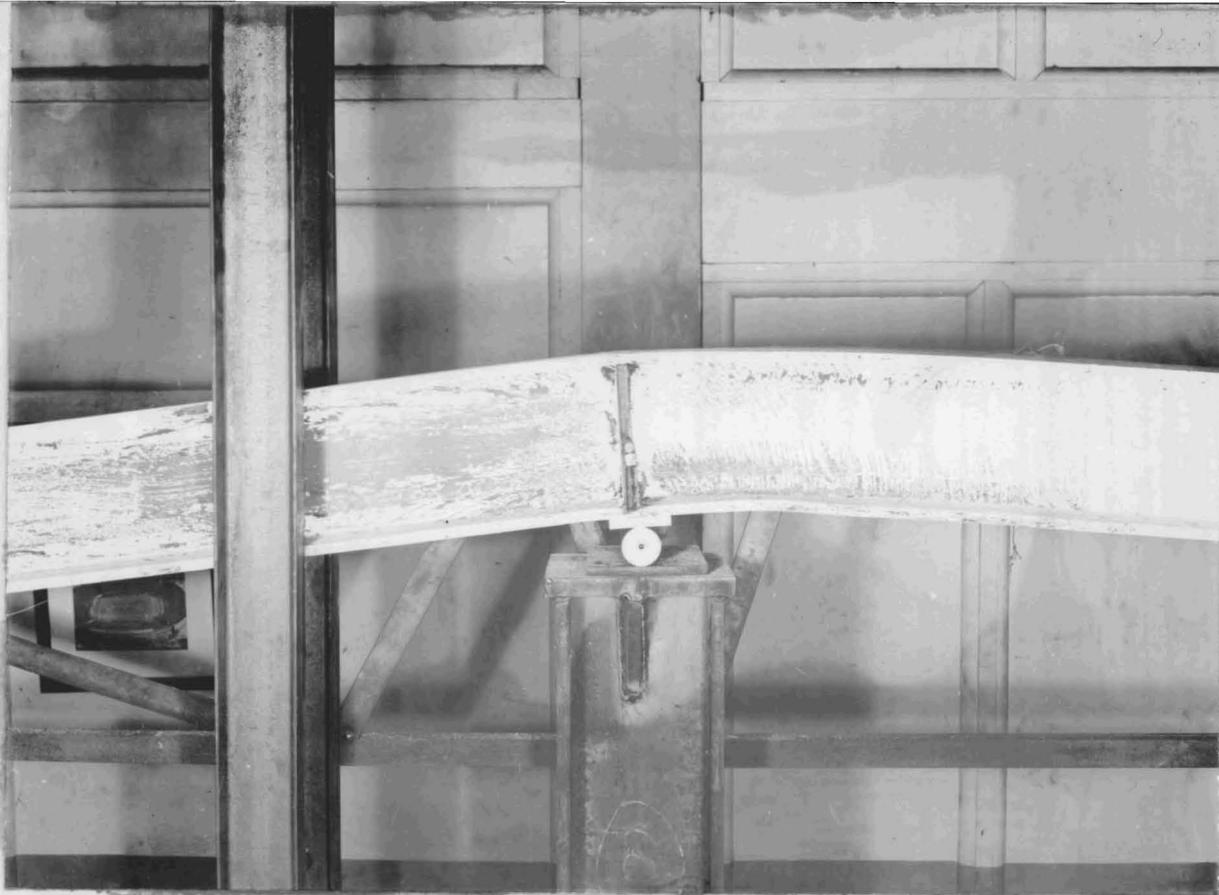
Fig.31 . Local buckling of lower flange near the support in continuous beam B2.

The lower flange at the support of beam B2 failed in this fashion as shown in Fig. 31.
