Proposal: structural steel investigations (continuous beams, Connections, Frames) to O.N.R.

Progress Report B

PLASTIC BEHAVIOR OF CONTINUOUS BEAMS

May 26, 1949

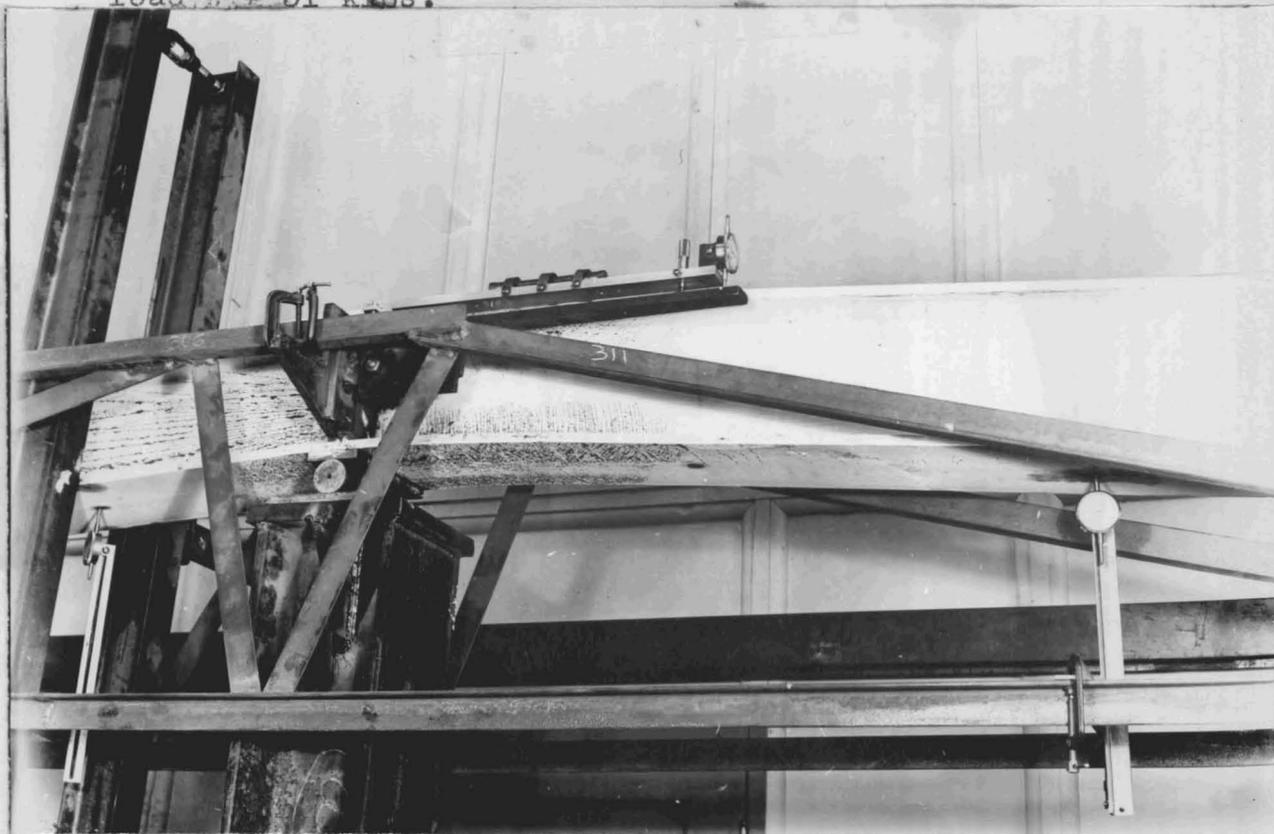
Fig.32 . Lueder line patterns in the cantilever portion of . continuous beam B3 showing the penetration of plastic zone into the web at a load $W = 51$ kips.

M - δ curves are plotted from strain and deflection gages for both tests in Fig. 20 - 22. M - δ curves are also plotted from strain gages in cantilever beams in Figs. 30 and 45. They all show good agreement with the result obtained in the control test. Different depth of plastic zone penetration in the web of a cantilever beam under different resisting moment in test B3 is shown in Fig. 32.

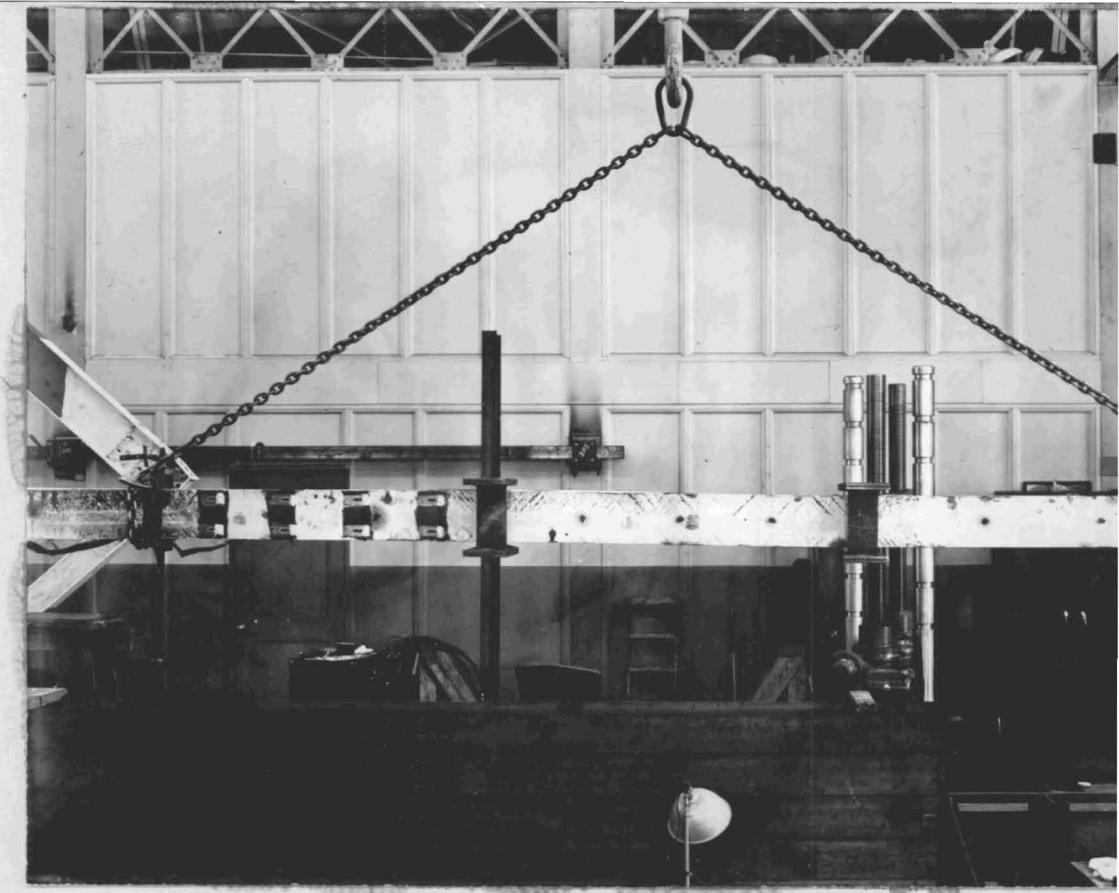
Fig. 34. Continuous beam B2 twisted after test due to lateral buckling.

The two continuous beams tested buckled laterally in the plastic range in spite of the lateral support provided (Fig. 4). Two level bars were mounted on continuous beam B3 to measure the lateral rotation of the beam. The load-lateral rotation curve is plotted in Fig. 33. The beam buckled in two half-waves between the three lateral support points in the central span at a load $W = 47$ kips. The beam was twisted after test due to lateral buckling. A picture of the twisted beam is shown in Fig. 34.

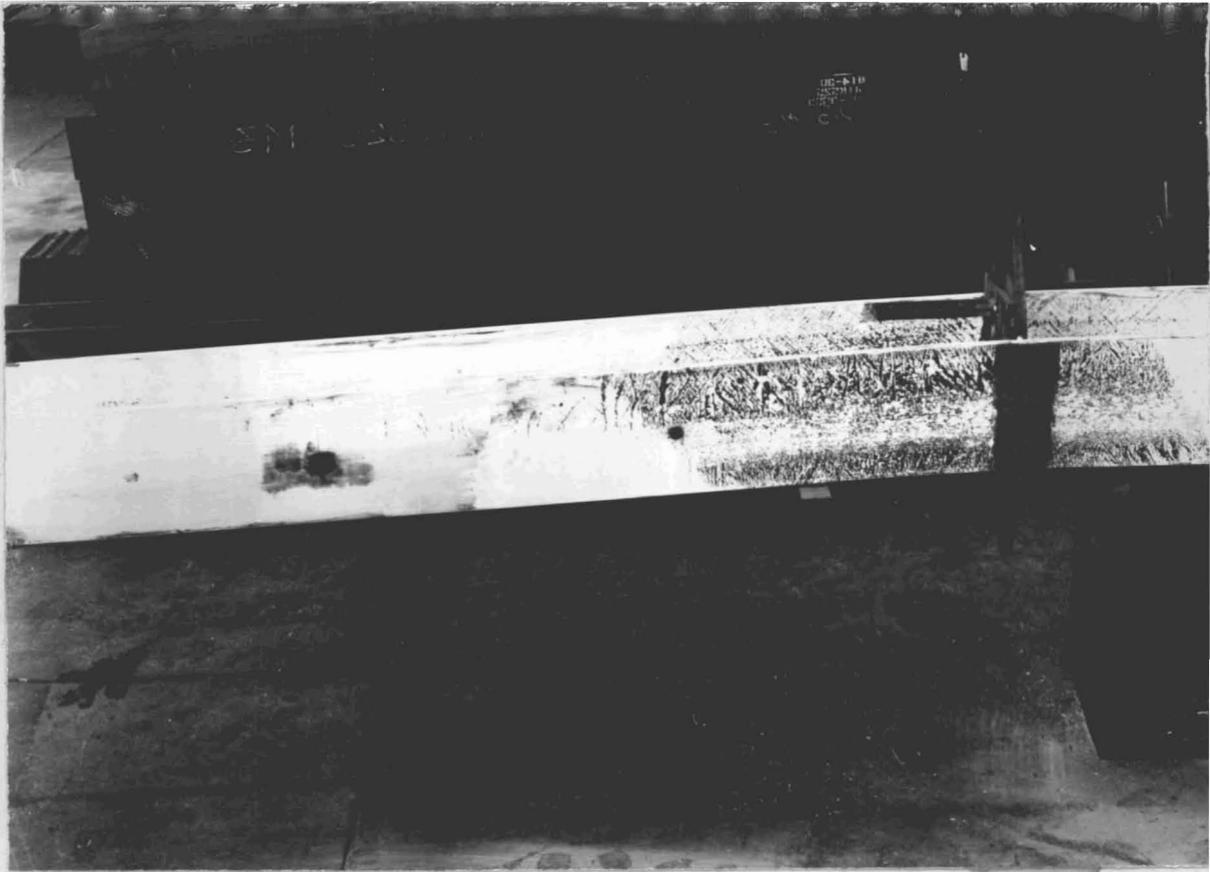
Fig. 34A. Lueder line pattern near the support of continuous beam B3 showing torsional stress developed due to lateral buckling.

The torsional stresses developed by lateral buckling are revealed by yield lines as shown in Fig. 34A.

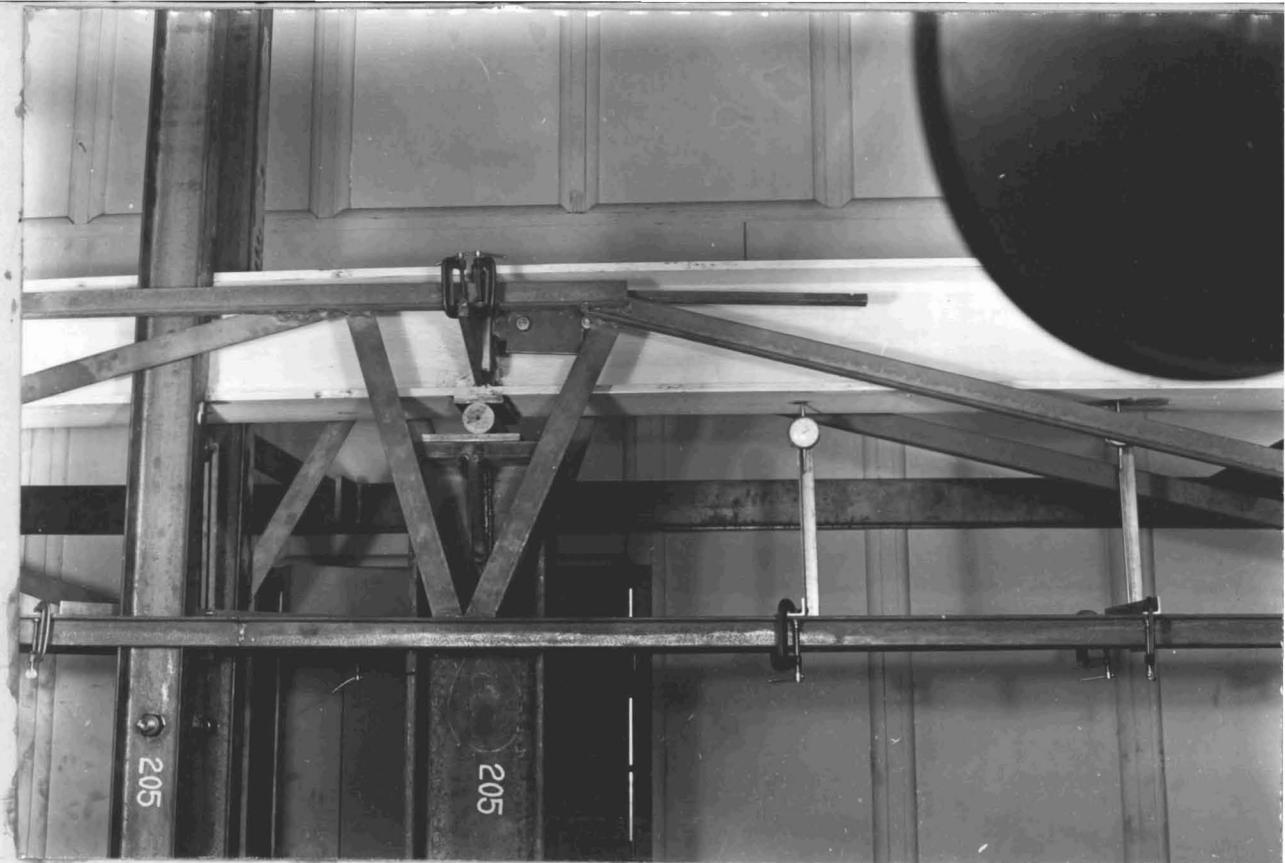
Fig. 35. Lines developed by local shear failure in web near the support at a load $W = 39$ kips. Continuous beam test B3.

The local shear yielding lines were observed in Test No. B3 at a load $W = 39$ kips, which is shown in strain gage data Fig. 35. The Lueder lines began to extend in the web at a load

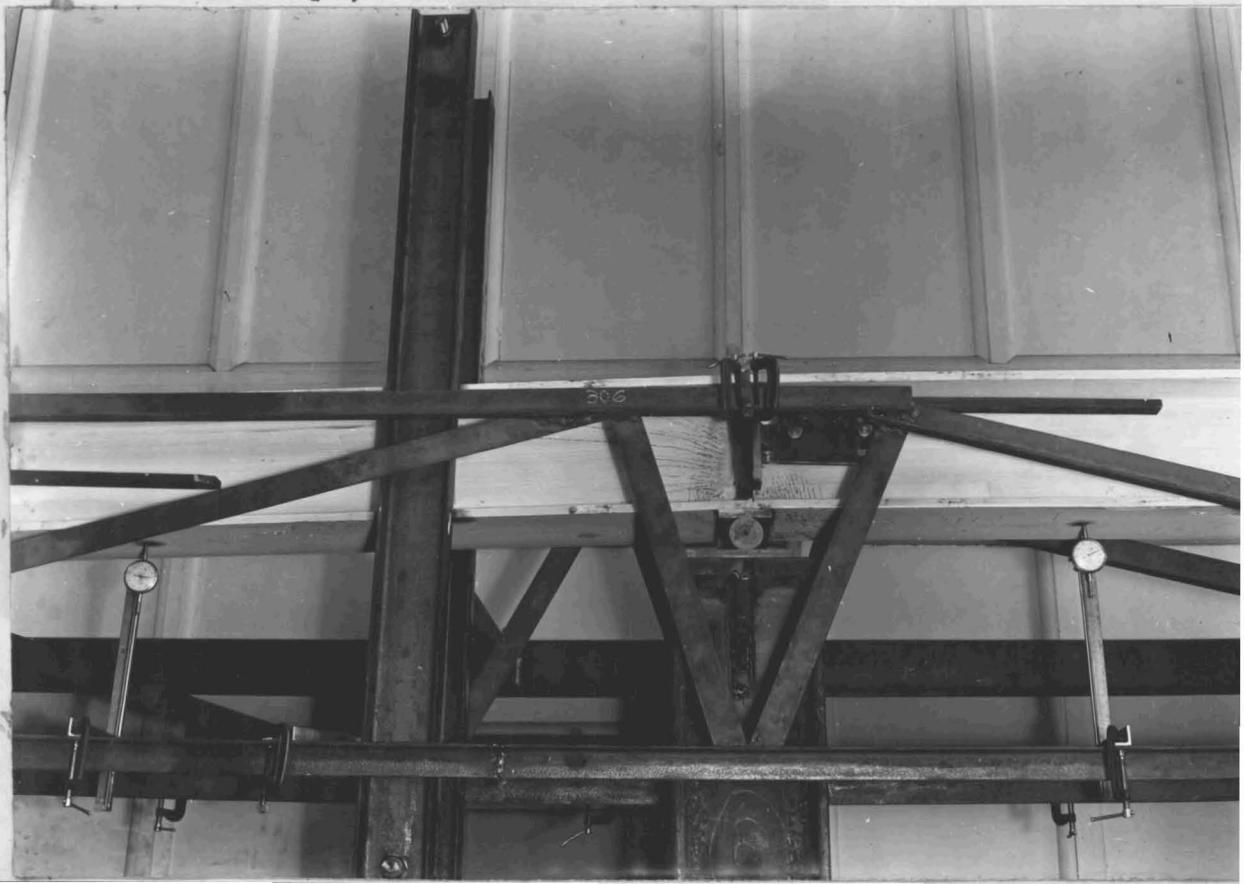
Fig. 36. Progression of shear yielding in the web. $W = 47.5$ kips, test B3.

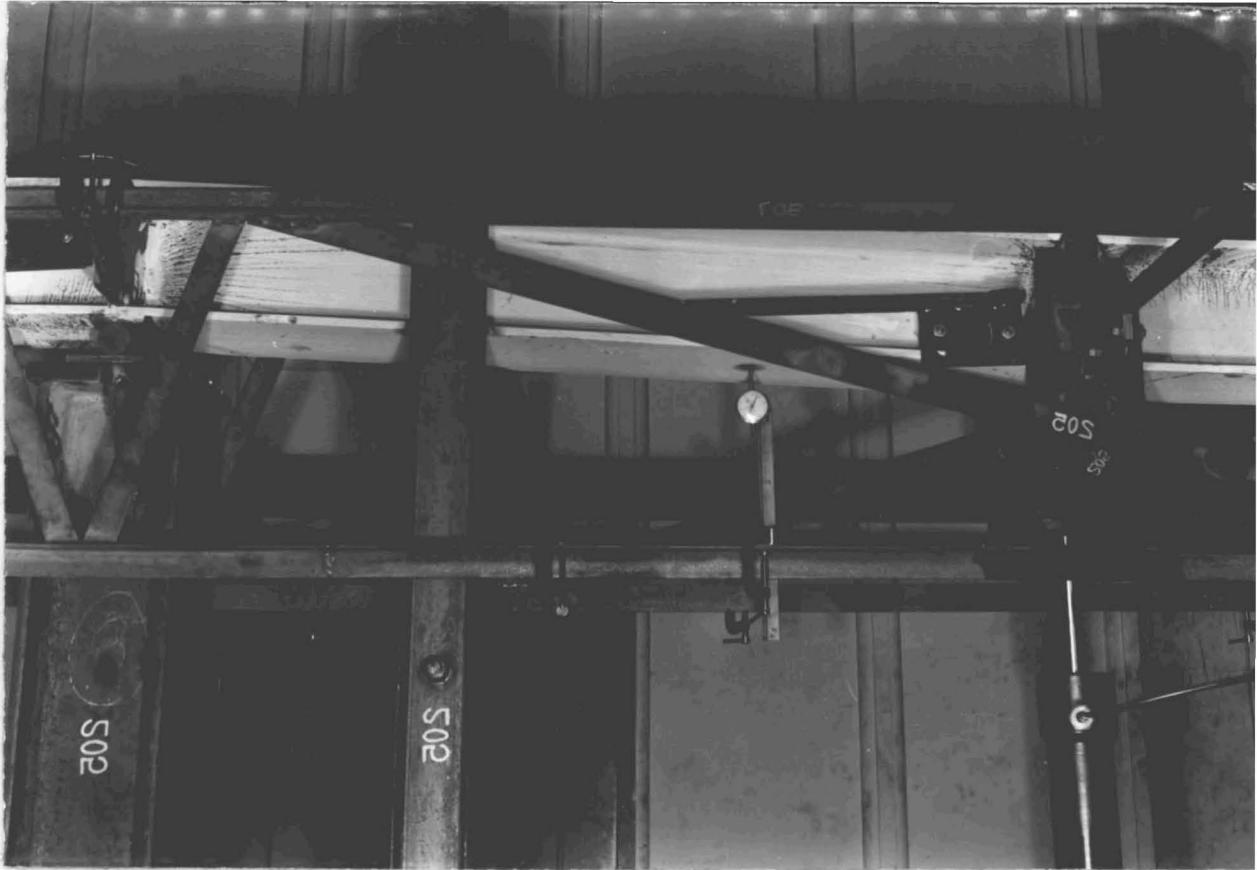
Fig.37 . Progression of Lueder lines developed in the web by shear failure at a load $W = 48$ kips. Test B3.

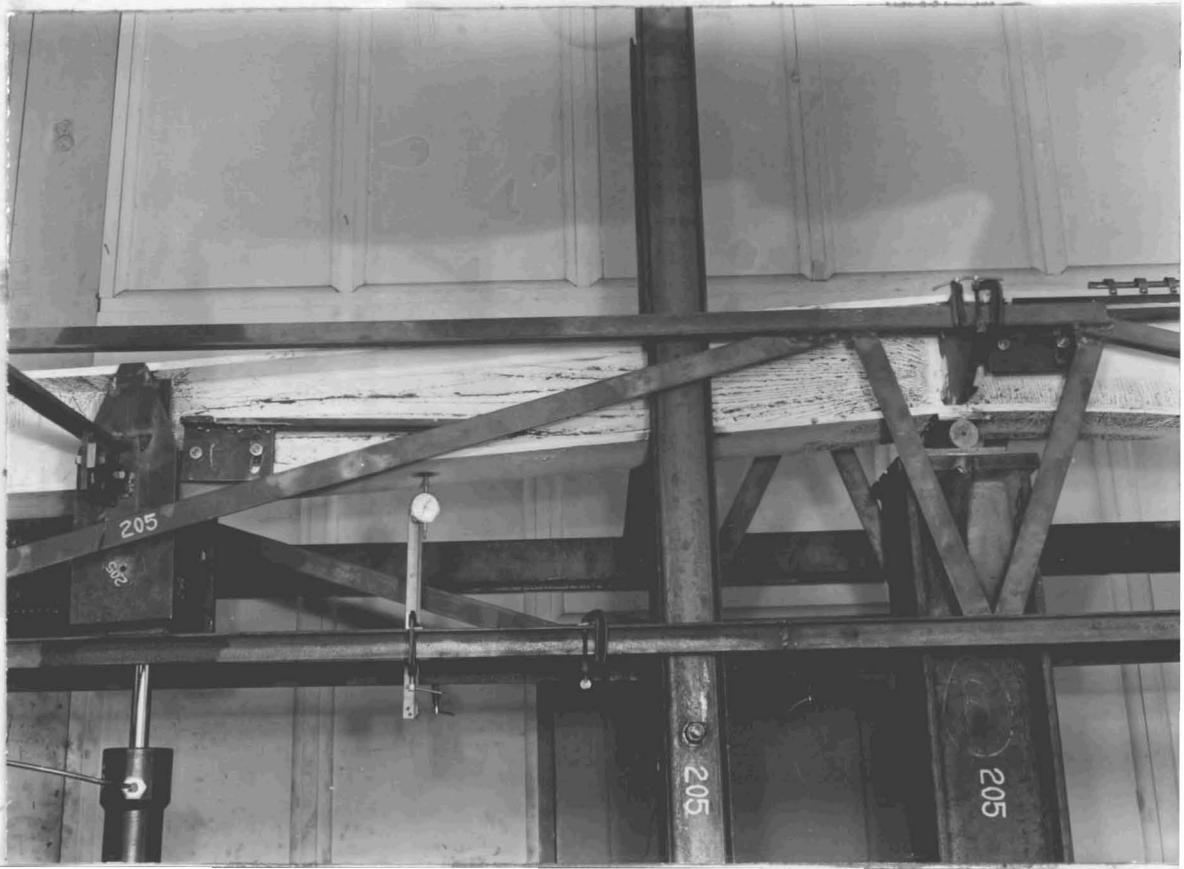
Fig.38. Shear pattern of continuous beam B3.
 $W = 51$ kips.

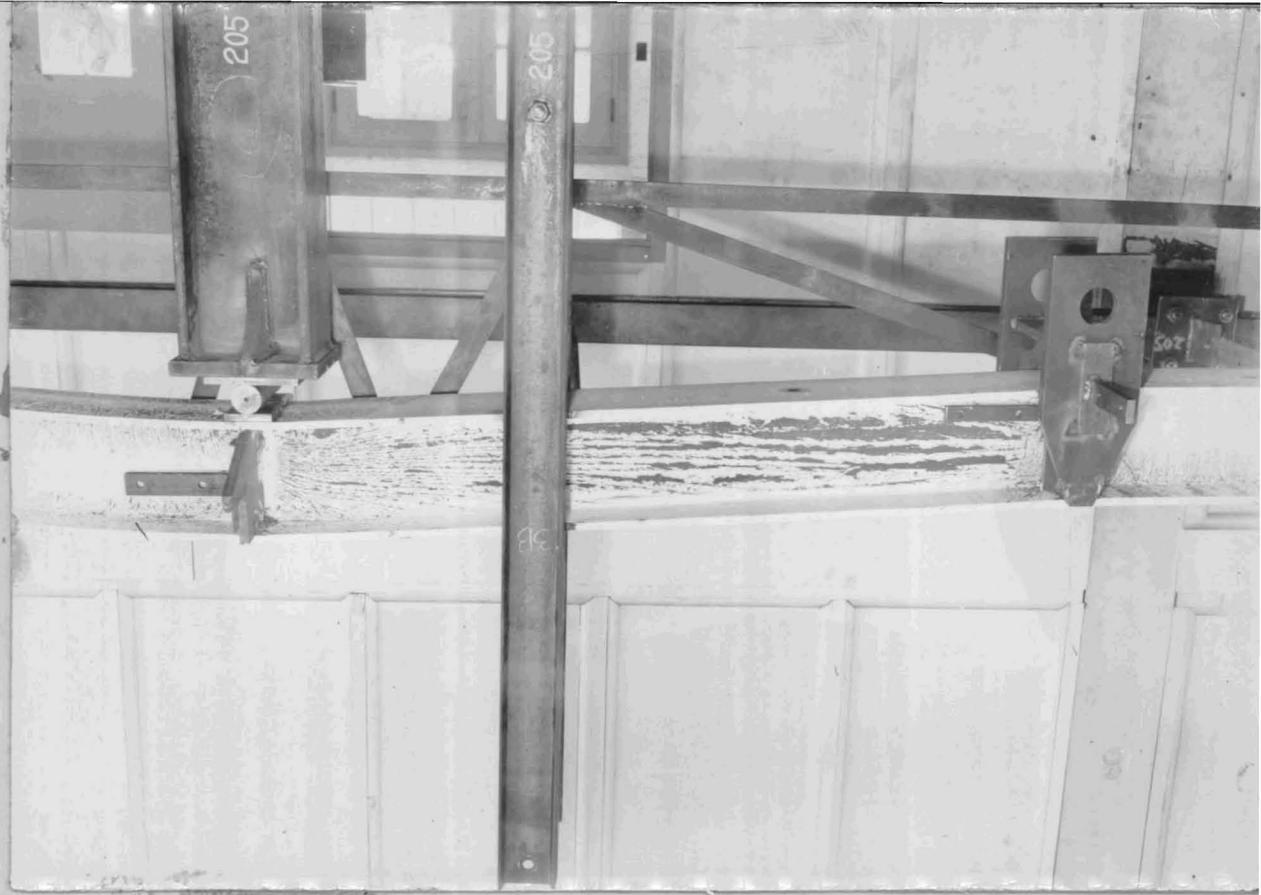
Fig.39. Lueder line pattern of continuous beam B3 after test.

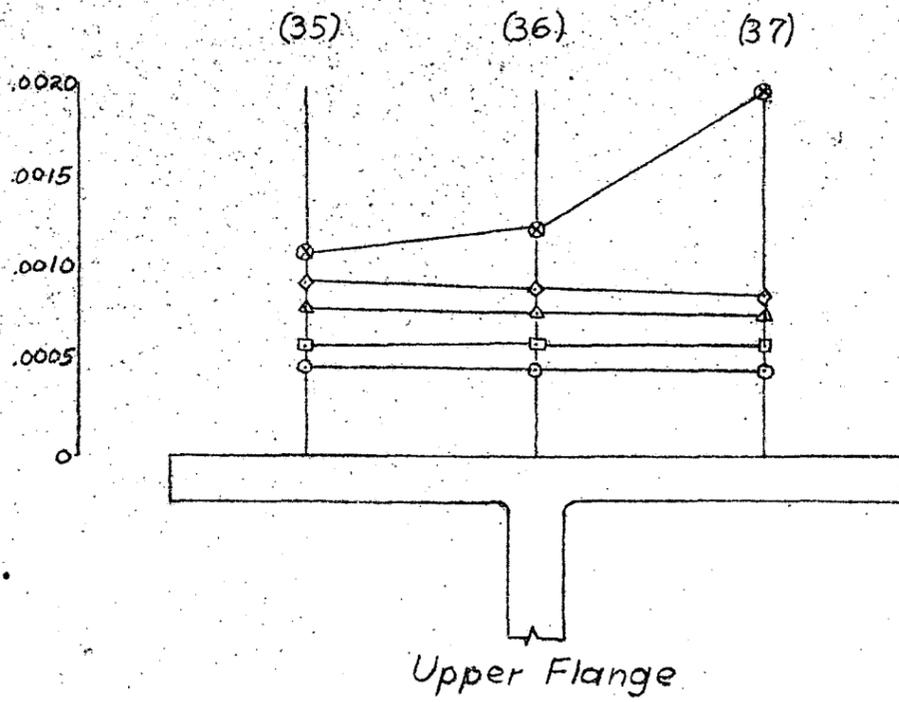
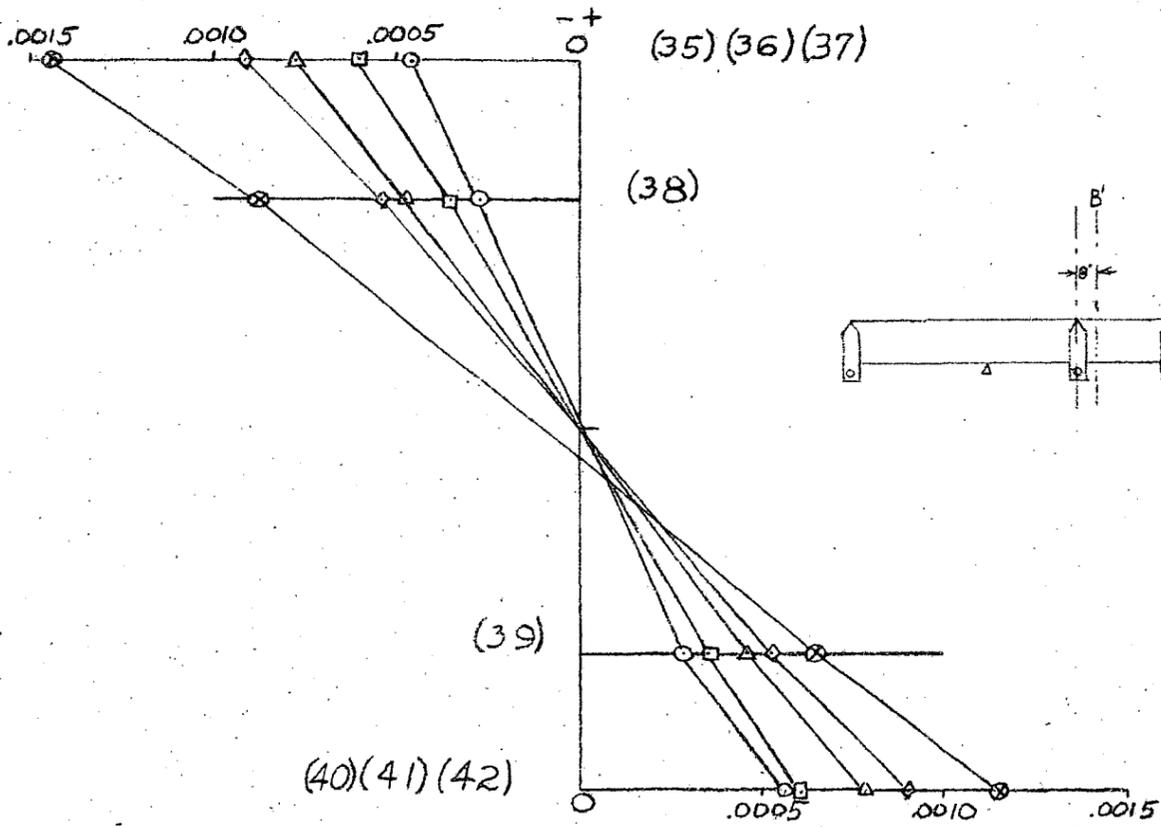
- 27,000 lb
- 33,000 lb
- △ 39,000 lb
- ◇ 42,000 lb
- ⊗ 47,000 lb

Test No. B-2
Strain Distribution
at Section B'
Fig. 41

Strain distributions at various loads and at several cross sections of the beam are plotted in Figs. 41 to 44 for beam B2. In the central section under constant moment without shear (Fig. 41) it is seen that the strain distribution remained plane even after the beam flanges went far into plastic range. But in sections under high shear, strain distributions became irregular after shear failure occurs. This is shown in Figs. 42 and 43. Fig. 44 shows the strain distribution of a section on the cantilever beam which was under small shearing force and in which the web was not yielded by shearing stress.

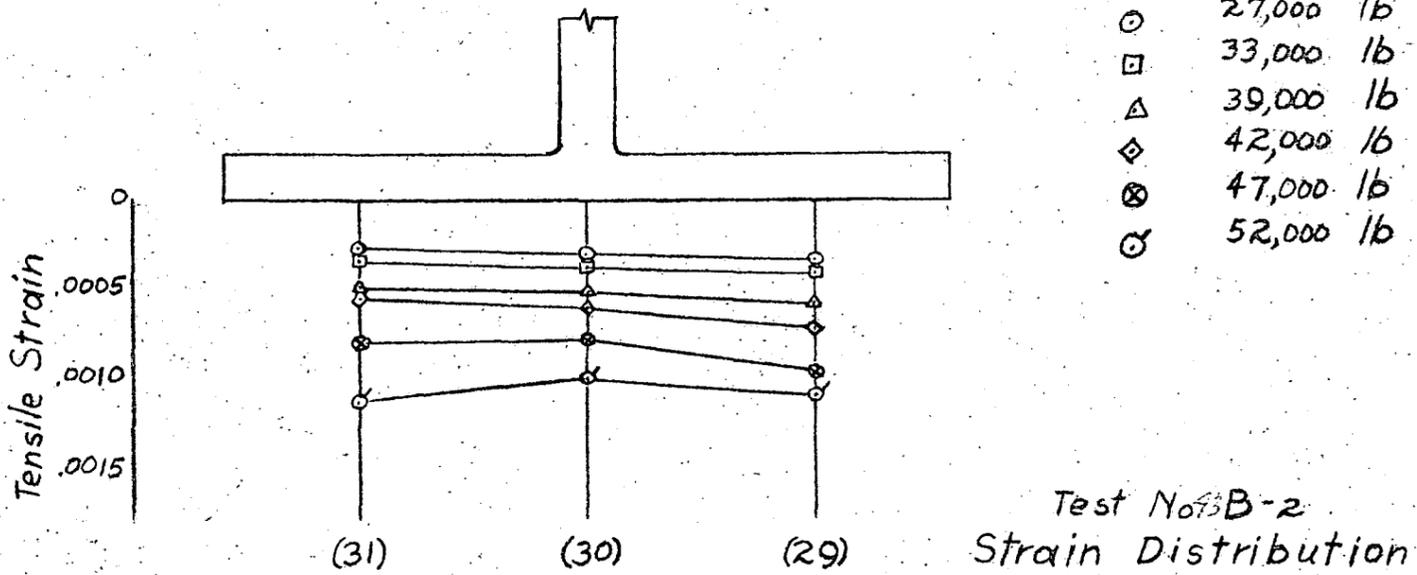
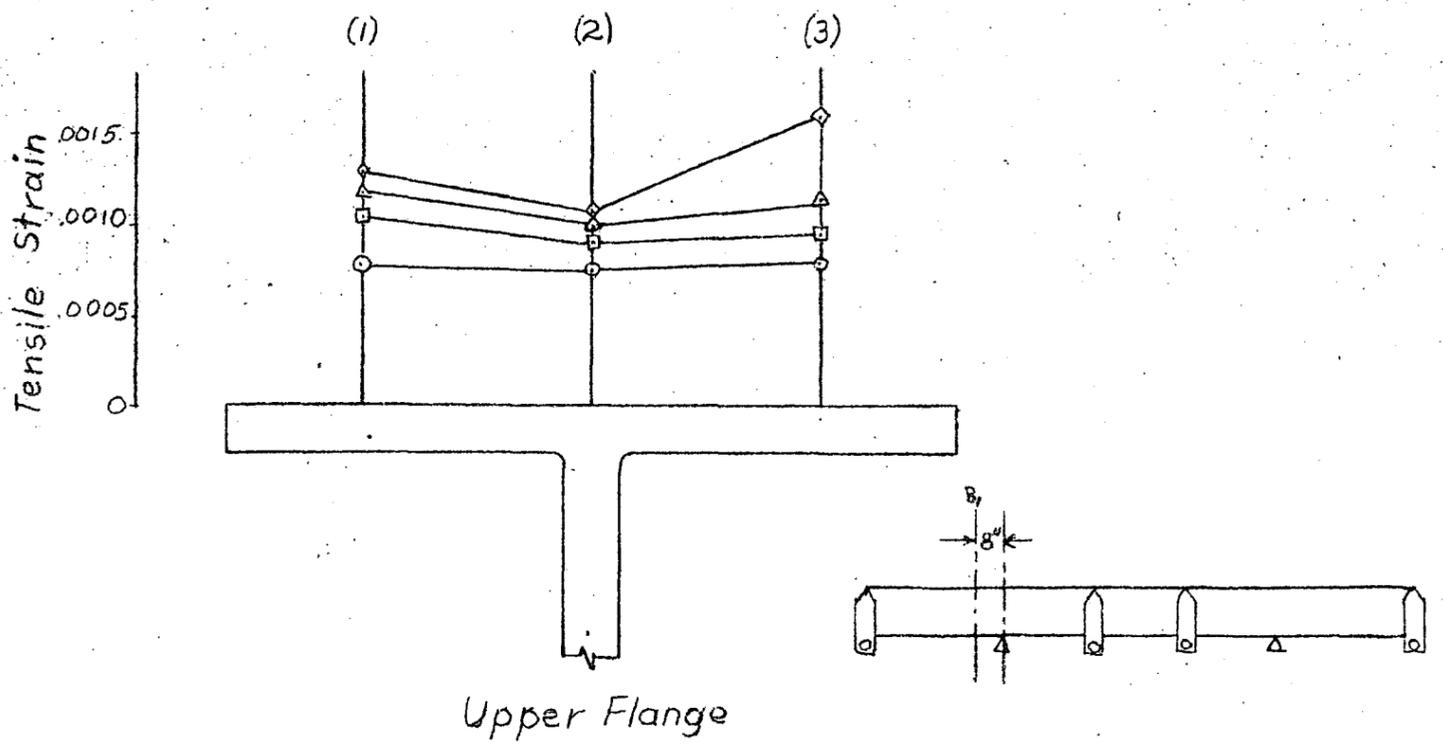
- 27,000 lb
- 33,000 lb
- △ 39,000 lb
- ◇ 42,000 lb
- ⊗ 47,000 lb
- ⊙ 52,000 lb

Test No. B-2
Strain Distribution
at Section B
Fig. 43

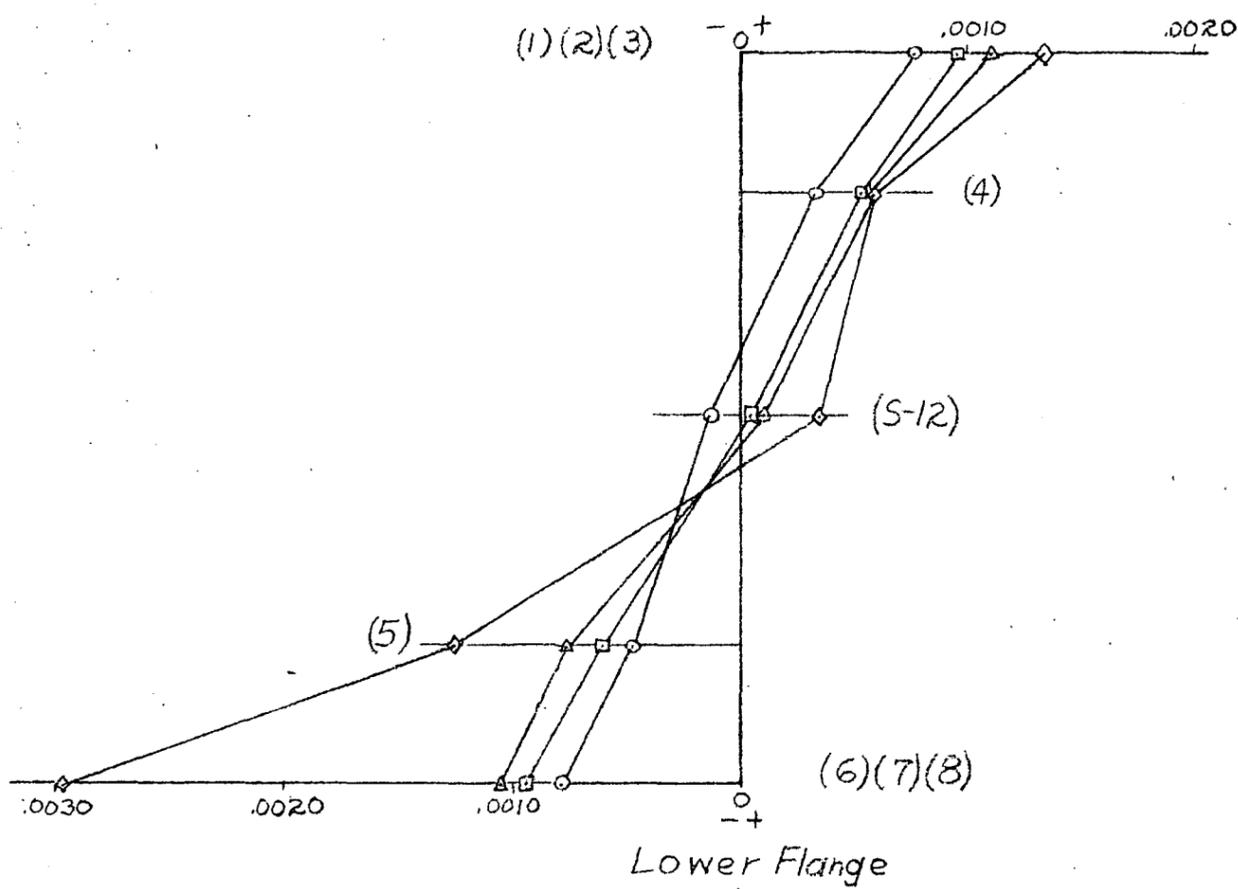
- 27,000 lb
- 33,000 lb
- △ 39,000 lb
- ◇ 42,000 lb

Test No. B-2
Strain Distribution
at Section B,
Fig. 44

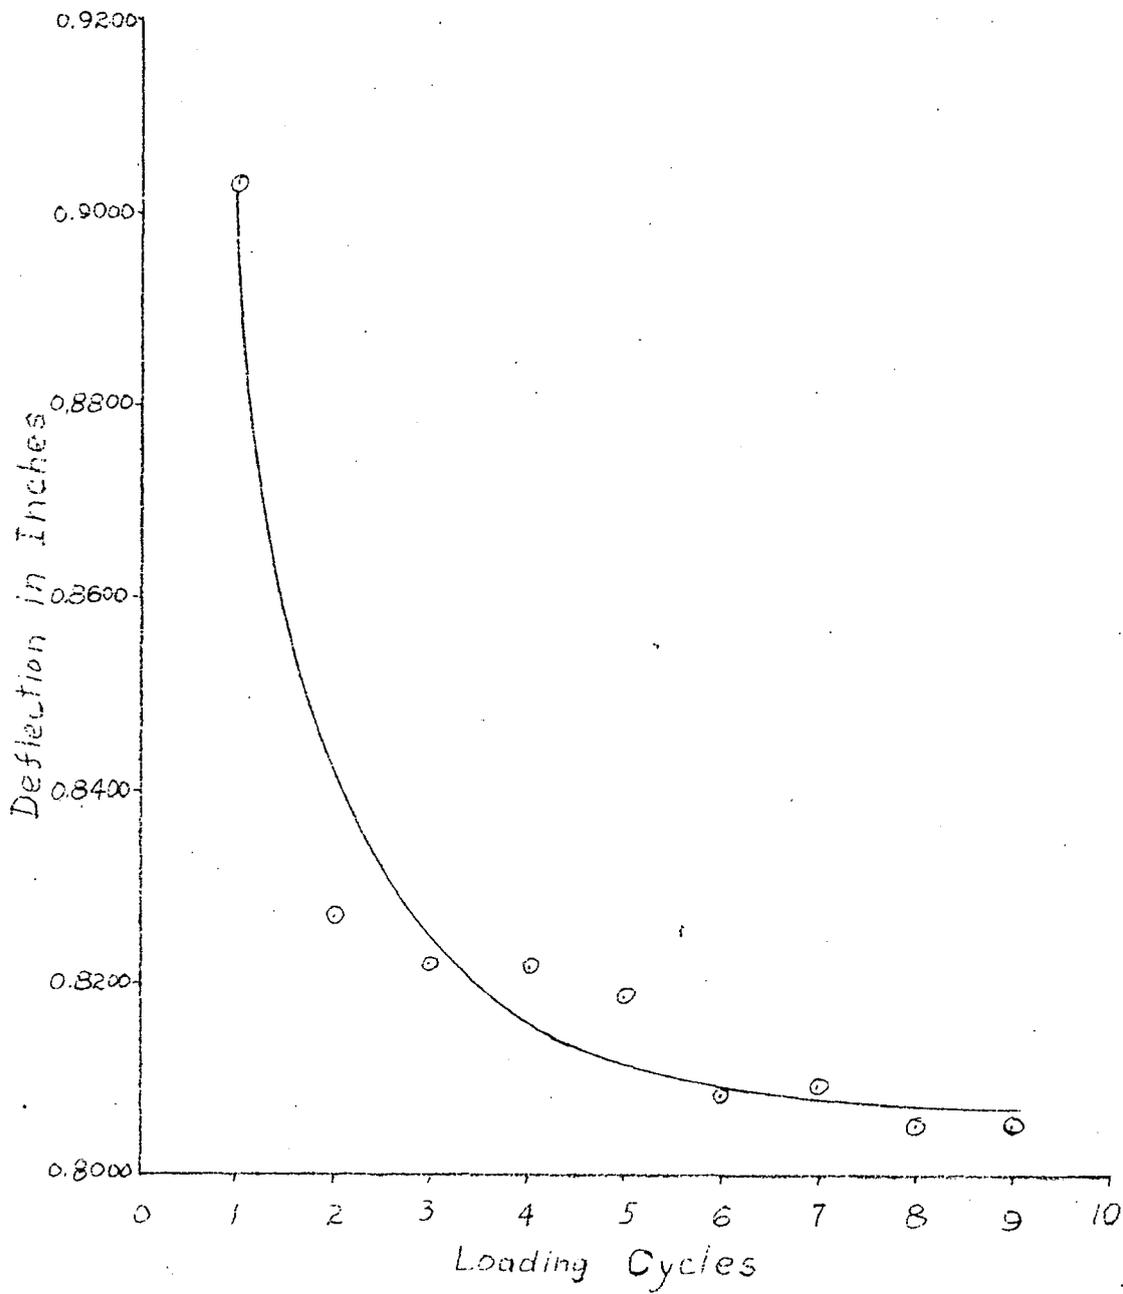
Test No. B₂

Fig 47 The Increment of Deflection
from $W=3$ Kips to $W=23$ Kips
under Repeated Load

The test was made to see if the beam behaved elastically and if the deflection of the beam would remain constant. Decreasing deflection between the loads $W = 3$ kips and $W = 23$ kips was observed in the first few loading cycles as is plotted in Fig. 47.

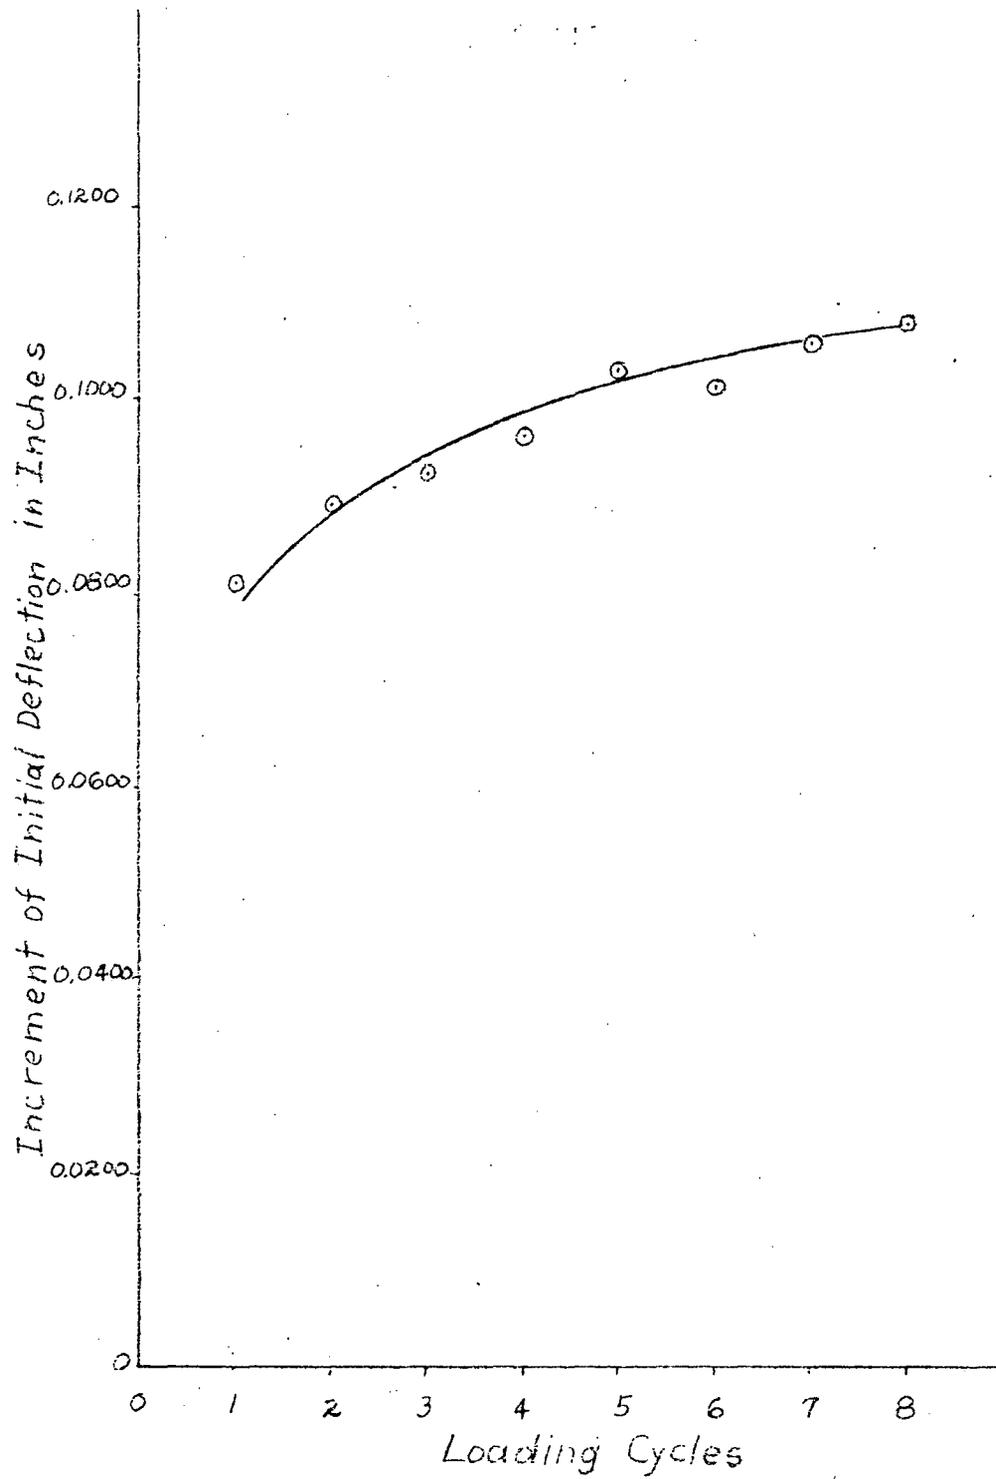
Test No. B3
Fig. 48 Increment of
Initial Deflection
under Repeated Load

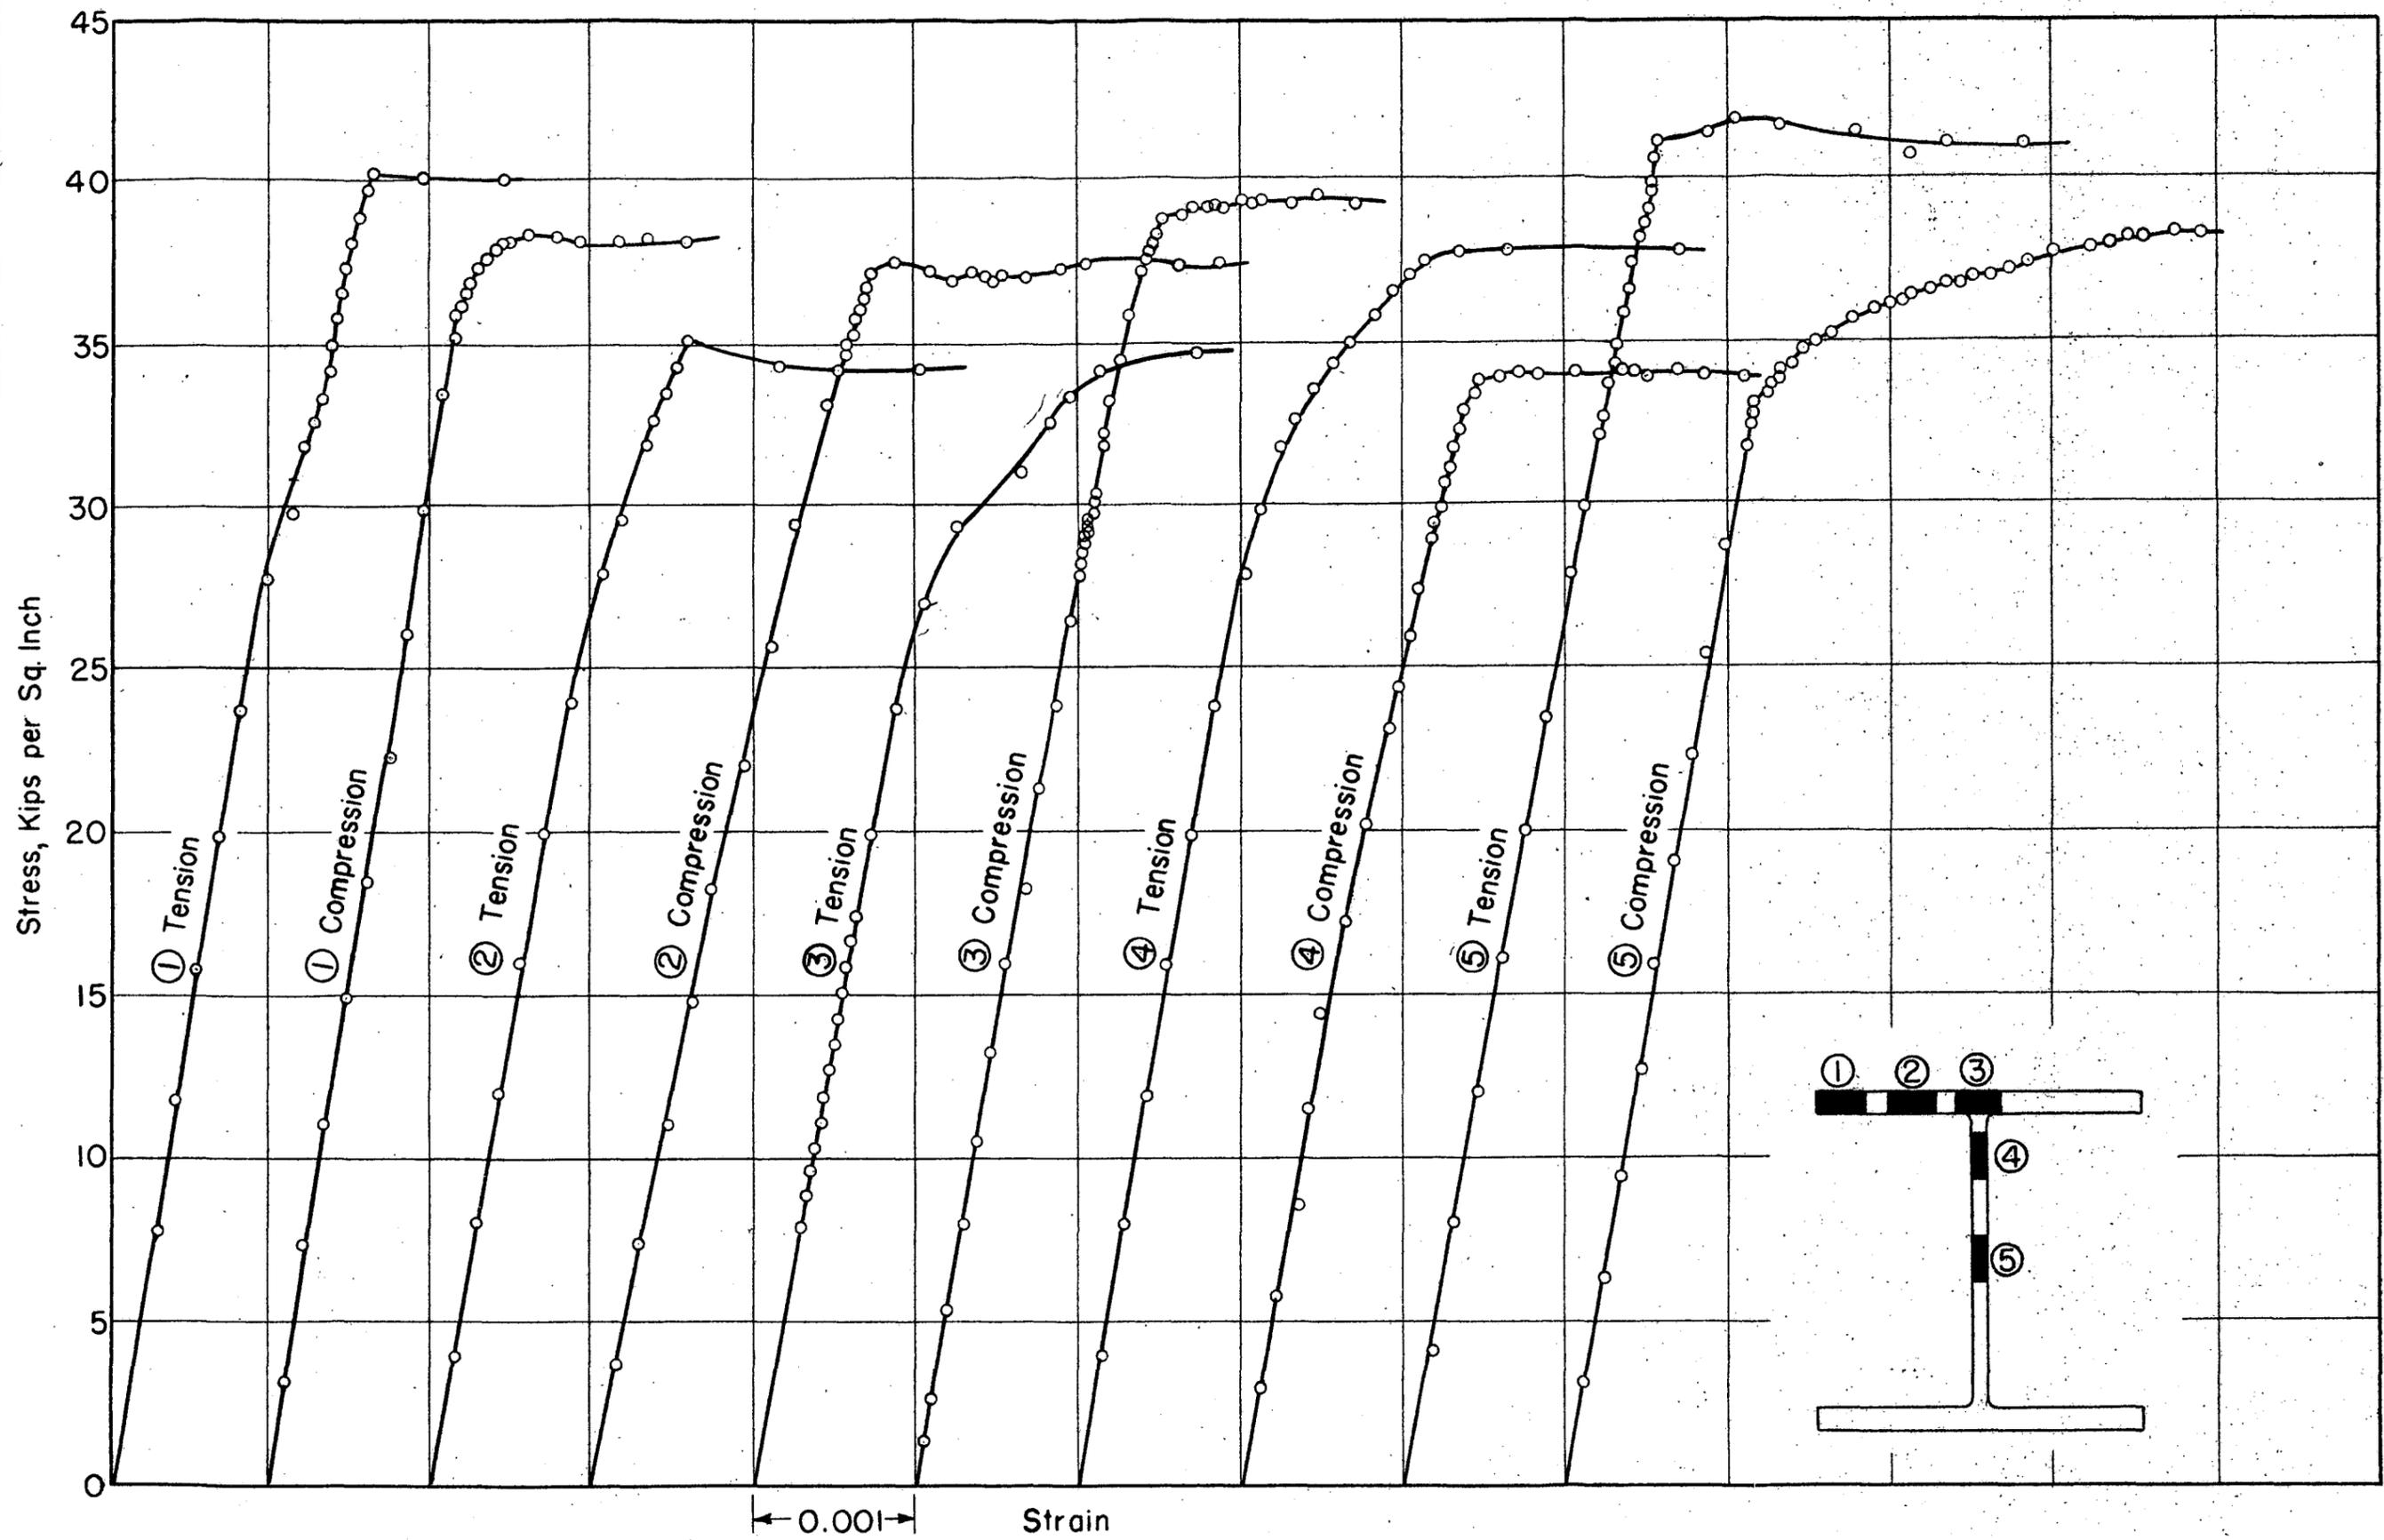
FIG. 49 TENSION AND COMPRESSION STRESS-STRAIN CURVES FOR AN 8W40 BEAM
