Proposal: structural steel investigations (continuous beams, Connections, Frames) to O.N.R.

Progress Report B

PLASTIC BEHAVIOR OF CONTINUOUS BEAMS

May 26, 1949

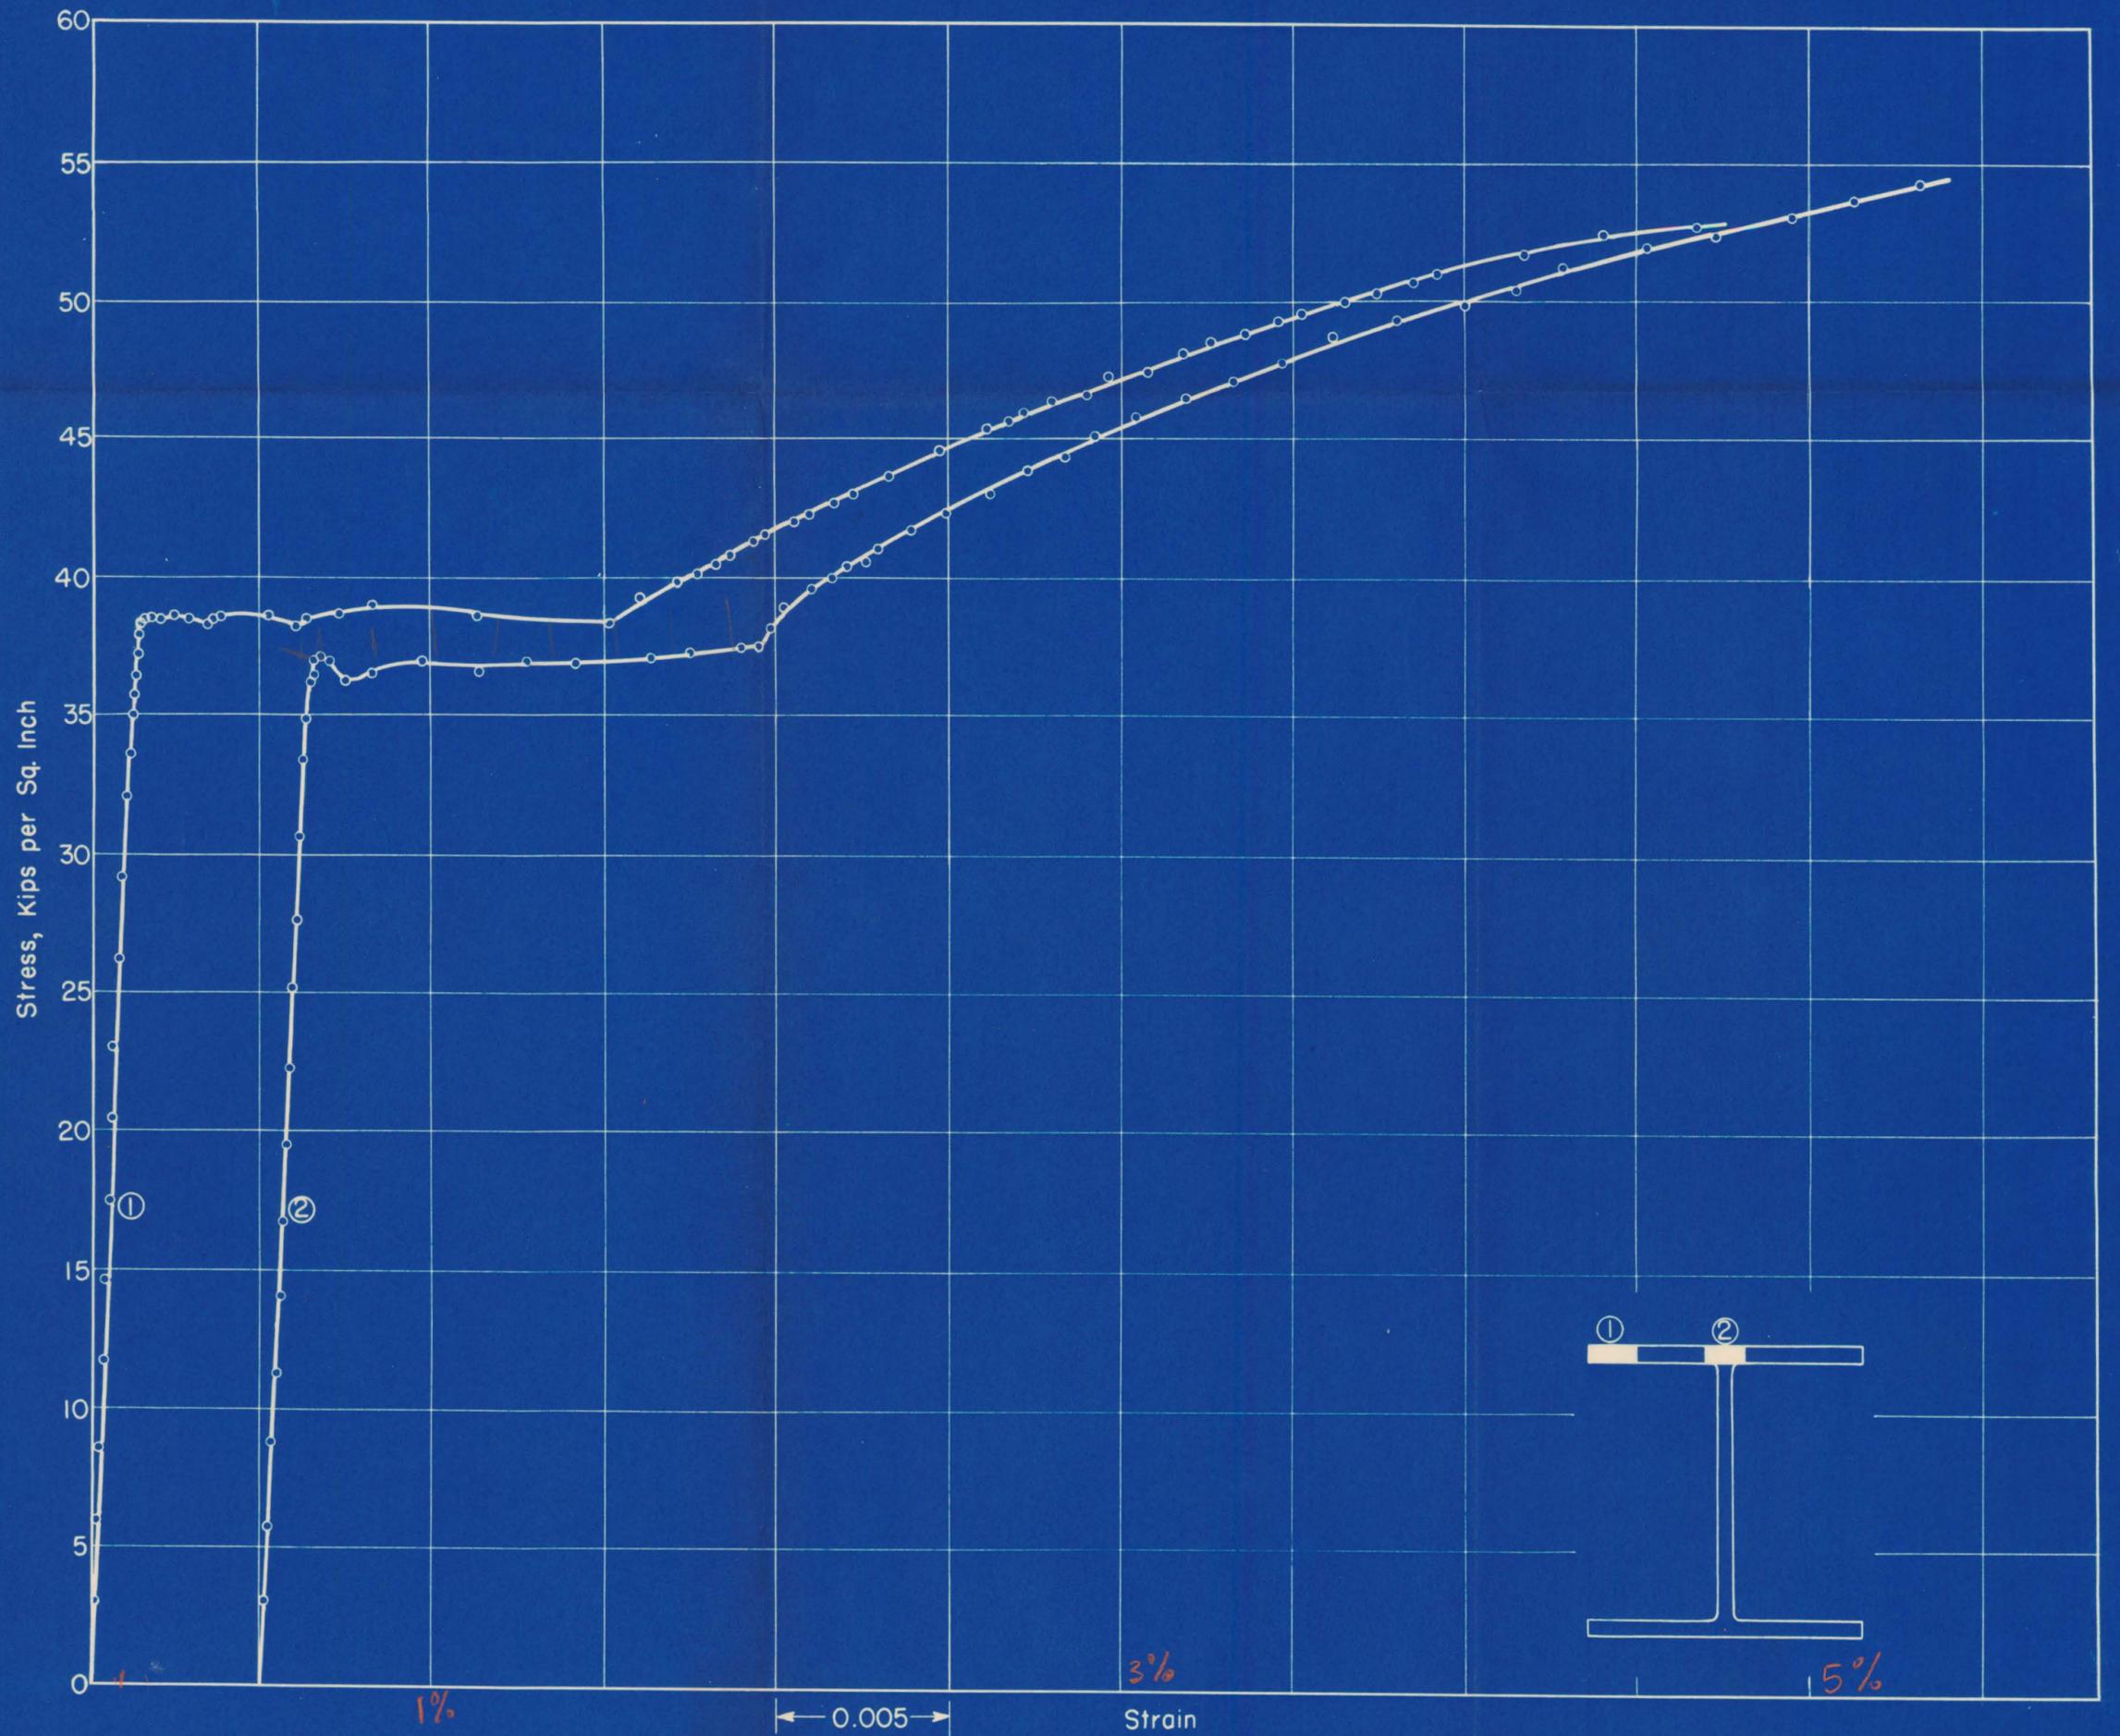
FIG. 50 TENSION STRESS-STRAIN CURVES FOR AN 8WF40 BEAM
(Including strain-hardening range)
