**CONTINUOUSLY REINFORCED CONCRETE PAVEMENT  
RESEARCH IN PENNSYLVANIA**

**PRELIMINARY REPORT**

**R. L. Schiffman, I. J. Taylor, W. J. Eney**

**Fritz Laboratory Report 252.1**

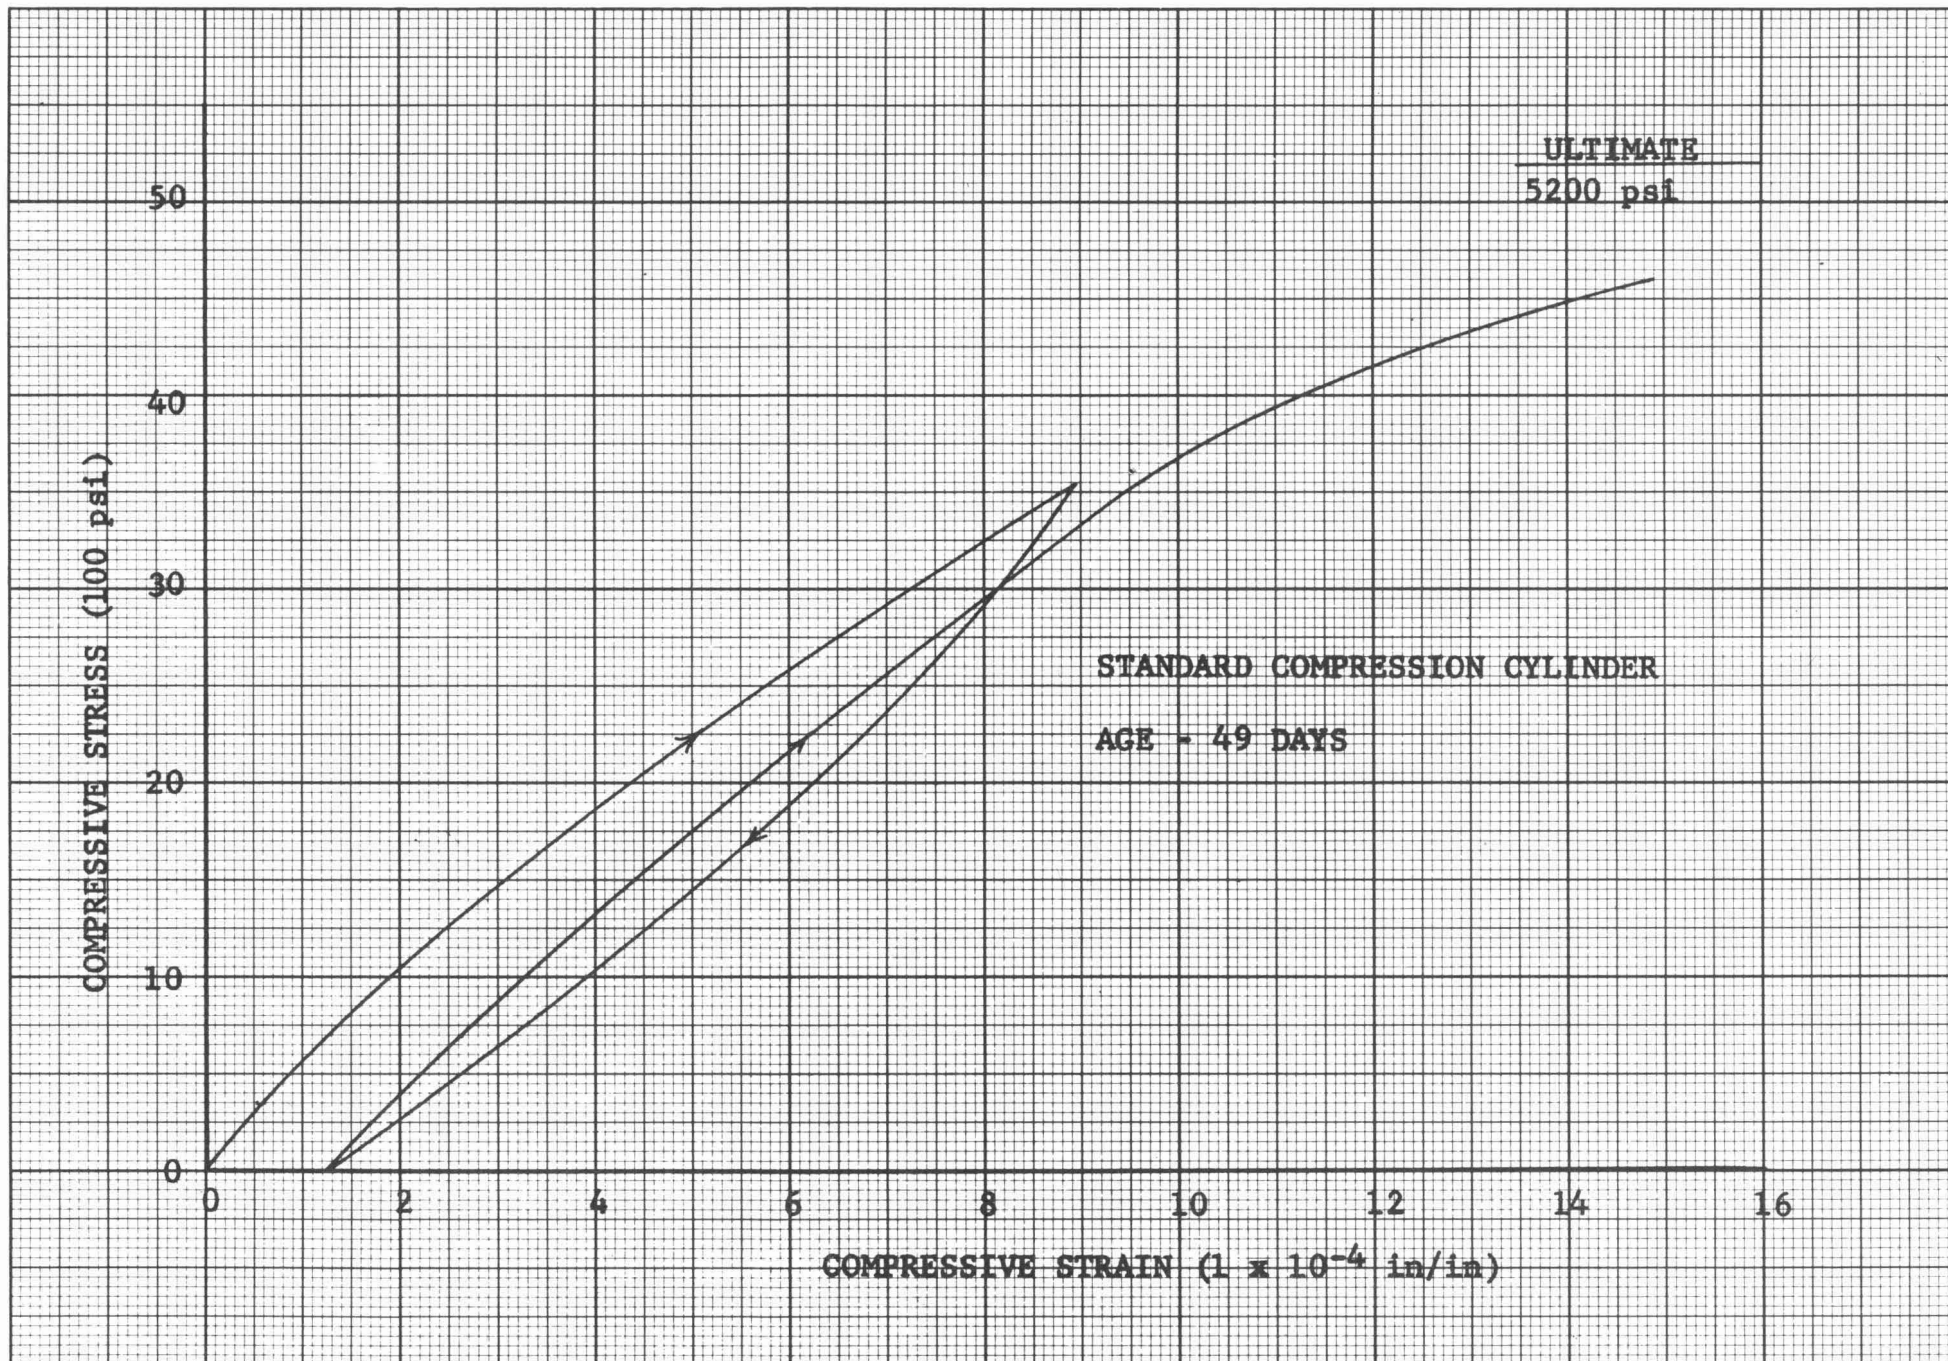
Figure 2 Compression Stress-Strain Curve For Concrete Cylinders

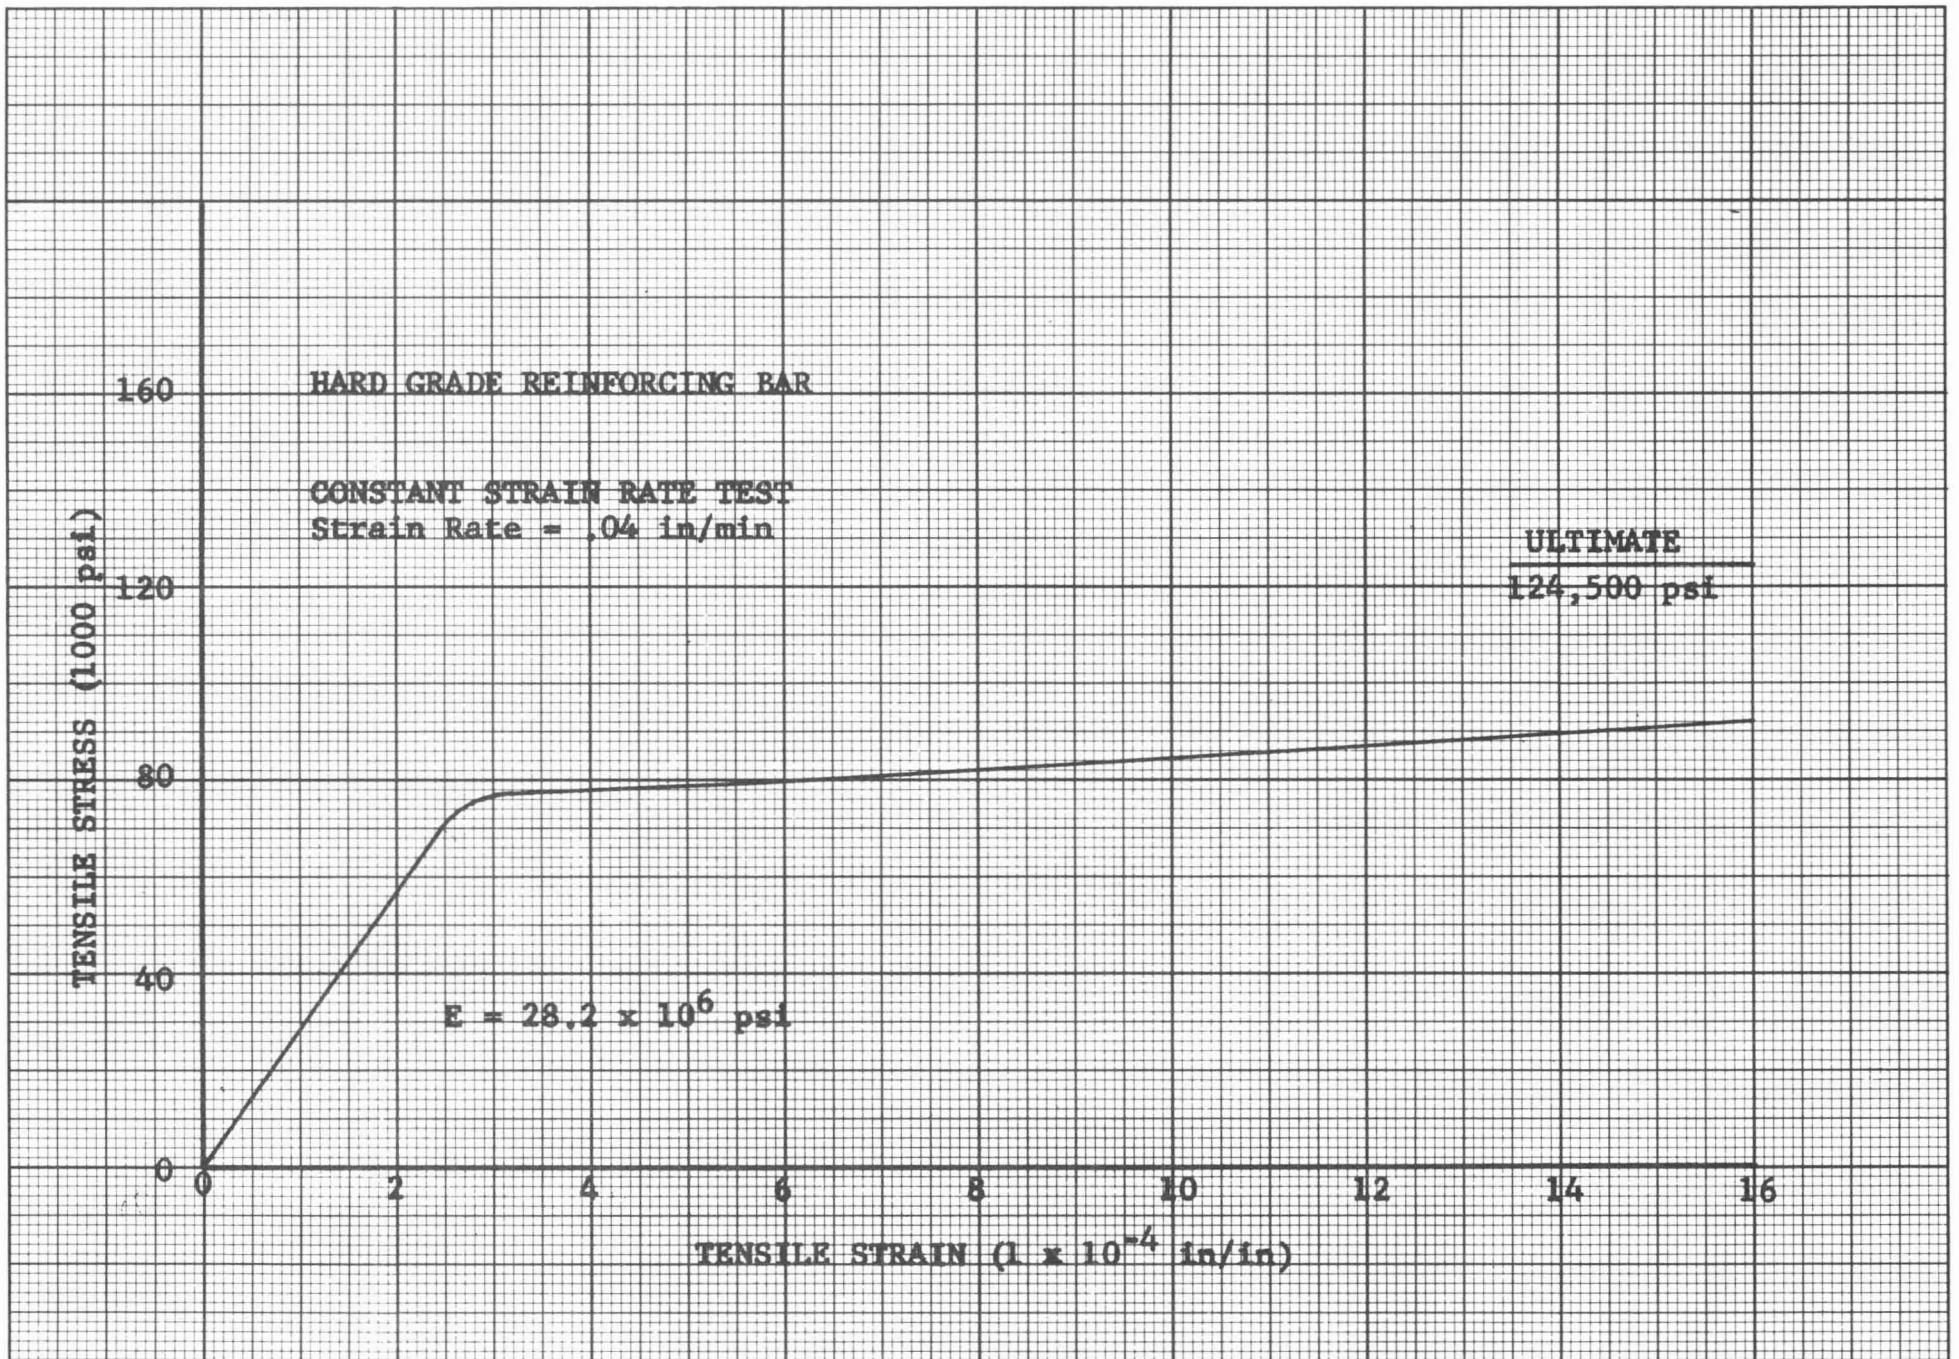
Figure 3 Tension Stress-Strain Curve — Reinforcing Bars

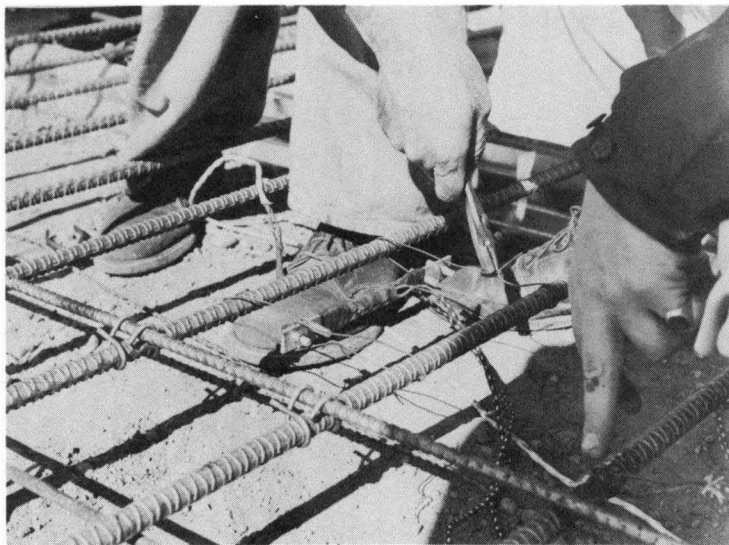
Figure 11 Placing of Concrete Strainometer in Test Panel

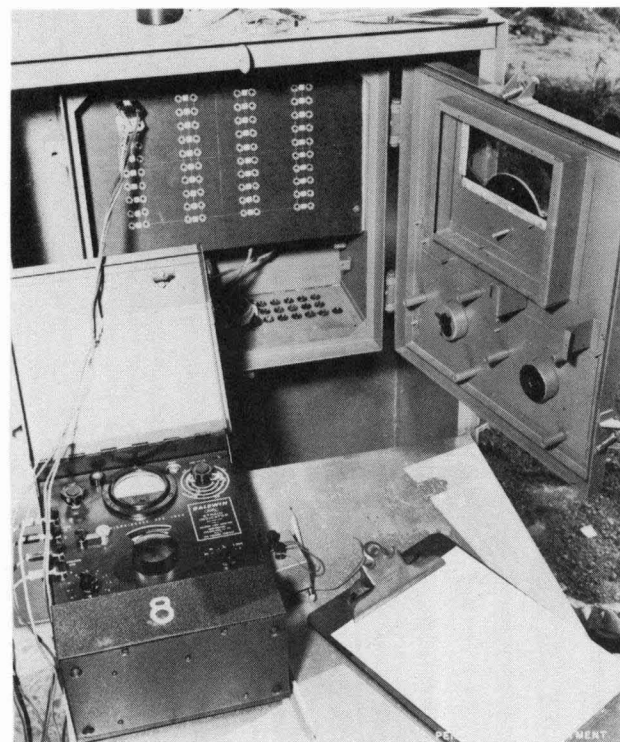
Figure 13 Terminal Board Ready for Gage Reading, Showing Indicator Box and Jack Plugs Inserted into Board

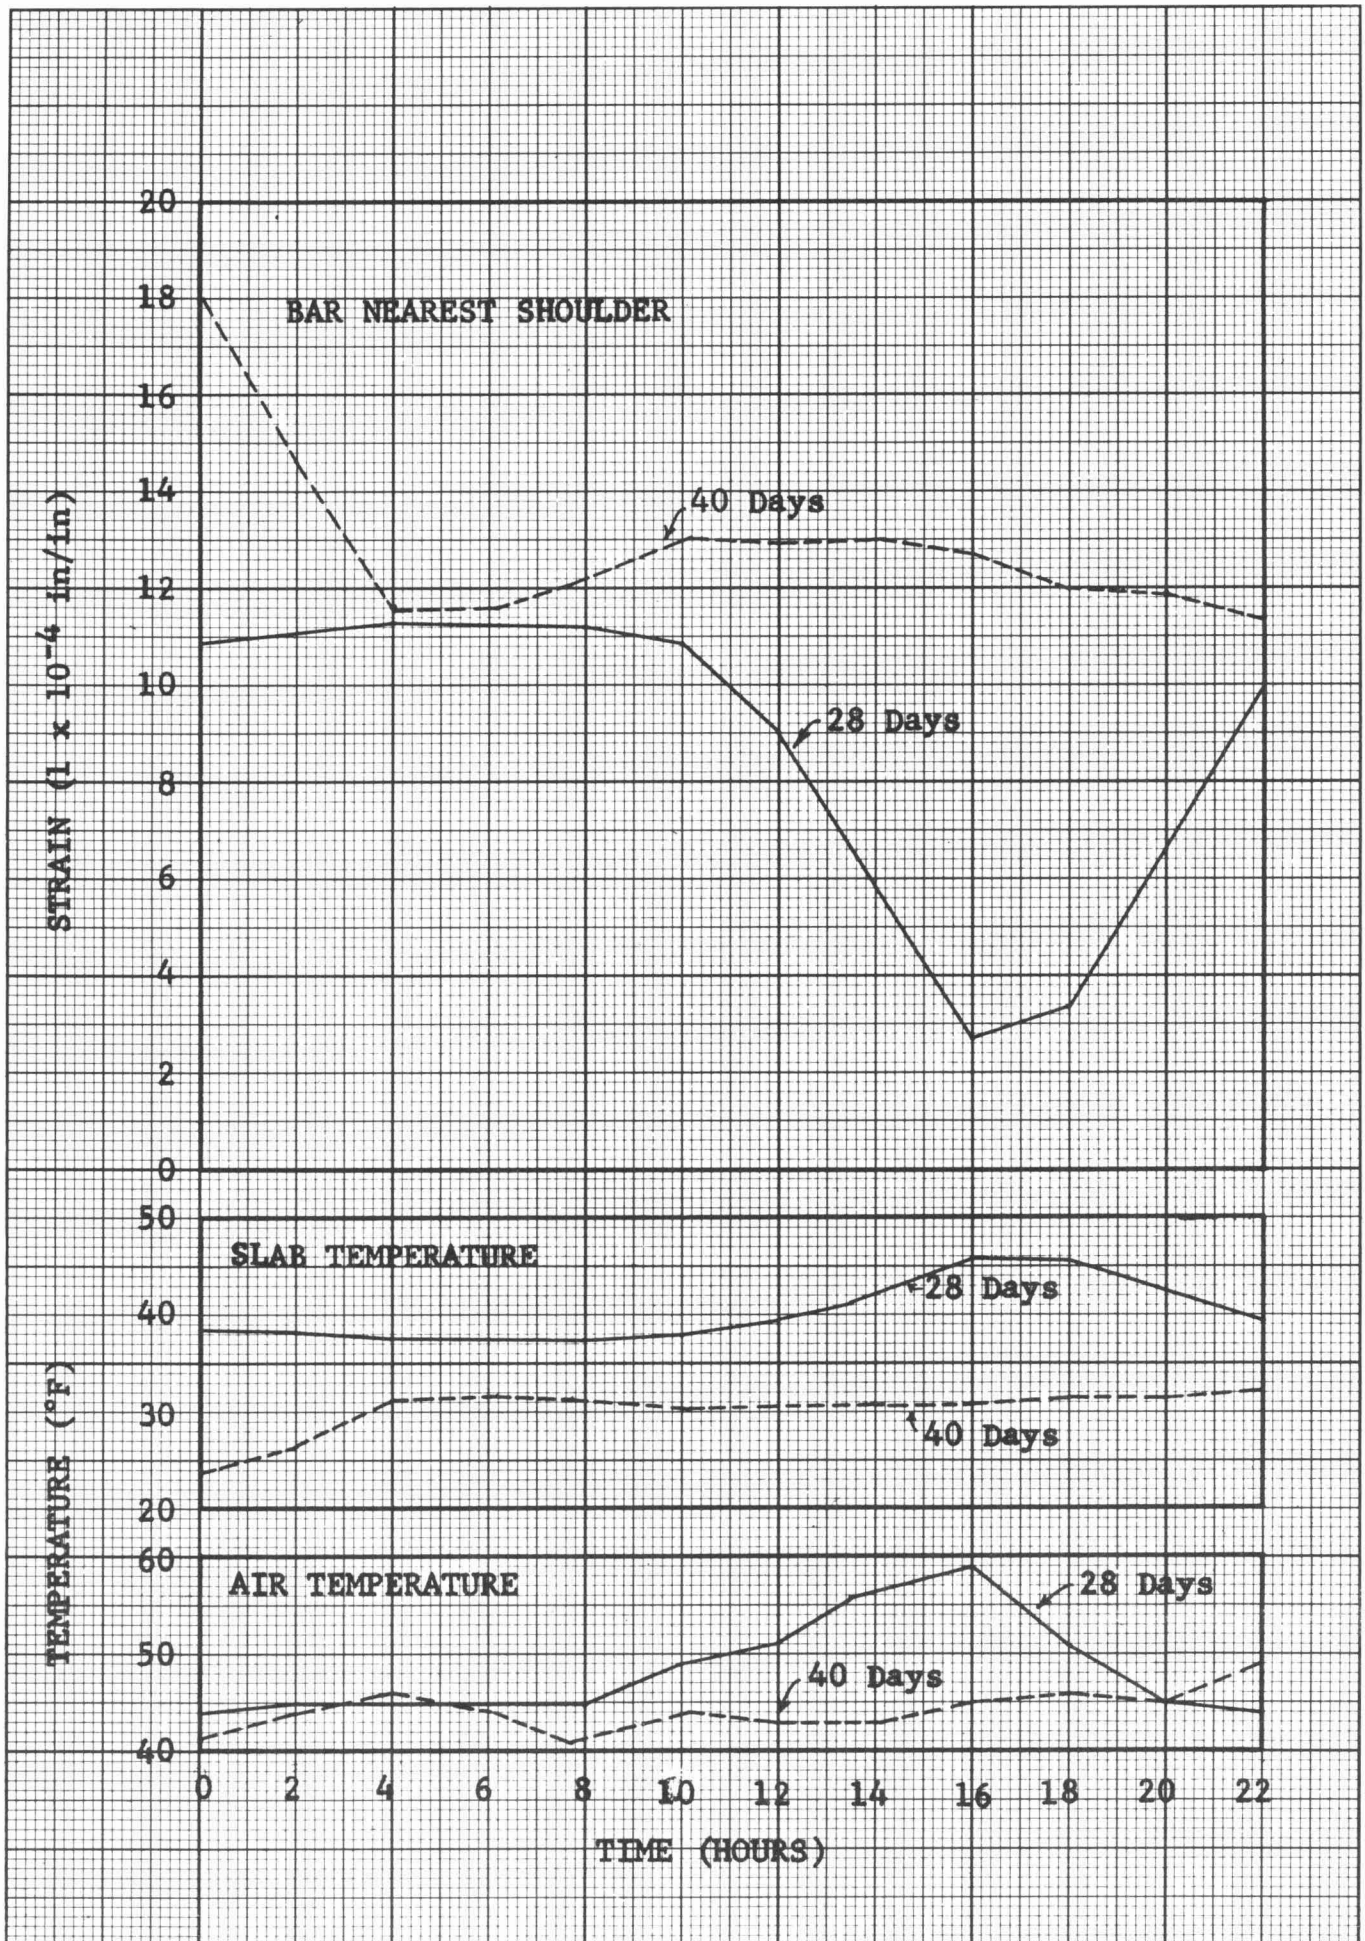
Figure 14 Short-Term Strain-Temperature Record for Instrumented Bar Nearest Shoulder at Preformed Crack

Figure 14 presents a complete strain temperature record for the shoulder edge bar on the 28th and 40th days after pour. It should be noted that equal slab temperature gradients result in equal strains over an intermediate period of time. This should not be surprising, except that with complete analysis, it should be possible to establish quantitative strain mechanisms based on the temperature gradients. Thus the design of these pavements can be keyed to the expected temperature fluctuations in a given geographical region.

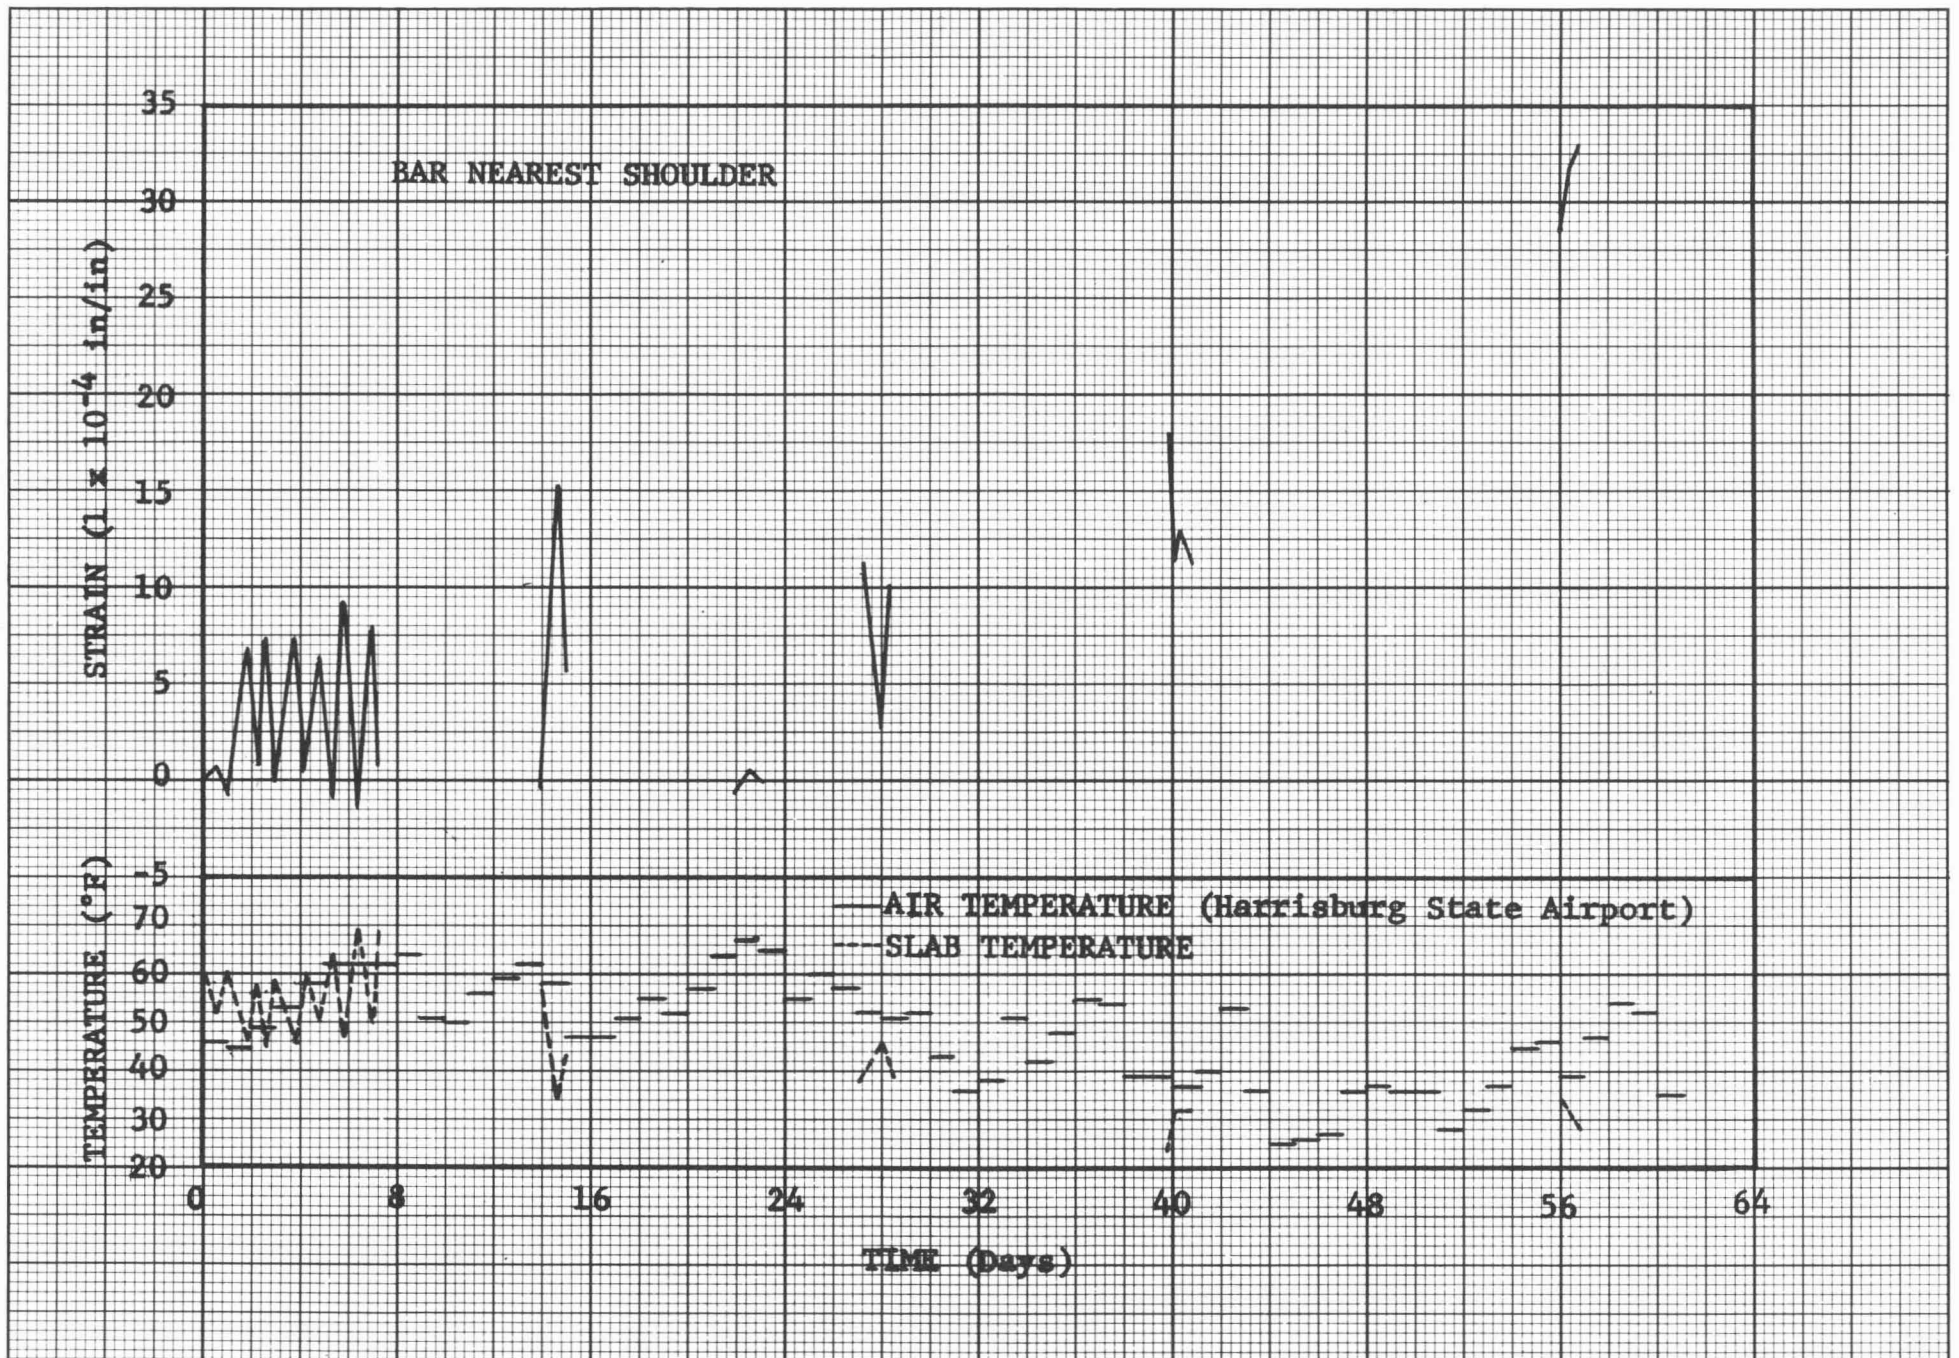
Figure 15 Strain-Temperature Record for First Fifty-Six Days of Pavement Life for Instrumented Bar Nearest Shoulder, at Preformed Crack

Between 40 and 56 days of age, the pavement steel reached such strains as to be in the yield range. Immediately after the 40th day observation, the temperature dropped suddenly and markedly, as shown in Figure 15. This temperature drop, although abnormal, was not of such magnitude as to be statistically of remote possibility. The increase in the restraint forces were then such as to exceed the yield point of the steel at the crack.
