ULTIMATE STRENGTH TEST OF A
HORIZONTALLY CURVED
COMPOSITE BOX GIRDER

J. Hartley Daniels

October 1985

Fritz Engineering Laboratory Report No. 454.3

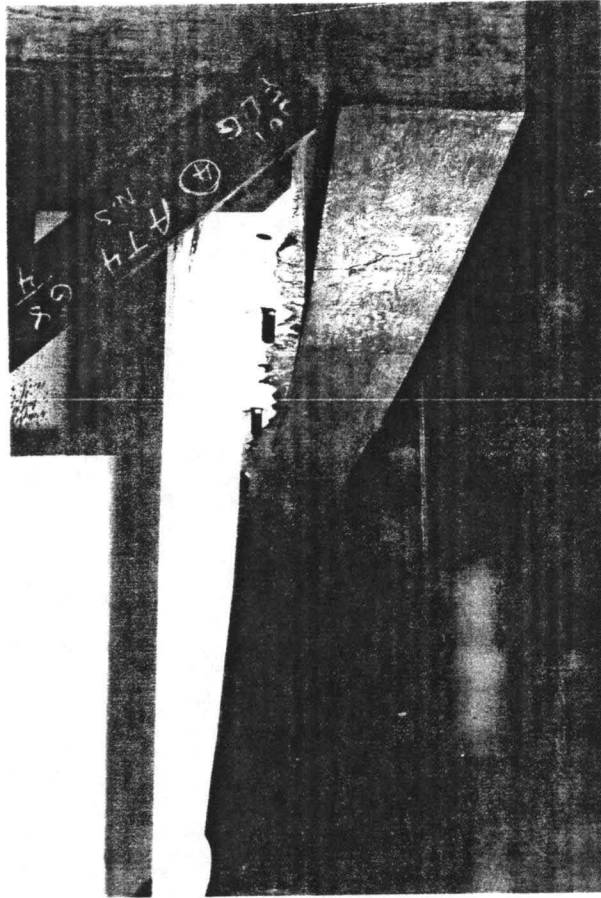
Fig. 24 Separation of Concrete Slab and
Bridgeform from the Top of the
Outside Girder - West End

- B - At a load of 200 kips and a deflection of 1.04 in. the concrete slab and Bridgform separated from the top of the web at the west end of the outside web, as shown in Fig. 24. The figure shows the west end of the outside web. The concentrated load is at mid-span over this outside web. The top of the outside web appears to have moved horizontally to the left relative to the concrete slab. Actually the entire slab has moved horizontally to the right as the box girder rotates clockwise at mid-span under the load. The displacement shown in the figure was accompanied by a large noise as the shear connectors and Bridgform near the ends of the outside web failed in shear.

the separation of the concrete slab and Bridgform from the top of the outside girder, as shown in Fig. 24. Figure 24 also shows the steel bars that were welded to the west end of the outside girder to reinforce this area during the ultimate strength test. Following the test, these bars were cut away as shown in Fig. 38. This figure shows the tearing of the upper part of the west end diaphragm from the outside web which occurred at a load of 200 kips (Point B, Fig. 23).
