**CYCLIC TESTS OF COMPONENTS OF ONE-STORY
REINFORCED CONCRETE
FRAME-WALL-DIAPHRAGM ASSEMBLAGE**

Kai Yu, Ti Huang and Le Wu Lu

Fritz Engineering Laboratory

December, 1989

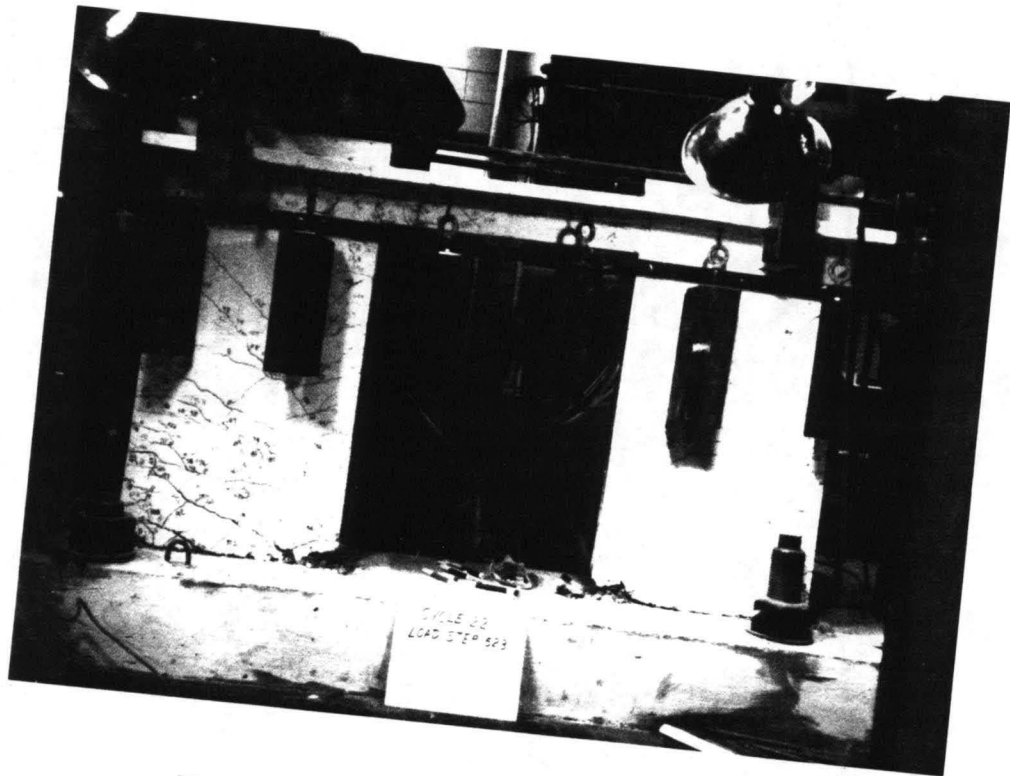
Figure 3-3: Failure Mode of Shear Wall

Some failure modes of the structure and its elements and the concrete cracking pattern on the walls are shown in Figs. 3-2 to 3-4.

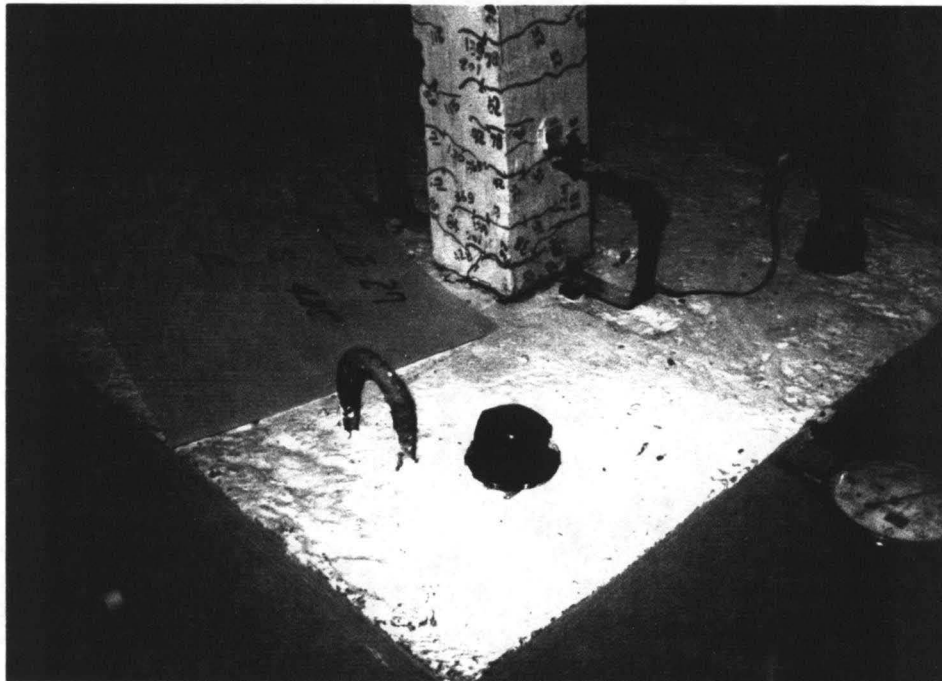
Figure 3-7: Deformation at Base Region of the E. Column

Figs. 3-7 to 3-10 give the details of the failure modes and deformation of the structure and its elements.

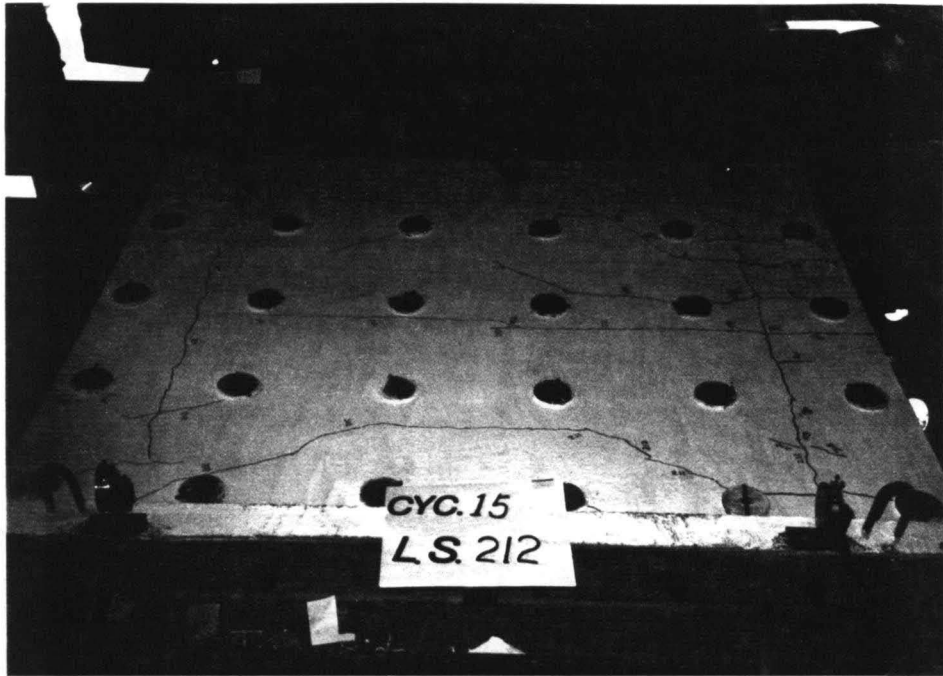
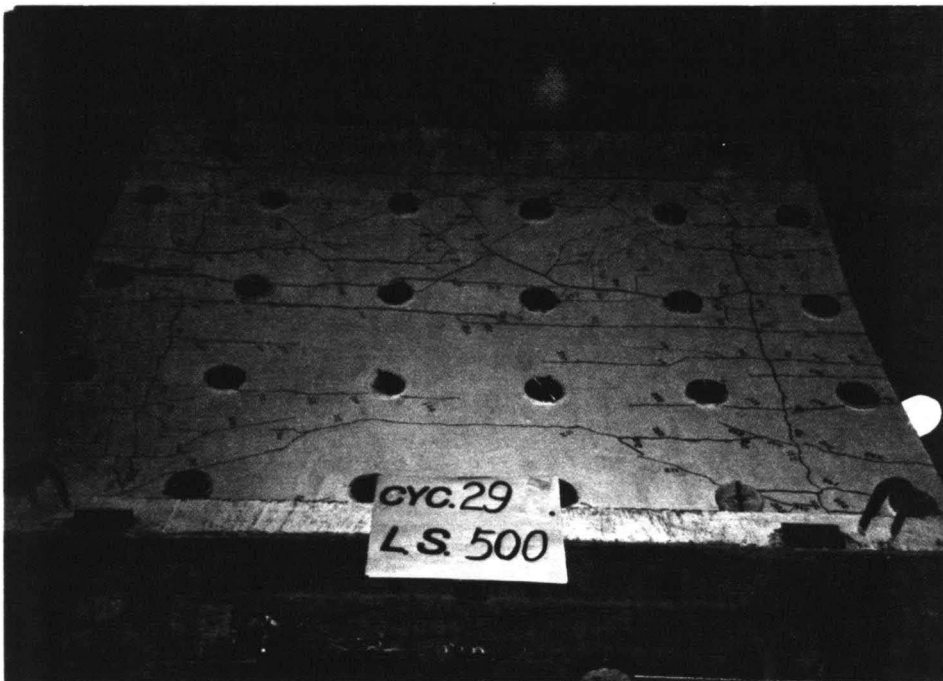
Figure 3-13: Concrete Cracking Pattern of Slab

Figs. 3-13 to 3-16 illustrate the details of the cracks and the failure mode of the slab.

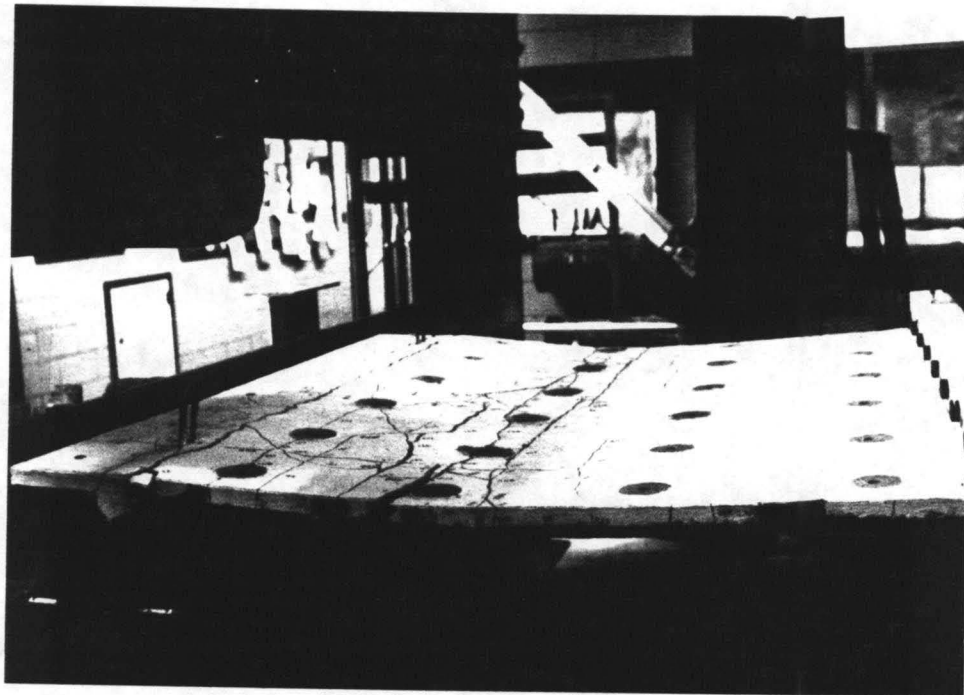
Figure 3-16: The Failure Mode of the Slab
