Field study of a prestressed concrete bridge, Final Report, Vol 1 of PennDOT Project 86-05, January 1993

Research Project No. 86-05
Field Testing of a Steel Bridge and a Prestressed Concrete Bridge

FINAL REPORT
Vol. I
FIELD STUDY OF A PRESTRESSED CONCRETE BRIDGE

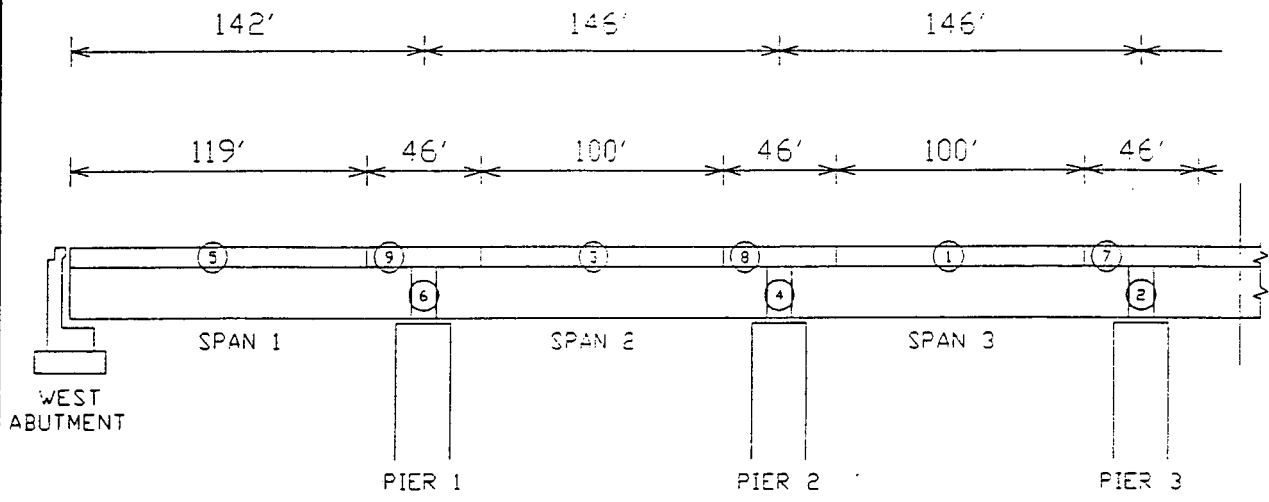
FIGURE 2.7 CASTING SEQUENCE FOR SPANS 1, 2, AND 3

JUNE 1, 1987 (MONDAY)	P1 } P2 }
JUNE 5, 1987 (FRIDAY)	P3 } P4 }
JUNE 8, 1987 (MONDAY)	P5 } P6 }
JUNE 9, 1987 (TUESDAY)	P7
JUNE 10, 1987 (WEDNESDAY)	P8
JUNE 11, 1987 (THURSDAY)	P9

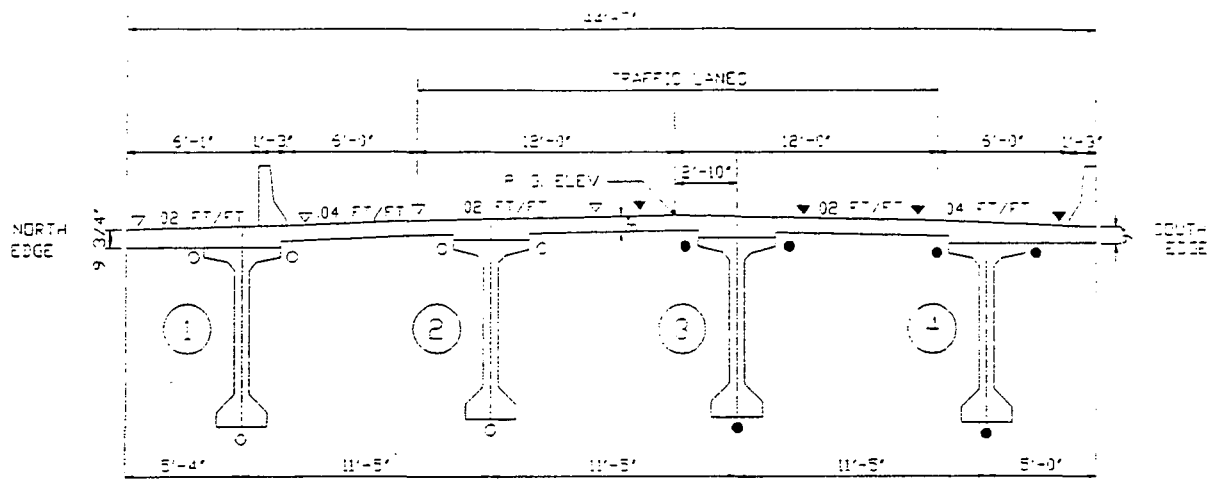
FIGURE 2.9 STRAIN GAGE LOCATIONS

- LONGITUDINAL GAGES (9 CROSS-SECTIONS)
- LONGITUDINAL GAGES (3 CROSS-SECTIONS)
- ▼ 2 GAGES AT 90° ON SLAB (3 CROSS-SECTIONS)
- ▽ 2 GAGES AT 90° ON SLAB (2 CROSS-SECTIONS)

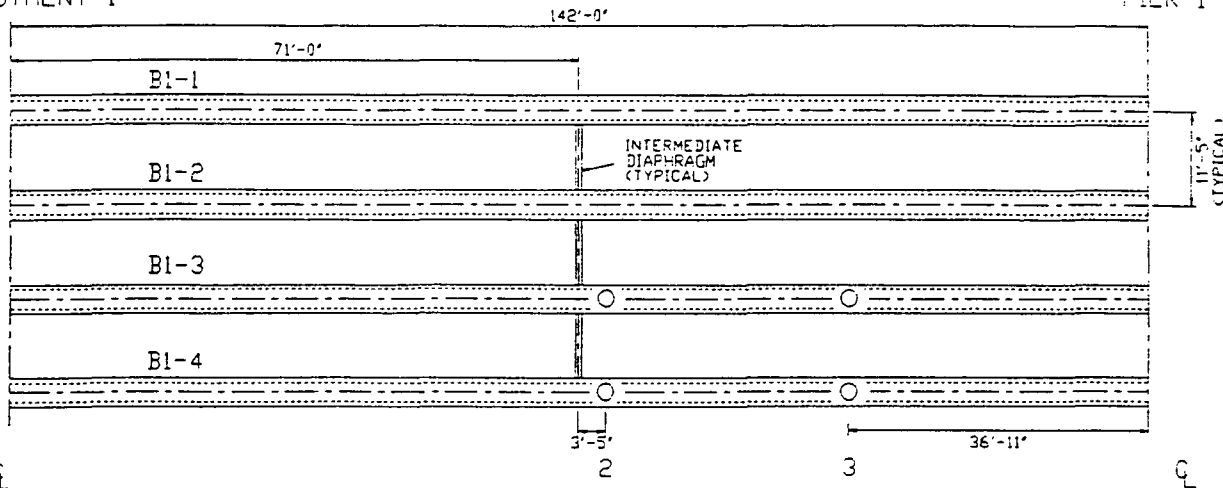
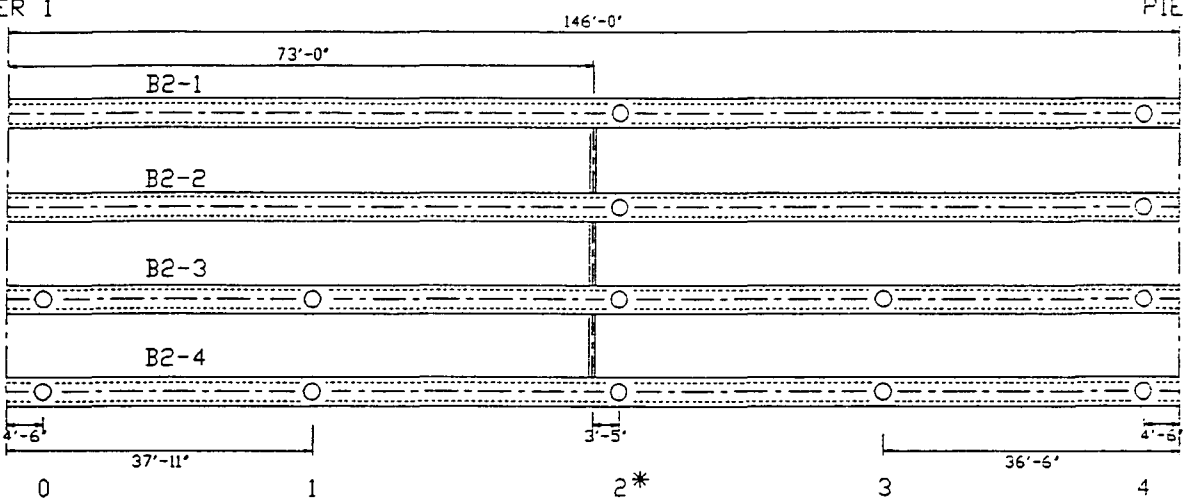
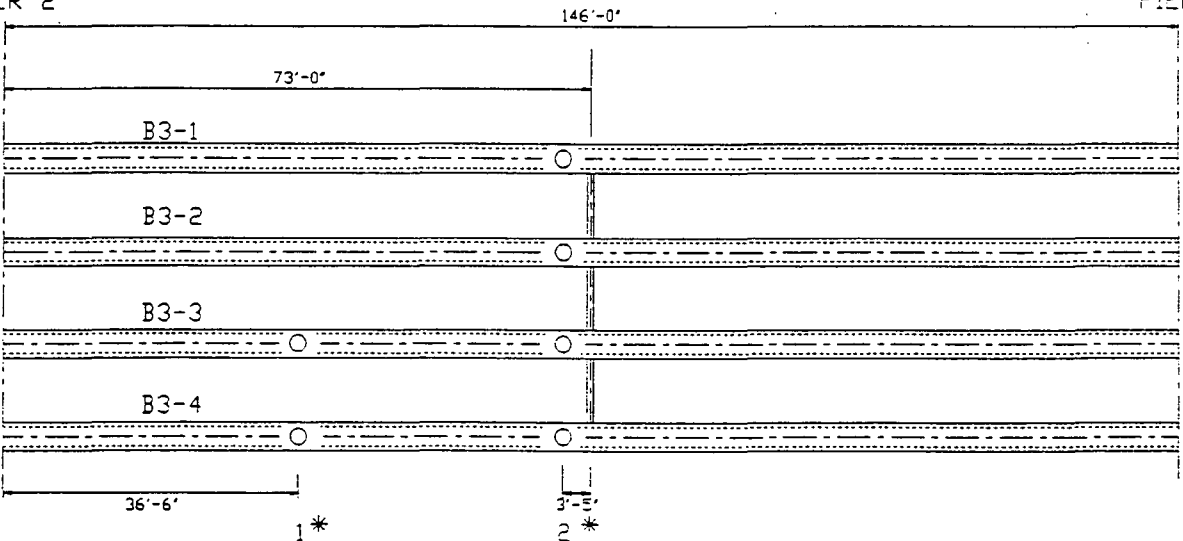
FIGURE 2.12 STRAIN GAGE LOCATIONS - PLAN VIEW

* : NOMINAL DISTANCE FOR EACH GAGE
O : GAGE POINTS (EACH GAGE POINT HAS THREE GAGES)

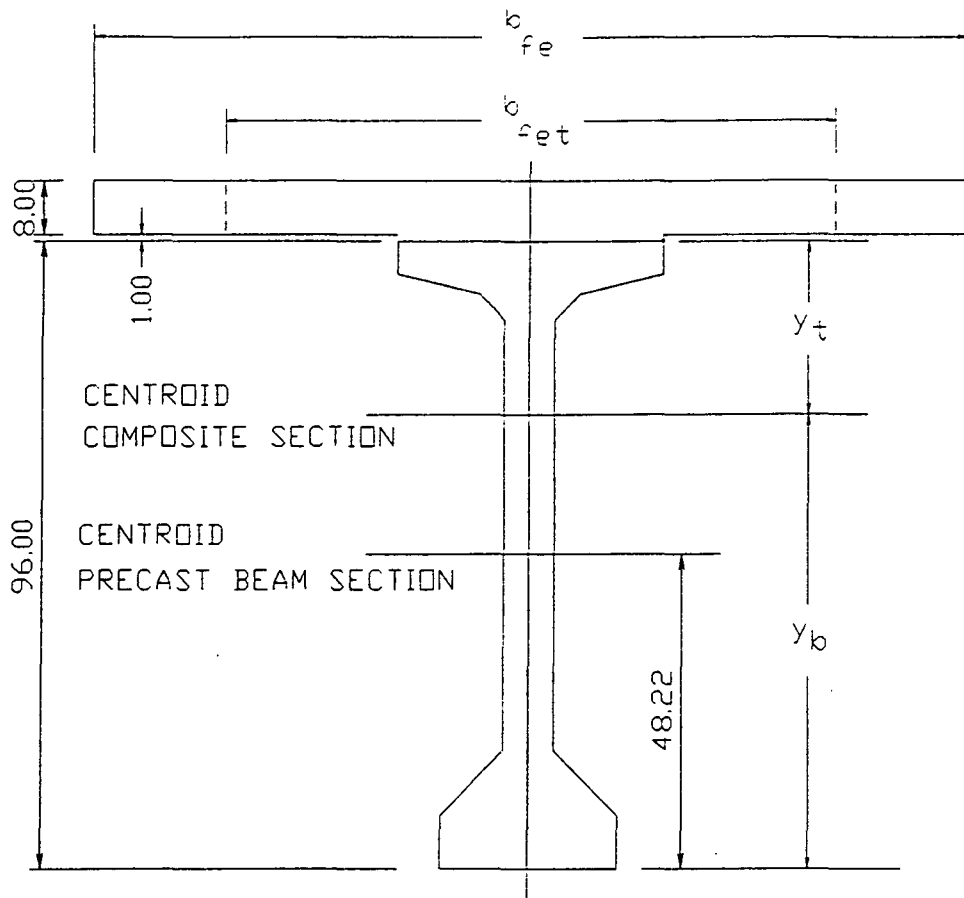
FIGURE 4.4 PROPERTIES OF COMPOSITE SECTION

$$f'_{cs} = 4500 \text{ PSI} \quad f'_{cb} = 7600 \text{ PSI} \quad n = \frac{E_{cs}}{E_{cb}} = 0.77$$

A	\bar{y}_b	I
PRECAST BEAM SECTION	1277 IN. ²	48.22 IN.	1,522,000 IN. ⁴
COMPOSITE SECTION	$b_{fe} = 96 \text{ IN.}$	65.47 IN.	2,682,000 IN. ⁴

level of the experimental measurements. In this present study, the preferred level of comparison is the stress at each strain gage location. However, it should be noted that the "computed" stresses were not directly generated by the computer programs. Actually, the programs provided bending moments in individual beams. These moments were then used by Modjeski and Masters to determine stresses at the gage locations, using properties of the precast beam and composite section as shown in Fig. 4.4.

Since all four computer programs generated very similar beam bending moments under the same loading conditions, it was initially suspected that the substantial differences between computed and measured stresses may have been caused by the use of the composite beam cross section shown in

Fig. 4.4 More specifically, it was felt that the effective flange width used in the calculations may not be appropriate for determining stresses under loading by one test truck (or two test trucks) in a single lane. An in-depth investigation of this problem -- the selection of cross section properties of beams for the analysis of stresses under specific loading conditions other than design load conditions -- would be very useful in the enhancement of current bridge analysis methods, and would be of great future interest. While a current study of this problem is in progress⁽³⁾, the inclusion of the results is beyond the scope of this study.
