Welded Continuous Frames and Their Components

FURTHER STUDIES

WELDED CORNER CONNECTIONS

(Tension Loading)

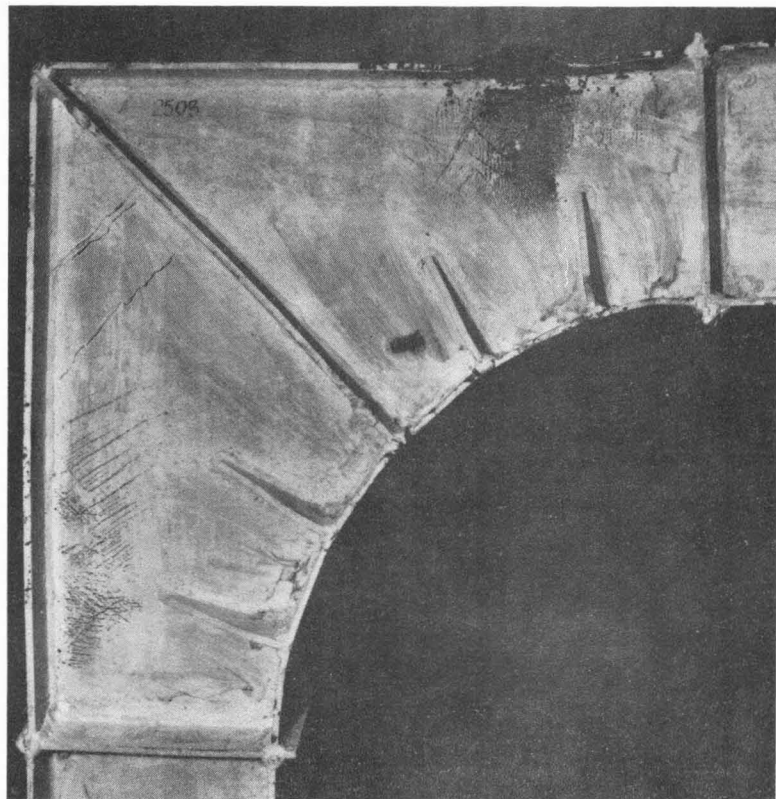
Fig. 5 shows Connection G at the end of the test. The localized yielding and the lateral buckling which brought about the final collapse of this connection are evident. Fig. 17 shows specimen I after failure and at the end of the test. Connection J is shown in Fig. 18.

Fig. 18 Connection J
