Report of tests of welded top-plate and seat building connections

J. L. Brandes

REPORT OF TESTS OF WELDED TOP-PLATE
AND SEAT BUILDING CONNECTIONS

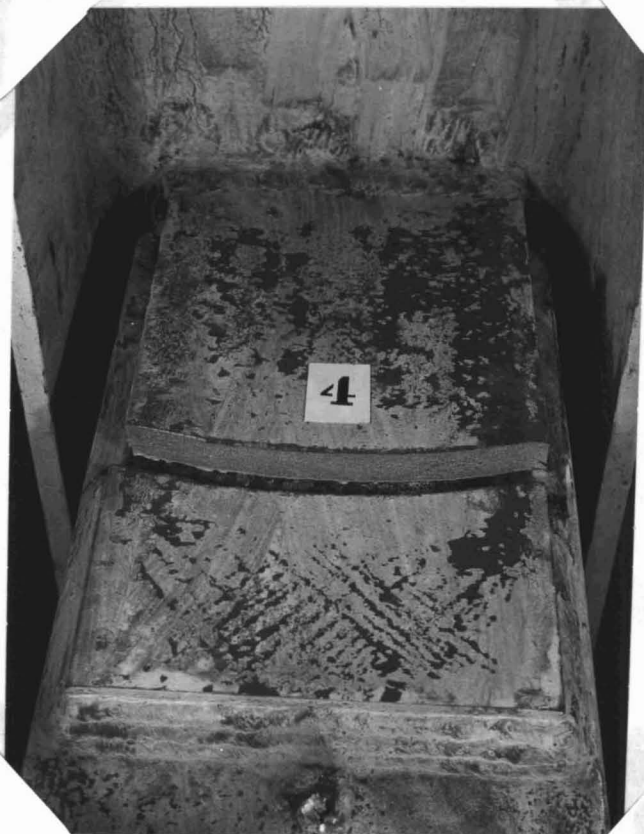
Fig. 17(b) - Fracture of Test 4 Top Plate

The top plate failed suddenly with a brittle fracture at $V = 192$ kips, $M = 6630$ kip-in. The fracture section is shown in Fig. 17(b). The rather coarse-grained character of the fracture surface and the lack of any necking down may be noted, also the fact that the fracture started at the end of the fillet return. Control tests of the plate material before the specimen was fabricated showed an elongation in 2 in. of 43 per cent, a reduction in area of 31 per cent, and an ultimate strength of 63,000 p. s. i., which should normally indicate a "ductile" steel.

The "brittle" fracture of the top plate of Specimen 4 in metal which should normally have been ductile, was unexpected and was thought to be quite unusual. Possible explanations of the brittle fracture might be:

(1) A tri-axial tension state of stress may have been developed at the edge of the fillet return, though this could not very well have been true at the center of the top plate where the fracture was also brittle in character.

(2) The welding process may have caused a brittle structure to be formed near the fillet weld, but again this does not explain the brittle fracture exhibited at the center of the top plate. Also, the size of the weld and the accompanying high heat input during welding make the formation of a brittle structure rather improbable.

(3) A bi-axial tension state of stress probably existed in the top plate along the fracture line. If the "normally ductile steel" had some peculiar characteristics which would make it behave in a brittle fashion under bi-axial tension, then that characteristic would explain the failure observed.

(4) A brittle crack was formed in the top plate at the end of the fillet weld return as discussed in either item (1) or (2). The cross-sectional area under tension was thereby reduced considerably. If the crack had been formed rather quickly, the remaining area could have been subjected to a sudden increase of stress as the testing machine recovered its elastic strain. This sudden increase of stress on the plate and the notch effect of the cracks could cause a brittle failure in a sufficiently notch-sensitive material.

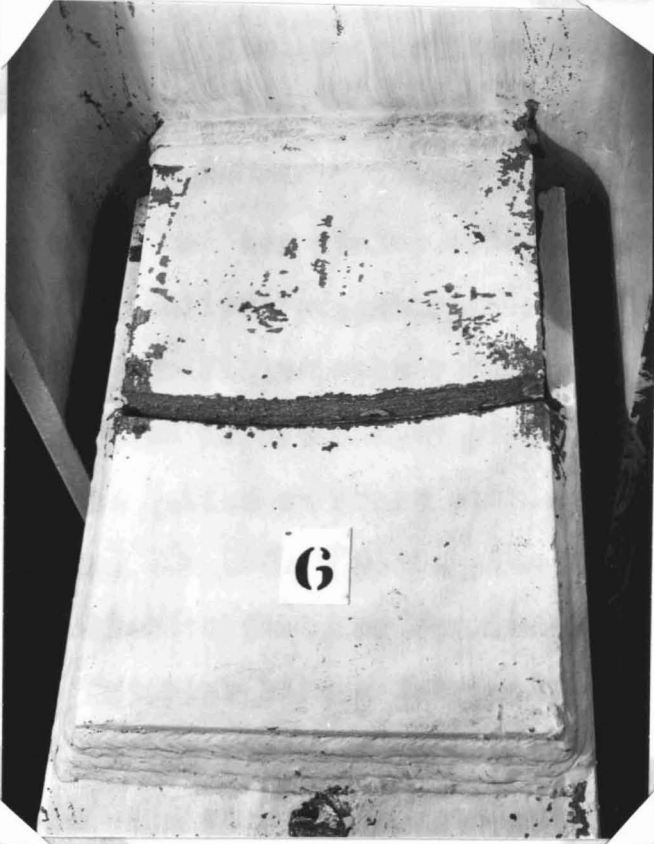
Fig. 19 - Top Plate Failure In Test 6

The top plate failed suddenly with a brittle fracture at $V = 173$ kips, $M = 5960$ kip-in. The failure, shown in Fig. 19, was similar to that for Specimen 4. Control tests of the plate material before fabrication showed an elongation in 2 in. of 55 per cent, a reduction of area of 50 per cent, and an ultimate strength of 58,500 p.s.i., which was again what would normally be called a "ductile" steel.

The failures of these two specimens were almost identical with that of No. 4, with brittle behavior in what should normally have been ductile material. The fracture of

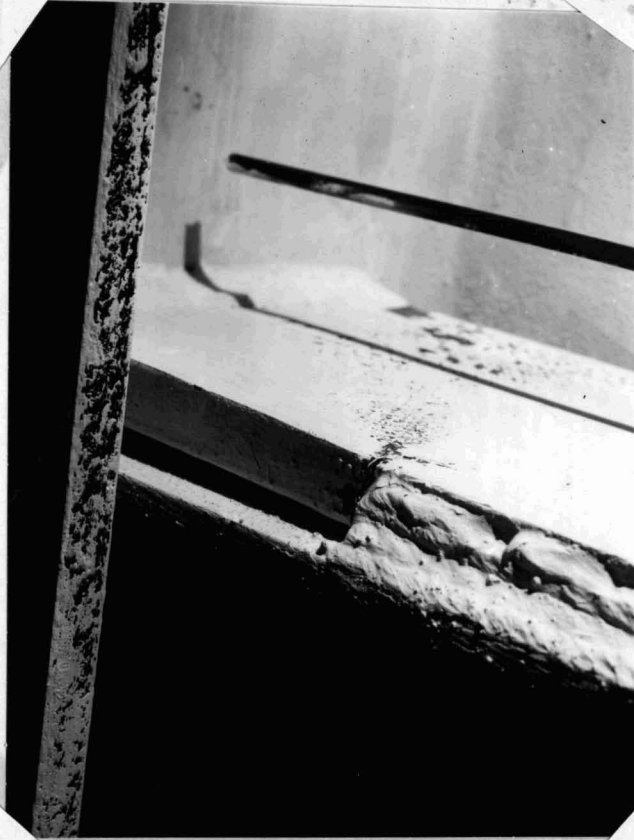
Fig. 20(a) - Top Plate at the Verge
of Failure in Test 7

At $V = 170$ kips, $M = 5860$ kip-in., brittle cracks in the top plate appeared at the edge of the fillet weld return. The test was stopped long enough to take the photograph shown in Fig. 20(a). The specimen was then loaded further until failure occurred at $V = 174$ kips, $M = 6000$ kip-in., by tearing of the top plate. The first 1/2-in. of the test was similar to those of Tests 4 and 6,

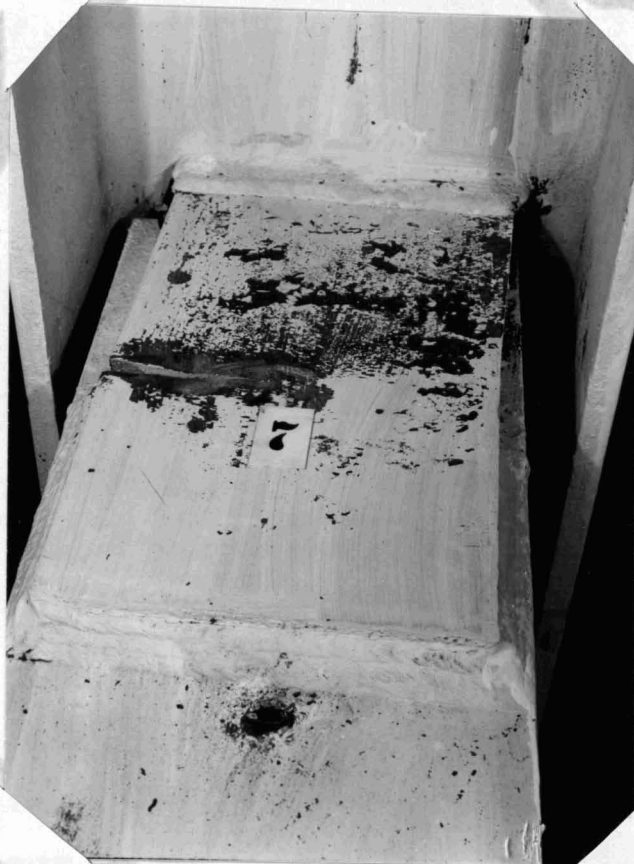
Fig. 20(b) - Top Plate Failure
of Test 7

coarse-grained with no necking down, but from there on the fracture showed distinct necking down. An examination of Fig. 20(b) will bear out these statements.

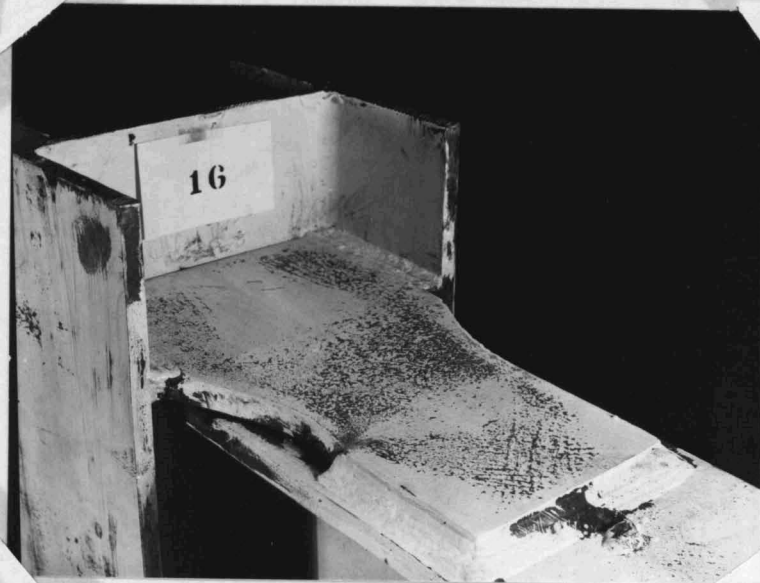
Fig. 32 - Top Plate of Test 16
After Failure

At $V = 145$ kips, $M = 4990$ kip-in., a weld ping was heard. Later examination of the specimen showed that the butt weld had broken away from the column web at the end of a weld pass which the welder had carried around to the web in finishing off the pass. The crack was parallel to the column web and in no way interfered with the structural action of the butt weld to the flange. At $V = 165$ kips, $M = 5690$ kip-in., failure occurred by the tearing of the top plate at the edge of the fillet return. Fig. 32 shows the tear on the left side of the top plate.

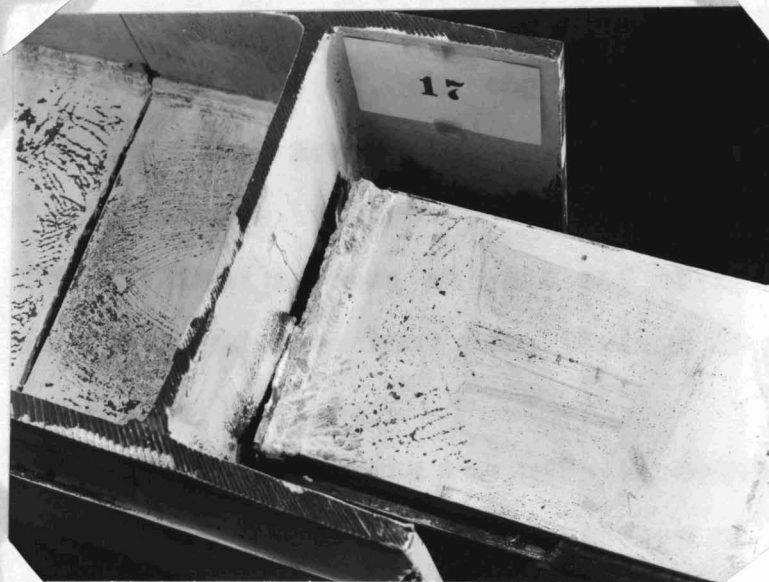
Fig. 36(a) - Failure of Test 17

$V = 109$ kips, $M = 3760$ kip-in., the top plate suddenly pulled out half the thickness of the column web. Fig. 36 (a) shows this failure as it appeared after test, and Fig. 36(b) shows the oxidized surface at each end of the fracture after the plate had been bent down through 90 degrees.

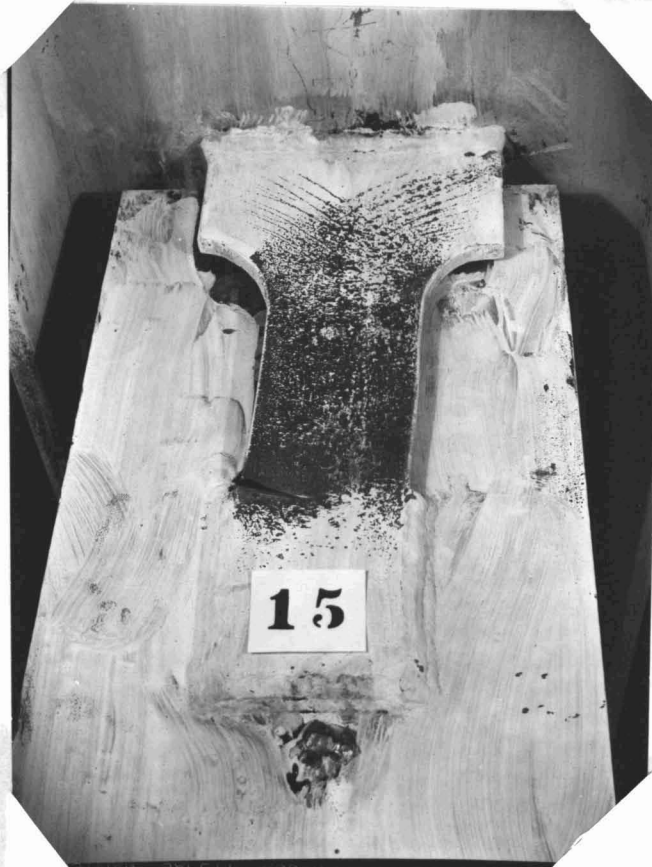
Fig. 45 - Typical Failure
of Flexible Top Plate

A series of six specimens was made to determine whether or not a light top plate with a reduced or "throat" section would give a satisfactory flexible connection. Specimens 11 and 15 were web connections and Specimens 13 and 14 were flange connections. Design details are shown in Fig. 37 to 40; moment-rotation curves are plotted in Fig. 41 to 44; and a photograph of a typical failure is shown in Fig. 45. Observations of strain lines during test are listed in Table III.

At $V = 98.5$ kips, $M = 1580$ kip-in., the top plate failed by tearing at the edge of the fillet weld return in the same fashion as shown in Fig. 45. As in Specimen 10, the reinforcing plates on the column webs at the top plate showed the weakness of the column web at the seat, since the web buckled in and showed heavy strain lines around the tee.
