A metallographic study of 18th century woodworking tools from the Williamsburg collection

Presented to the Graduate and Research Committee
of Lehigh University
in Candidacy for the Degree of
Master of Science

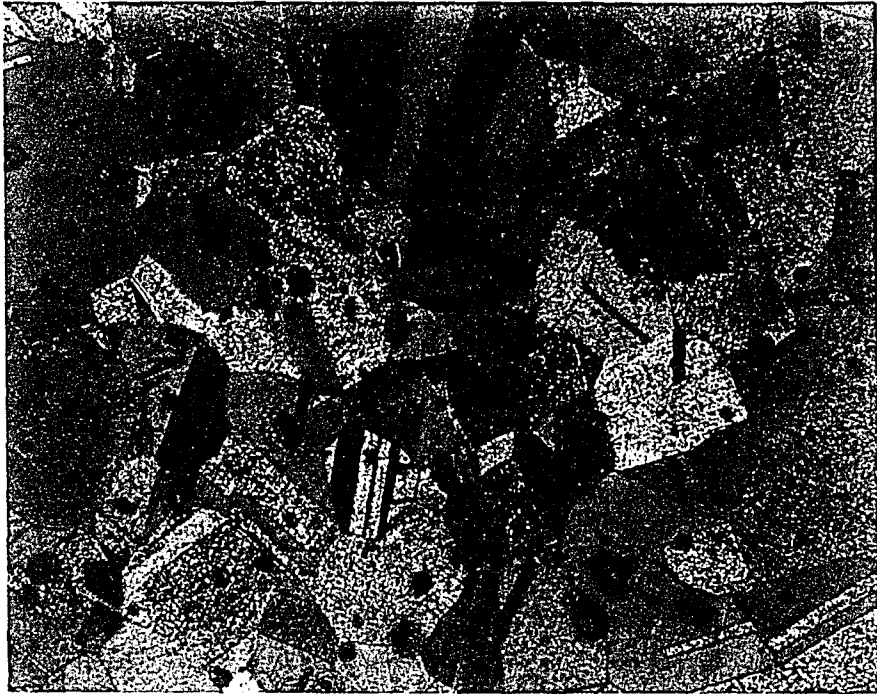
Figure 67 S3 backing, 150X, brass etch, polarized light

The typical microstructure obtained for the brass backings consisted of large grains with fairly straight annealing twins typical of a cold worked and annealed structure. The mounted brass piece cut from S3 showed only these twins (Fig 66, 67) while the other brass backings which were examined in situ showed some slip traces indicative of light cold working.(Fig 68) It appears that the brass was first fabricated into grooved rod-stack and the saw was then tapped into the backing groove.
