# Experimental evaluation of the behavior of spirally-reinforced high-strength concrete columns

Annette M. Pieroni  
*Lehigh University*

A Thesis

Civil Engineering

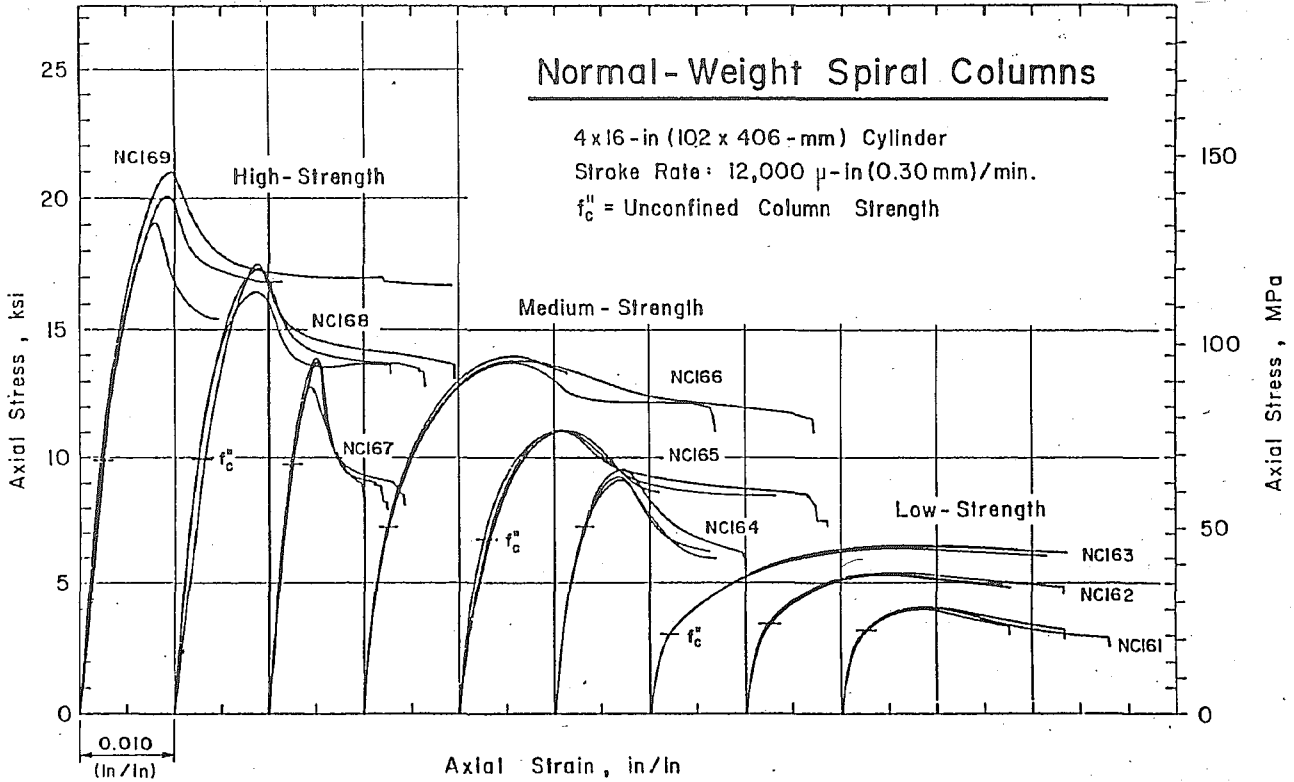
Figure 2.1 Axial stress-strain curves for normal weight concrete [Martinez et al. (1982)].

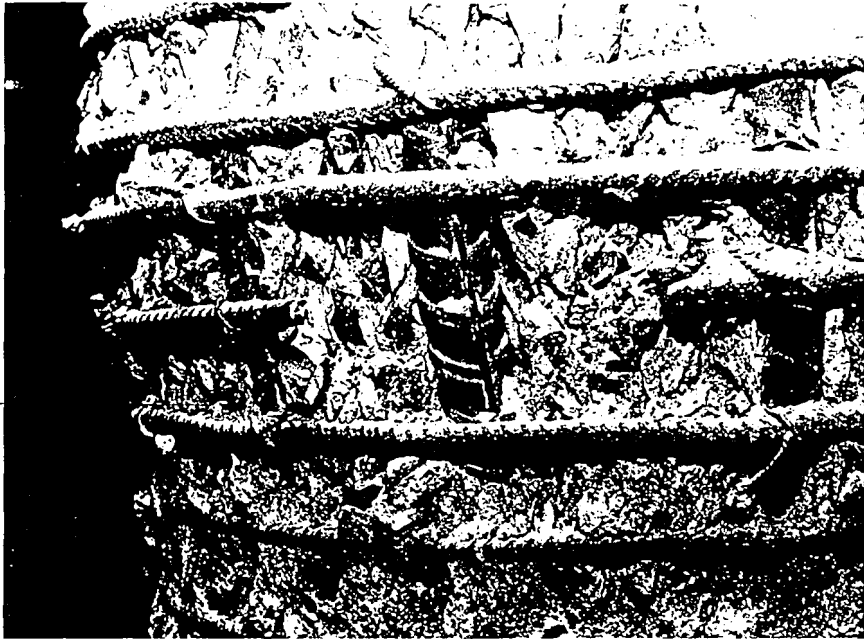
Figure 4.5(c) Specimen L1-series of key photographs; (c) fractured spiral.

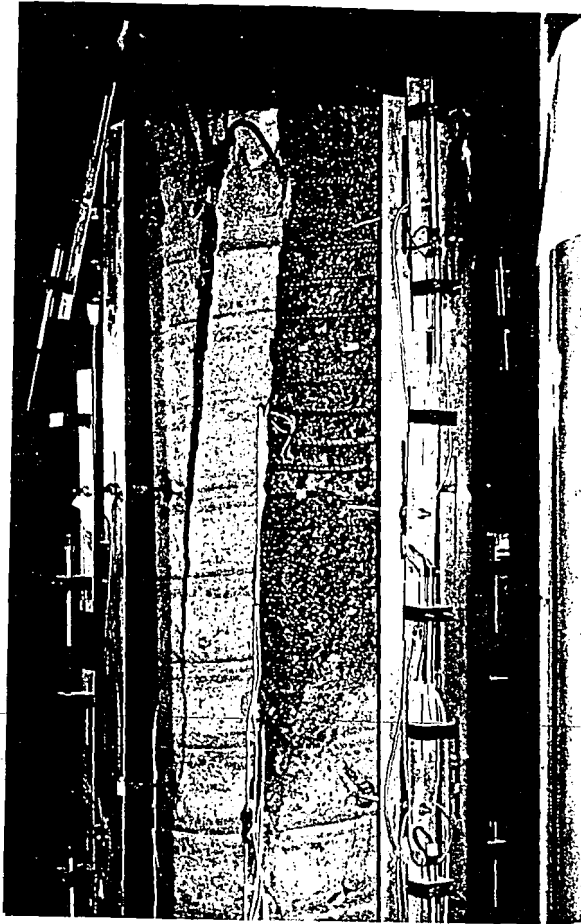
Figure 4.20(d)

Specimen M2-series of key photographs; (d) exposed core concrete after fracture of spirals.

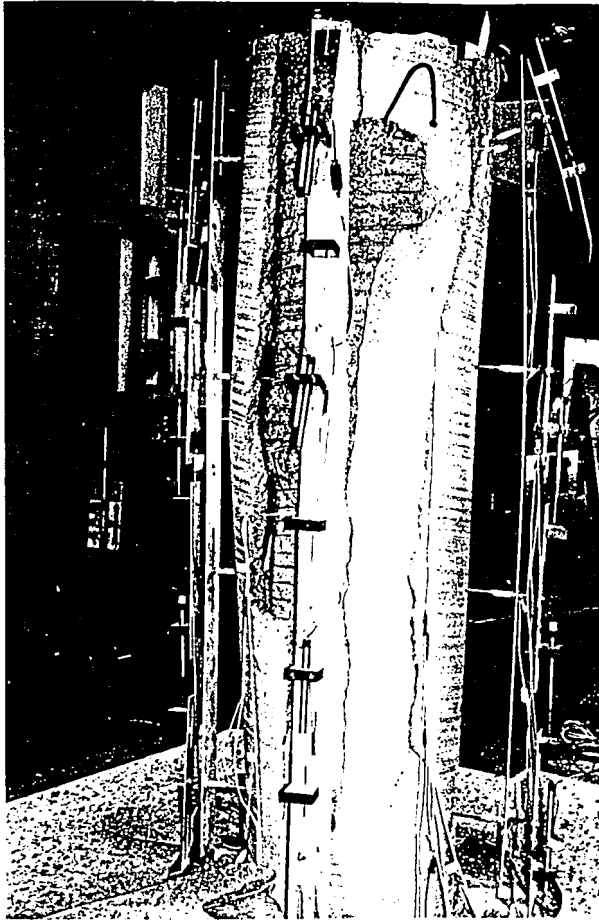
Figure 4.25(e)

Specimen M3-series of key photographs; (e) exposed core concrete after fracture of spirals.

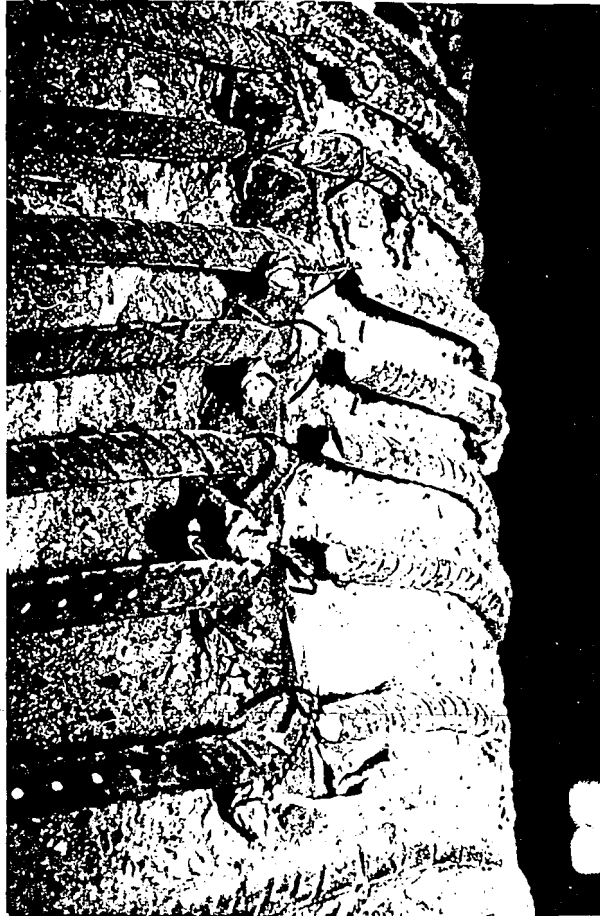
Figure 4.25(i)

Specimen M3-series of key photographs; (i) spiral fractures at location of buckled longitudinal bars.

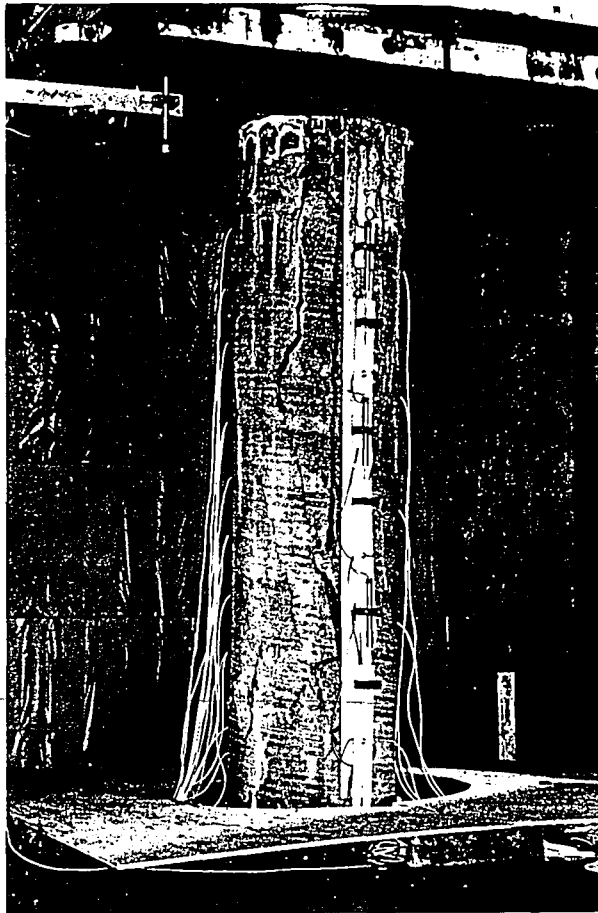
Figure 4.31(b)

Specimen H1-series of key photographs; (b) widening of longitudinal splitting crack on southwest face.

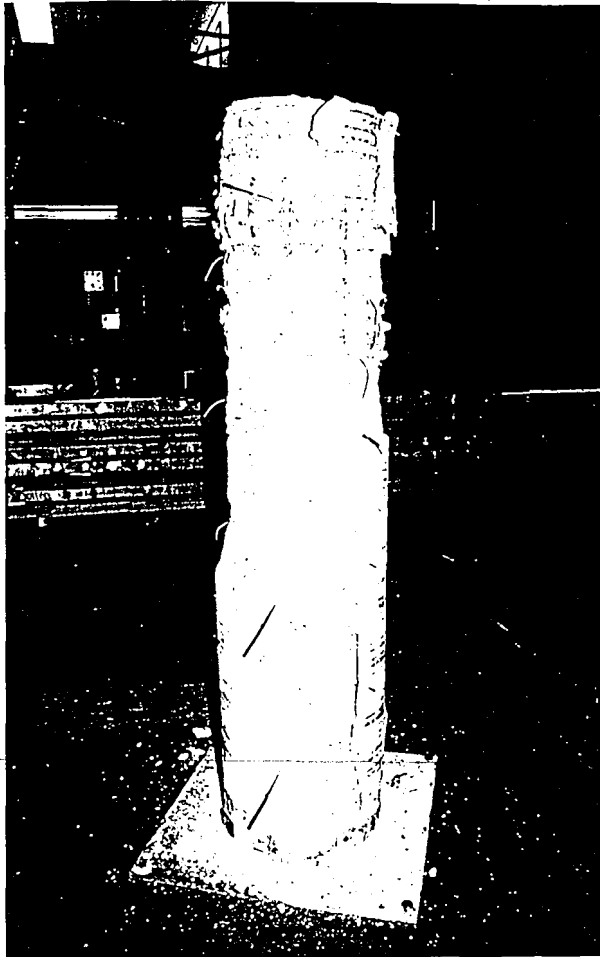
Figure 4.31(f)

Specimen H1-series of key photographs; (f) post-test photograph showing the inclined failure plane.

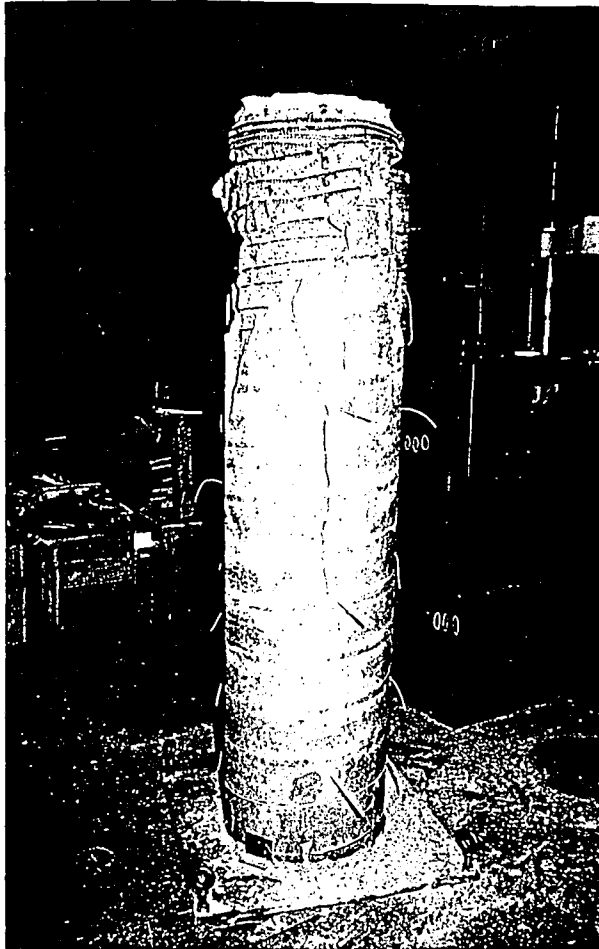
Figure 4.37(d) Specimen H2-series of key photographs; (d) post-test photograph showing the failure concentrated at the top of the column.

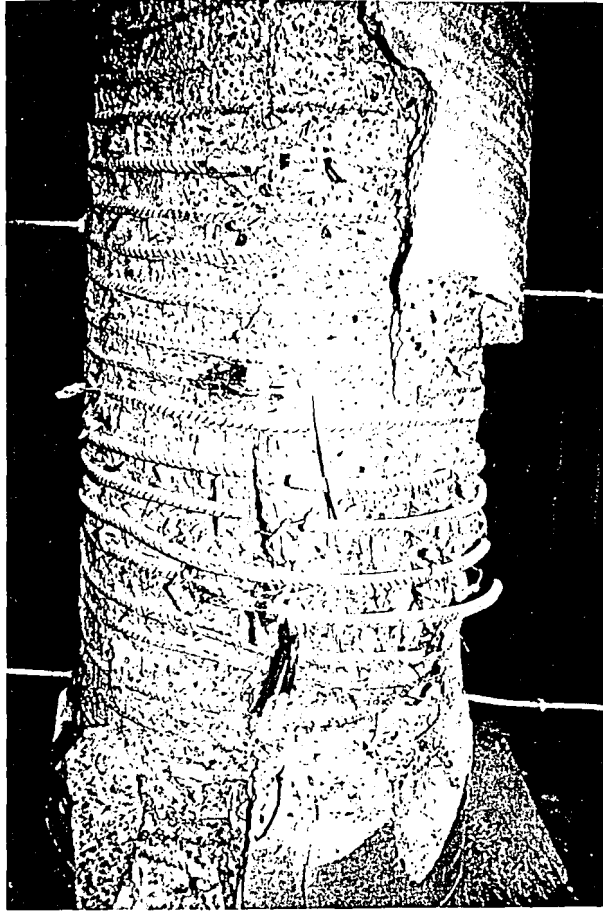
Figure 4.43(d)

Specimen H3-series of key photographs; (d) spiral fractures at location of buckled longitudinal bars.

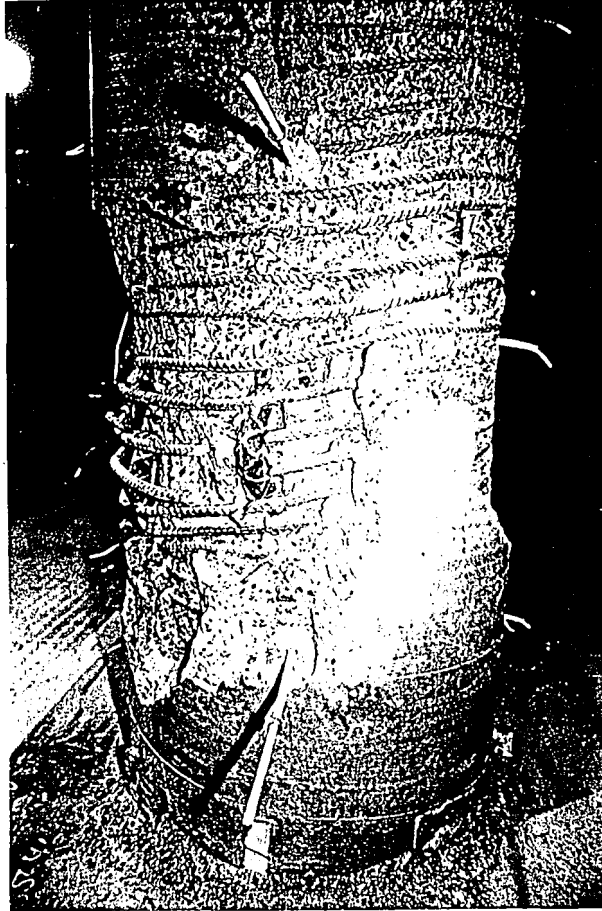
Figure 4.43(f)

Specimen H3-series of key photographs; (f) spiral fractures at location of buckled longitudinal bars.

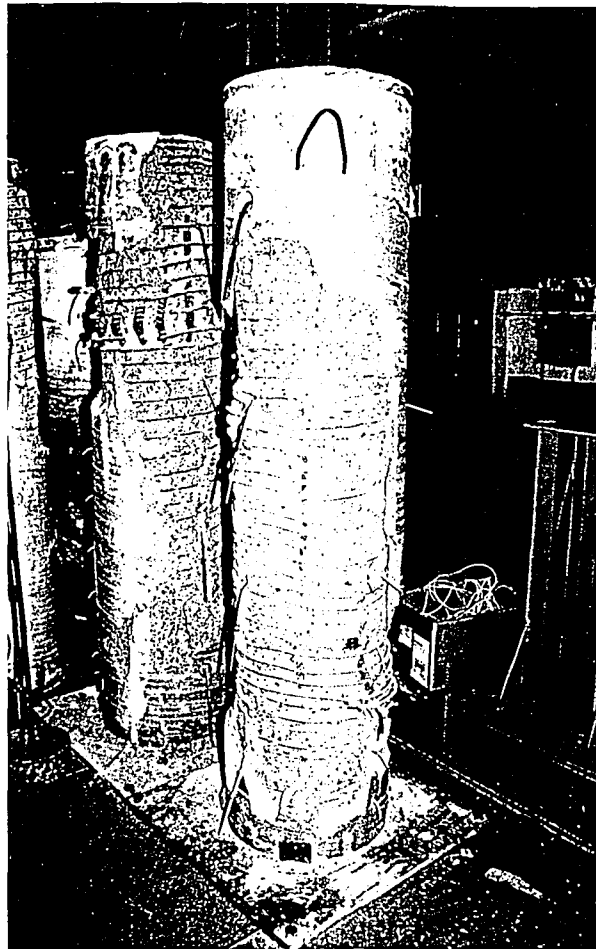
Figure 4.43(h)

Specimen H3-series of key photographs; (h) post-test photograph showing the inclined failure plane.
