# Investigation of the impact of environmental conditions on field welding of precast concrete connections

A Thesis

The Department of Civil and Environmental Engineering

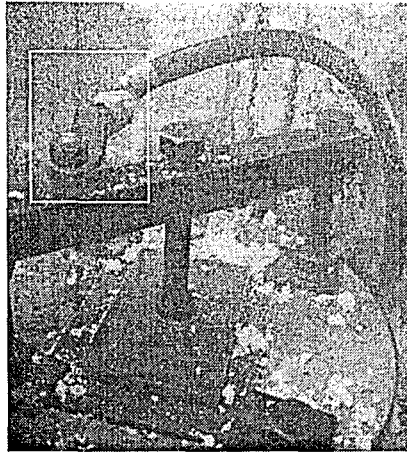
Figure 3.7: Welding Electrical Ground

The welding setup used a constant current welding power source. Grounding was provided directly to the restraint clamp which was in contact with the plates as shown in Figure 3.7.

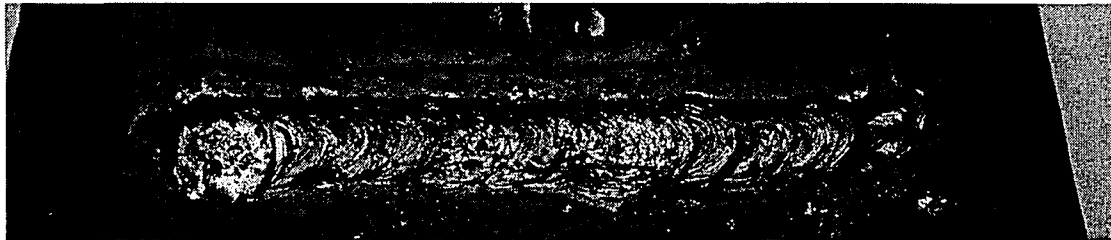
Figure 3.14: Example of Weld Classified as “Poor” (2)

Because profile measurements were only made at two locations where sections were cut, a “profile index” was established to quantify the regularity of the weld surface and profile along the length of the weld. The index assigns a 0, 1, or 2 based on a qualitative assessment of the overall weld appearance. A value of 0 for a “good” weld represents a weld with a smooth surface, no excessive ripples, and a consistent throat dimension along the length. A value of 1 for a “fair” weld represents a weld with moderate changes in throat dimension or the presence of some ripples in the weld surface. A value of 2 for a “poor” weld indicates that the weld was extremely irregular in the throat dimension, had a weld surface with deep ripples, or had significant melting along the top edge of the cover plate. A typical sample corresponding to each of the profile indices is shown in Figure 3.12, Figure 3.13, and Figure 3.14

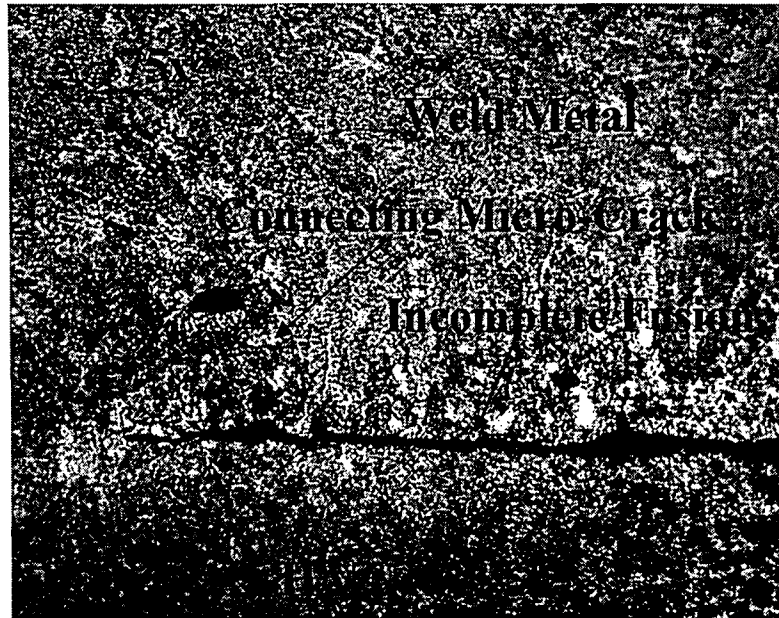
Figure 4.19: Incomplete Fusion and Micro-Cracking in Specimen 36-22, Bottom-left Section

The bottom-left section exhibited incomplete fusion as well as very small micro-cracks that appeared to connect the non-fused plate edge with a slag inclusion above the tip of the non-fused segment. The incomplete fusion found in the bottom-left section of Specimen 36-22 is

depicted in Figure 4.19, and the connecting micro-cracking to the slag inclusion can be seen on the left side of the image above the tip of the non-fused segment.

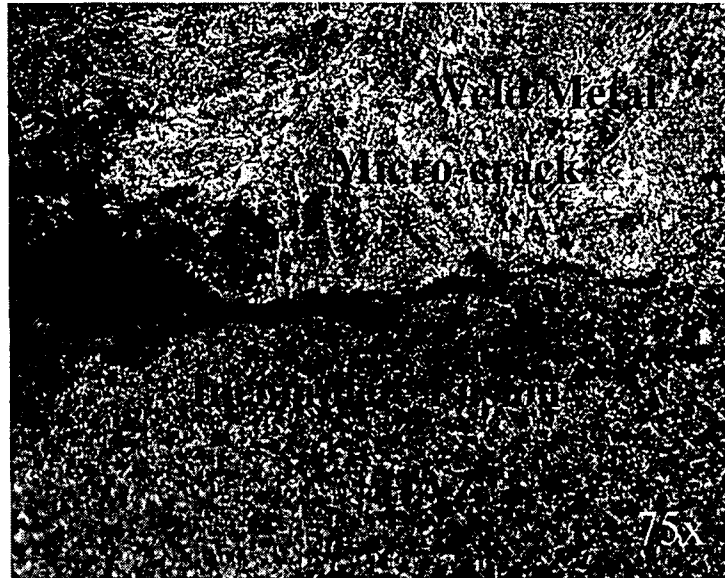
Figure 4.28: Micro-Cracking and Incomplete Fusion in Specimen 36-C1, Bottom-right Section

The discontinuities shown in Figure 4.28 and Figure 4.29 occurred along the fusion line and extend along the boundary between the weld metal and coarse-grained HAZ. The bottom image also shows a connecting micro-crack between the non-fused segment and a small slag inclusion above it.

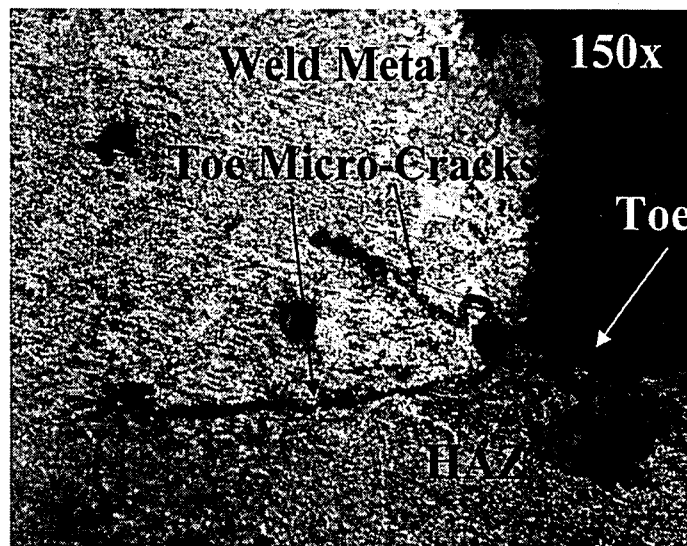
Figure 4.45: Toe Micro-Cracks in Specimen 36-PC6, Section PC-6(4)

Micro-cracks were also observed in section PC-6(4) at the toe and the root. An image of the toe micro-cracking is shown in Figure 4.45.

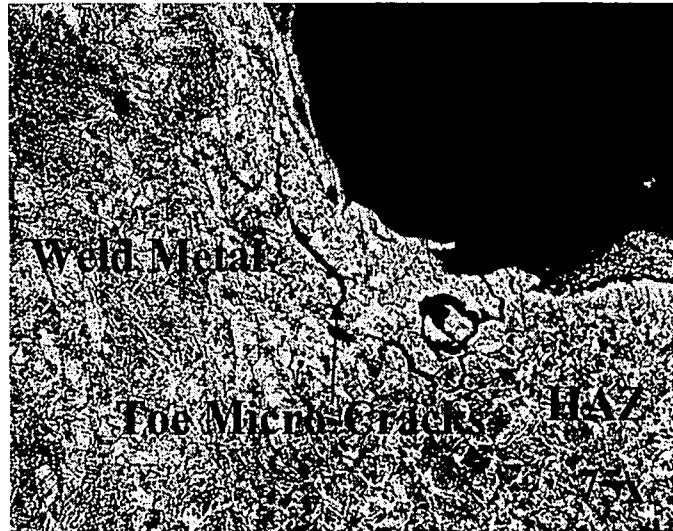
Figure 5.7: Toe Micro-Cracking in Specimen 36G-33(2)-Top-left Section

The bottom-right and bottom-left sections had root micro-cracks, while the top-left section had a toe micro-crack. Plates remained restrained for 24 hours prior to removal from the test block. The bottom-left and bottom-right sections exhibit micro-cracks like the one shown in Figure 5.6. These appear to be solidification hot micro-cracks that are likely the result of low solidification temperature zinc compounds being present in solution in the weld pool. As the weld cooled, the root was the last place to cool. The low solidification (melting) temperature zinc compounds solidified late, and the solidified steel around the root restrained the cooling contraction there, allowing a small micro-crack to open at a 45 degree angle. The micro-crack discontinuities seen in the toe vicinity of the top-left section may be a result of stress imposed by the restraint of the specimen for 24 hours due to delayed removal. These are likely cold micro-cracks, related to the presence of hydrogen. The micro-crack discontinuities are not detectable by visual inspection, and due to their small size, it is unlikely that these types of discontinuities would influence the strength of the weld.

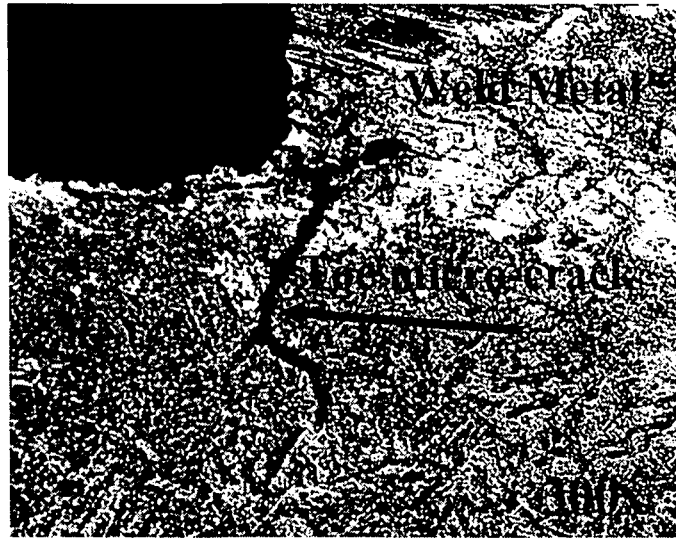
Figure 5.9: Toe Micro-Crack in Specimen 36G-17HR-Top-right Section

The top-right section had a small toe micro-crack, and the bottom-right section had a sizable [5/64-in.] crack protruding from the root. The following two images show the toe micro-crack and root crack from these two sections. The micro-crack shown in Figure 5.9 is likely a cold micro-crack (hydrogen related) based upon its location at the toe of the weld and its jagged appearance. It is extremely short, however, making it difficult to determine its type or cause. Figure 5.10 shows what appears to be a hot crack based upon its location and progression toward the surface of the weld. This crack is distinguishable without the aid of microscopy and is approximately 5/64-in. in length. This crack was caused by the solidification process which left the area around the root in the molten state while the remaining metal cooled around it and restrained its cooling contraction. This crack was also likely related to the low solidification temperature of zinc compounds from the galvanizing in solution with the solidifying steel. The steel cooled and solidified more rapidly than the zinc, providing restraint to the shrinkage of the solidifying and cooling zinc compounds and potentially resulting in a crack like that of Figure 5.10.

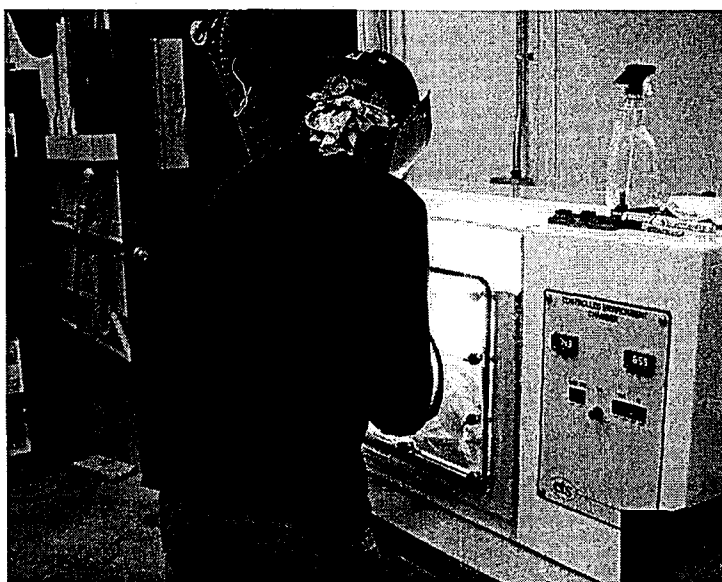
Figure 7.1: Welder Position During Welding Process

the frequency of unacceptable profiles was greater than would be identified in a field inspection. Based on the criteria used, 48% of the sections taken from A36 welds were acceptable, and the remaining 52% failed to meet the acceptability criteria for profile. This high frequency of unacceptable profiles was also a result of the unusual conditions under which the welds were made. The environmental chamber armholes required the welder to weld in an unnatural position without much flexibility of motion, which can be seen in Figure 7.1.

The smoke and, in some cases, steam generated by the welding process within the environmental chamber often resulted in poor visibility conditions that were not desirable for welding, coupled with the welder's need to wear a shielded facemask, which further deteriorated visibility when smoke or steam were present. The need for environmental control, however, outweighed the need for a more natural welder position, and the environmental chamber was used because it provided the best means of controlling environmental conditions.

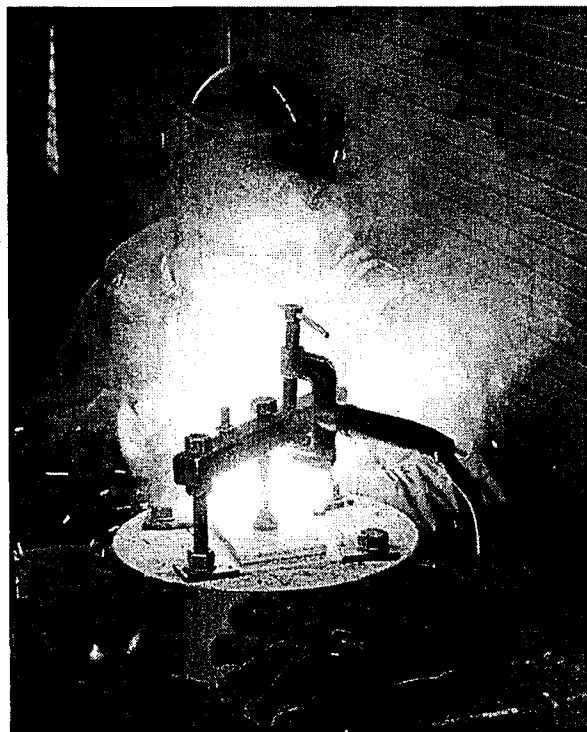
Figure 7.8: Outdoor Welding of Galvanized Steel

The number of galvanized specimens was limited due to excessive amounts of zinc oxide fumes generated during welding through the zinc galvanization. Within the environmental chamber, the smoke developed so densely and rapidly during welding that visibility was obscured,

preventing the creation of a sound weld. To overcome the poor visibility, a ventilation system was utilized to remove the smoke during welding. This required the side door of the chamber to be open during welding, which limited control of the environmental conditions. The “base” condition specimen was welded using the ventilation system in the chamber in order to determine if a satisfactory weld could be produced without removing the zinc coating. Upon examination, this specimen proved satisfactory in terms of weld quality, and it was determined that a number of specimens would be welded outdoors where adequate ventilation could be provided. Welds were made under prevailing ambient conditions which are noted for each specimen. The smoke produced by welding through the zinc coating on the plate is illustrated in Figure 7.8.

Two welds were carried out under the ambient outdoor environmental conditions typical of winter conditions in Pennsylvania. The conditions at the time of welding were approximately 37°F, 30% RH, 0 mph. Two specimens were welded at this time to compare results between the two welds and because the conditions outdoors were sufficiently cold to replicate a set of conditions from the test matrix.

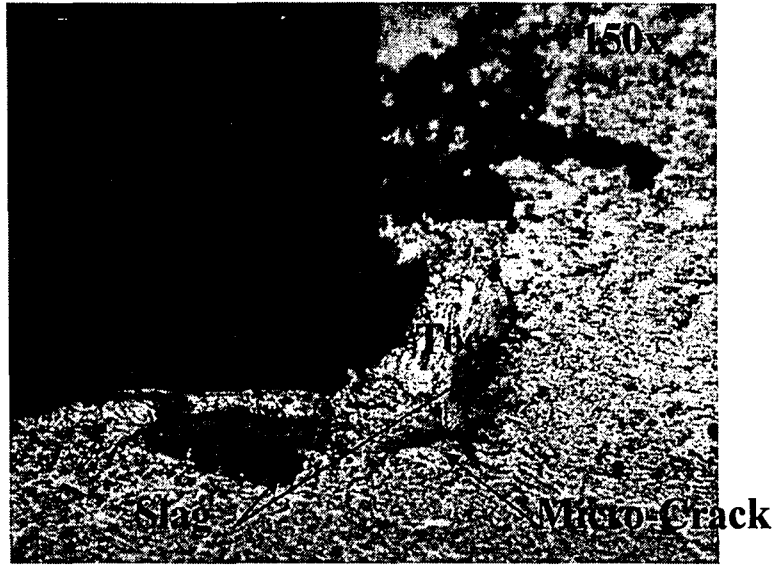
Figure 8.12: Toe Inclusions and Micro-cracking in Specimen T-3, Section B

Section A has a root inclusion and exhibits minor convexity, section B, taken from the oversized weld region, has extreme convexity and is unacceptable according to AWS D1.1 profile requirements. There were no cracks found in the section A; however, the section B has a small non-fused segment at the root, some slag and connecting micro-cracks at the root, and some slag and connecting micro-cracks at the toe, depicted in Figure 8.11 and Figure 8.12.

Section A has a root inclusion and exhibits minor convexity, section B, taken from the oversized weld region, has extreme convexity and is unacceptable according to AWS D1.1 profile requirements. There were no cracks found in the section A; however, the section B has a small non-fused segment at the root, some slag and connecting micro-cracks at the root, and some slag and connecting micro-cracks at the toe, depicted in Figure 8.11 and Figure 8.12.
