Environmentally enhanced thermal fatigue and cracking of a gamma- based titanium aluminide alloy

A Thesis

Master of Science

Applied Mechanics

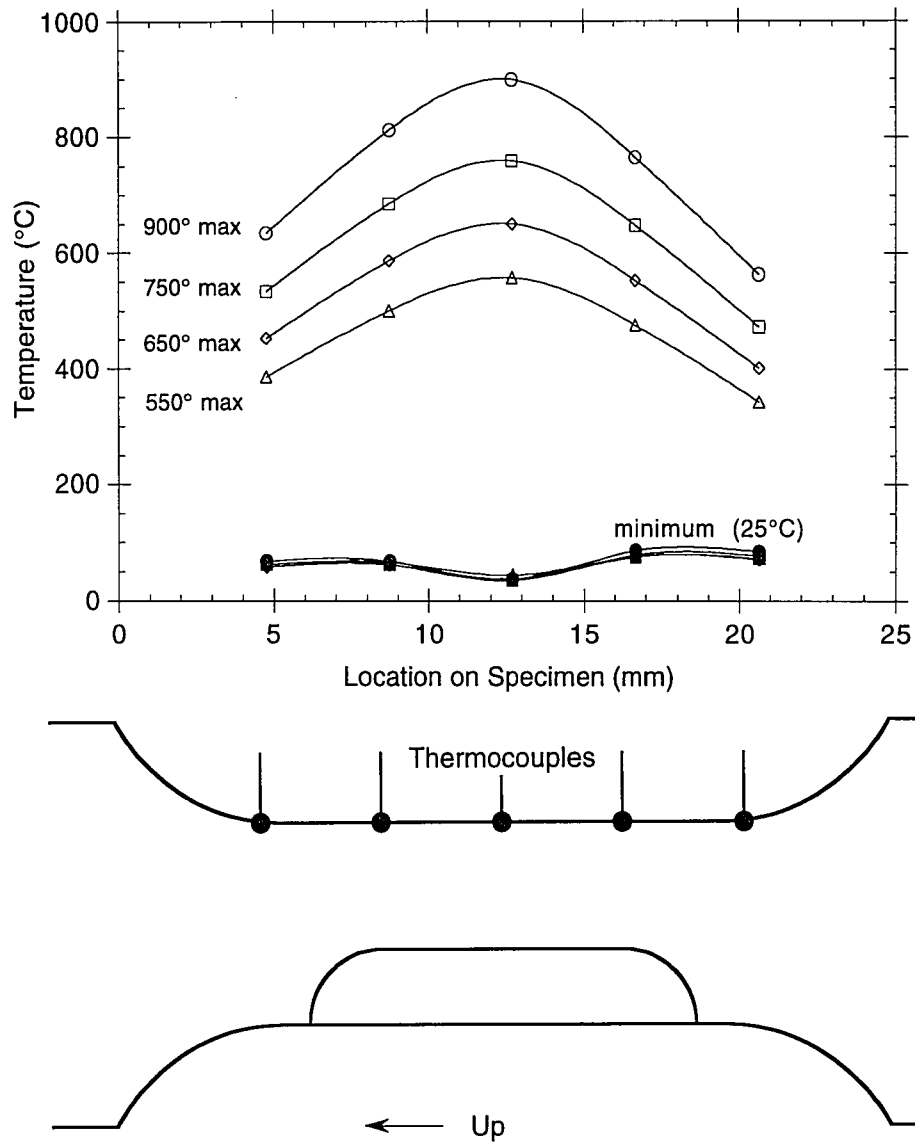
Figure 2.7: Thermal profiles along the thermal fatigue specimen gauge length at maximum and minimum temperatures for thermal cycling ranges between 25 °C and 900, 750, 650, and 550°C. Accuracy: $\pm 2.2^{\circ}\text{C}$ or 0.75%, whichever is greater.

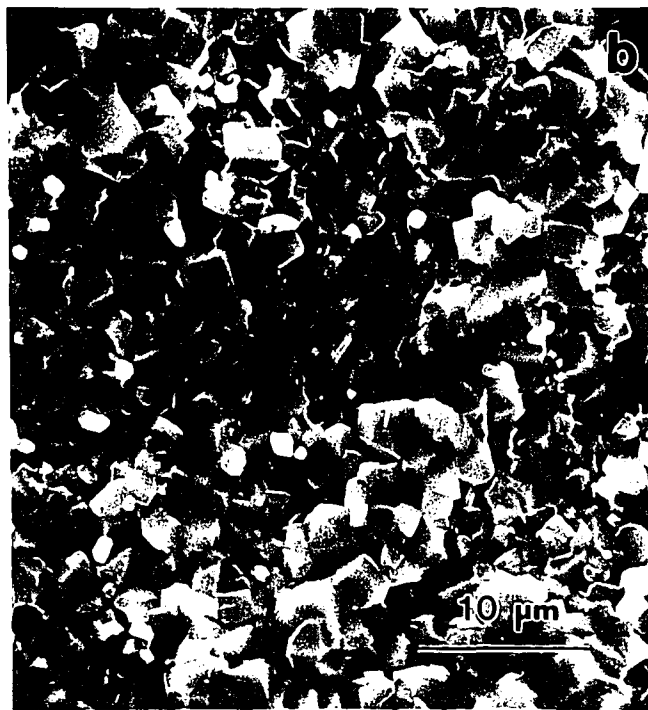
Figure 3.12: Backscattered electron image of a specimen thermally cycled in air between 25 and 900°C showing structure of titanium oxide. Lifetime: 2,106 cycles.

Figure 3.6 and 3.11 show a thick oxide layer which formed on specimens which were cycled to 900°C. This yellowish oxide layer was observed to locally buckle and flake off of the surface, exposing fresh surfaces below. These fresh surfaces were generally rough in appearance. By the end of the test, many specimens had the once-straight knife edge eroded away into a slightly concave shape. This erosion was not seen in other environments. Higher magnification views of this oxide, Fig. 3.12, reveal its rough and irregular crystallographic appearance.

would build up and eventually flake off, exposing rough fresh surfaces underneath for further oxidation. The random growth pattern of TiO_2 oxide with many voids can be clearly seen in Fig. 3.12, and compares well with the TiO_2 shown by Umakoshi [19]. This persistent attack obviously assists in crack nucleation.

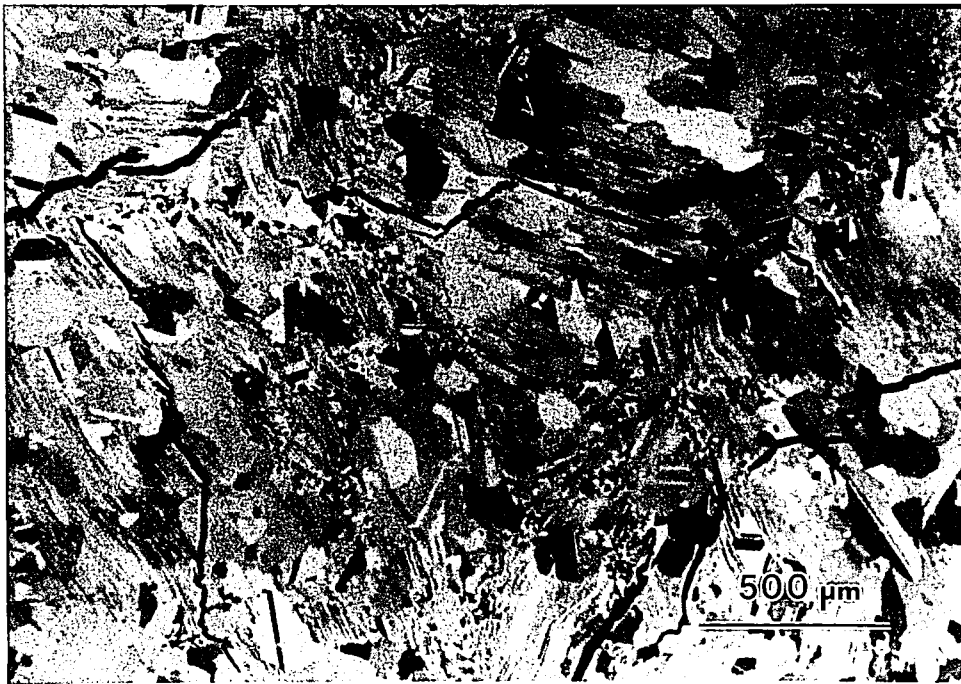
Figure 3.13: Surface cracks on a specimen cycled in hydrogen from 25 to 900°C, with a resulting lifetime of 3 cycles.

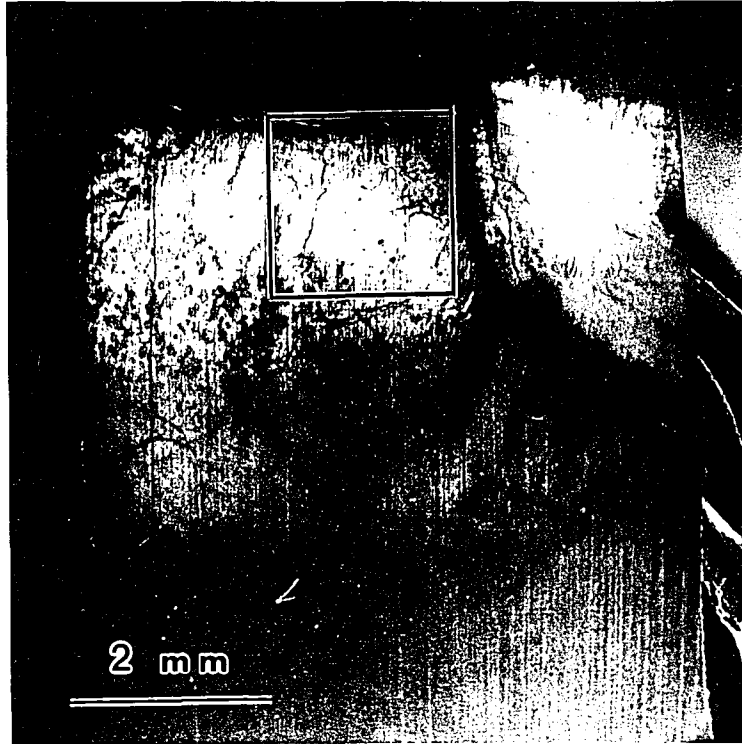
Figure 3.19: SEM image of a specimen with primary and secondary cracks thermally cycled in hydrogen between 25 and 750°C. Lifetime: 1,828 cycles.

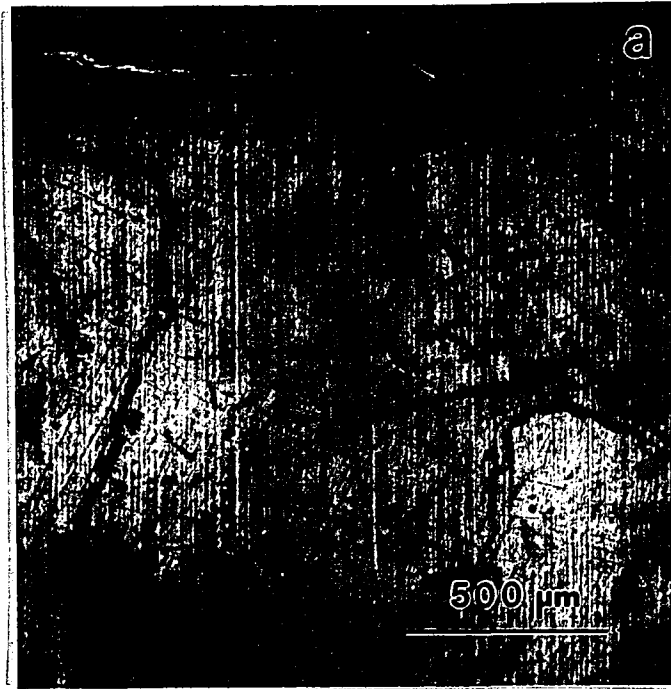
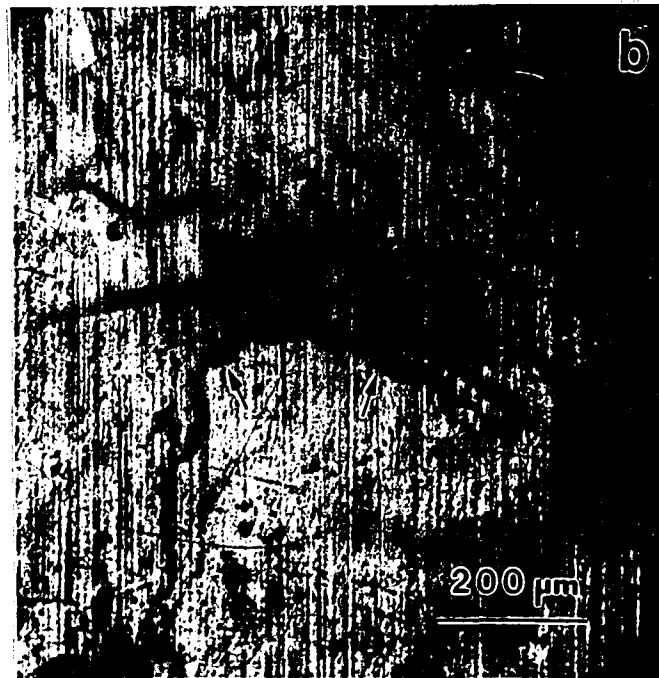
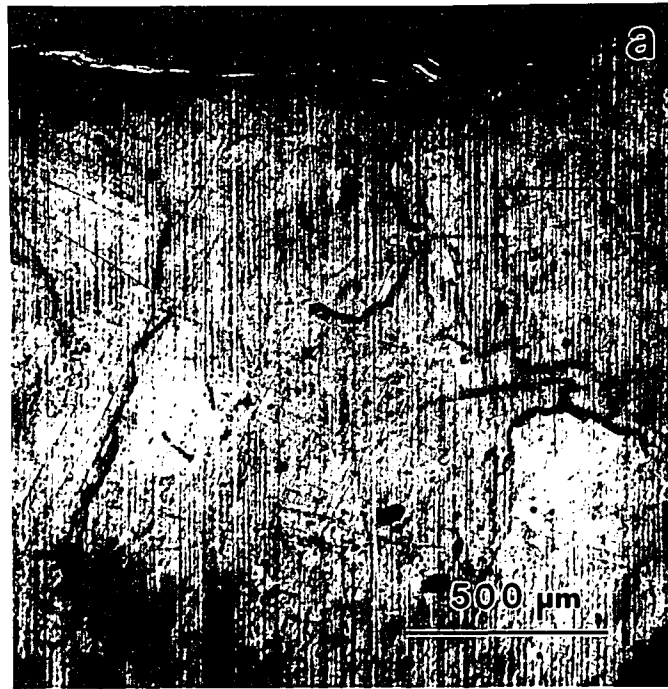
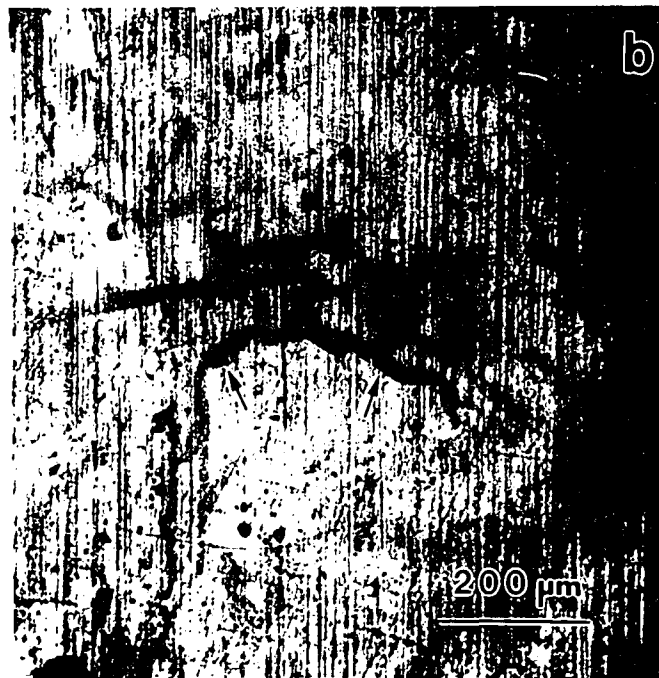
Figure 3.20: SEM image of secondary cracks formed on specimen in Fig. 3.16 during thermal cycling between 25 and 750°C. Lifetime: 1,828 cycles.

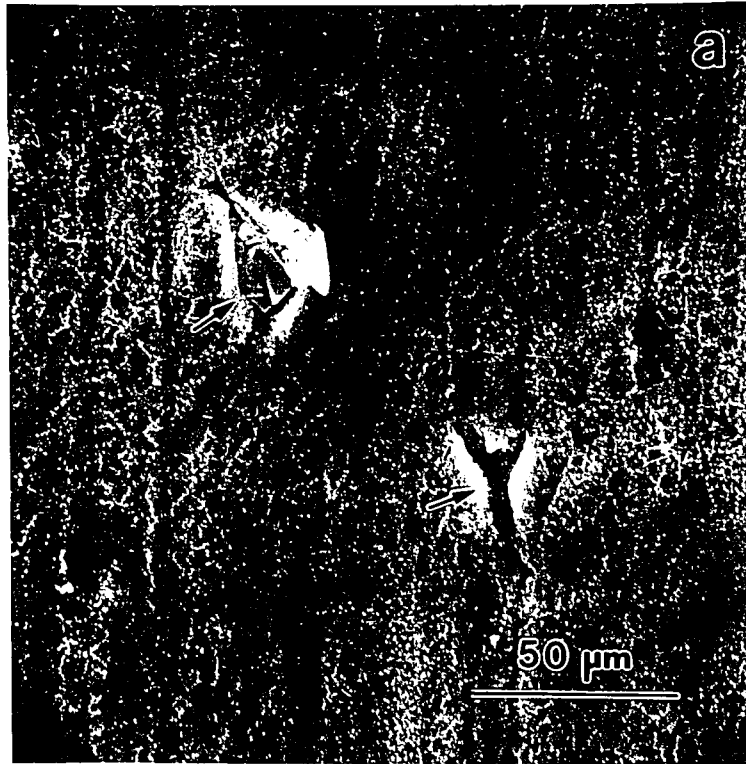
Figure 3.21: SEM image of extensive (a) grain attack and (b) surface cracks on a specimen thermally cycled in hydrogen from 25 to 750°C. Test duration: 200 cycles with no failure.

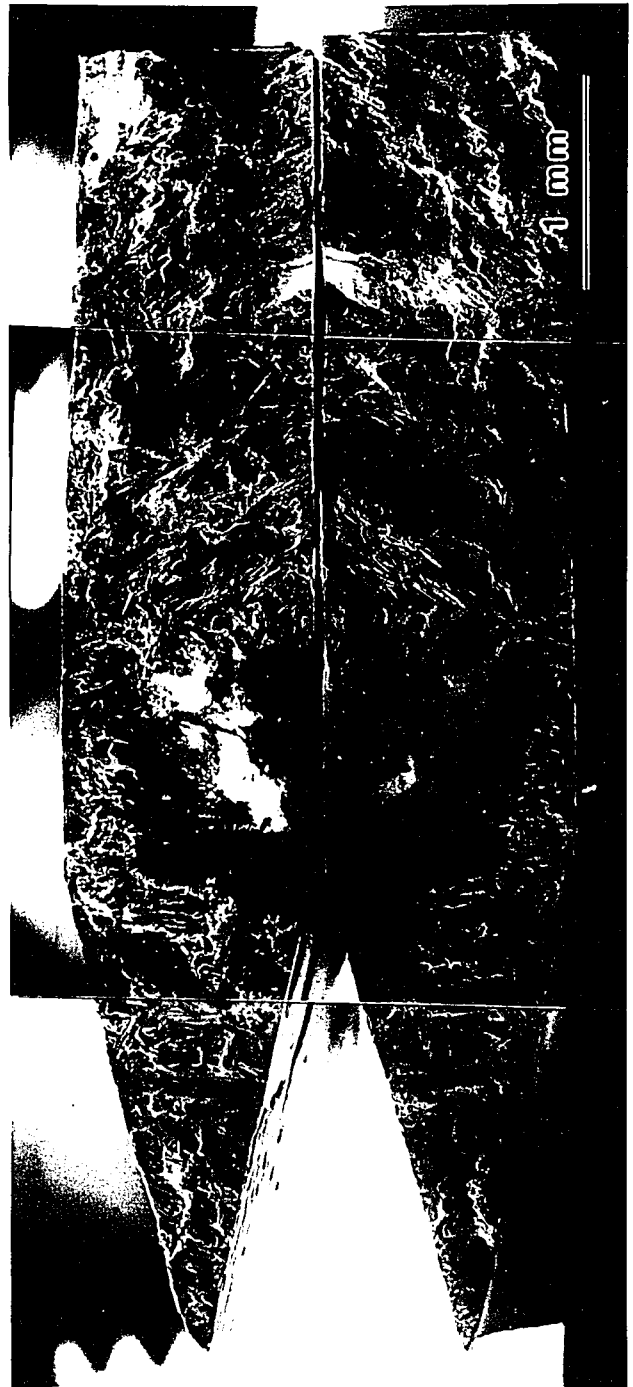
Figure 3.23: (a) Optical and (b) SEM micrographs of mating fracture surfaces of a specimen thermally cycled in air from 25 to 900°C. Lifetime: 2,782 cycles.

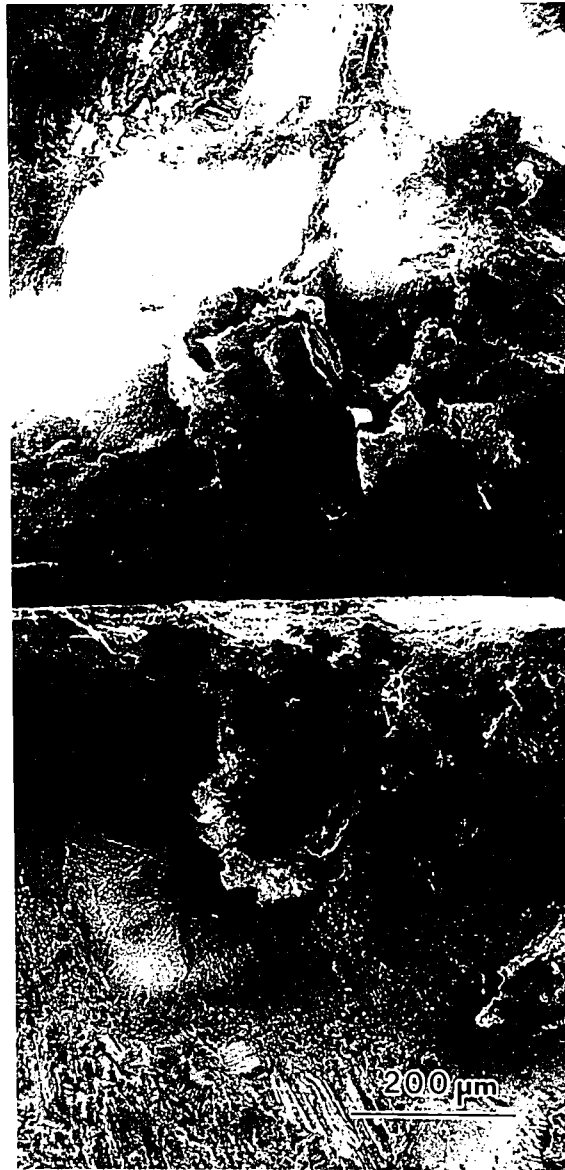
Figure 3.25: SEM image of mating fracture surfaces of a specimen thermally cycled in air from 25 to 900°C showing the nucleation and propagation zone. Lifetime: 2,782 cycles.

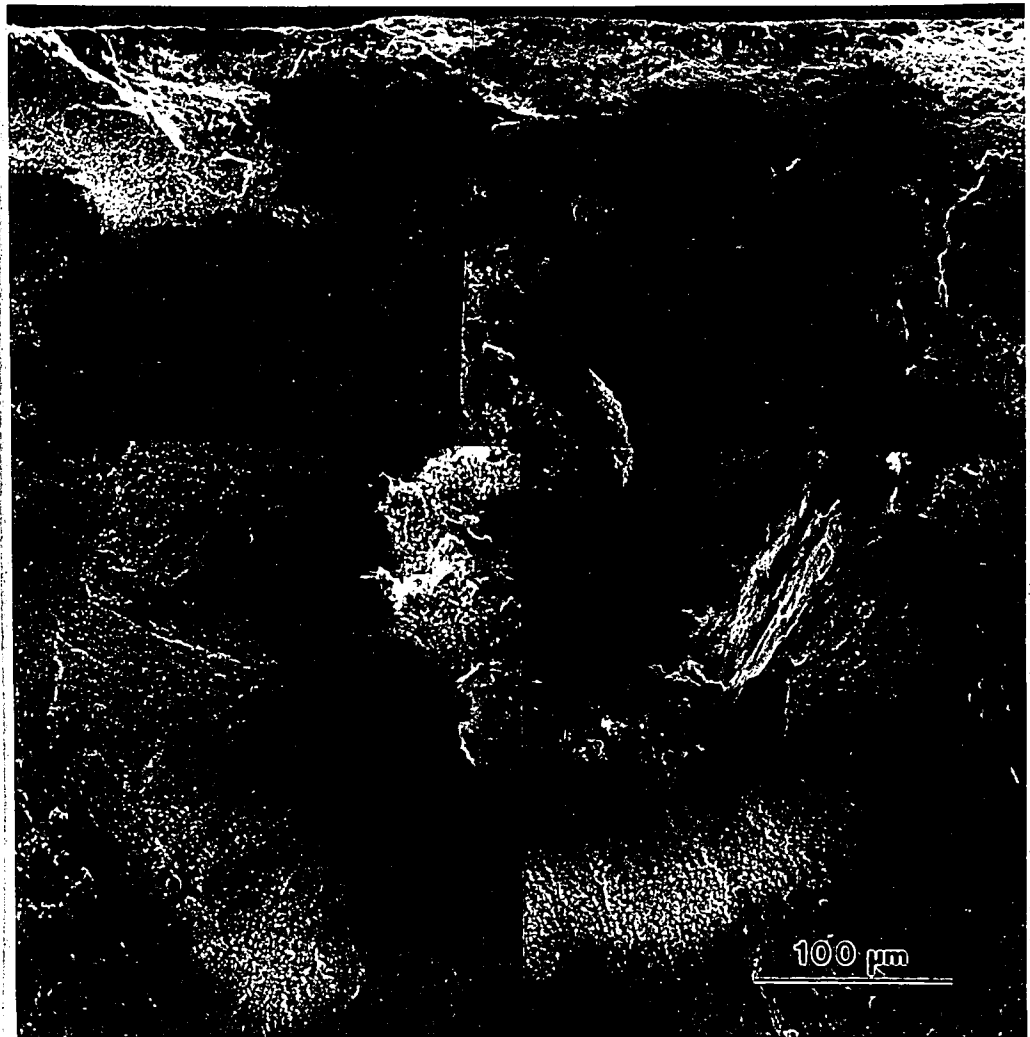
Figure 3.26: SEM image of the nucleation and propagation zone of a specimen thermally cycled in air from 25 to 900°C. Lifetime: 2,782 cycles.

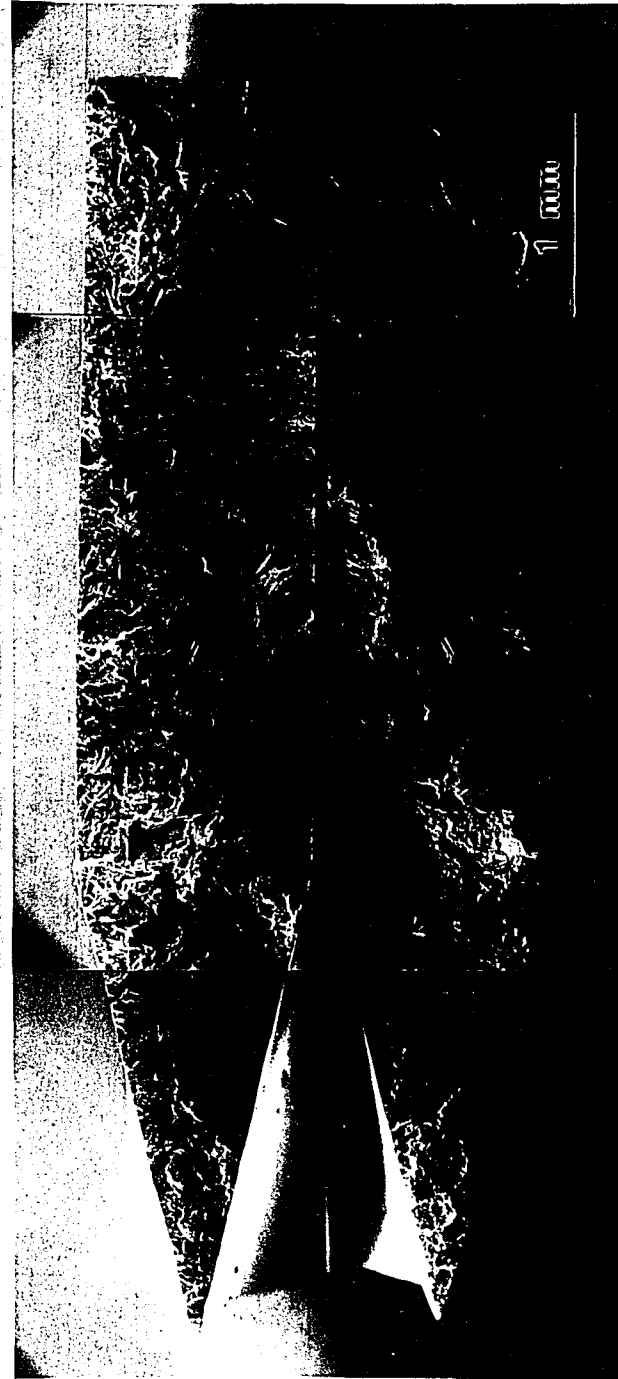
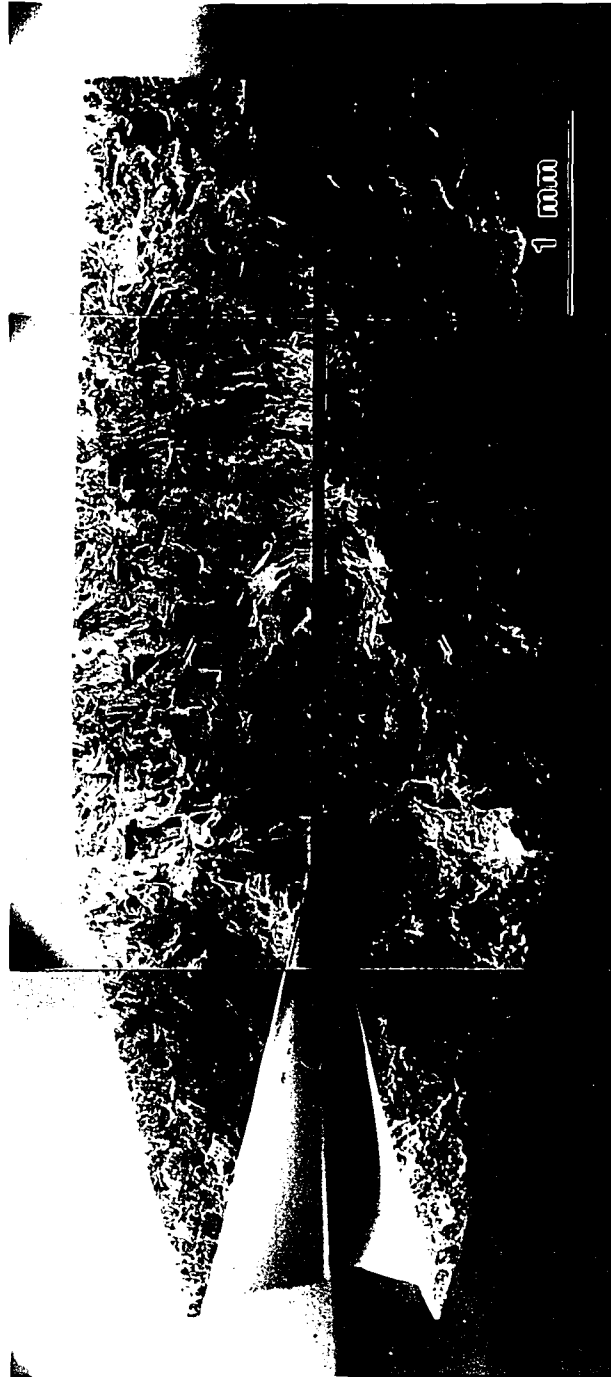
Figure 3.27: SEM image of mating fracture surfaces of a specimen thermally cycled in hydrogen from 25 to 900°C. Lifetime: 10 cycles.

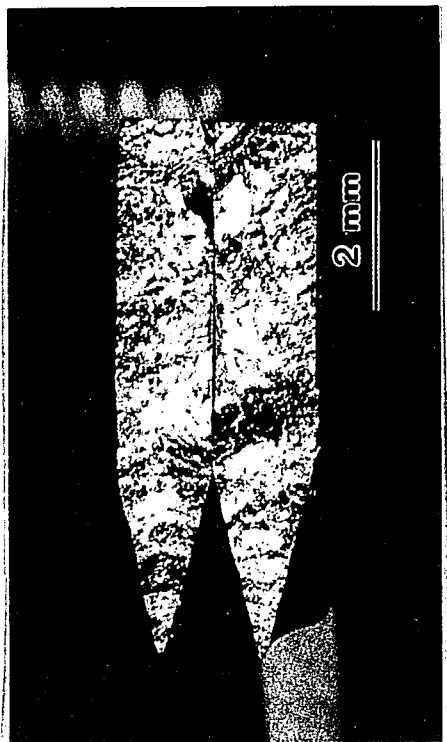
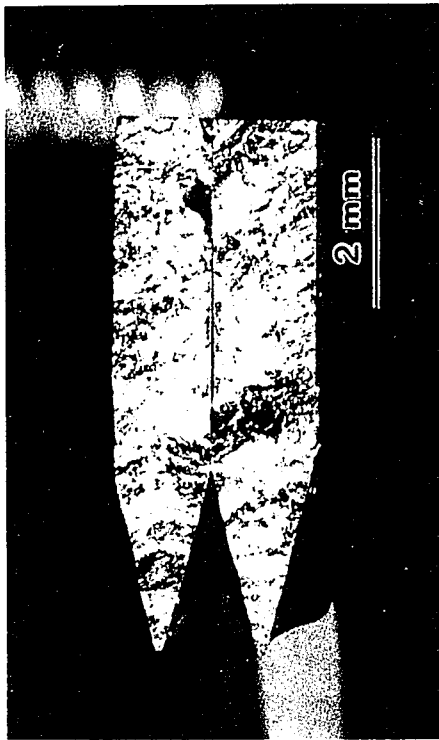
Figure 3.30: (a) Optical and (b) SEM micrographs of mating fracture surfaces of a specimen thermally cycled in hydrogen from 25 to 750°C. Lifetime: 1,828 cycles.

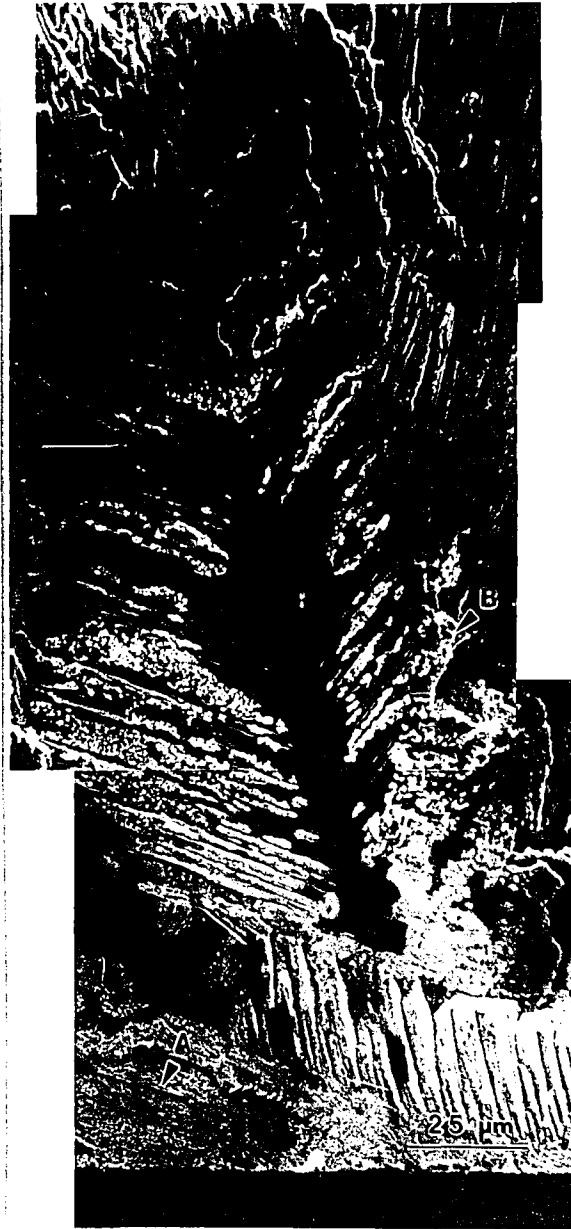
Figure 3.31: SEM image of a portion of the propagation zone on the fracture surface produced during thermal cycling in hydrogen from 25 to 750°C. (A) Nucleation zone near the specimen surface. (B) Oxidation on the propagation zone surface. Lifetime: 1,828 cycles.
