A STUDY IN
TECHNICAL IMPROVEMENTS
IN THE PRODUCTION OF
CENTRIFUGAL PUMP SHAFTS

BY
EDWARD H. FRY

A THESIS
PRESENTED TO THE GRADUATE COMMITTEE
OF LEHIGH UNIVERSITY
IN CANDIDACY FOR THE DEGREE OF
MASTER OF SCIENCE
IN
INDUSTRIAL ENGINEERING

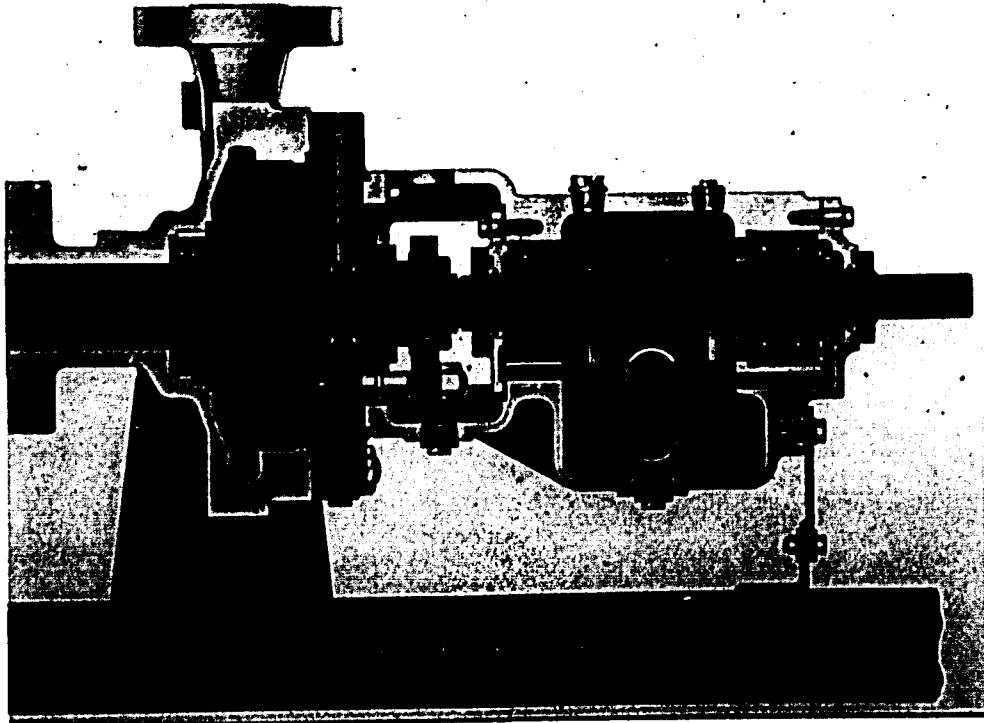
FIGURE 1 ASSEMBLY VIEW OF SINGLE STAGE, SINGLE
SUCTION, OVERHUNG, CENTRIFUGAL PUMP.

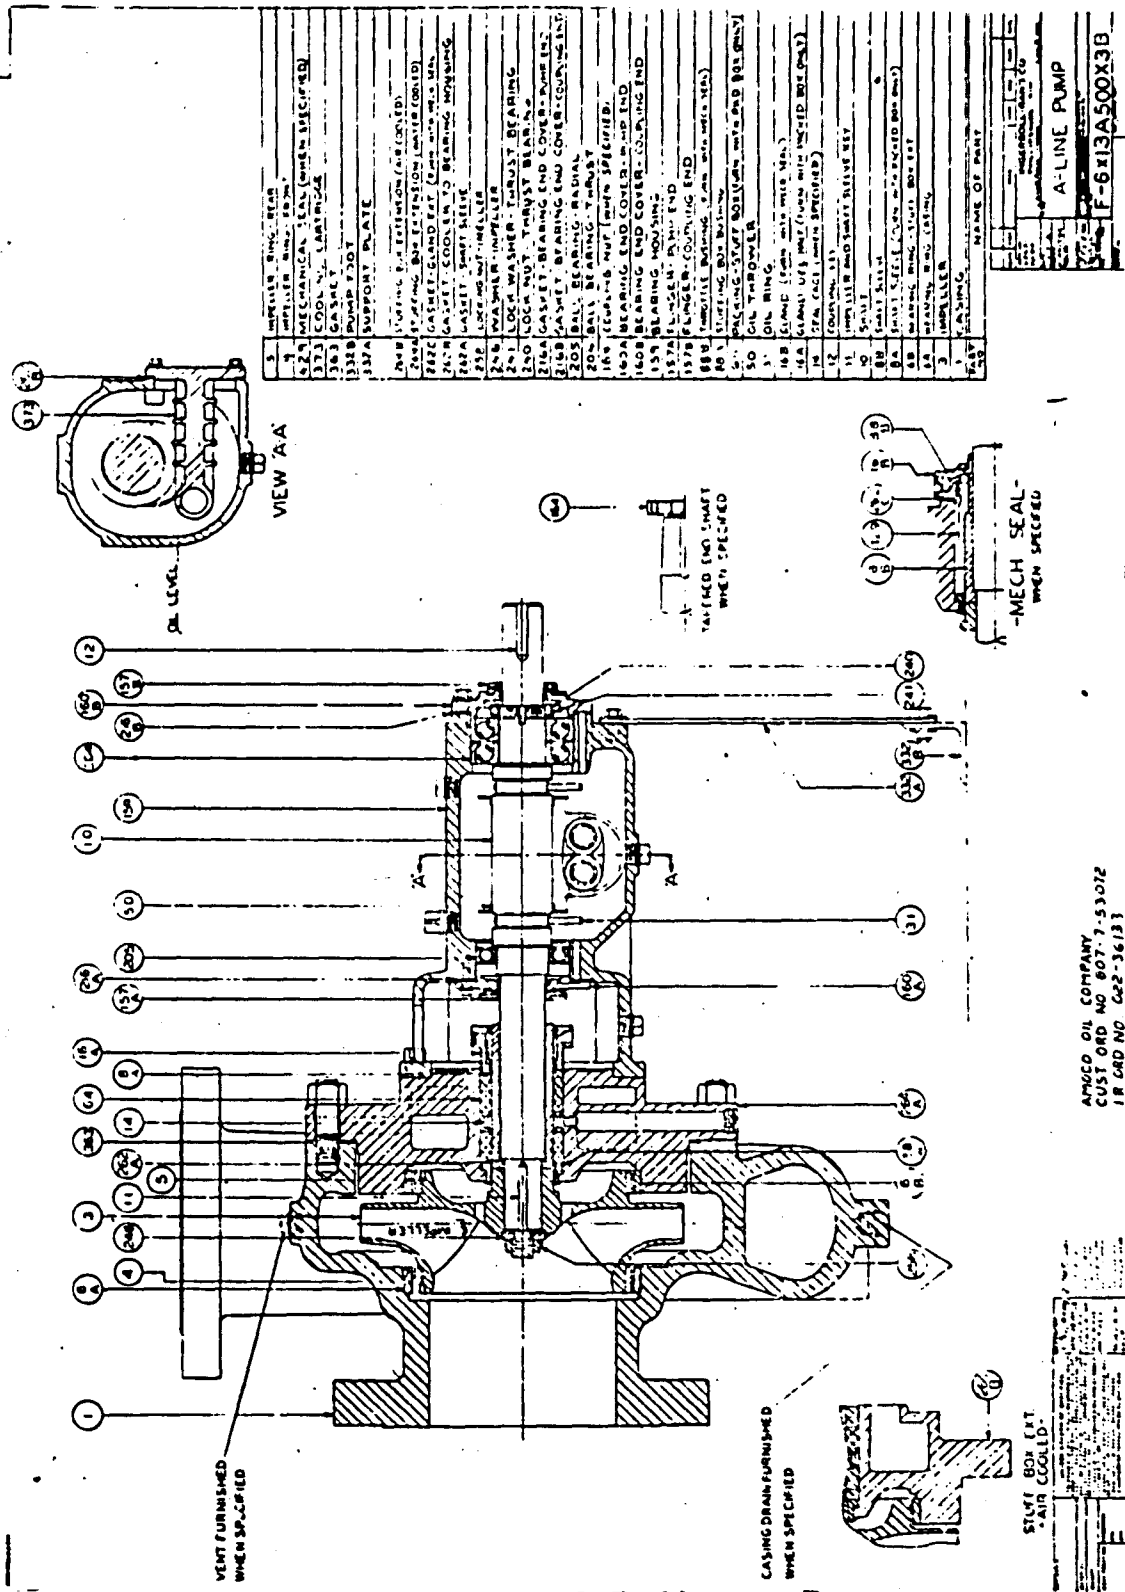
Fig.2 Assembly View of Refinery Pump

1. Review an assembly drawing, such as No. F6X13A500X3B, Figure 2, which is typical of the pumps being studied. Such a drawing, when drawn quite close to scale size, frequently reveals elements of weakness that require further study.
2. A master routing sheet for a typical shaft. The shaft material is specified on the sheet along with the sequence of operations, setup and operating times. A copy of the routing sheet is shown in Appendix E.
3. The metallurgical aspects with the:

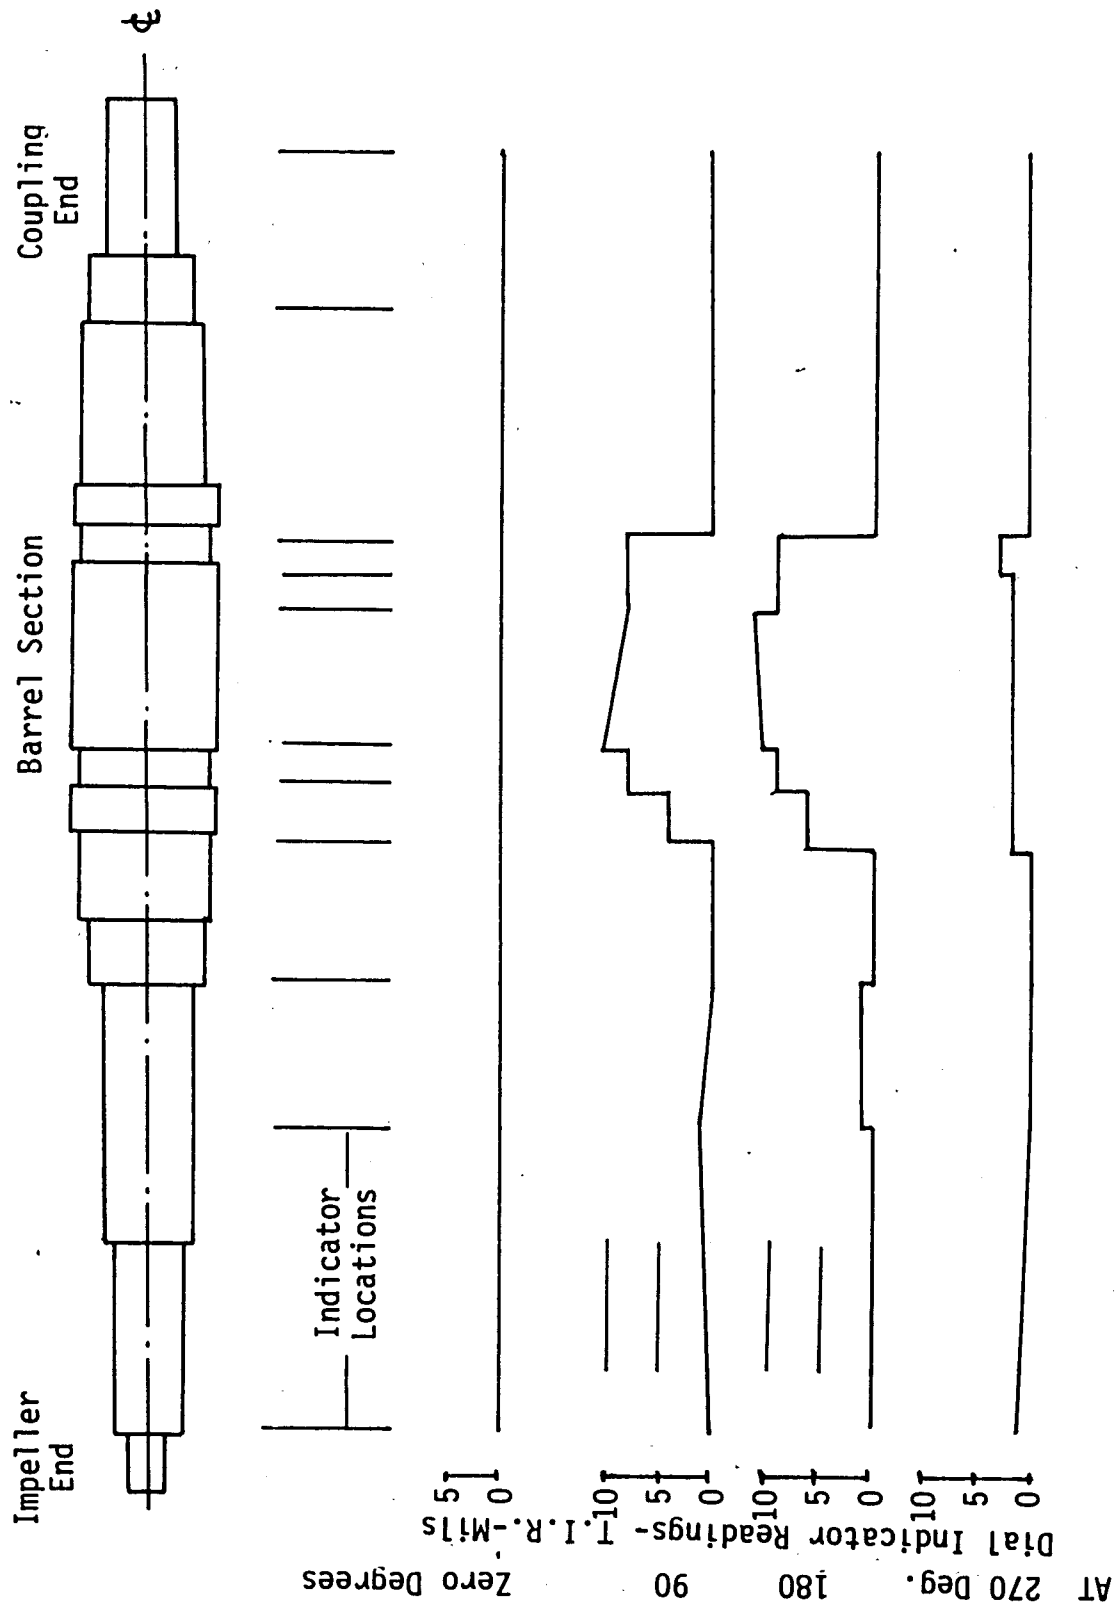
Figure 11 - Eccentricity Plot- Showing runout in four quadrants and demonstrating that shaft is not twisted.

In addition to "kinked" shafts, and those having a long "bow", an even greater concern relates to twisted shafts. Invariably, these cannot be straightened or made suitable for use. It was considered unlikely that machining stresses were sufficient to cause a permanent twist in the 3" dia bars. An easy way to determine whether or not a shaft is twisted, is to simply dial indicate the shaft in all 4 quadrants at various intervals along its length. A plot of one of the shafts indicated is shown in Figure 11. With the dial indicator set on zero at the zero degrees position, the shaft run out reaches 10 mils and 11 mils at the 90 degree and 180 degree quadrants. At some midpoint, near 135 degrees, the runout reached a maximum, and at a corresponding location halfway around the shaft, the indicator read a negative value. The plot is important in that it does not show maximum values at various shaft locations and quadrants, which would be indicative of a twisted shaft.

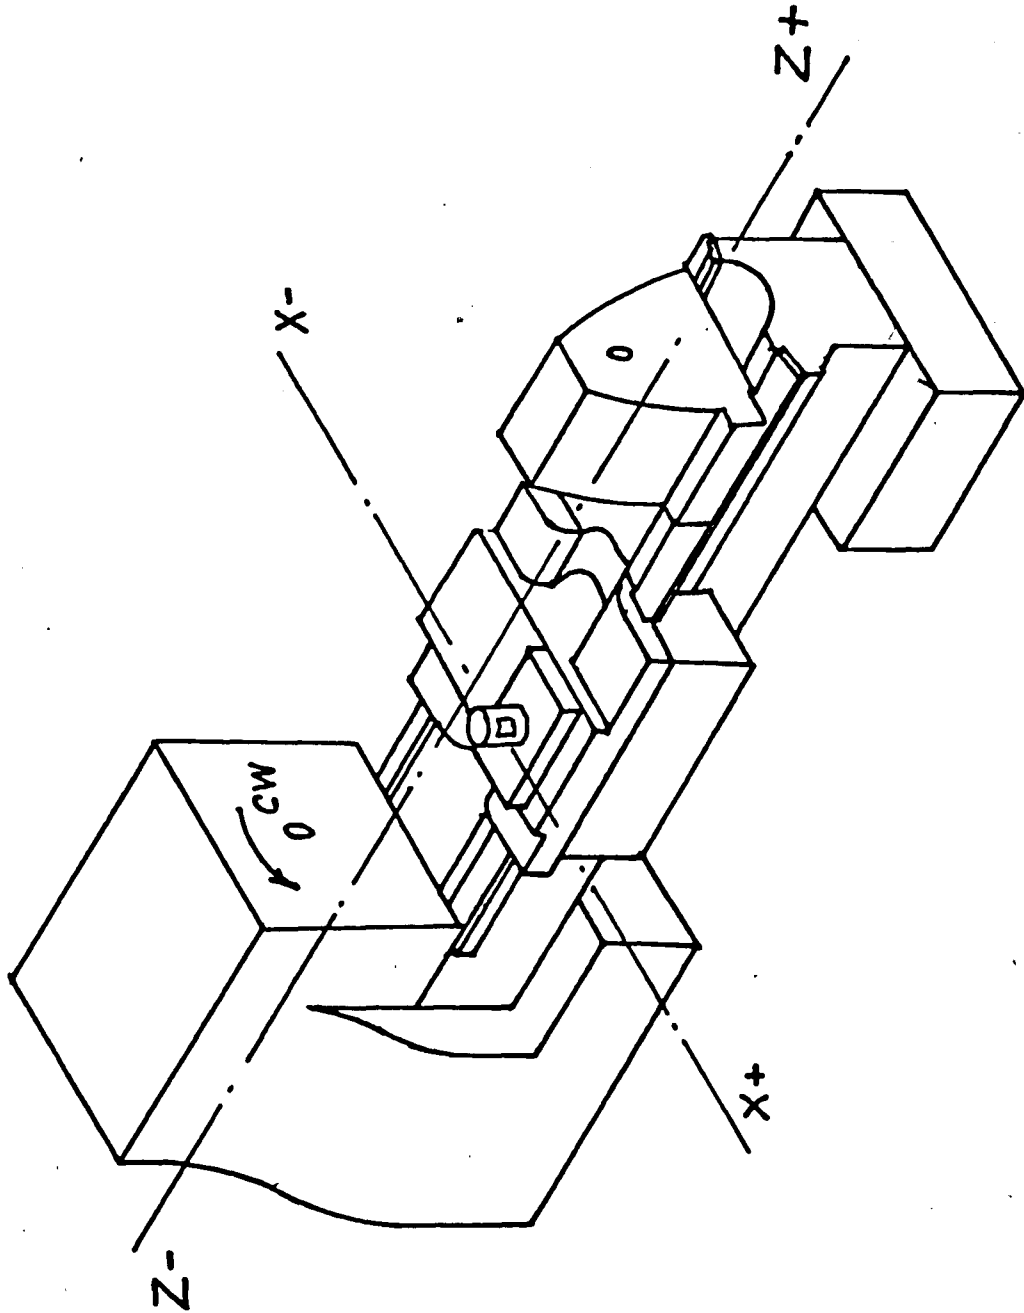
Axis Nomenclature LeBlond Tape II Numerical Control Lathe

A programming supervisor punched a tape to generate a path at 30 degrees to the machine axial centerline, or "Z" axis (see Appendix I). The tape was installed, console properly adjusted, grinding wheel dressed and the grinding of the center proceeded. The finish ground center ran almost perfectly true.
