An assessment of the kittanning bridge electrogas weldments.

AN ASSESSMENT OF THE KITTANNING BRIDGE
ELECTROGAS WELDMENTS

An investigation of the electrogas girder splice welds in the Kittanning Bridge superstructure was carried out to assess the fracture and fatigue characteristics of these weldments.

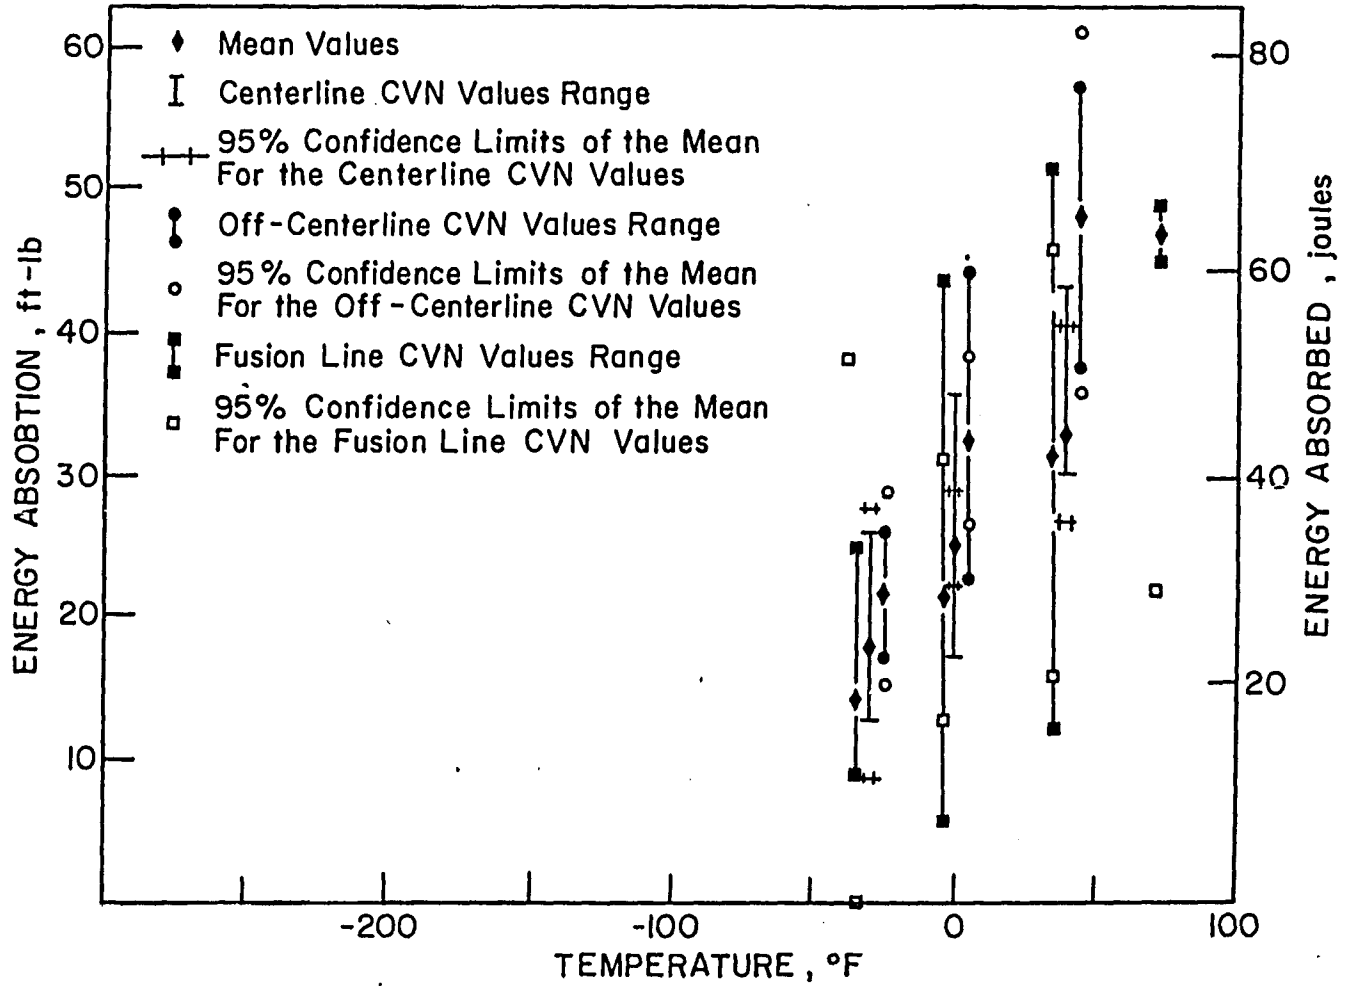
Figure 17 - Scatter chart of Charpy vee notch absorbed energy values.

The bulk of the scatter in CVN results from EG and ESW test groups has been shown to result from variations in the specimen notch location with respect to local grain orientation and grain size. In other words, the observed scatter in CVN absorbed energy values depicts the heterogeneous nature of the energy absorption response of electrogas weld metal when measured with a CVN sized specimen--a specimen with a fracture surface area of 0.80 cm^2 (0.124 sq.in.).

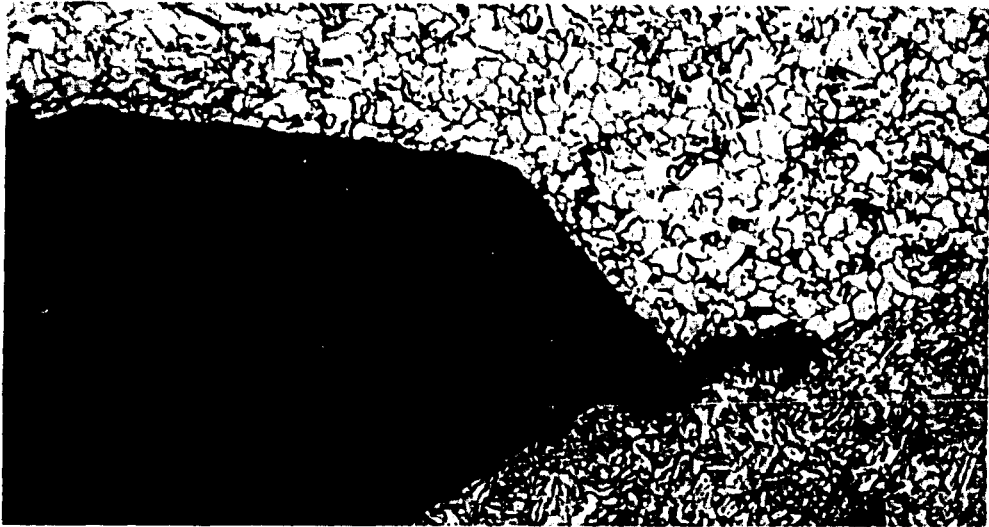
Figure 60 - Enlarged view of the tip of the entrapped slag shown in Figs. 57-59. Note the sharp radius of the defect in this area.
2% nital

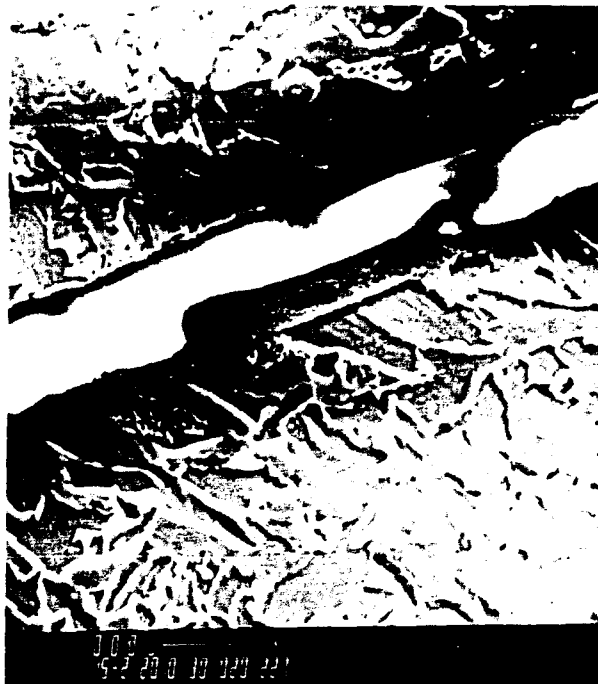
Figure 67A & B - Scanning electron micrograph showing a section of the defect seen in Figs. 63-66. An EDAX printout from the encircled region documents the presence of copper, aluminum, silicon, manganese and iron in this area.

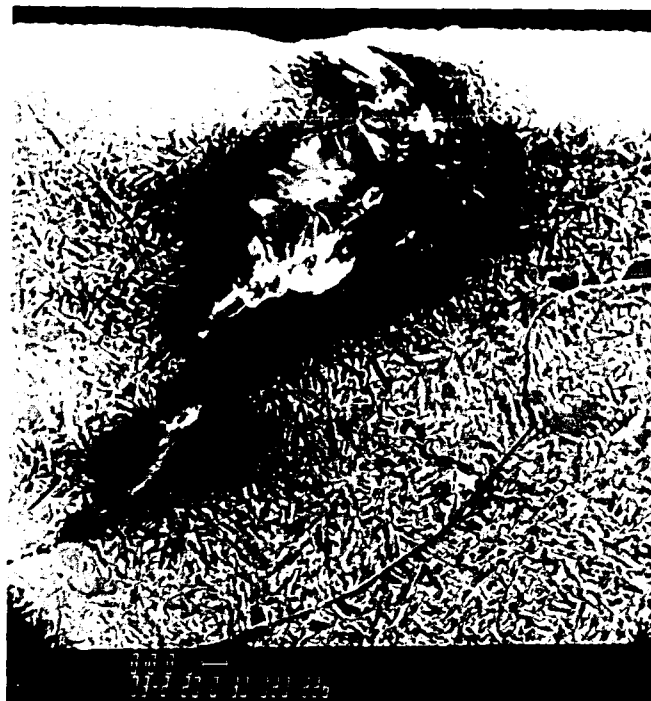
Figure 68A & B - Another view of the defect found in Core KJ. The embedded material found in this region showed high silicon, calcium, titanium and manganese concentrations.

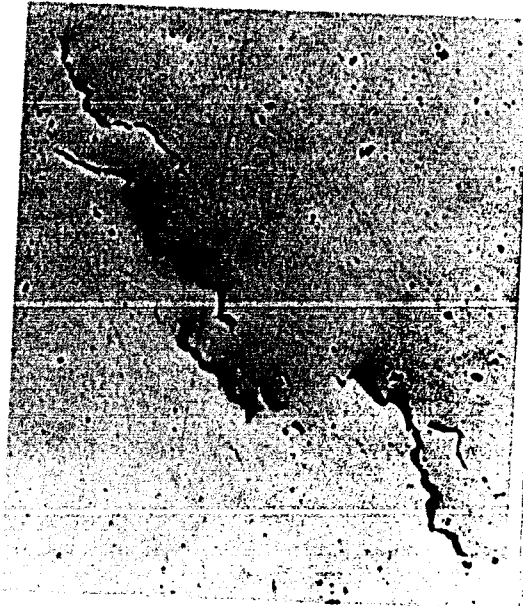
Figures 72 & 73 - Photomicrographs showing the defect found in the encircled area shown in Fig. 71. unetched/2% nital
Mag: 50X

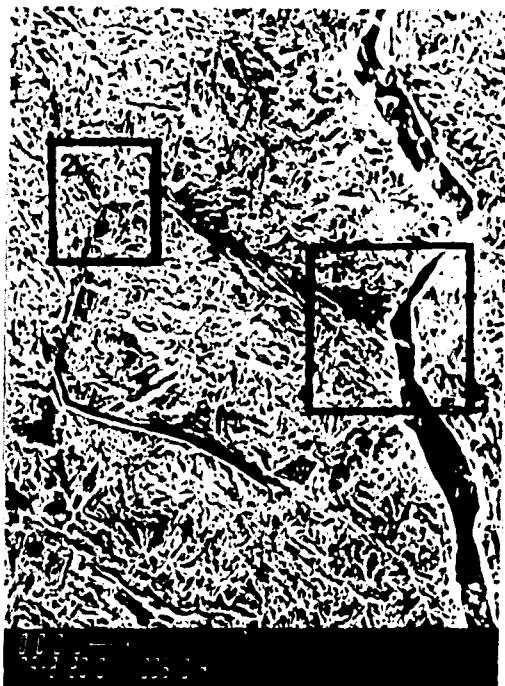
Figures 75-77 - Scanning electron micrographs of the defect found in Core KC (see Figs. 71-74). Note the intergranular character of these cracks. These cracks appear to be located along the interface of proeutectoid ferrite which nucleates along prior austenite grain boundaries.
