Measurements and Assessment of Stresses in Structural Members of the Saw Mill Run Bridge, Pittsburgh, PA

Final Report: July 1999

ATLSS Report No. 99-10

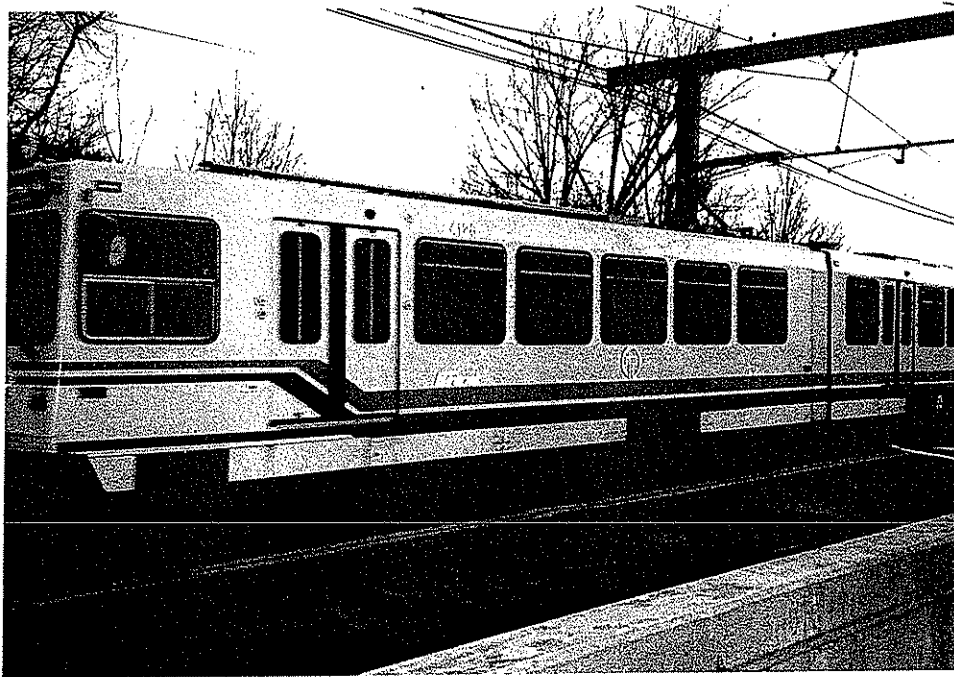
Figure 2: Bridge Structure and Light Rail Vehicle

b) The typical articulated light rail vehicle (LRV) (2/99/25-18)

The bridge typically has four main, parallel girders. However, Spans 4 and 5, and part of Span 6 near Pier 5, have irregular framing to assist a transition into Span 3. When constructed in 1977, the bridge had only these main girders with a concrete deck. It was strengthened in 1985 for LRVs. At that time, sub-stringers and new floorbeams were added, and coverplates and web doubler plates were added at some girder locations. Figure 2a shows the typical structure in Spans 6 through 9. Figure 2b shows a typical articulated LRV; the LRVs traveled as either 1-car or 2-car units during the measurements.

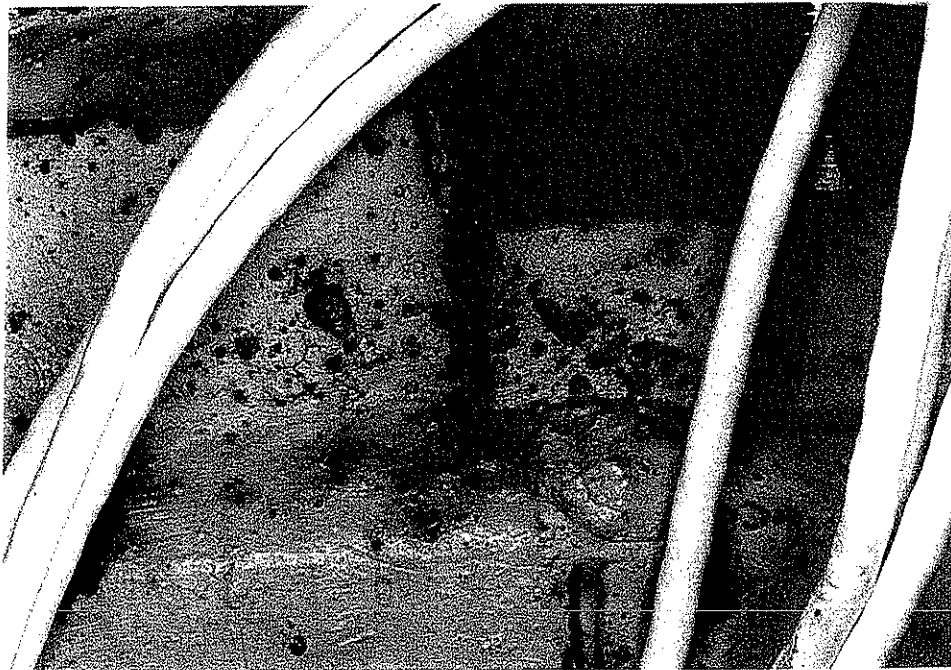
Figure 11: In Span 7, Open 1 1/4 " Fill-Plate Junction at East Side of Girder 3 at Section 7/22

b) Closeup of seal weld area shown in (a) (2/99/15-0)

There are several potentially fatigue-critical details in the bridge spans. In order of decreasing severity, these include the fill-plate terminations (Category E'; fatigue limit stress range = 2.6 ksi), coverplate terminations (Category E'), doubler plate fillet welds (Category E, fatigue limit stress range = 4.5 ksi), web stiffener to flange welds (Category C, fatigue stress limit range = 10 ksi), and welded girder splices (Category B, fatigue limit stress range = 16 ksi). Of these, the fill-plate terminations led to the maximum measured cyclic stress ranges and, therefore, a fatigue damage model is developed for this governing fatigue-critical detail. Sketches of elevation and transverse sections for the fill plate in Girder 3 at Section 7/22, Span 7, near Gages 7.22 - 7.24 are given below, along with the photograph of the section as shown earlier in Figure 11b. This section had the maximum cyclic stress ranges that were recorded in the study.

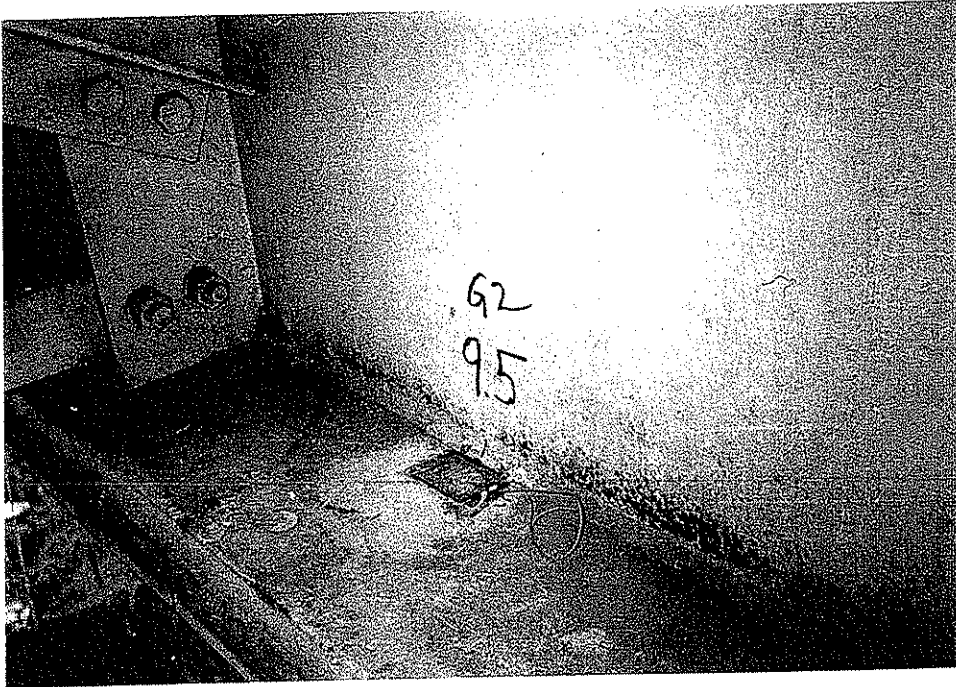
Figure 13: Representative Gage Installations on Span 9 Girders at Section 9/c

a) Gage 9.5 on Bottom Flange of Girder 2 (3/99/12-3)

In Span 9, there were 20 gages, Table 5. Twelve were on the flanges of the four girders and two sub-stringers about 66 ft south of Pier 9, and eight were on the flanges of the four girders at the seal weld/fill plate cross section about 19 ft south of Pier 9. Figure 13 illustrates gages on top and bottom girder flanges, and Figure 14 illustrates an open fill-plate junction on Girder 3. This junction was open across the entire width of the flange.

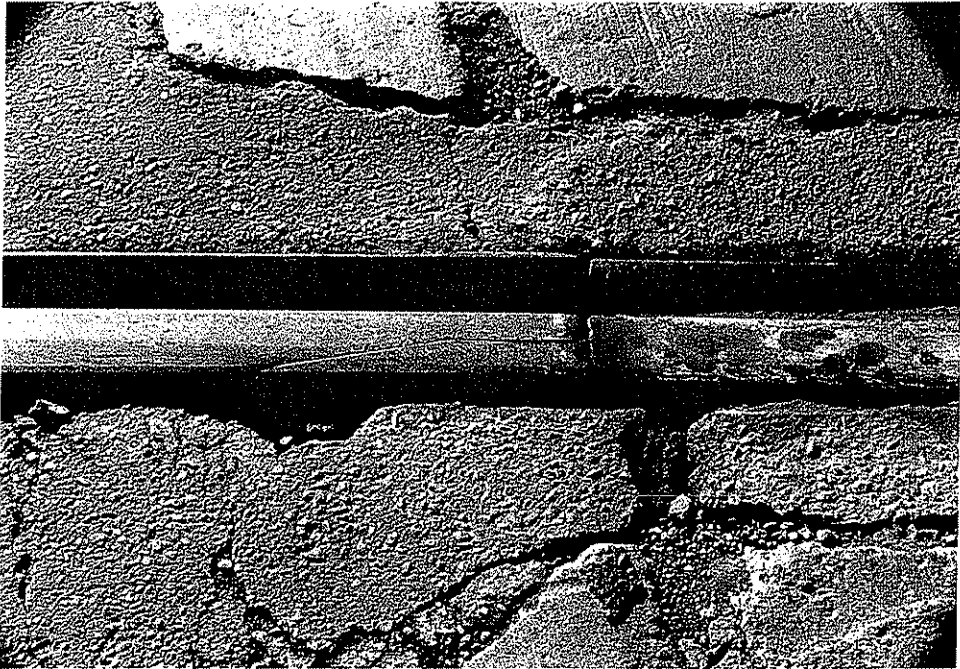
Figure 16: Mitered Rail Joint on Inbound Track in Span 10 (2/99/15-9)

In Span 10, there were 12 gages, Table 6. Four were on the flanges of Girders 2 and 3 at the seal weld/fill plate section about 5 ft north of Pier 9, and eight were at or near midspan on the flanges of the four girders and the sub-stringer and a floorbeam between Girders 3 and 4. Figure 15 illustrates the fill-plate/seal weld area in Girder 2. Figure 16 shows a mitered rail joint (which is scheduled for repair) in one of the inbound-track rails that caused a loud, distinct thump with every LRV traversing it, thus adding a potential for transmitting impact stress into Girders 3 and 4.

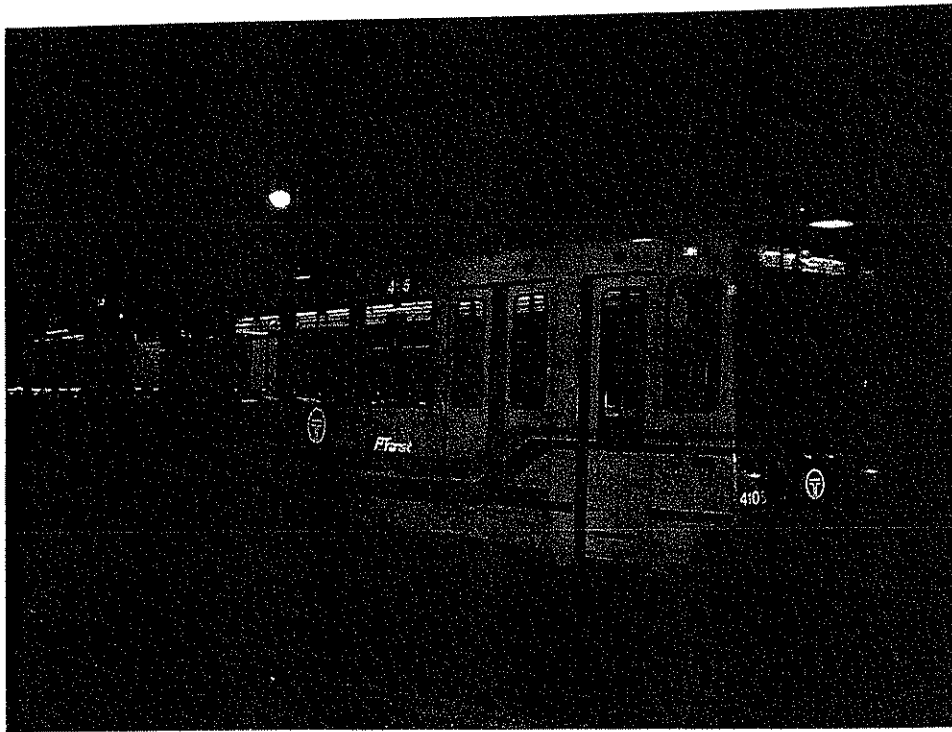
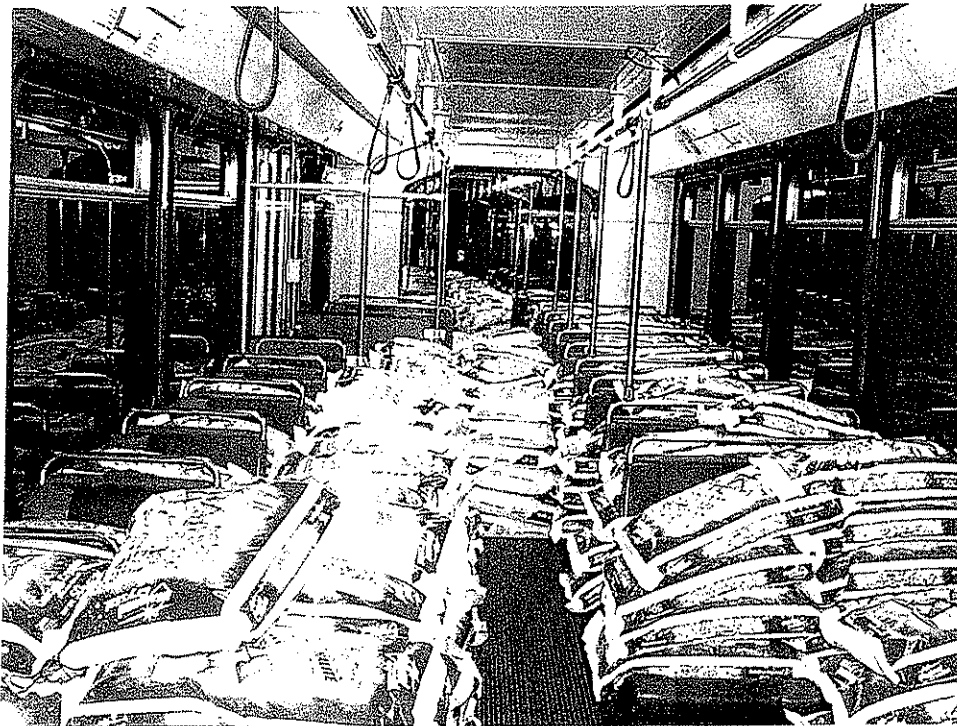
Figure 18: LRV with Salt Bags Used as Test Vehicle

a) Exterior View of Test Vehicle (P000 1144)

b) Interior View of Test Vehicle (P000 1142)

The Port Authority and Parsons Brinckerhoff arranged for one articulated LRV to make several runs over the bridge during early morning hours when revenue vehicles were not operating. The LRV was loaded with salt bags to simulate a fully-loaded vehicle of 280 riders each weighing 150 lb, or a total rider load of 42,000 lb. The empty LRV weighed 88,000 lb, for a total test vehicle weight of 130,000 lb. The LRV with salt bags is illustrated in Figure 18.

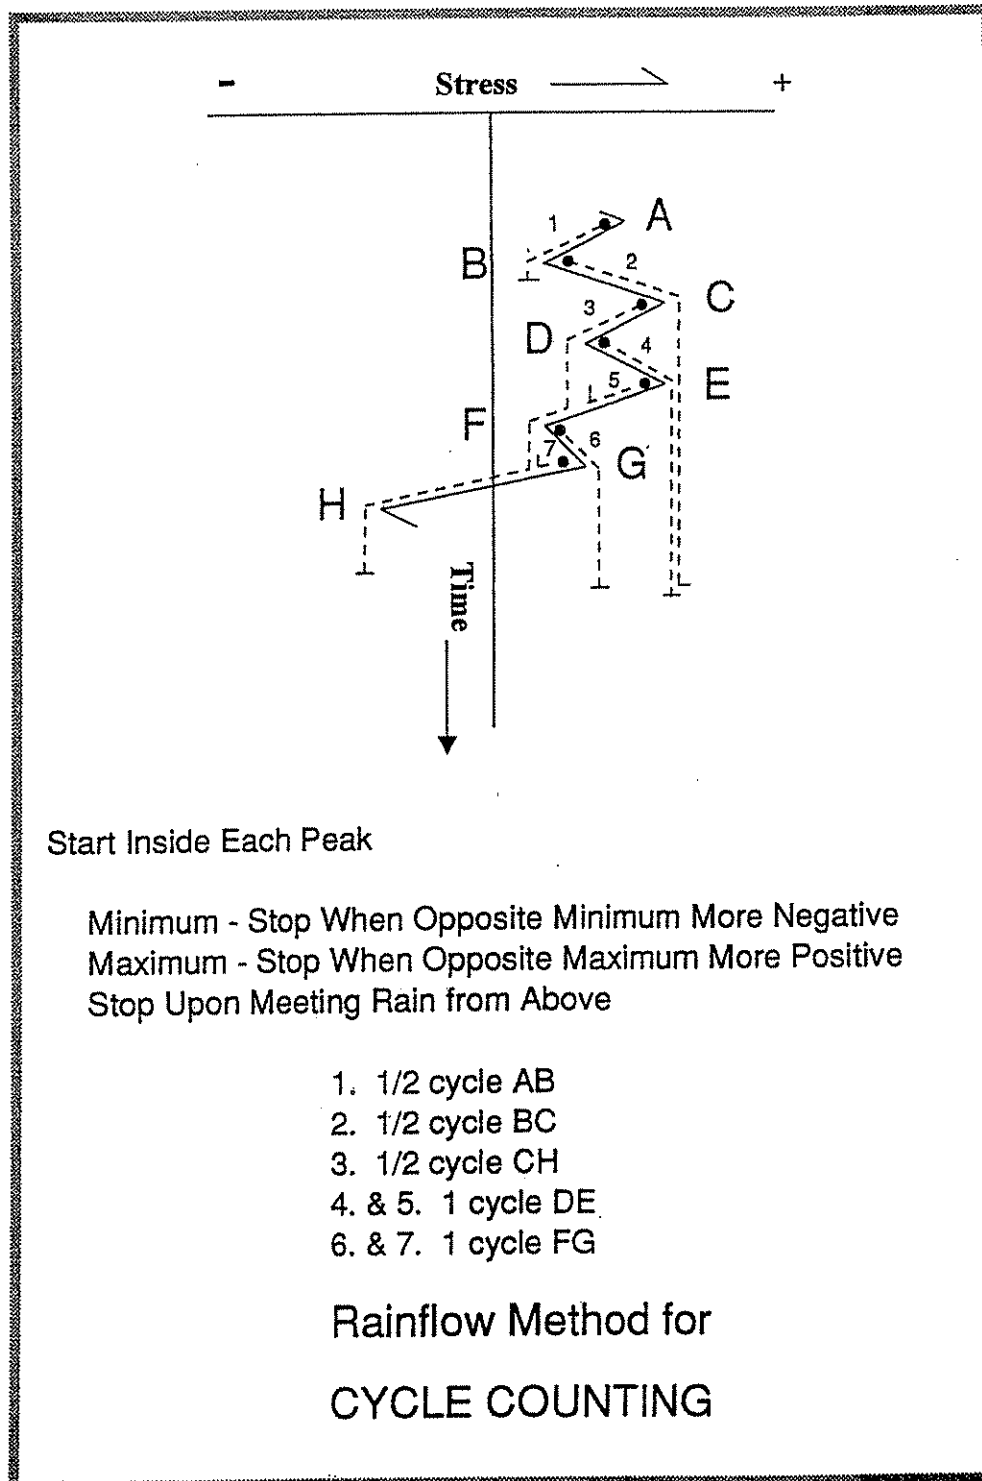
A graphical description is provided below illustrating the use of the rainflow counting method that was employed in the computer algorithm to determine the number of stress cycles caused by the vehicles on the Saw Mill Run Bridge.
