Seismic Performance of Sprayed Fire Resistive Material (SFRM) on Steel Moment Frame Buildings

ATLSS Report No. 10-03

April 2010

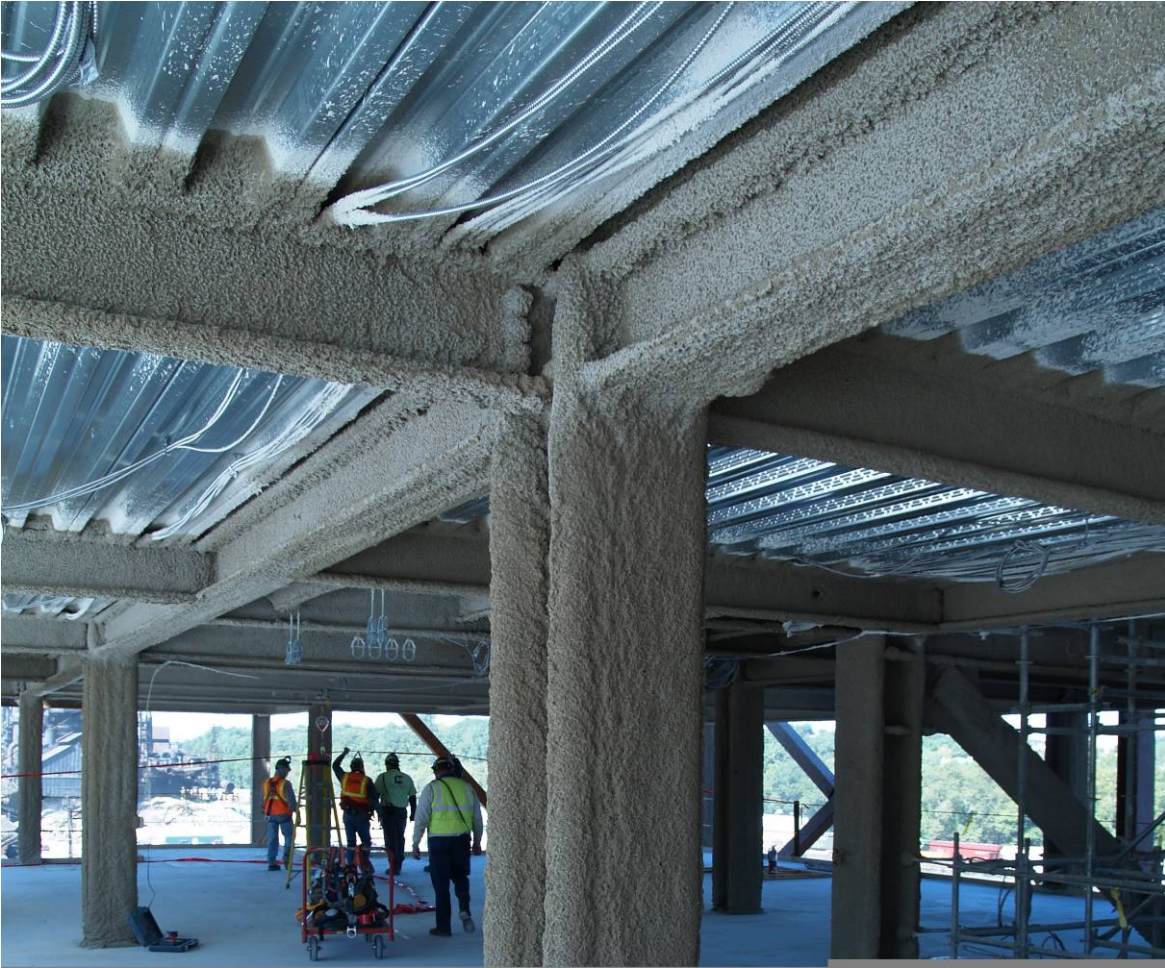
Figure 2.1 – Photograph of sprayed fire resistive material in building

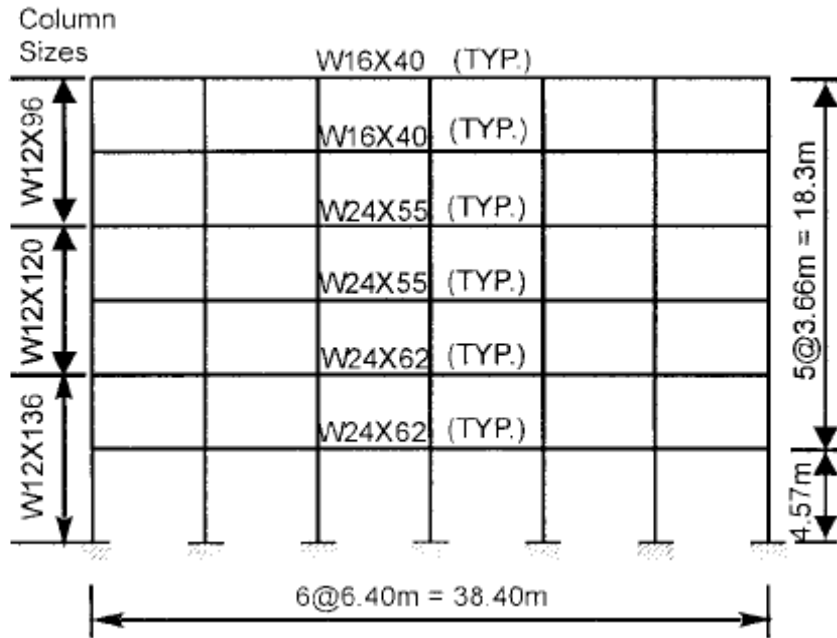
Figure 2.6 – Elevation of prototype moment resistant frame used by Ricles et al. (2001)

A study by Ricles et al. (2001) described the design and analysis of typical welded MRFs based on the prototype frame shown in Figure 2.6. This figure shows a general six story, six bay office building located in the Los Angeles area. The frame was designed based on 1994 NEHRP provisions for special moment-resisting frames and was based on seismic hazard exposure Group III, soil type D, and an effective peak velocity-related coefficient of 0.4. The member sizes and overall geometry of this frame will be used in the assemblage tests presented in Chapter 5 and Chapter 6 and the finite element analyses in Chapter 7 and Chapter 8.

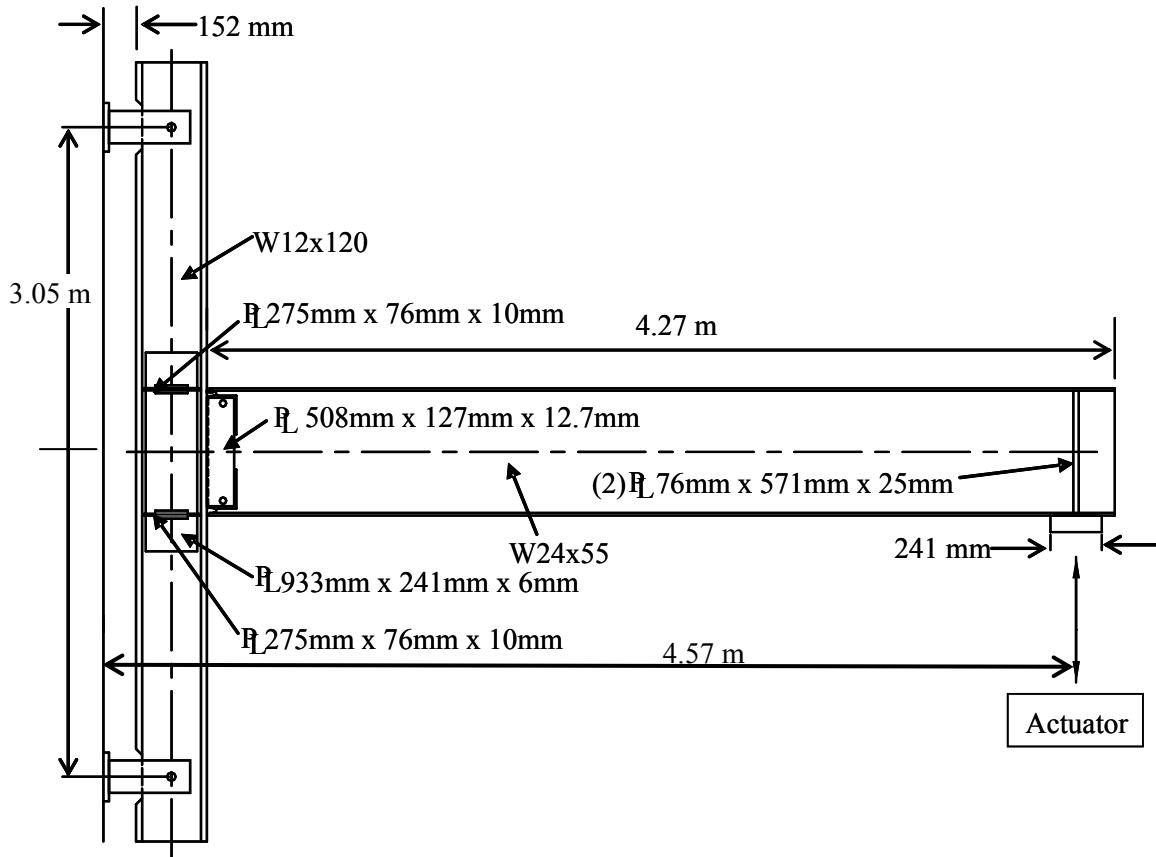
Figure 3.1 – Overall specimen geometry and setup

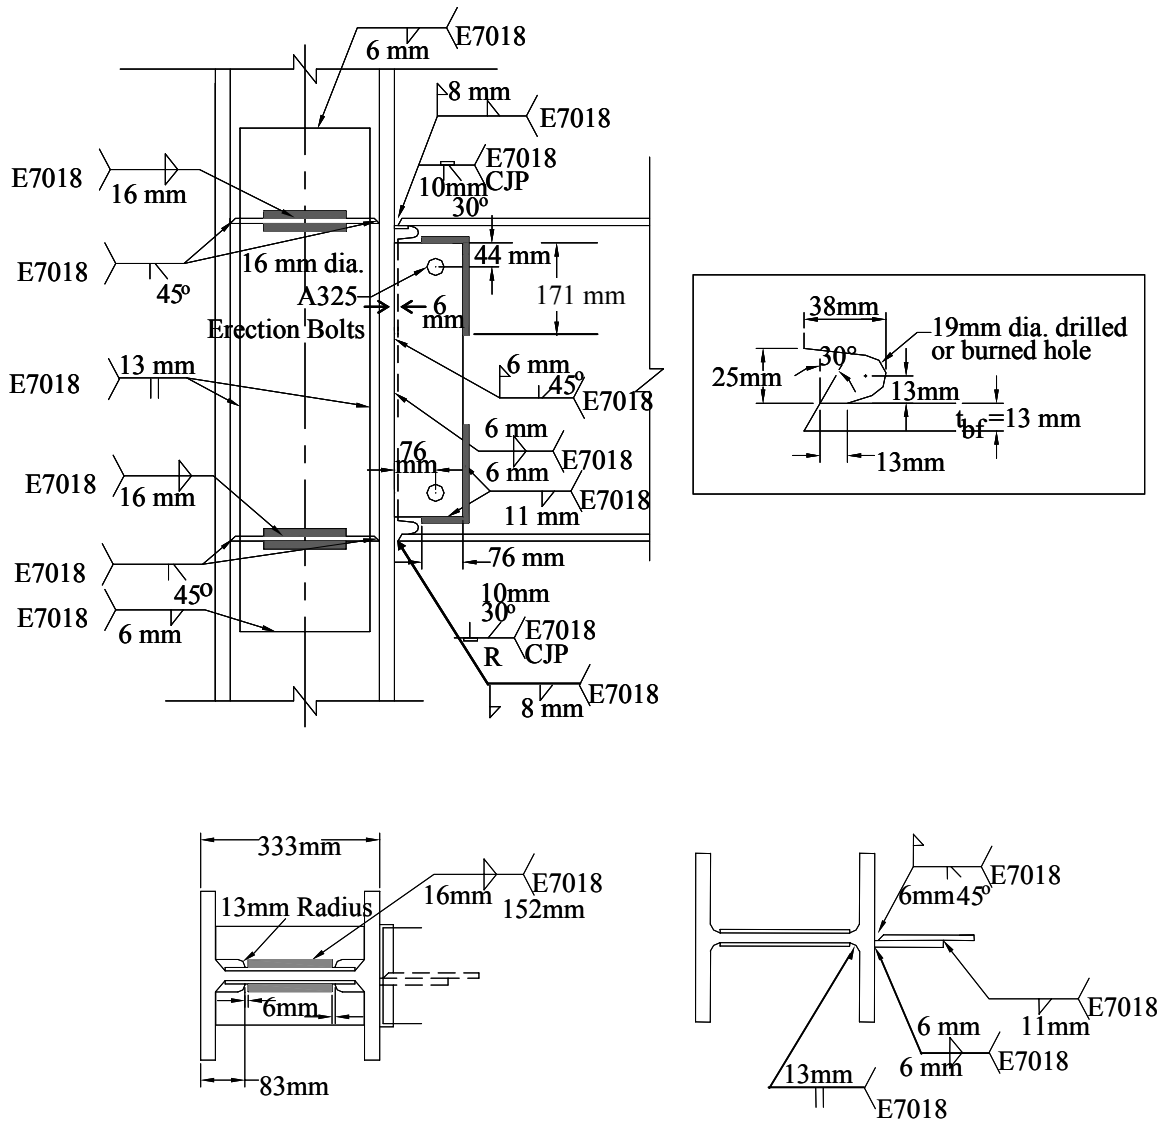
Figure 3.2 – Weld details for connection in assemblage tests

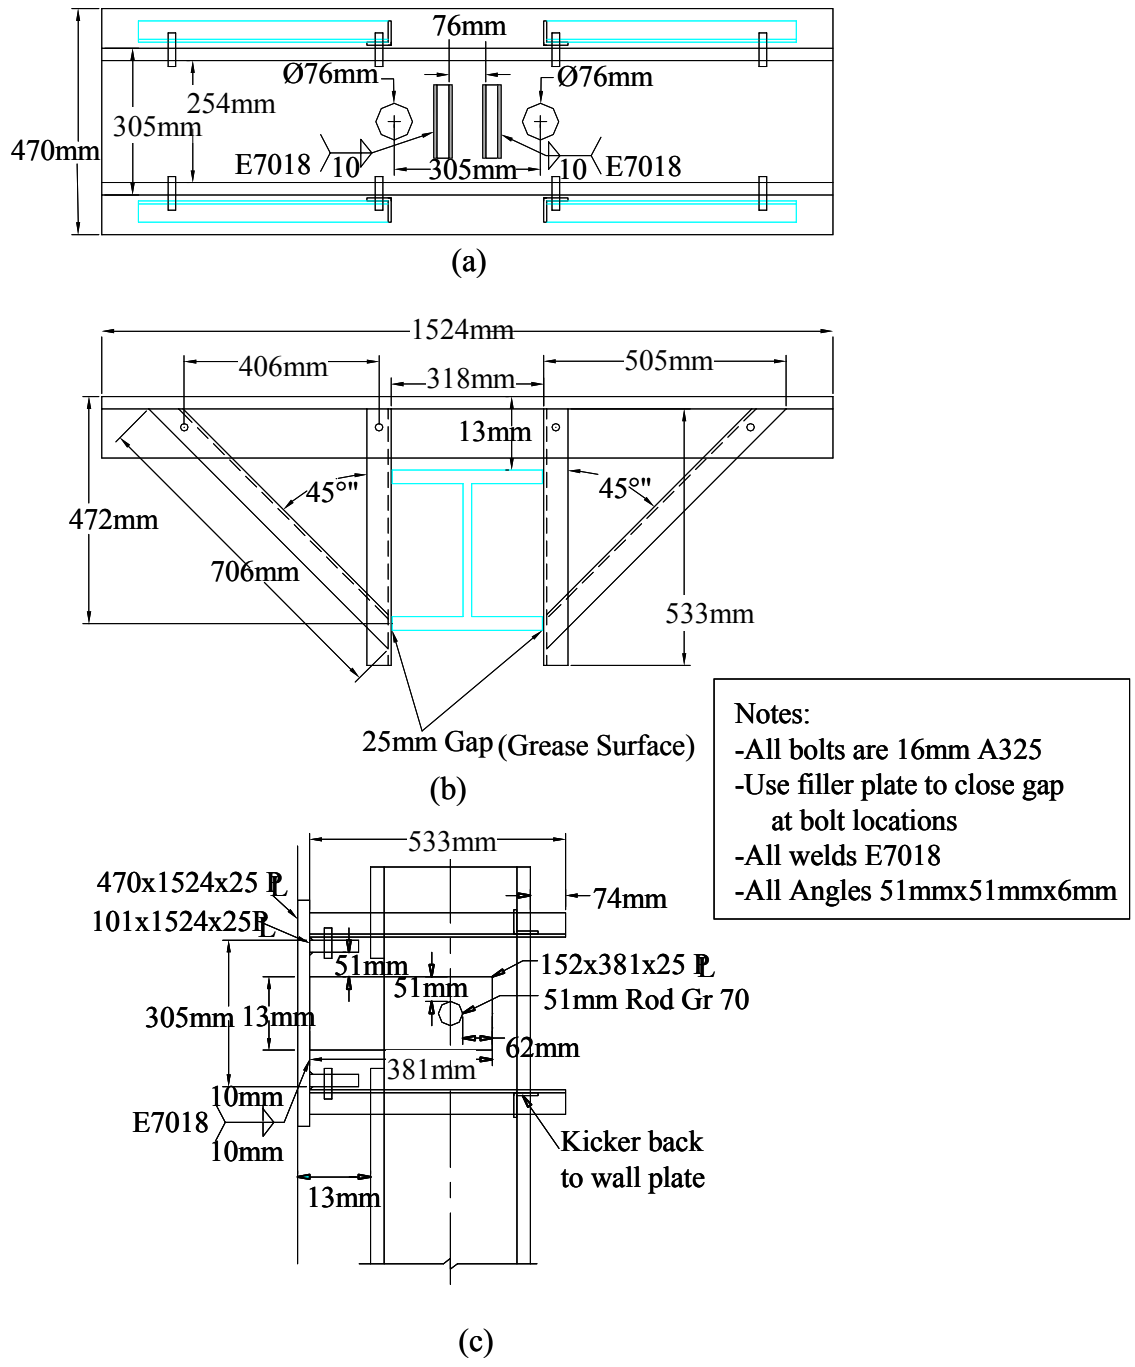
Figure 3.3 – Clevis details for wall fixture: (a) front view; (b) top view; and (c) side view

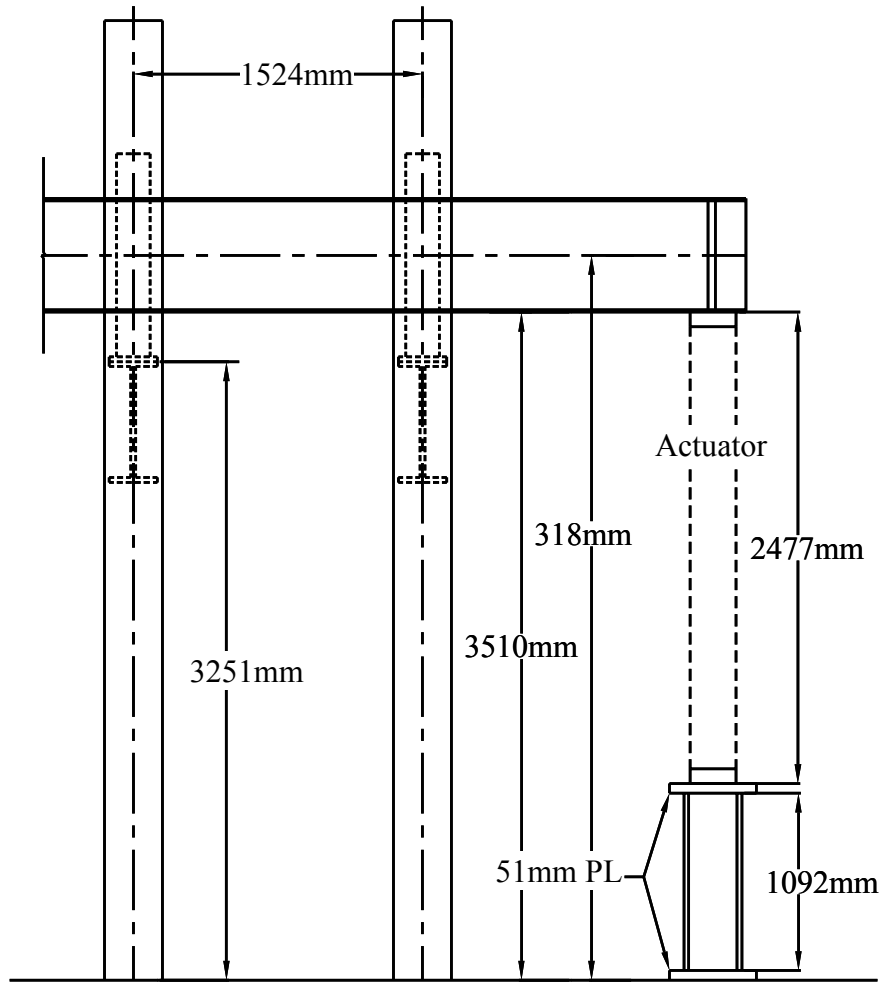
Figure 3.4 – Actuator base details

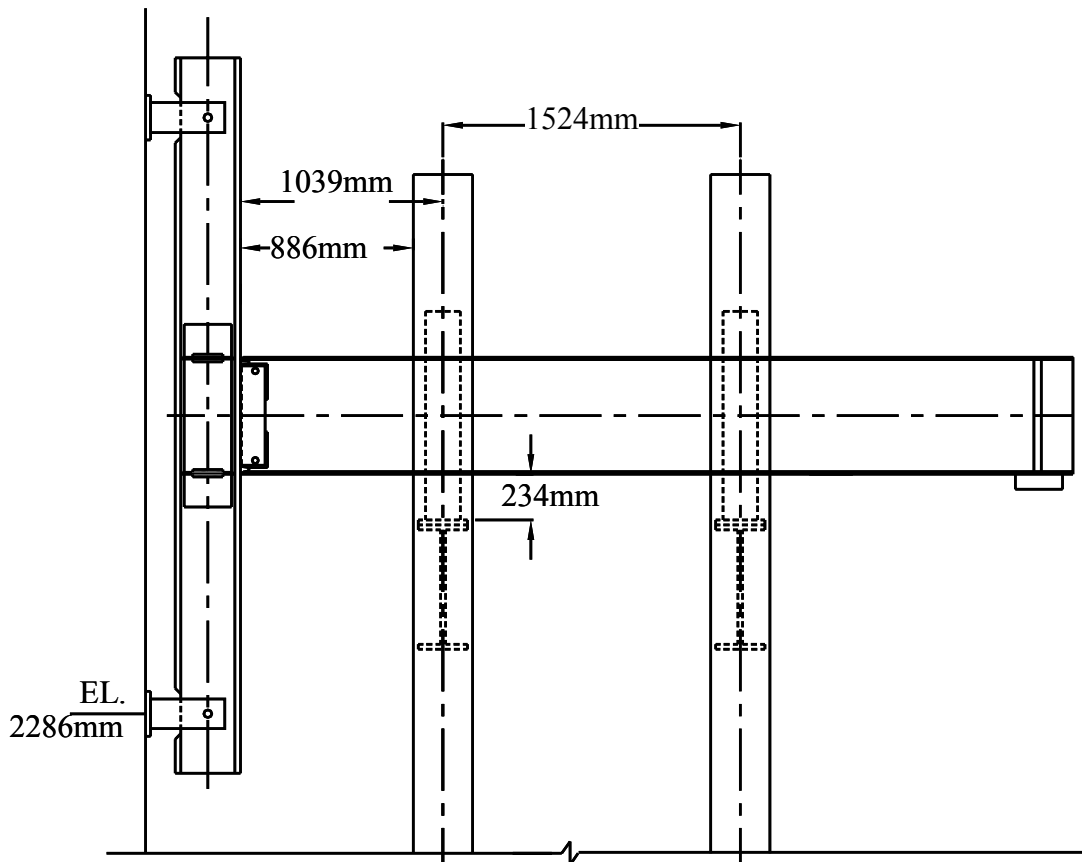
Figure 3.5 – Beam bracing layout

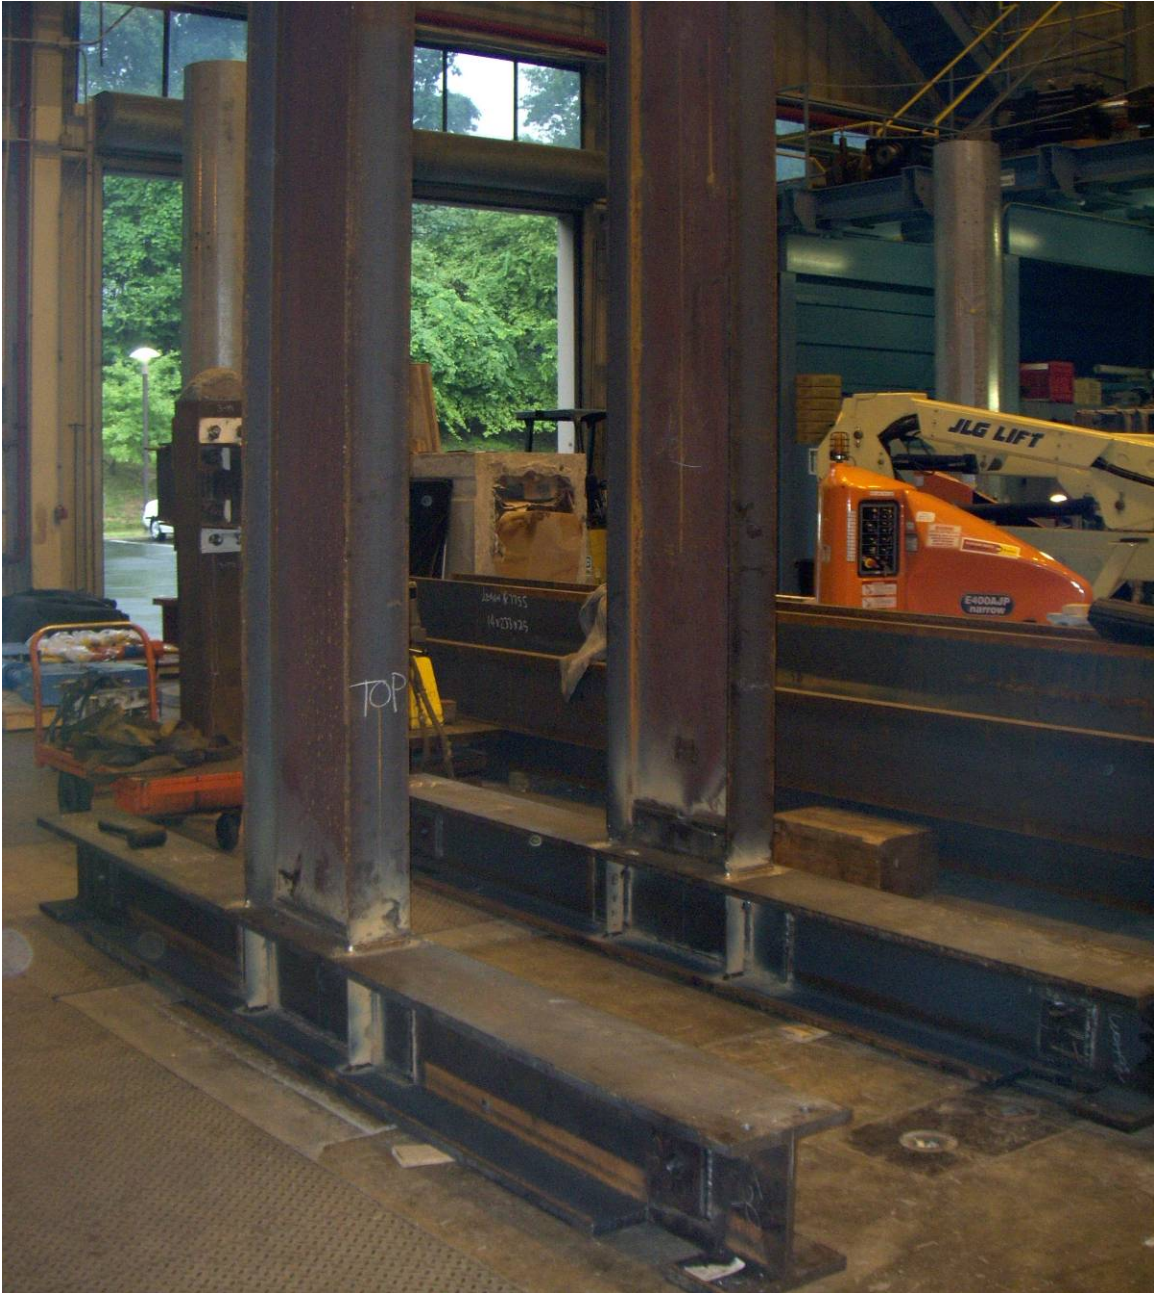
Figure 3.6 – Specimens after steel fabrication and before sprayed fire resistive material application

All steel fabrication was performed in house at Lehigh University's ATLSS laboratory. Figure 3.6 shows both specimens after fabrication was complete, before the application of SFRM and Figure 3.7 shows the details of the connection. When fabrication was complete, ultrasonic testing was performed in the connection region to ensure quality of the welds as seen in Figure 3.8. Results of the ultrasonic testing can be found in Appendix A.3. There were no defects found in the welds and the connection was found satisfactory.

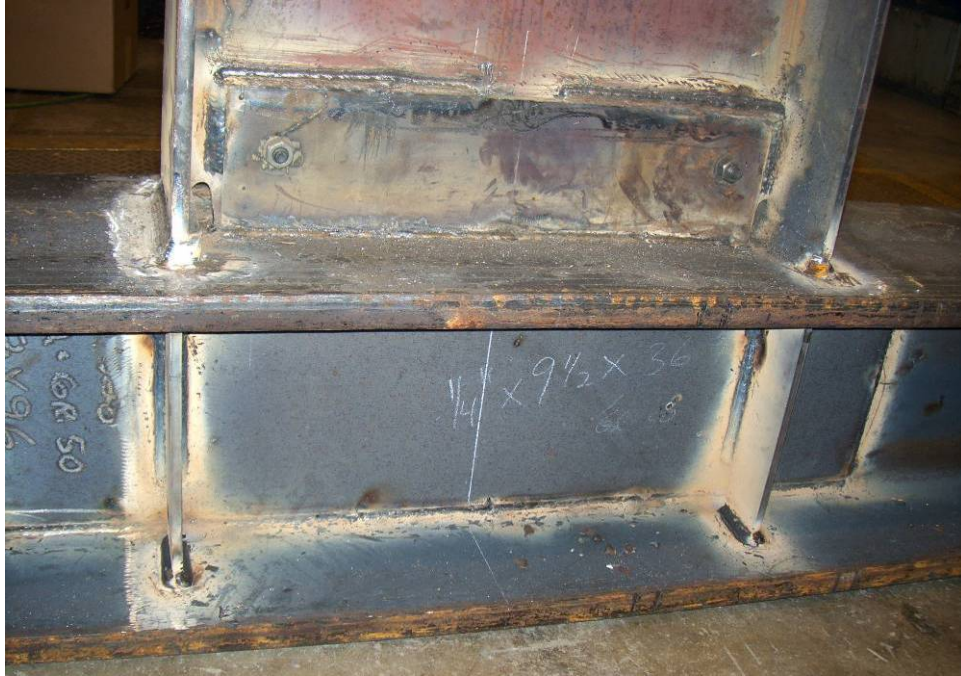
Figure 3.7 – Photograph of connection region after steel fabrication

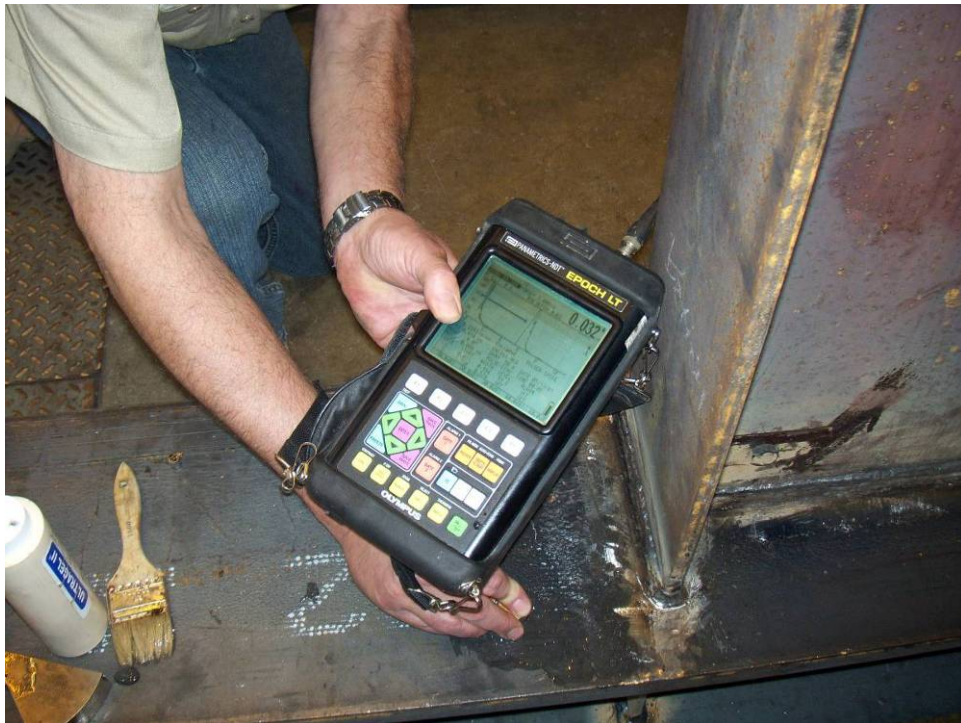
Figure 3.8 – Ultrasonic testing of specimen

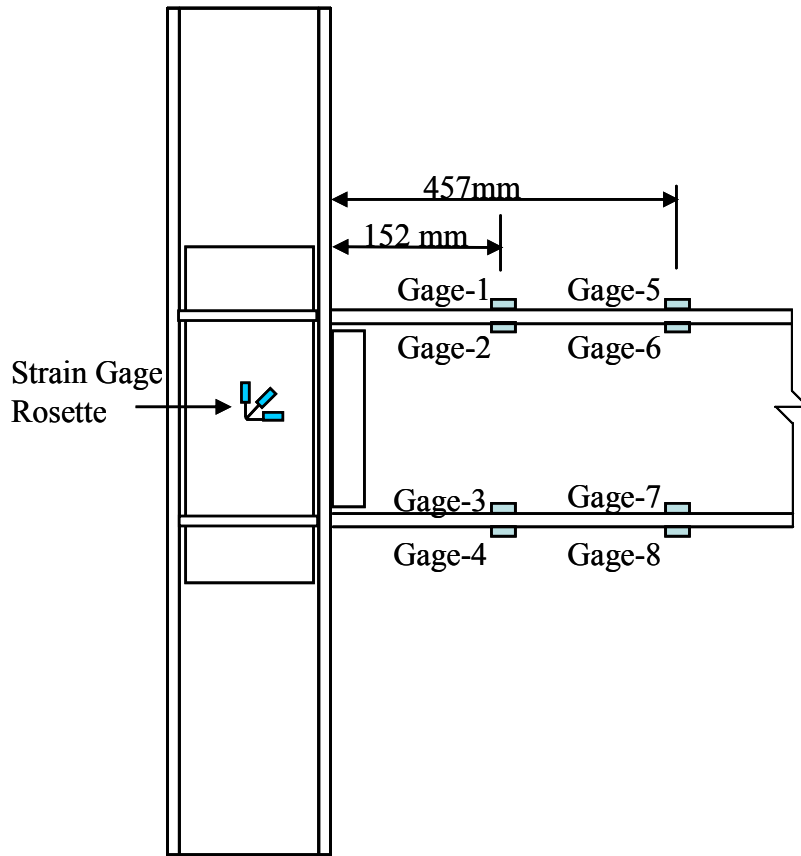
Figure 3.9 – Strain gage layout for assemblage testing

Figure 3.9 shows the layout of the strain gages. One gage is placed on the top and bottom of each flange at 152 mm from the column face and 457 mm from the column face to measure flange deformations. Care was taken to ensure that the strain gages were not damaged during the application of the SFRM. This included application of silicon rubber, Teflon, and waterproofing on the gages. These protective materials remained in place during SFRM application, and then when the SFRM was sufficiently dry, these layers were carefully peeled away effectively leaving a void in the SFRM on top of each gage

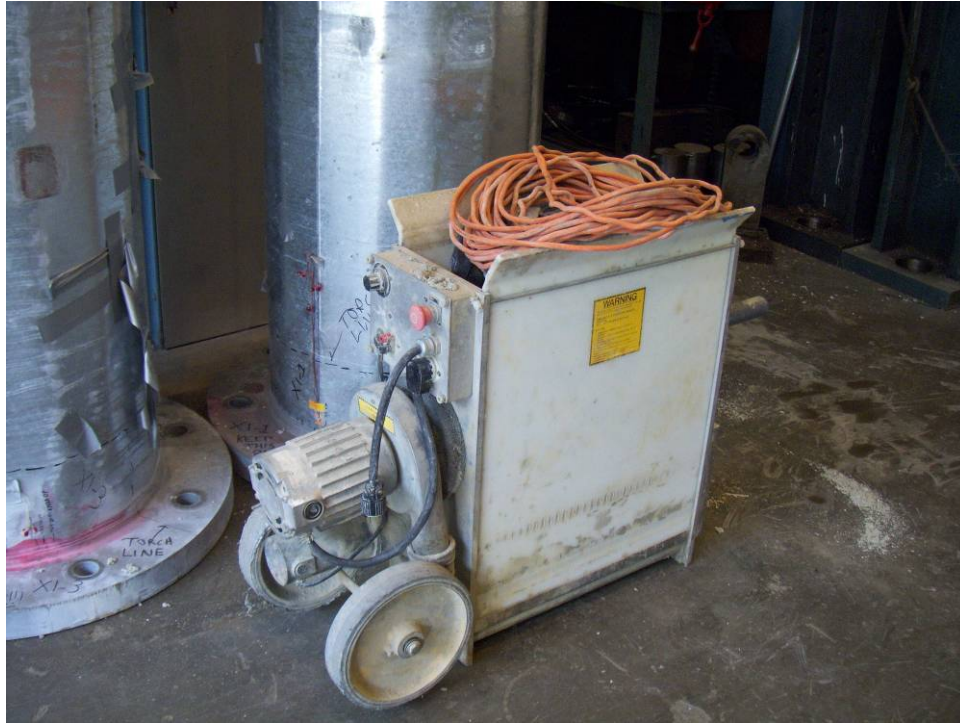
Figure 3.10 – Spray applicator for DM

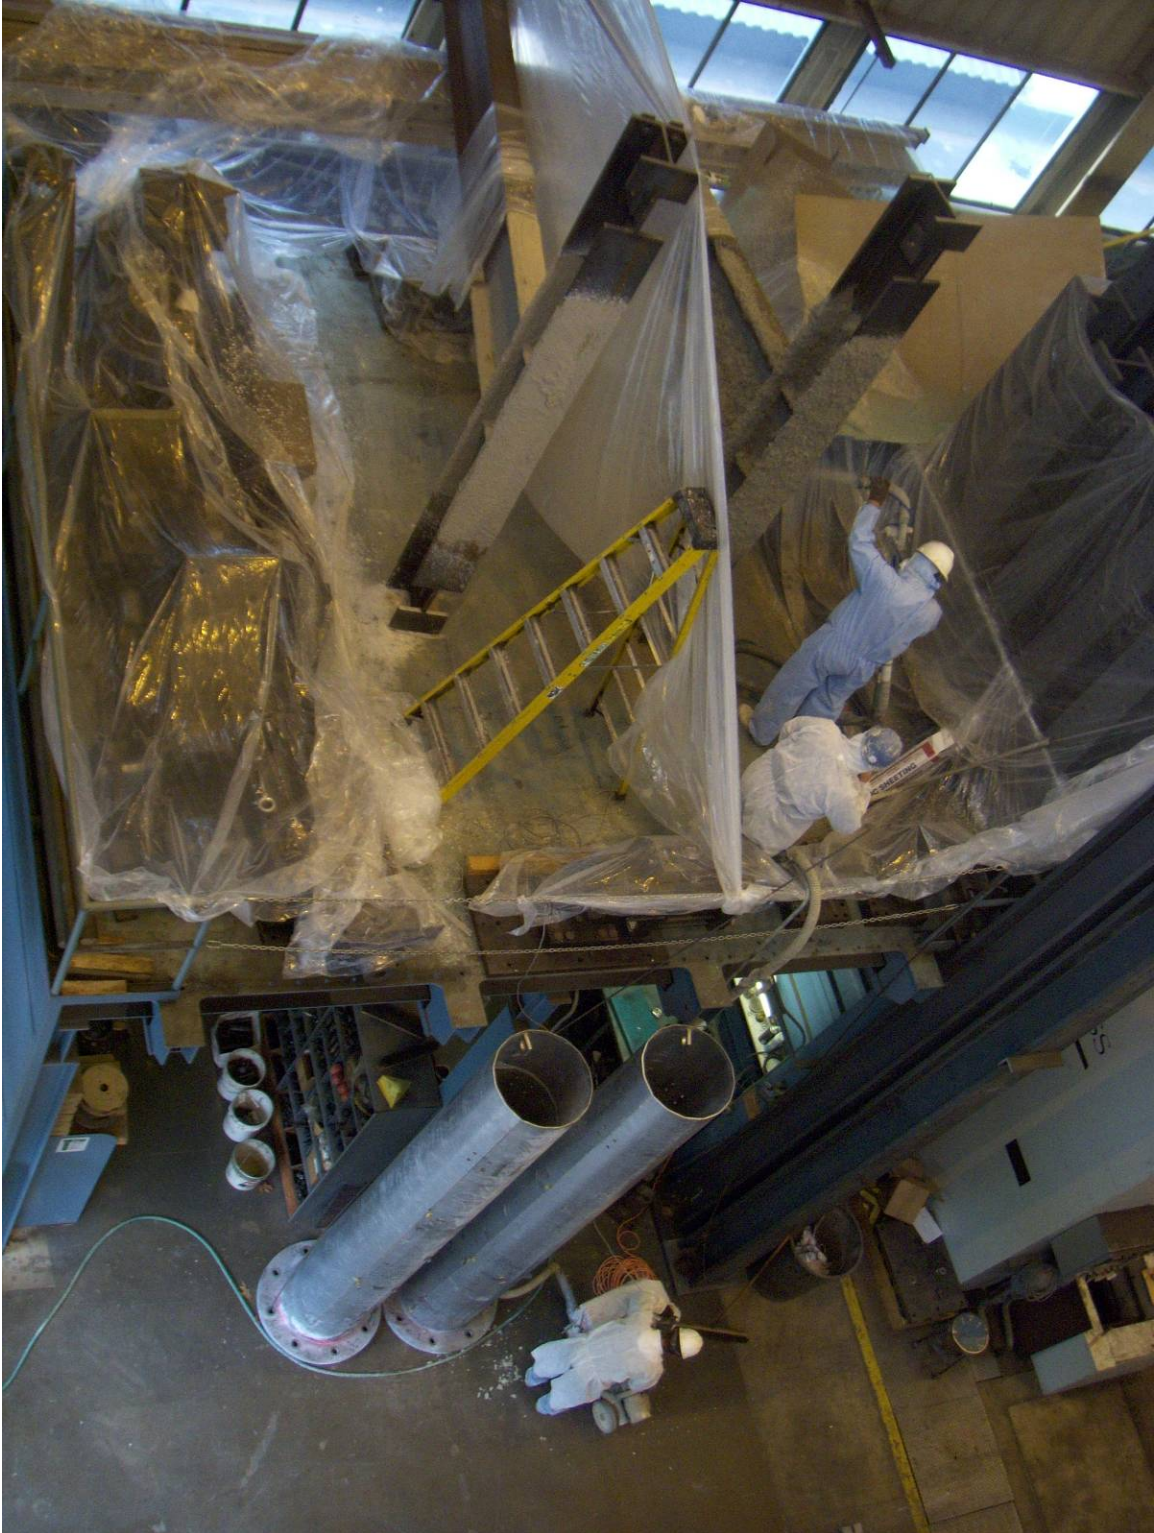
Figure 3.12 – Staging area for application

application process. The dry materials are pumped through an applicator and a separate water jet moistens the material as it is applied to the specimen. Figure 3.12 shows the working area for application, with the DM applicator located on the ground level below the specimens. The DM was applied in one application, in contrast to the 2-day application of the WM.

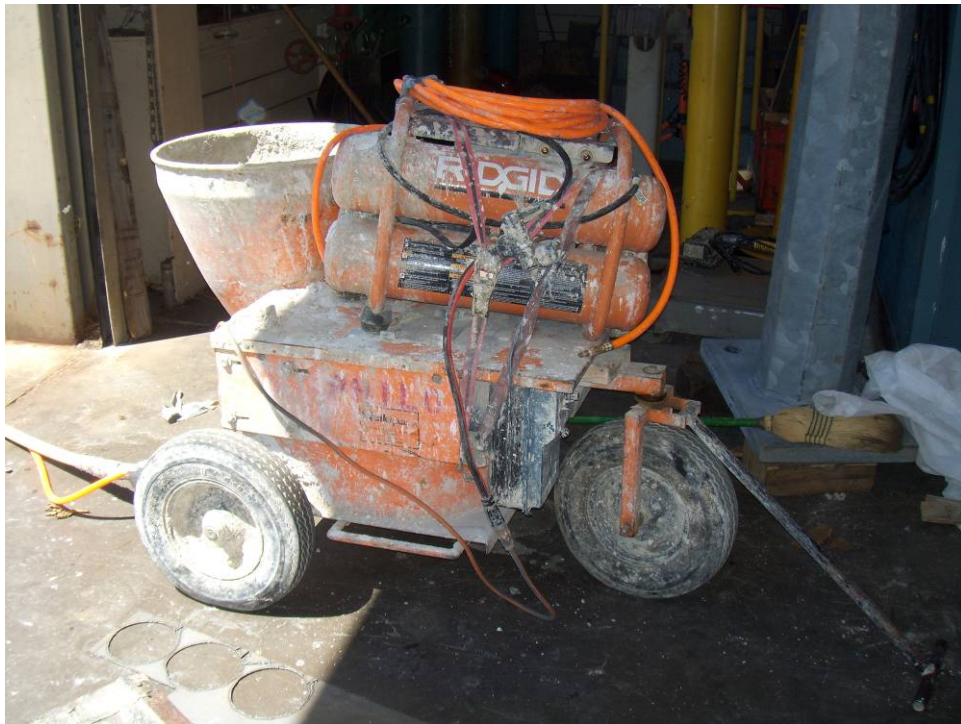
Figure 3.14 – WM spray applicator

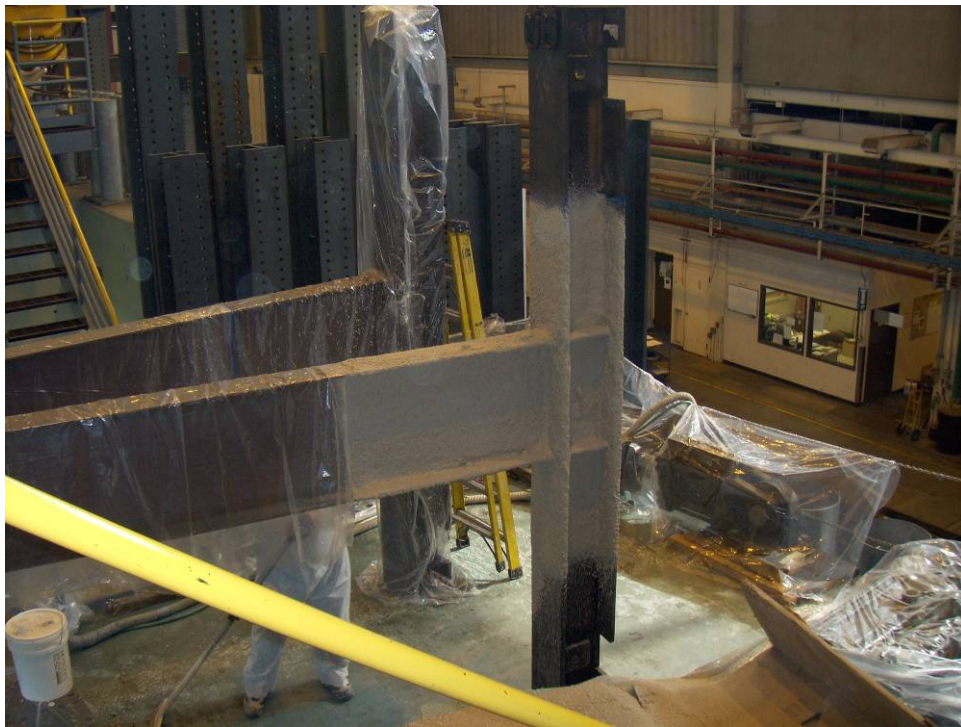
Figure 3.16 – Specimen after first coat of WM

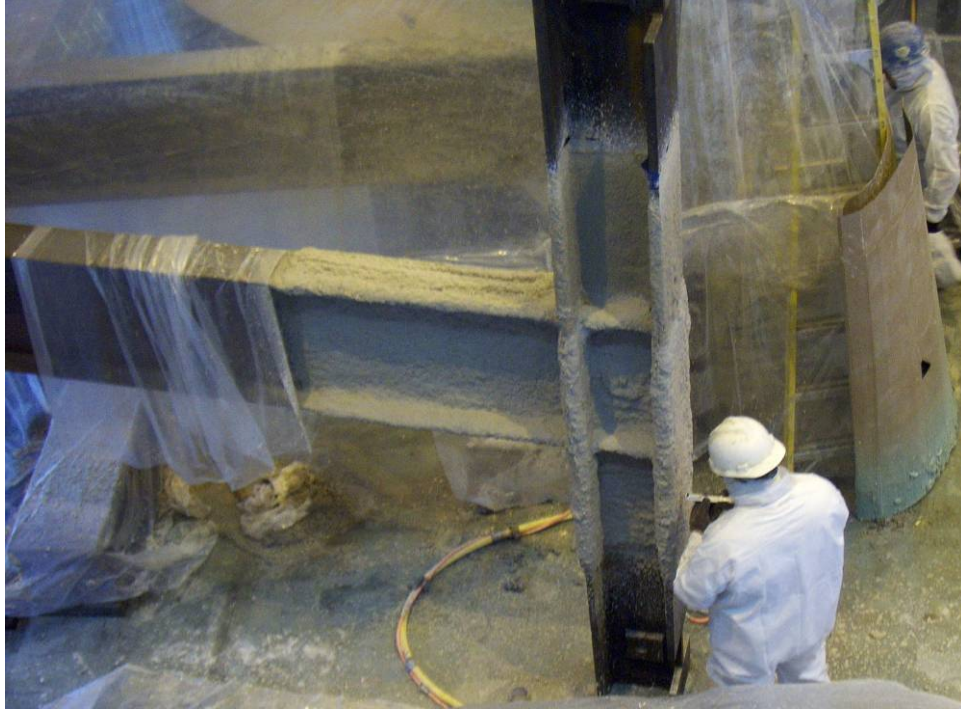
Figure 3.18 – Technician checking the thickness of the WM

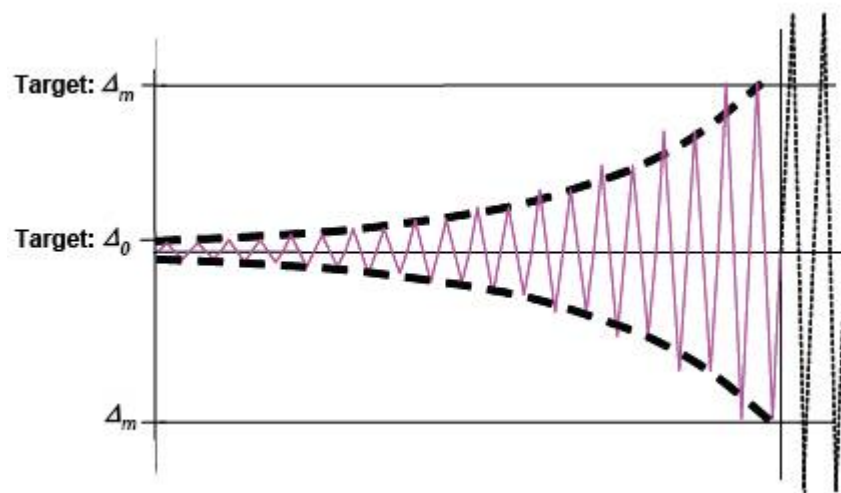
Figure 3.19 – FEMA 461 recommended deformation controlled loading history (FEMA 461, 2007)

Testing was performed by cycling beam tip displacements in the vertical direction. Figure 3.19 shows FEMA 461 step-wise increasing cycles for deformation-controlled loading histories. Each step consists of 2 cycles at the same amplitude. Relative step amplitudes were defined as ratios of the step amplitude to the last planned amplitude. The last planned amplitude was chosen to be close to the targeted maximum deformation, Δ_m , corresponding to a severe damage state. For this testing a story drift index of 0.03 was selected on the basis that significant yielding in the beam is expected, and the smallest deformation amplitude Δ_o was chosen such that it corresponded to a story drift of 0.0015 since prior monotonic testing did not exist.

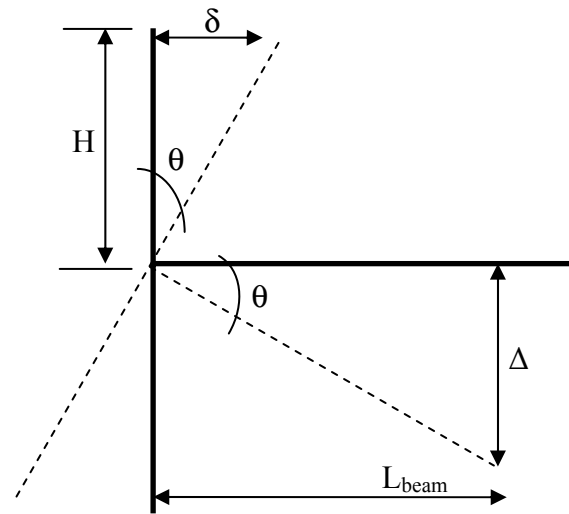
Figure 3.20 – Interstory drift relationships

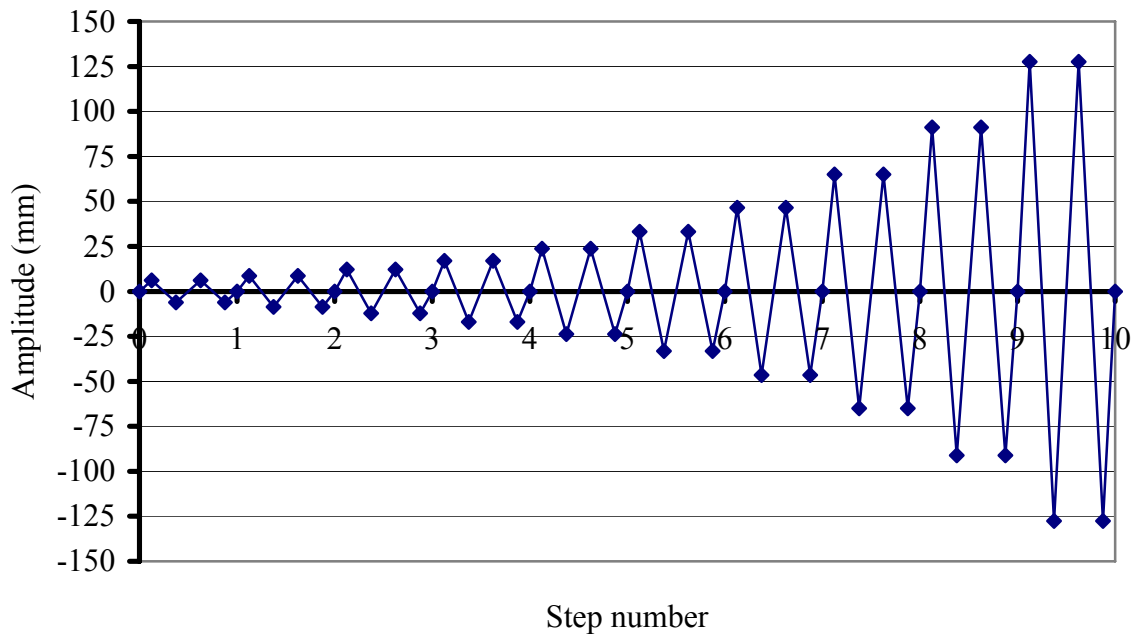
Figure 3.21 – Loading history for assemblage test

The final amplitude, a_n , was set equal to the maximum deformation, Δ_m , of 128 mm and the relative amplitudes previously defined were used to define the loading amplitudes for each step. This is shown in Table 3.4 and also plotted graphically in Figure 3.21. If sufficient damage was not found after the maximum deformation of 128 mm, the amplitude was increased at a rate of $0.3\Delta_m$ per step.

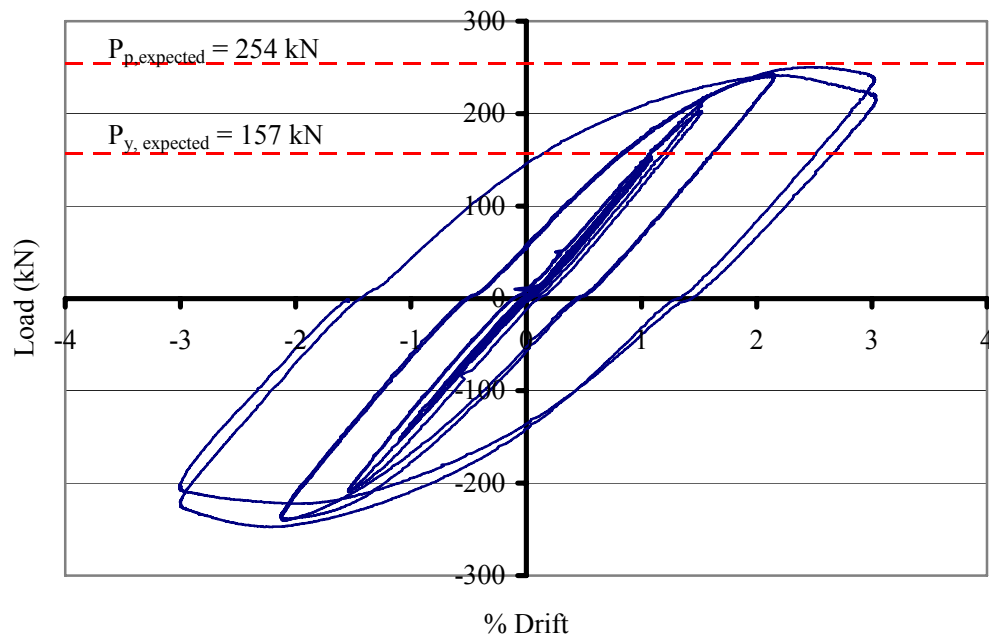
Figure 4.1 – Load vs. percent drift for DM assemblage test

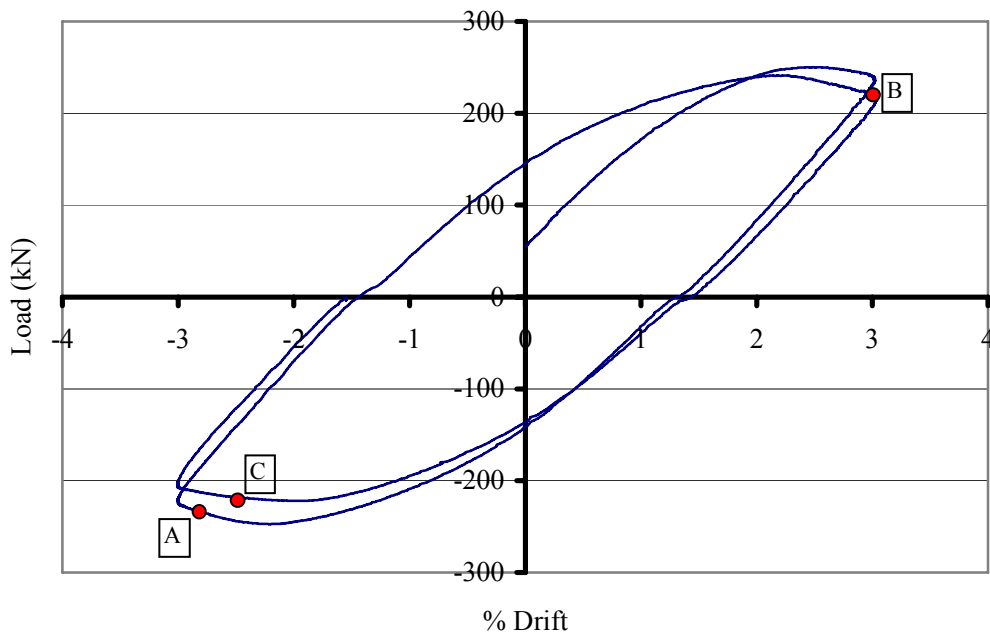
Figure 4.6 – Load vs. percent drift – step 10 of DM assemblage test

A review of Figure 4.6 shows damage to the SFRM in step 10. During the first cycle of downward loading, a large tear in the SFRM was seen on the bottom flange when this flange is in compression, shown as point A in this figure and also shown in the photograph in Figure 4.7. During the second upward segment of loading, a large tear in the SFRM in the top flange was seen, also when the flange is in compression. This is shown as point B in Figure 4.6 and also shown in the photograph in Figure 4.8. Finally, during the second downward segment of loading at a displacement of -122.4 mm, a large portion of SFRM fell off of the bottom of the bottom flange of the specimen when that flange was in compression. This is shown as point C in Figure 4.6 and in the photograph in Figure 4.9. Details on the size and location of the damage to the SFRM are discussed further in Section 4.4.1.

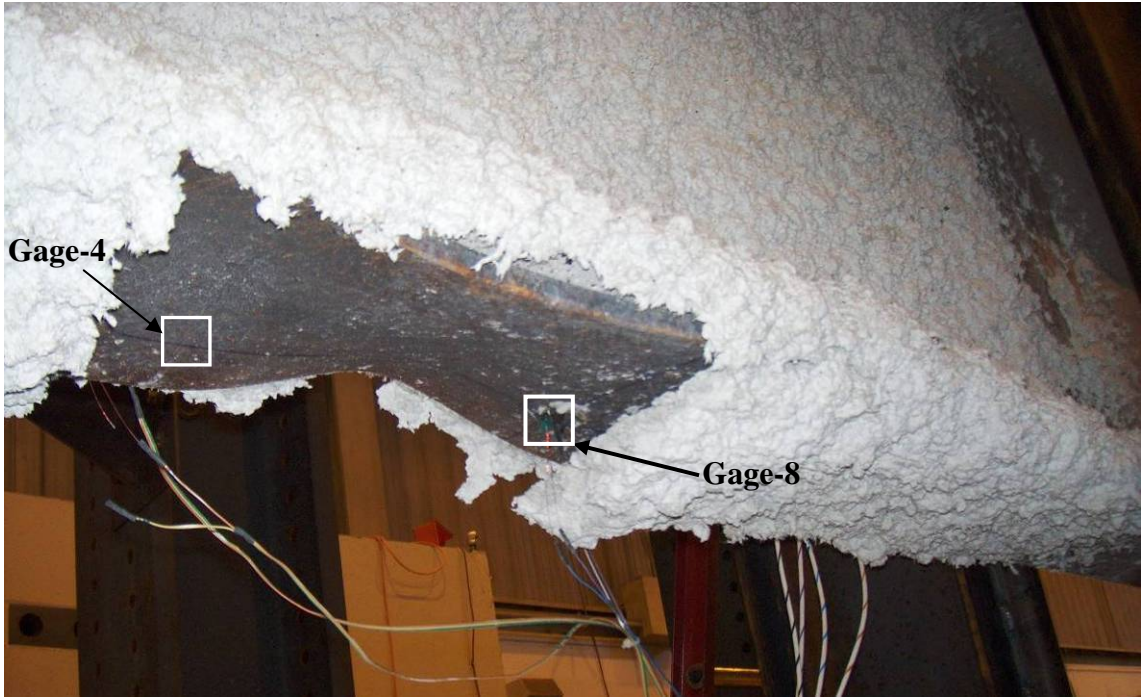
Figure 4.9 – Damage to the SFRM that occurred during step 10 of the DM test shown as Point C in Figure 4.6
