Seismic Performance of Sprayed Fire Resistive Material (SFRM) on Steel Moment Frame Buildings

ATLSS Report No. 10-03

April 2010

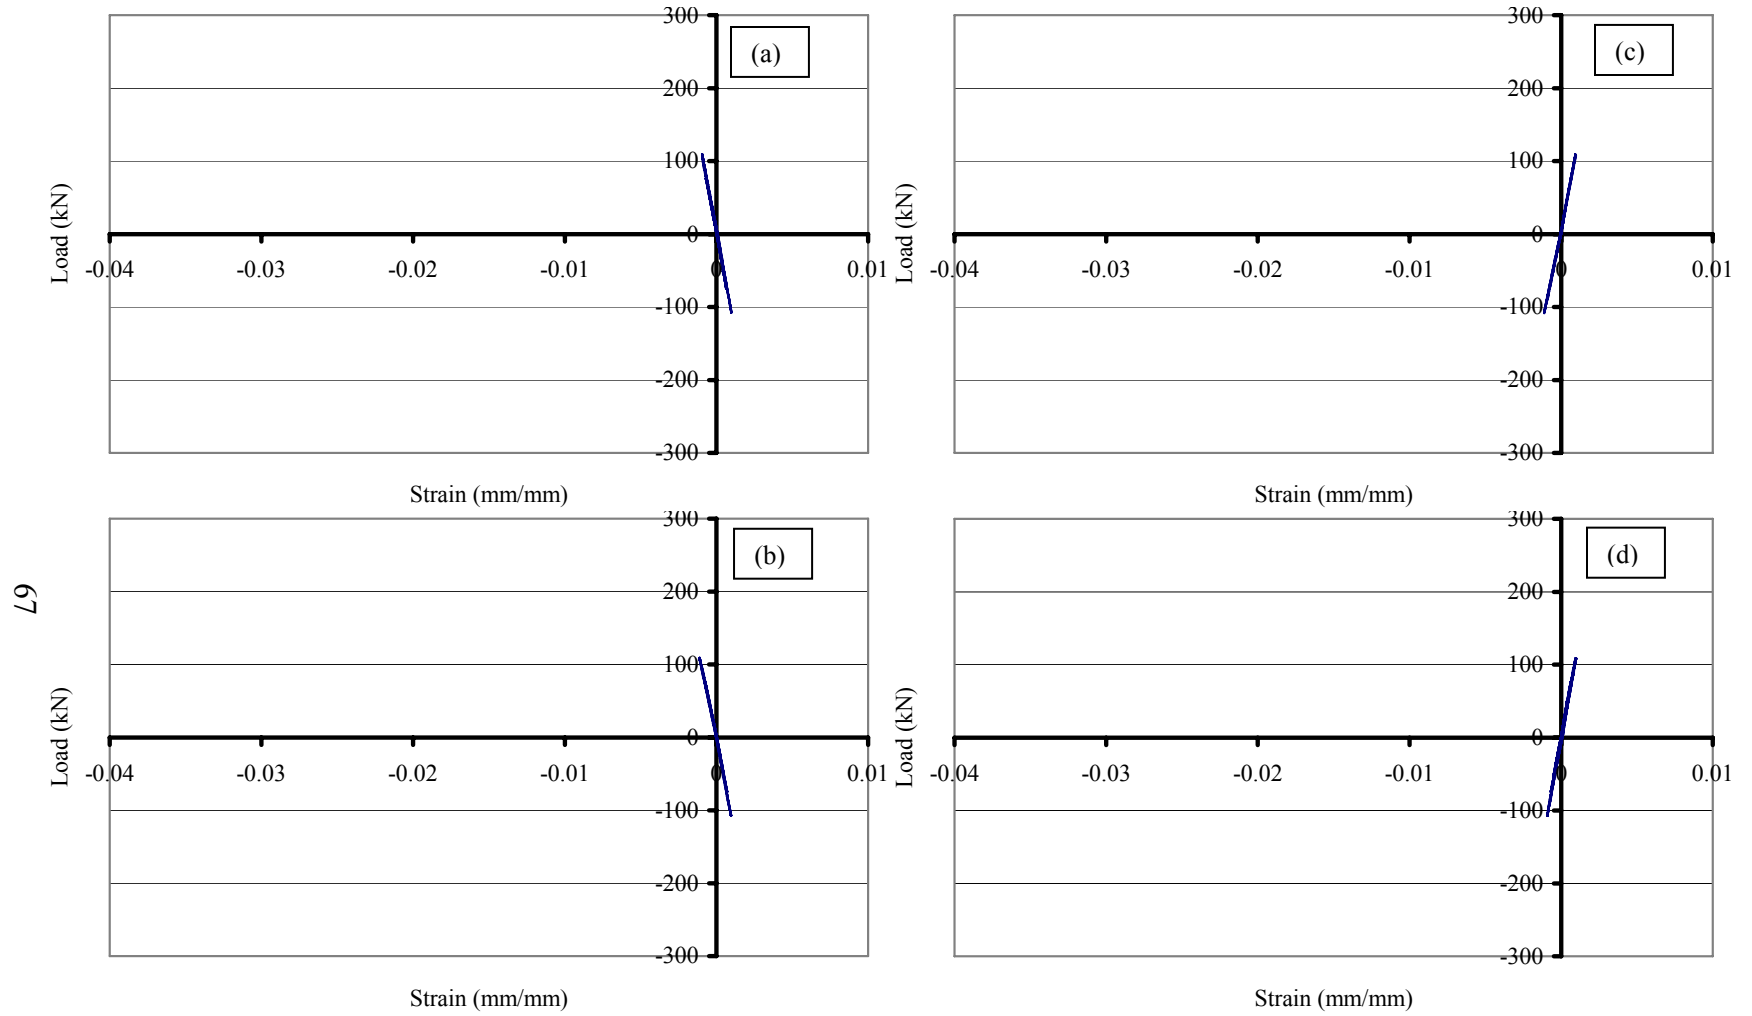
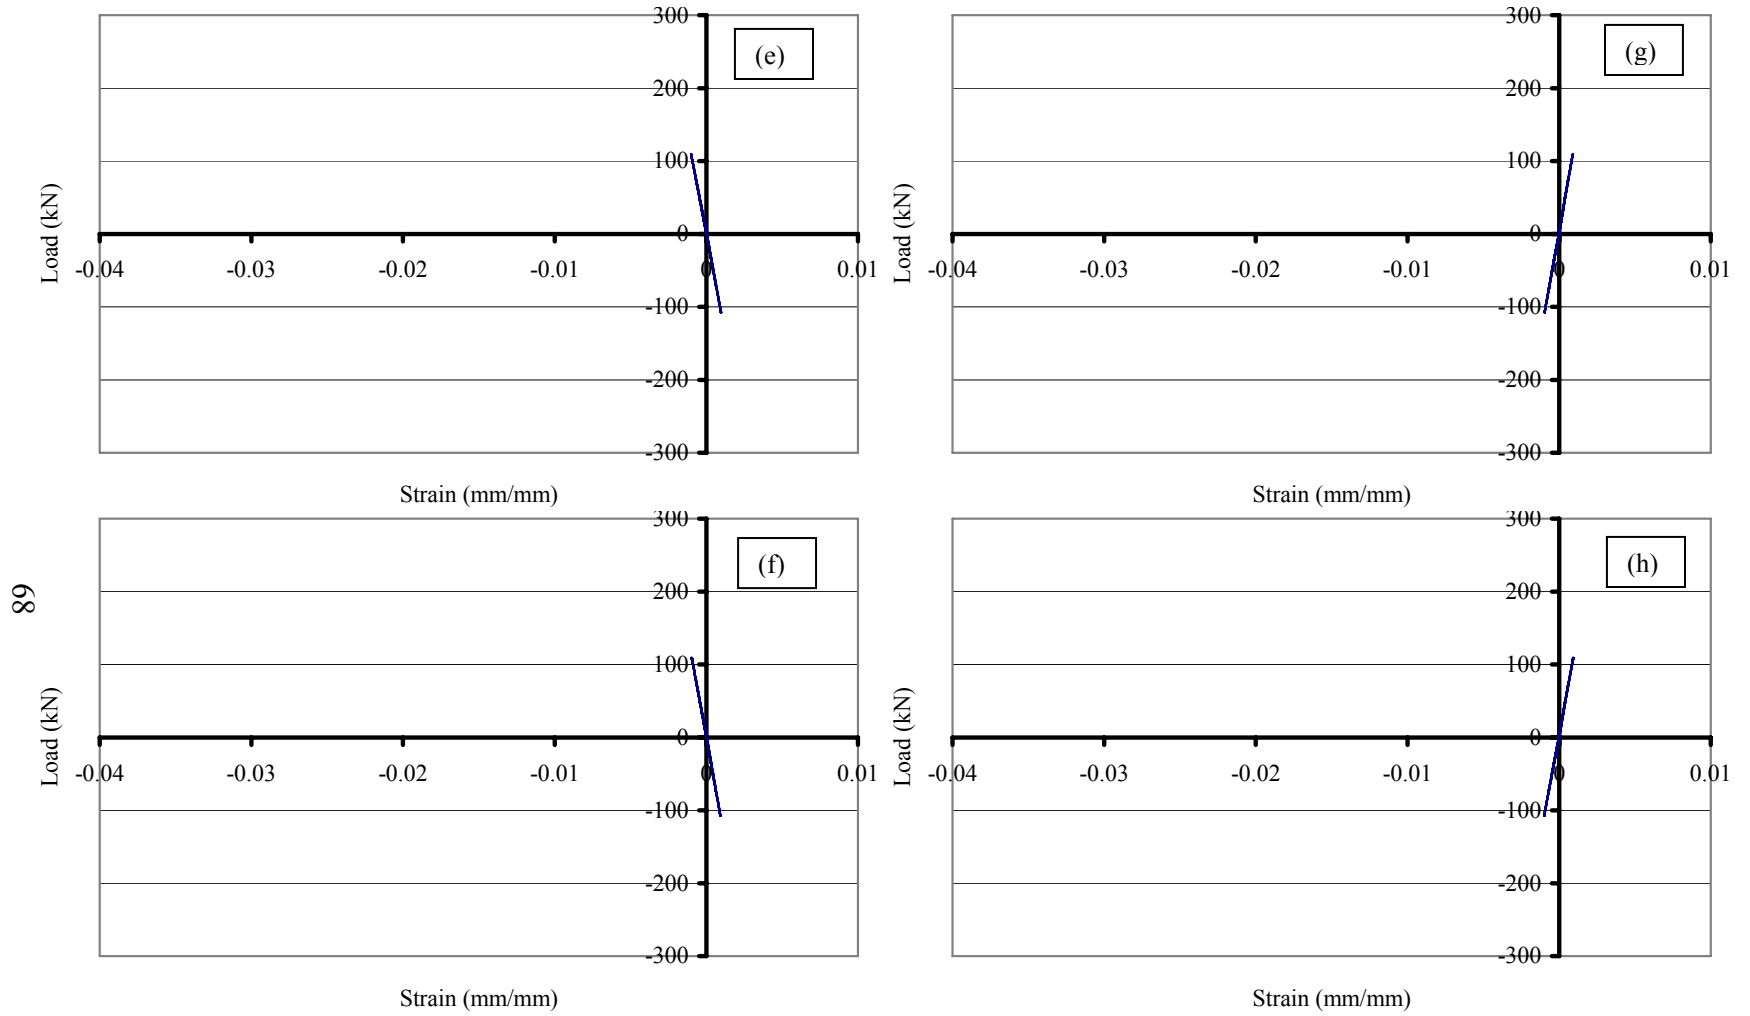
Figure 4.10 – DM assemblage test strain data – steps 1 through 6: (a) Gage-1; (b) Gage-2; (c) Gage-3; (d) Gage-4; [continued]

Figure 4.10 – [continued] DM assemblage test strain data – steps 1 through 6: (e) Gage-5; (f) Gage-6; (g) Gage-7; and (h) Gage-8

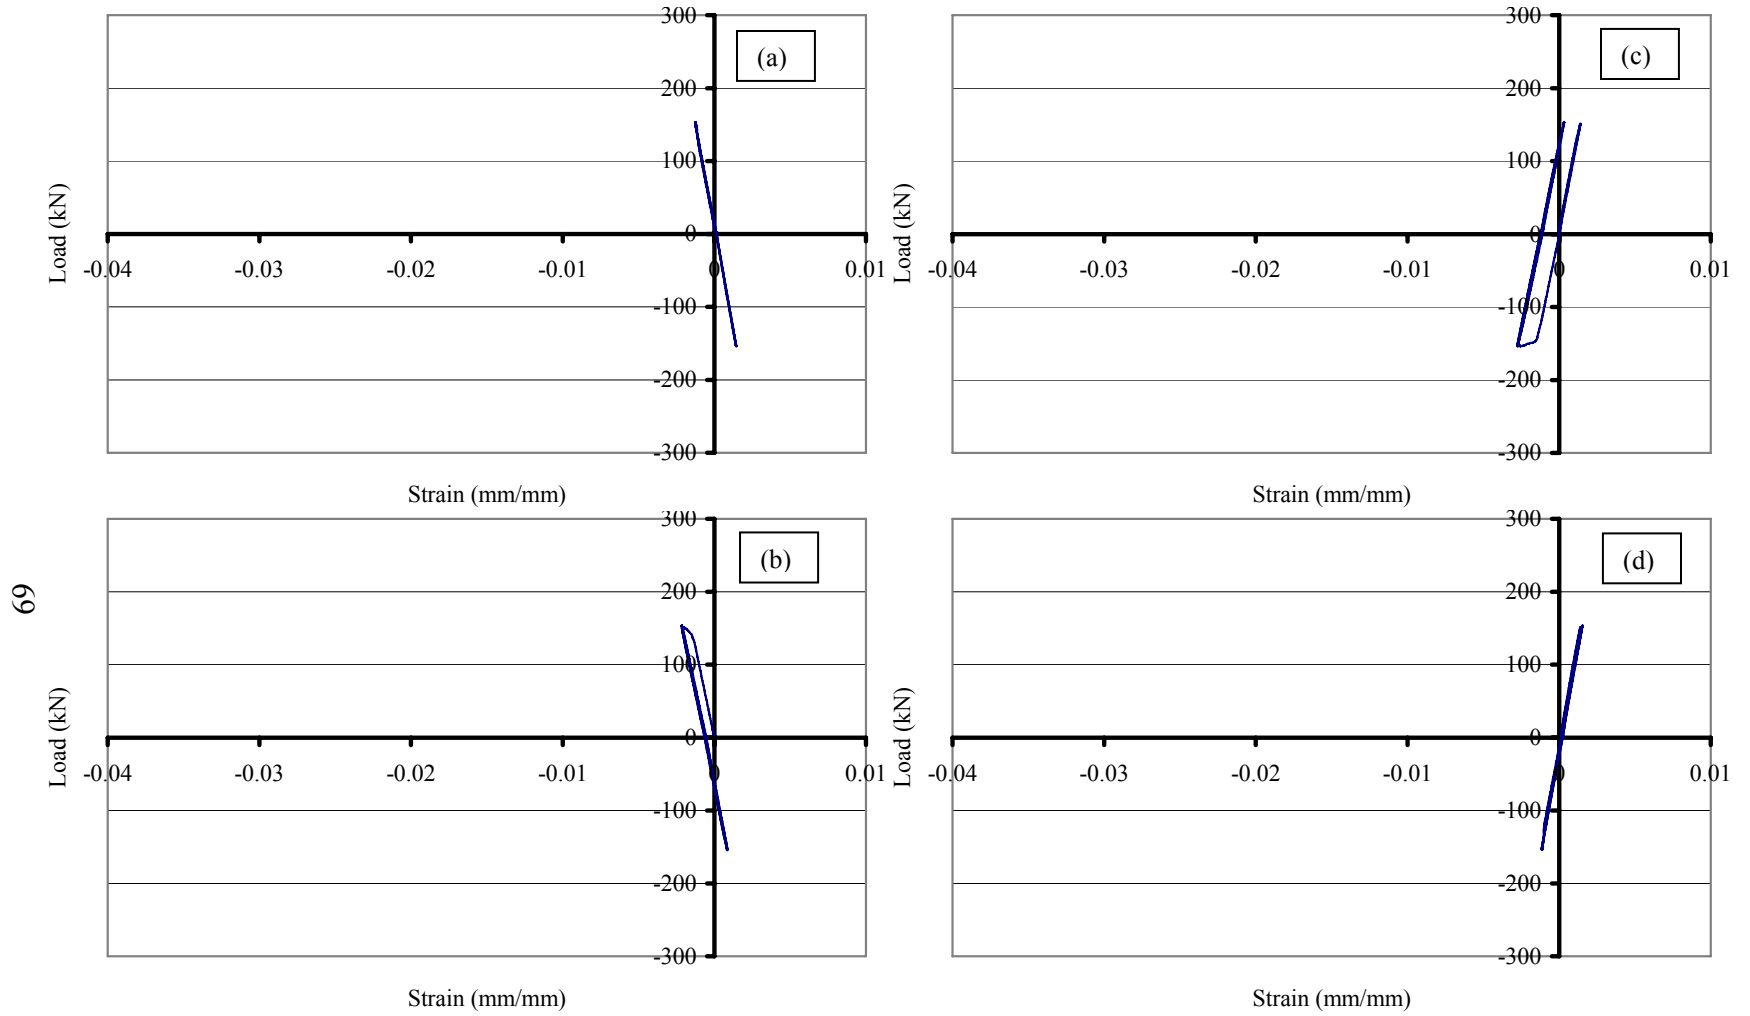
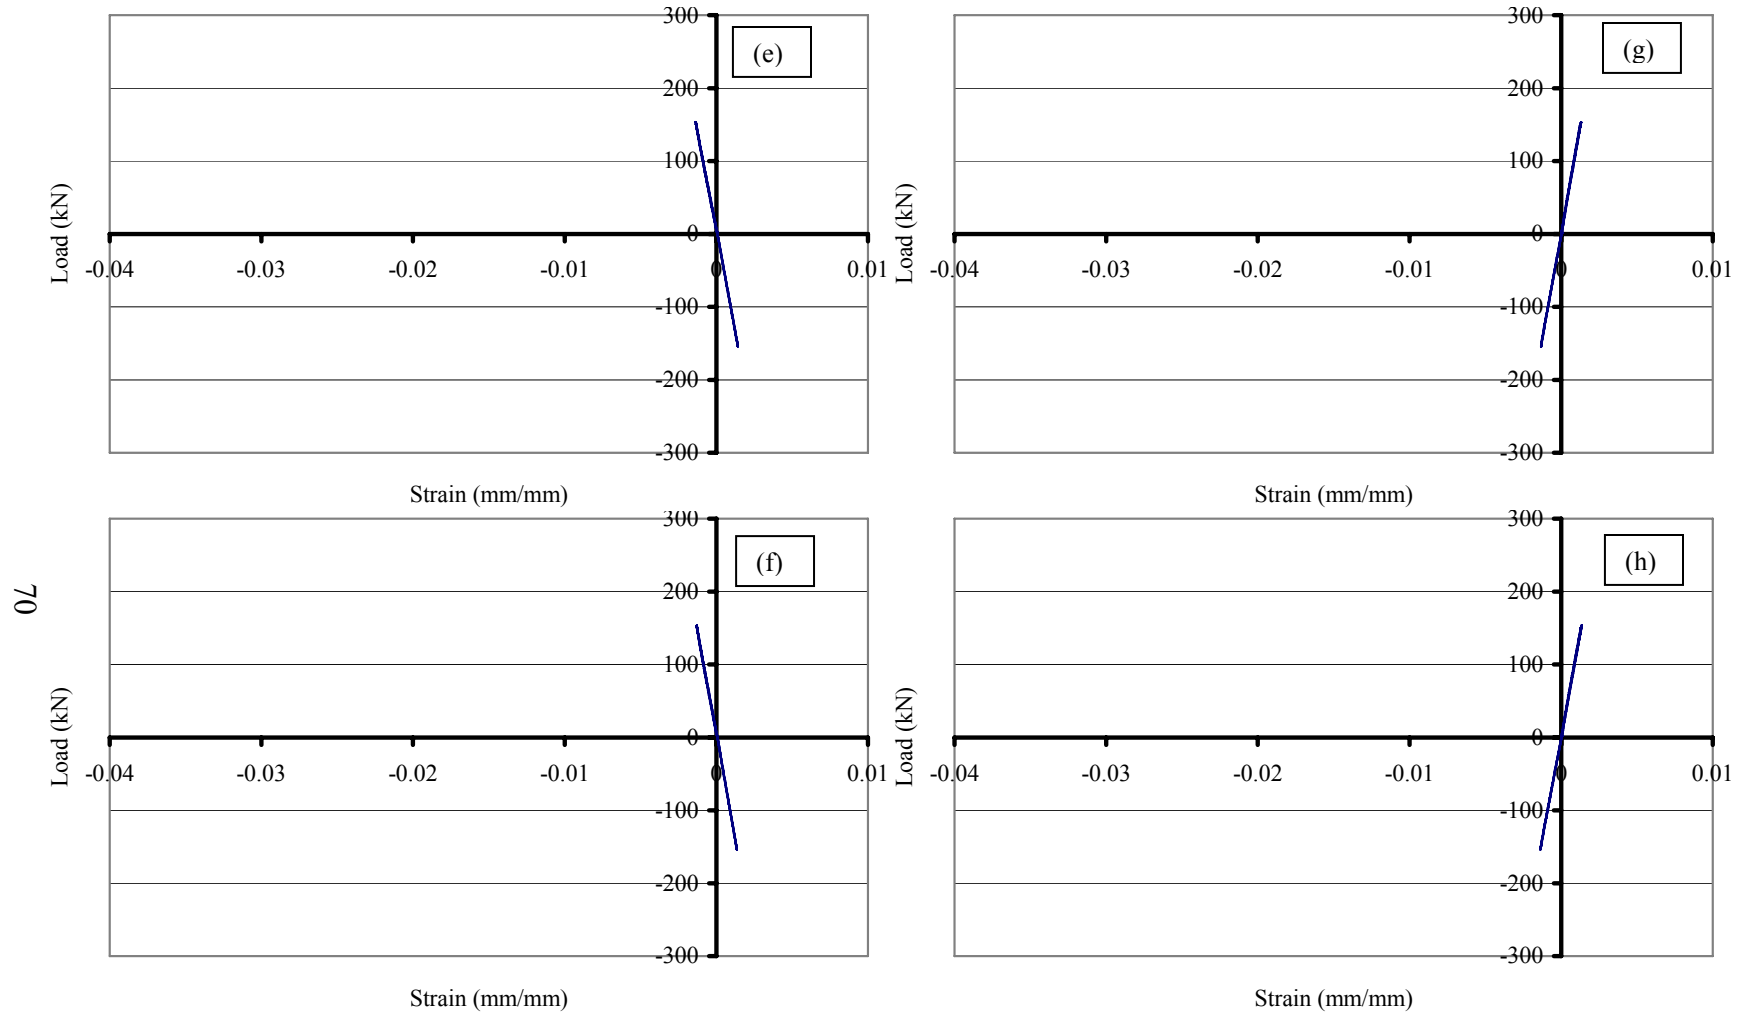
Figure 4.11 – DM assemblage test strain data – step 7: (a) Gage-1; (b) Gage-2; (c) Gage-3; (d) Gage-4; [continued]

Figure 4.11 – [continued] DM assemblage test strain data – step 7: (e) Gage-5; (f) Gage-6; (g) Gage-7; and (h) Gage-8

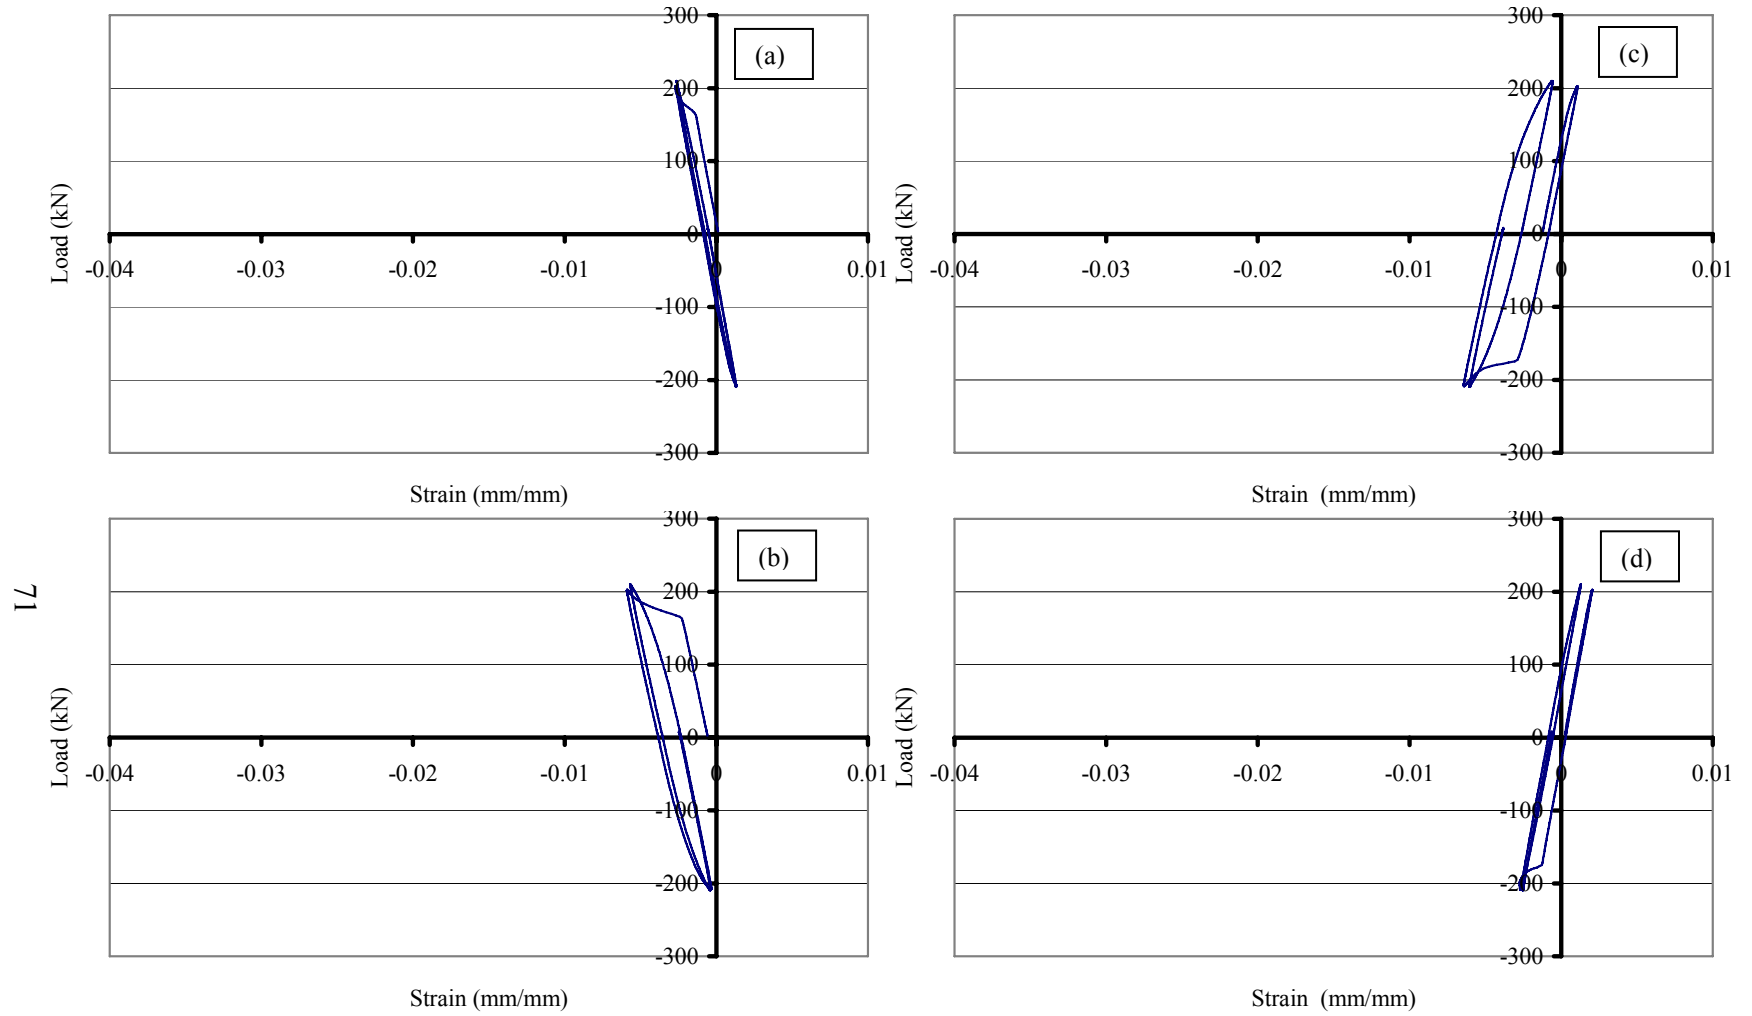
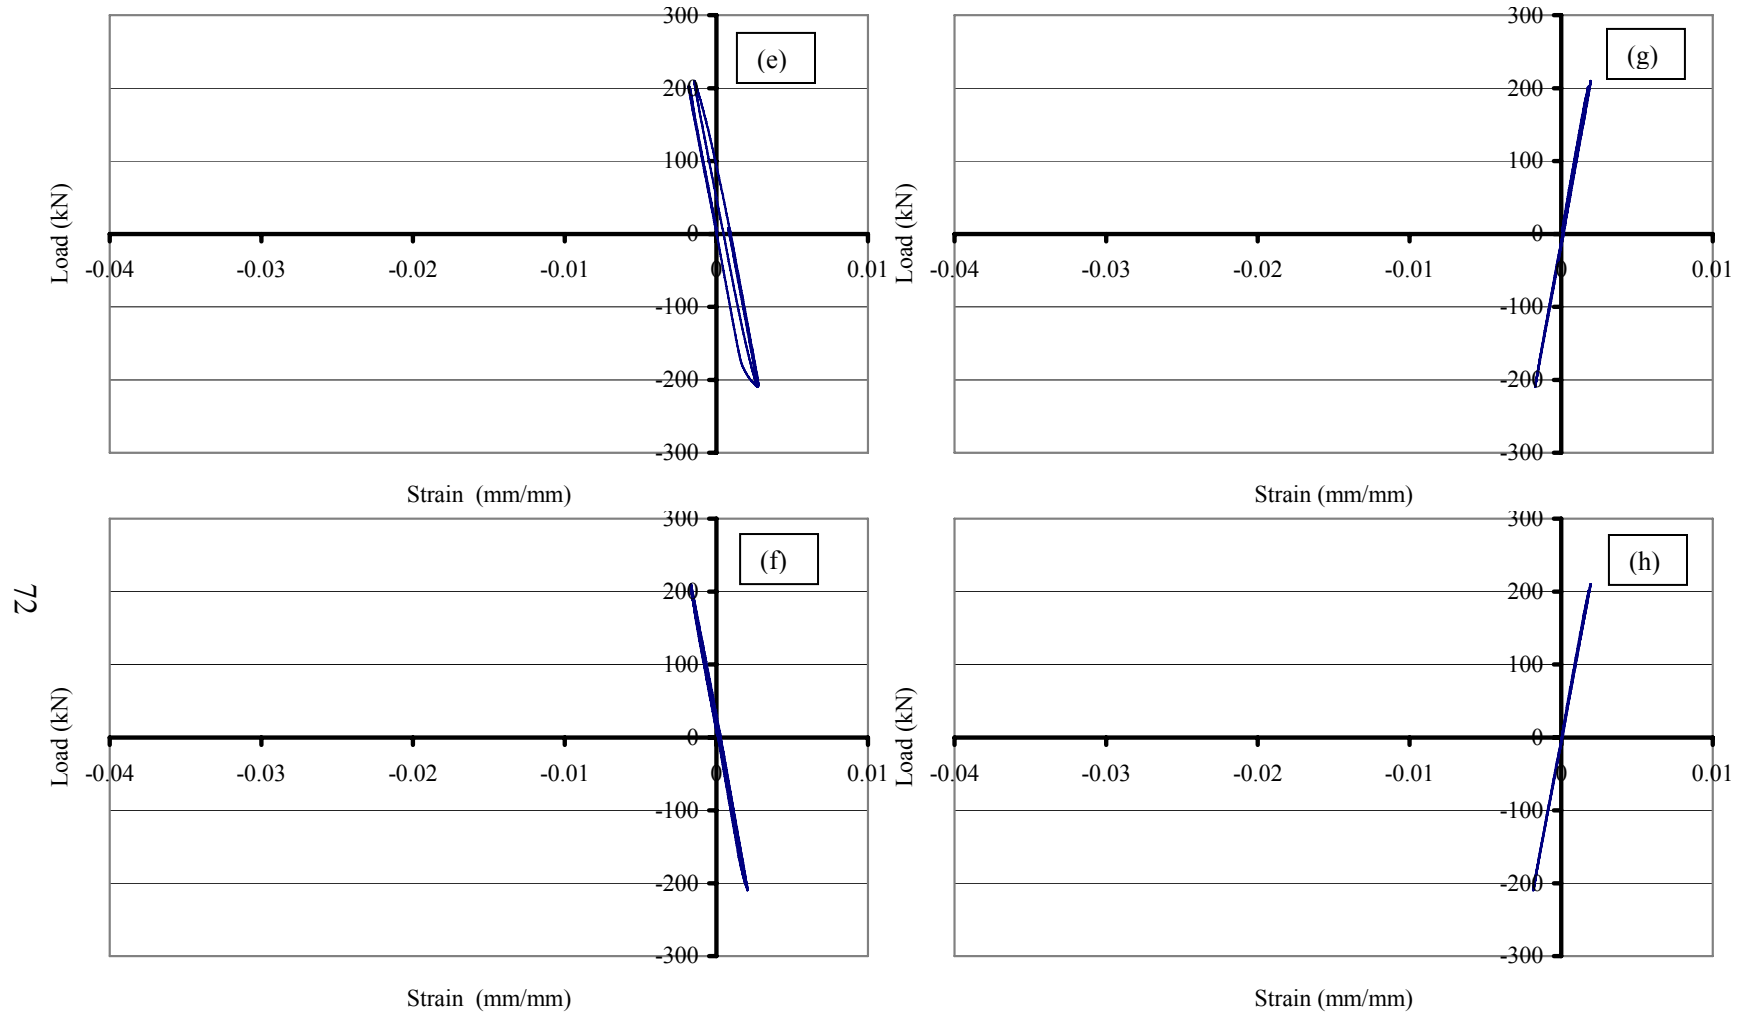
Figure 4.12 – DM assemblage test strain data – step 8: (a) Gage-1; (b) Gage-2; (c) Gage-3; (d) Gage-4; [continued]

Figure 4.12 – [continued] DM assemblage test strain data – step 8: (e) Gage-5; (f) Gage-6; (g) Gage-7; and (h) Gage-8

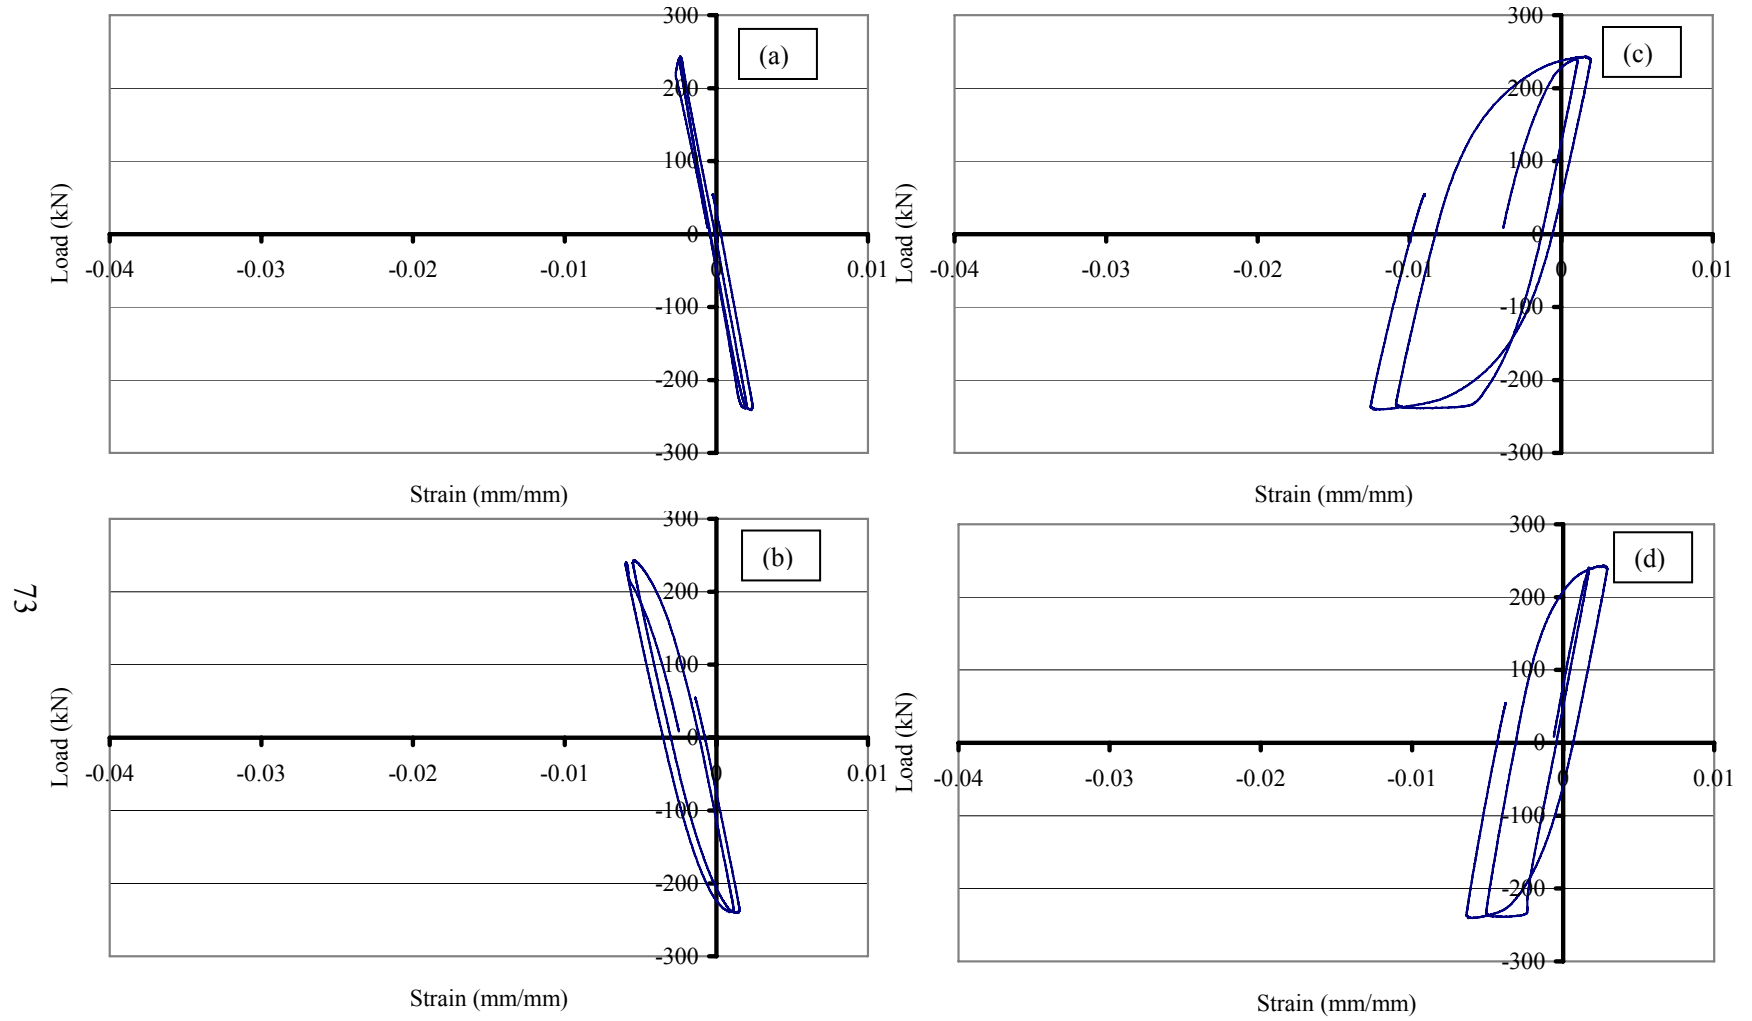
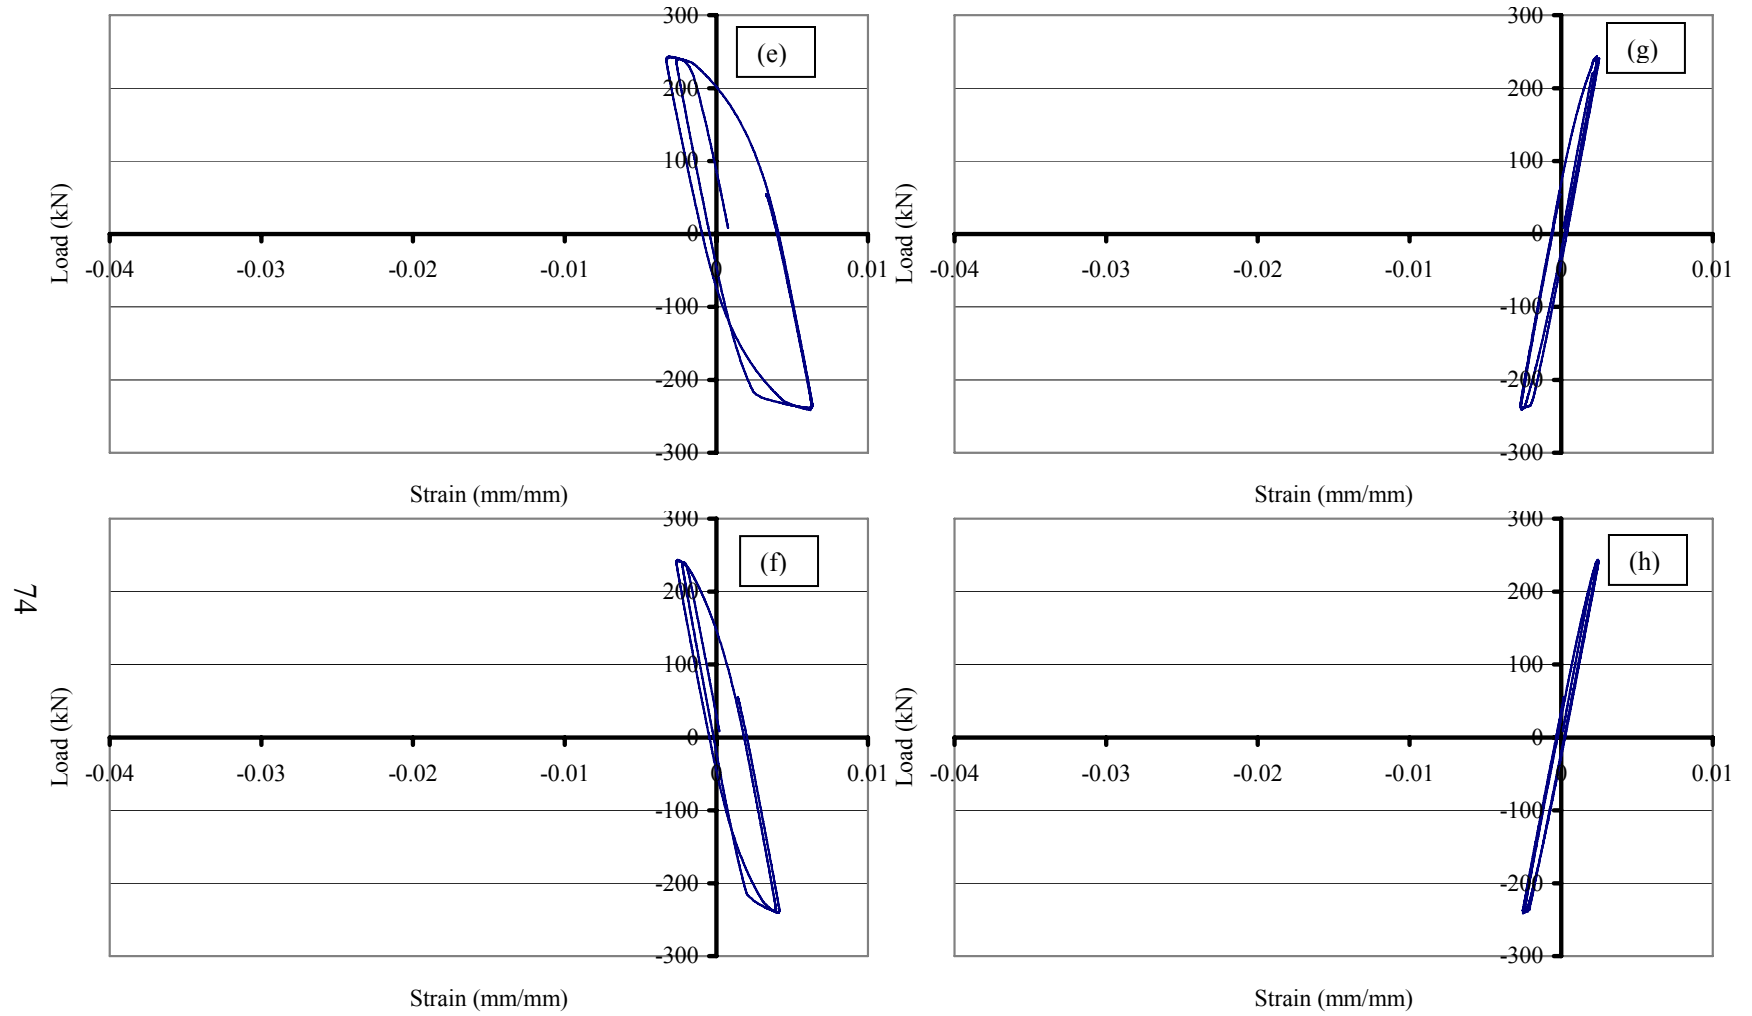
Figure 4.13 – DM assemblage test strain data – step 9: (a) Gage-1; (b) Gage-2; (c) Gage-3; (d) Gage-4; [continued]

Figure 4.13 – [continued] DM assemblage test strain data – step 9: (e) Gage-5; (f) Gage-6; (g) Gage-7; and (h) Gage-8

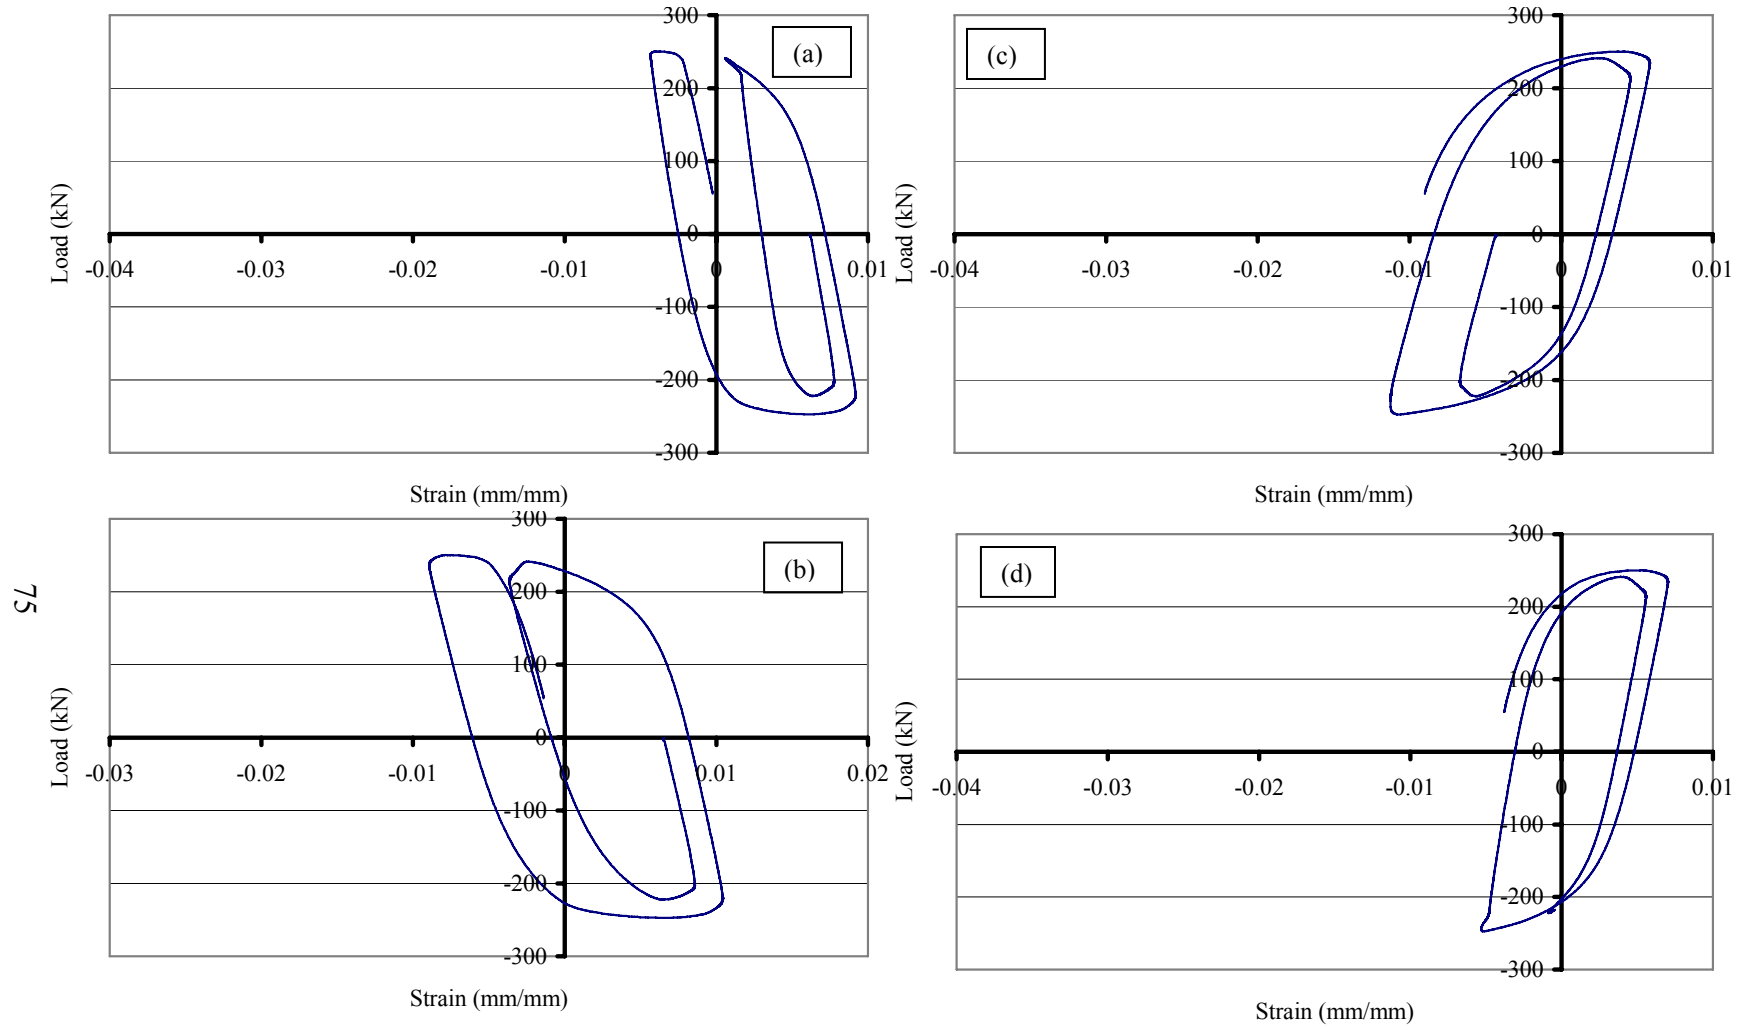
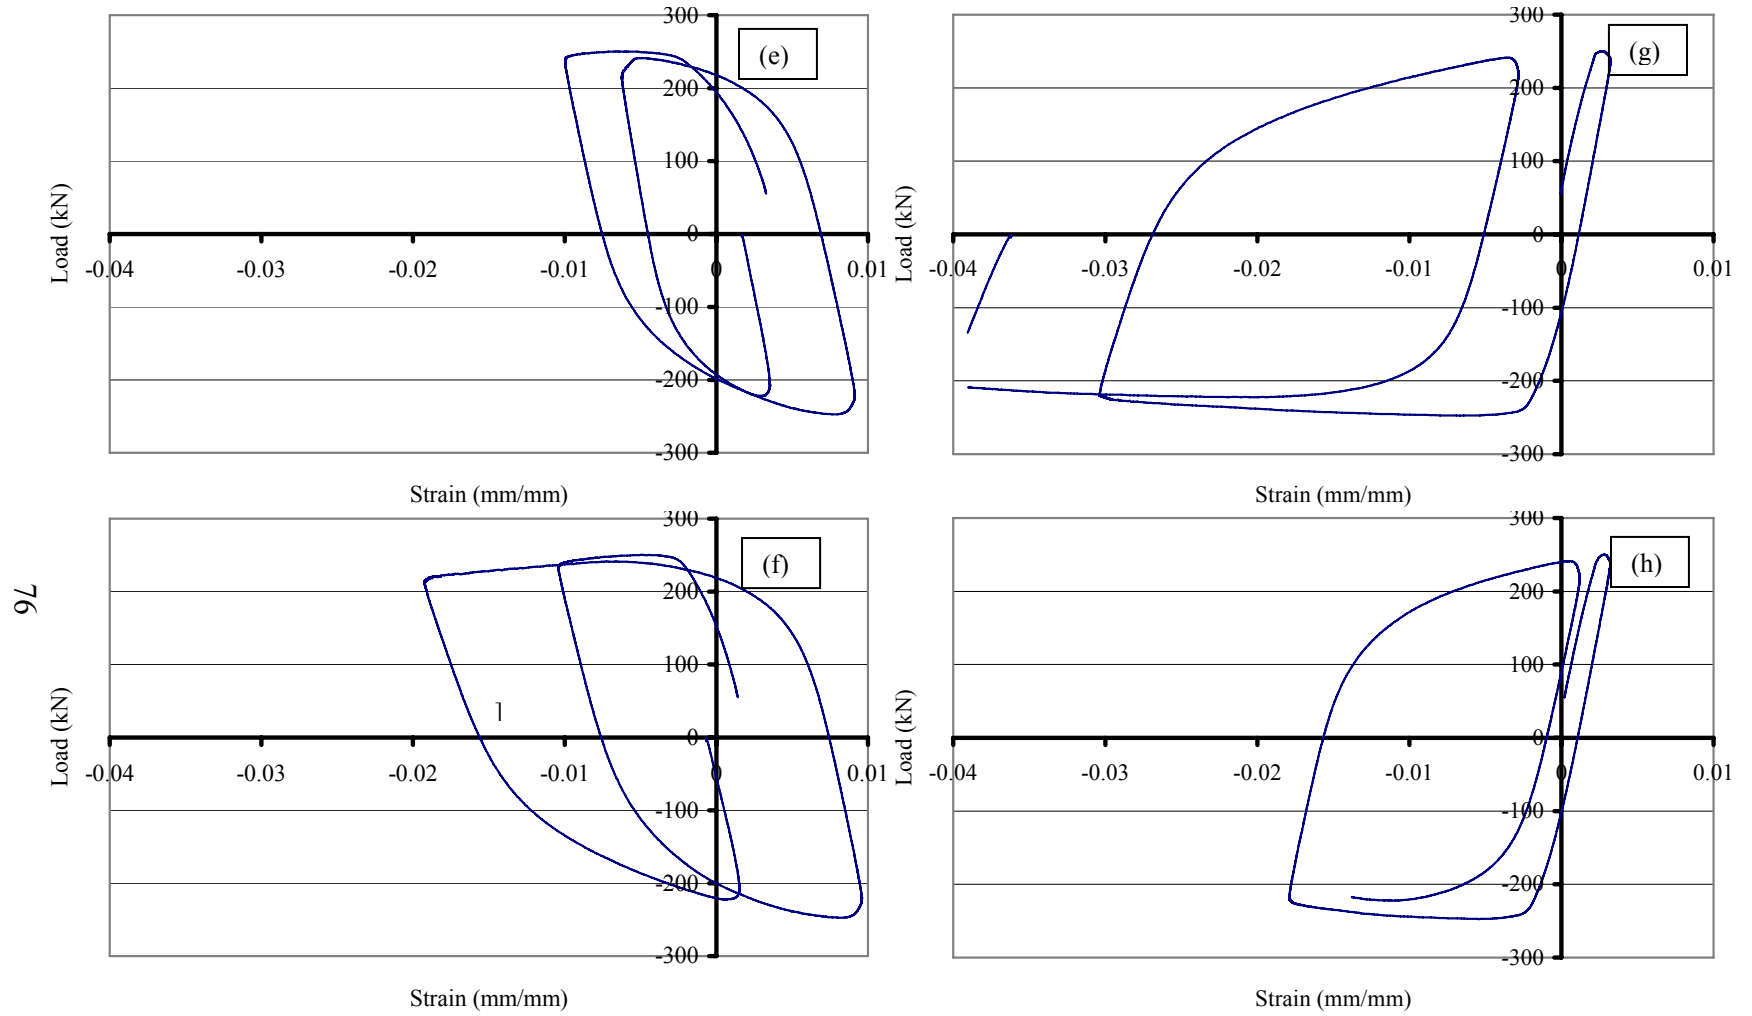
Figure 4.14 – DM assemblage test strain data – step 10: (a) Gage-1; (b) Gage-2; (c) Gage-3; (d) Gage-4; [continued]

Figure 4.14 – [continued] DM assemblage test strain data – step 10: (e) Gage-5; (f) Gage-6; (g) Gage-7; and (h) Gage-8

Gage-3 and Gage-4 were on the bottom flange, 152 mm from the column face. Gage-3 indicated a strain range of -0.01126 to +0.00586, however Gage-4 was damaged in the second cycle of step 10 when the SFRM fell off, and thus final strain readings are missing. At the end of the test there was residual compressive strain in Gage-3 and it can be deduced from the trend in the graph that there would also have been residual compressive strain in Gage-4.

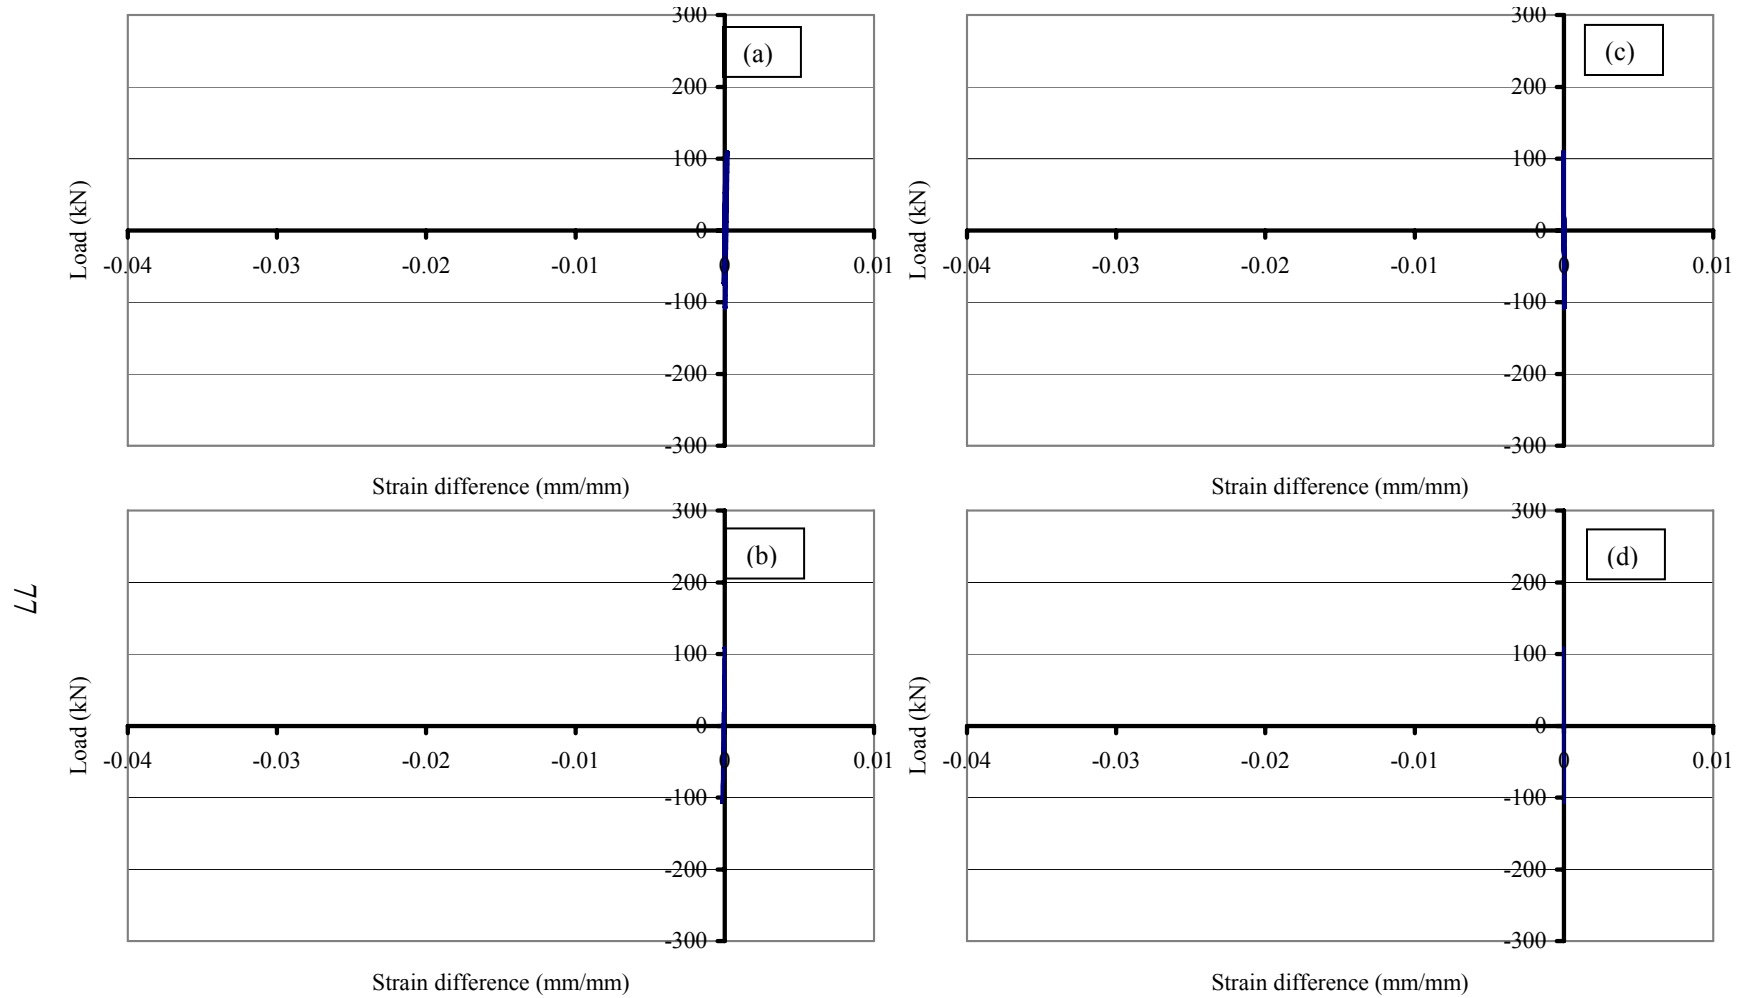
Figure 4.15 – Strain difference in flanges for DM assemblage test – steps 1 through 6: (a) top flange-152 mm; (b) bottom flange-152 mm; (c) top flange-457 mm; and (d) bottom flange-457 mm

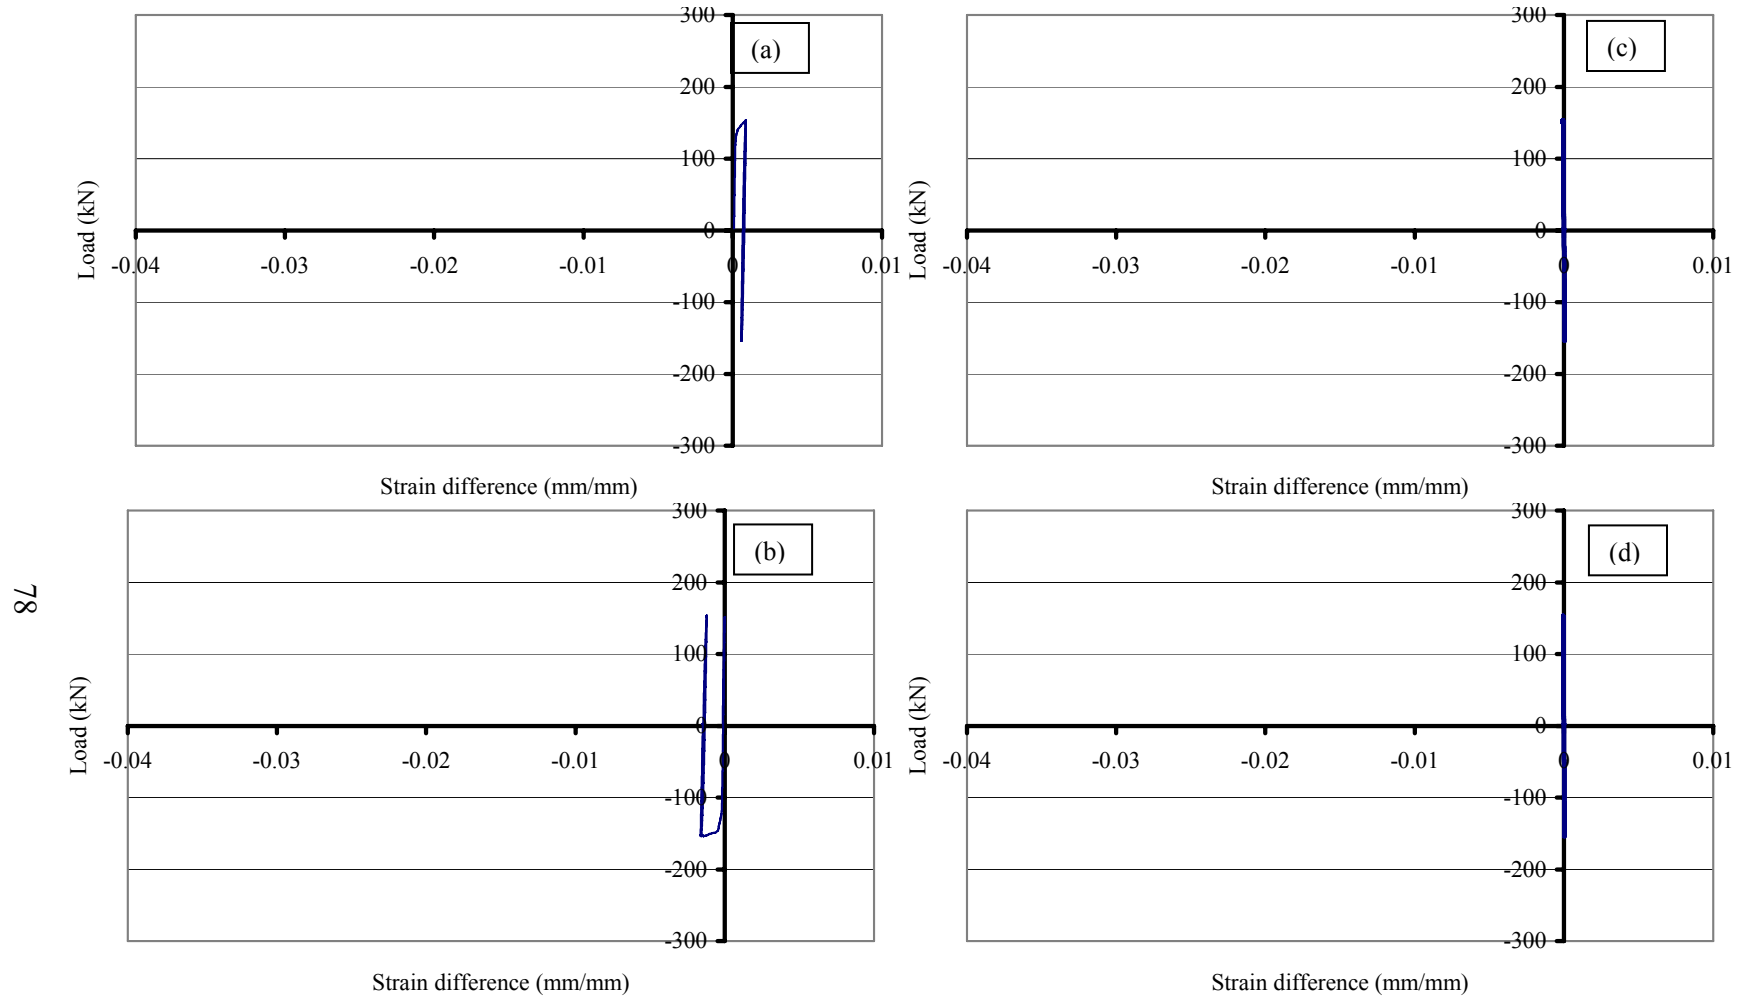
Figure 4.16 – Strain difference in flanges for DM assemblage test – step 7: (a) top flange-152 mm; (b) bottom flange-152 mm; (c) top flange-457 mm; and (d) bottom flange-457 mm
