Seismic Performance of Sprayed Fire Resistive Material (SFRM) on Steel Moment Frame Buildings

ATLSS Report No. 10-03

April 2010

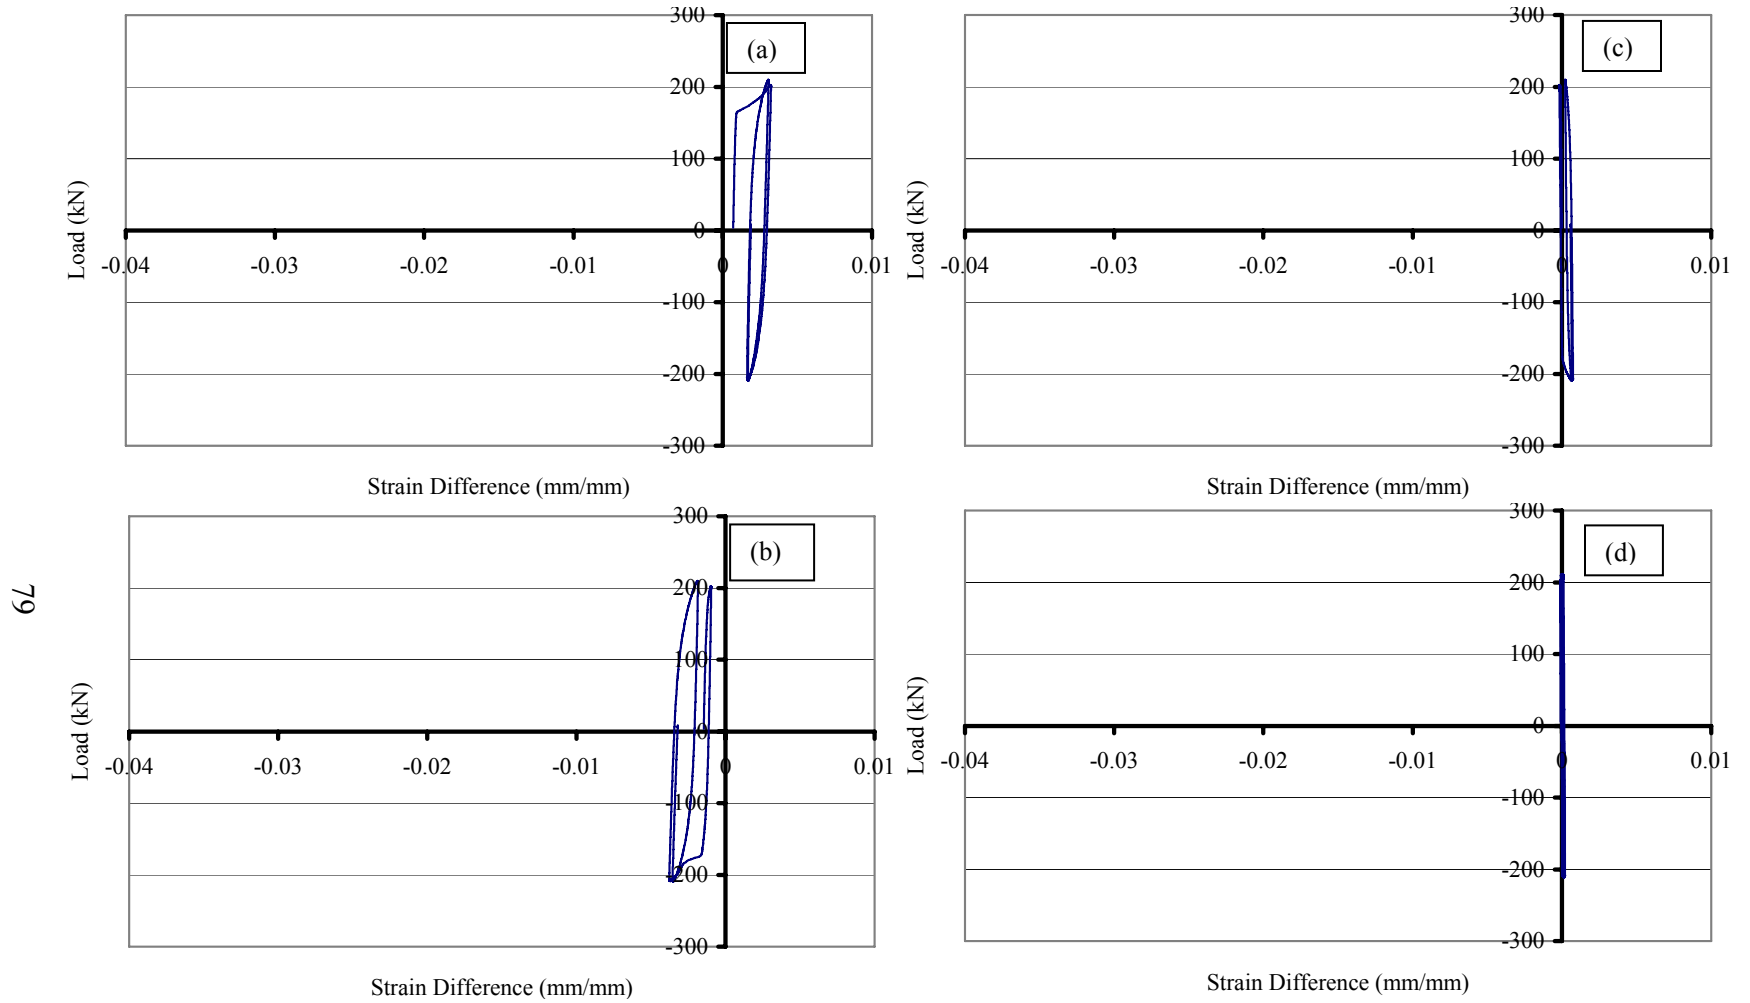
Figure 4.17 – Strain difference in flanges for DM assemblage test – step 8: (a) top flange-152 mm; (b) bottom flange-152 mm; (c) top flange-457 mm; and (d) bottom flange-457 mm

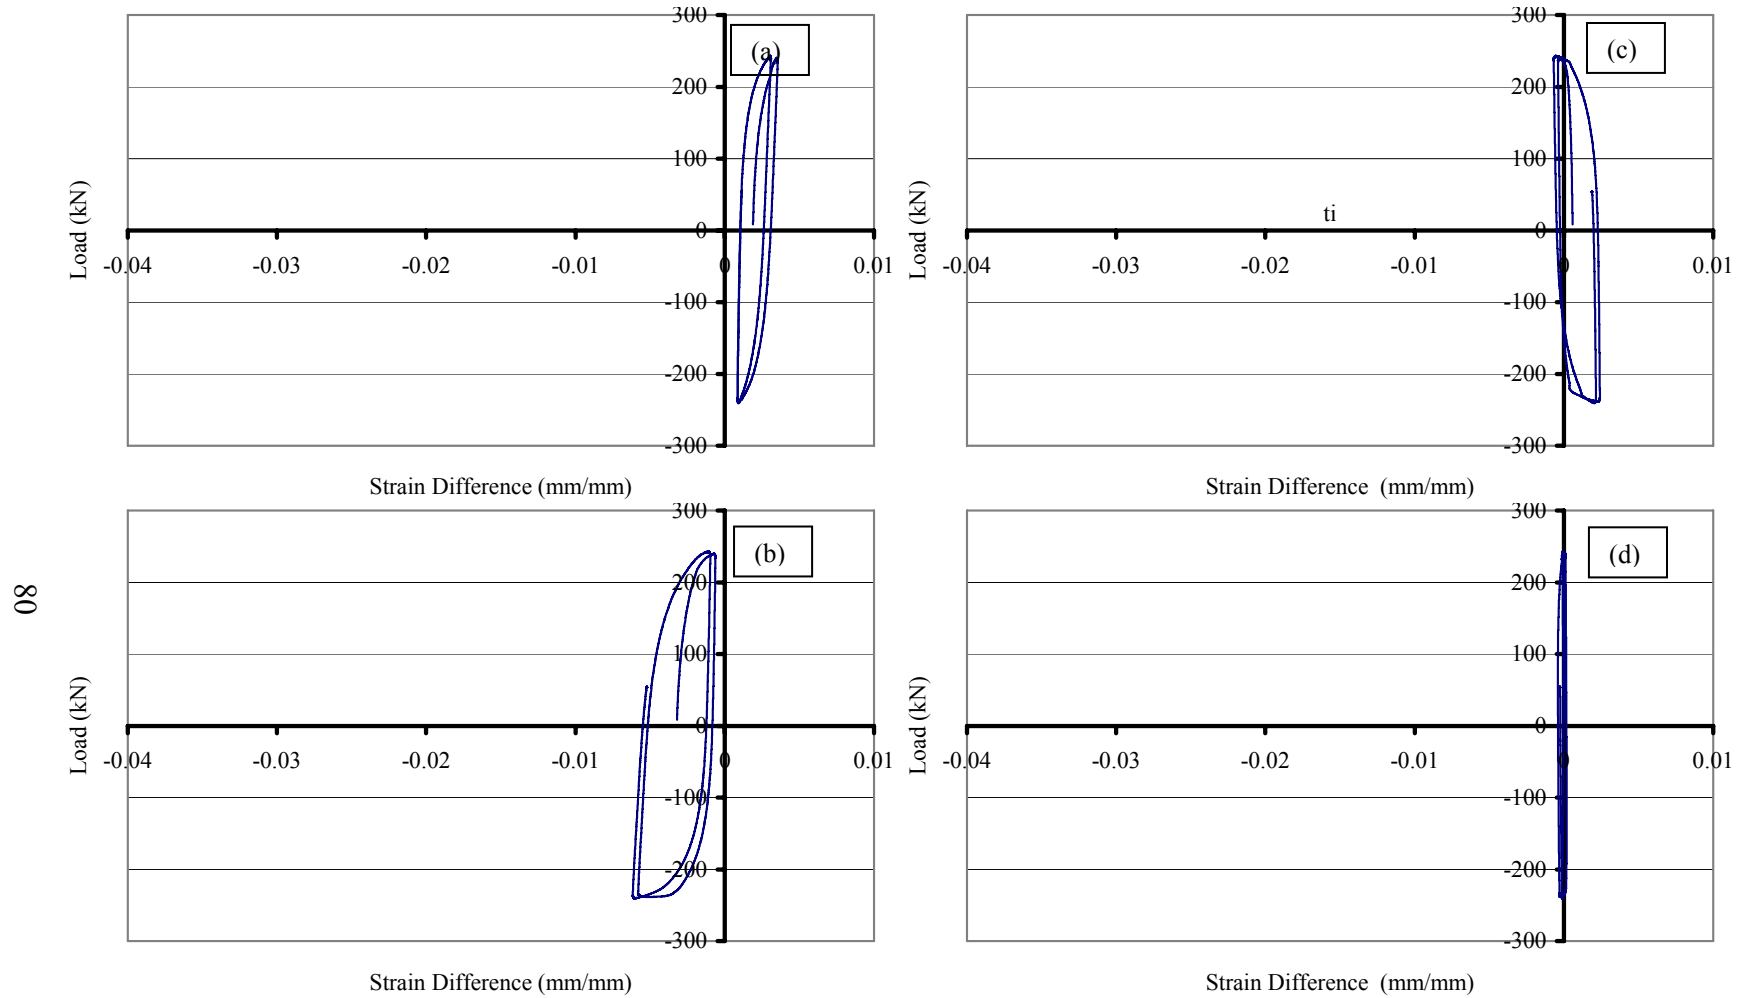
Figure 4.18 – Strain difference in flanges for DM assemblage test – step 9: (a) top flange-152 mm; (b) bottom flange-152 mm; (c) top flange-457 mm; and (d) bottom flange-457 mm

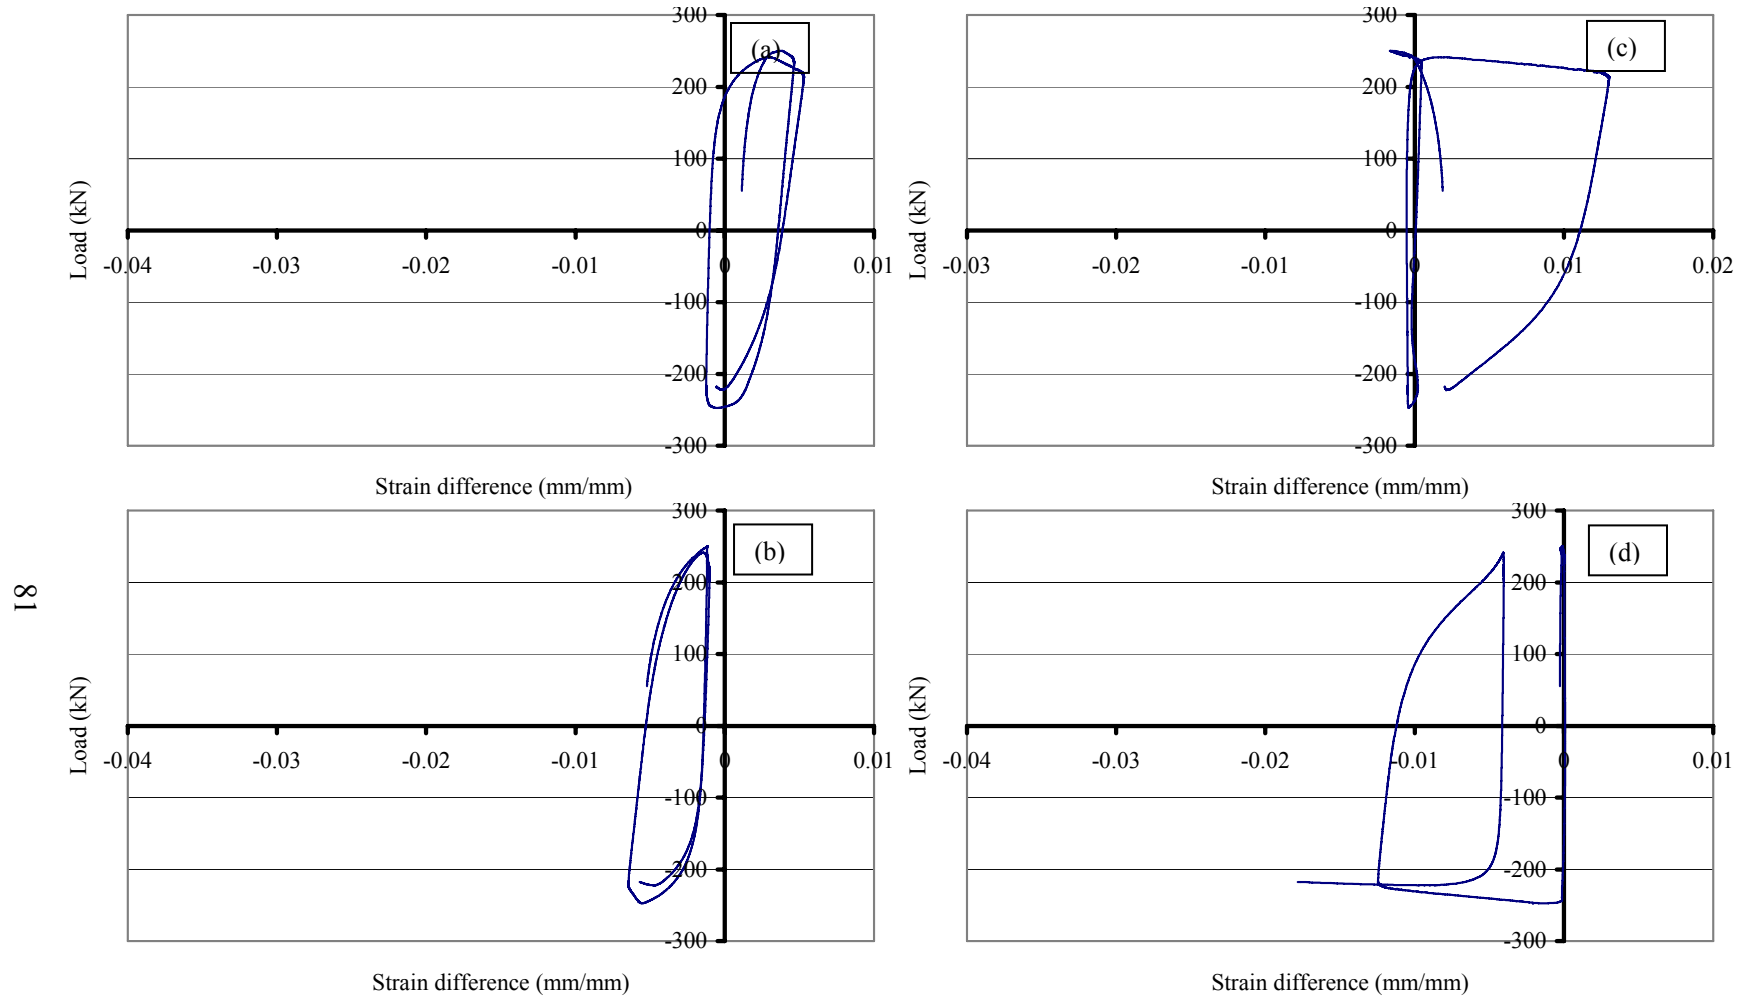
Figure 4.19 – Strain difference in flanges for DM assemblage test – step 10: (a) top flange-152 mm; (b) bottom flange-152 mm; (c) top flange-457 mm; and (d) bottom flange-457 mm

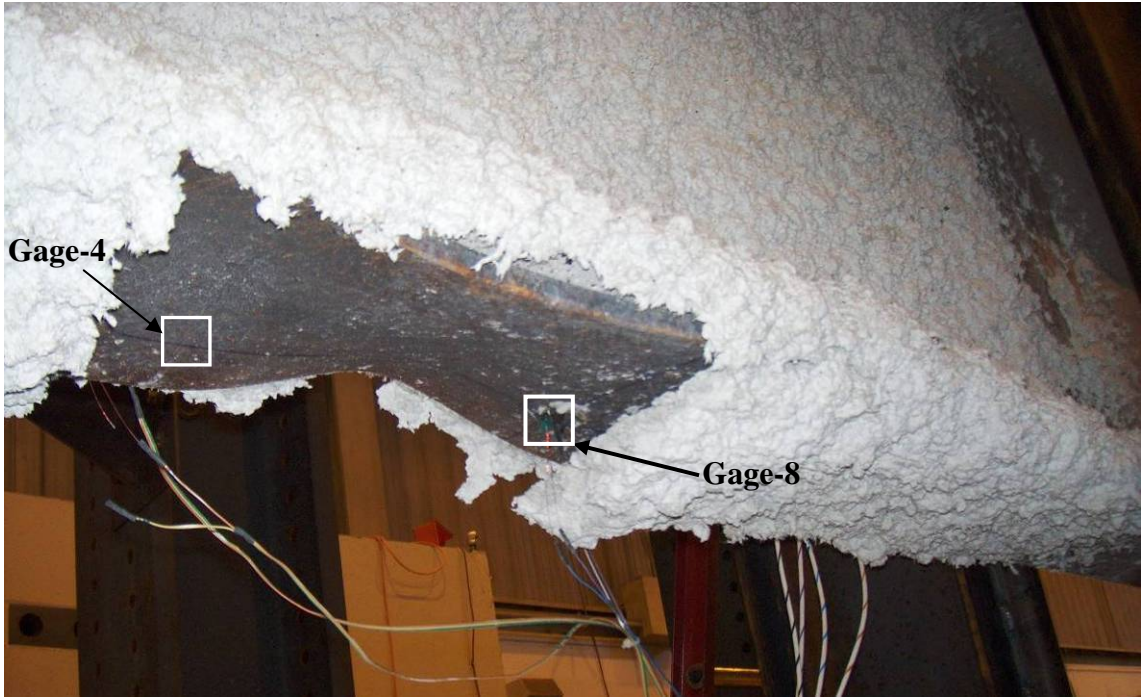
Figure 4.20 – DM assemblage showing buckling in the bottom flange at completion of testing

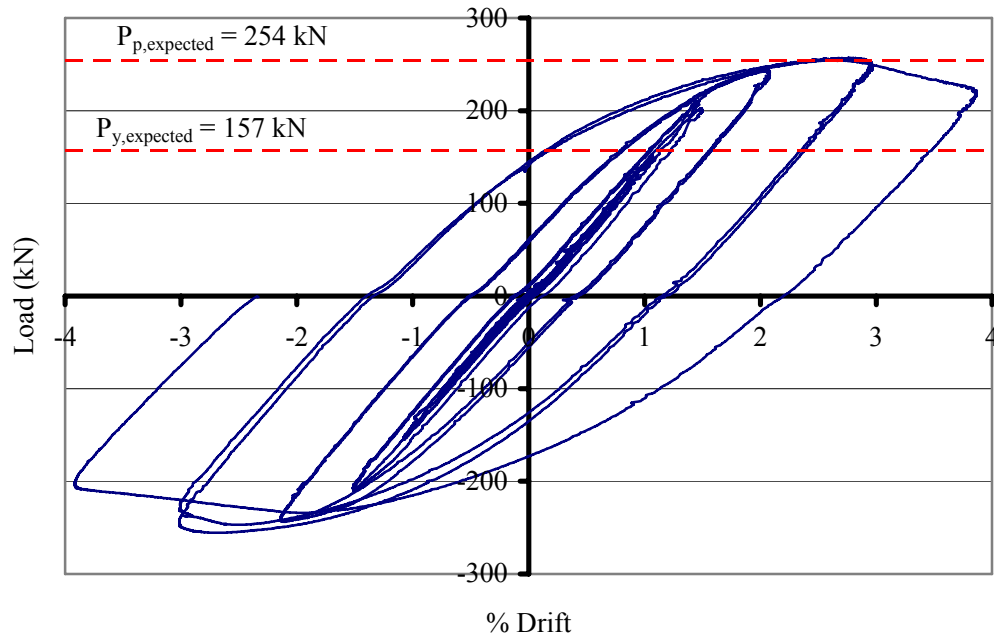
Figure 4.24 – Load vs. percent drift for WM assemblage test

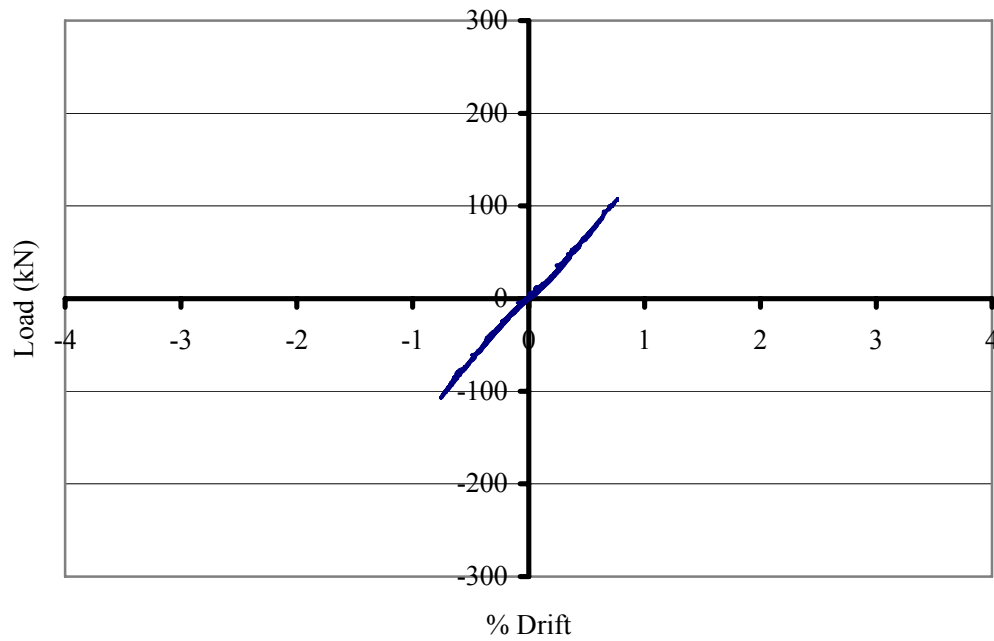
Figure 4.25 – Load vs. percent drift for WM assemblage test – steps 1 through 6

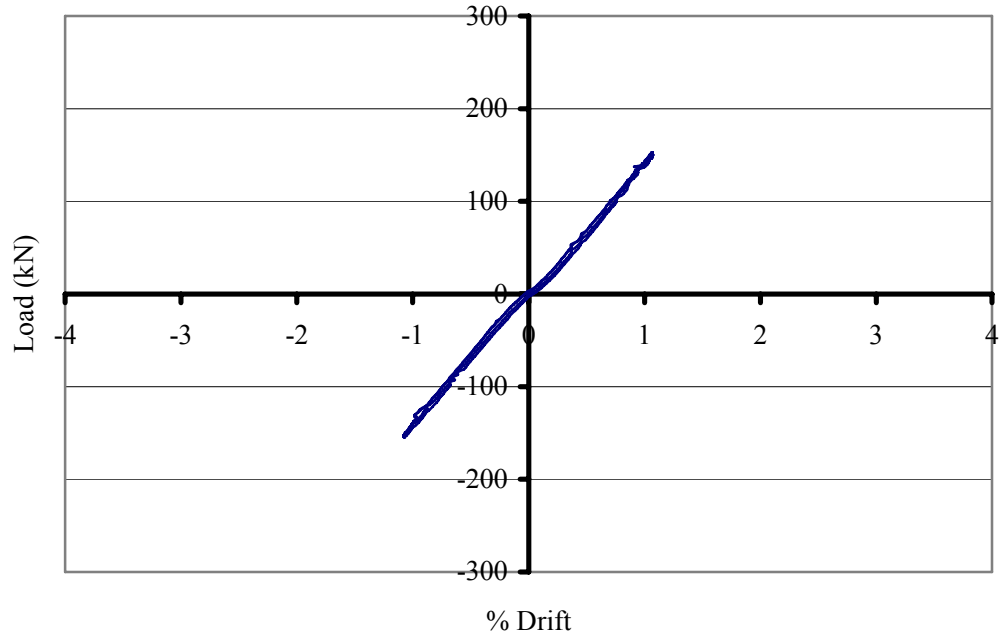
Figure 4.26 – Load vs. percent drift for WM assemblage test – step 7

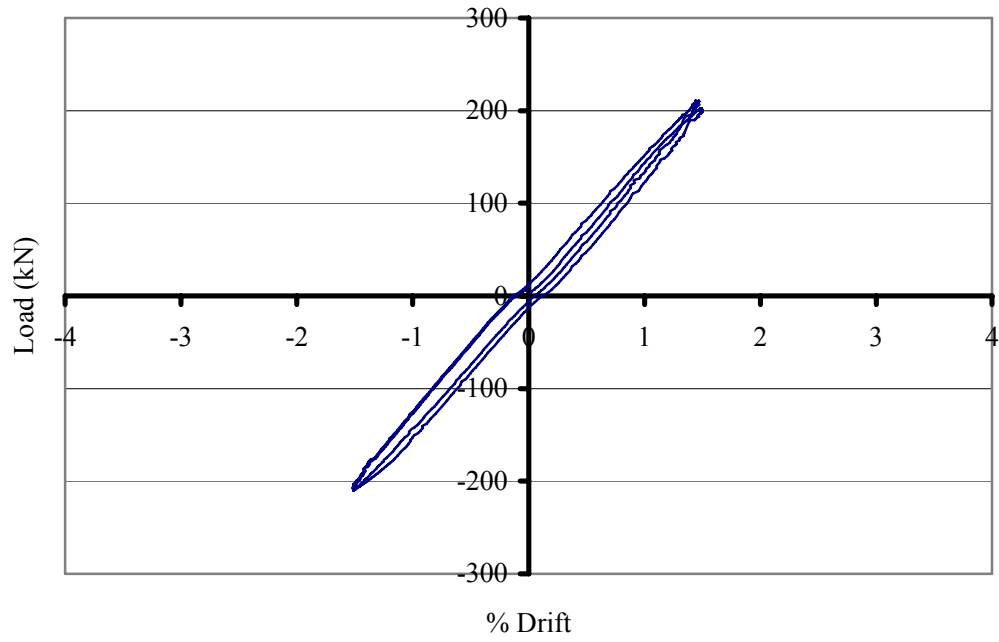
Figure 4.27 – Load vs. percent drift for WM assemblage test – step 8

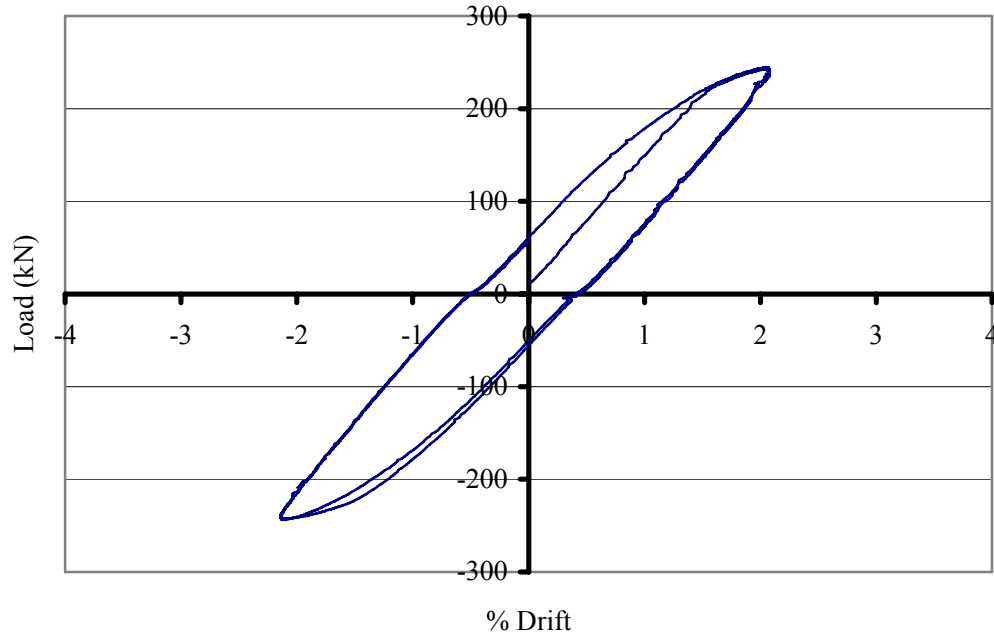
Figure 4.28 – Load vs. percent drift for WM assemblage test – step 9

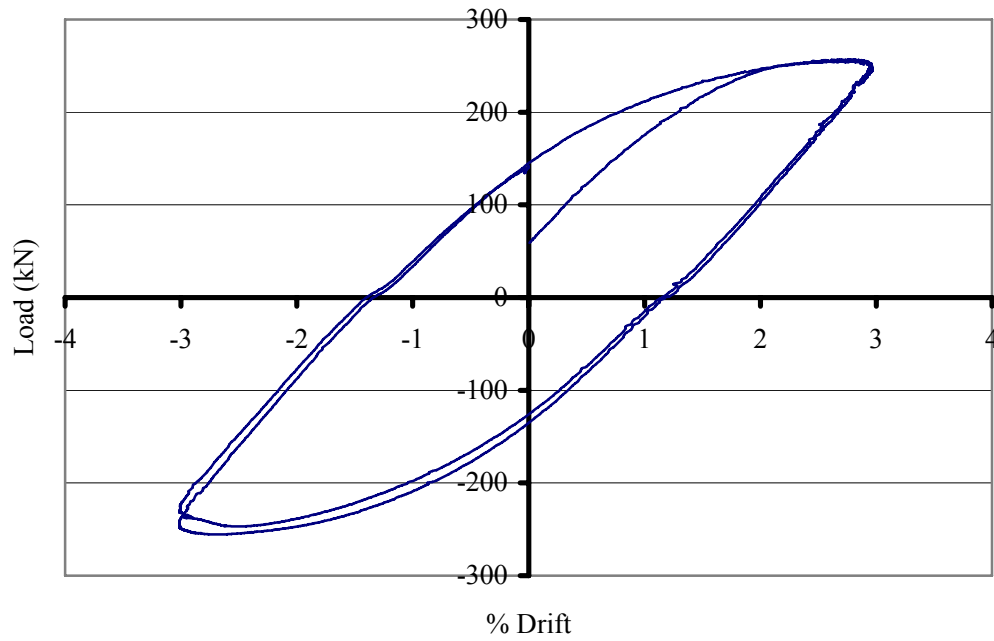
Figure 4.29 – Load vs. percent drift for WM assemblage test – step 10

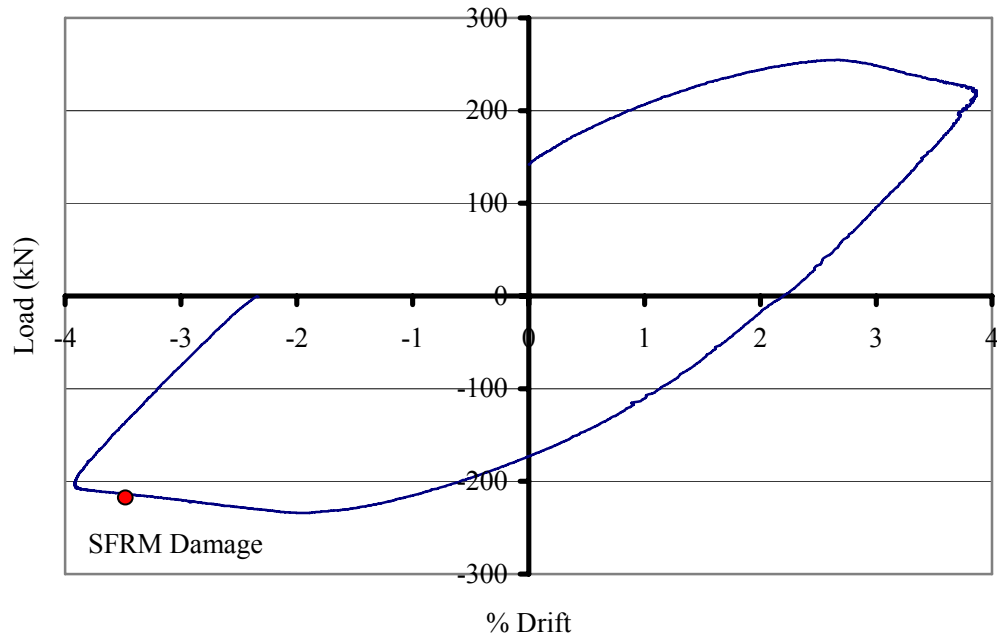
Figure 4.30 – Load vs. percent drift for WM assemblage test – step 11

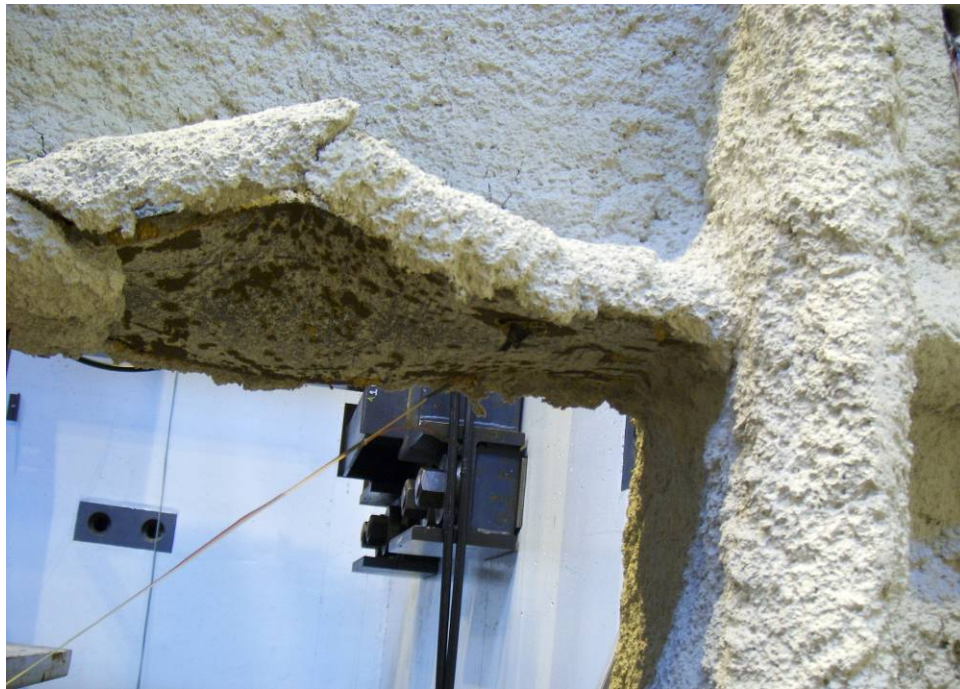
Figure 4.31 – Damage to SFRM during step 11 of WM assemblage test

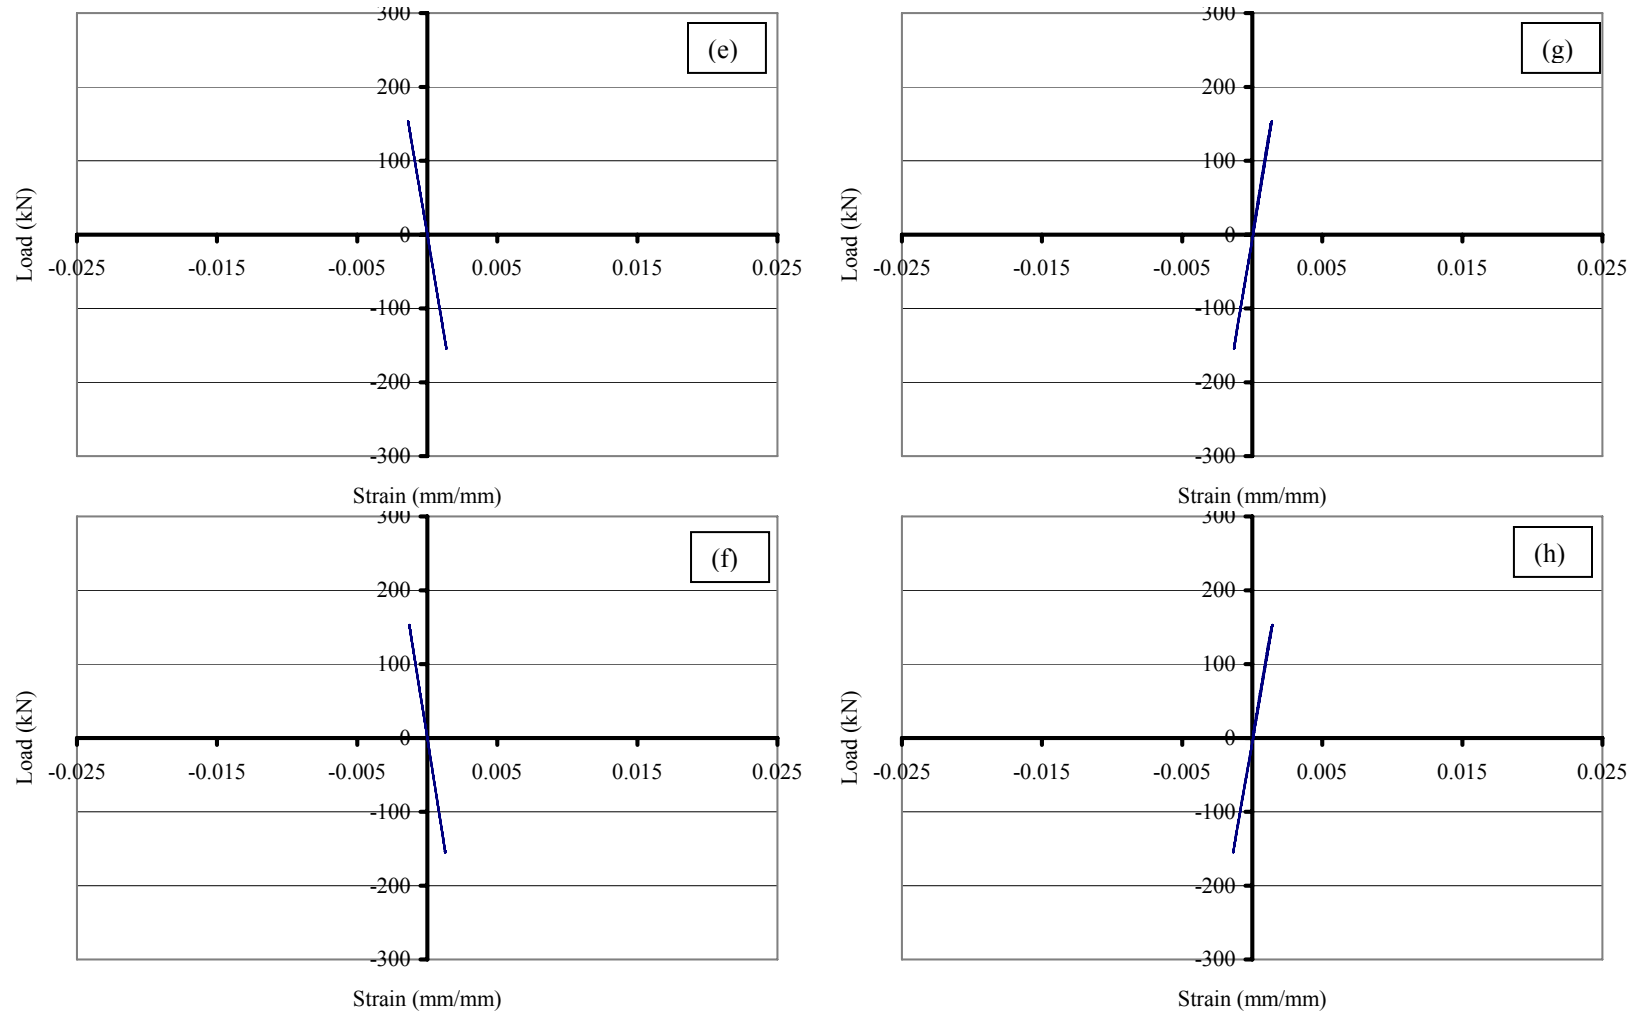
Figure 4.33 – [continued] WM assemblage test strain data – step 7: (e) Gage-5; (f) Gage-6; (g) Gage-7; and (h) Gage-8

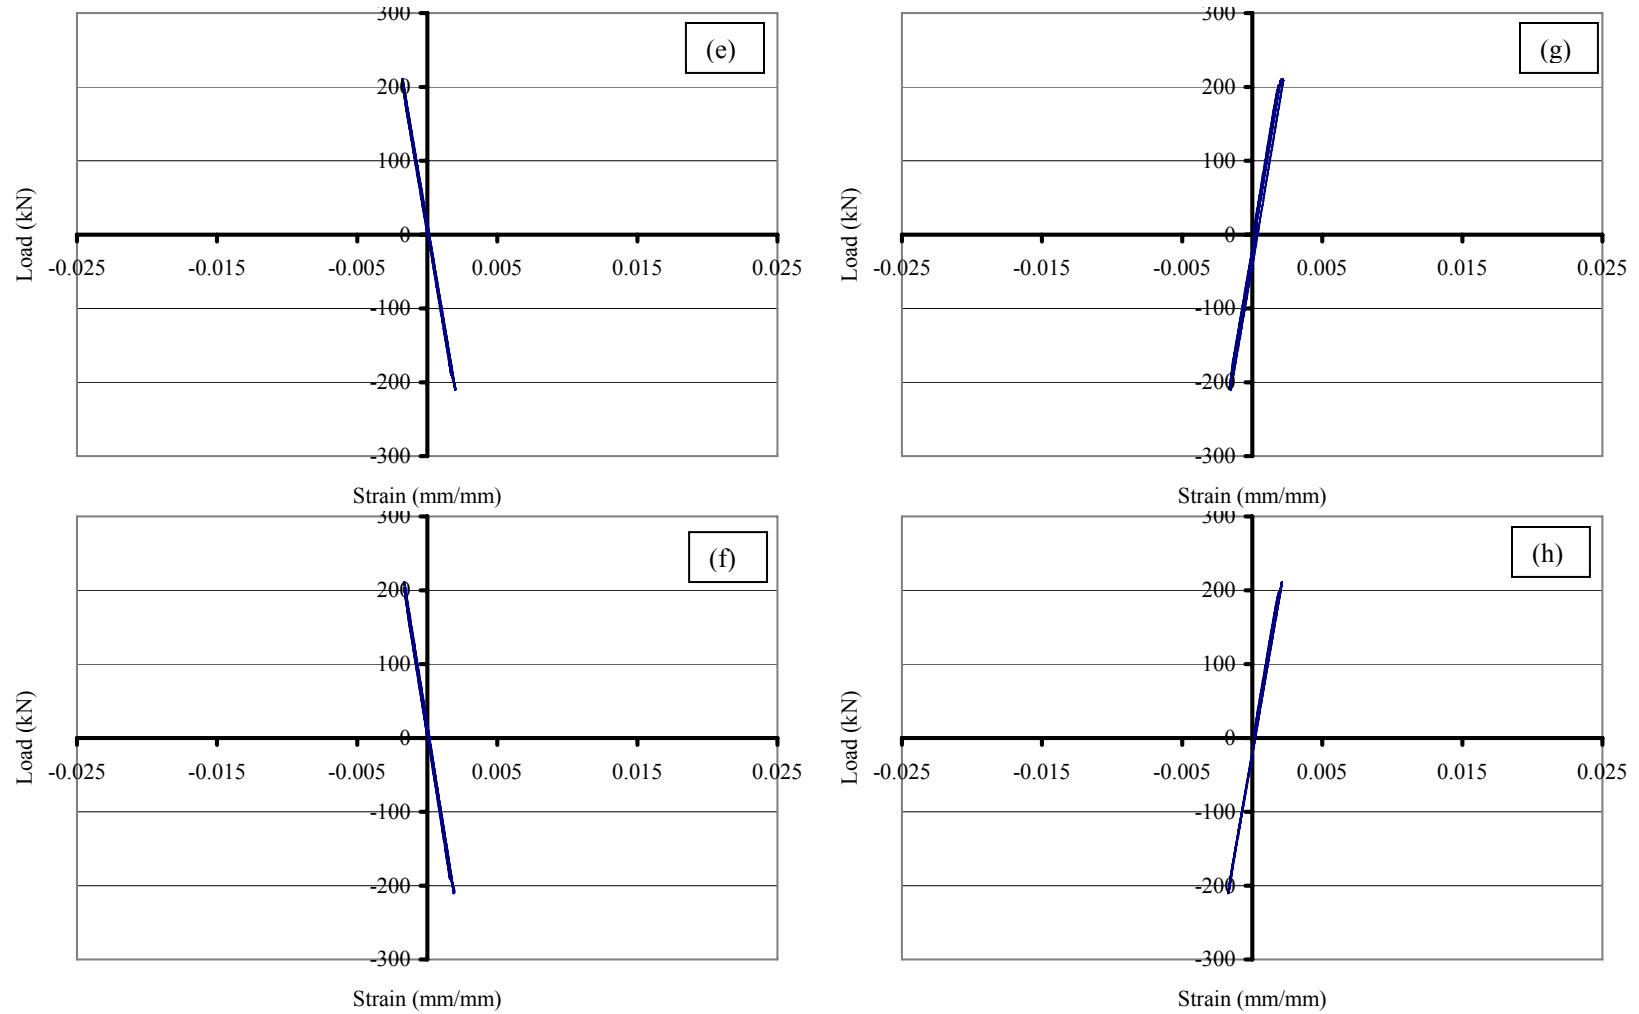
Figure 4.34 – [continued] WM assemblage test strain data – step 8: (e) Gage-5; (f) Gage-6; (g) Gage-7; and (h) Gage-8

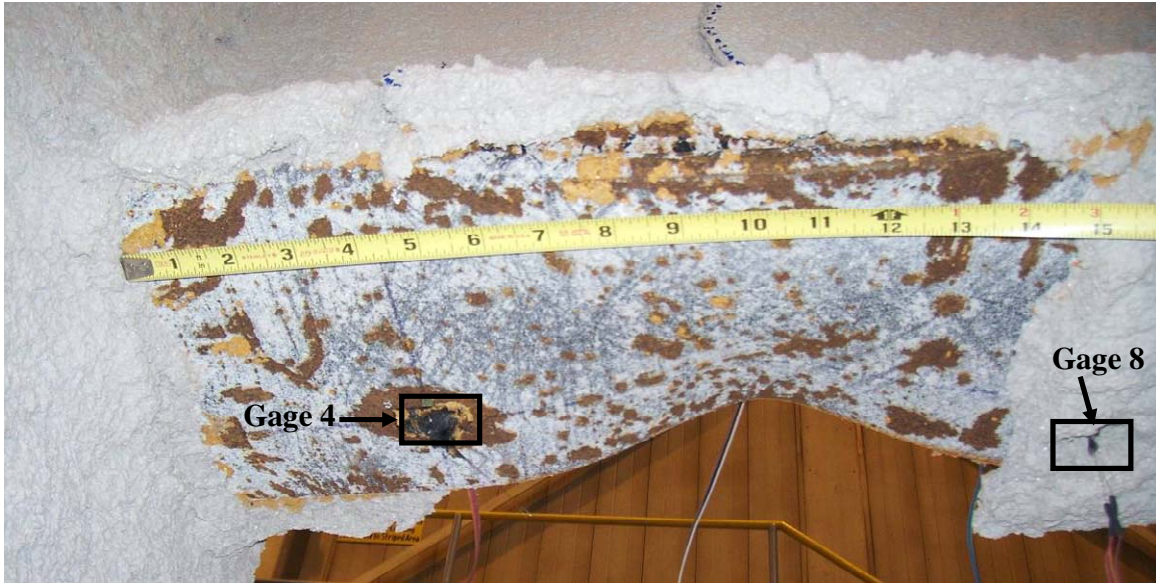
Figure 4.44 – Location of strain gages with respect to proximity to local flange buckling at completion of WM assemblage test

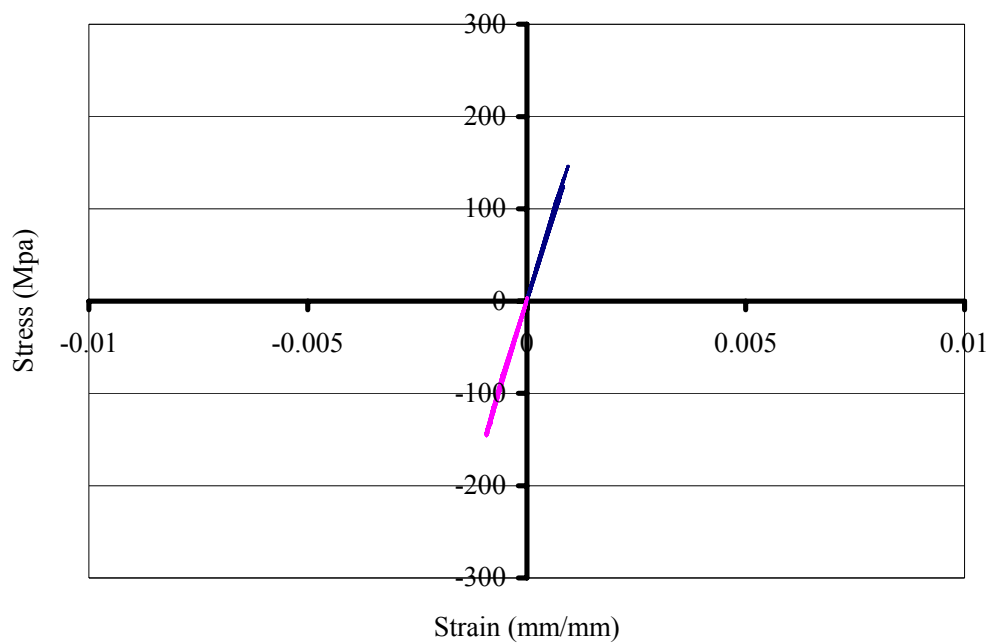
Figure 4.47 – Principle stresses vs. principle strains in panel zone for WM assemblage test

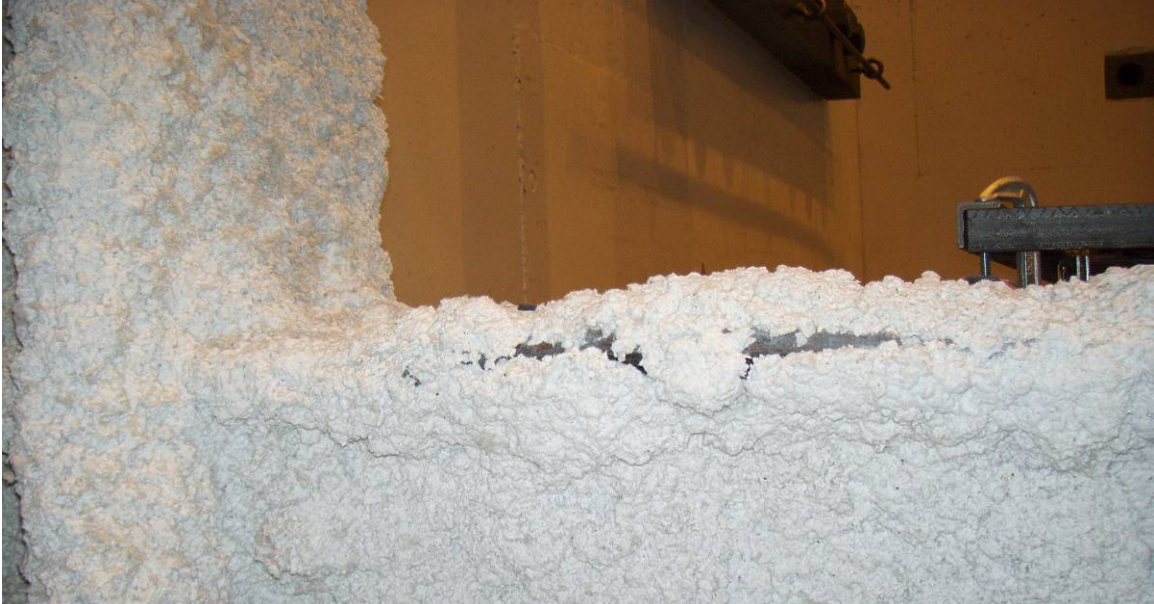
Figure 4.48 – Longitudinal splitting on top flange SFRM of DM assemblage during step 10

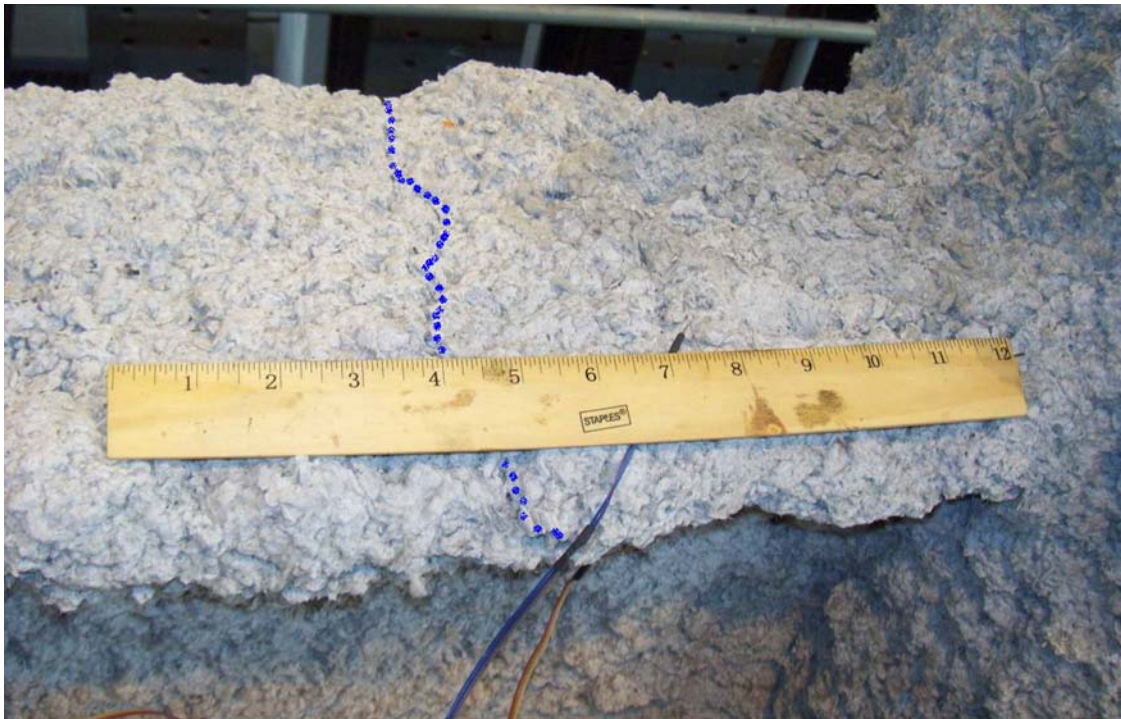
Figure 4.49 – Transverse crack in top flange of DM assemblage during post-testing inspection

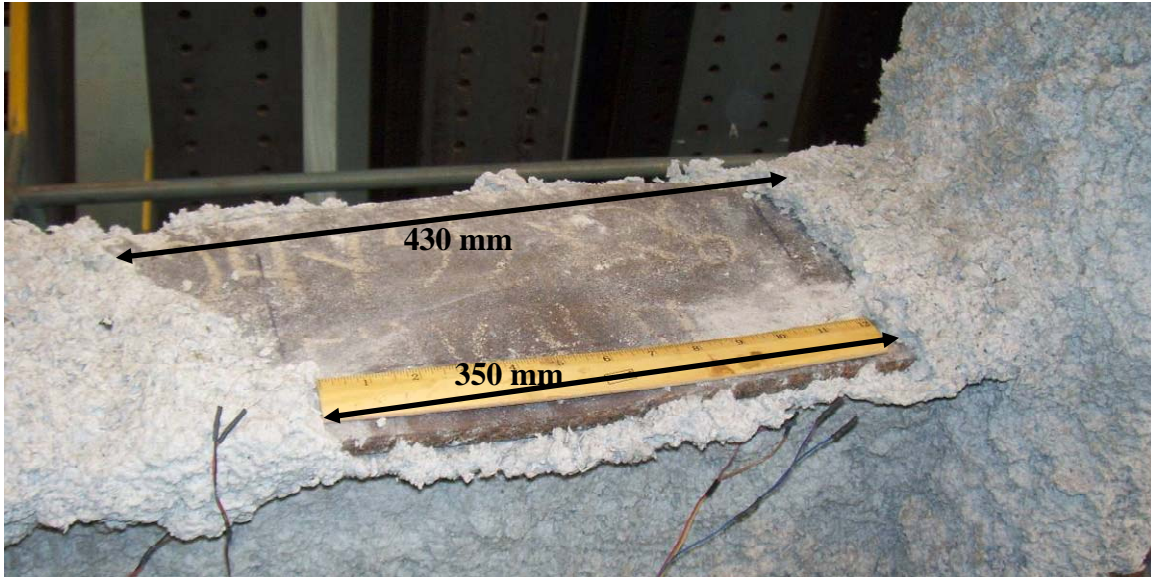
Figure 4.50 – Top flange of DM assemblage after loose SFRM was removed during post-testing inspection

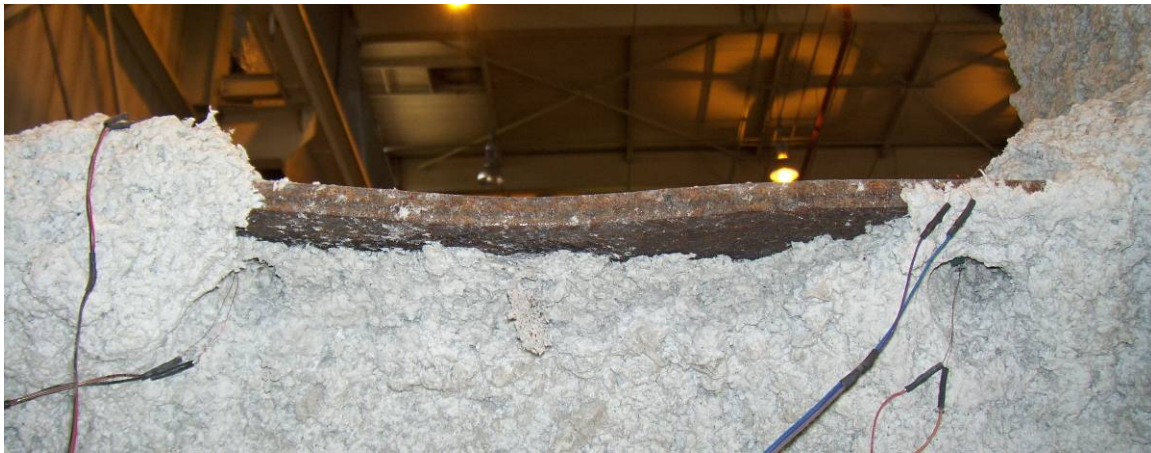
Figure 4.51 – Top flange of DM assemblage after loose SFRM was removed from underside of flange post-testing inspection

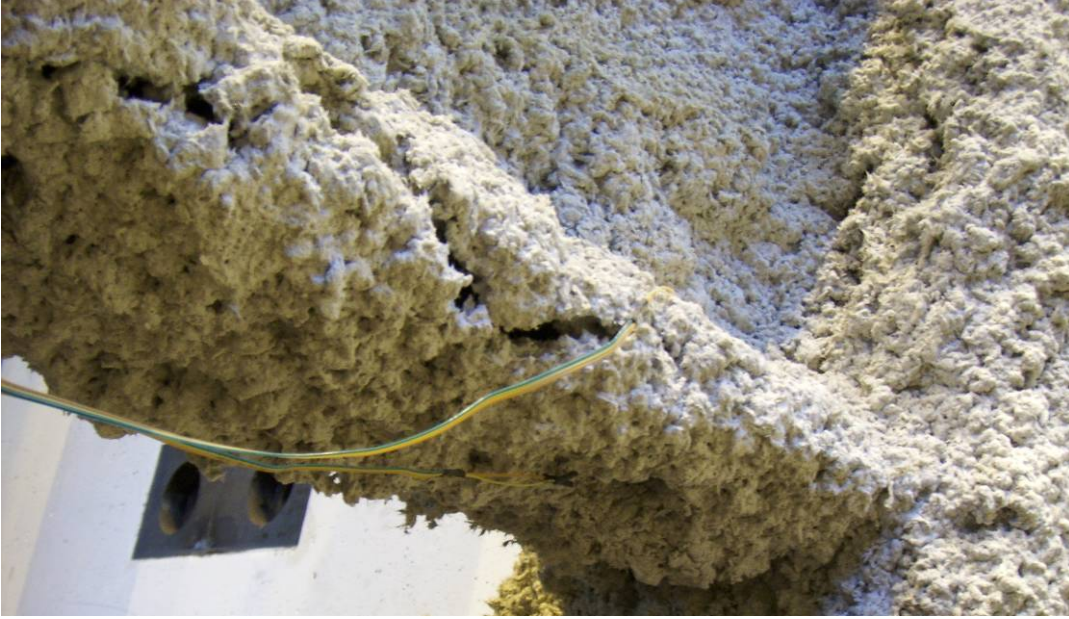
Figure 4.52 – Close-up view of longitudinal splitting in bottom flange SFRM of DM assemblage during step 10

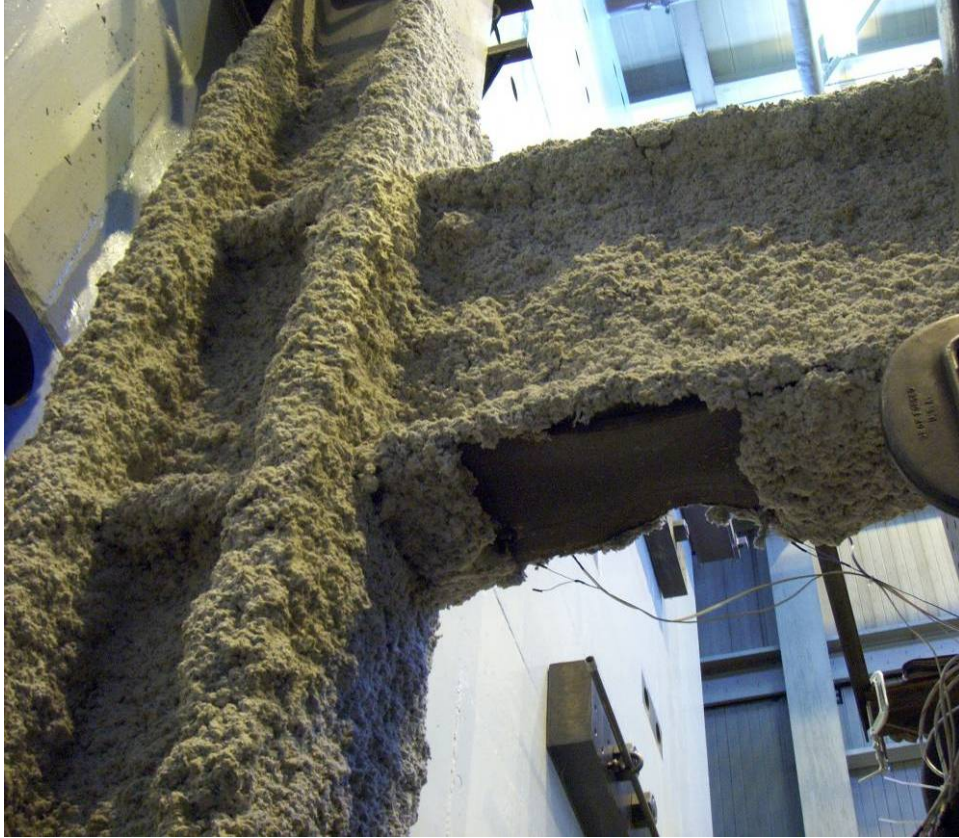
Figure 4.53 – First damaged portion of SFRM on bottom flange of DM assemblage during step 10

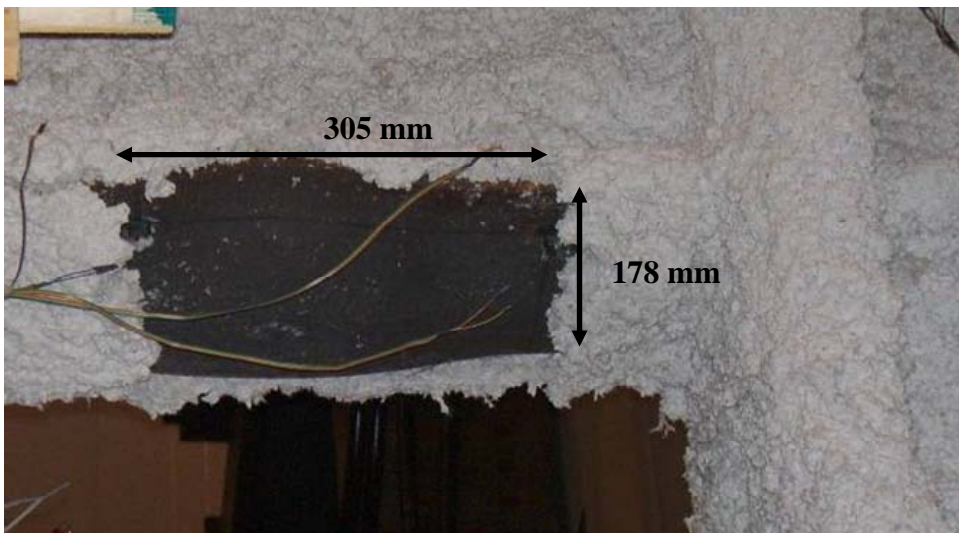
Figure 4.54 – Details of first damaged portion of SFRM on bottom flange of DM assemblage during step 10

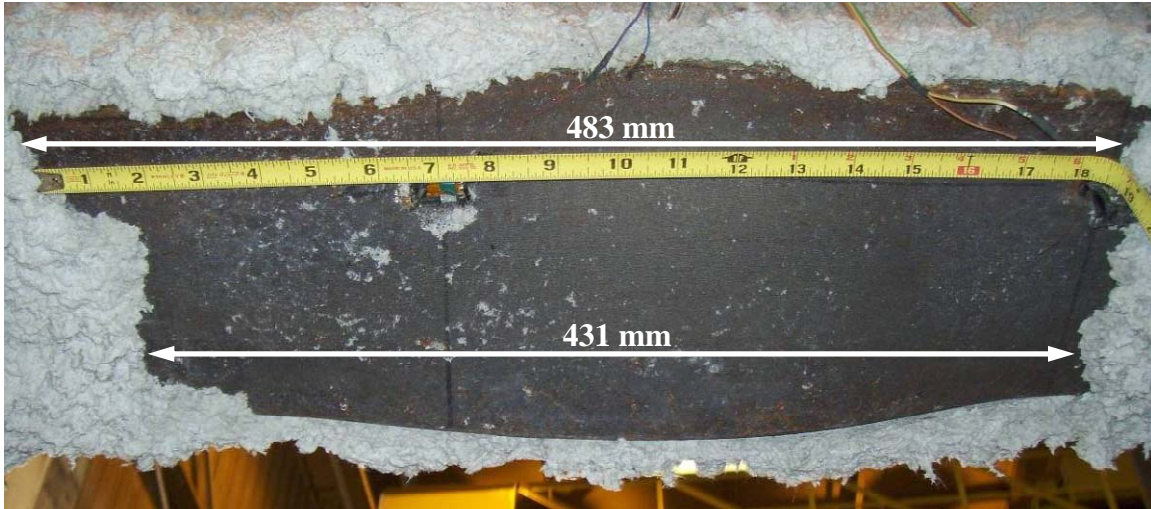
Figure 4.55 – Final section of SFRM on bottom flange of DM assemblage during post-testing inspection

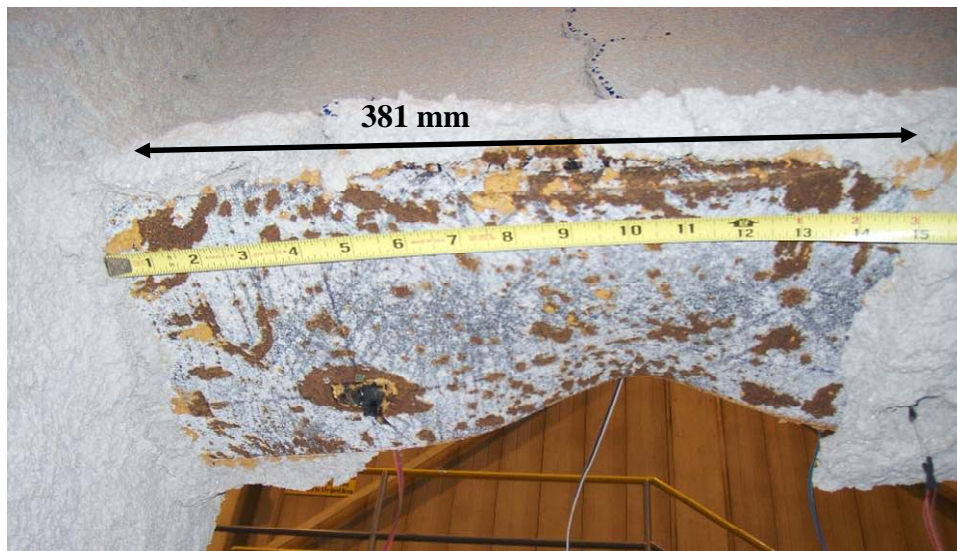
Figure 4.56 – Damage to SFRM on bottom flange of WM assemblage test during step 11

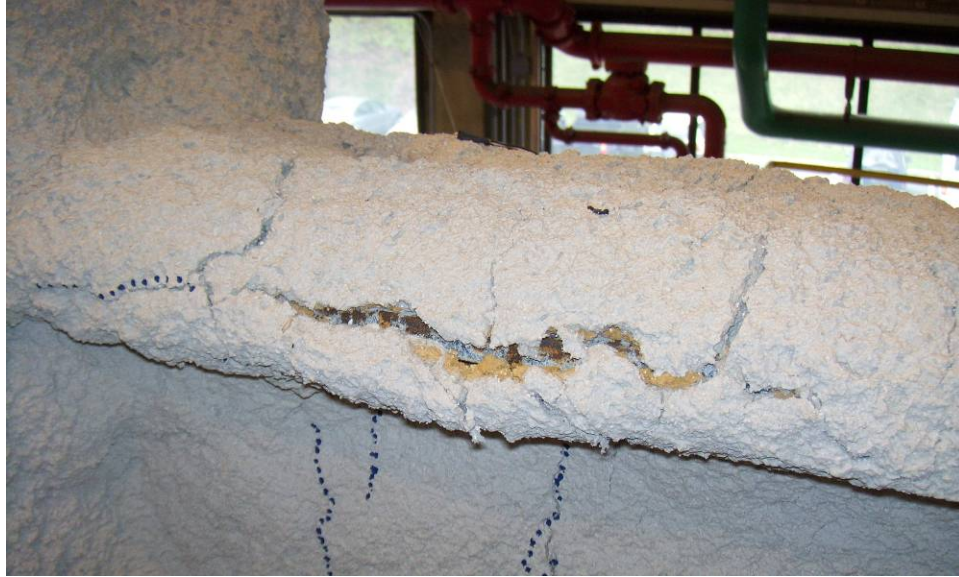
Figure 4.57 – Extensive cracking of SFRM on top flange of WM assemblage during post-testing inspection
