Seismic Performance of Sprayed Fire Resistive Material (SFRM) on Steel Moment Frame Buildings

ATLSS Report No. 10-03

April 2010

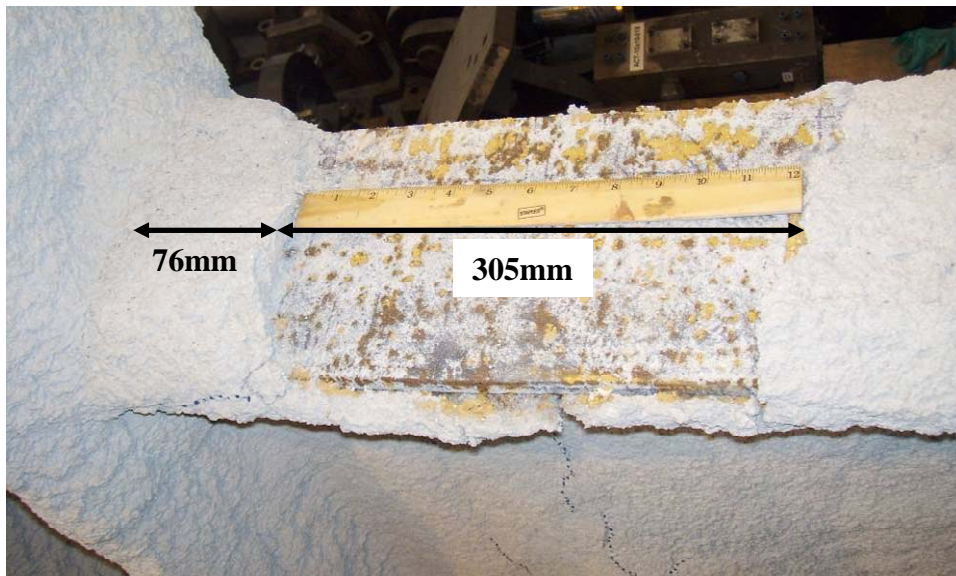
Figure 4.58 – Damage to SFRM on top of top flange of WM assemblage during post-testing inspection

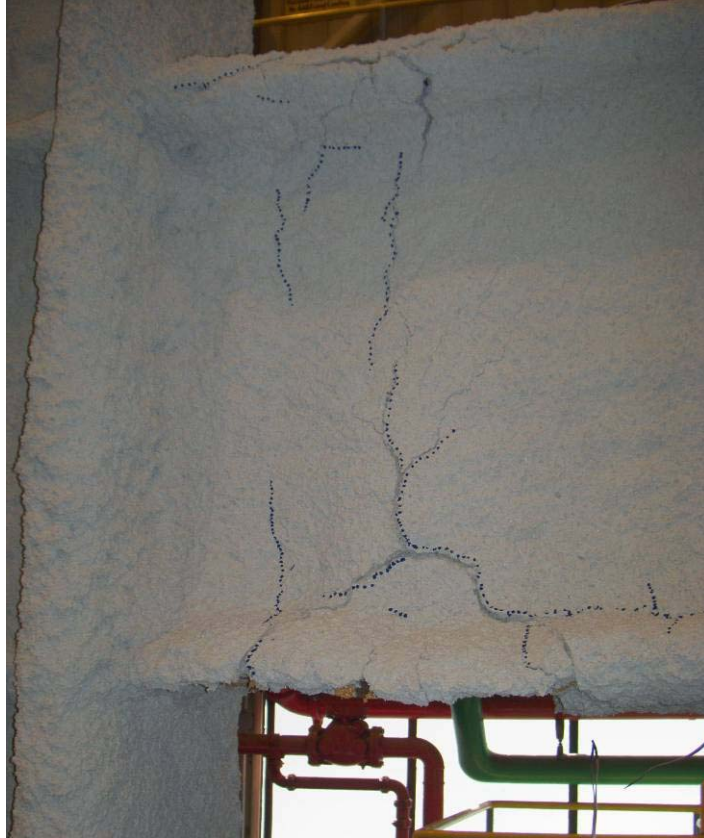
Figure 4.59 – Extensive cracking in SFRM of WM assemblage throughout web during post-testing inspection

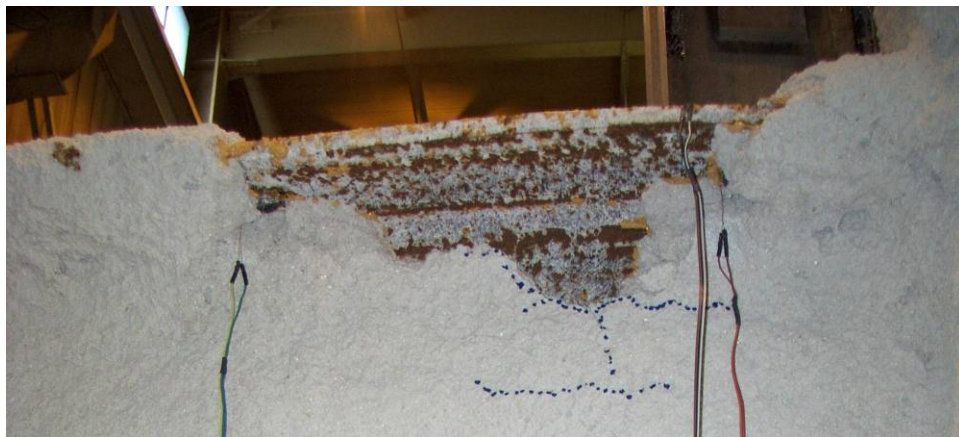
Figure 4.60 – Damage to SFRM on bottom of top flange, progressing into web of WM assemblage during post-testing inspection

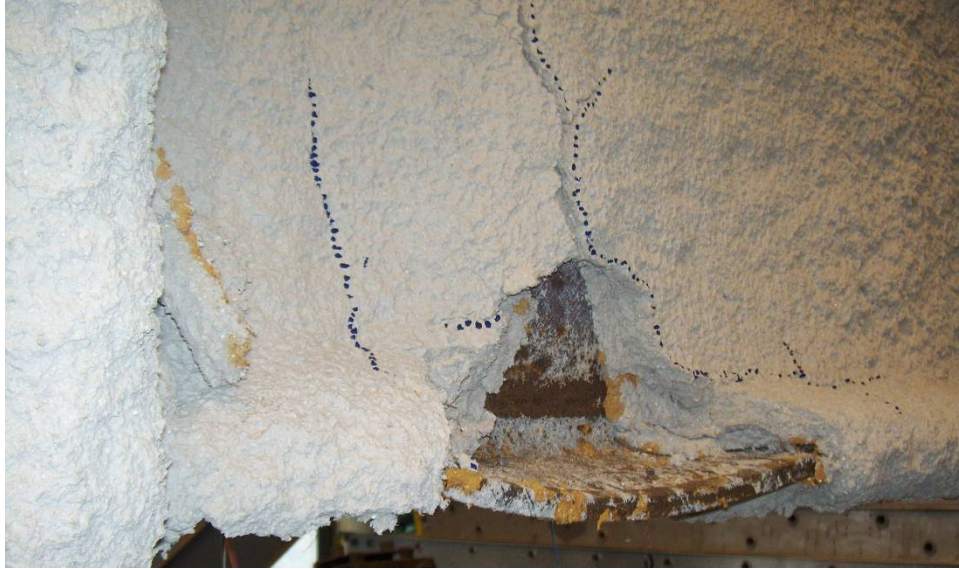
Figure 4.61 – Damage to SFRM on top of bottom flange, progressing into web of WM assemblage during post-testing inspection

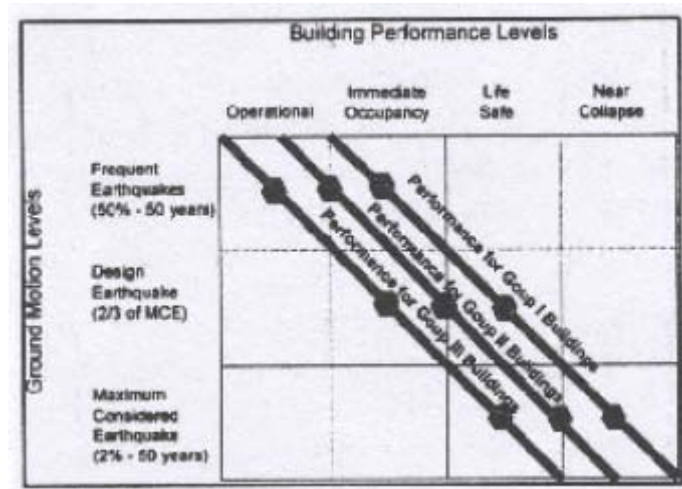
Figure 4.62 – Expected building performance during earthquakes (FEMA 450, 2003)
