# **Residual Strength and Grout Repair of Dented Offshore Tubular Bracing**

**Phase 1 Study**

**ATLSS Report No. 92 -14**

**October 1992**

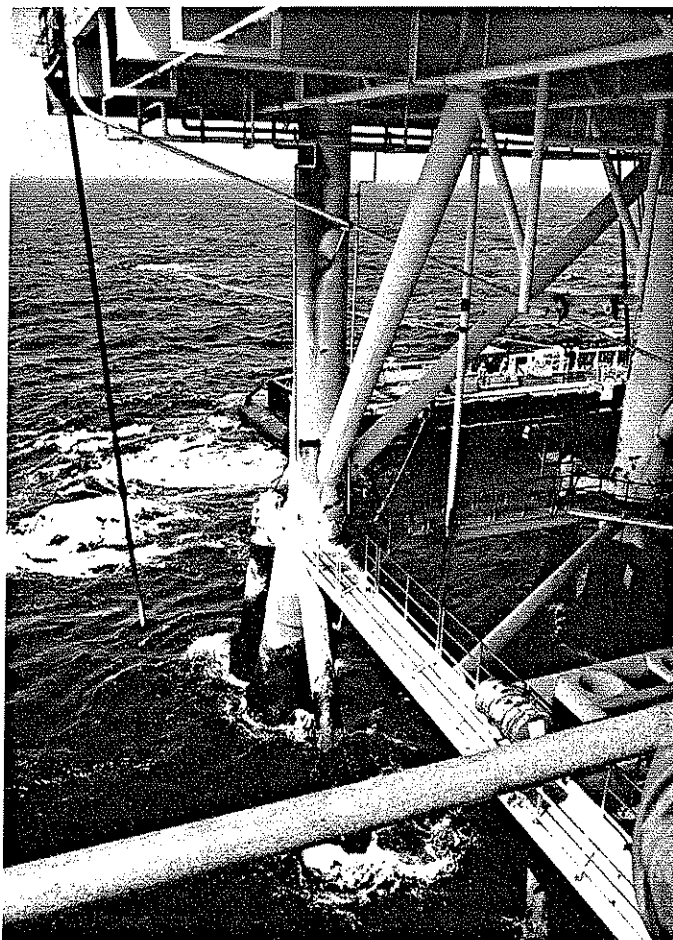
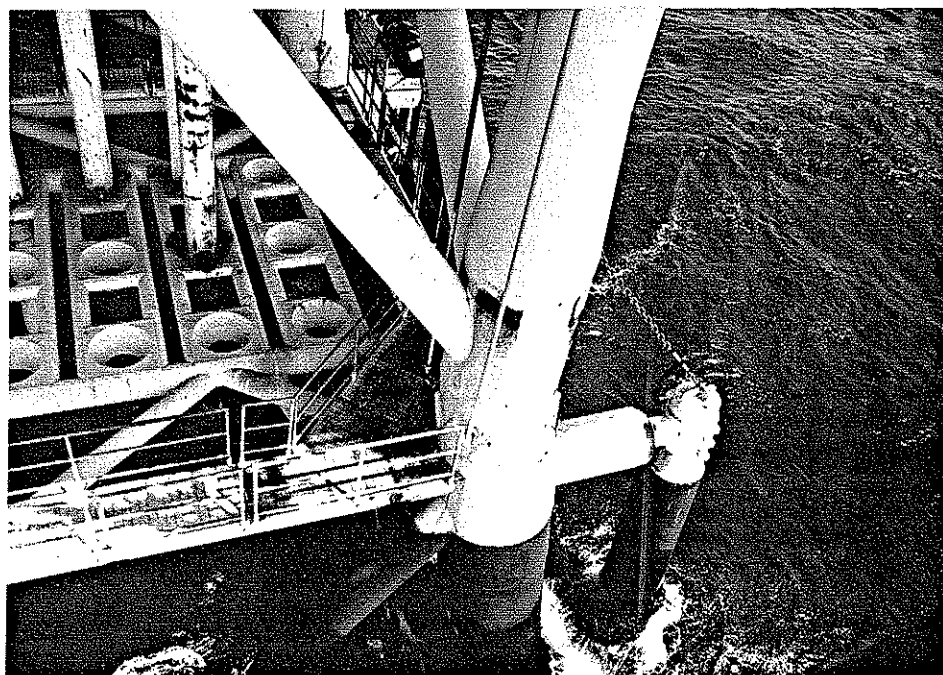
Figure 1.1 (a) and (b). View of diagonal bracing members framing into platform jacket leg at waterline.

A large number of existing platforms are known to have suffered some form of damage. Damage records from a decade of recorded experiences worldwide indicate that a majority of accidents result from ship/platform collisions and impact with debris, including dropped objects from the deck. These accidents account for nearly 17% and 12% respectively of all recorded accidents [2]. In most cases the damage is less than severe, but an appreciable number (14%) result in severe damage or total loss of structure [2]. Typical bracing members susceptible to impact from a ship due to their location at the waterline are shown in Figures 1.1(a) and (b).

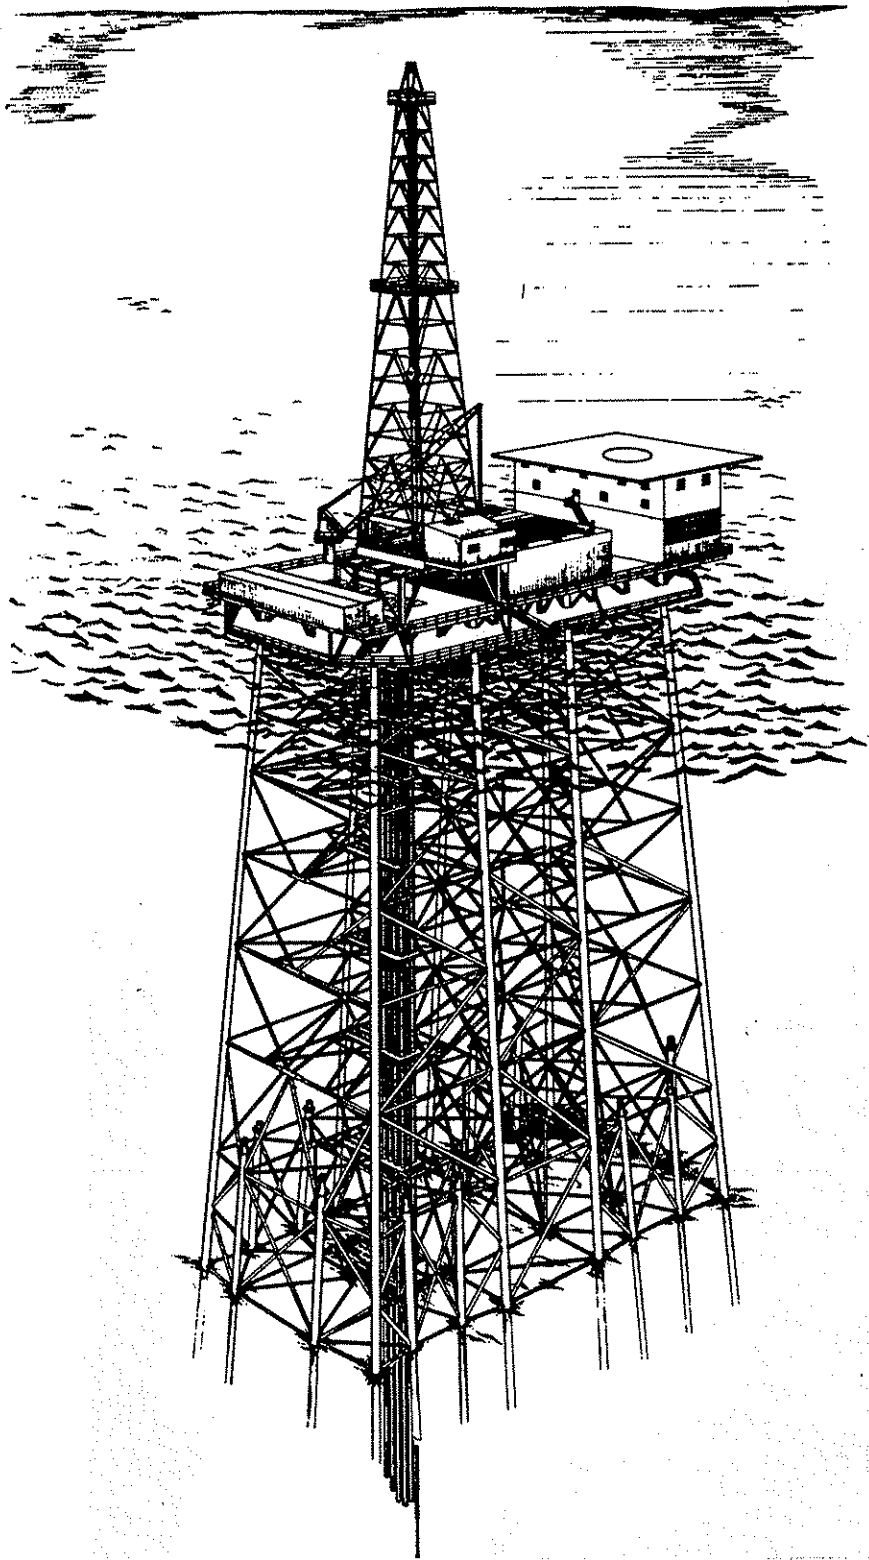
Figure 1.2. Sketch of a typical offshore platform steel jacket showing structural members above and below waterline.

The steel jacket of an offshore platform is a complex system of cylindrical steel tubular members used to support large gravity loads while resisting large lateral loads, see Figure 1.2. Tubular members are important elements because of their minimization of hydrodynamic forces, high torsional rigidity, and small outer surface subject to corrosion. Most importantly, they provide the same global buckling strength in all directions. Under lateral impact, the circular cross section is susceptible to localized denting and ovalization. Such

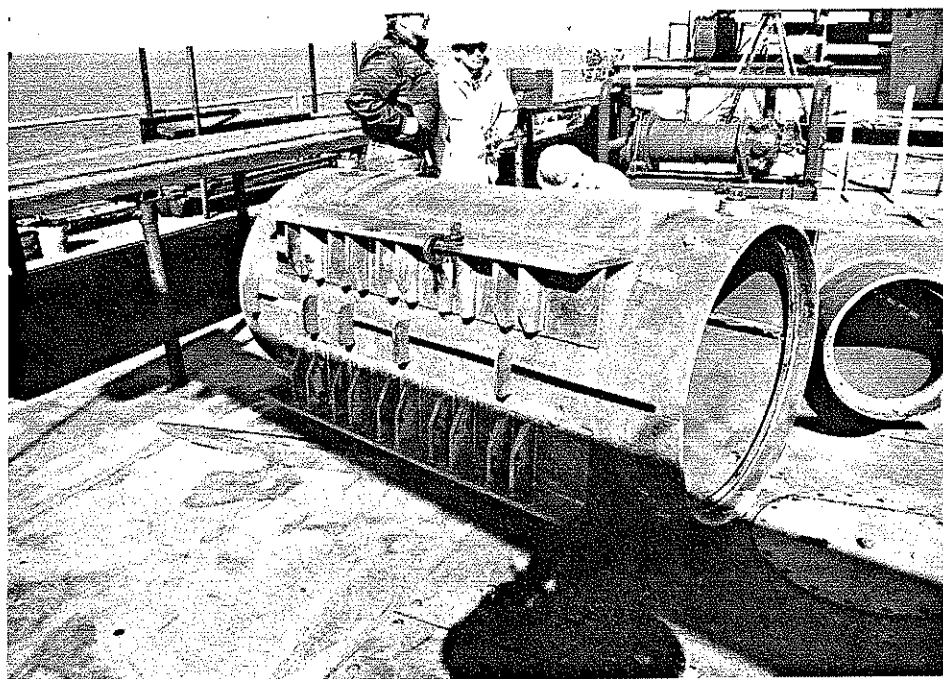
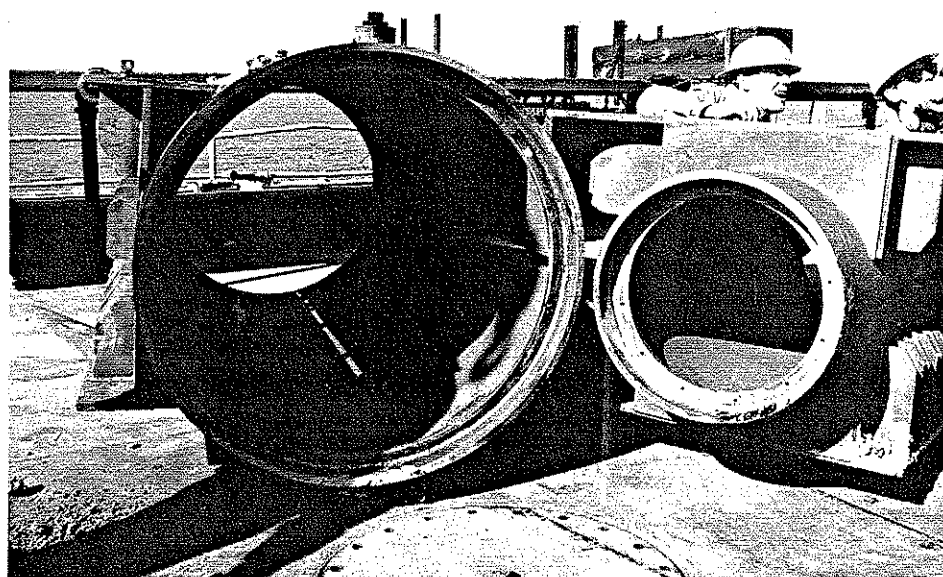
Figure 1.3 (a) and (b). A typical grouted clamp installed at Unocal operated offshore platform EVA to strengthen a fatigue damaged joint connection.

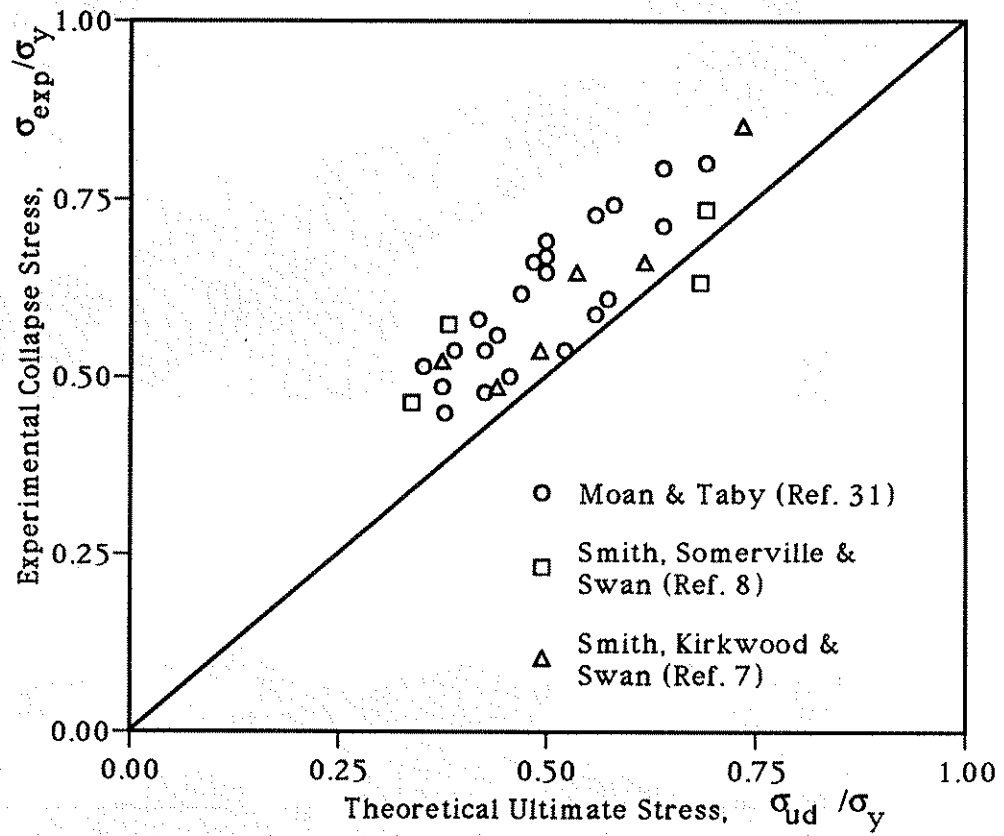
Figure 1.4 Comparison of Ellinas Strength Equation with Past Experimental Results, Showing Lower Bound.

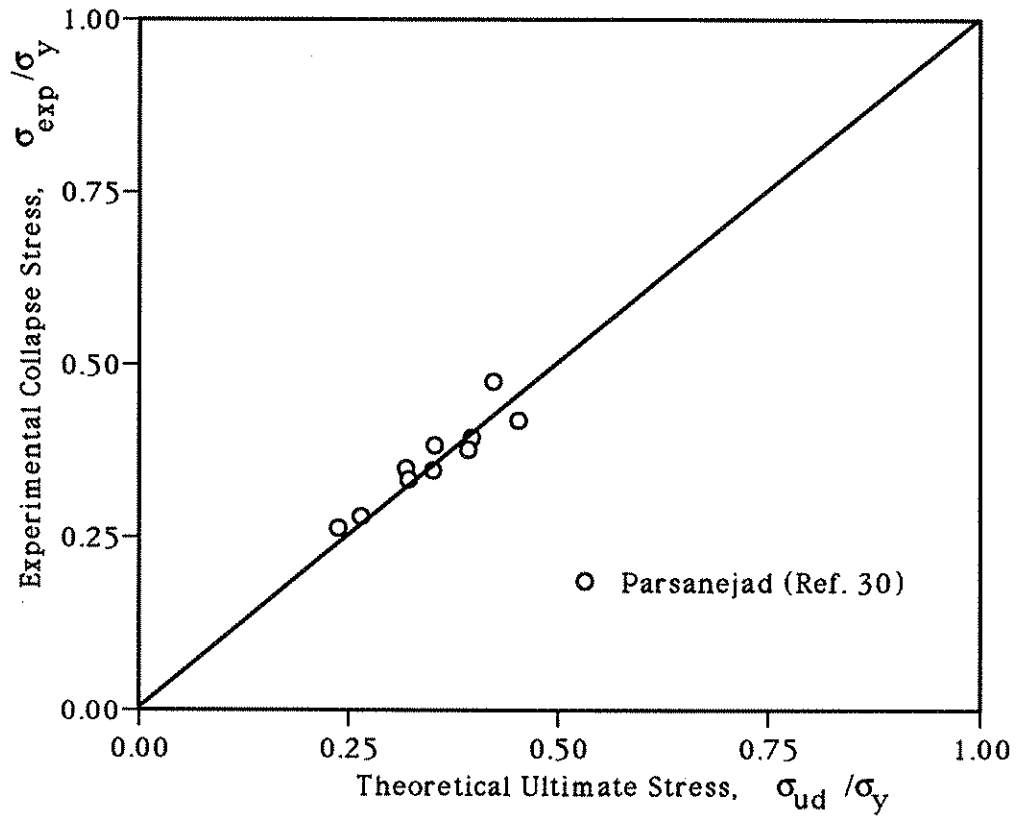
Figure 1.7 Comparison of Parsanejad's Strength Equation for Grout Repaired Tubulars with his Experimental Results

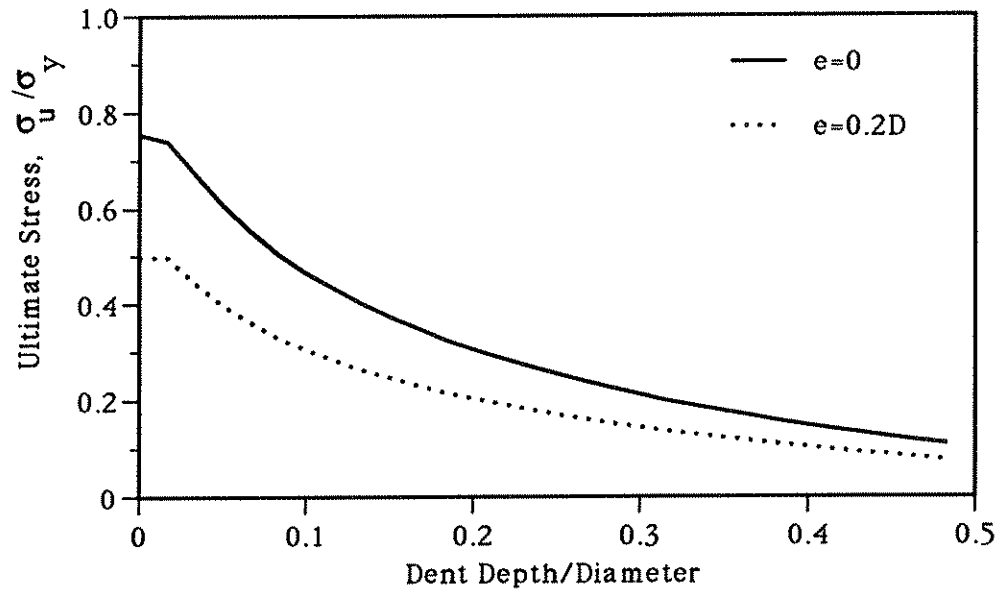
Figure 1.8 UC-DENT Normalized Residual Strength Curves for Dented Tubular Members of  $D/t = 34.5$ .

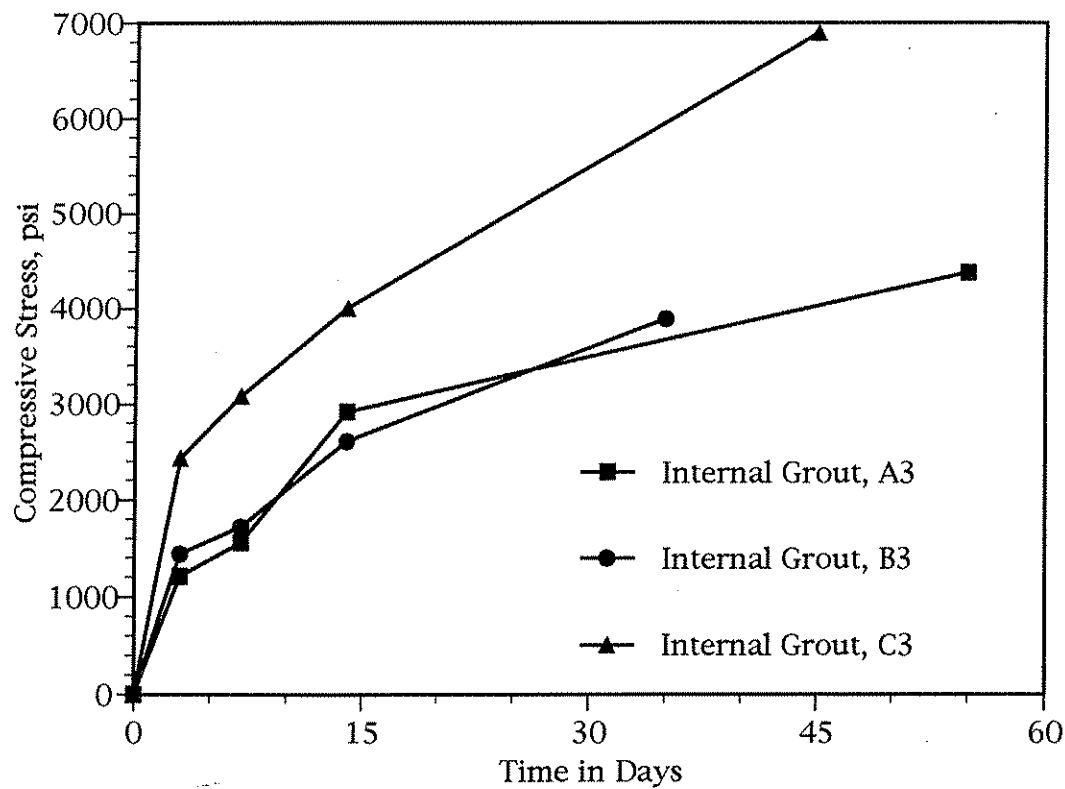
Figure 2.9(a). Compressive Strength Curves for Internal Grout Repaired Specimens. Last Data Point Represents the Grout Strength at Time of Testing.

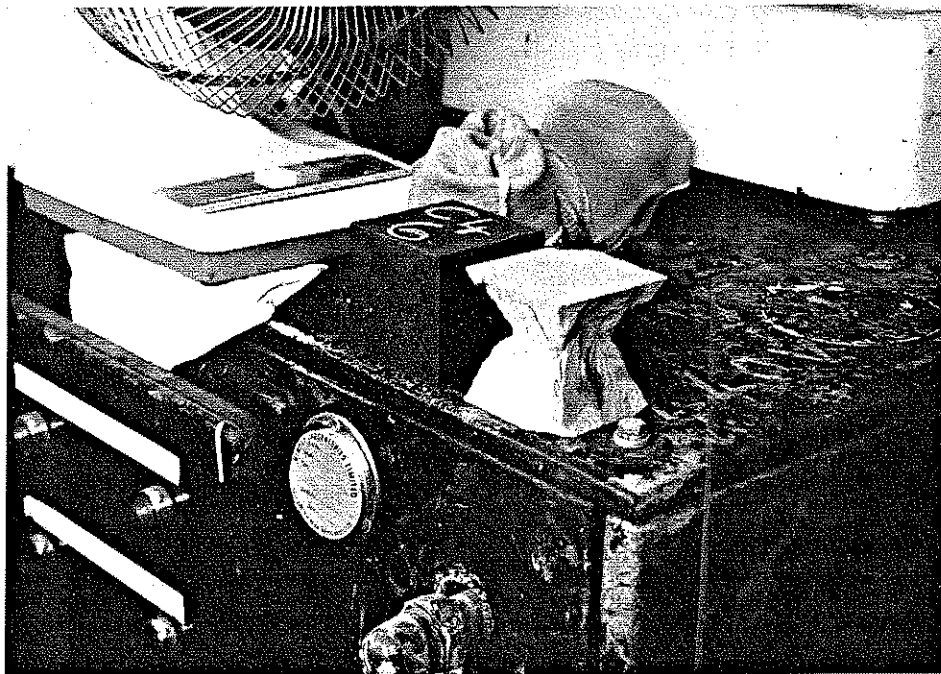
Figure 2.9(b). Typical grout cube utilized for compressive strength tests.

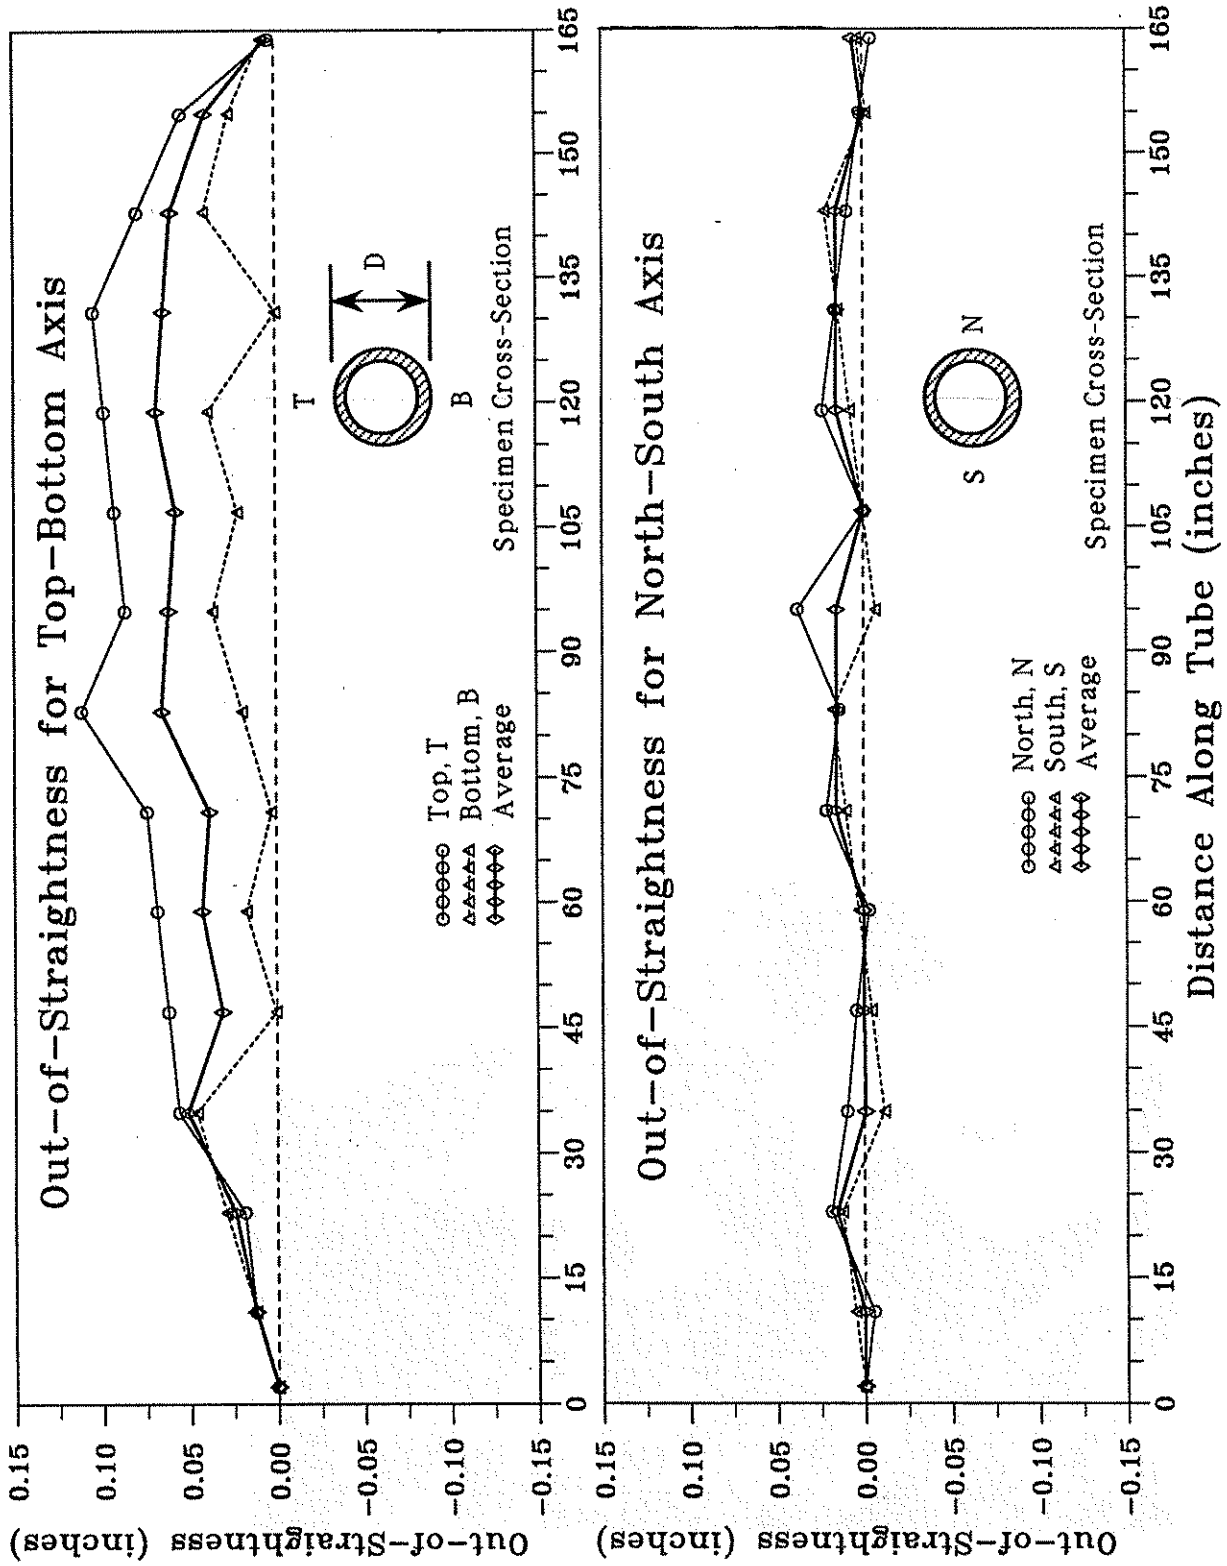
Figure 2.10. Initial Out-Of-Straightness for Specimen A1.

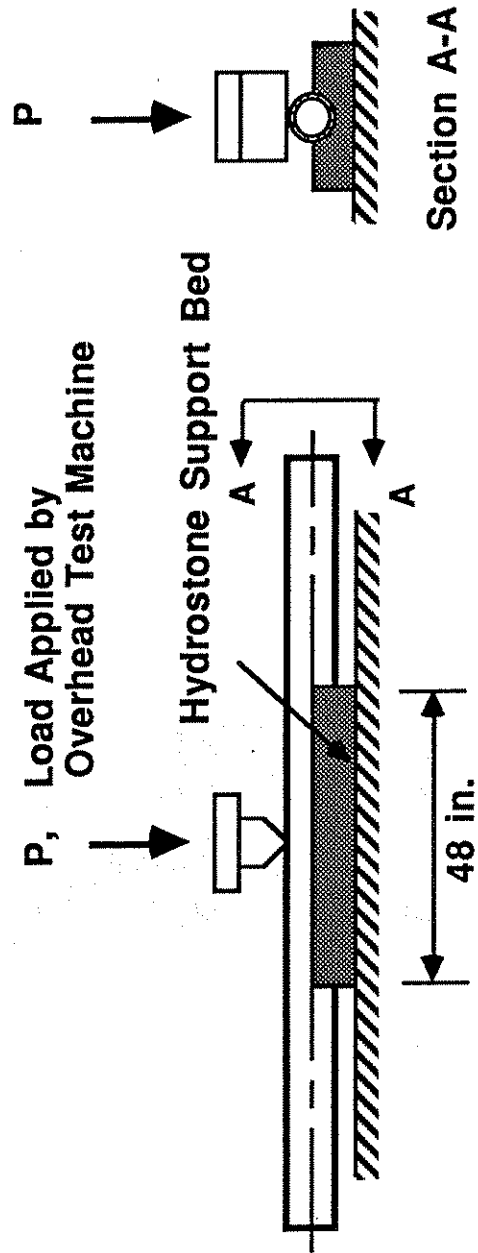
Figure 2.11. Indentation Device

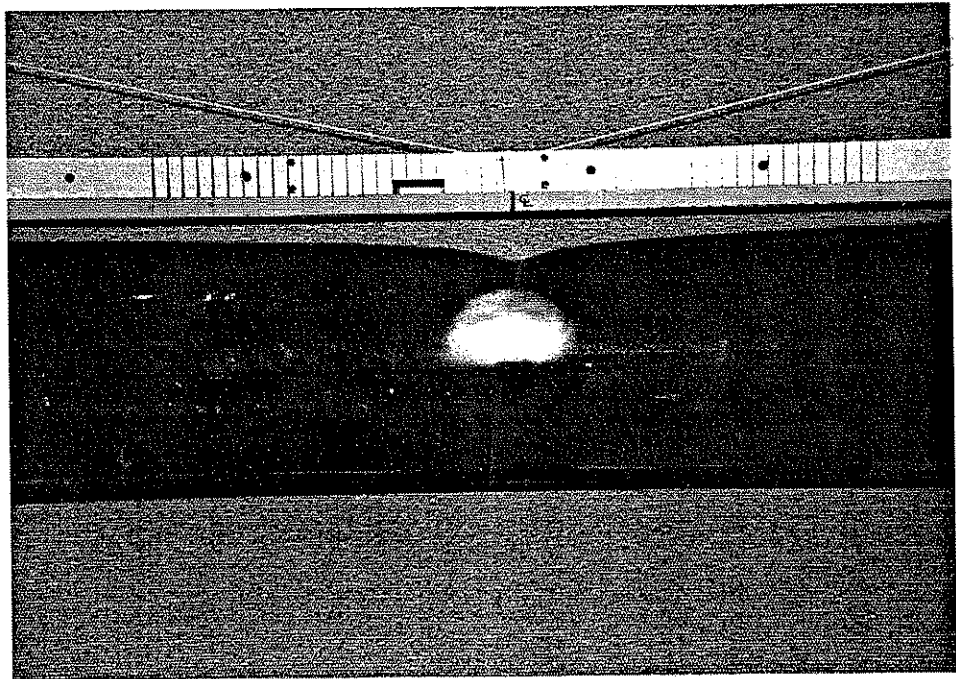
Figure 2.13. Photograph of dent damaged Specimen A1.

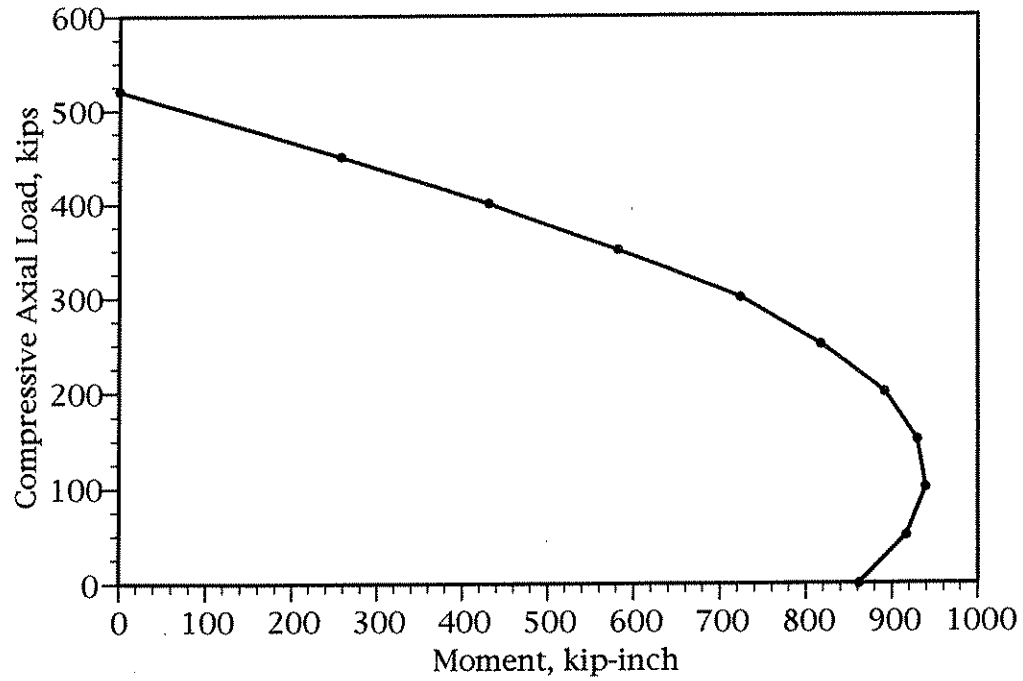
Figure 2.14. Moment-Axial Load Interaction Surface for Full Composite Action of Internal Grout Repaired Specimen A3.

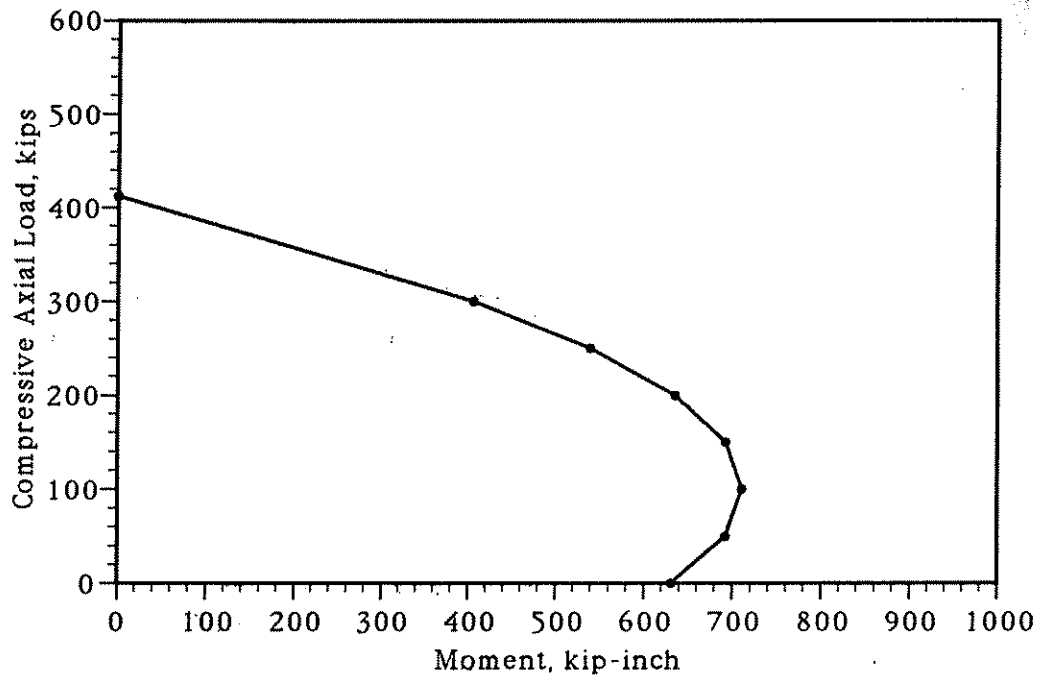
Figure 2.15. Moment-Axial Load Interaction Surface for Full Composite Action of Internal Grout Repaired Specimen B3.

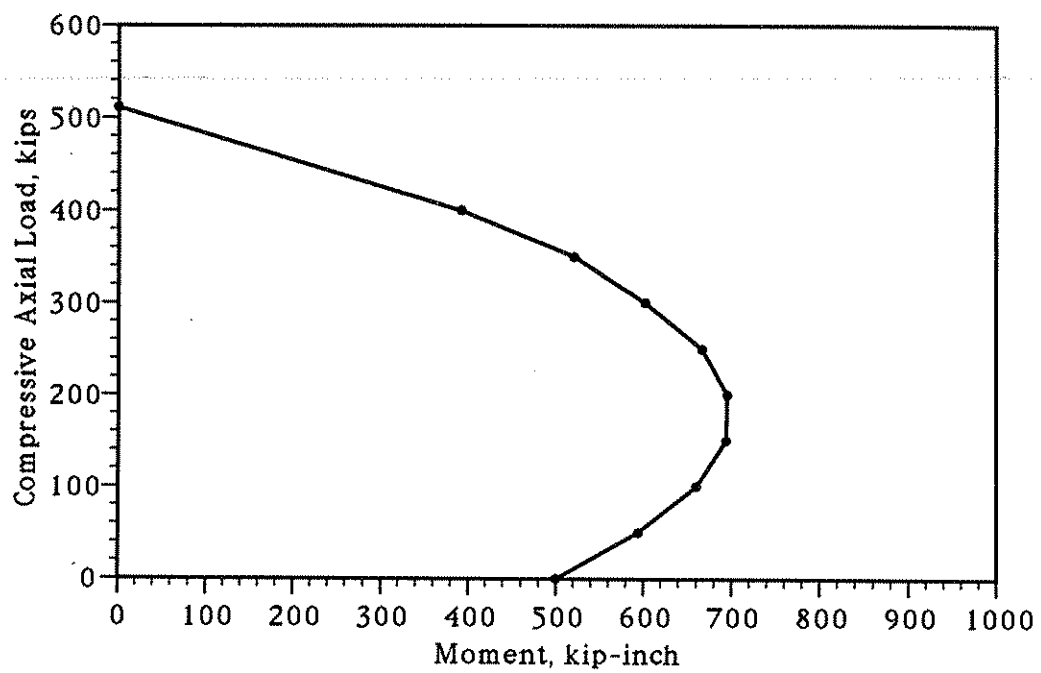
Figure 2.16. Moment-Axial Load Interaction Surface for Full Composite Action of Internal Grout Repaired Specimen C3.

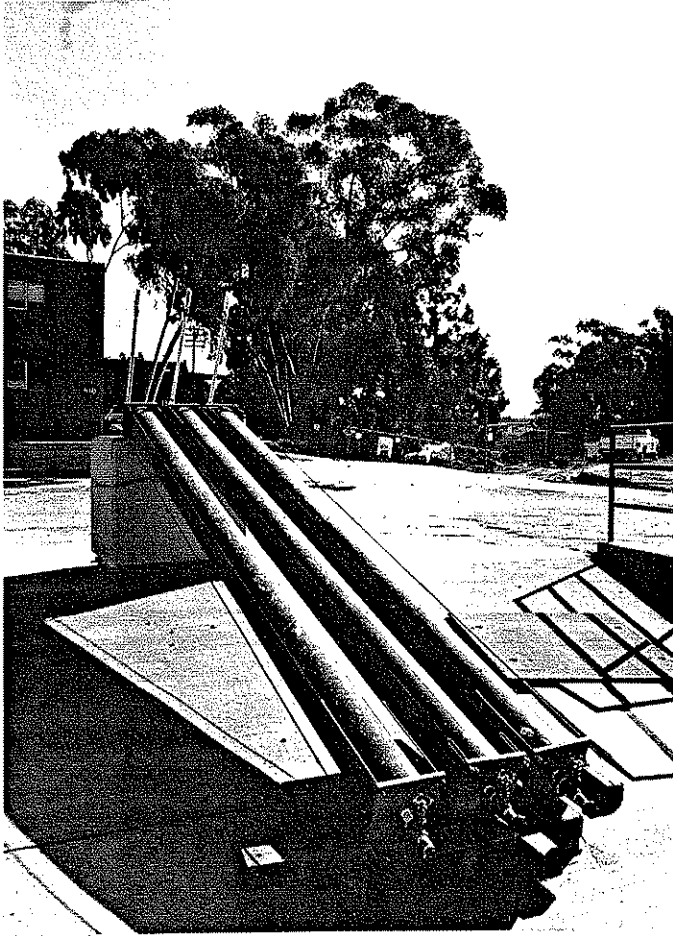
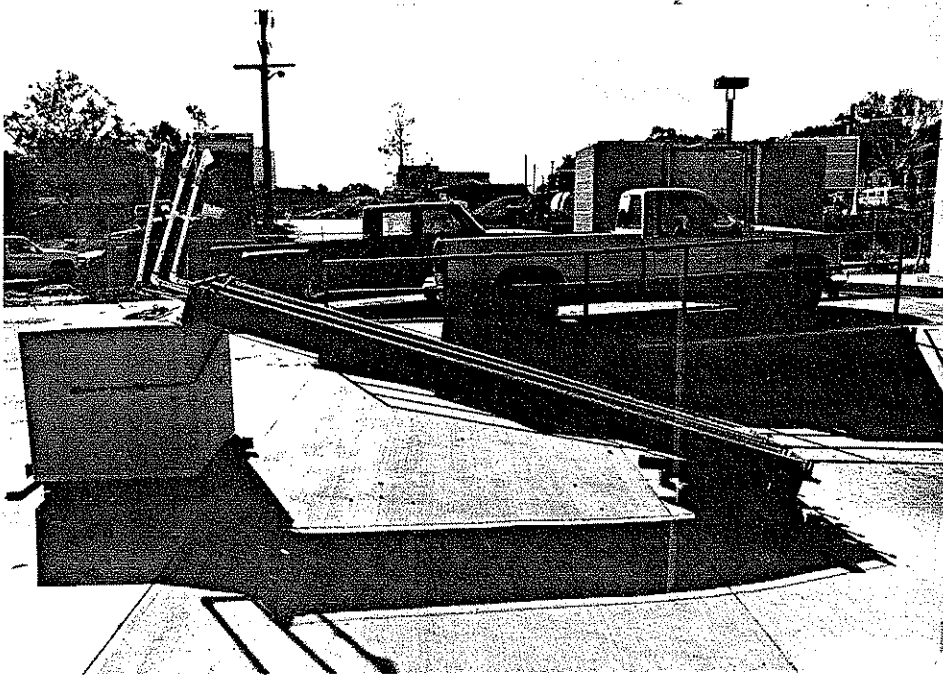
Figure 2.17(a) and (b). Setup for the internal grouting of Specimens A3, B3 and C3.

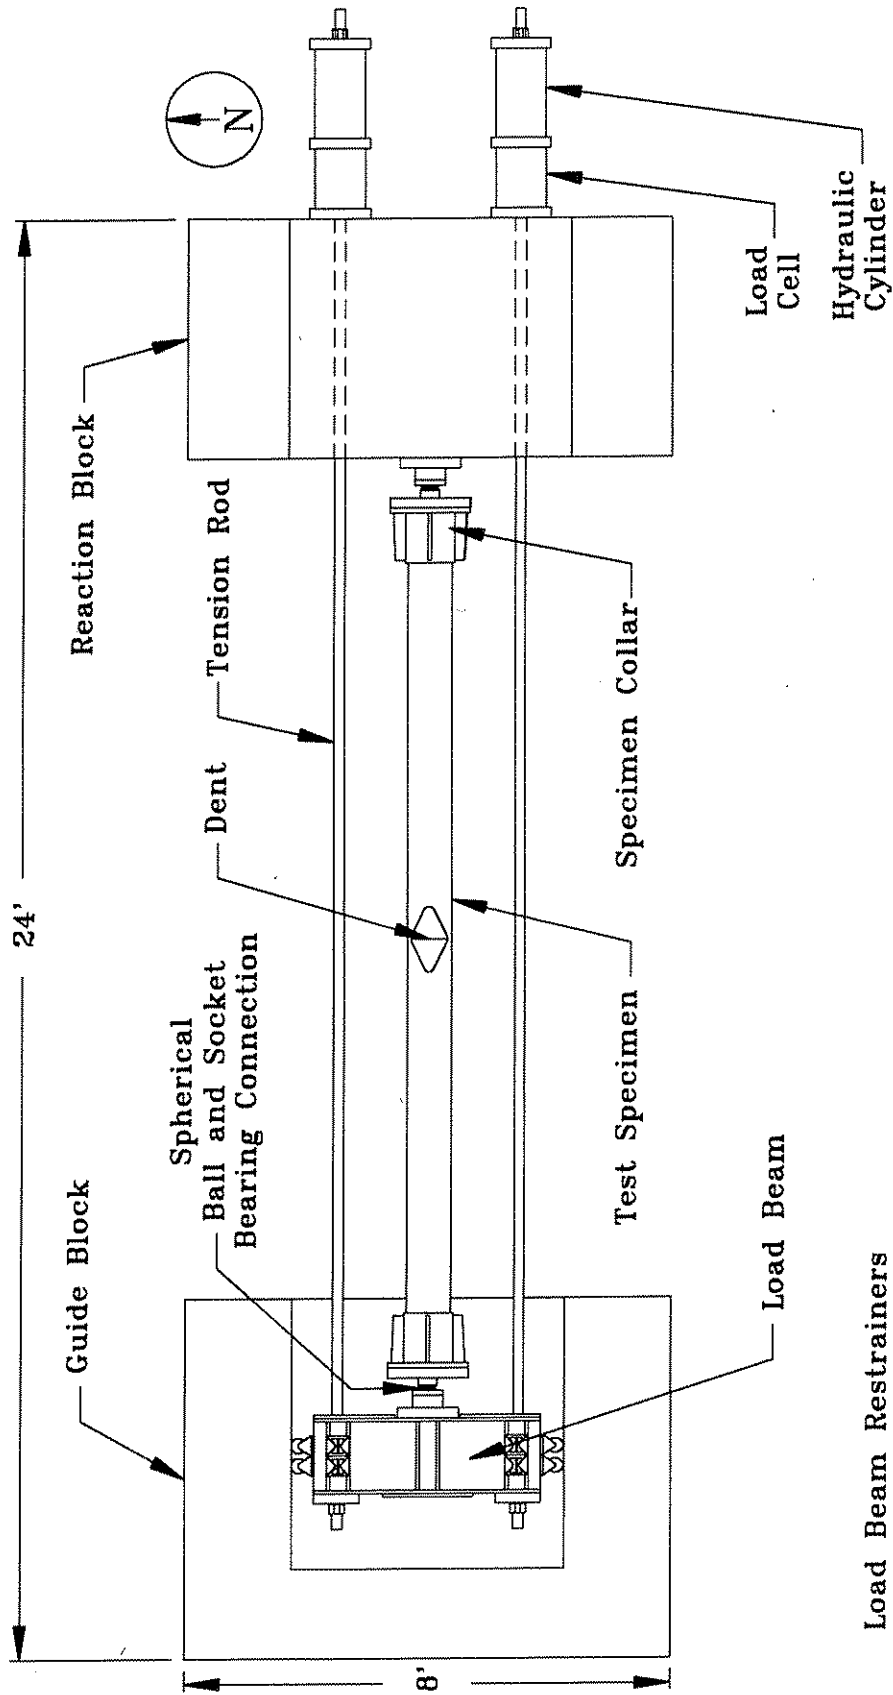
Load Beam Restrainers  
Not Shown For Clarity

Figure 2.21. Plan View of Test Frame.

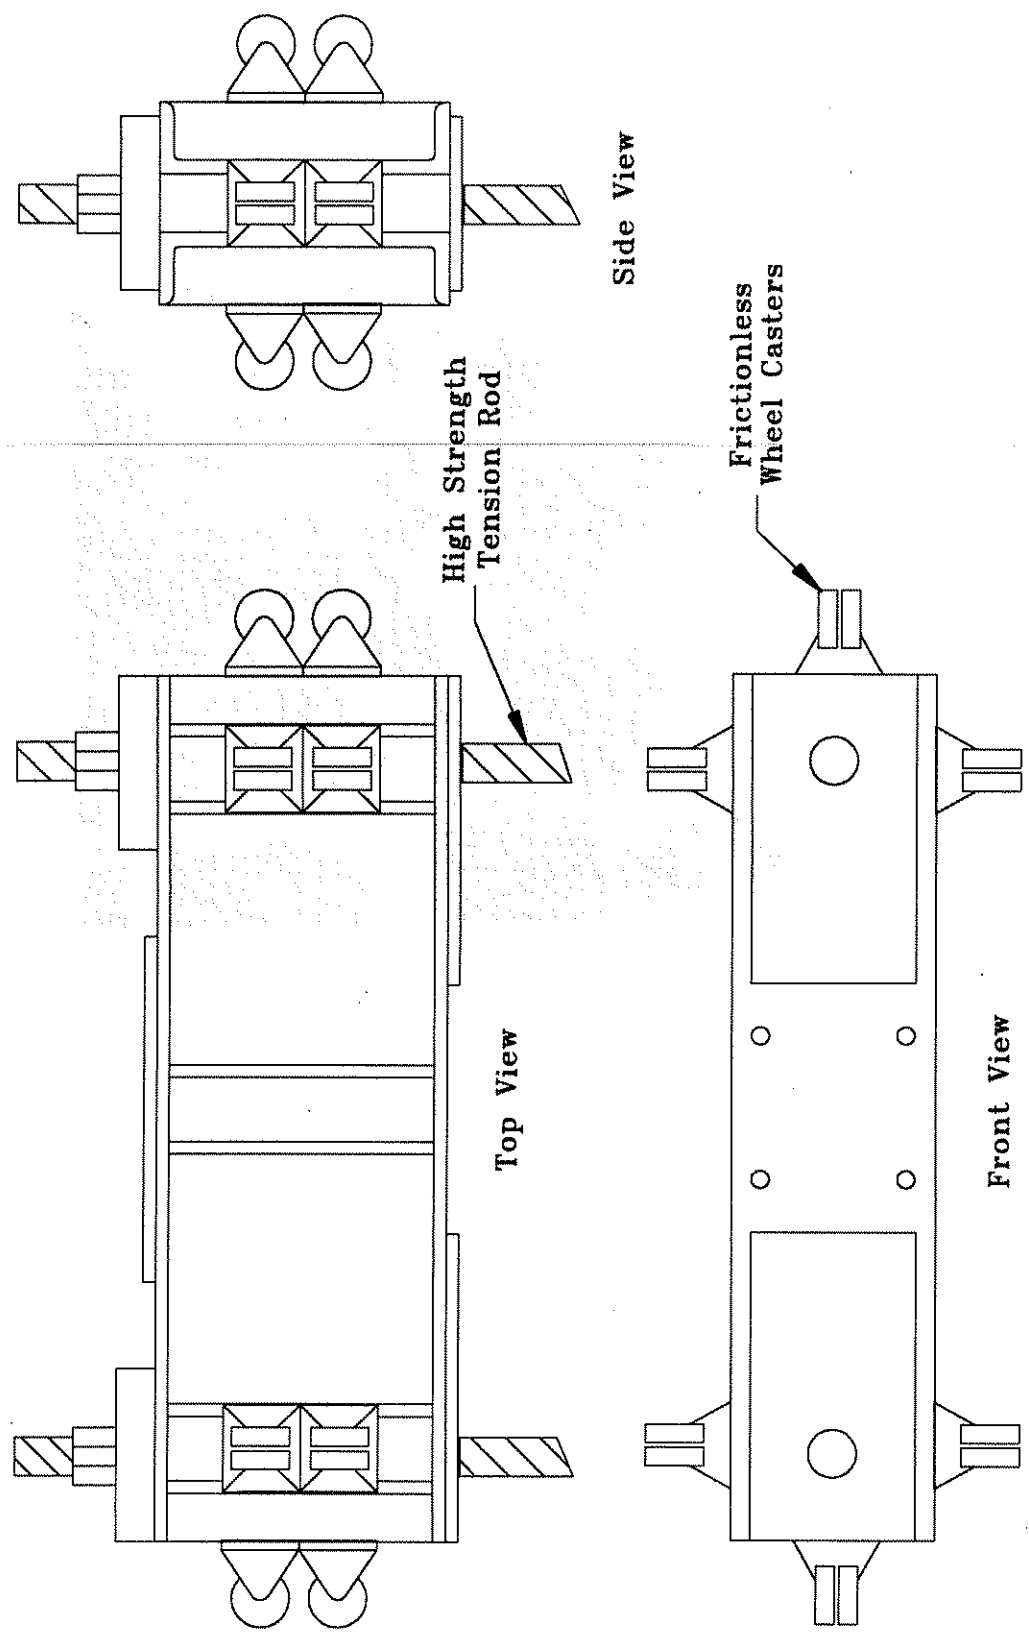
Figure 2.26: Load Beam Details

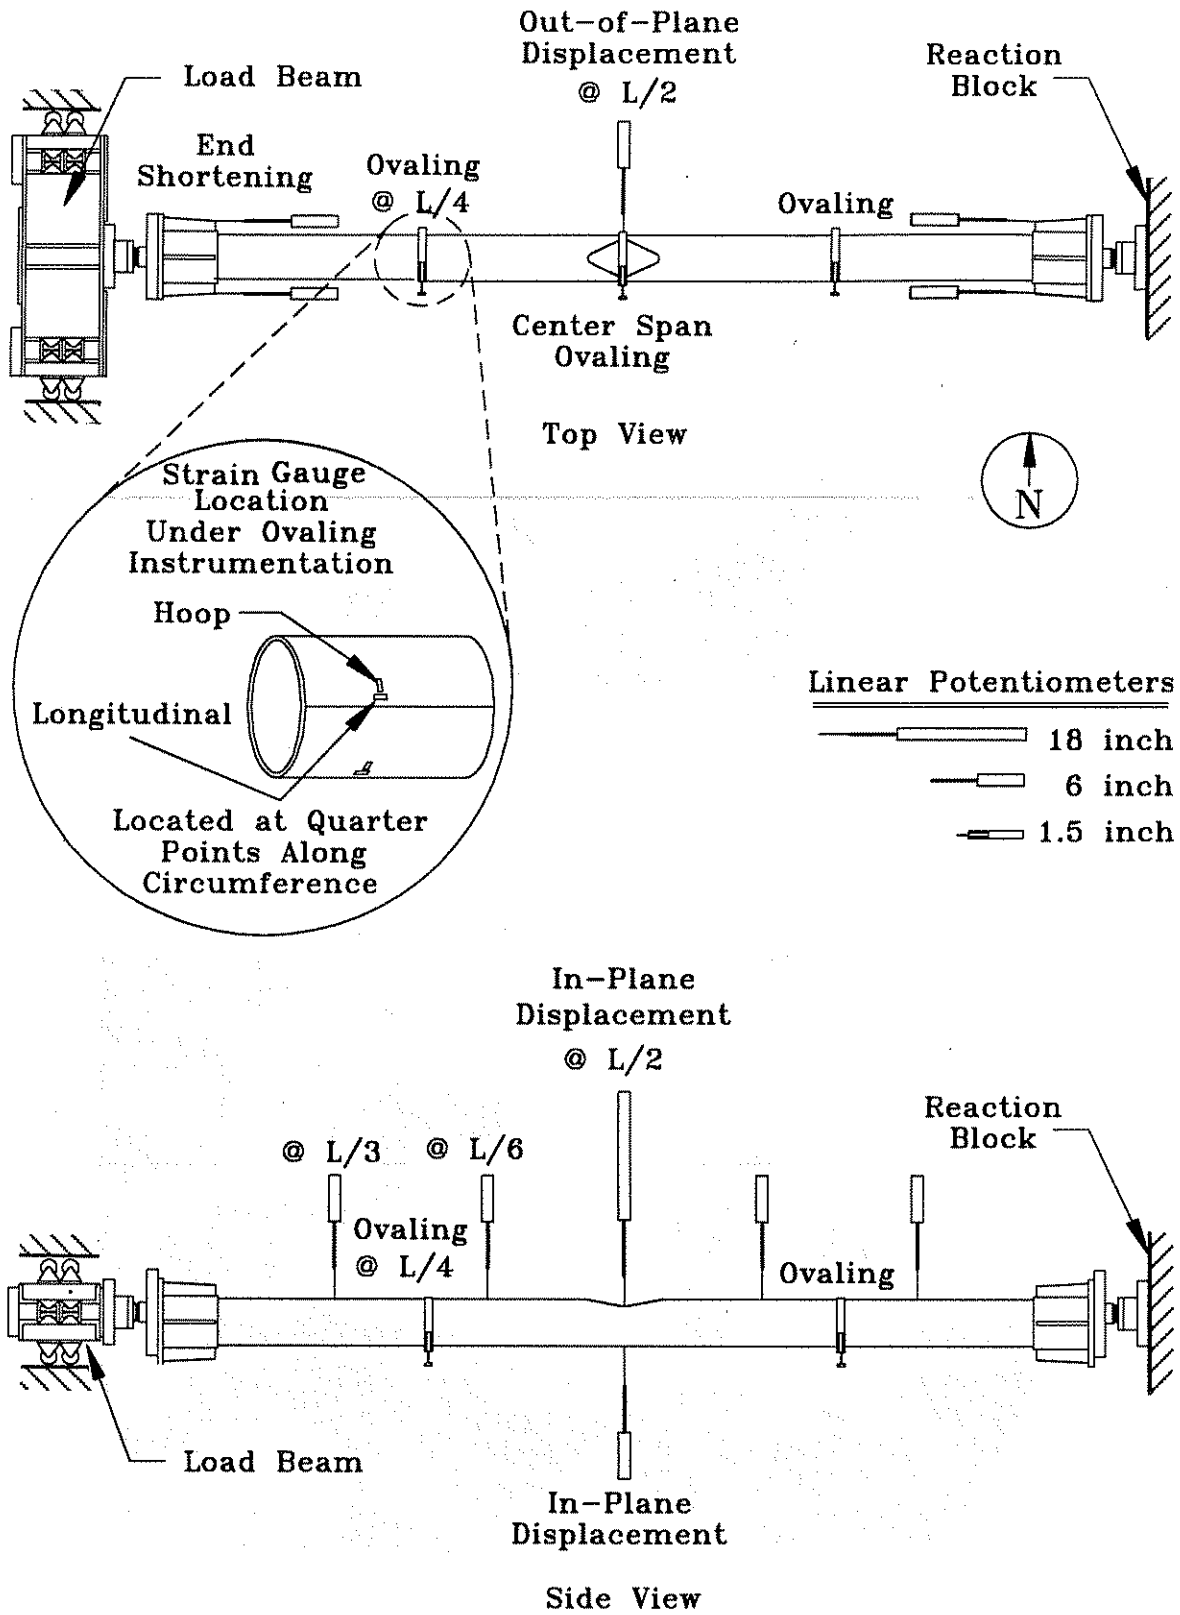
Figure 2.29. Instrumentation for Unrepaired and Internally Grout Repaired Specimens.

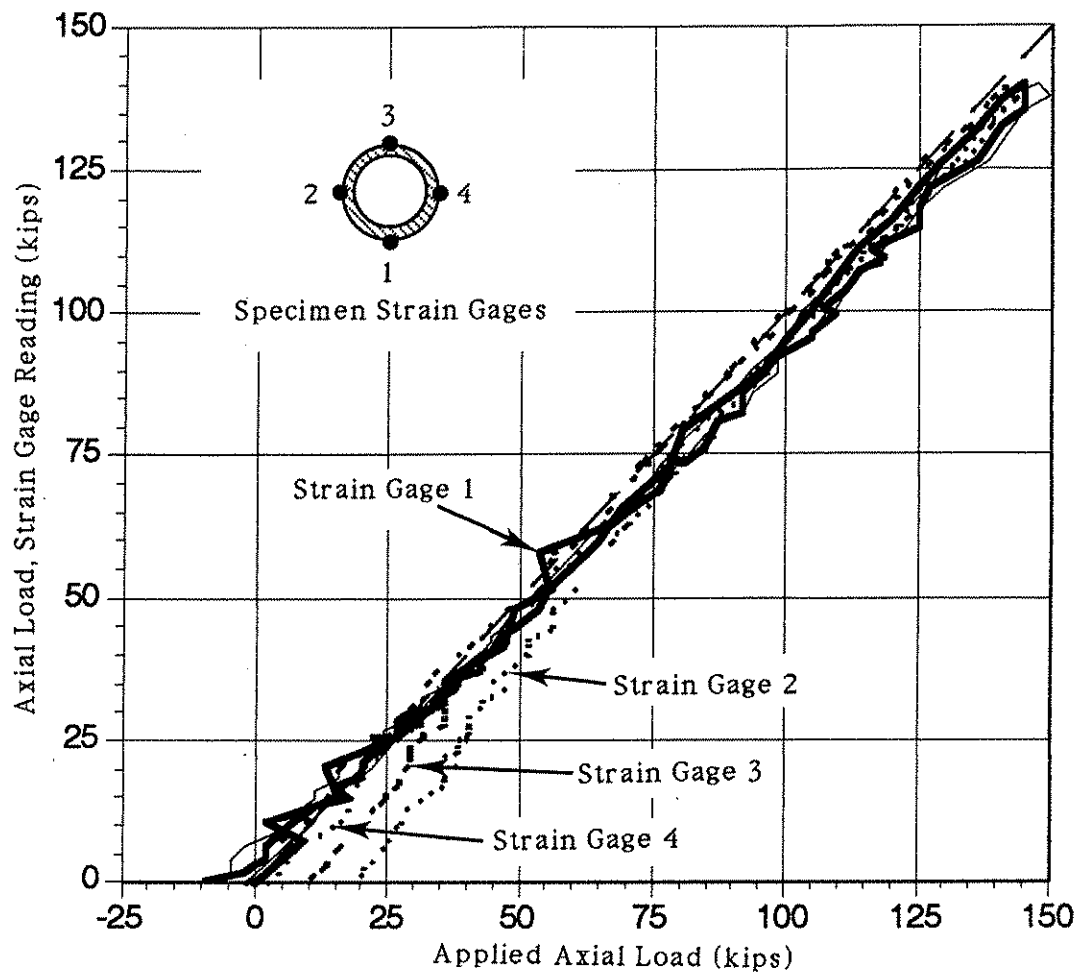
Figure 2.30. Verification of Monitored Load by Comparison of Load Cell Readings with Load Calculated from Measured Longitudinal Strains, Specimen A1.

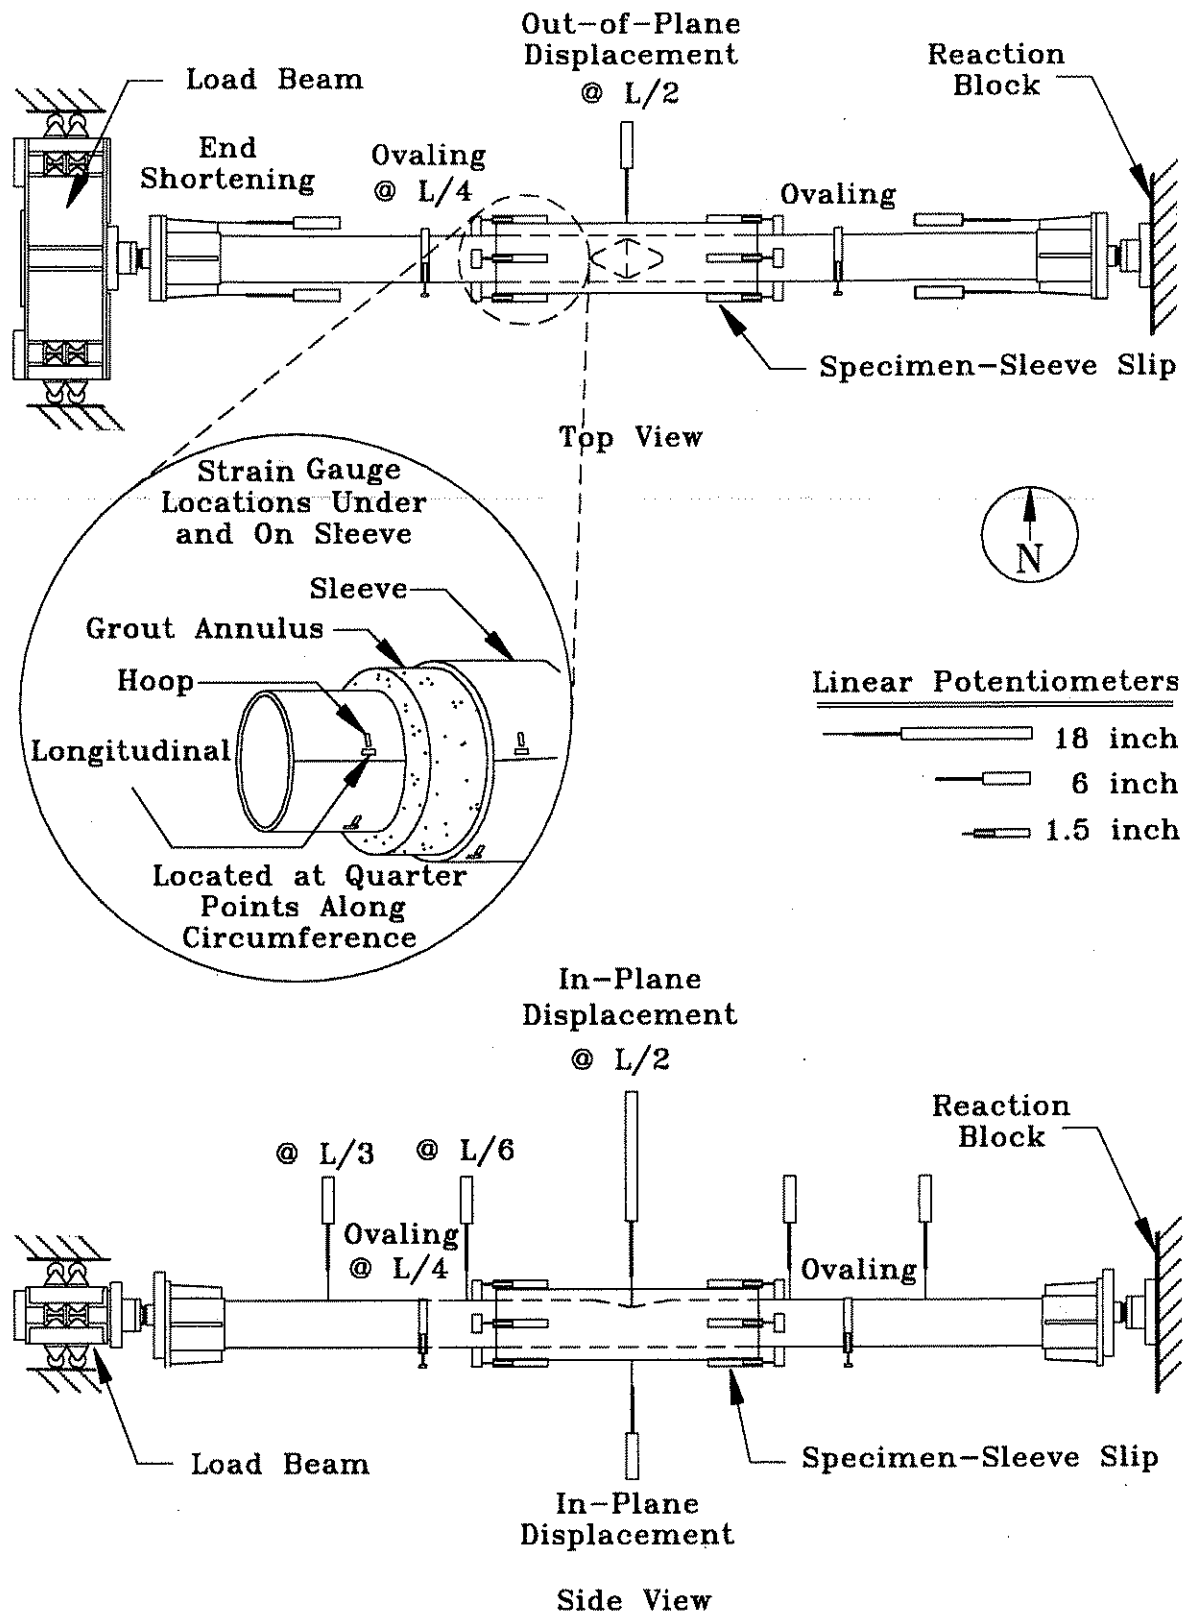
Figure 2.31. Instrumentation for Grouted Clamp Repaired Specimen C4.
