# **Residual Strength and Grout Repair of Dented Offshore Tubular Bracing**

**Phase 1 Study**

**ATLSS Report No. 92 -14**

**October 1992**

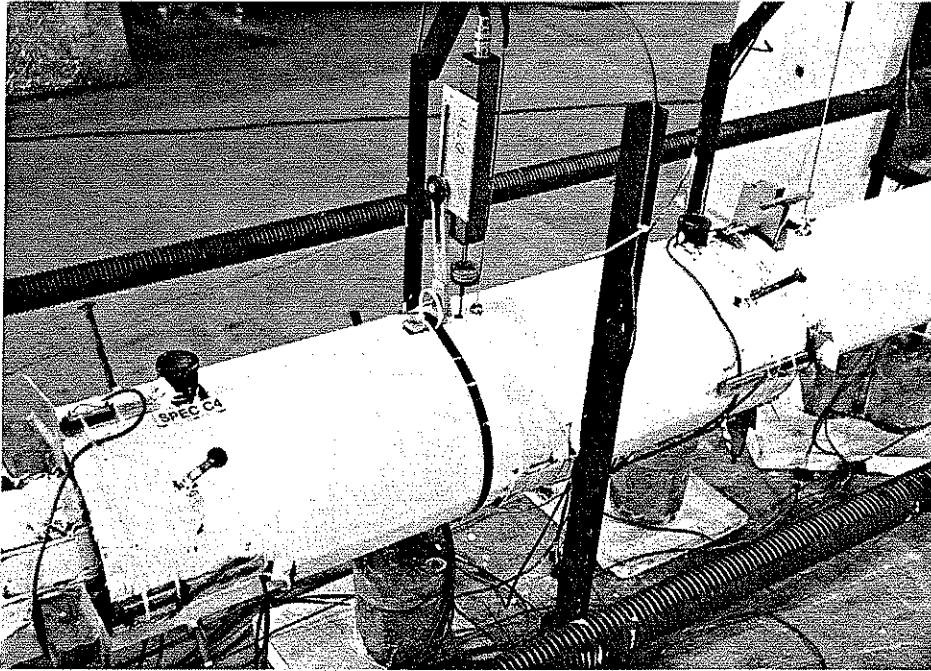
Figure 2.32. Instrumentation of grouted sleeve on Specimen C4.

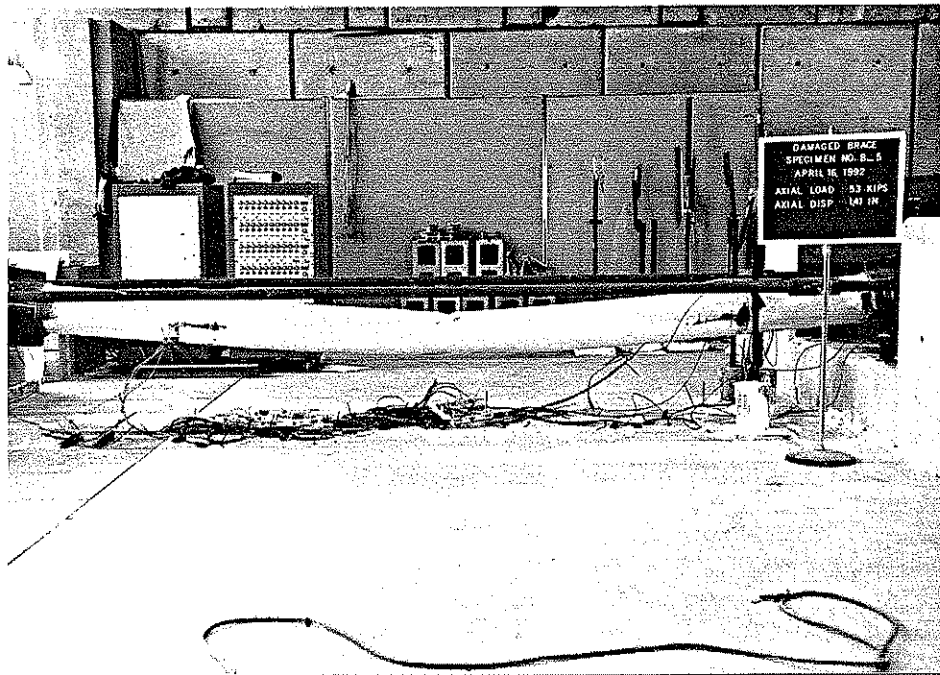
Figure 3.9. Displacement of Specimen B5 in the plane of bending following the formation of the local buckle and subsequent failure.

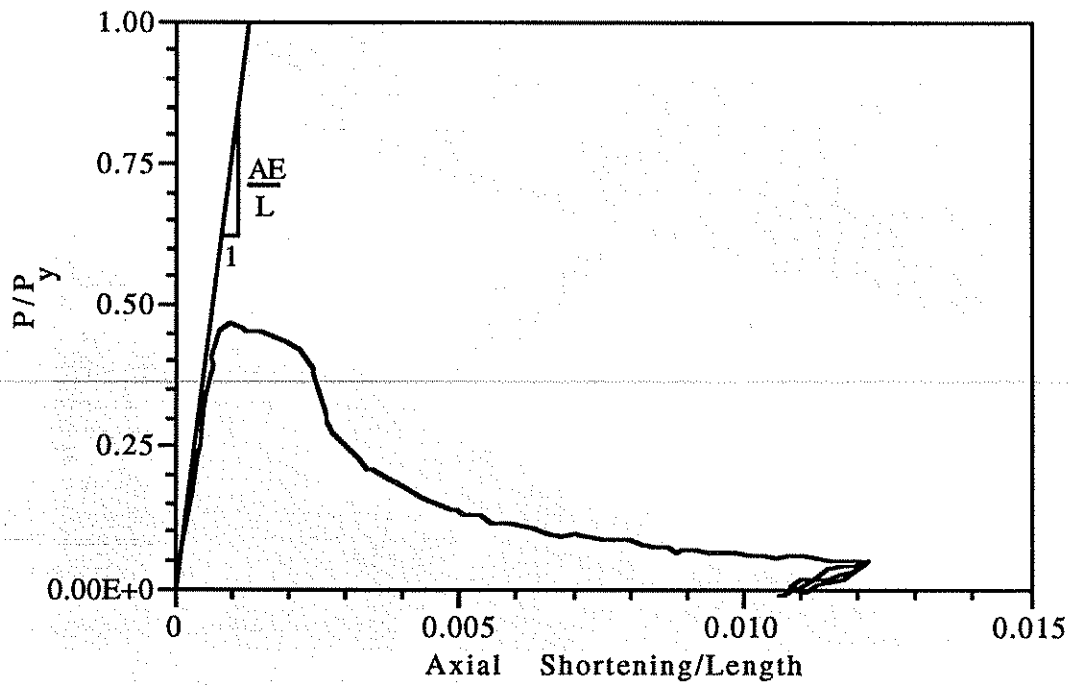
Figure 3.10. Axial Load - End Shortening Relationship for Specimen C5.

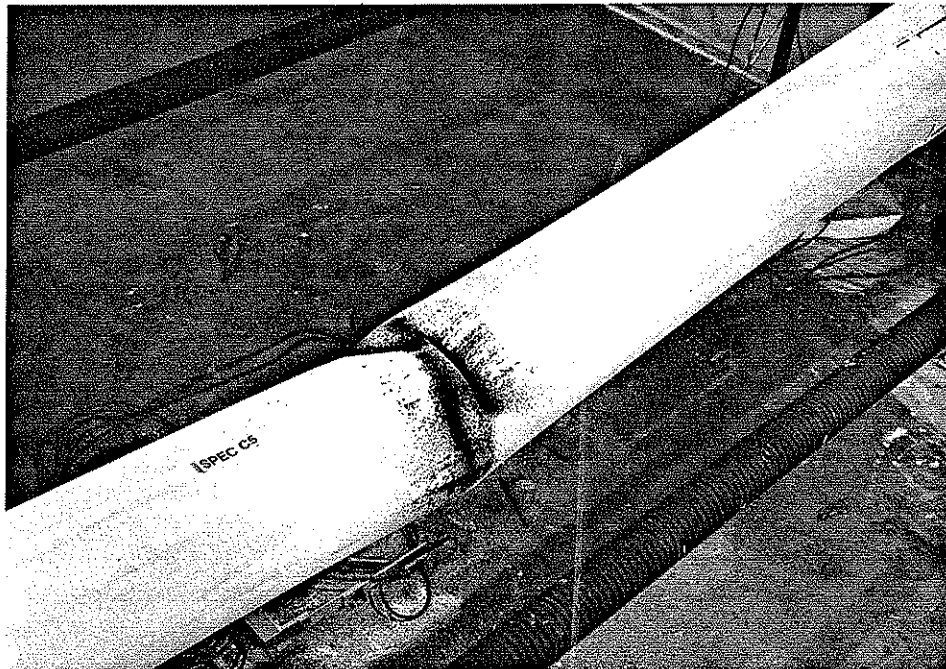
Figure 3.13. Deterioration of the buckled region following continued shortening.

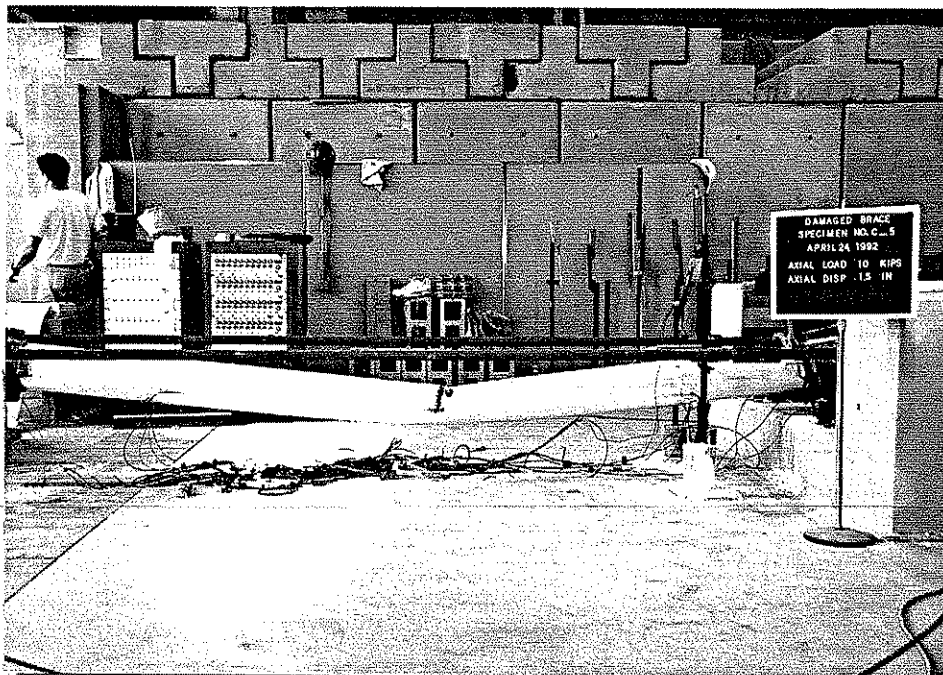
Figure 3.14. Corresponding in-plane displacement of Specimen C5 after continued shortening.

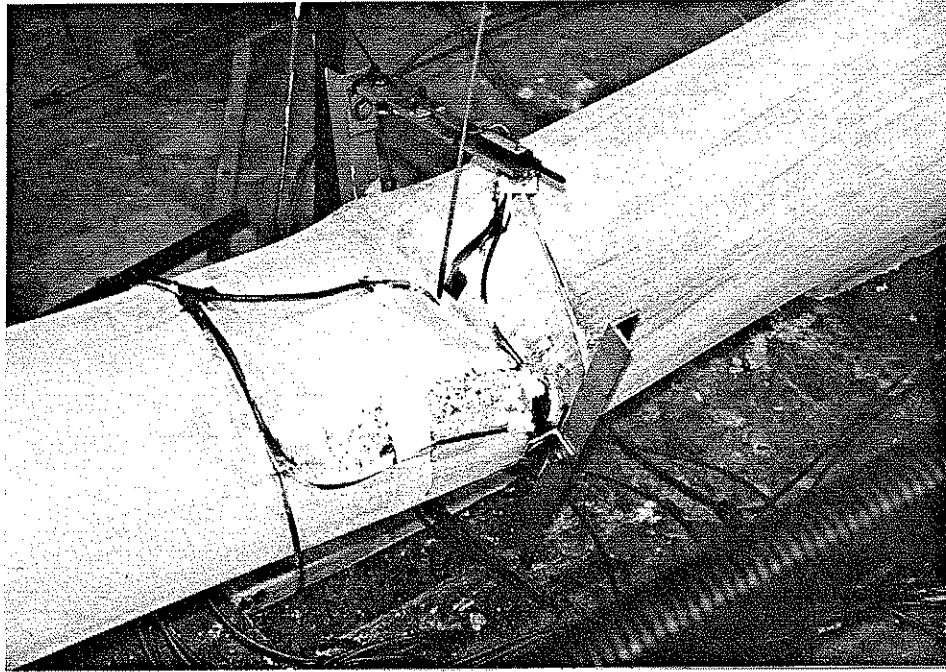
Figure 3.24. View of the deformed cross section after failure of Specimen A2.

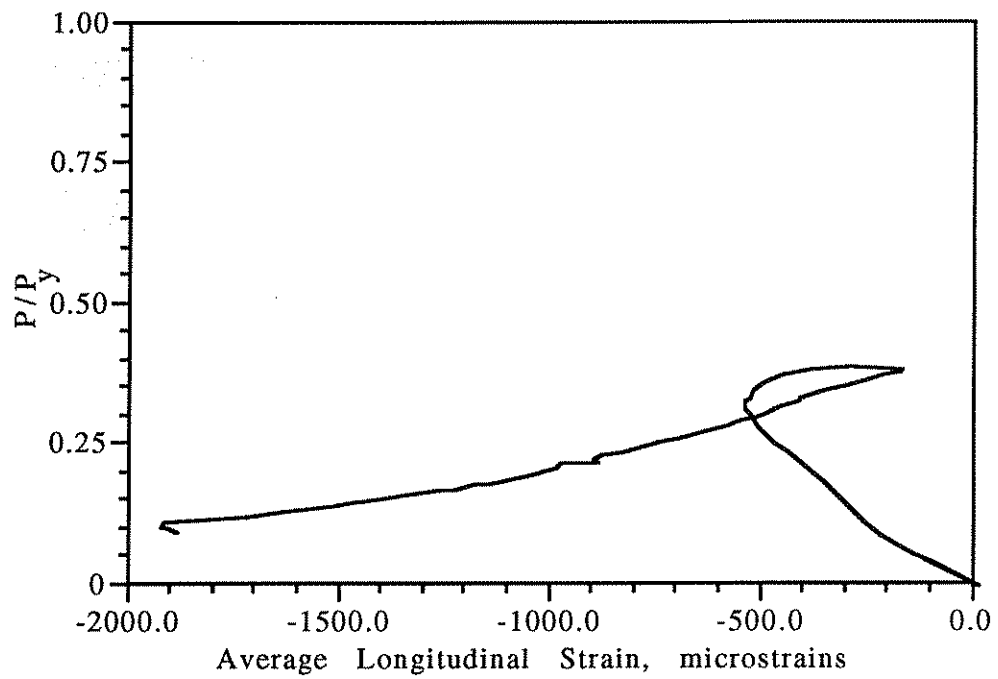
Figure 3.25. History of Longitudinal Strain in Dent for Specimen A2.

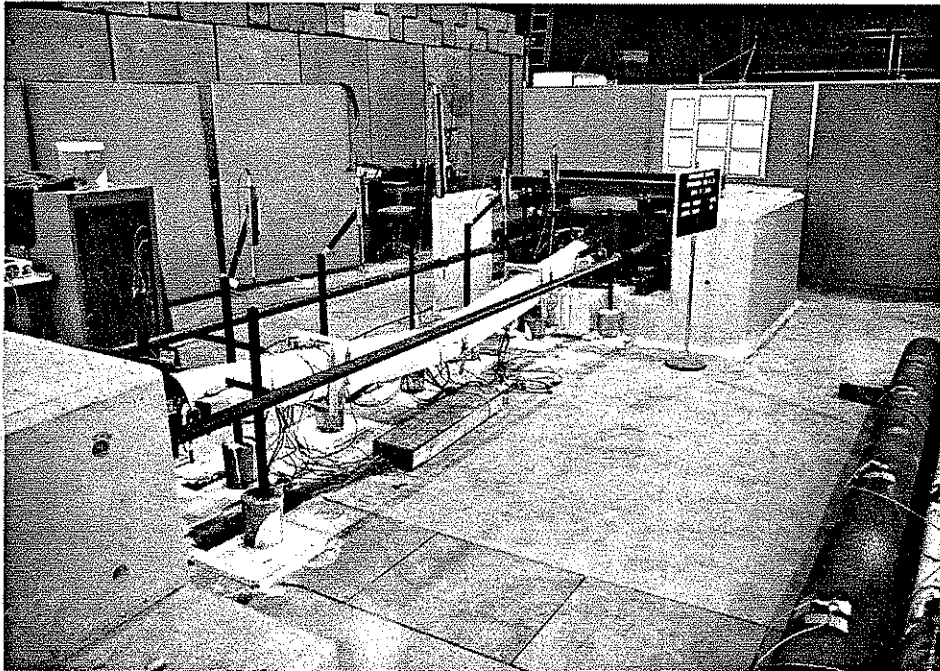
Figure 3.27. View of the failed Specimen A2 showing the concentration of curvature at the dented section.

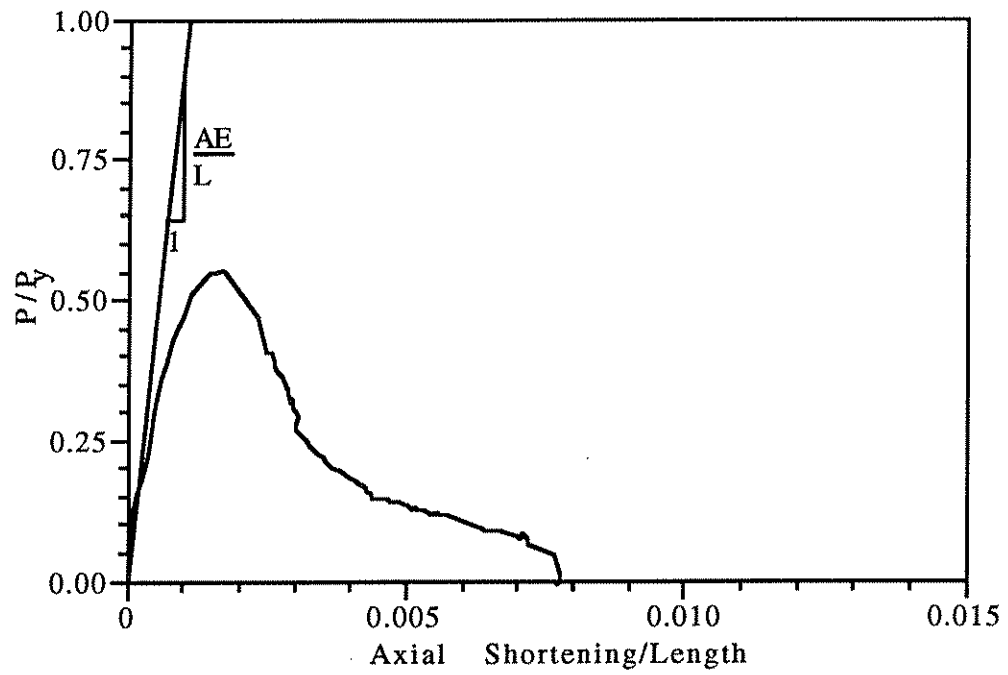
Figure 3.28. Axial Load - End Shortening Relationship for Specimen B1.

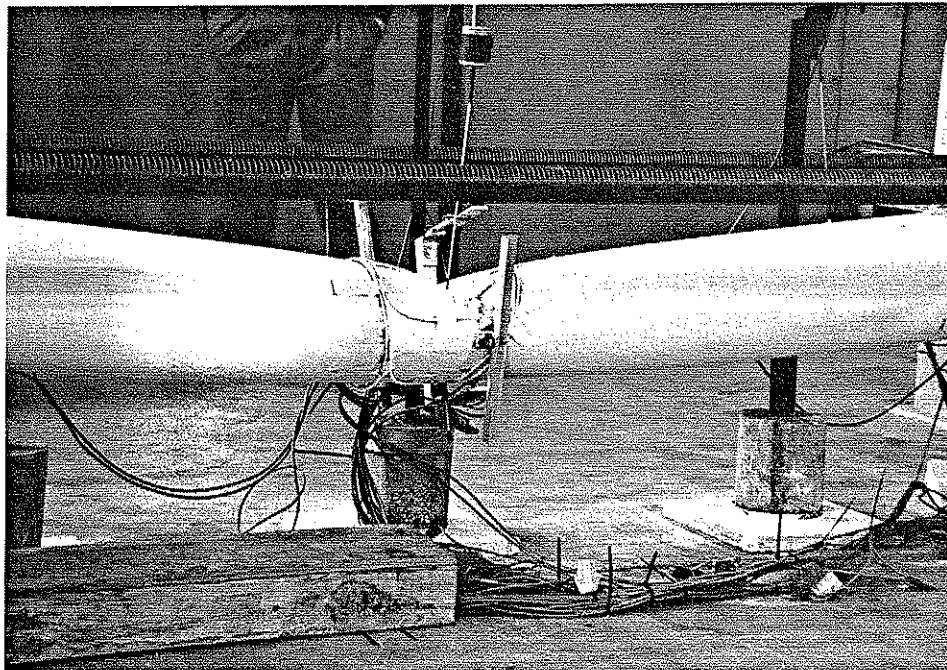
Figure 3.48. View of the Dented Section of Specimen C2 Following Failure.

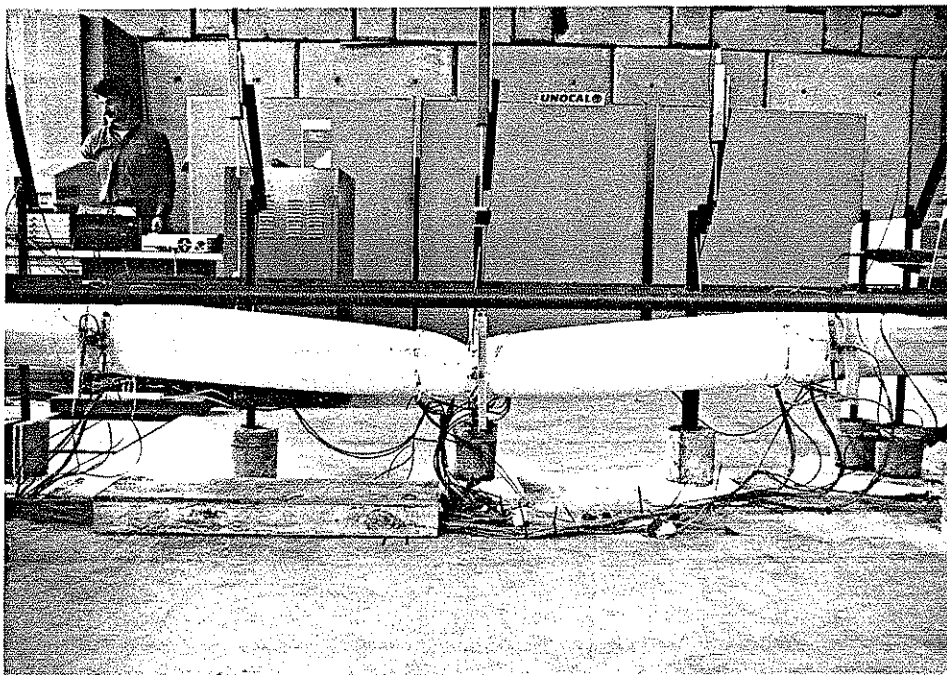
Figure 3.49. Formation of a Plastic Hinge Across the Dented Section of Specimen C2.

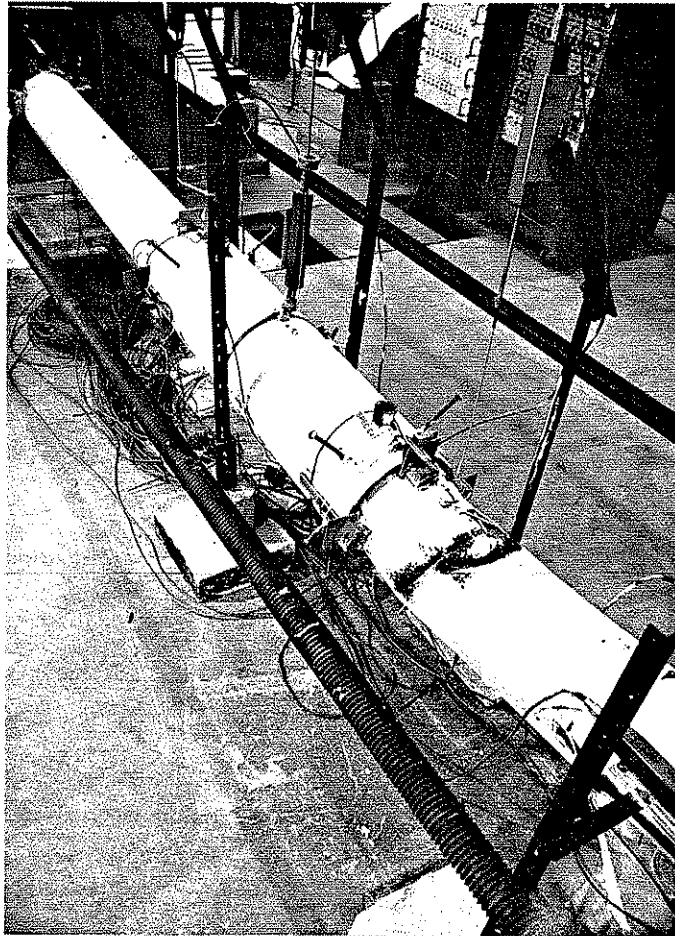
Figure 3.74. View of deteriorated buckled region outside of grouted clamp region.

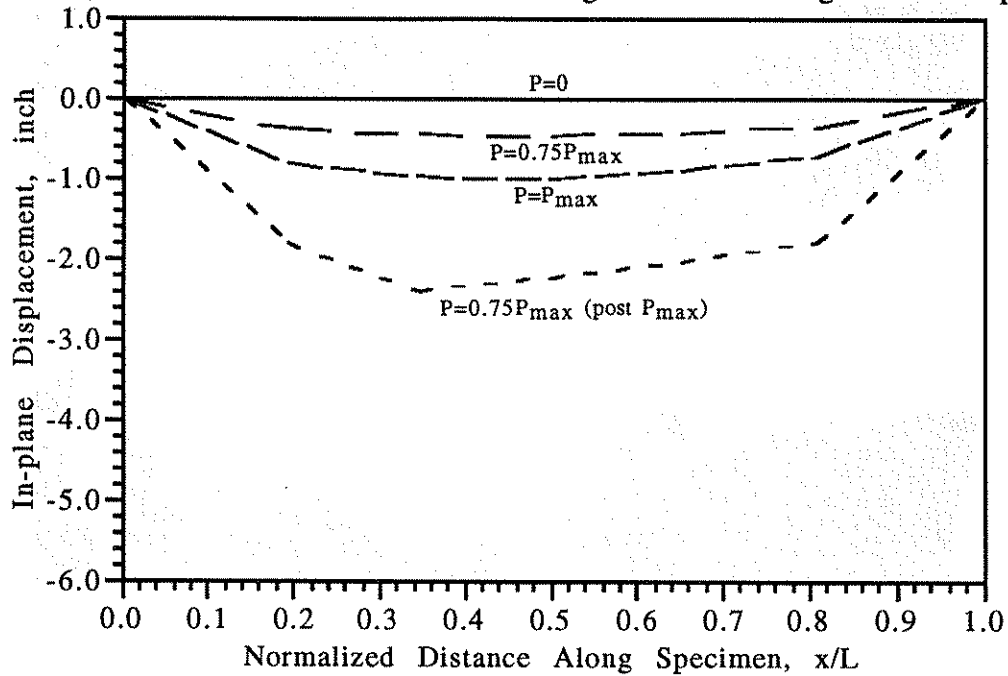
Figure 3.75. Measured In-plane Displacements of Specimen C4 at Various Stages of Loading.

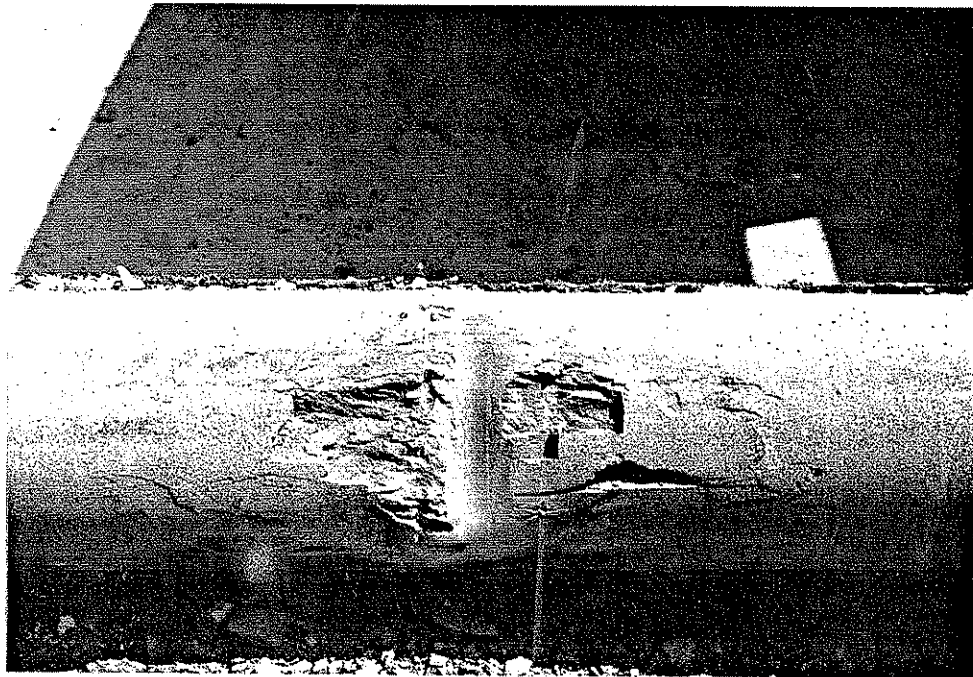
Figure 3.80. Closeup View of Exposed Grout Beneath Dent (a) Before, and (b) After Removing Loose Grout, Specimen A3.

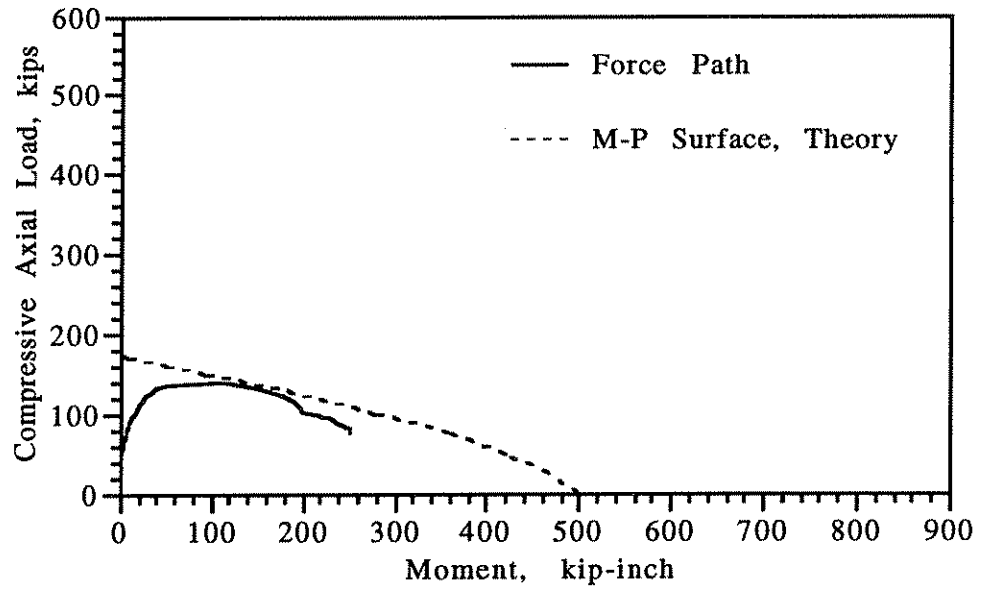
Figure 4.1. Moment-Axial Load Interaction, Specimen A1.

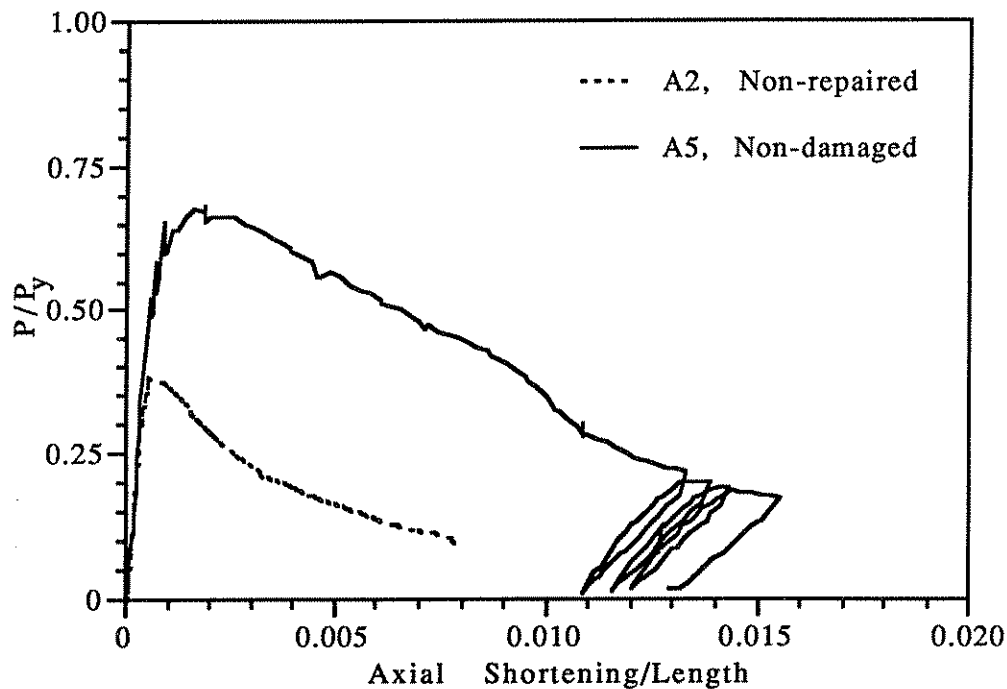
Figure 4.9. Axial Load - Shortening Relationship for Repaired and Unrepaired Specimens with  $D/t=34.5$ , Showing Loss in Capacity Due to Damage.

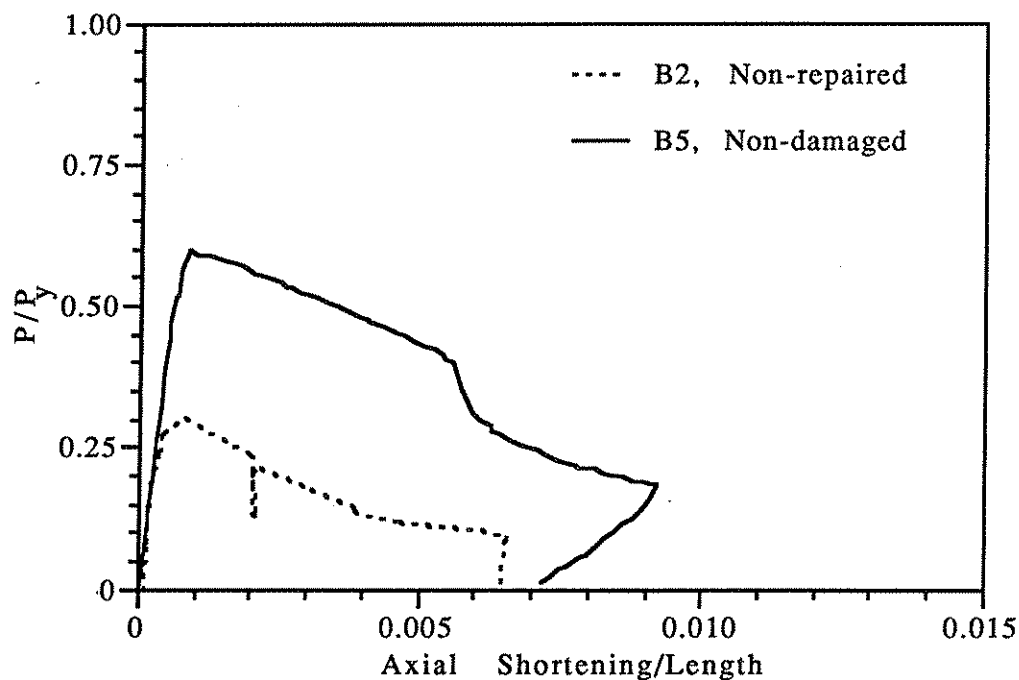
Figure 4.10. Axial Load - Shortening Relationship for Repaired and Unrepaired Specimens with  $D/t=46$ , Showing Loss in Capacity Due to Damage.

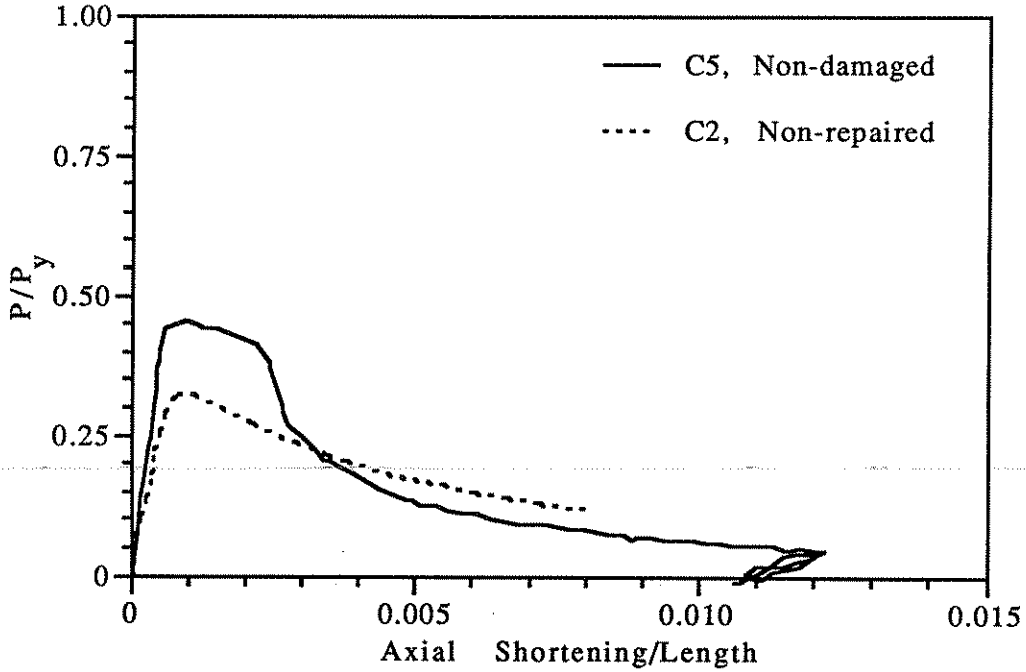
Figure 4.11. Axial Load - Shortening Relationship for Repaired and Unrepaired Specimens with  $D/t=64$ , Showing Loss in Capacity Due to Damage.

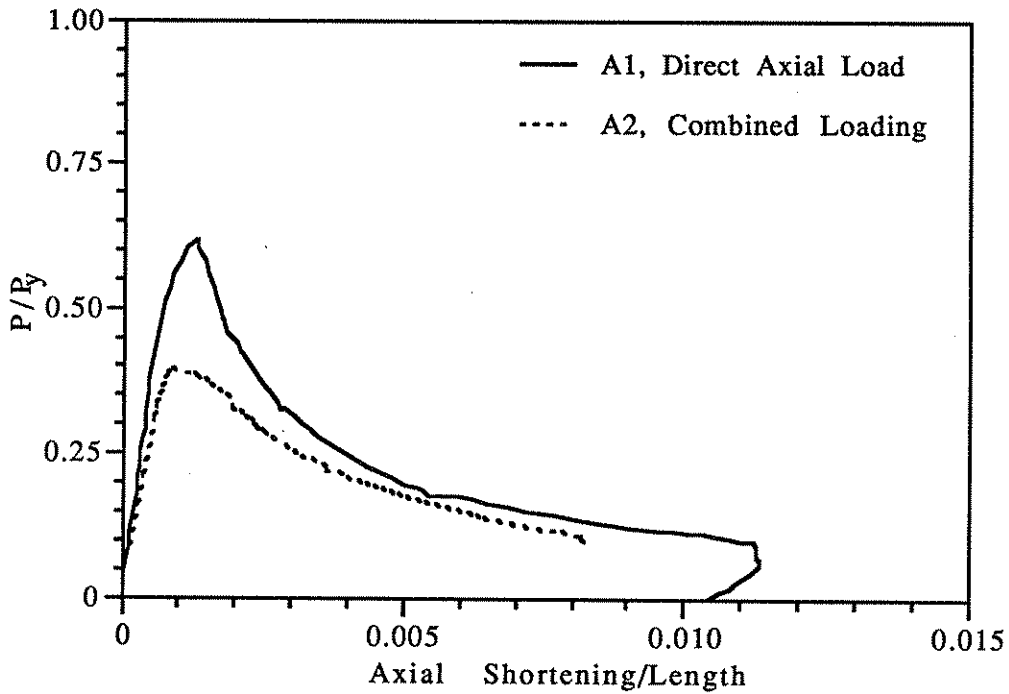
Figure 4.12. Axial Load - Shortening Relationship for Unrepaired Specimens with  $D/t=34.5$ , Showing Effect of Combined Loading.

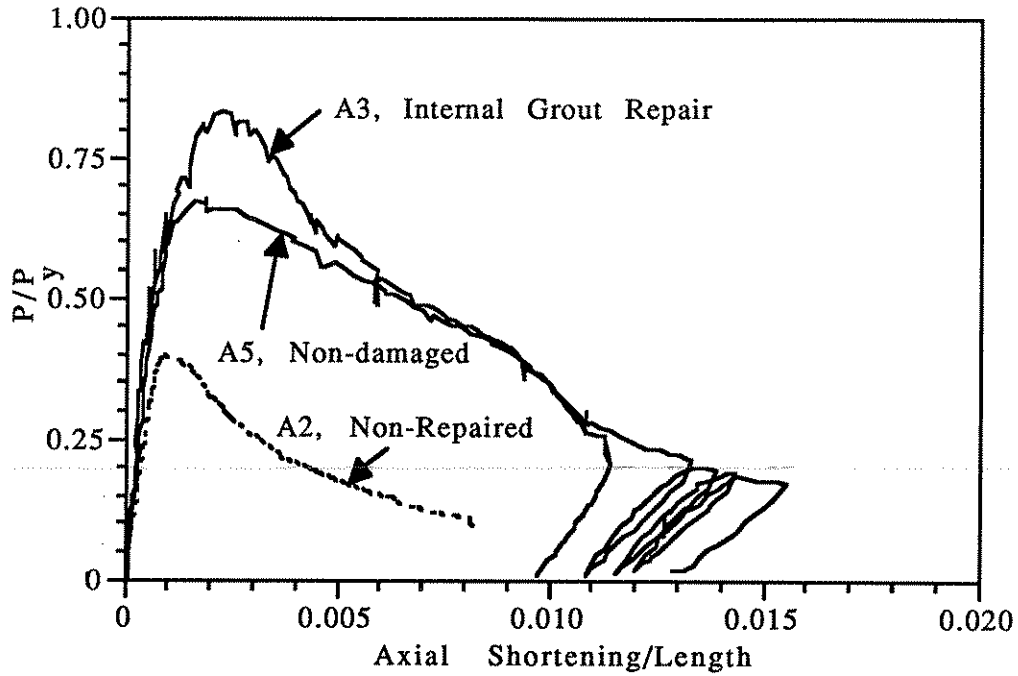
Figure 4.15 Axial Load - Shortening Relationship for Specimens with  $D/t=34.5$ , Showing Effectiveness of Internal Grout Repair .

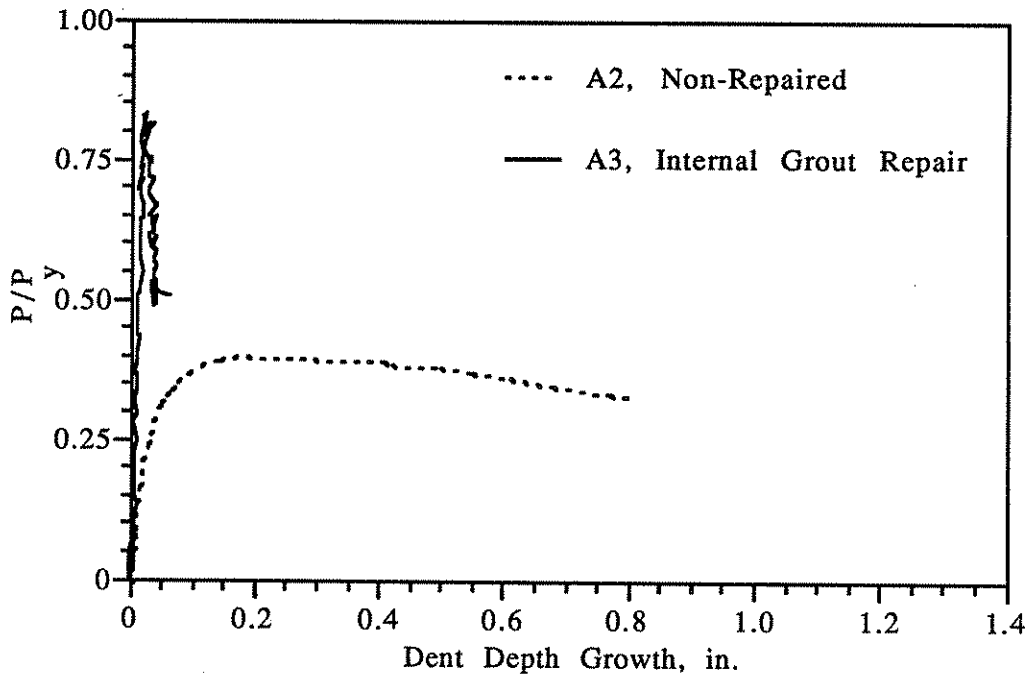
Figure 4.16 Axial Load - Dent Depth Relationship for Specimens with  $D/t=34.5$ , Showing the Arrest of Dent Growth by Internal Grout Repair .

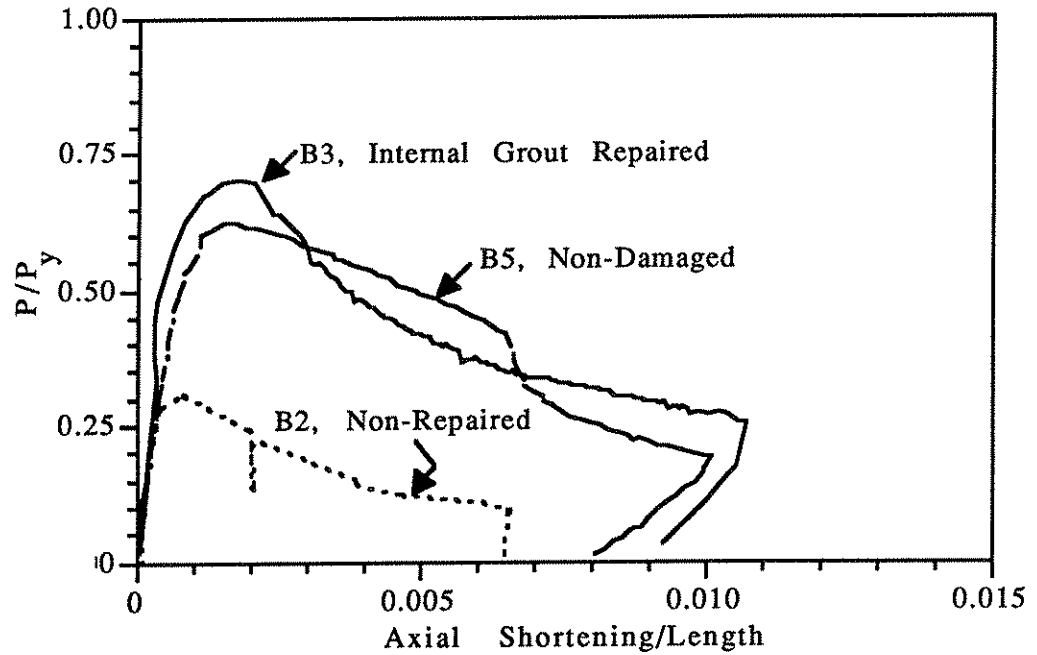
Figure 4.17 Axial Load - Shortening Relationship for Specimens with  $D/t=46$ , Showing Effectiveness of Internal Grout Repair.

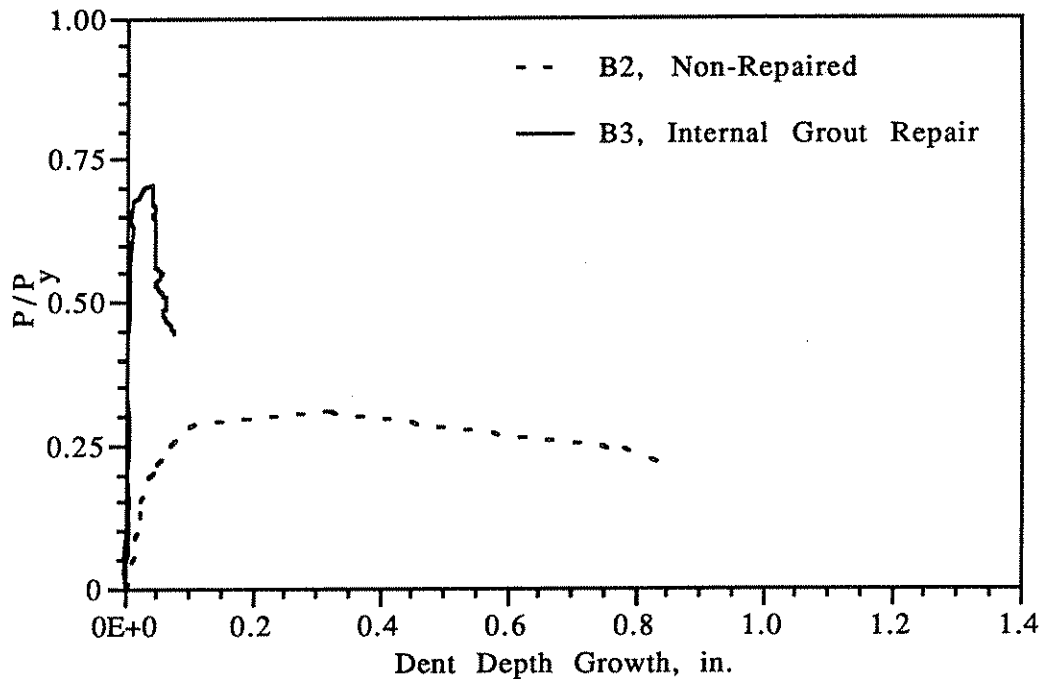
Figure 4.18 Axial Load - Dent Depth Relationship for Specimens with  $D/t=46$ , Showing the Arrest of Dent Growth by Internal Grout Repair .

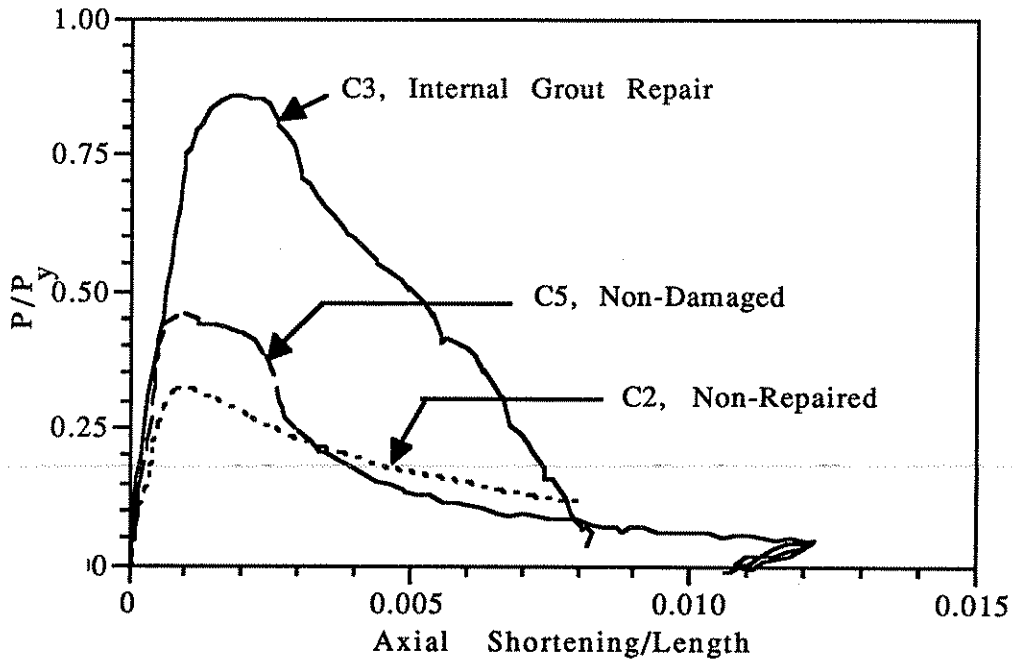
Figure 4.19 Axial Load - Shortening Relationship for Specimens with  $D/t=64$ , Showing Effectiveness of Internal Grout Repair.

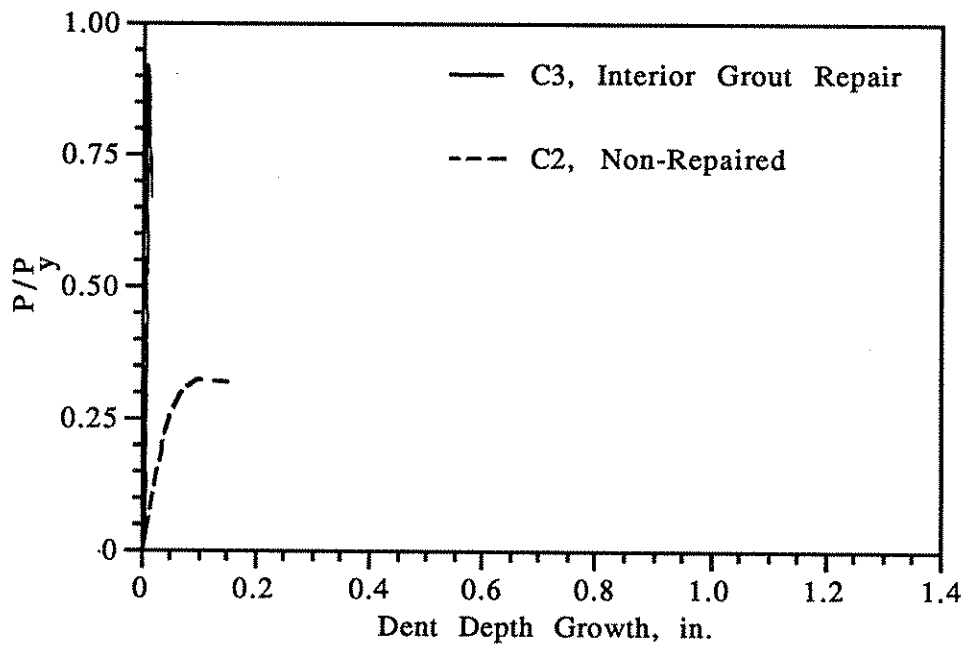
Figure 4.20 Axial Load - Dent Depth Relationship for Specimens with  $D/t=64$ , Showing the Arrest of Dent Growth by Internal Grout Repair .

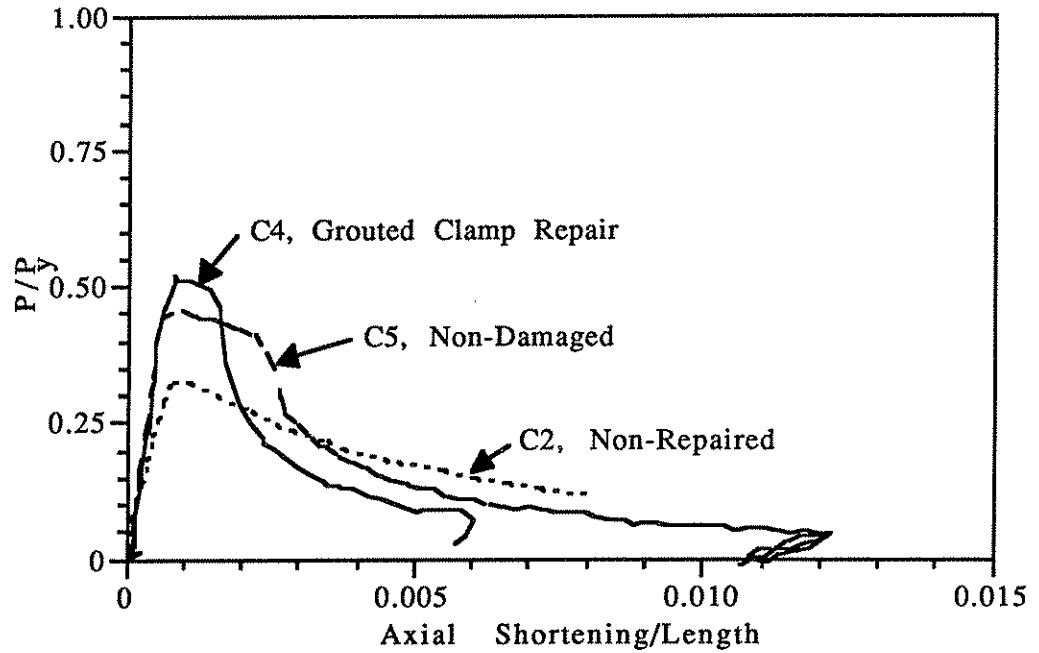
Figure 4.21 Axial Load - Shortening Relationship for Specimens with  $D/t=64$ , Showing Effectiveness of Grouded Clamp Repair.

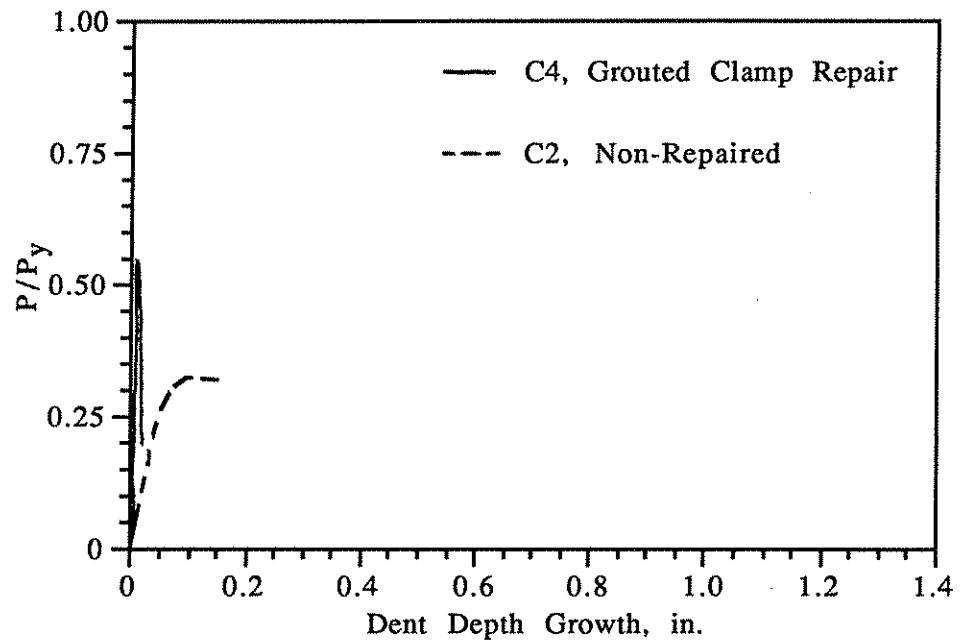
Figure 4.22 Axial Load - Dent Depth Relationship for Specimens with  $D/t=64$ , Showing the Arrest of Dent Growth by Grouded Clamp Repair .

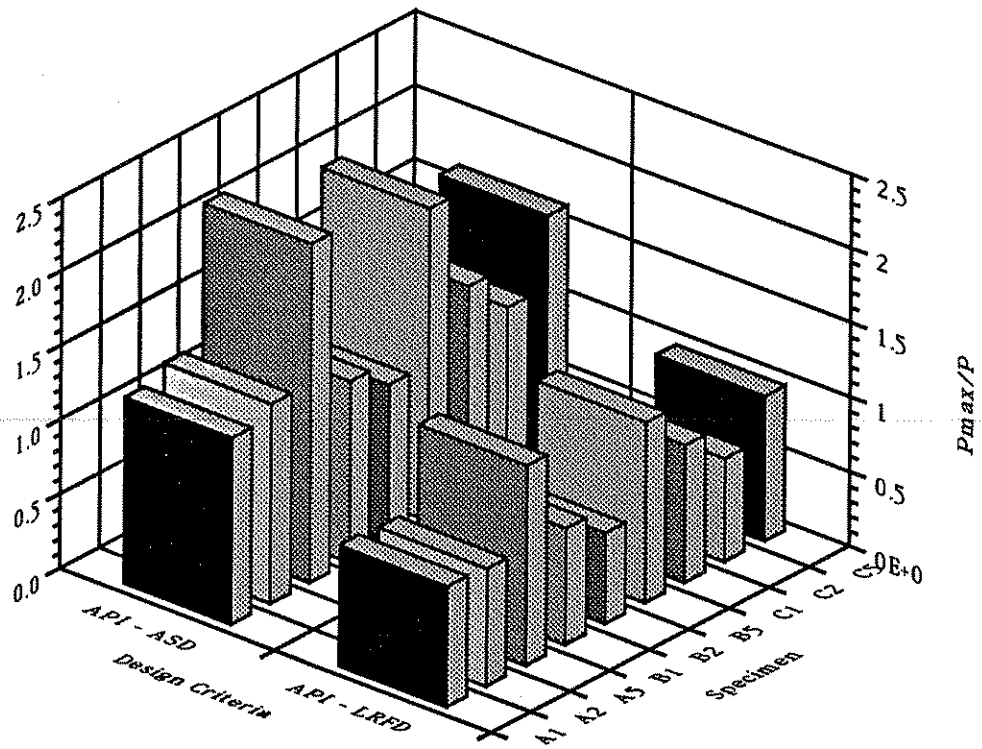
Figure 4.23. Comparison of API Design Criteria (P) With Specimen Capacity Pmax, Showing Reduced Margin of Safety for Damaged, Non-Repaired Specimens.

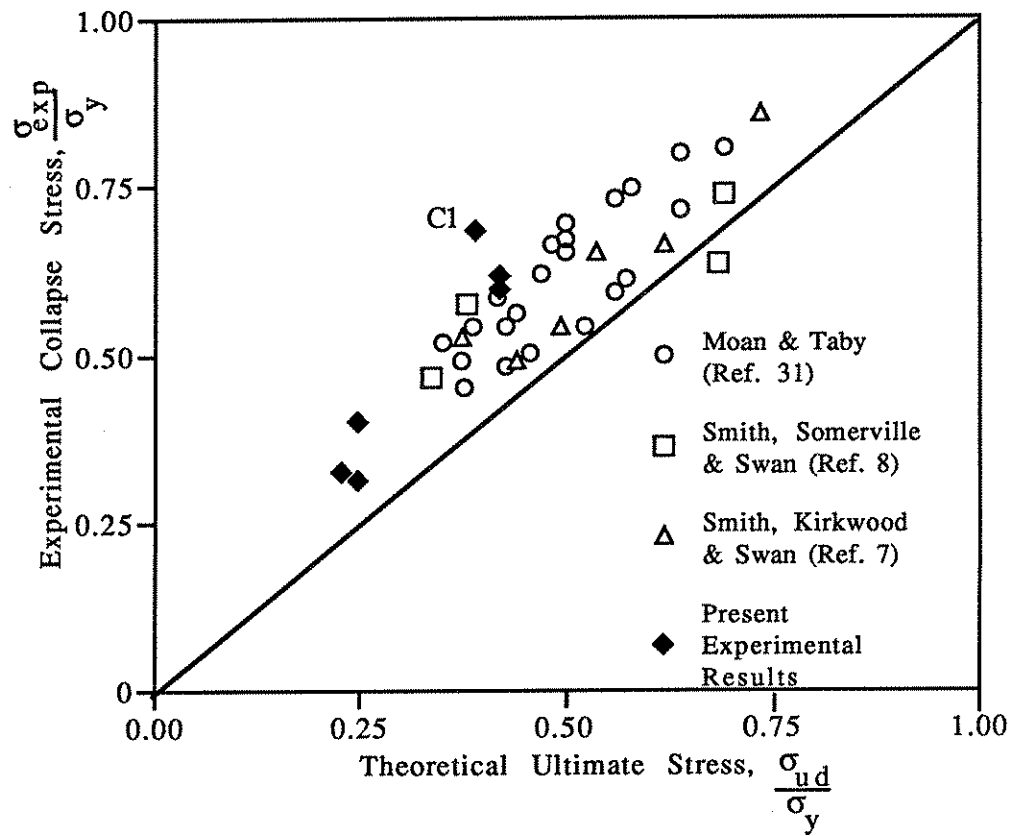
Figure 4.24. Comparison of Experimental Results With Modified Ellinas' Design Equation.

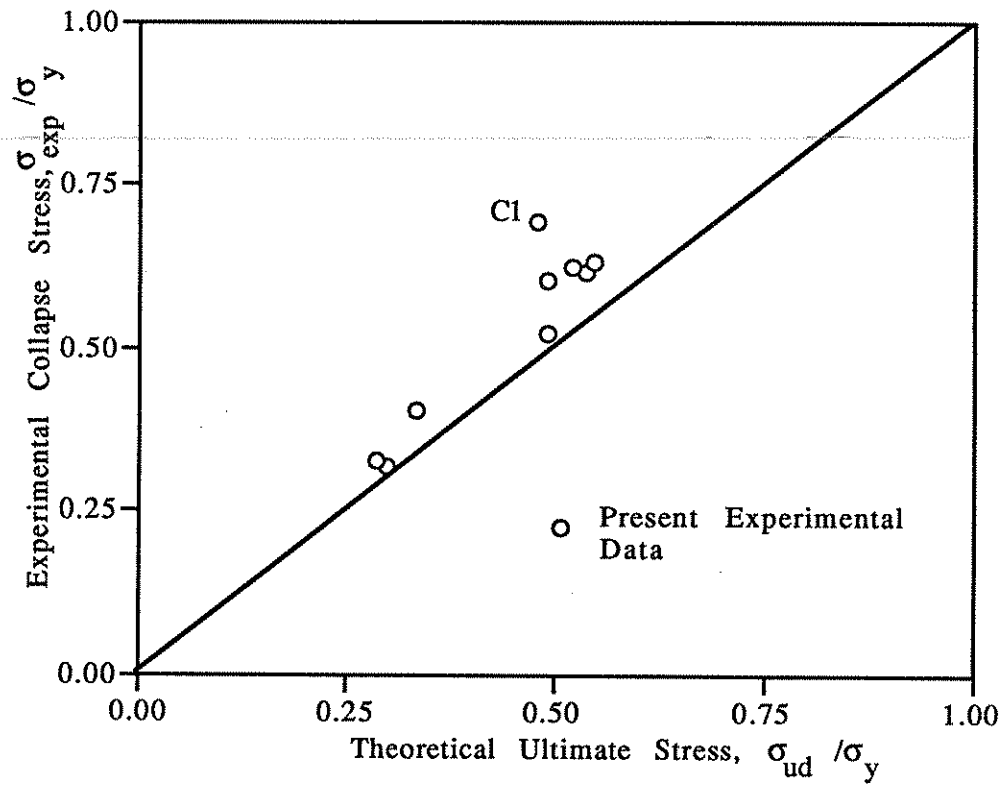
Figure 4.25. Comparison of Experimental Results with UC-DENT Analysis, Non-Repaired Members.

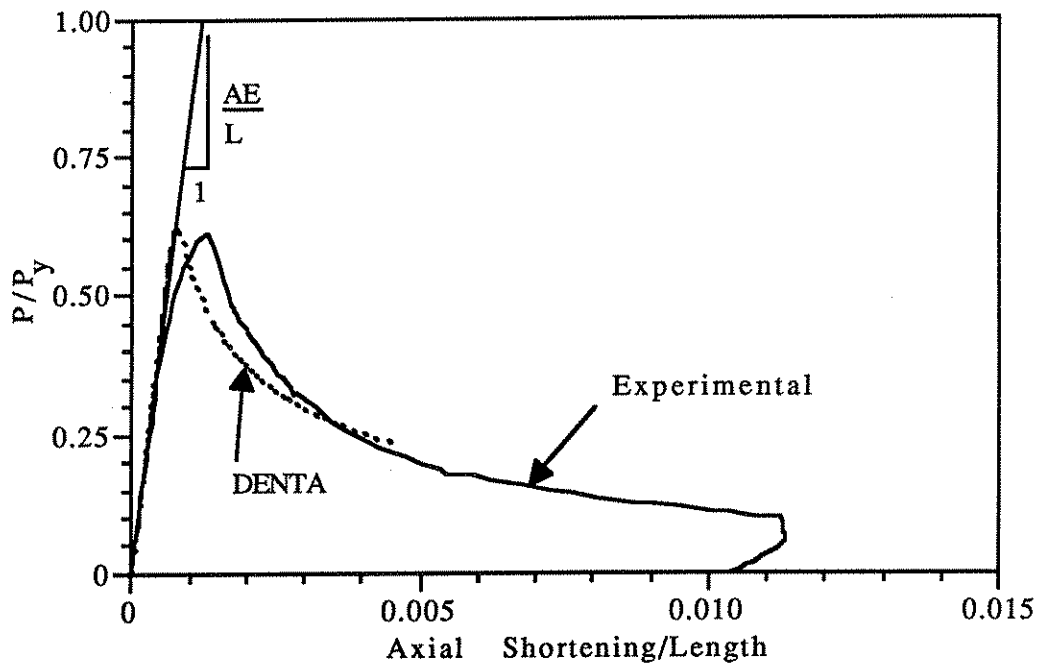
Figure 4.26. DENTA and Experimental Comparisons for the Axial Load - Shortening Relationship of Specimen A1.

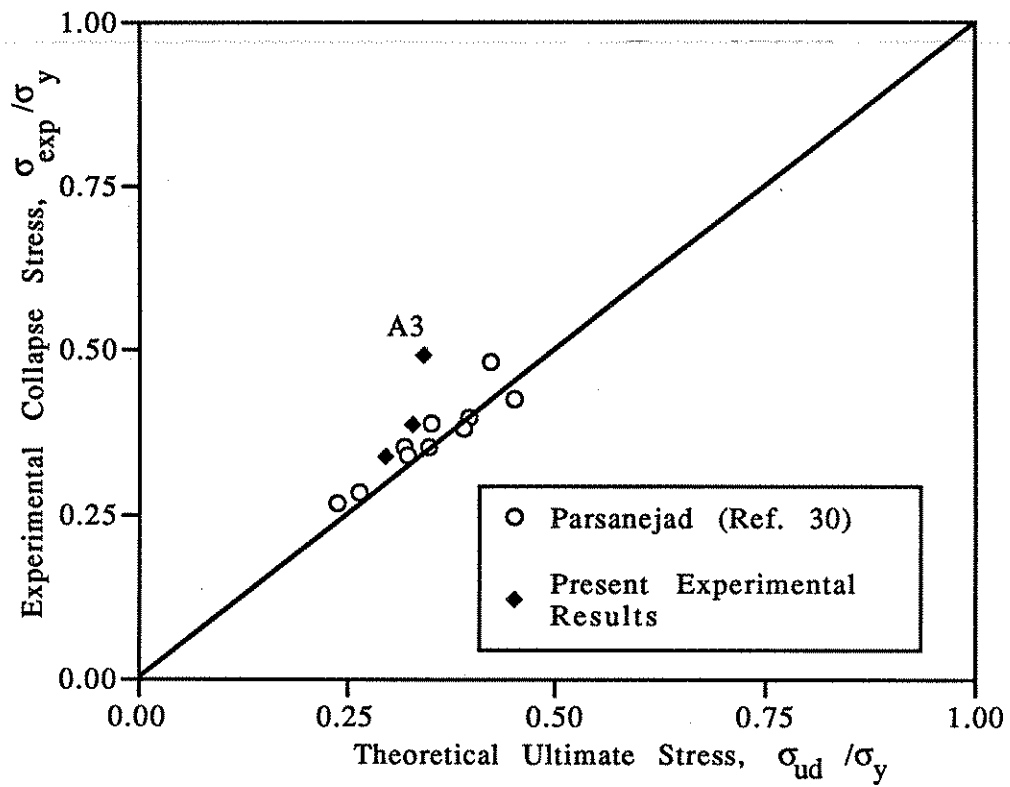
Figure 4.32. Comparisons of Experimental Results with Parsanejad's Method, Internally Grout Repaired Members.
