# **Residual Strength and Grout Repair of Dented Offshore Tubular Bracing**

**Phase 1 Study**

**ATLSS Report No. 92 -14**

**October 1992**

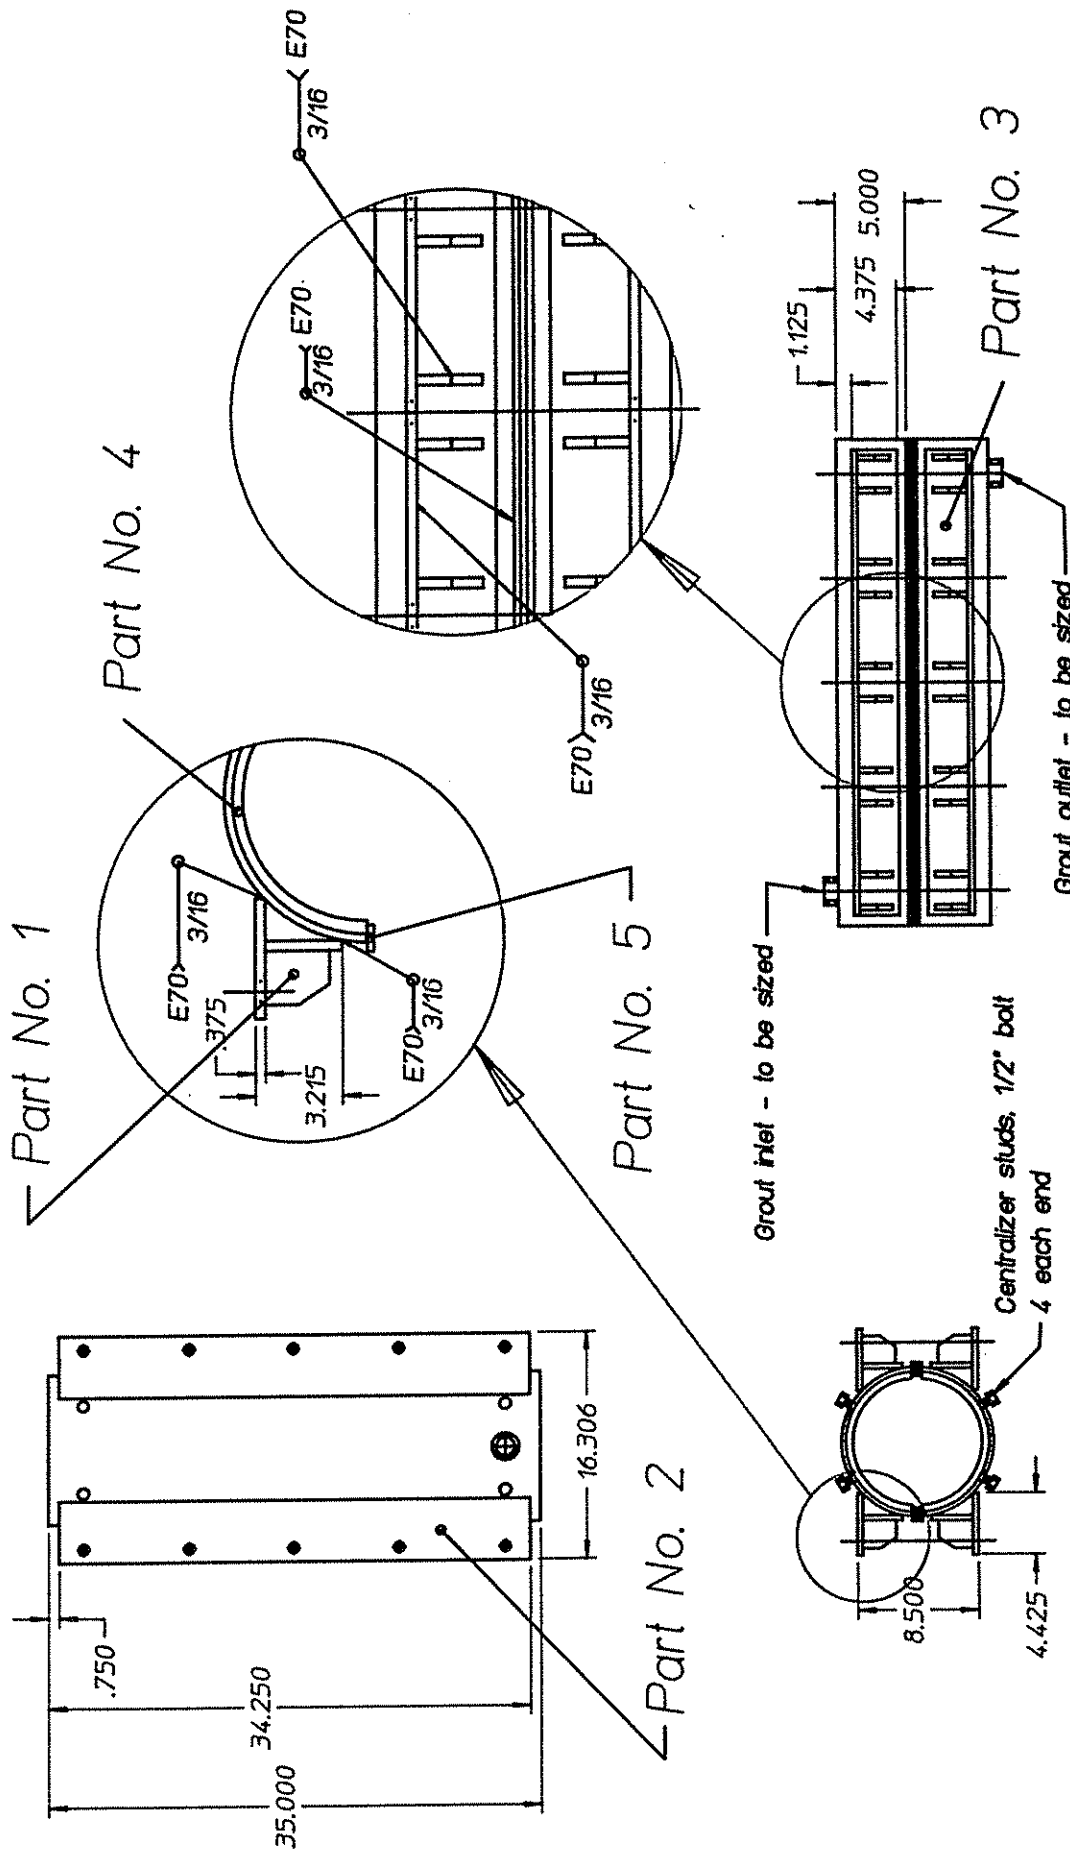
# Exterior Clamp for Repair of Damaged Brace

1. Cut length of clamp (Carbon ERW Pipe with 42 ksi yield stress).
2. Cut slice along both sides of clamp, leaving a 2 inch length of material at each end uncut.
3. Tack weld small temporary plates across slice, spaced at 16 inches.
4. Weld stiffeners and plates of clamp (Part No. 1, 2, and 3), using a symmetric placement sequence to minimize distortion to clamp body due to welding.
5. Place one ring stiffener (Part No. 4) at each end of clamp.
6. Check fitup of clamp with member to be repaired, using a member of 8.625 in. outside diameter.
7. Cut clamp into two pieces, by removing remaining material along slices and temporary plates.
8. Place slice bearing plates (Part No. 5), using a symmetric placement sequence to minimize clamp distortion due to welding.
9. Recheck clamp fitup.

Note: All dimensions in inches

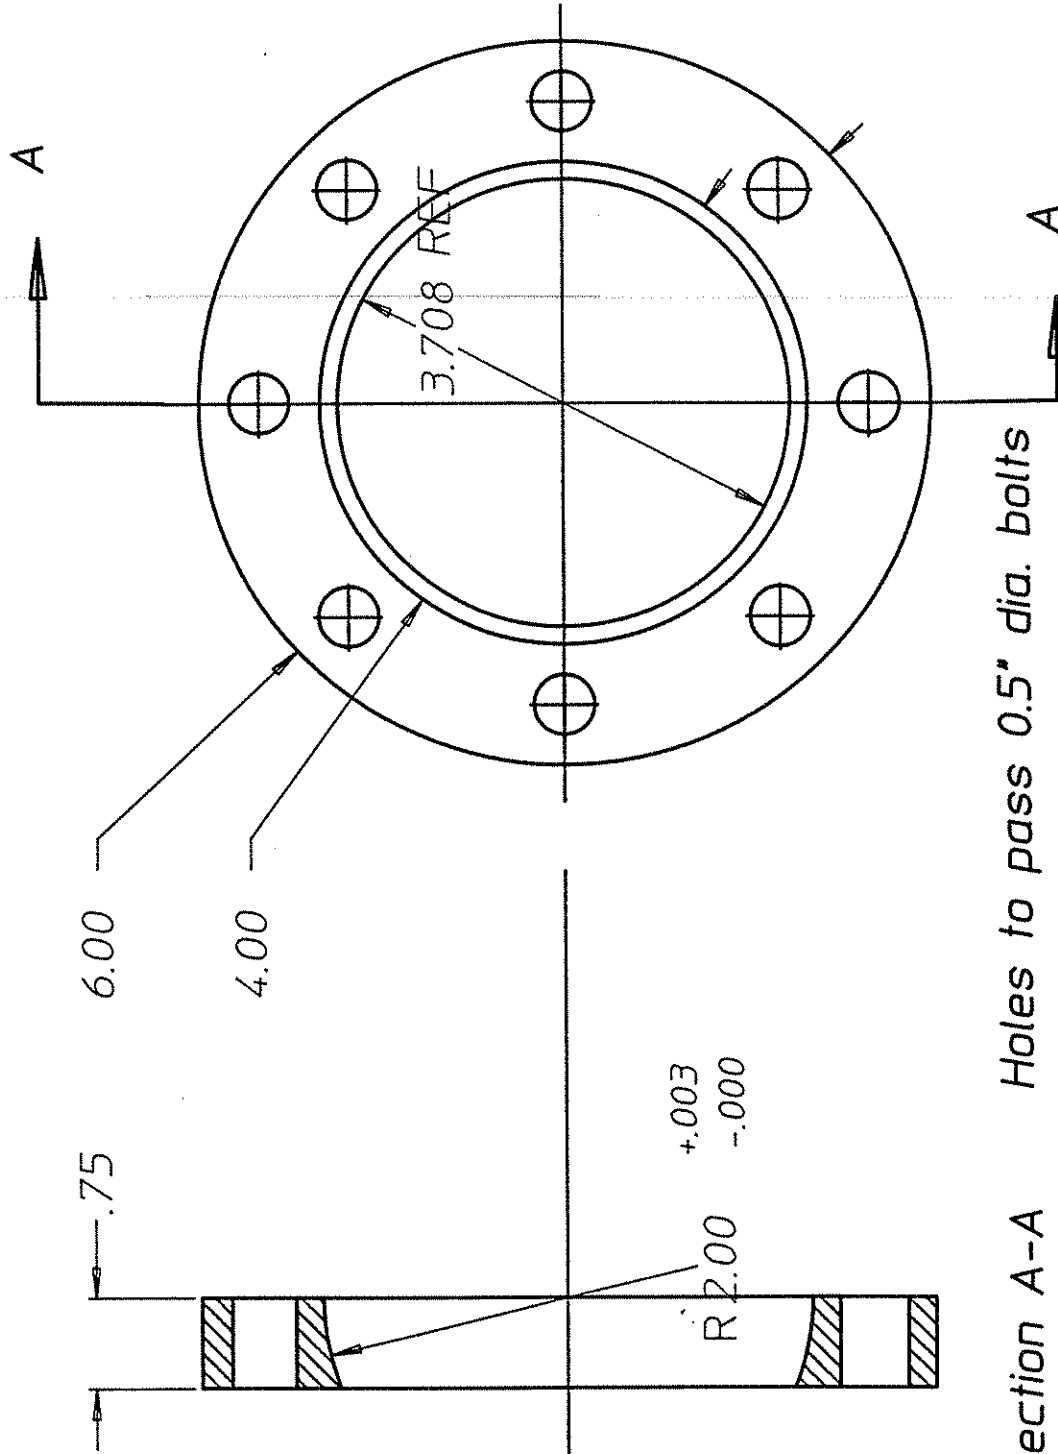
section A-A Holes to pass 0.5" dia. bolts

MATERIAL: A36 STEEL, 2 REQUIRED

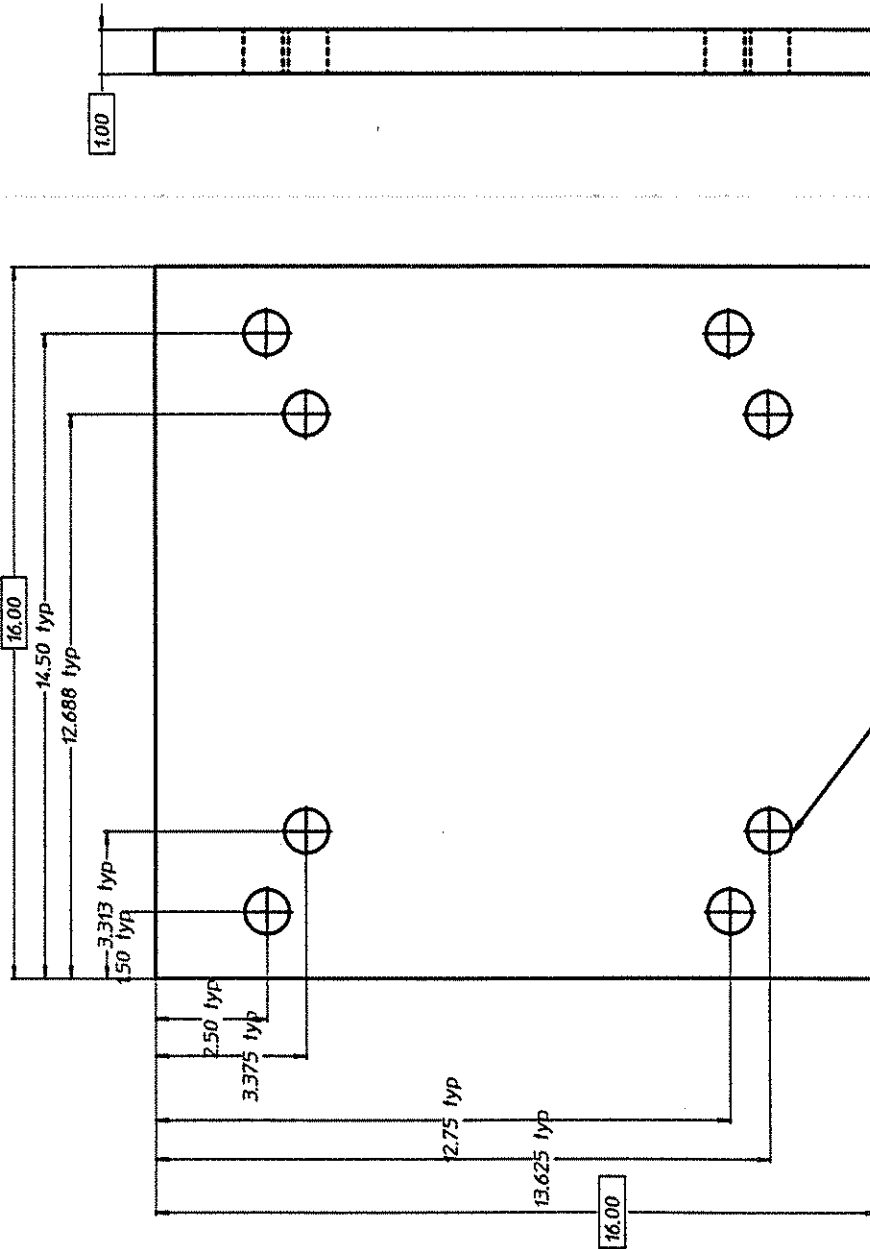
Holes to pass 1" bolt

MATERIAL: A36 STEEL, 2 REQUIRED		FILE NAME	b-plate-b
APPROVED BY	BUDGET #	DRAWING #	part no. 6
REVIS	FAB #

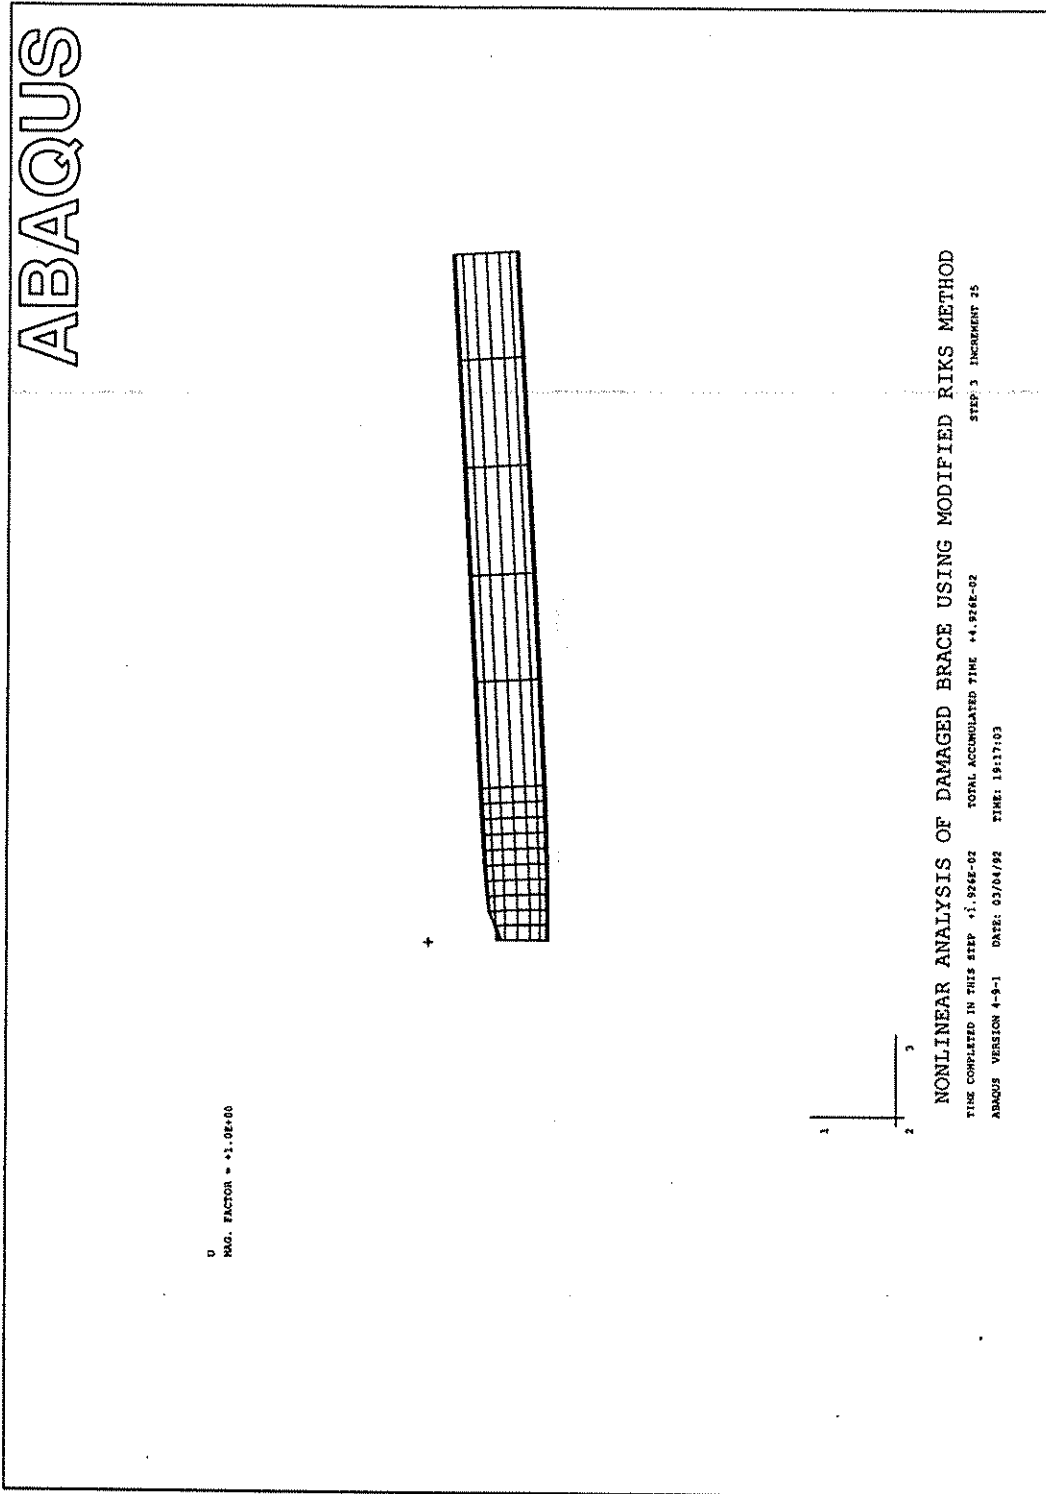
Figure G.3 Deformed Mesh in Step 3, Near Peak Axial Load.

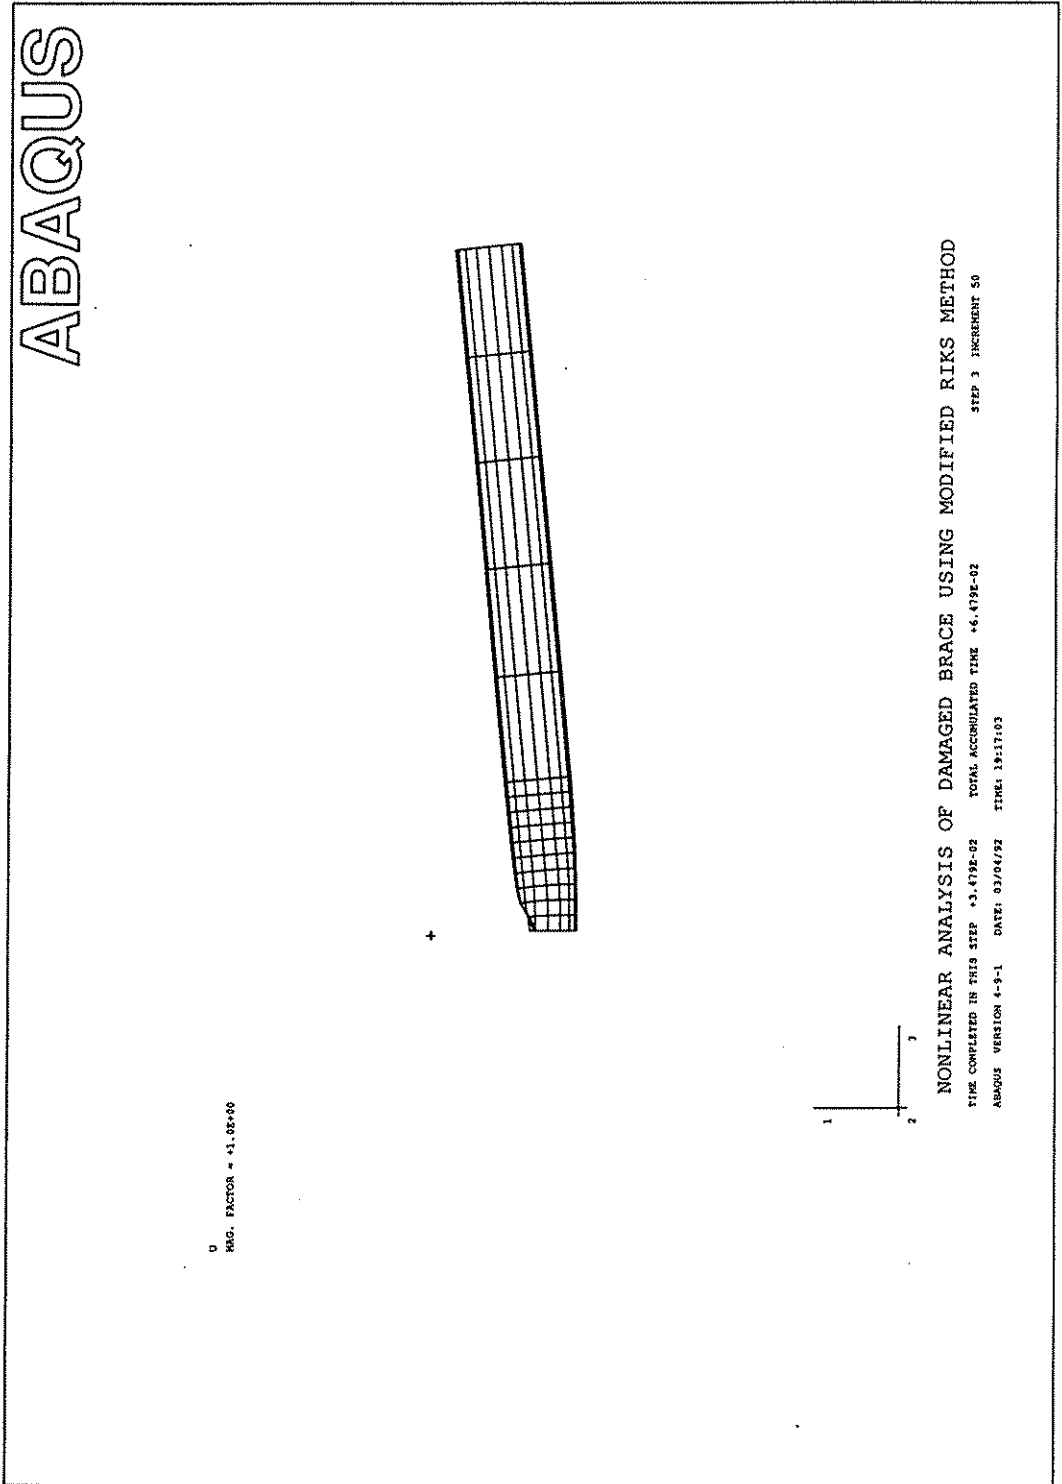
Figure G.4 Deformed Mesh in Step 3, At Deformation Beyond Peak Load.
