Investigation of the Impact of Environmental Conditions on Field Welded Precast Concrete Connections

PCI RESEARCH PROJECT

Investigation of the Impact of Environmental Conditions on Field Welding of Precast Concrete Connections

ATLSS REPORT NO. 07-03

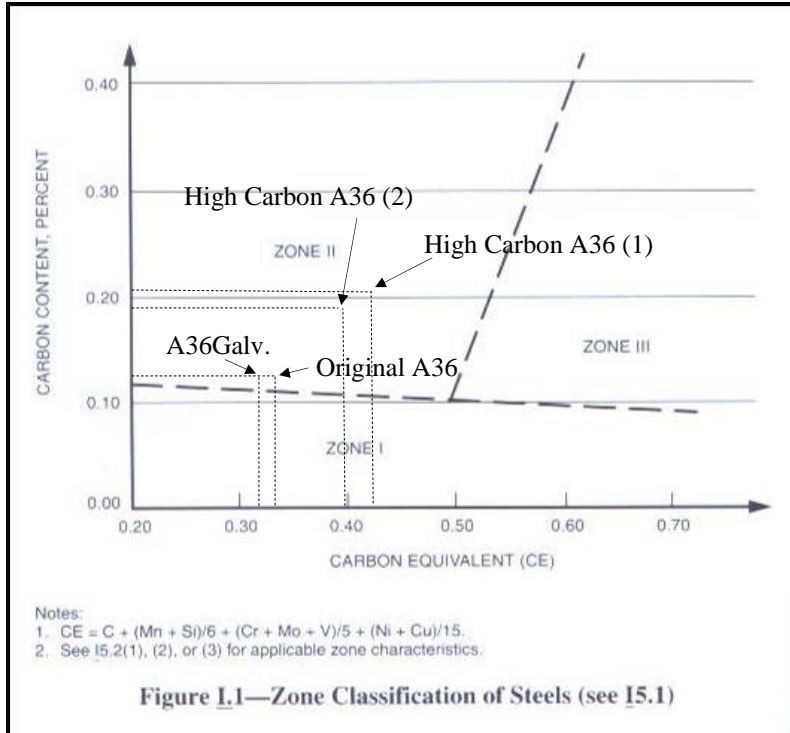
Figure 3.4: AWS Steel Carbon Classification⁴

The carbon content and carbon equivalent of all of the carbon steel plates are plotted on Figure 3.4 to provide a means of comparison of the steels with regard to their sensitivity to cracking.

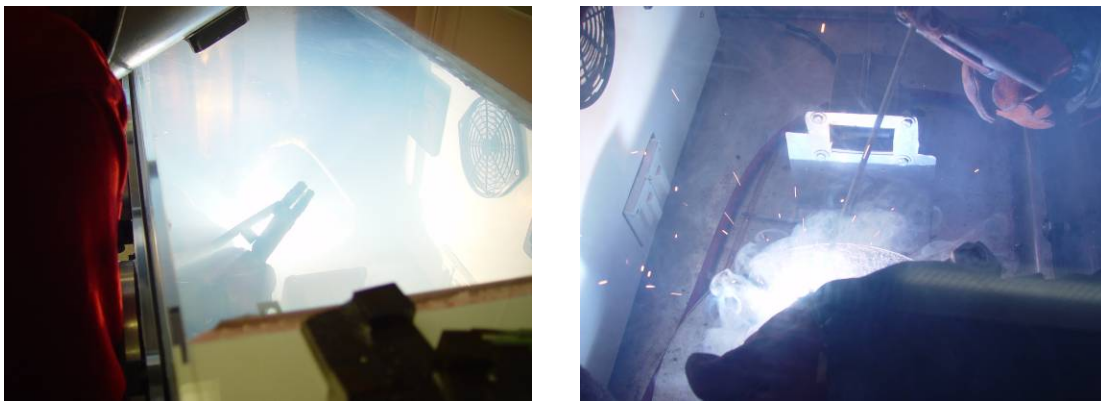
Figure 3.6: Welding Process

Within the chamber, the ambient temperature and relative humidity were controlled, with the ability to create temperatures as low as -18°F [-27.8°C] and relative humidity from approximately 35%RH to 100%. Wind was simulated with a variable powered centrifugal blower with air flow in a direction transverse to the fillet weld (normal to weld axis). The fan was configured to achieve wind speeds ranging from 0 to 35 mph at the weld, with the wind being applied at a nominal distance of 6-in. from the fillet weld. Airflow remained unobstructed by the welder during welding, as can be seen in the right most image of Figure 3.6, where the welding is underway and the fan orifice can be seen.

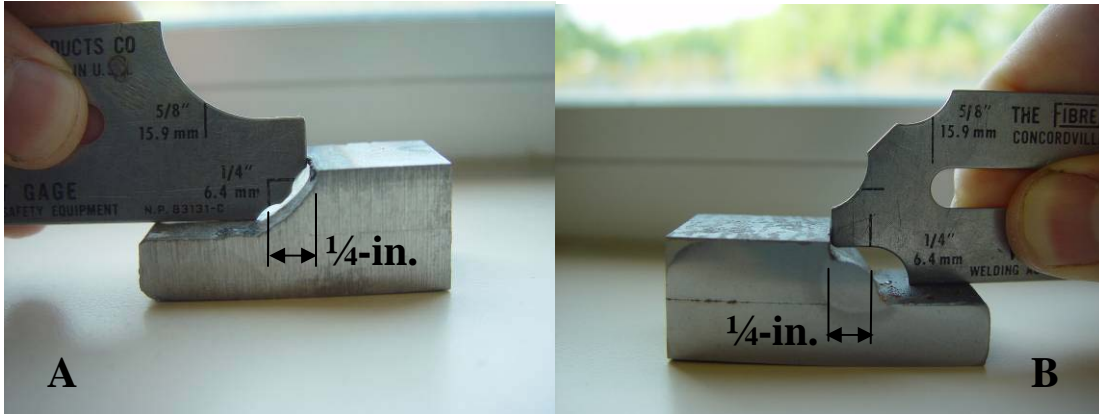
Figure 3.11: Fillet Weld Gauge—Concave Weld Measurement (A), Convex Weld Measurement (B)

It is noted that these acceptability levels were more stringent than AWS D1.1 provisions, which allow 3/16-in. welds to be undersized by 1/16-in. and 1/4-in. welds to be undersized by 3/32-in. (AWS D1.1:Table 6.1). However, AWS 1.1 allows the undersized portion to be as much as 10% of the weld length. Because profile measurements were made accurately at only four points along the weld length where the sections were taken, a more stringent undersize requirement was incorporated into the profile inspection criteria. It should also be noted that this profile measurement technique could not be applied in the field due to its destructive nature, but it nonetheless provides a consistent basis for determining whether welds made in the study were undersized at standard locations along each weld. In a field inspection, weld size should be determined through the use of a fillet weld gage, as demonstrated in Figure 3.11. The figure illustrates the measurement of a concave weld using the gage with three points. The middle point of the gage must touch the weld face for the weld to have an adequate throat dimension. The leg length is determined using the black tick-mark on the gage, as shown in Figure 3.11. A weld with adequate leg length but an undersized concave throat is shown in (A). A convex weld with adequate leg length and throat is shown in (B).

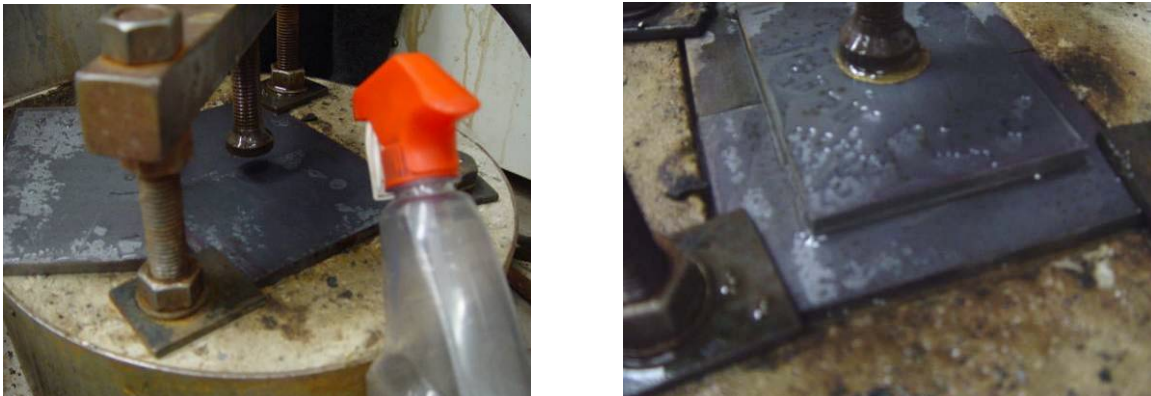
Figure 4.35: Wetting Process and Surface Wet Plate Assembly

As discussed previously welding is prohibited when plate surfaces are wet. To assess this condition, several specimens were welded to examine the effects of surface moisture on the porosity of fillet welds. Plate surfaces were wet using a spray bottle, as shown below in Figure 4.35.

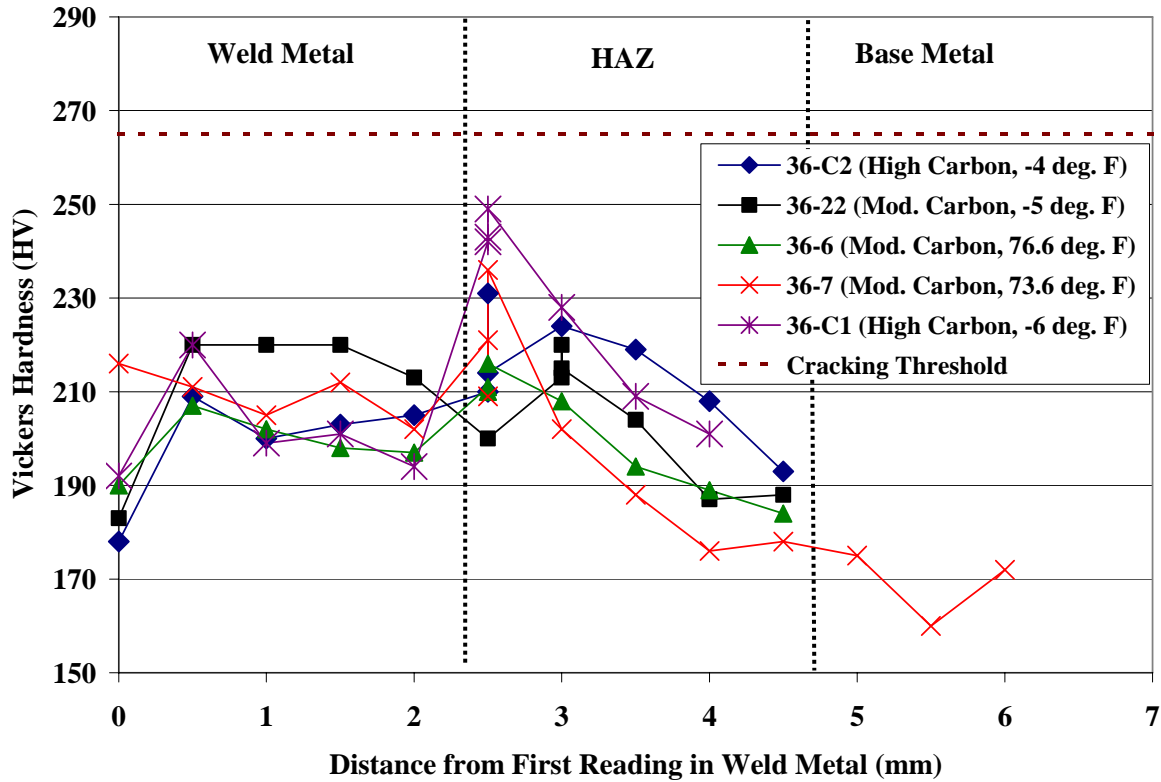
Figure 4.47: Plot of Vickers Hardness From Microhardness Tests

The values from the hardness measurements for all five specimens listed above are depicted graphically in Figure 4.47. The approximate crack-susceptibility threshold of 265 HV is indicated on the figure, as well as the approximate zones (weld metal, HAZ, and base metal) for the tested specimens.

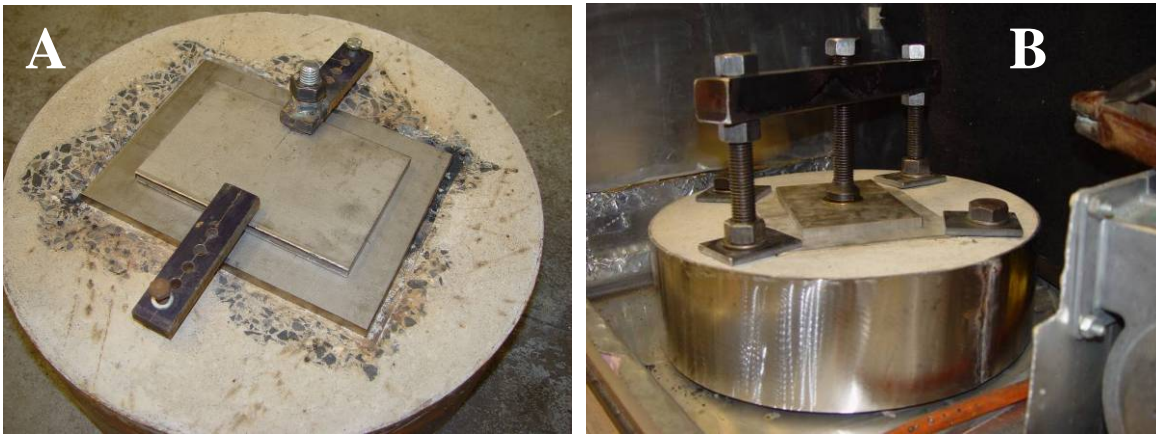
Figure 6.1: Stainless Steel Specimen in Setup: Original (A), Modified(B)

The stainless steel used for the welded plate specimens consisted of Type 304 material with properties given in Table 6-1. Plates were pre-cut to the required size of $\frac{3}{8}$ -in. x 4-in. x 6-in and arranged and welded in accordance with the welding setup procedure described in Section 3.1. The stainless steel specimens SS-73—SS-88 were welded while restrained at the middle of the plate and unrestrained at the ends as shown in Figure 6.1(A) in the original test setup, described in Section 3.1. The remaining specimens, SS-89-SS-96, SS-4HR, SS-1/4(X), were welded using the test setup shown in the Figure 6.1(B).
