**ERECTOR CONNECTOR  
MEADOW BURKE COMPANY  
IN-PLANE AND OUT-OF-PLANE  
PERFORMANCE**

**FINAL REPORT**

**ATLSS REPORT NO. 07-12**

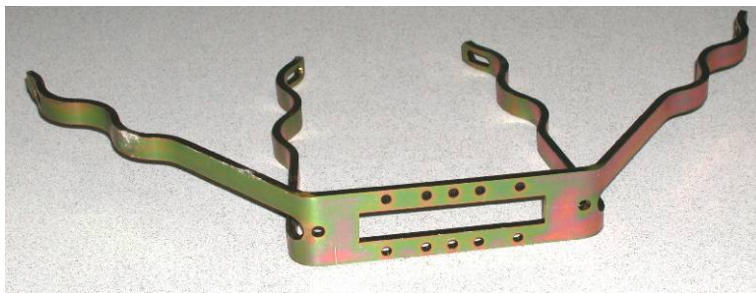
Figure 3: Type A erector connector without slug

The Erector Connector developed by the Meadow Burke Company is evaluated. The connector (Figures 2, 3, 4, and 5) is designed for placement in 4-in. double tee flanges. It consists of two connector types A and B. Connector type A (Figures 2 and 3) consists of a bent plate connector with four anchor legs, two oriented at 45-degrees and 2 and 90-degrees from the face plate. A slug is included with the connector which allows it to be pulled out once the DT members are in place. Connector type B (Figure 4) has a similar configuration to type A, but does not include the removable slug. A mockup of the two connectors is shown in Figure 5. Both connectors are fabricated from ASTM A36 steel and welded to the adjacent panel the embedded Type A ASTM A36 steel slug and a E7018 weld electrode. The welds were conducted at room temperature using a SMAW process according to AWS specifications. Variations on welding were used in some cases a weld was placed only at the connection B face and in other cases at both the B and A faces. Photographs of a 3.25” Altus Panel prior to concrete placement is presented in Figure 7.

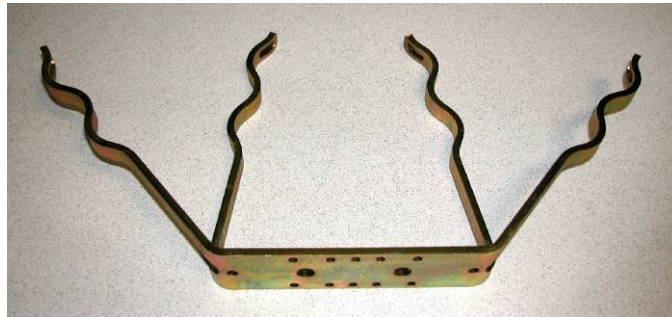
Figure 4: Type B erector connector

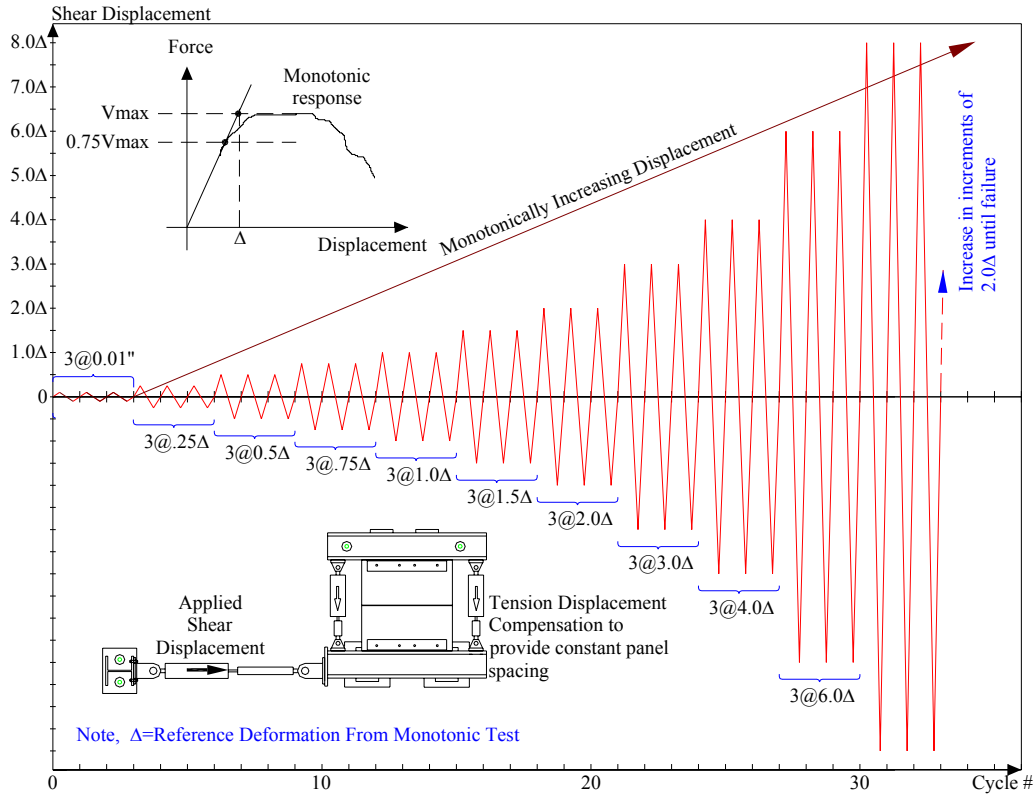
Figure 10: Shear loading protocol

Cyclic in-plane shear tests provide insight on the degradation of shear properties (i.e., stiffness and ultimate strength) under loading reversals. The loading protocol is based on the PRESSS program [Priestley 1992]. Three preliminary cycles to 0.01-in. are conducted to evaluate control and acquisition accuracy. The remaining protocol consisted of groups of three symmetric shear cycles at increasing deformation levels. Each level is based on a percentage of a reference deformation computed from the preceding monotonic test. The reference deformation represents the effective yield deformation of the connector. It is computed by taking the intercept of a horizontal line at the max load and a secant stiffness line at 75% of the max load (Figure inset). Three elastic levels of 0.25 $\Delta$ , 0.50 $\Delta$  and 0.75 $\Delta$  followed by inelastic cycles to 1.0 $\Delta$ , 1.5 $\Delta$ , 2.0 $\Delta$ , 3.0 $\Delta$ , 4.0 $\Delta$ , 6.0 $\Delta$ , 8.0 $\Delta$ , *etc...* were conducted. The loading protocol is illustrated in Figure 10.

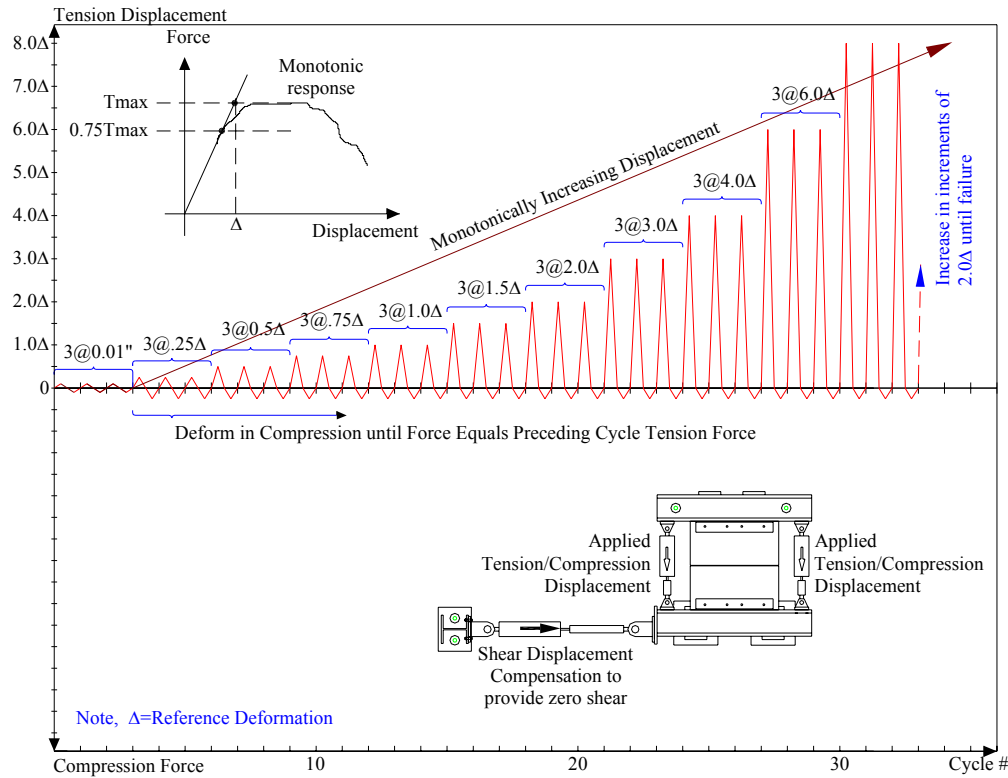
Figure 11: Tension/Compression protocol

Cyclic in-plane tension tests provide insight on the degradation of tension properties (i.e., stiffness and ultimate strength) under loading reversals. The loading protocol is illustrated in Figure 11.

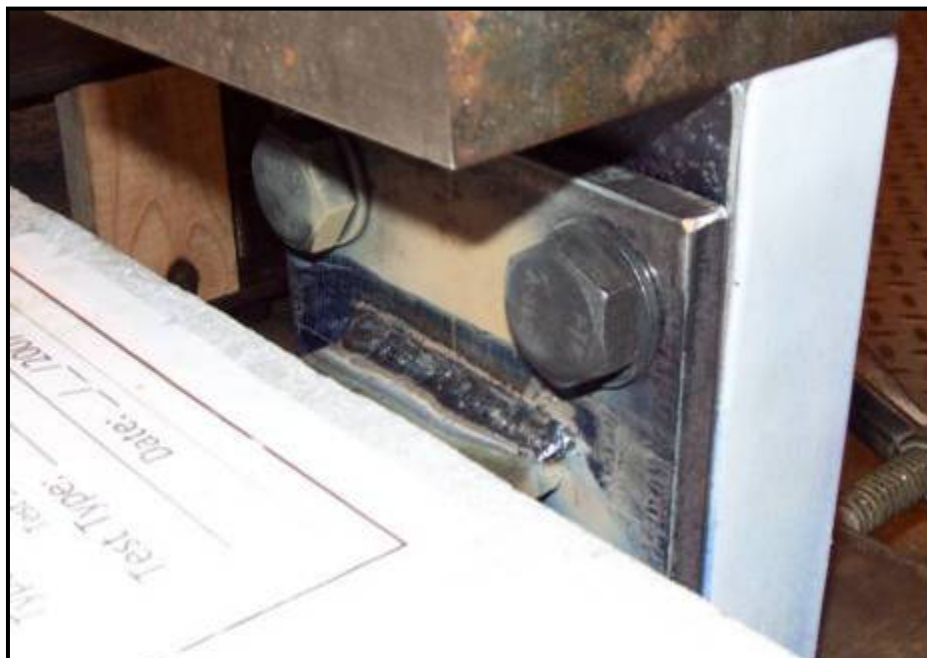
Figure 14: Out-of-plane tests – detail showing a Type A tab welded to the loading block

Load was applied through a loading block attached to the slab. For Type A slabs, the slab tab was extended and welded to the front face of the loading block. For Type B slabs, a slug section was placed between the slab plate and the loading block. The slug was welded to both the loading block and the slab plate. The gap between the slab plate and loading block plate was kept between 1/4" and 3/8". Figure 14 shows an extended Type A tab welded to the loading block. The tab was pushed in and the loading block was positioned to obtain the 1/4" to 3/8" gap. The loading block was pulled up via a threaded rod passing through a hydraulic jack and load cell. The loading mechanism sat on the C channels that spanned across the W6 sections. Rotation of the loading block as it was pulled was restrained by a C channel on the opposite side of the block as the slab. Friction between the loading block and channel was minimized by a Teflon sheet affixed to the loading block. A hand pump was used to slowly increase the pressure and the resulting uplift force to the slab plate. The vertical displacement was measured using an LVDT. The load and displacement were recorded at one second intervals on a Campbell Scientific CR5000 data logger.

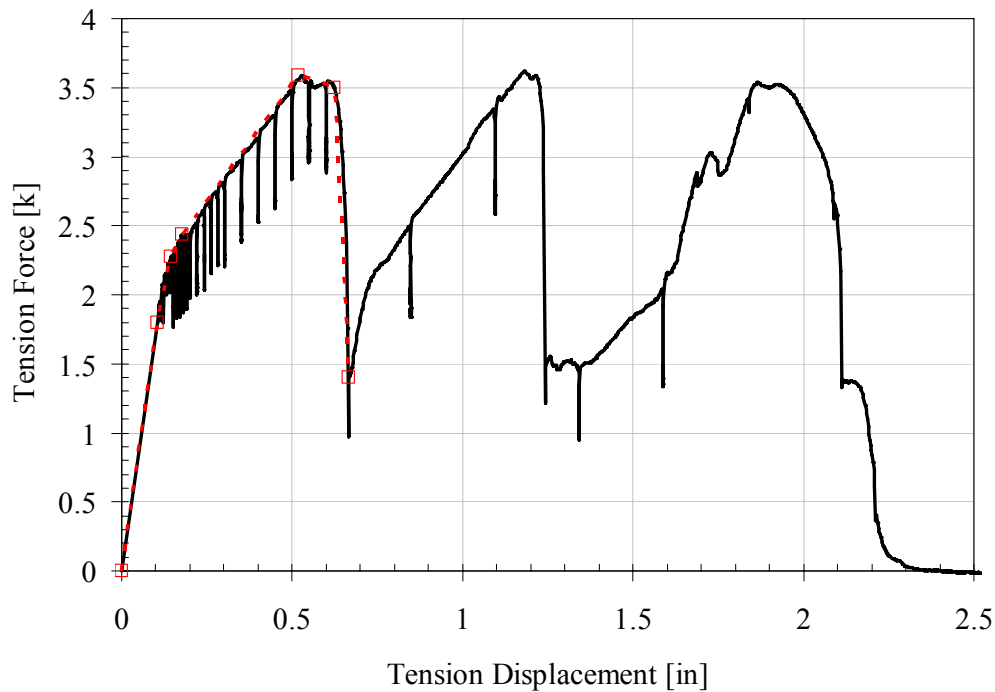
Figure 17: Force and axial displacement (Monotonic Tension)

Table 6: Experimental Results Backbone Curve (Monotonic Tension)		
Event	Tensile Displacement [in.]	Tensile Force [kips]
Elastic Limit	0.104	1.80
-	0.145	2.28
-	0.177	2.44
Peak Load	0.518	3.59
-	0.624	3.50
-	0.668	1.40
End of test	2.35	0

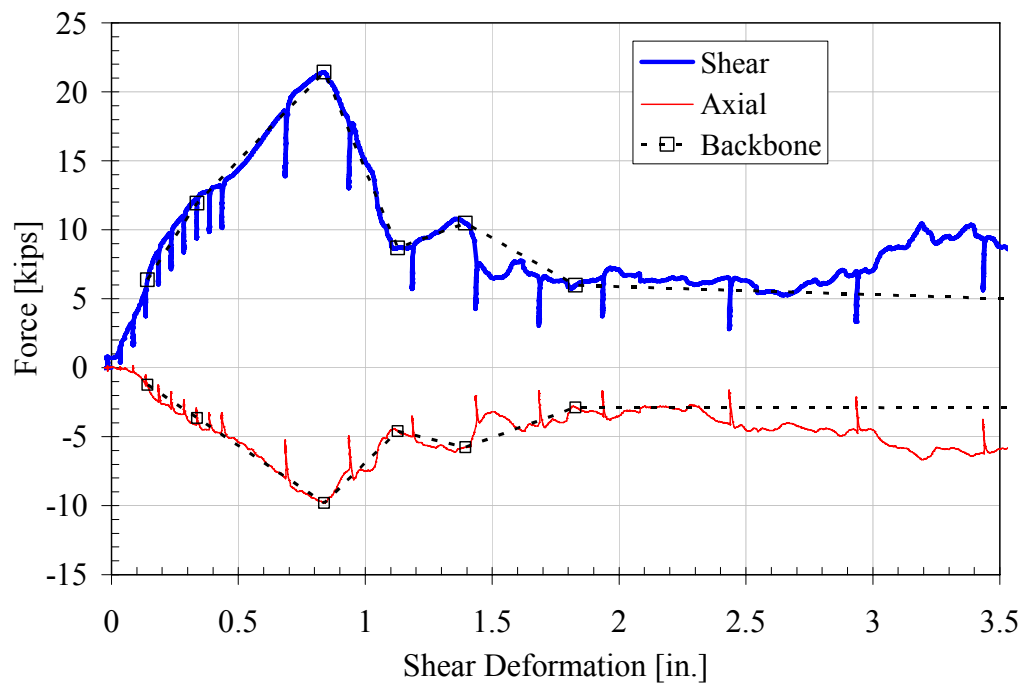
Figure 21: Shear force and displacement (monotonic shear w/ 1 weld)

Table 10: Experimental Results Backbone Curve Erector Connector - 1 Weld (Monotonic Shear)			
Step	Shear Displacement [in.]	Shear Force [kips]	Axial Force [kips]
	0.143	6.38	-1.25
	0.337	11.92	-3.65
Max Load	0.838	21.43	-9.80
	1.128	8.68	-4.60
	1.395	10.46	-5.76
	1.828	5.97	-2.89
End of Test	4.233	4.61	-2.91

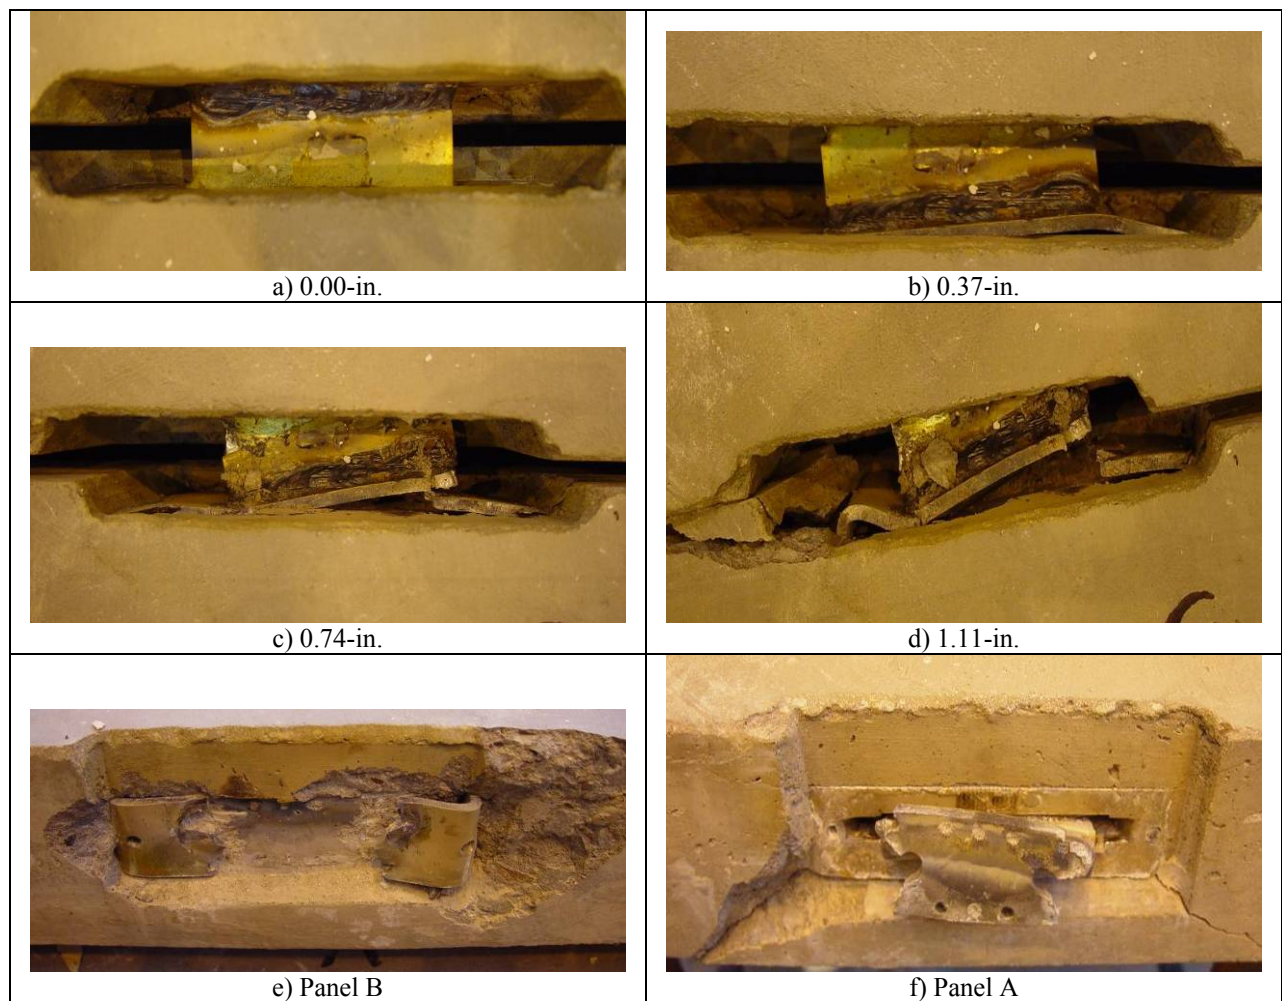
Figure 22: Damage states cyclic shear with 1 weld

Table 11: Key Test Observations Erector Connector – 1 Weld (Cyclic Shear)			
Event #	Shear $\Delta$ [in.]	Tension $\Delta$ [in.]	Event Description
1	0.555	0	Spalling on connector B
2	-0.74	0	Fracture on connector B
3	1.11	0	Through fracture on connector B
4	-1.11	0	90% fracture on other side of connector B
5	-1.48	0	Complete fracture of connector B
6	1.48	0	Test Stopped

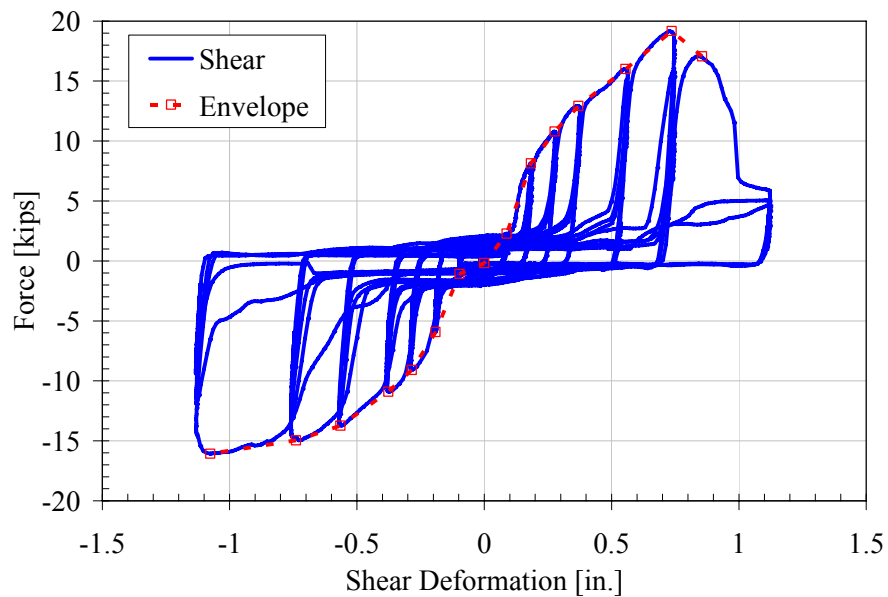
Figure 23: Force and shear displacement cyclic shear with 1 weld

Table 12: Experimental Results Backbone Curve Erector Connector – 1 Weld (Cyclic Shear)		
Event	Shear Displacement [in.]	Shear Force [kips]
	0.855	17.07
Positive Peak	0.736	19.18
	0.555	16.01
	0.370	12.93
	0.276	10.79
	0.183	8.14
	0.088	2.28
Zero	0.000	-0.18
	-0.097	-1.08
	-0.191	-5.93
	-0.284	-9.10
	-0.377	-10.90
	-0.565	-13.73
	-0.739	-14.96
Negative Peak	-1.076	-16.08

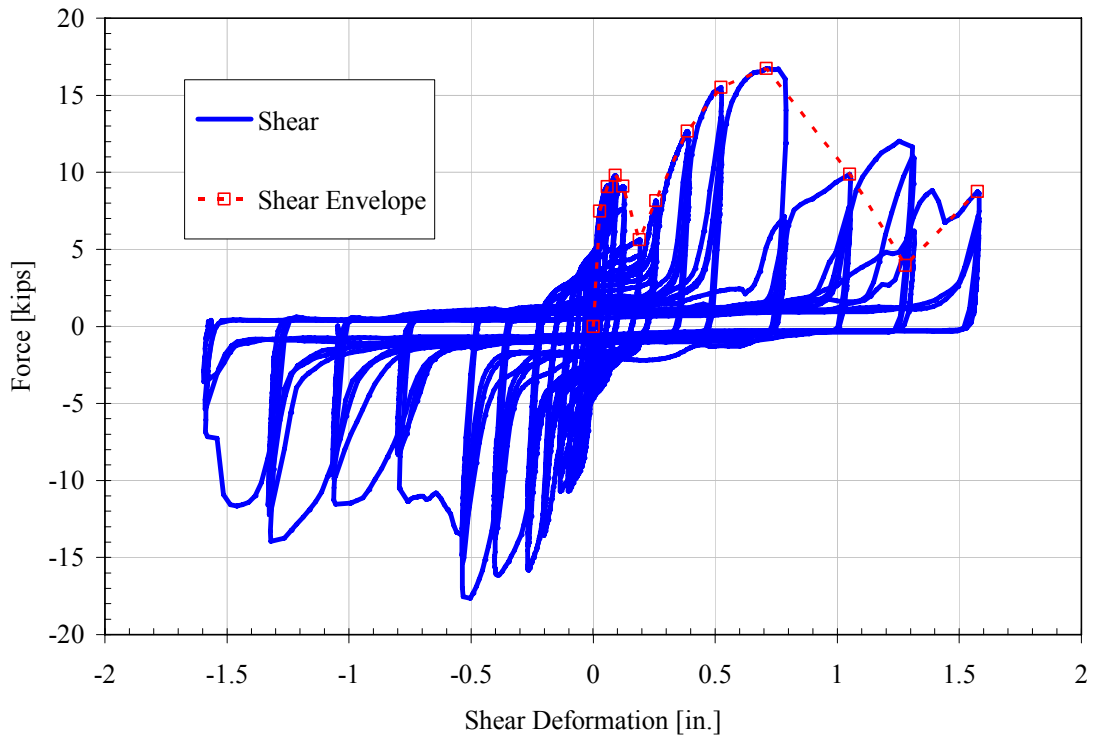
Figure 26: Force and shear displacement CV both sides welded

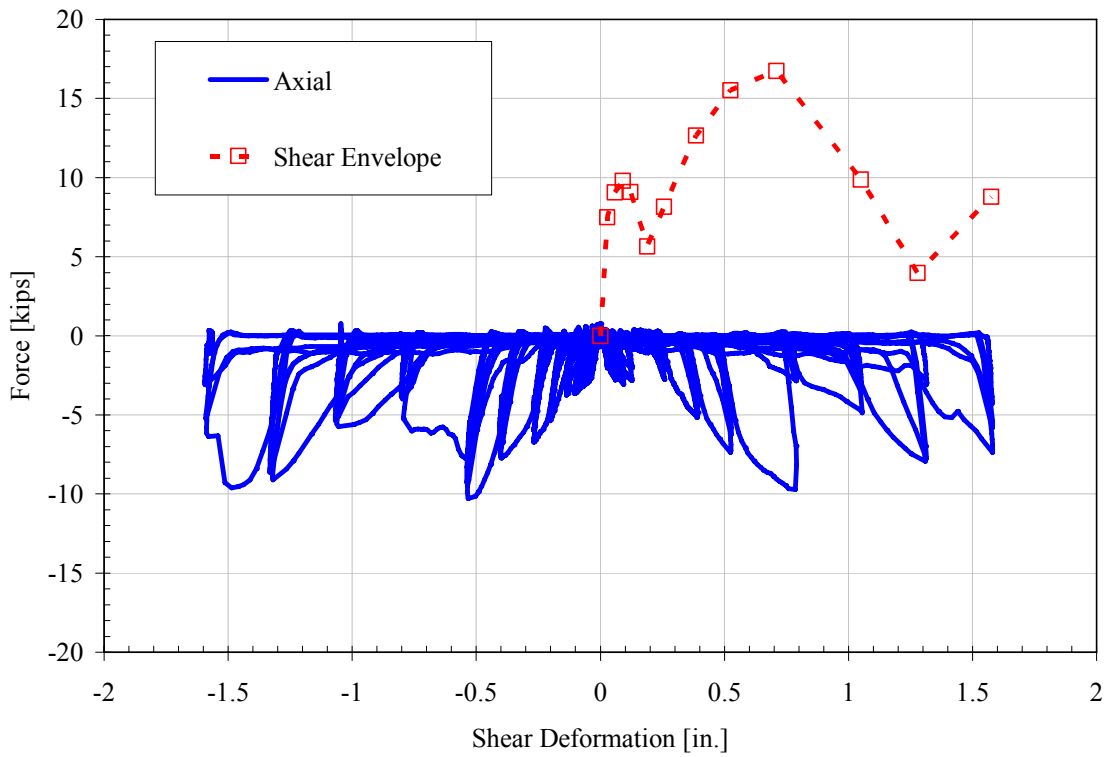
Figure 27: Axial force and shear displacement CV both sides welded

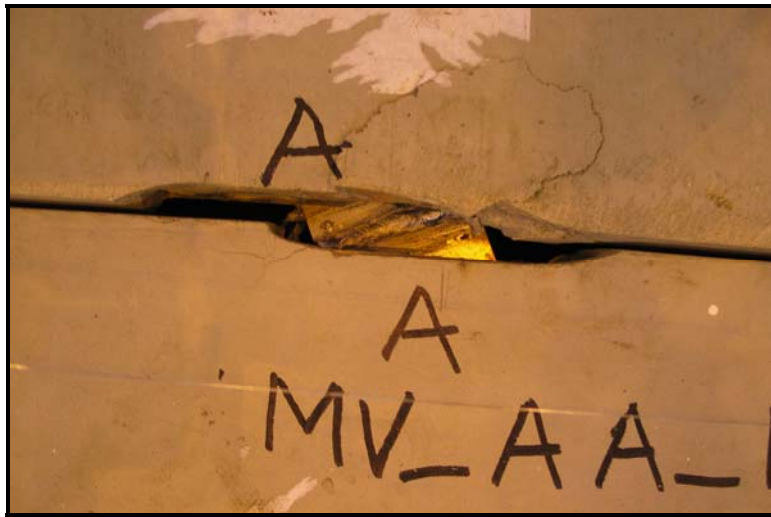
Figure 34: Specimen MV\_AA-1 - condition of A-A connector at a shear load of 10.5 kips showing spalling of concrete

The in-plane shear behavior of the connector was investigated in Test Series 4. In this test series, five specimens were tested. Each specimen consisted of two stepped panels with an “A-A” connector configuration. The first specimen, MV\_AA-1, was tested under monotonically increasing shear load while tensile deformations were restrained. Figure 34 contains a photograph of the condition of the A-A connector at a shear load of 10.5 kips. It can be seen that there is significant rotation of the connector in the pocket. The load versus displacement curve is shown in Figure 35.

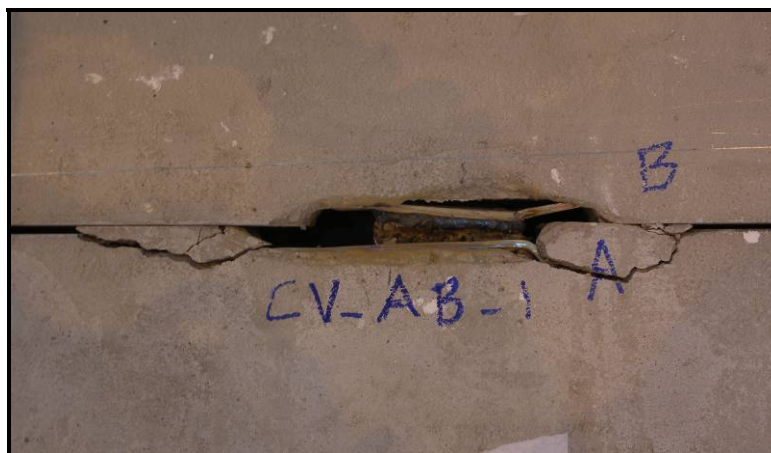
Figure 43: Specimen CV\_AB-1 - spalling of top surface of panel at a load of 8.9 kips

Four cyclic shear tests were performed (tests CV\_AB-1 through CV\_AB-4). The behavior of the four specimens was generally similar. Figure 43 shows the onset of spalling in specimen CV\_AA-1 at a load of 8.9 kips (displacement of 1.2 inches). This type of behavior was typical of all specimens. Figure 44 through 47 contain the load versus displacement relationship for the four specimens. Finally Table 21 contains the peak load and displacements for all specimens. It can be seen that the peak displacements are lower than the specimens of Test Series 4 most likely due to the fact that the A to B connection has increased stiffness.

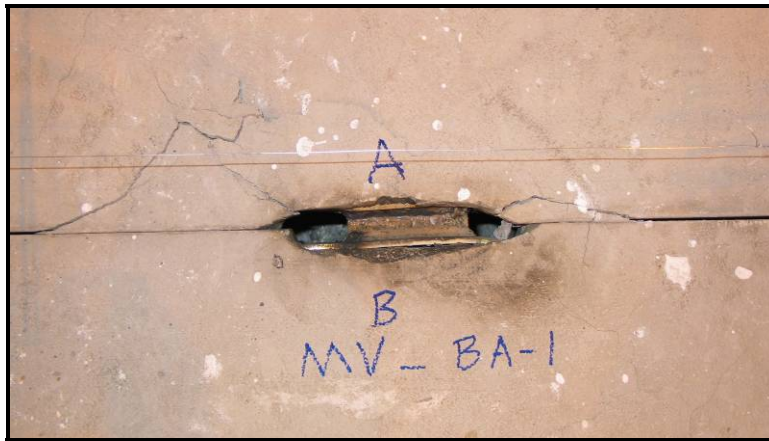
Figure 48: Specimen MV\_BA-1 - condition of A-B connector at a shear load of 15.2 kips showing spalling of concrete

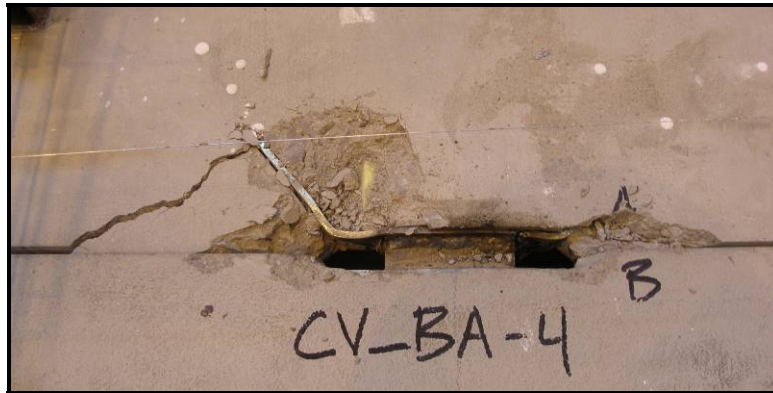
Figure 50: Specimen CV\_BA-4 - spalling of top surface of panel at a load of 2.2 kips (displacement of 0.225 inches)

Four cyclic shear tests were performed (tests CV\_BA-1 through CV\_BA-4). The behavior of the four specimens was generally similar. Figure 50 shows the onset of spalling in specimen CV\_BA-1 at a load of 2.2 kips (displacement of 0.225 inches). This type of behavior was typical of all specimens. Figure 51 through 54 contain the load versus displacement relationship for the four specimens. Note that the integrity of the data collected during test CV\_BA-1 (see Figure 42) was compromised and is therefore incomplete as shown. Finally Table 22 contains the peak load and displacements for all specimens. It can be seen that the peak displacements are lower than the specimens of Test Series 4 most likely due to the fact that the A to B connection has increased stiffness.

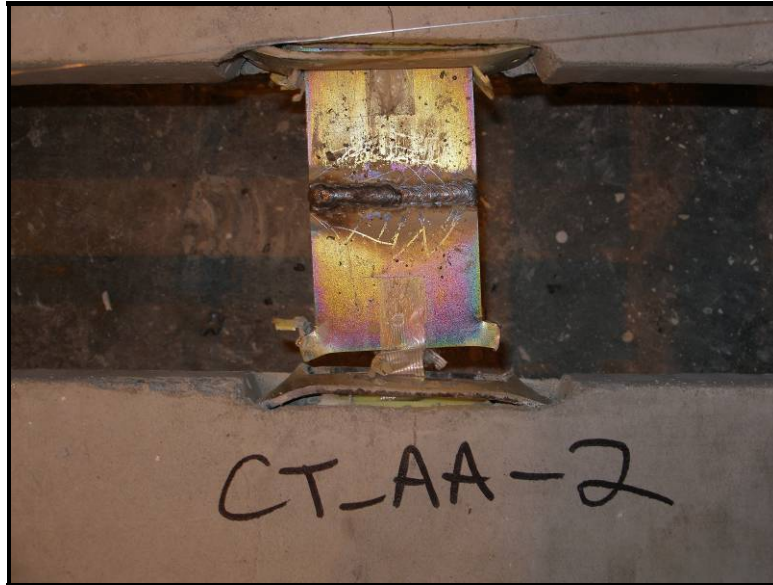
Figure 56: Specimen CT\_AA-2 – after fracture of connector at a displacement of 3.6 inches

Three cyclic tension tests were performed (tests CT\_AA-1 through CT\_AA-3). The behavior of the three specimens was generally similar. Similar to the monotonic test, during the initial small cycles, there is no bearing of the connector and therefore only nominal friction forces resist the imposed deformations. Once bearing occurs (at approximately 0.25, 1.25, and 0.25 inches for tests CT\_AA-1, CT\_AA-2, CT\_AA-3, respectively) the load increases. Figure 56 shows the onset of spalling in specimen CV\_BA-1 at a load of 2.2 kips (displacement of 0.225 inches). This type of behavior was typical of all specimens. Figure 57 through 59 contain the load versus displacement relationship for the three specimens. Finally Table 23 contains the peak load and displacements for all specimens. Peak displacements shown are the difference between the maximum imposed displacement and the displacement at the onset of bearing (i.e., where tension loads increased above the friction threshold).

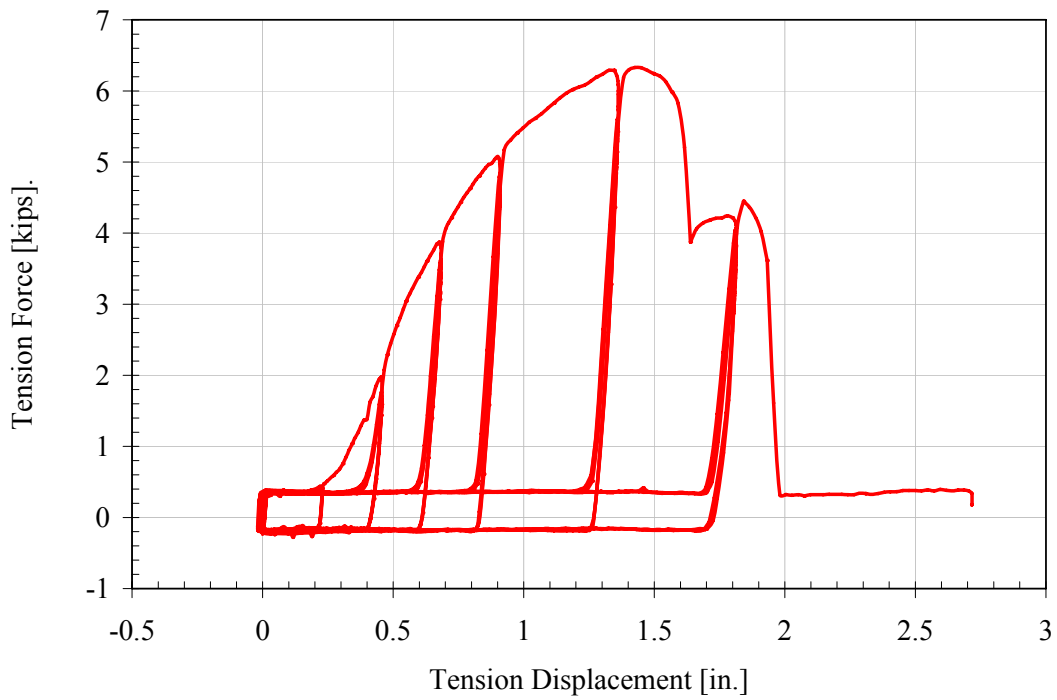
Figure 57: Cyclic shear test CT\_AA-1 - tension load versus tension displacement

Figure 58: Cyclic shear test CT\_AA-2 - tension load versus tension displacement

Figure 59: Cyclic shear test CT\_AA-3 - tension load versus tension displacement

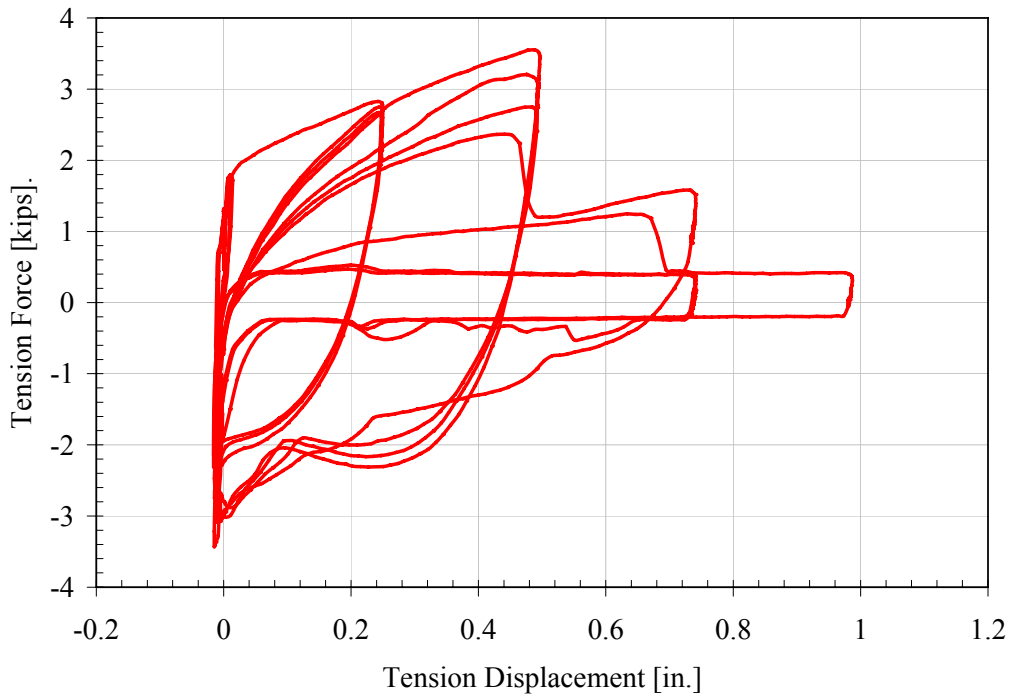
Figure 62: Cyclic shear test CT\_BA-1 - tension load versus tension displacement

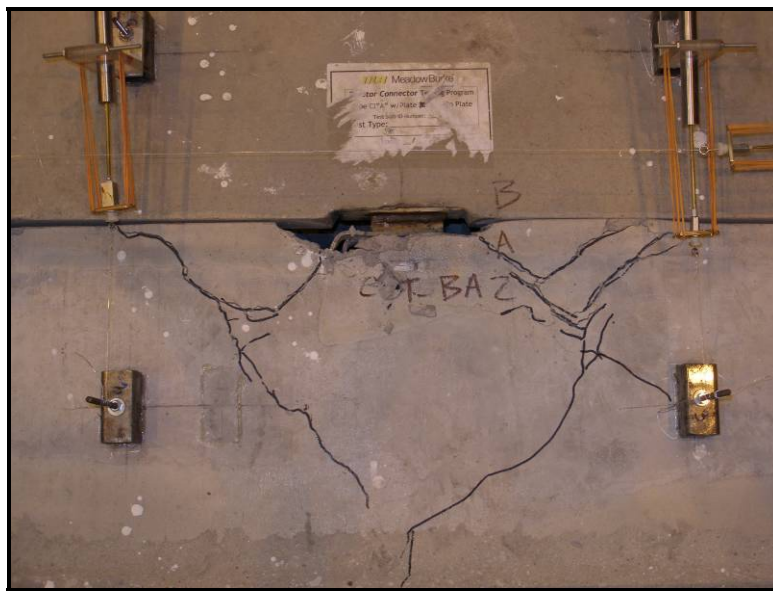
Figure 66: Specimen CVT\_BA-2 – cracking and spalling of top surface at a shear load of 4.1 kips and a tension load of -1.0 kips (shear displacement of 0.3 inches)

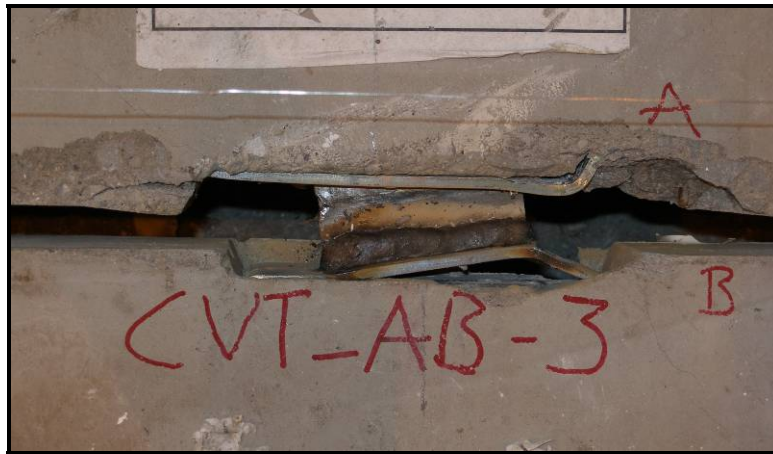
Figure 70: Specimen CVT\_AB-3 – deformation of the “B” connector face plate at a shear load of 4.1 kips and a tension load of 1.1 kips (shear displacement of 0.3 inches)

The in-plane behavior under combined shear and tension of the connector was further investigated in Test Series 10. In this test series, four specimens were tested. Each specimen consisted of two stepped panels with an “A-B” connector configuration. Each specimen (CVT\_AB-1 through CVT\_AB-4) was tested under cyclic shear with proportional tension. The shear deformation commands were twice the tension deformation commands. The behavior of the four specimens was generally similar, however, the post-yield behavior was slightly different. Figure 70 shows the specimen CVT\_AB-3 under a shear load of 8.6 kips and tension load of 1.0 kips. The face plate is severely deformed. This type of behavior was typical of all specimens. Figure 71 through 74 contain the load versus displacement relationship for the four specimens. Note that the shear and tension loads are plotted separately versus the shear displacement. Finally Table 25 contains the peak load (tension and shear) and displacements for all specimens.

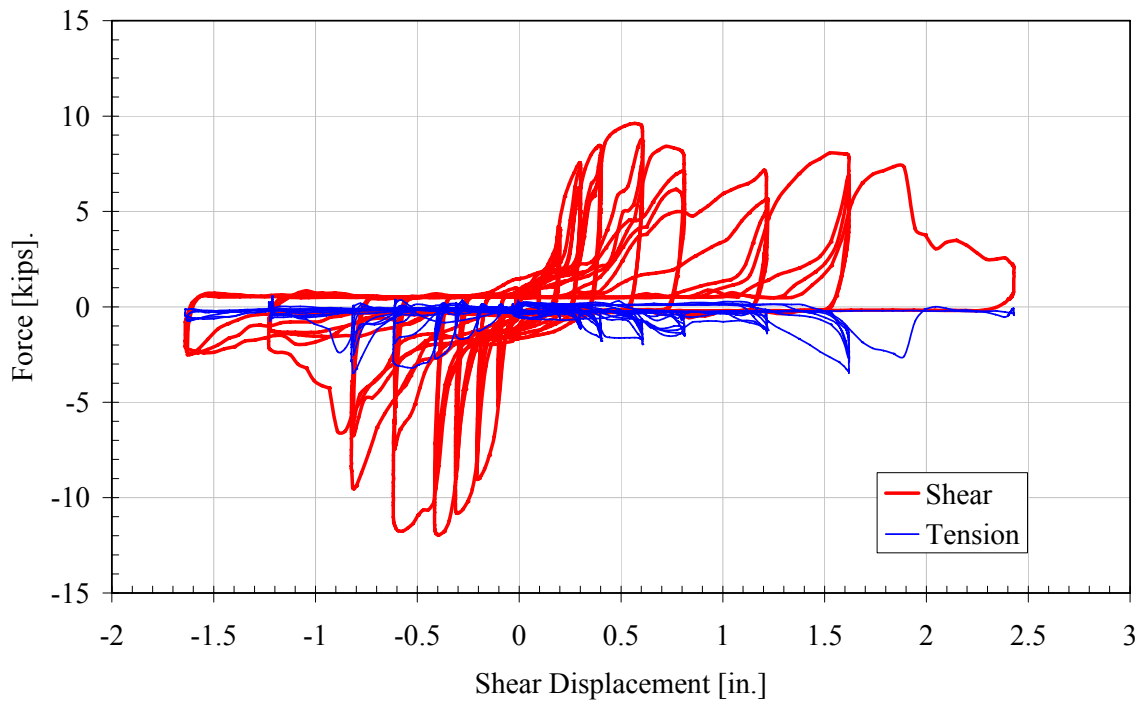
Figure 71: Cyclic combined shear/tension test CVT\_AB-1 – shear and tension load versus shear displacement

Figure 72: Cyclic combined shear/tension test CVT\_AB-2 – shear and tension load versus shear displacement

Figure 73: Cyclic combined shear/tension test CVT\_AB-3 – shear and tension load versus shear displacement

Figure 74: Cyclic combined shear/tension test CVT\_AB-4 – shear and tension load versus shear displacement

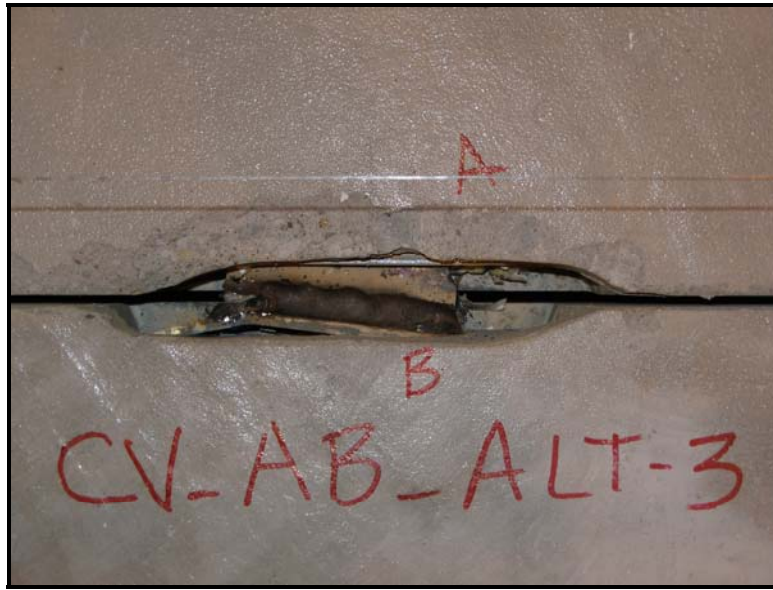
Figure 77: Specimen CV\_AB\_ATLUS-3 – deformation of “B” connector faceplate at a shear load of 14.0 kips (displacement of 0.6 inches)

Four cyclic shear tests were performed (tests CV\_AB\_ALTUS-1 through CV\_AB\_ALTUS-4). The behavior of the four specimens was similar, however the post-yield behavior varied. Specimen CV\_AB\_ALTUS-1 had the lowest displacement capacity. Figure 77 shows specimen CV\_AB\_ALTUS-3 at a load of 14.0 kips (displacement of 0.6 inches). Large inelastic deformation of the “B” connector face plate is evident. This type of behavior was typical of all specimens. Figure 78 through 81 contain the load versus displacement relationship for the four specimens. Finally Table 27 contains the peak load and displacements for all specimens.

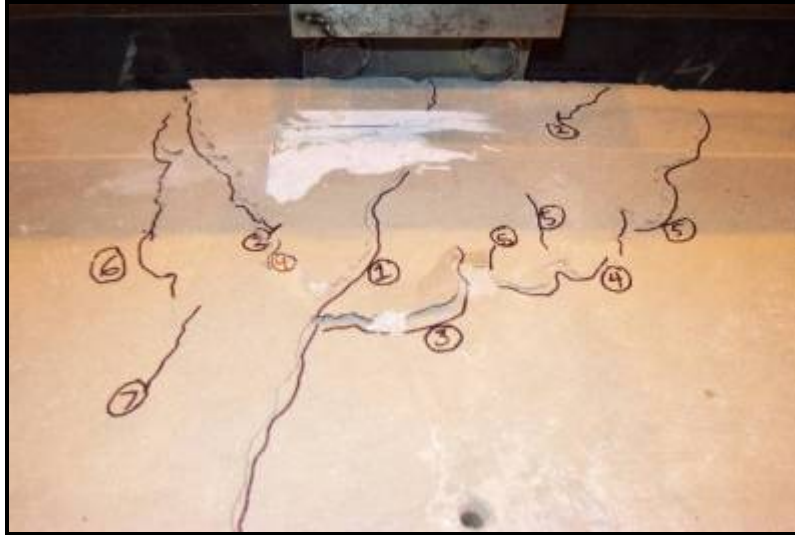
Figure 83: Altus slab top surface crack patterns (near end of test)

As load was increased, cracks formed on the slab upper surface, as shown in Figure 83. The load at which the first crack appeared was noted (see Table 28). The slab continued to accept increasing loads beyond the initial cracking load. As additional cracks appeared, they were marked and noted. Maximum loads for each specimen are presented in Table 28.

As load was increased, cracks formed on the slab upper surface (see Figure 83). The load at which the first crack appeared was noted (see Table 29). The slab continued to accept increasing loads beyond the initial cracking load. As additional cracks appeared, they were marked and noted. Maximum loads for each specimen are presented in Table 29.

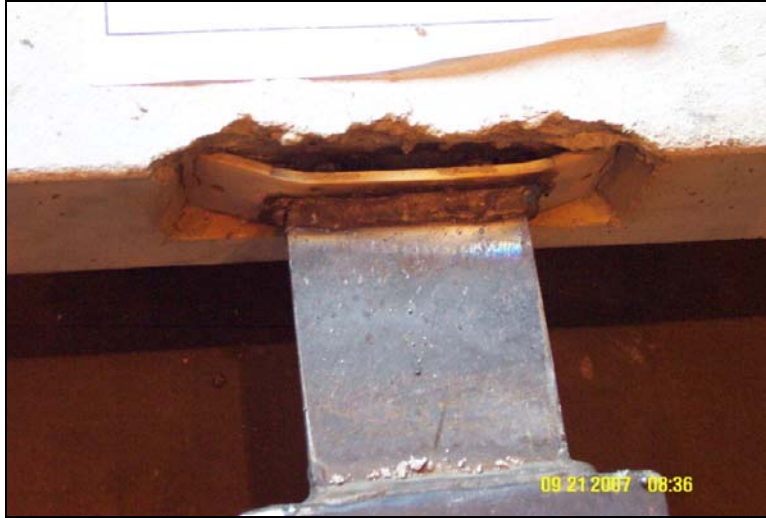
Figure 86: Bowing of connector plate

All specimens exhibited similar behavior. As the load increased, the B connector began to bow outwards. The bow continued until the connector plate fractured at the edge of the attachment plate weld. Figures 86 and 87 show the progression during one of the tests. Maximum loads for each specimen are presented in Table 30.

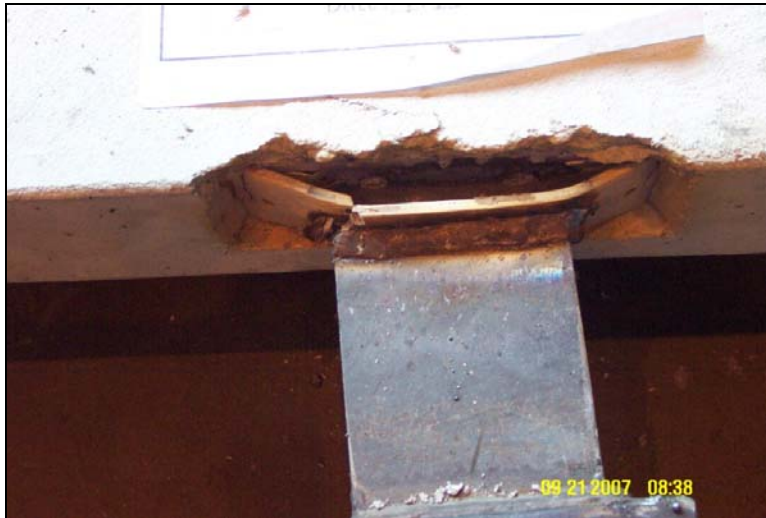
Figure 87: Connector plate fracture
