Field Testing of the Orthotropic Deck on the Bronx-Whitestone Bridge

FIELD TESTING OF THE ORTHOTROPIC DECK ON THE BRONX-WHITESTONE BRIDGE

Final Report

ATLSS Report 09-01

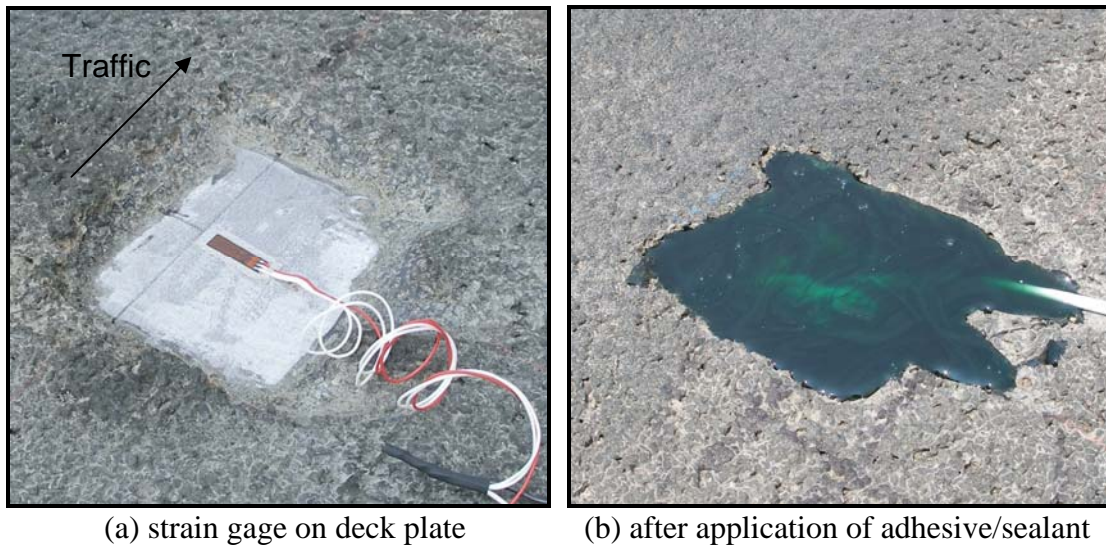
Figure 3.1 – Installation of strain gages on top surface of deck

To access the deck plate, a small area (approximately 2 in. by 2 in.) of the overlay was chipped away. After grinding the surface of the deck plate smooth, the strain gage was installed (see Figure 3.1). The removed overlay was then replaced with a fast curing acrylic adhesive, as shown in Figure 3.1.

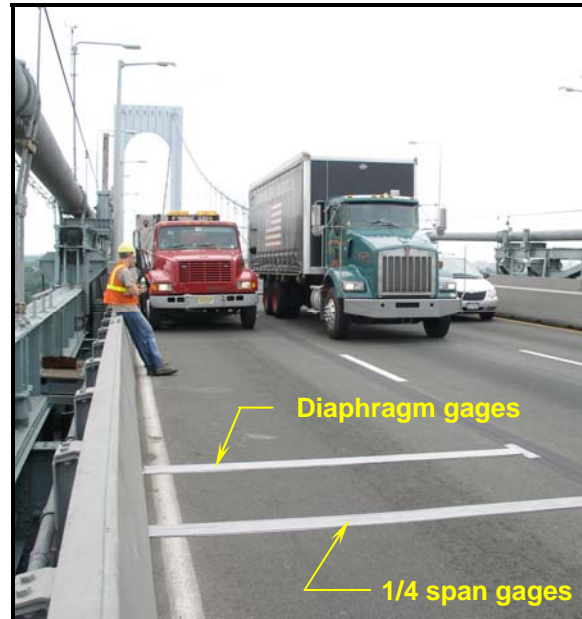
Figure 3.2 – Final configuration of strain gages installed on the top surface of the deck in the rightmost northbound roadway (photo looking south)

The strain gage wiring was placed transversely across the rightmost roadway to the barrier and then below the deck to the data acquisition system. To protect the wires and patched area over the strain gages from damage due to the heavy wheel loads, multiple layers of a 4 in. wide heavy-duty fabric-backed mastic tape were applied to the roadway surface over the wiring and strain gages. This tape was developed for use with temporary weigh-in-motion systems.

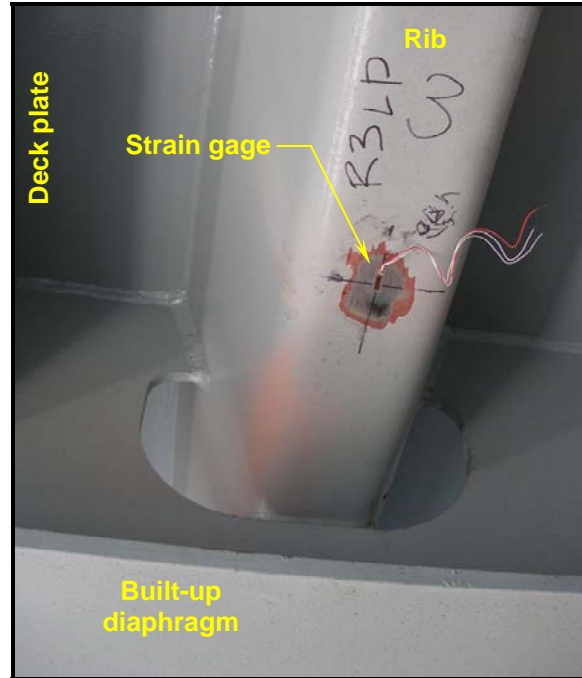
Figure 3.3 – Longitudinally-oriented strain gage R3LP located 12 inches north of the intermediate built-up diaphragm (prior to weatherproofing)

Strain gages were installed on the bottom flange of Ribs 3 and 6. Under the northbound lanes, strain gages were installed at Floorbeam 88 (located 12 inches from the floorbeam) and at the built-up diaphragm between Floorbeams 88 and 89 (located 12 inches from the diaphragm). Figure 3.3 contains a photograph of strain gage R3LP located 12 inches north of the built-up diaphragm. The other rib strain gage installations are similar.

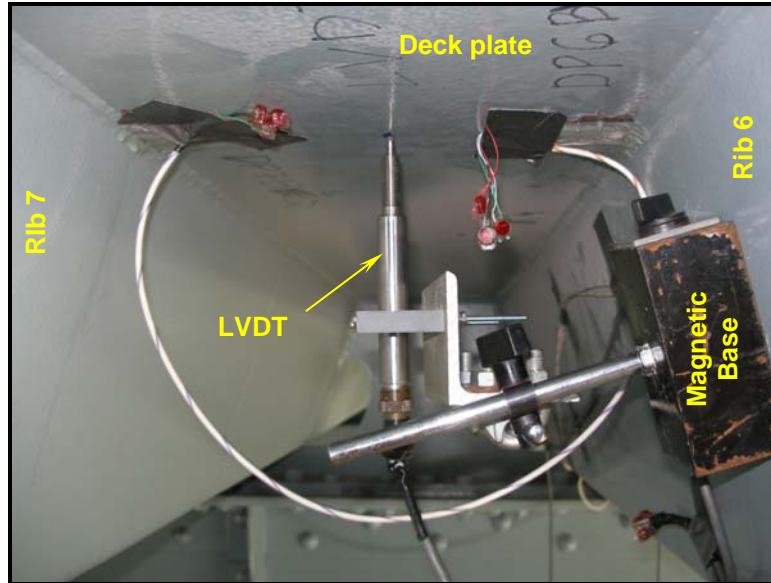
Figure 3.4 – LVDT installed between Ribs 6 and 7 at the quarterspan point between Floorbeams 88 and 89

The LVDTs were attached to a magnetic base mounted to the rib wall on one side. Figure 3.4 contains a photograph of LVDT67Q. As shown the LVDT is mounted to Rib 6 and measures the relative vertical displacement between the deck plate and Rib 6.

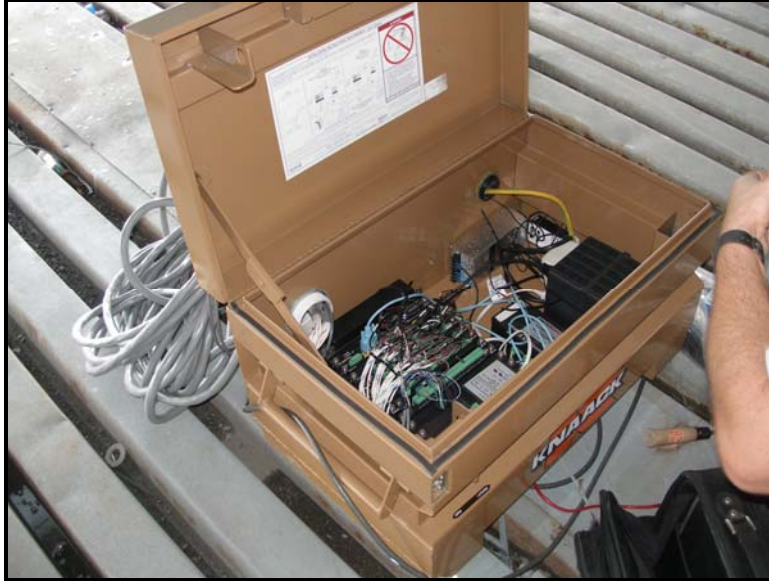
Figure 3.5 – Weather-tight enclosure used to house the data acquisition system and wireless communications

The data logger was enclosed in a weather-tight enclosure located on the temporary shield below the deck. Figure 3.5 contains a photograph of the weather-tight enclosure containing the data acquisition system. In addition to the CR9000 data logger, communications equipment and a power supply were housed the enclosure.

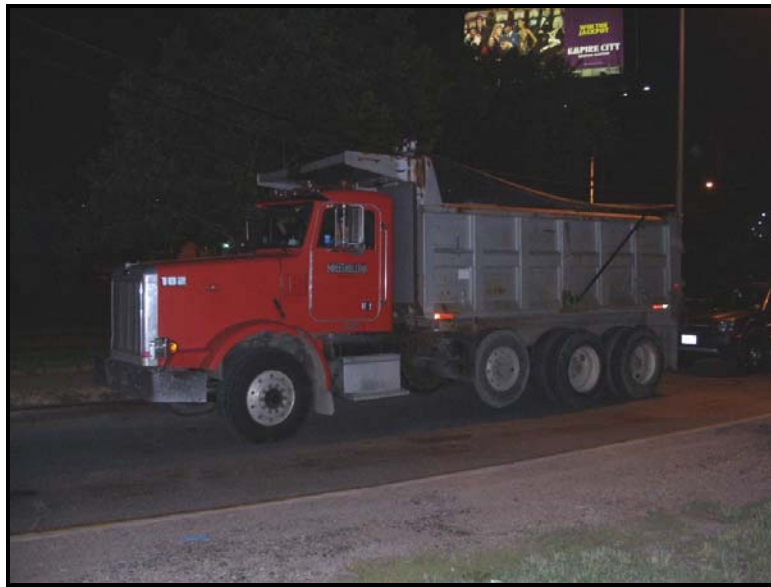
Figure 4.1 – Test truck used during controlled load tests

A series of controlled load tests were conducted using a test truck of known geometry and weight. The truck had three main axles and a fourth floating rear axle which remained in the up position for all tests. The test truck was fully loaded with 3/4” stone and had a gross vehicle weight (GVW) of 73,000 pounds (44,000 pounds of stone). The truck was weighed on scales at the loading facility immediately before departing for the bridge. The individual axles of the truck were not measured. However, the individual axle weights were estimated using a linear regression on past test truck geometry and weight data. Figure 4.1 contains a photograph of the truck used for the testing. Table 4.1 contains the weight at each axle. Table 4.2 provides the key dimensions of the test truck.

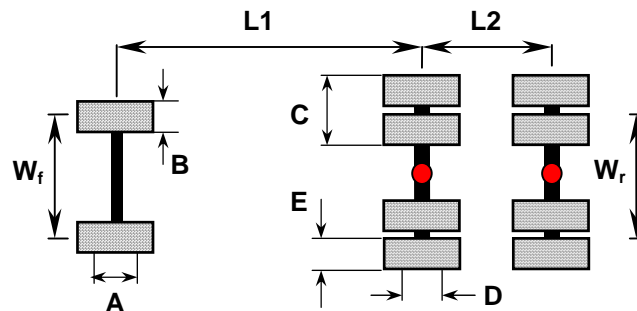
Rear Axle	L1 (in)	L2 (in)	W _f (in)	W _r (in)	A (in)	B (in)	C (in)	D (in)	E (in)
Tandem	192	54	80	72	12	10	21	13	8.25

Table 4.2 – Geometry of test truck used for controlled load tests

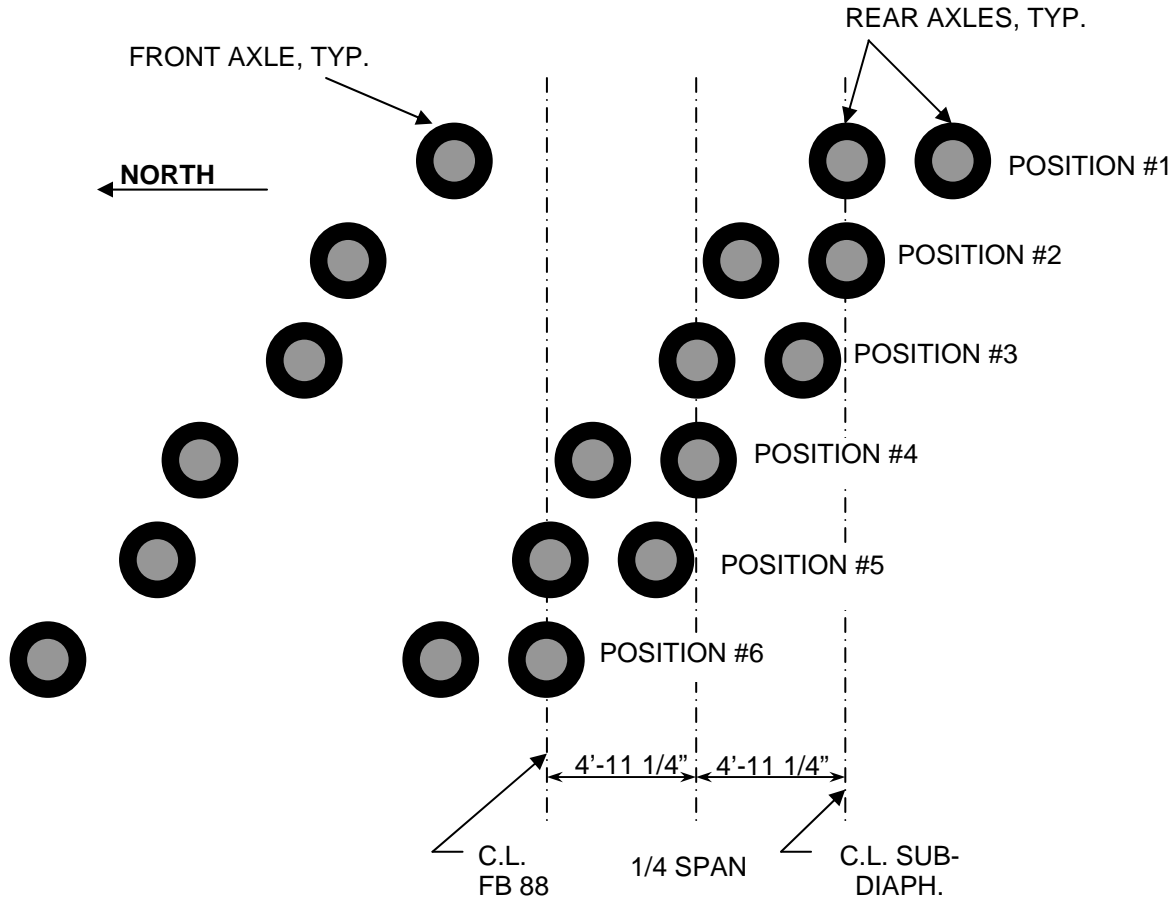
Figure 4.2 – Park test location plan (6 park positions in total)

The park test was conducted first. Each axle of the rear tandem axle was parked on three locations, namely the built-up diaphragm between Floorbeams 88 and 89, the quarterspan point, and over Floorbeam 88, as shown in Figure 4.2. Therefore, the test truck was parked at a total of six different positions.

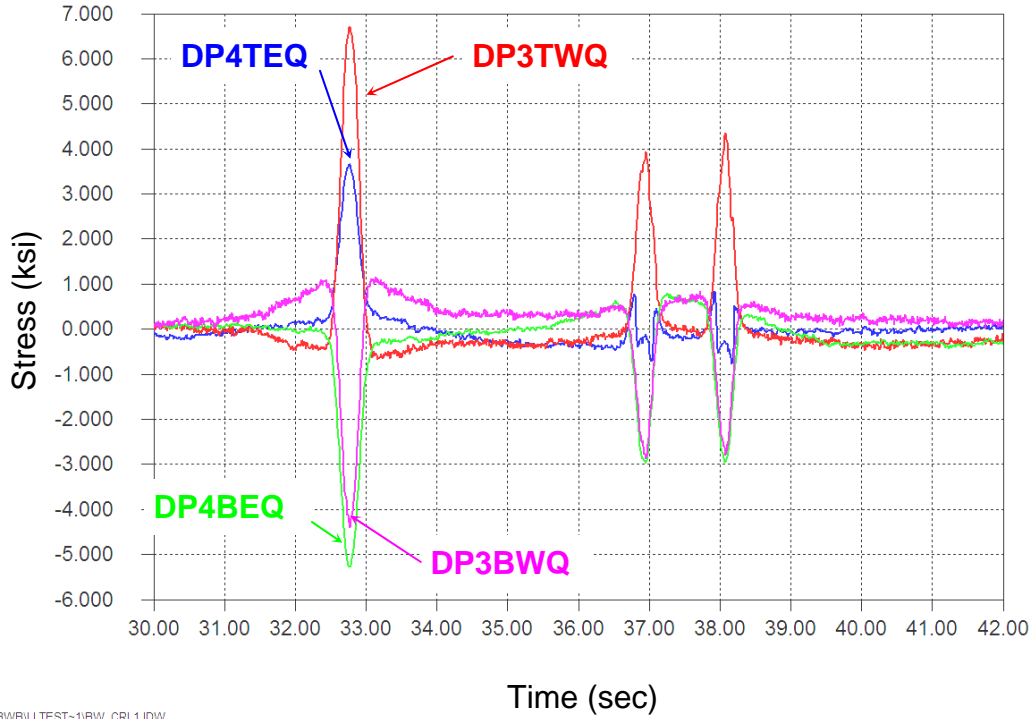
Figure 5.1 – Stress time-history for two pairs of back-to-back (top and bottom) strain gages on the deck plate at quarterspan for test BW_CRL1 (test truck centered in lane)

Shown in Figure 5.1 is a stress-time history for these four strain gages, for a crawl test with the test truck centered in the right lane (test BW_CRL1). The passage of the front and rear tandem axles can be clearly seen in the plot. Furthermore, the response of the deck plate is dominated by flexure, evidenced by the comparable stresses in the back-to-back gages. Finally, the peak stresses are the result of the local presence of the wheels. Wheel loads cause high tension (positive) stresses on the top surface and compression stresses (negative) on the underside of the deck plate. It should also be noted that in addition to the peaks in the response due to the local wheel loading, there is a global bending response of the deck plate which causes opposite direction bending stresses. This causes stress reversal on the underside of the deck (i.e., peak stresses are compressive, however there is a small amount of tension reversal).

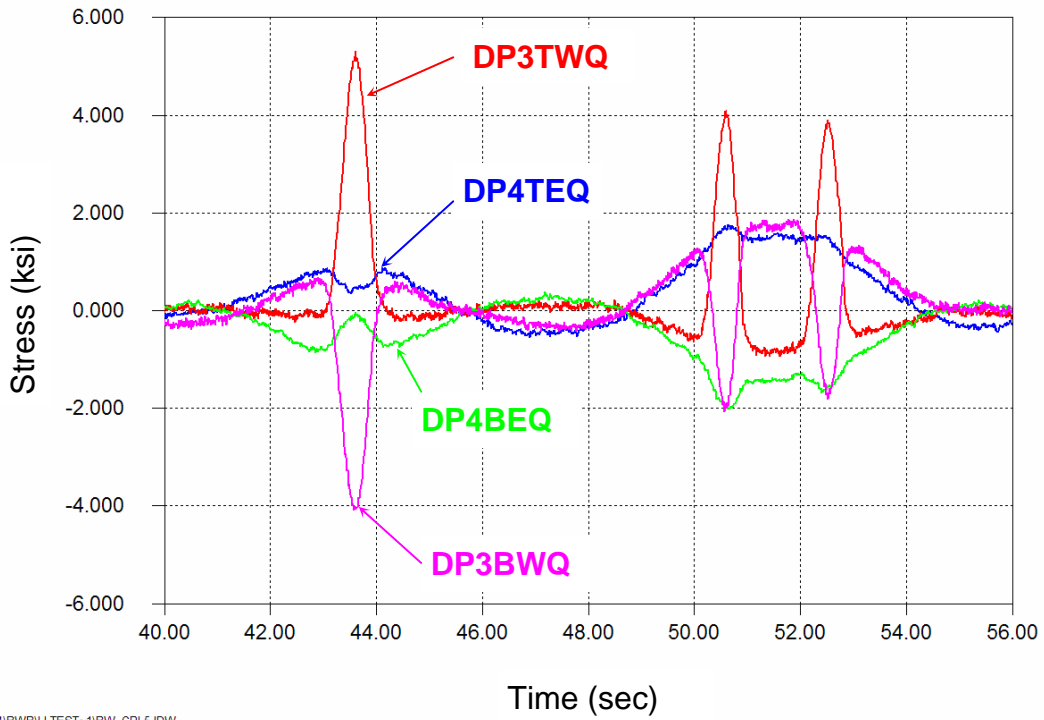
Figure 5.2 – Stress time-history for two pairs of back-to-back (top and bottom) strain gages on the deck plate at quarterspan for test BW_CRL5 (test truck against barrier)

Figure 5.2 and Figure 5.3 contain similar plots for crawl tests with the test truck against the barrier and with the left edge of the test truck on the striping between the middle and right lanes, respectively. It can be seen that with the test truck against the barrier (Figure 5.2) the response is similar though at the underside against Rib 4 (DP4BEQ) the stresses are reduced. With the test truck shifted left in the lane (Figure 5.3) the stresses are significantly reduced and the response is markedly different.

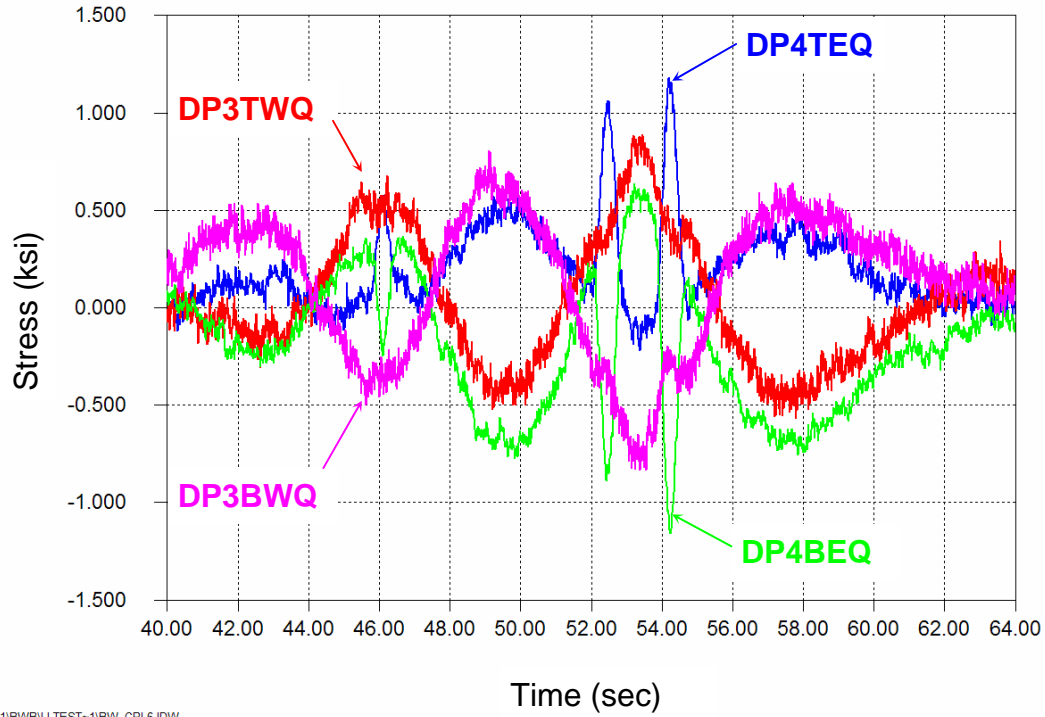
Figure 5.3 – Stress time-history for two pairs of back-to-back (top and bottom) strain gages on the deck plate at the quarterspan for test BW_CRL6 (test truck against left edge)

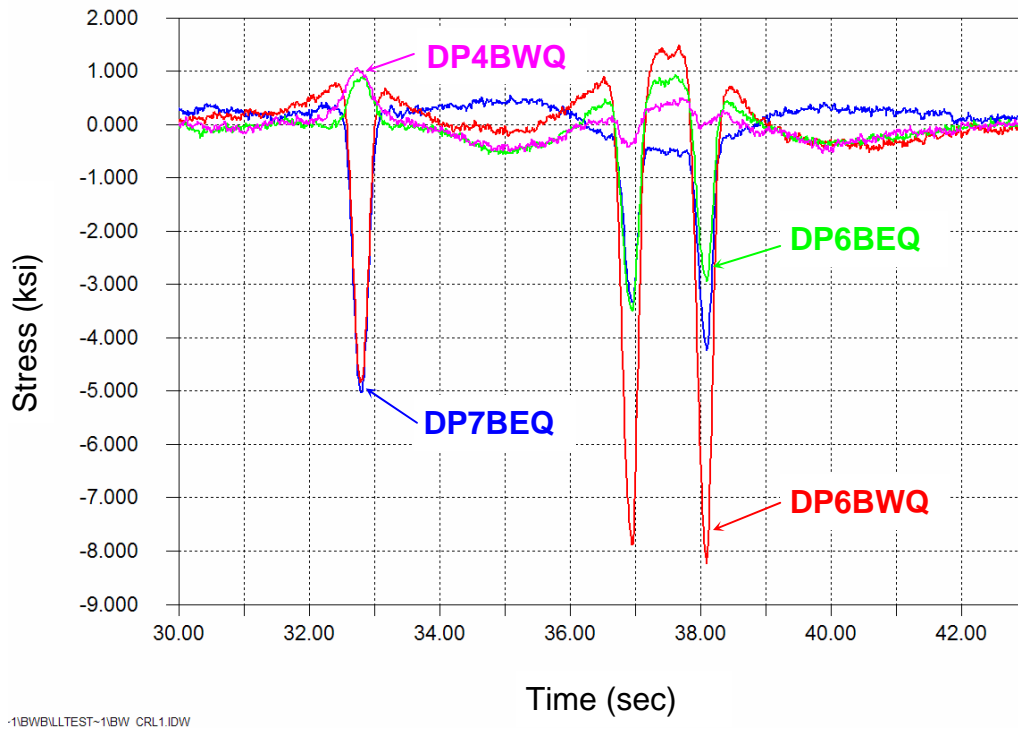
Figure 5.4 – Stress time-history for four strain gages on the bottom surface of the deck plate at quarterspan for test BW_CRL1 (test truck centered in lane)

Shown in Figure 5.4, Figure 5.5, and Figure 5.6 are the stress time-histories for the remainder of the underside strain gages at the quarterspan, for the test truck centered, shifted right in the lane, and shifted left in the lane, respectively. As seen in the plots, the general response is similar for the three truck positions. Additionally, the observations noted above are echoed in these figures. The peak stresses were observed with the test truck centered in the lane. A peak stress of just over 8 ksi in compression was measured at strain gage DP6BWQ, with a 1.3 ksi tension reversal.

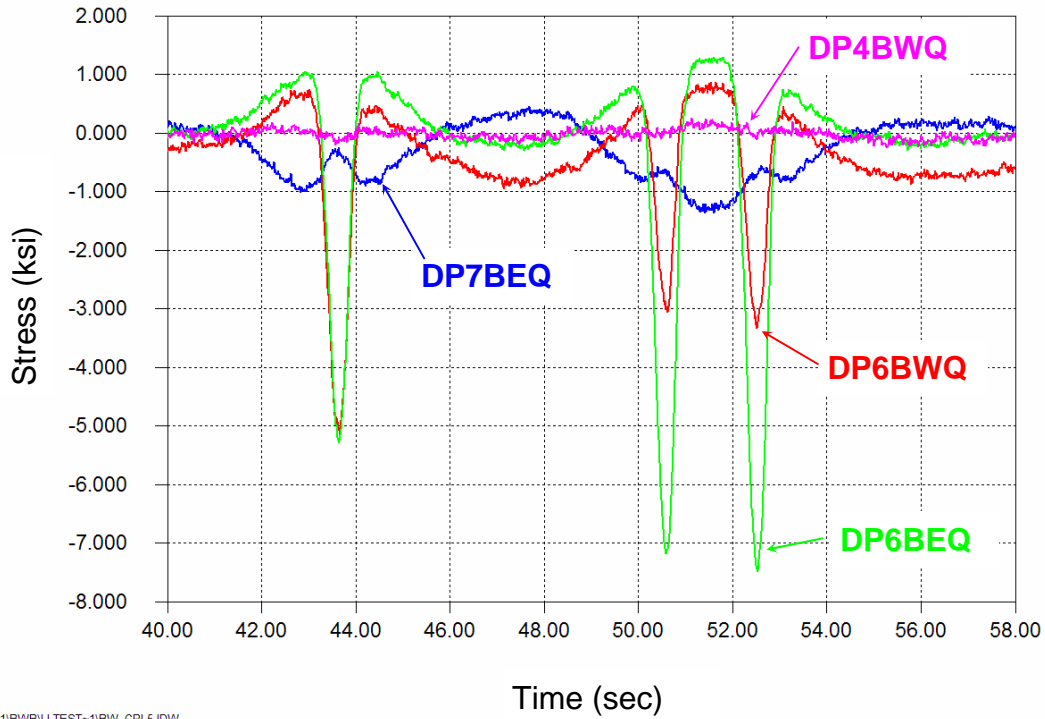
Figure 5.5 – Stress time-history for four strain gages on the bottom surface of the deck plate at quarterspan for test BW_CRL5 (test truck against barrier)

The peak stresses decrease only slightly with the truck shifted to the right (Figure 5.5). However, when the truck is shifted to the left side of the lane, the stresses are decreased significantly, though the response is similar.

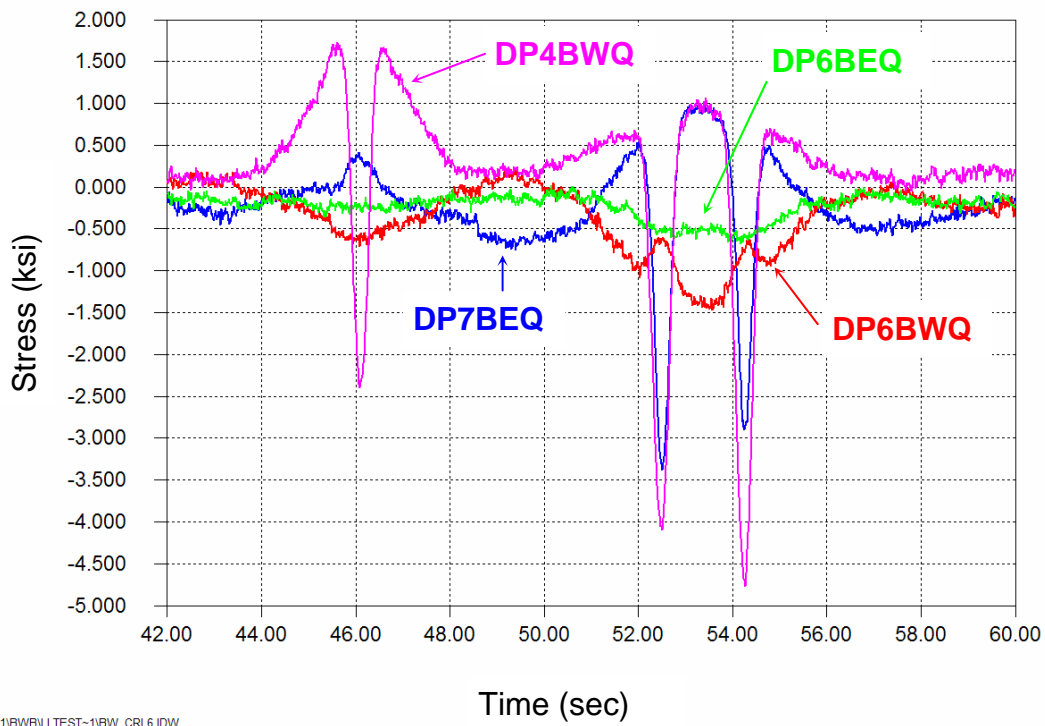
Figure 5.6 – Stress time-history for four strain gages on the bottom surface of the deck plate at quarterspan for test BW_CRL5 (test truck against left edge of lane)

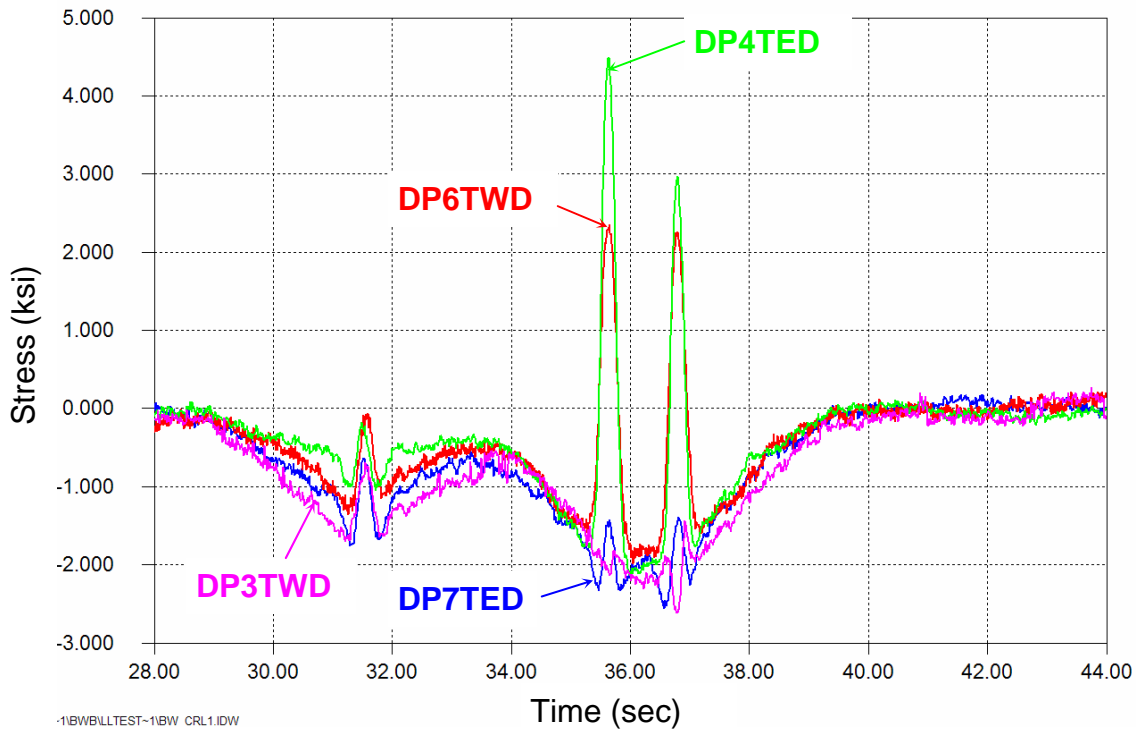
Figure 5.7 – Stress time-history for four strain gages on the top surface of the deck plate at the diaphragm for test BW_CRL1 (test truck centered in lane)

Shown in Figures Figure 5.7, Figure 5.8, and Figure 5.9 are the stress time-history plots for the four strain gages located on the top surface of the deck plate above the built-up diaphragm with the test truck in the center, right side, and left side of the lane, respectively. The response is very sensitive to the transverse position of the truck. For example, the peak stress in strain gage DP4TED with the test truck centered in the lane was 4.5 ksi (Figure 5.7) however, the peak stress at the same strain gage with the test truck to the right side of the lane was less than 0.5 ksi (Figure 5.8).

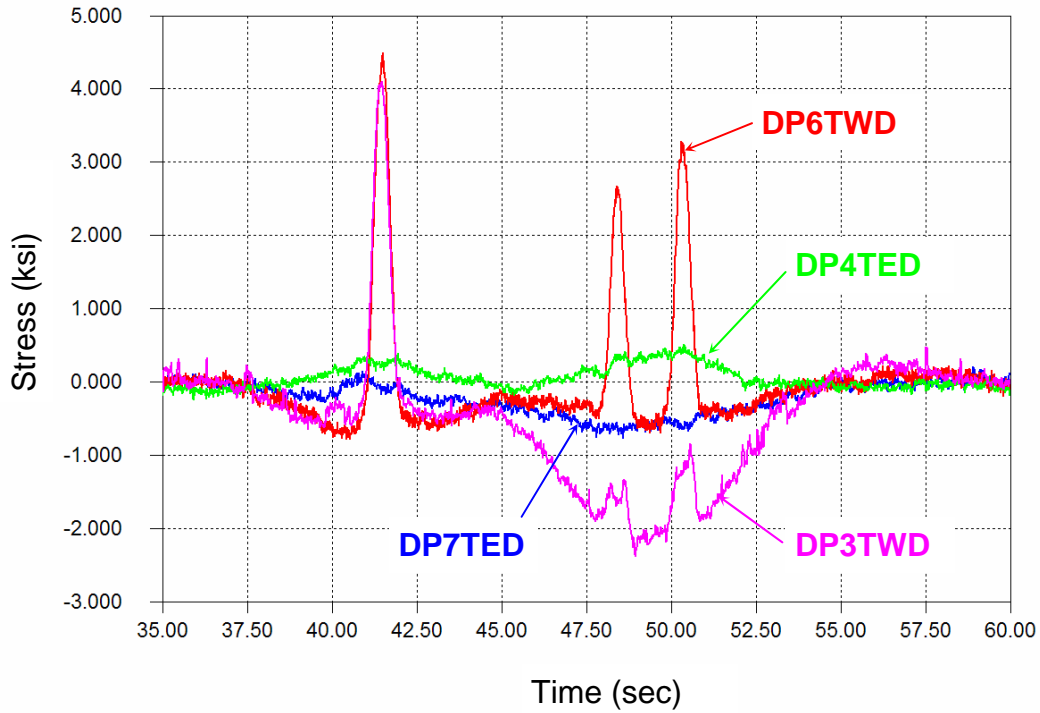
Figure 5.8 – Stress time-history for four strain gages on the top surface of the deck plate at the diaphragm for test BW_CRL5 (test truck against barrier)

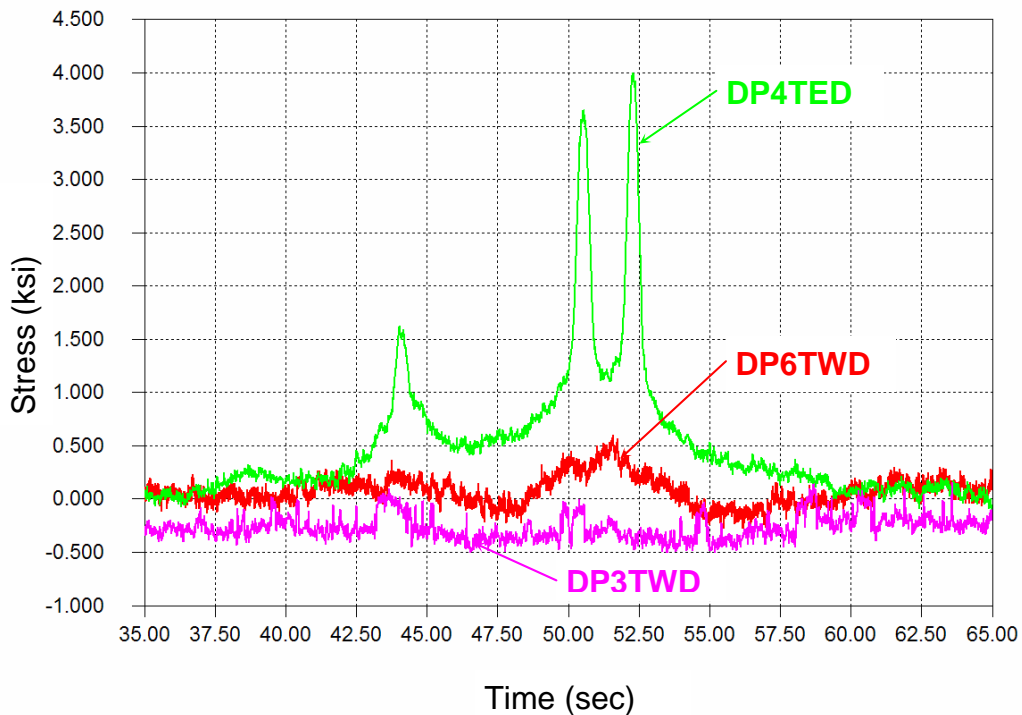
Figure 5.9 – Stress time-history for four strain gages on the top surface of the deck plate at the diaphragm for test BW_CRL6 (test truck against left edge of lane)

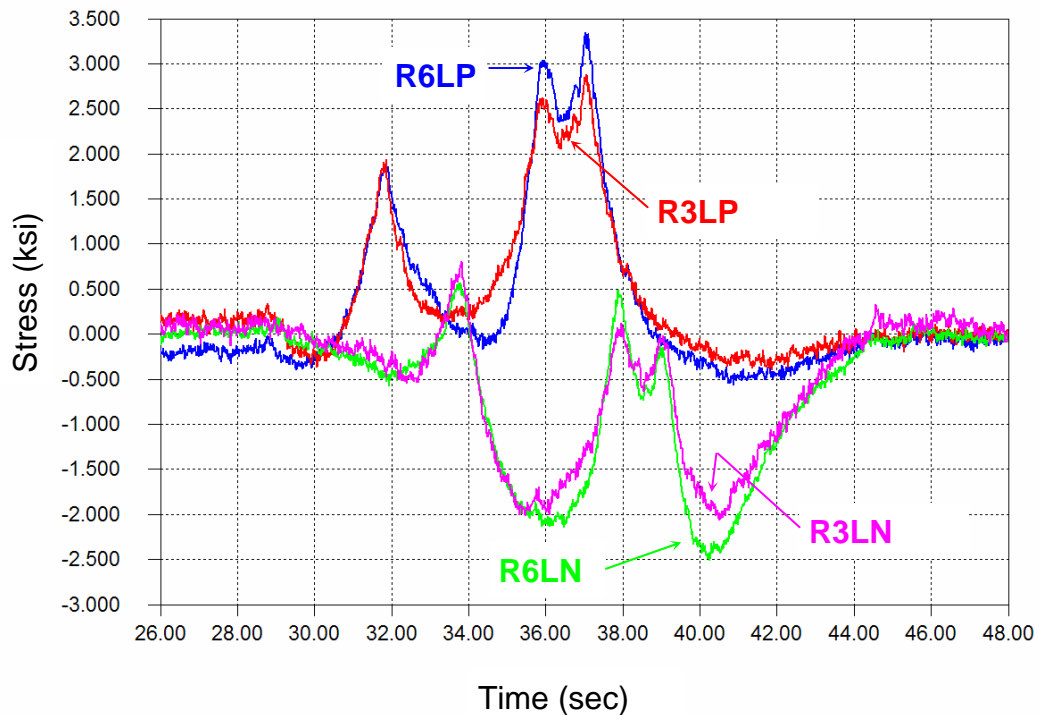
Figure 5.10 – Stress time-history for four strain gages on Ribs 3 and 6 at the floorbeam (denoted by “N”) and at the diaphragm (denoted by “P”) with test truck centered in lane

The longitudinal ribs were not sensitive to the transverse position of the test truck. This is due to the fact that the bottom flange of the rib is not directly subjected to wheel loads (unlike the deck plate). Figure 5.10 shows the stress time-history plot for the four strain gages installed on Ribs 3 and 6. It can be seen that the response of R3LP and R6LP are very similar in magnitude and shape. The same can be said of strain gages R3LN and R6LN. Note that R3LP and R6LP (located at the built-up diaphragm) are dominated by tension response indicating positive bending. Peak tension occurs when the axles cross over the built-up diaphragm.

Strain gages R3LN and R6LN (located at Floorbeam 88) are dominated by compression response indicating negative bending. However, peak compression occurs when the axle groups are away from the floorbeam. When the axles pass directly above the floorbeam, tension stresses are induced at these locations.

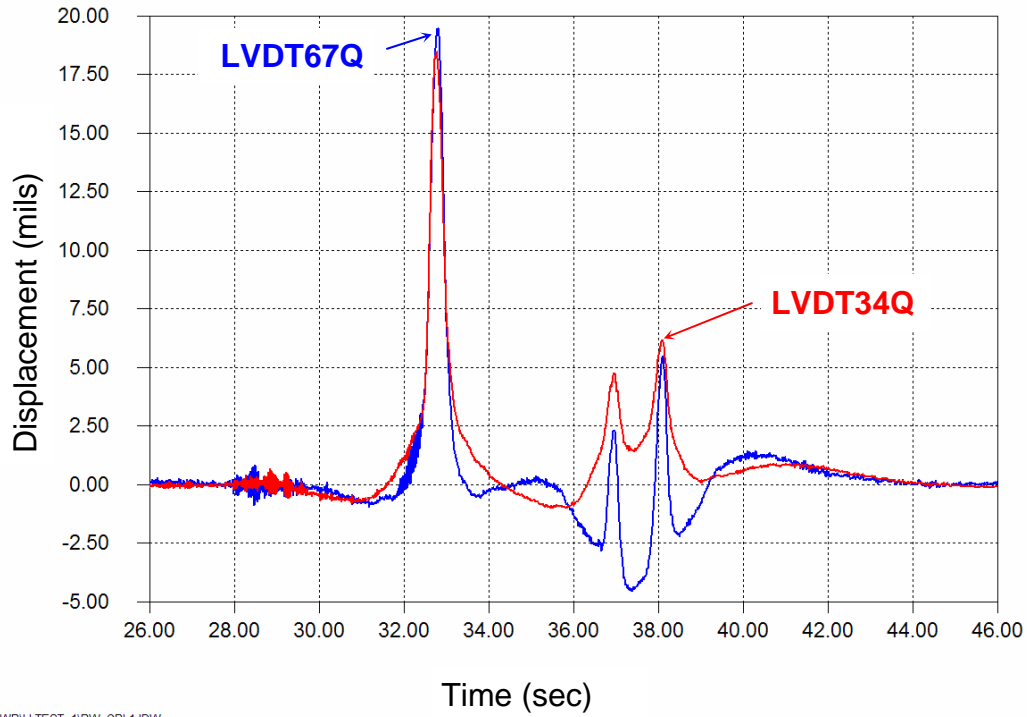
Figure 5.11 – Time-history for relative vertical displacement between deck plate and rib wall at quarterspan between Ribs 6&7 and Ribs 3&4 for test BW_CRL1 (test truck centered in lane)

As indicated in the plots, the transverse position of the test truck has a major influence on the displacement response. A peak downward displacement of just under 20 mils was observed in both sensors with the test truck centered in the lane (Figure 5.11). However, with the test truck shifted to the right, an upward displacement of 13 mils was measured between Ribs 6 and 7, and a downward displacement of 8 mils was measured between Ribs 3 and 4 (Figure 5.12).

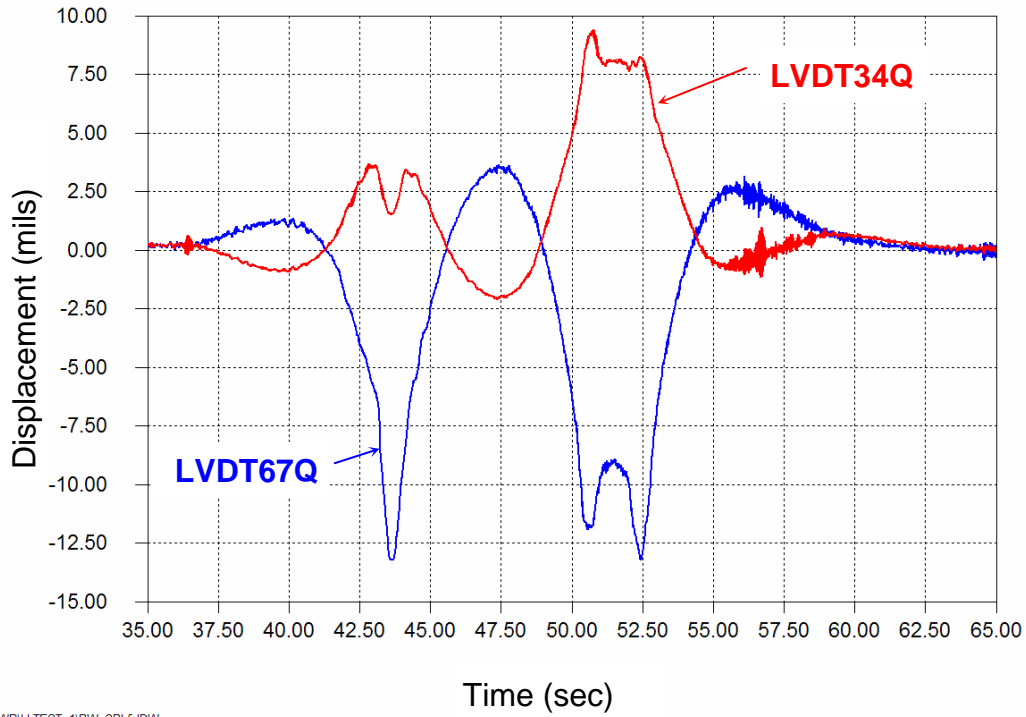
Figure 5.12 – Time-history for relative vertical displacement between deck plate and rib wall at quarterspan between Ribs 6&7 and Ribs 3&4 for test BW_CRL5 (test truck against barrier)

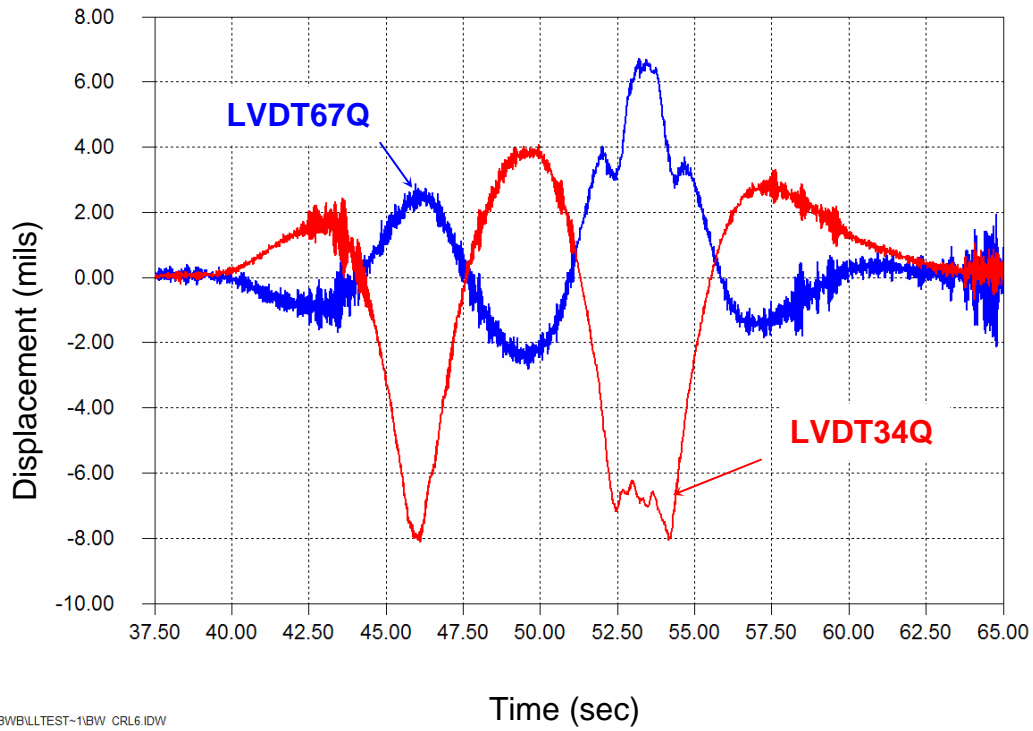
Figure 5.13 – Time-history for relative vertical displacement between deck plate and rib wall at quarterspan between Ribs 6&7 and Ribs 3&4 for test BW_CRL6 (test truck against left edge of lane)

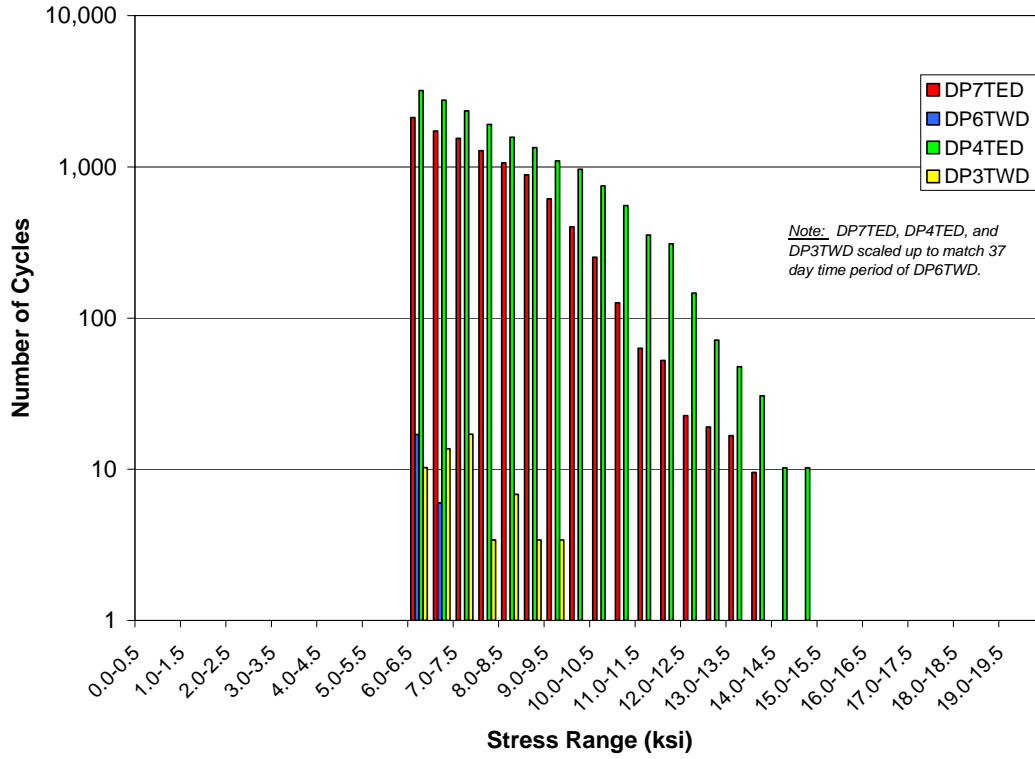
Figure 6.1 – Stress-range histogram for strain gages installed on top surface of deck plate at built-up diaphragm

On the underside however, the CAFL was exceeded at all of the locations. In all but one of the locations, the frequency of exceedence was greater than 0.01%, and therefore at these locations, finite fatigue life is expected. At the worst location (DP4BEQ) the predicted remaining fatigue life is 75 years which is at least equal to the design life. All other locations have a predicted fatigue life over 100 years (effectively infinite life). The stress range histograms are presented in Figure 6.1, Figure 6.2, and Figure 6.3

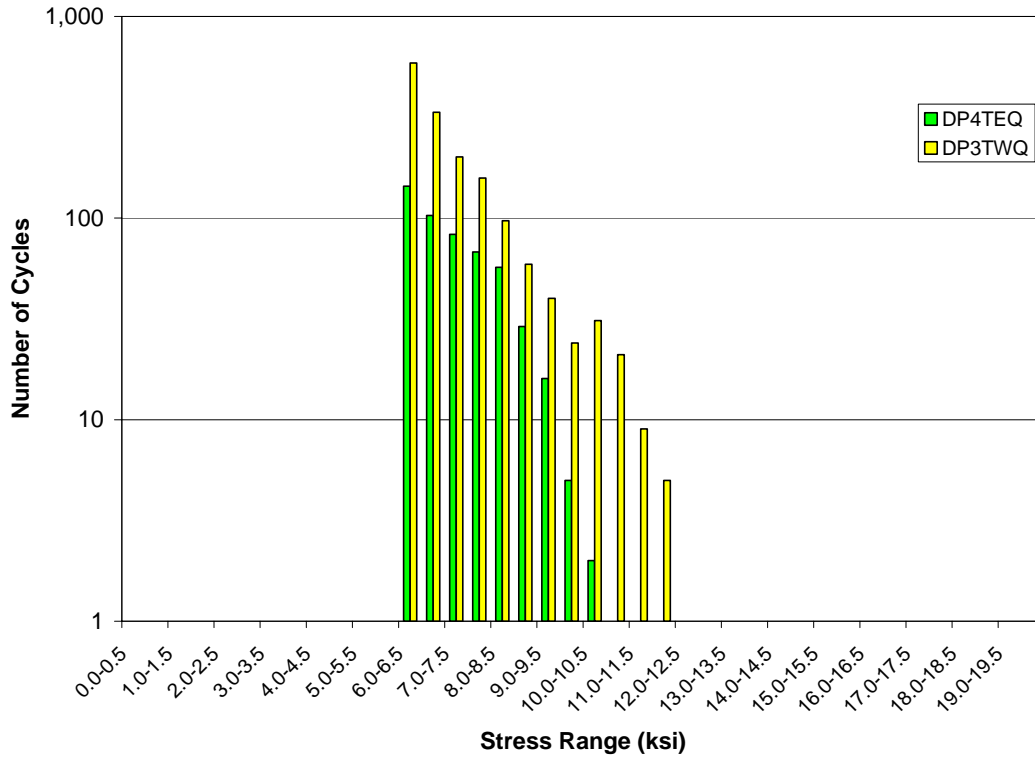
Figure 6.2 – Stress-range histogram for strain gages installed on top surface of deck plate at quarterspan

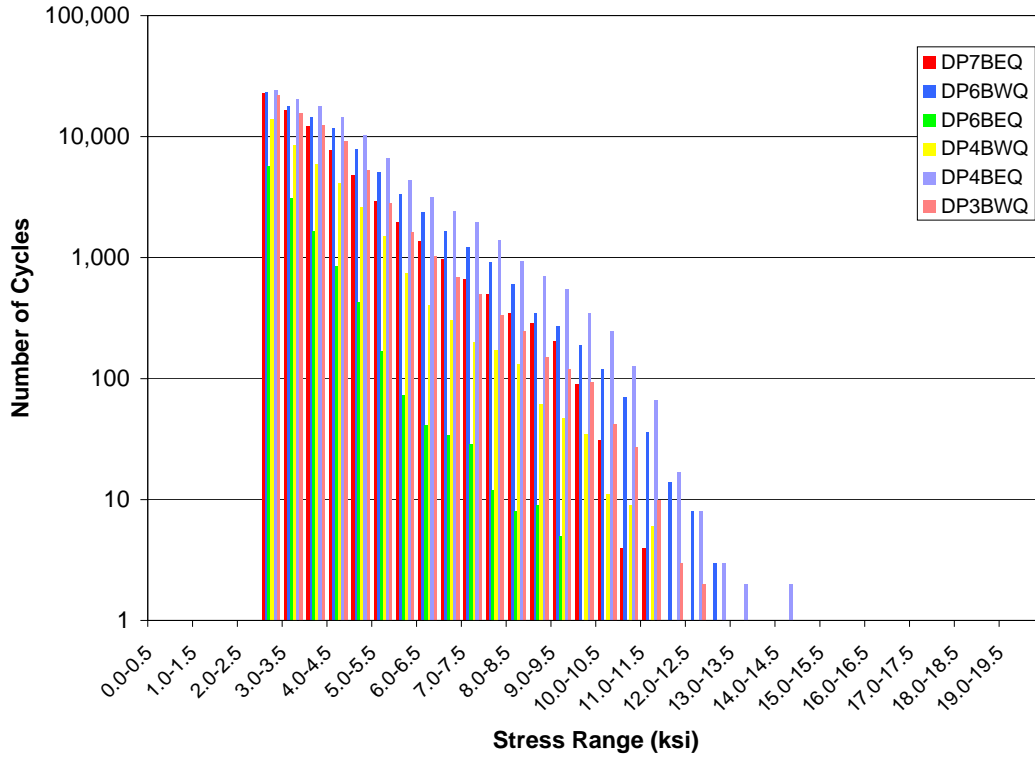
Figure 6.3 – Stress-range histogram for strain gages installed on underside of deck plate at quarterspan

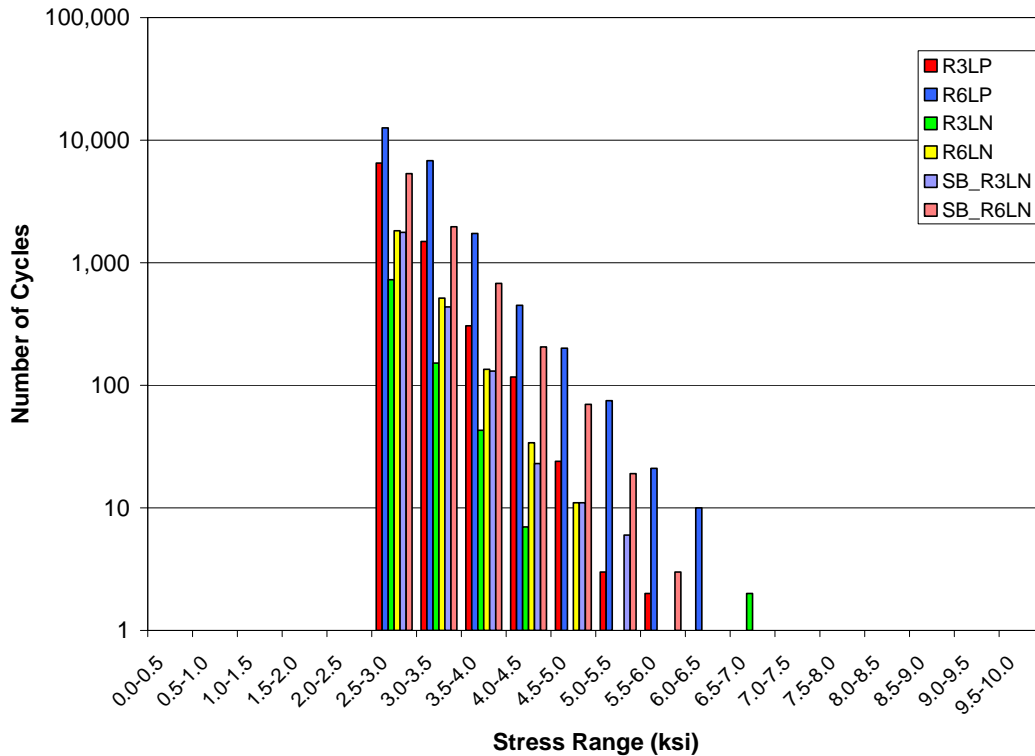
Figure 6.4 Stress-range histogram for strain gages installed on bottom flange of Ribs 3 and 6 at quarterspan and at built-up diaphragm

As shown in the Table, the CAFL was never exceeded. The maximum stress range was 9.0 ksi, and the maximum effective stress was 2.7 ksi. All locations are expected to exhibit infinite fatigue life. Figure 6.4 contains the stress range histograms for the six strain gages installed on the orthotropic ribs.
