Field Testing of the Orthotropic Deck on the Bronx-Whitestone Bridge

FIELD TESTING OF THE ORTHOTROPIC DECK ON THE BRONX-WHITESTONE BRIDGE

Final Report

ATLSS Report 09-01

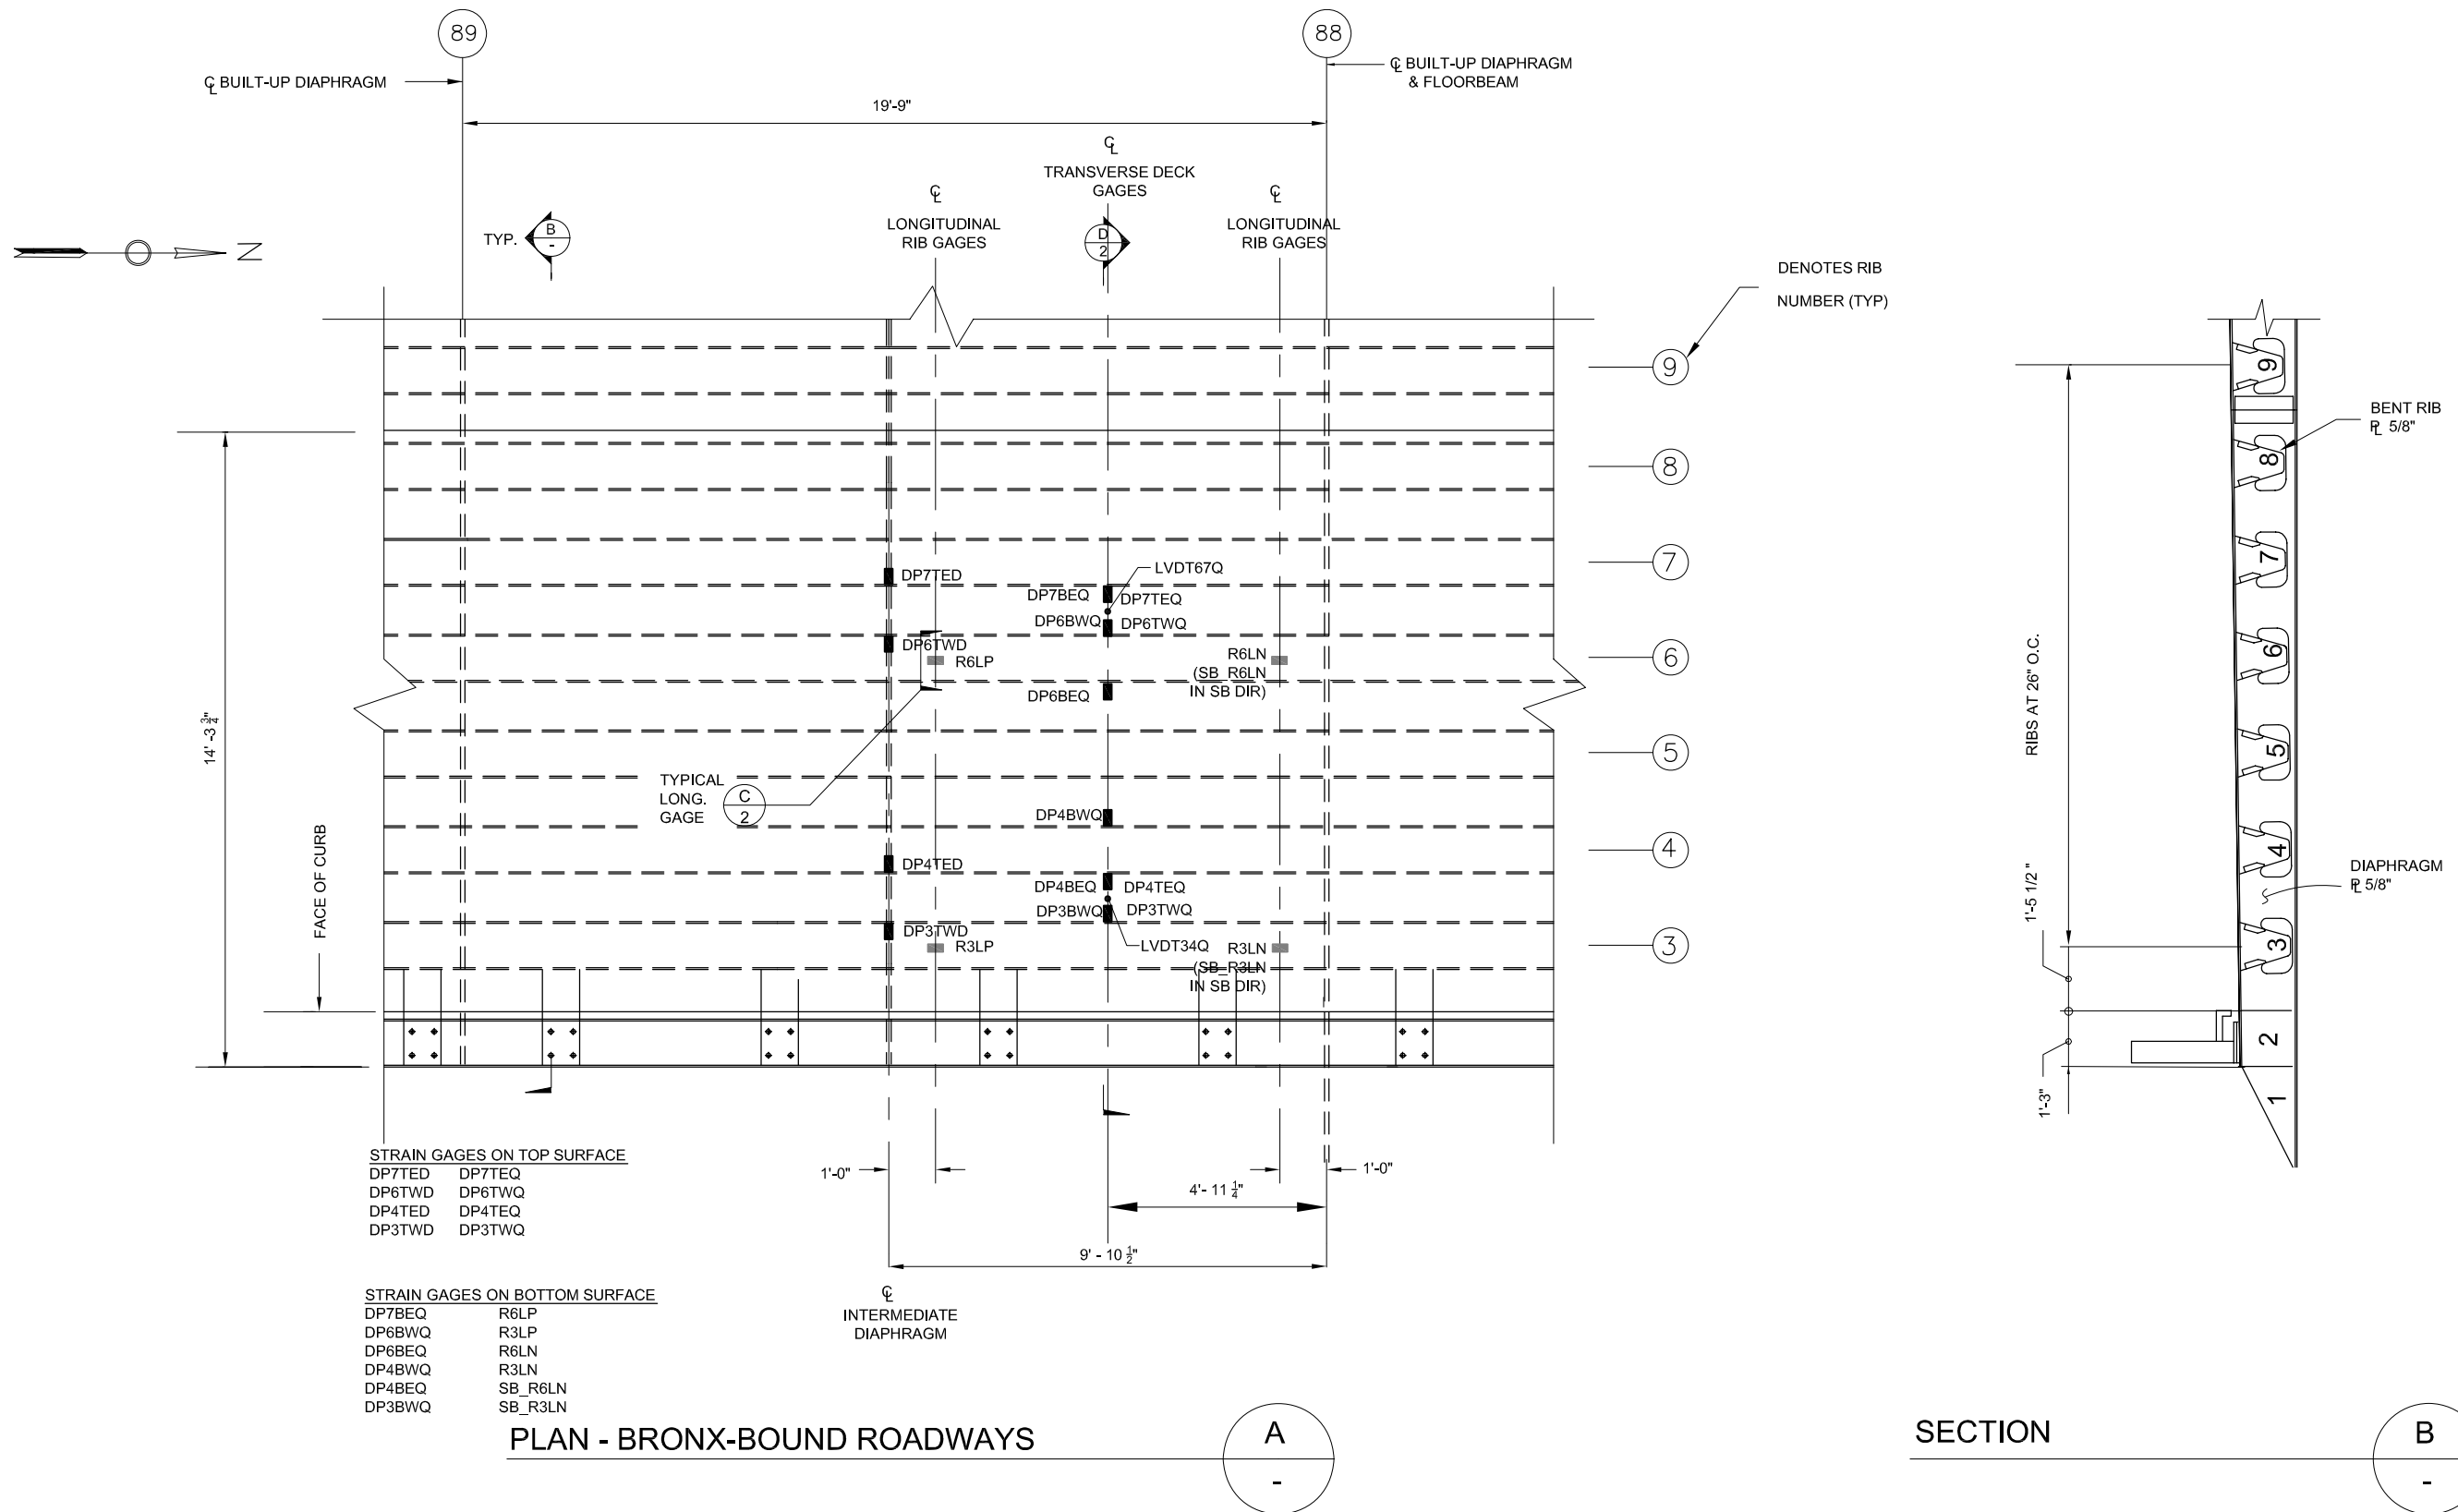
STRAIN GAGES ON TOP SURFACE
DP7TED DP7TEQ
DP6TWD DP6TWQ
DP4TED DP4TEQ
DP3TWD DP3TWQ

STRAIN GAGES ON BOTTOM SURFACE
DP7BEQ R6LP
DP6BWQ R3LP
DP6BEQ R6LN
DP4BWQ R3LN
DP4BEQ SB_R6LN
DP3BWQ SB_R3LN

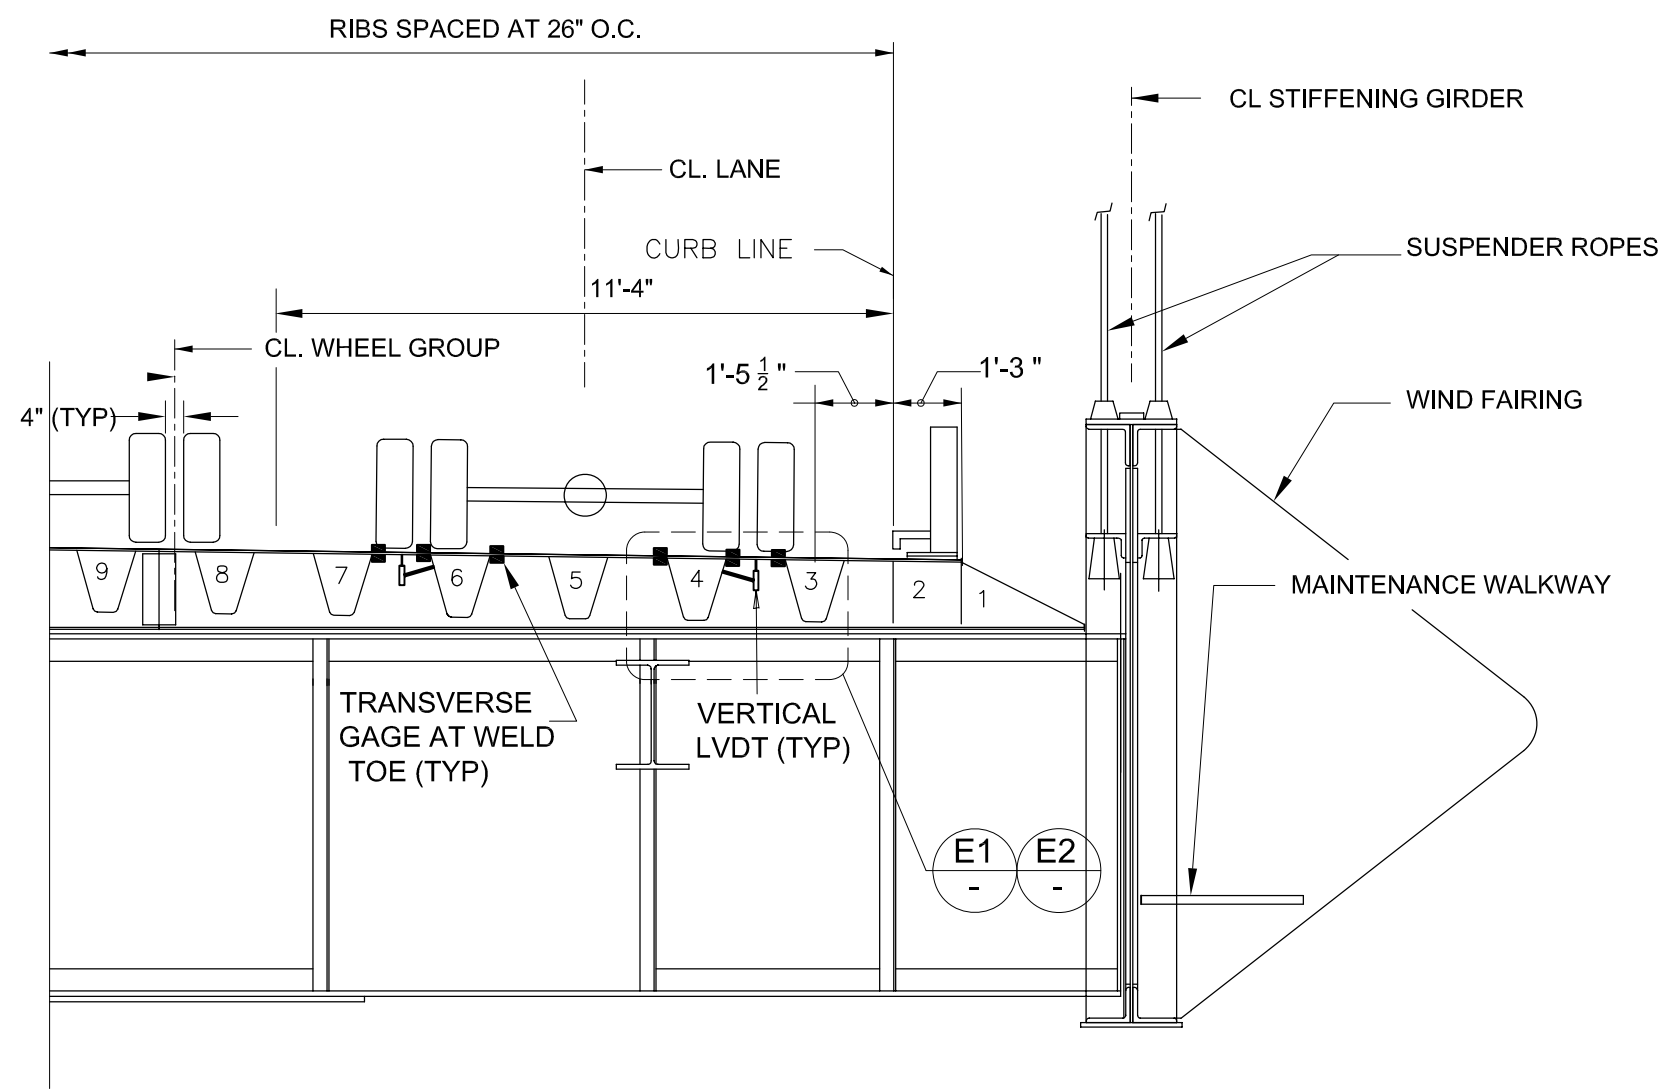
D
1

SECTION LOOKING NORTH

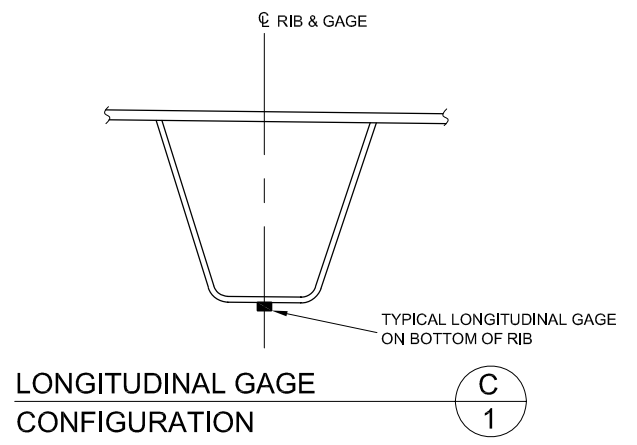
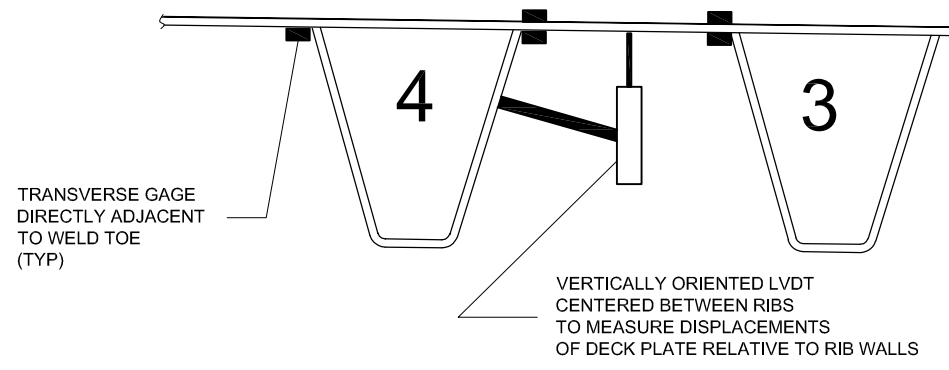
E1

TRANSVERSE GAGE CONFIGURATION @ QUARTER SPAN

NOTE:
1. RIBS 3 & 4 SHOWN. (RIBS 6 & 7 OPP. HAND)
2. SEE PLAN, SHEET 1, FOR GAGE IDENTIFICATION & LOCATION.

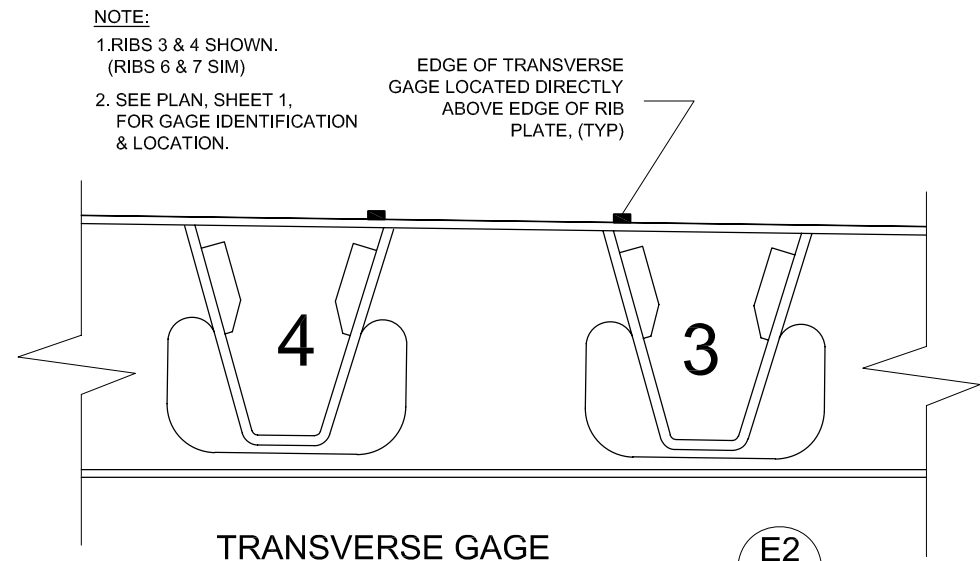
E2

TRANSVERSE GAGE CONFIGURATION @ DIAPHRAGM

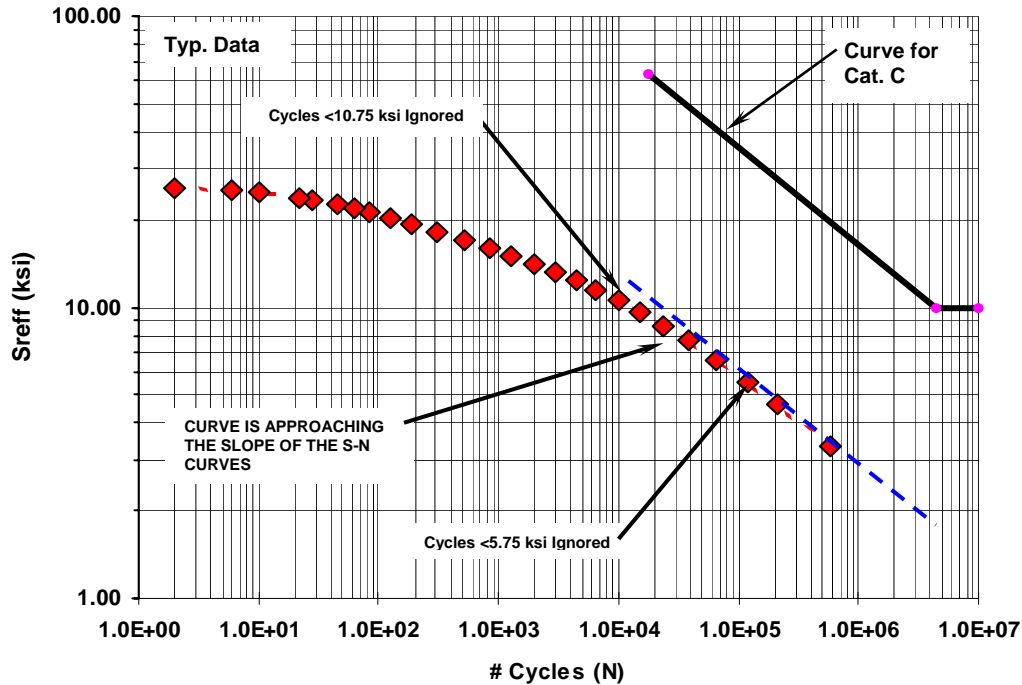
Figure B.1 – Effect of truncating cycles at different stress range cut off levels
(Typical data from a strain gage at a fatigue sensitive detail)

Figure B.1, shows the effect on the calculated effective stress range for several levels of truncation using typical field acquired long-term monitoring data collected from strain gage installed on a bridge. The data presented in Figure B.1 are also listed in Table B.1 showing the selected truncation level and its impact on the effective stress range.

As demonstrated by Figure B.1, as the truncation level decreases (from the lowest level), the effective stress range and corresponding number of cycles approaches the slope of the S-N curve for Category C, which is also plotted in Figure B.1 (i.e., a slope of -3 on a log-log plot). As long as the cut off level selected is consistent with the slope of the fatigue resistance curve, considering additional stress cycles at lower truncation levels does not improve the damage assessment and can therefore be ignored. As can be seen, using a truncation level as high as 10 ksi, the curve is nearly asymptotic to the slope of the S-N curves. Hence, an accurate prediction of the total fatigue life results.
