# **Horizontal Shear Capacity of Composite Concrete Beams without Interface Ties**

**June 2008**

**ATLSS REPORT NO. 08-05**

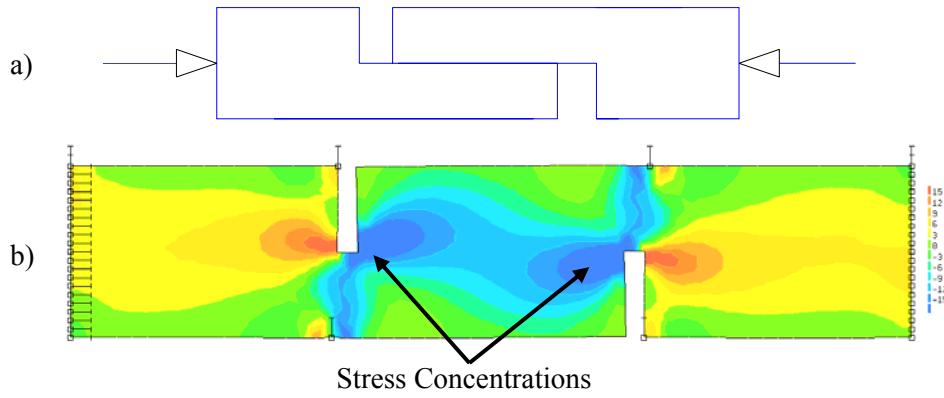
conditions, stress concentrations can occur resulting in a non-conservative estimate of the horizontal shear capacity. The stress concentrations are demonstrated by the finite element model shown in Figure 3-2b.

Figure 3-2: Push-off Test Specimen: a) Concentric loading; b) Non-uniform shear stress

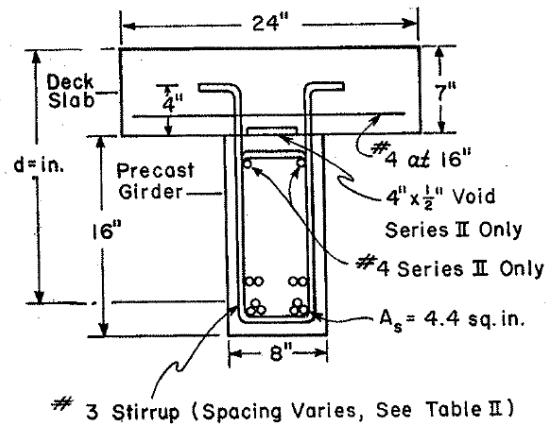
Hanson tested ten T-shape composite girders of which two did not have shear ties crossing the interface. One of the beams had a rough interface (specimen BR-I) and the other was cast monolithically (specimen M-I). The purpose of this experimental program was to study the process of horizontal shear transfer. The test variables included surface bond, roughness, the effect of keys, and the effect of stirrups. The girders were “designed in such a way that the horizontal shear at the girder/slab contact surface reached high values at loads well below flexural failure.” The section was designed so that the neutral axis of bending strains was near the contact surface. The cross-section of the girder can be seen in Figure 3-4. There were two series of tests. It can be seen in Figure 3-4 that for the second series Hanson reduced the area of the interface in order to increase the value of the horizontal shear stress. Hanson reported that “the calculation of the horizontal shear stress was based on the equation  $v = VQ/Ib_v$ , in which  $Q$  is the first moment about the neutral axis of all areas from the horizontal section considered to the extreme compression edge. This equation was applied to the contact surface section, considering the cracked transformed cross

Figure 3-4: Cross-Section of Beam Tested by Hanson

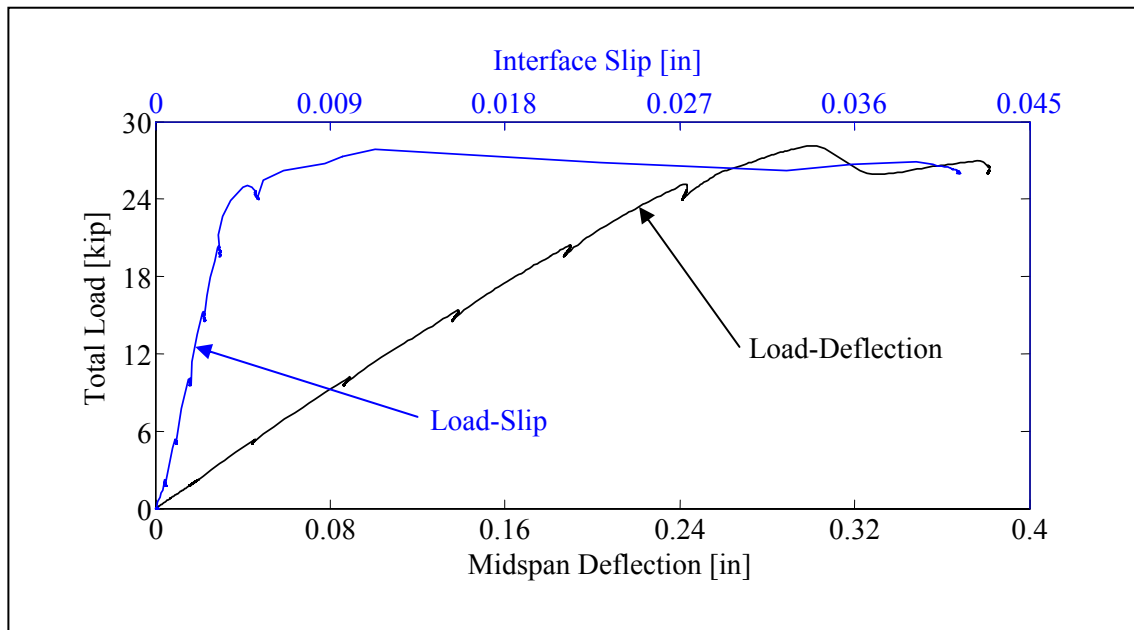
Figure 5-11: Typical Load-Slip and Load-Deflection Curves [Beam 13: R2.2]

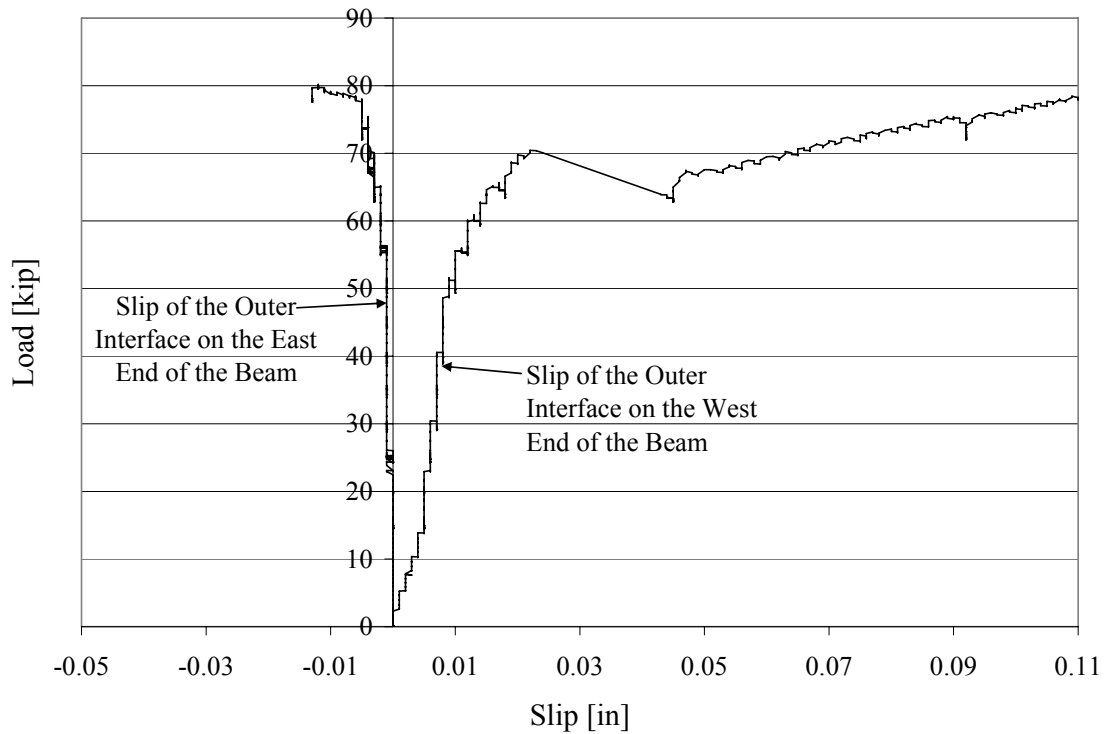
Figure 9-5: Variation in the Slip Behavior on Opposite Ends of a Beam [Specimen 6A6]

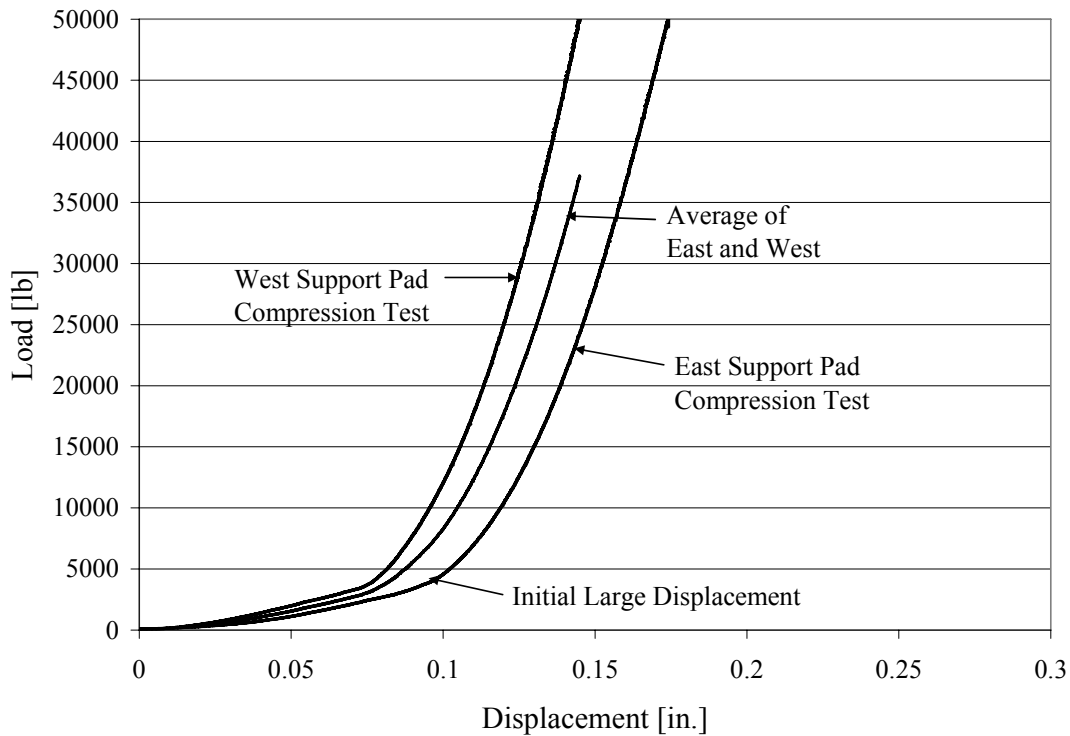
Figure 9-18: Support Pad Compression Test Results

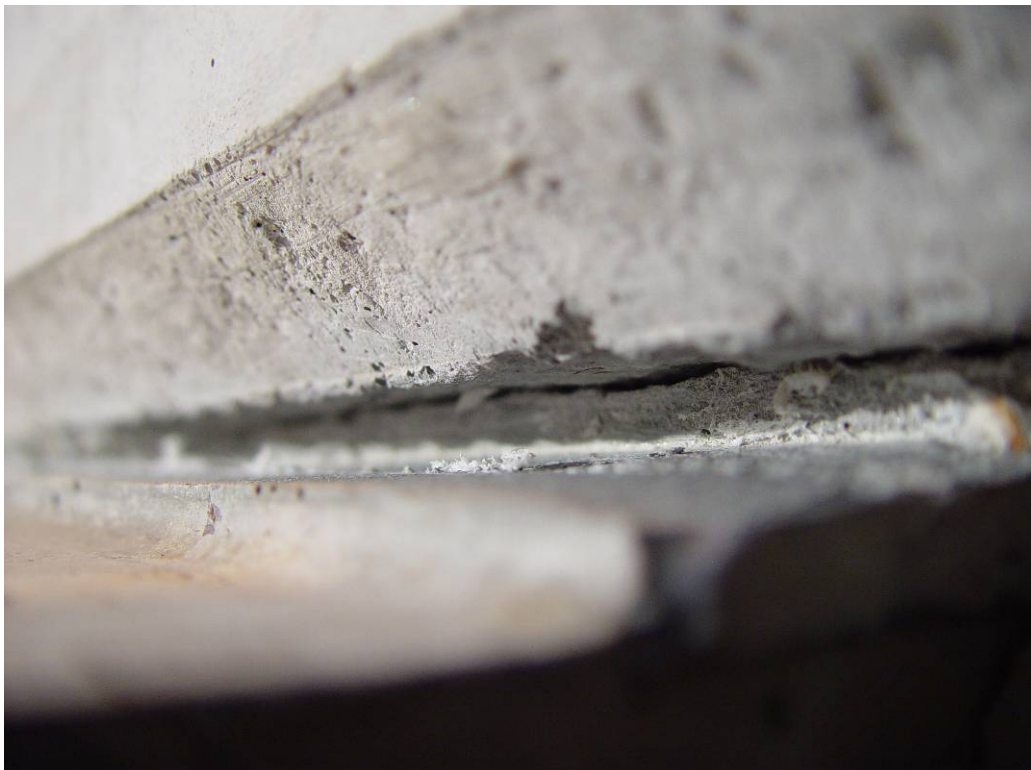
Figure 9-26: Failure of the Composite Interface
