Field Instrumentation and Long-Term Monitoring of the FRP Bridge over Dubois Creek in Great Bend, PA

**FIELD INSTRUMENTATION
AND LONG-TERM MONITORING
OF THE
FRP BRIDGE OVER DUBOIS CREEK
IN GREAT BEND, PENNSYLVANIA**

FINAL REPORT

ATLSS Report No. 03-28

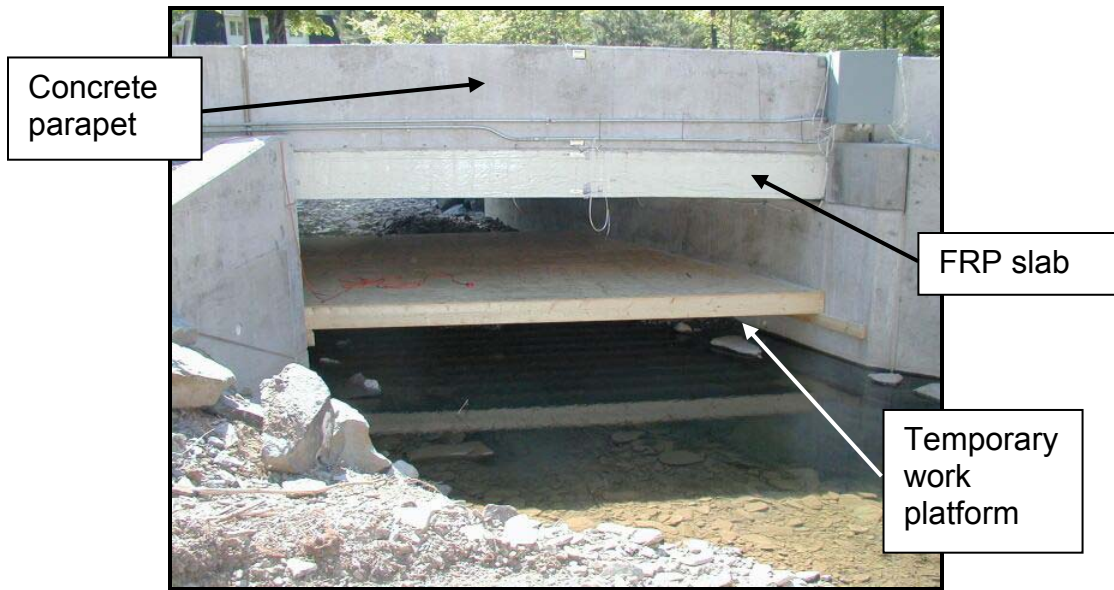
Figure 1.1 – Photograph of FRP bridge over Dubois Creek in Great Bend Twp., PA

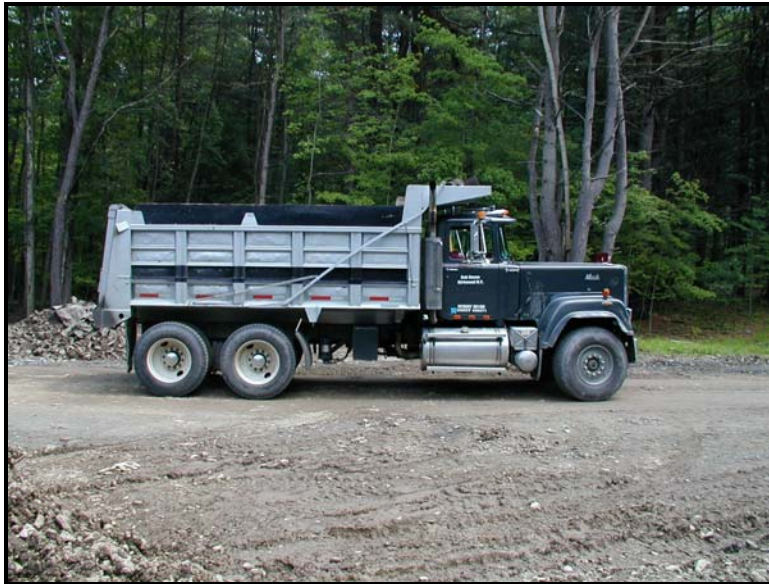
Figure 3.1 – Photograph of test truck utilized during the controlled load tests

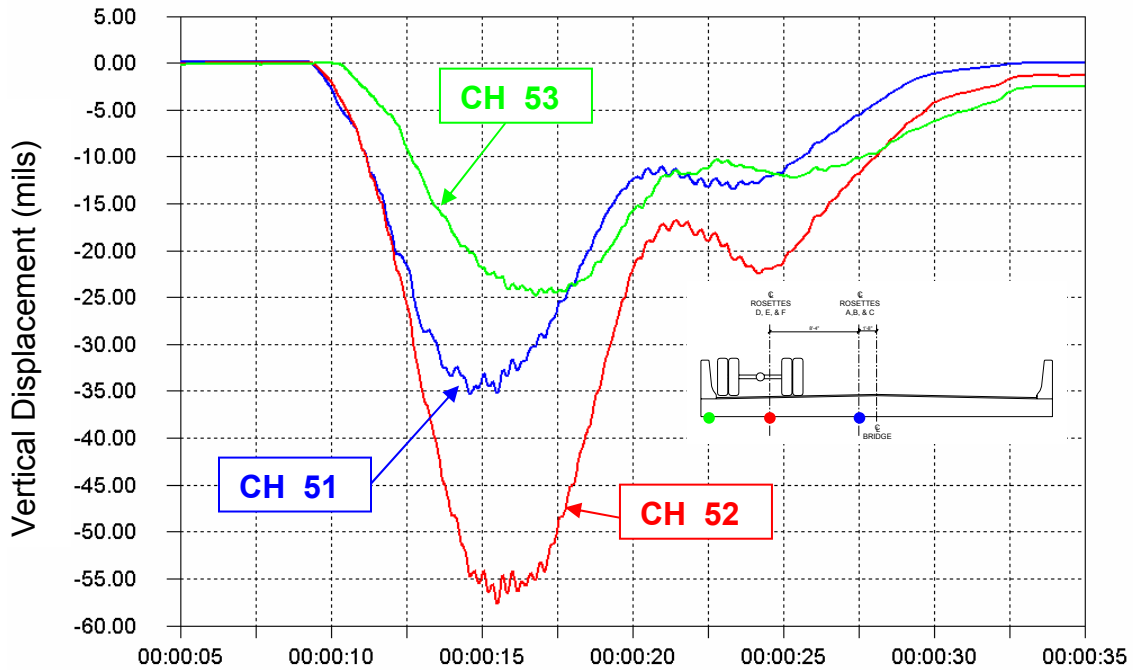
Figure 4.2 – Vertical displacement time-history for load test CRL_PPT1
(Test truck located as close as possible to downstream parapet)

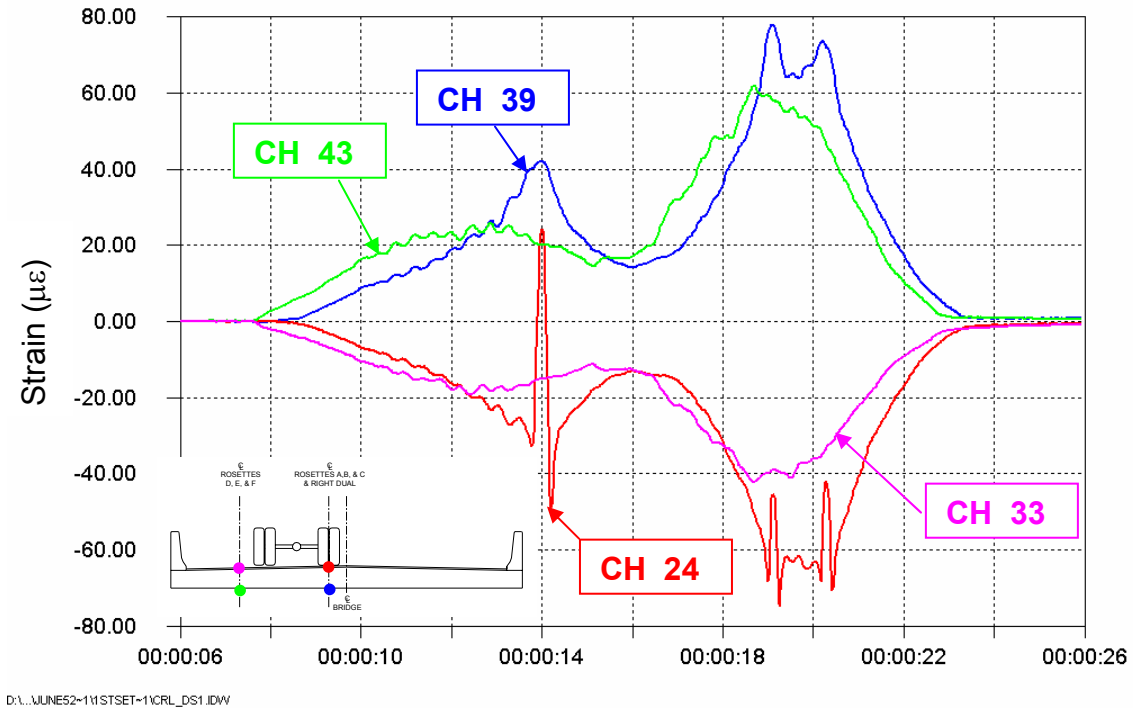
Although the strain magnitudes are less than those in the longitudinal direction, these plots indicate that there is significant bending of the FRP slab in the transverse direction.

Figure 4.9 – Transverse strain history at midspan for load test CRL_DS1 (Centerline right dual over CH_22)

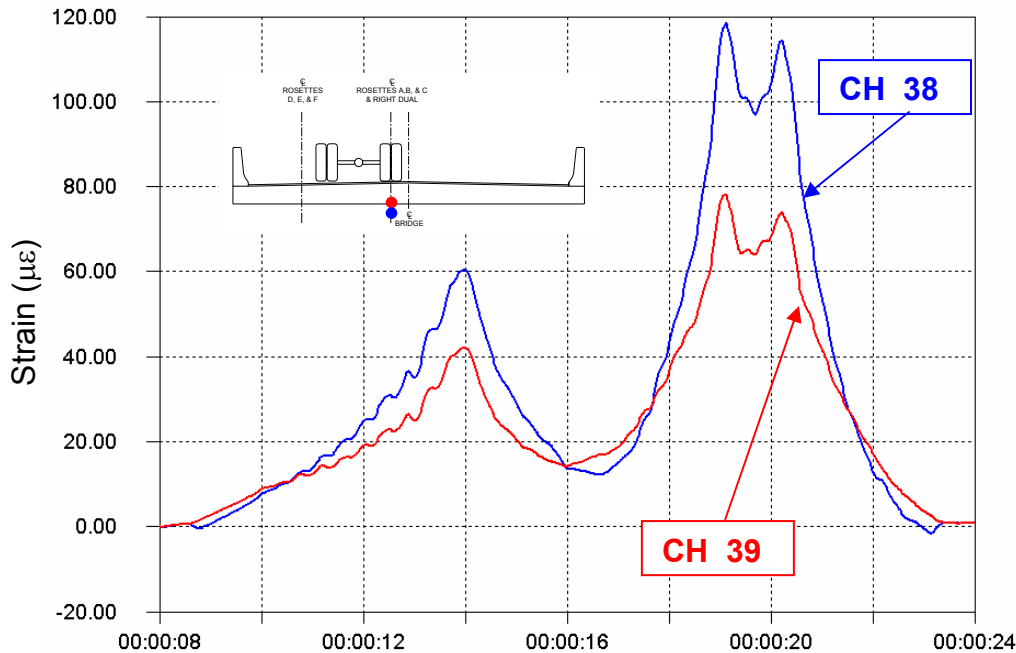
Figure 4.14 – Strain history at bottom of FRP slab at midspan for static load test CRL_DS1 (CH_38 is longitudinal, CH_39 is transverse)

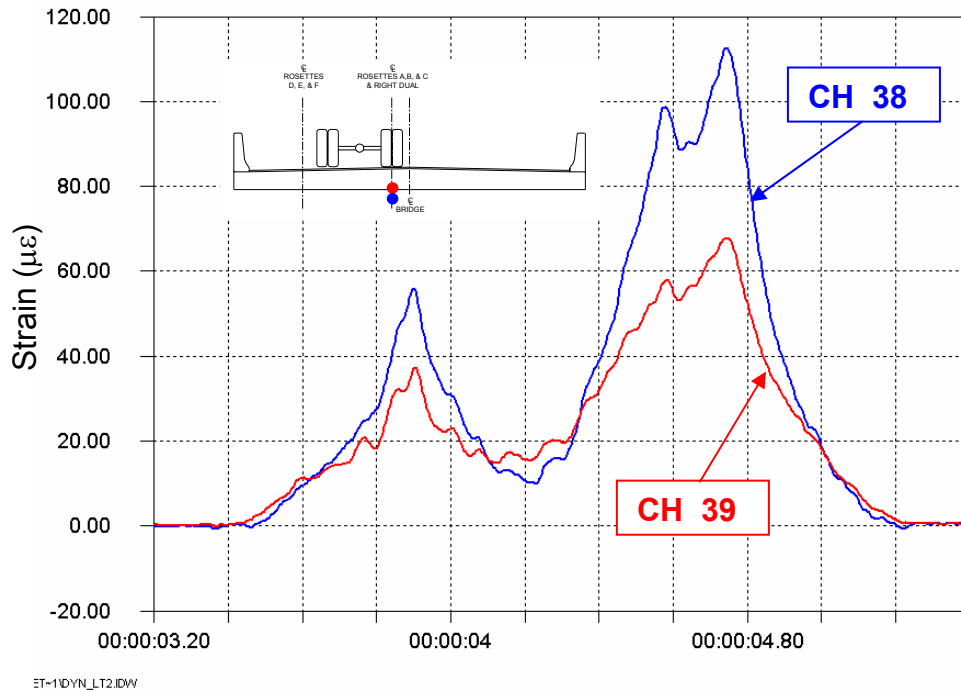
Figure 4.15 – Strain history at bottom of FRP slab at midspan for dynamic load test DYN_LT2 (CH_38 is longitudinal, CH_39 is transverse)

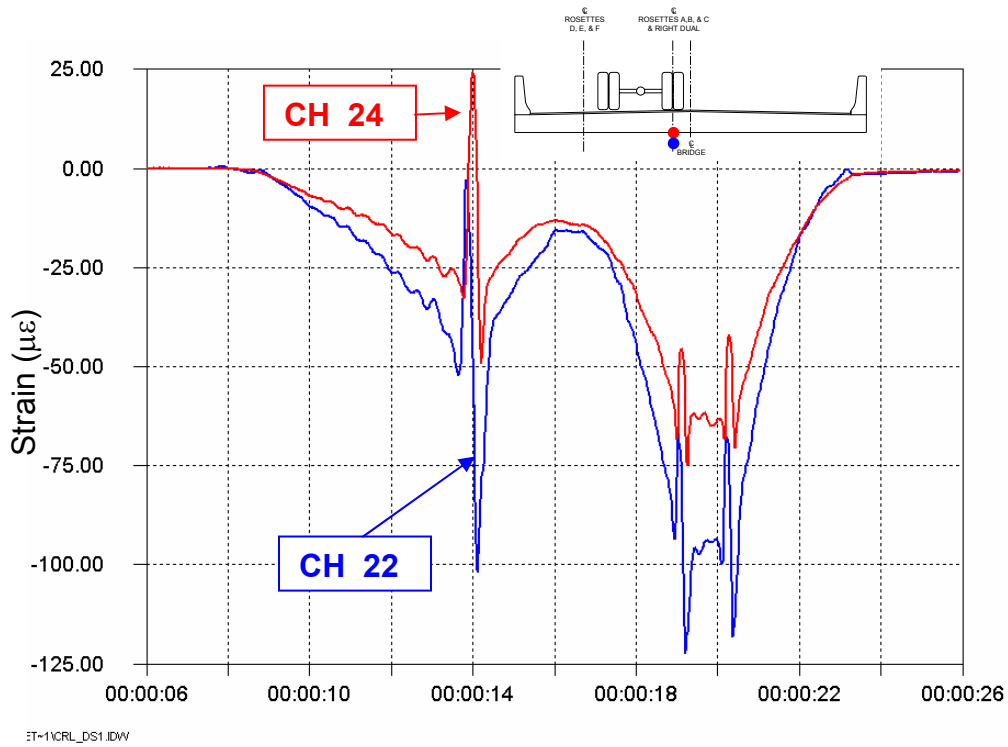
Figure 4.16 – Strain history at top of FRP slab at midspan for static load test CRL_DS1 (CH_22 is longitudinal, CH_24 is transverse)

The peak strain at CH_22 during the static test is approximately 120 microstrain (Figure 4.16). The corresponding peak strain from the dynamic test is approximately 150 microstrain (Figure 4.17). This is a dynamic amplification of approximately 25%. It must be noted that part of the difference may be attributed to variations in the transverse position of the wheel.

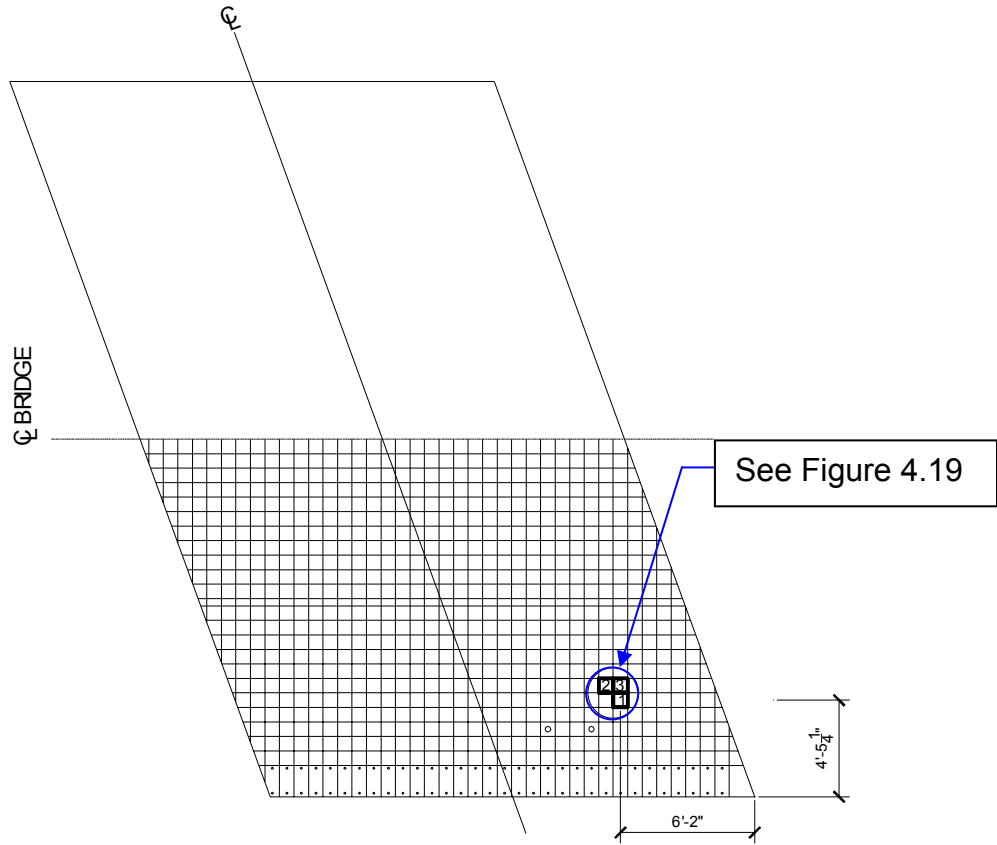
Figure 4.18 – Location plan of instrumented bottle

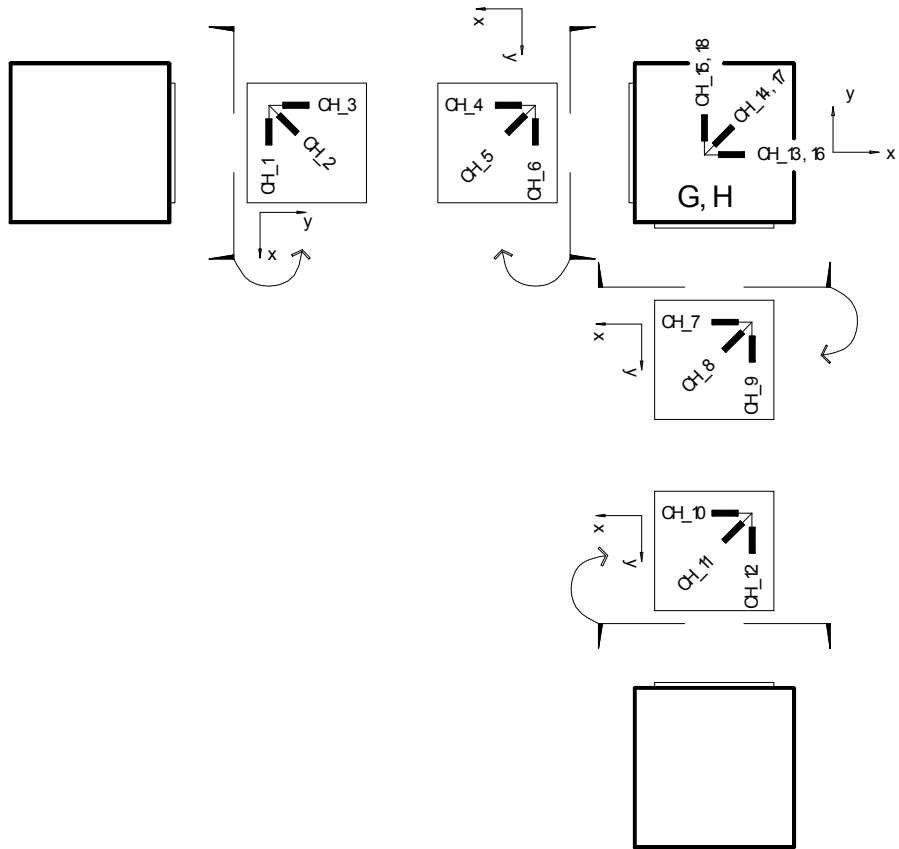
Figure 4.19 – Rosette configuration on instrumented bottle
(Coordinate system of each rosette is indicated)

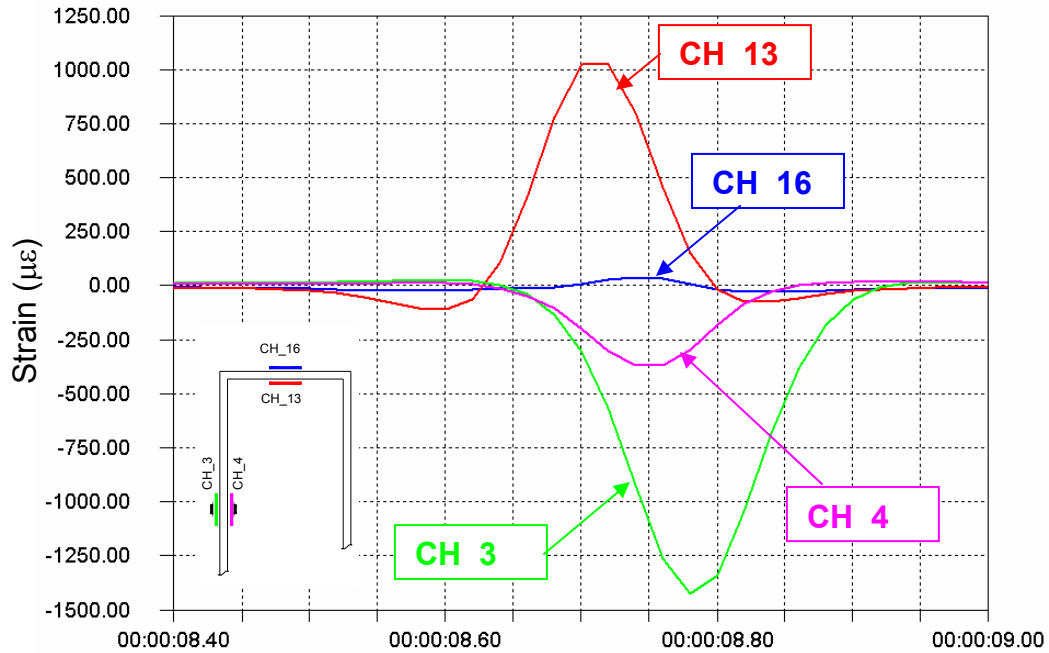
Figure 4.21 contains a strain history plot for the longitudinal “frame” consisting of the web and top plate gages (see the figure inset). This event represents the passing of the front wheel of the truck. It can be seen that the magnitude of the strains are an order of magnitude larger than those observed during global response to load. The peak strain occurs at the underside of the top plate, with a magnitude of approximately 1000 microstrain. This occurs at the underside of the top plate (CH_13) as the wheel load passes above. The top plate is in positive bending since this strain is tensile (positive). It is also evident that CH_16 shows a low positive tensile strain. Comparable compressive

Figure 4.21 – Strain history in top plate of bottle for longitudinal “frame” action (see section A-A of Figure 4.20)

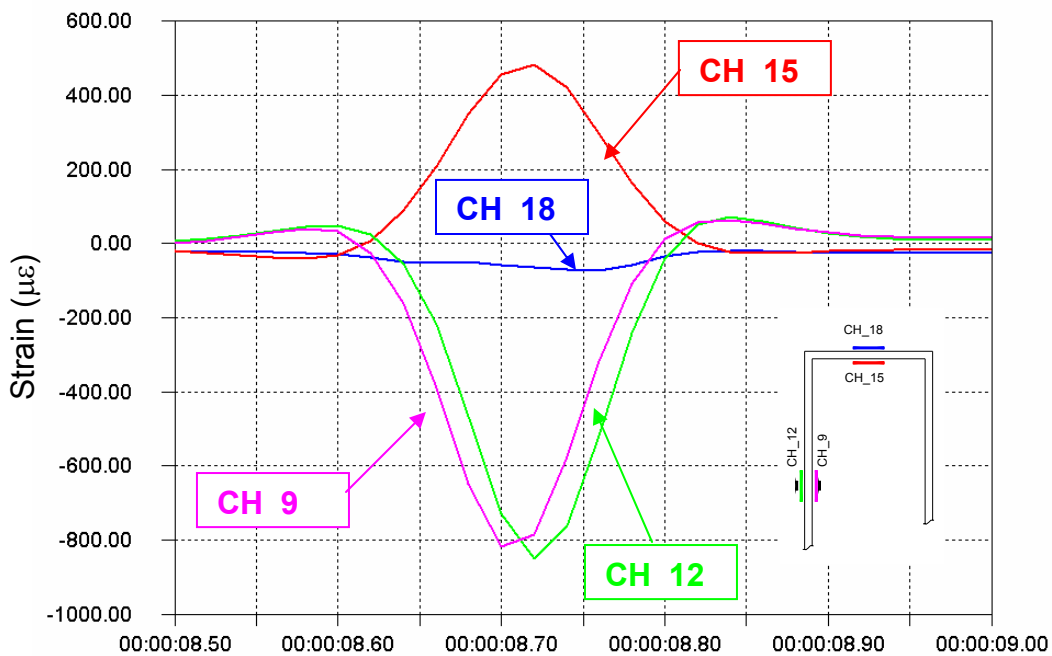
Figure 4.22 contains a similar plot for the transverse “frame.” The magnitudes of strain in the transverse direction are approximately half of those in the longitudinal direction. The peak stress occurs at the underside of the top plate, as in the longitudinal direction (Figure 4.21). However, the web gages indicate that there is very little bending, due to the fact that the two web gages (CH_9 and CH_12) have comparable magnitudes.

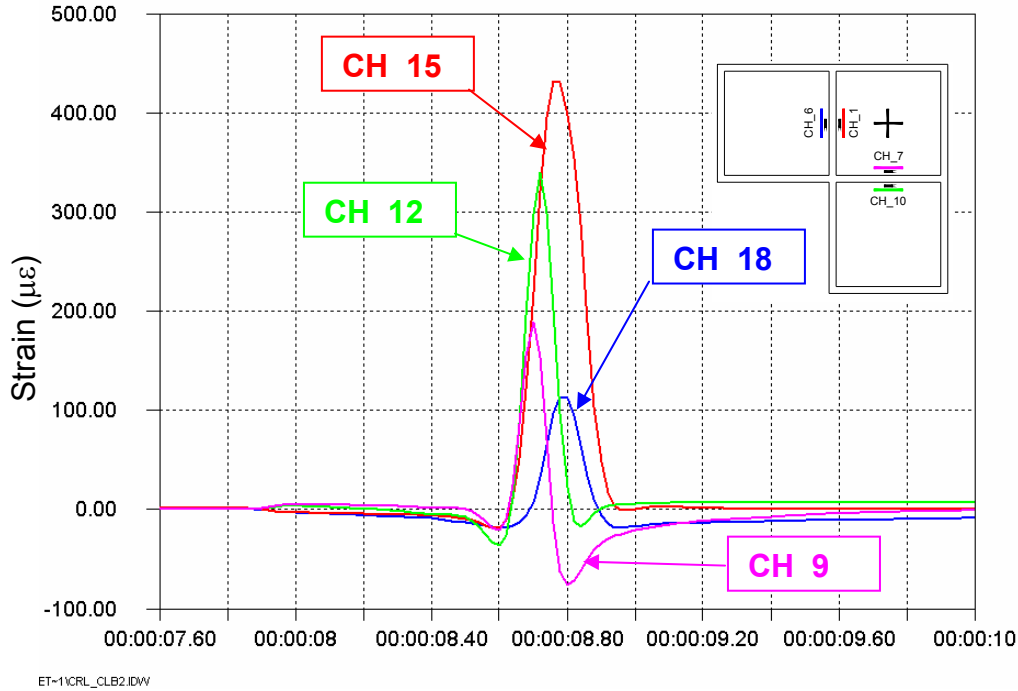
Finally, Figure 4.23 contains strain history plots for the four horizontal gages mounted to the web plates (see the figure inset). This direction of bending is caused by the restraint at the sides of the web plate. Due the fact that FRP slab is a three dimensional structure (and not two dimensional frames as considered above), a point load at the center of the top plate (between webs) causes bending in both directions in the web plates it is attached to. Furthermore, for the wheel load of the test truck considered, these strains are significant.

Figure 4.23 – Strain history in webs of bottle for bending in the plane of the FRP slab (see plan view of Figure 4.20)

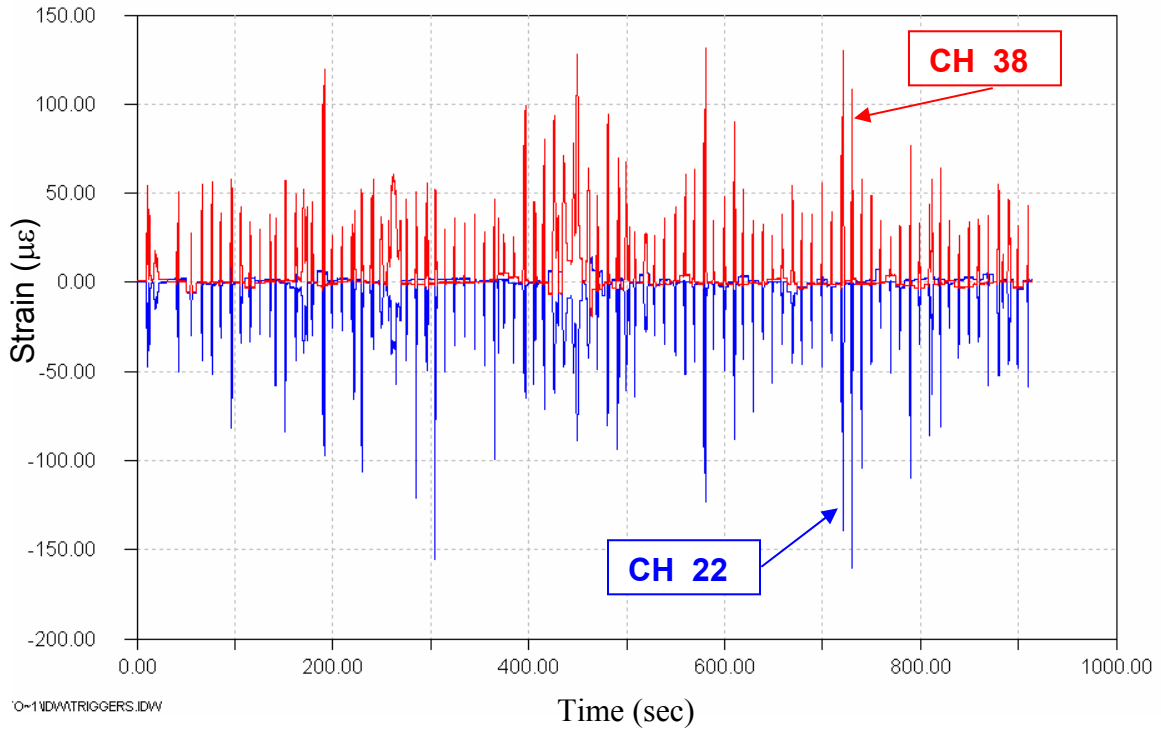
Figure 5.1 – Triggered time histories for entire monitoring period

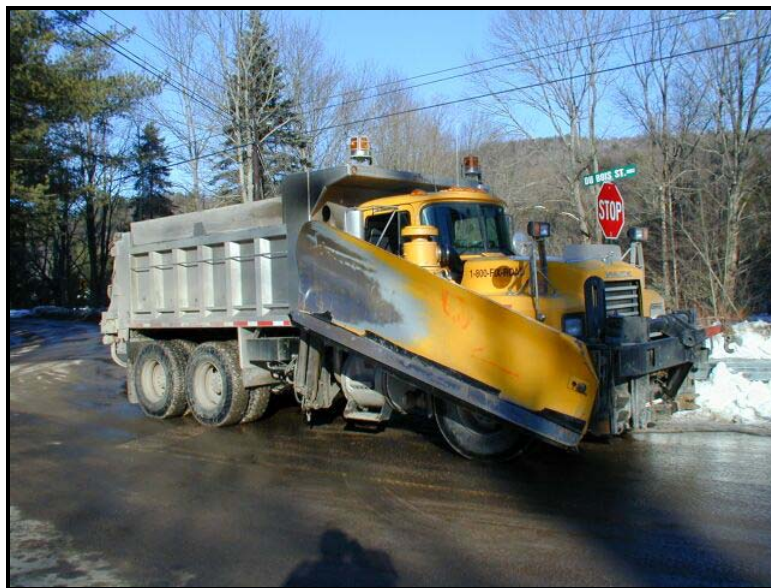
Figure 7.1 – Photograph of test truck #1 (425-8076) utilized during controlled load testing

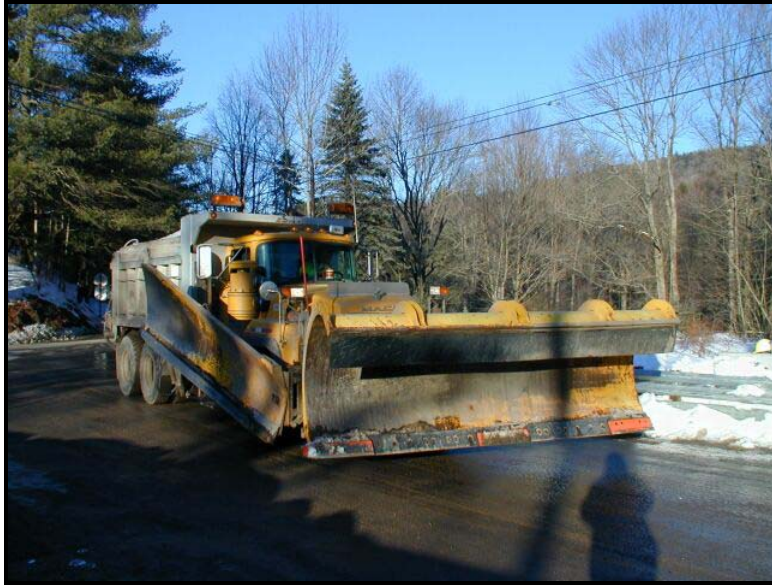
Figure 7.2 – Photograph of test truck #2 (107-8076) utilized during controlled load testing

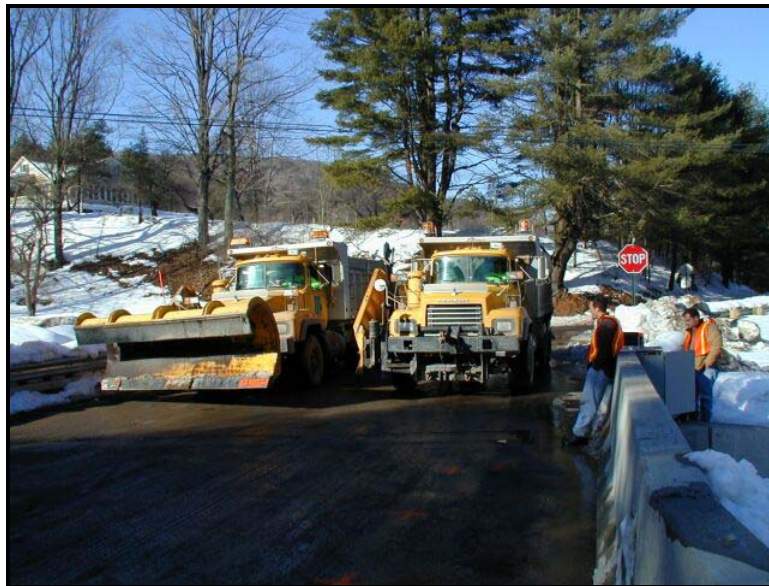
Figure 4- Photograph of side-by-side static crawl test

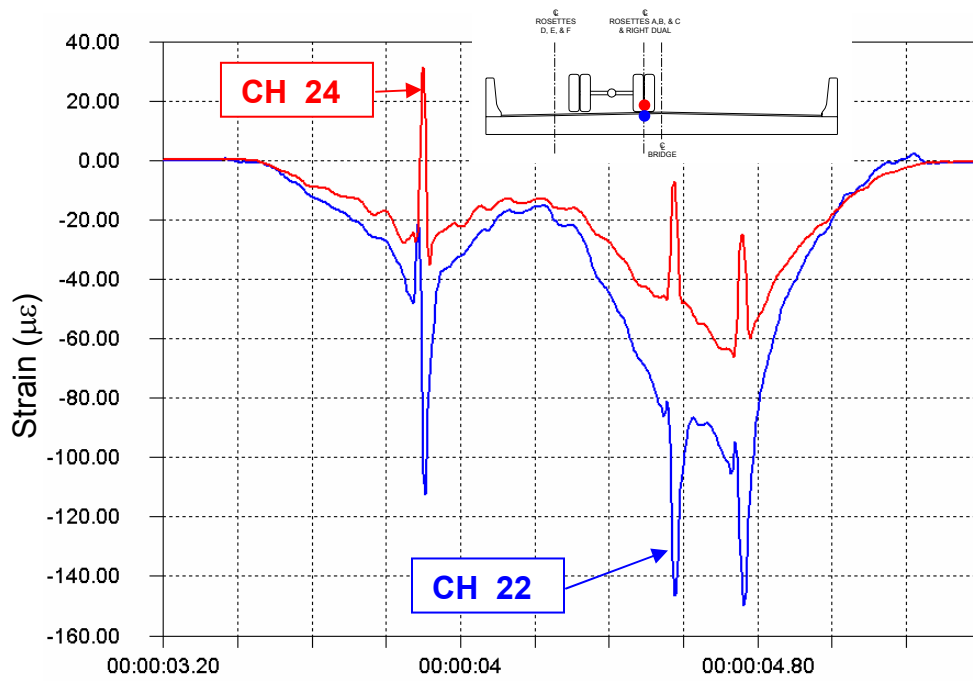
ET-11DYN_LT2.IDW
 Figure 8.7 – Strain history at top of FRP slab at midspan for dynamic load test DYN_LT2
 PHASE 1 TEST
 (CH_22 is longitudinal, CH_24 is transverse)

However, when the strain reversals are considered, the peak positive (tensile) transverse strains are $+31 \mu\epsilon$ (CH_24, Figure 8.7) and $+104 \mu\epsilon$ (CH_24, Figure 8.8), for Phase 1 and 2, respectively. Similarly, the peak positive (tensile) longitudinal strains are $0 \mu\epsilon$ (CH_22, Figure 8.7) and $+70 \mu\epsilon$ (CH_22, Figure 8.8), for Phase 1 and 2, respectively. This is a significant change in behavior. However, it is not clear if it is the result of dynamic loading. As discussed above, there were significantly higher strain reversals observed in the static load tests. In general however, despite this apparent change in behavior, the strains in the slab due to dynamic loading do not appear to be excessive.

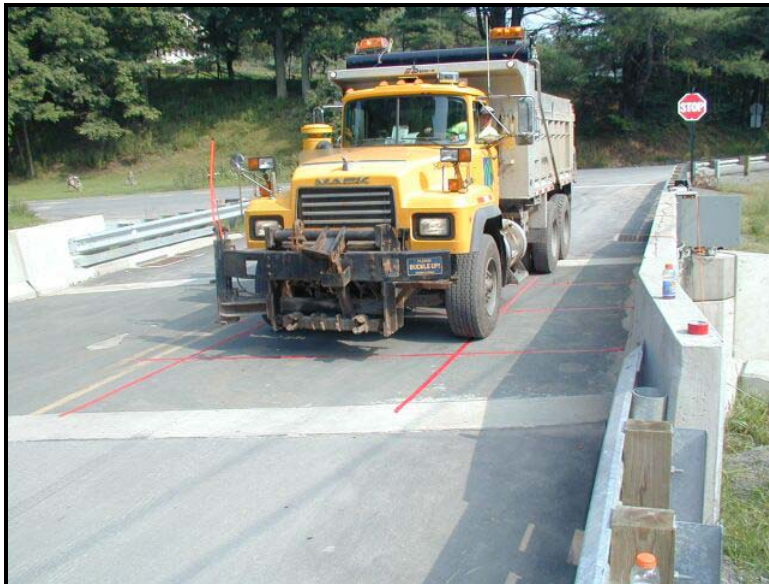
Figure 11.1 – Photograph of test truck #2 (107-8076) utilized during controlled load testing

The same two test trucks used in Phase 2 were made available for the third phase of testing. New tests were conducted investigate the sensitivity of truck position on stress in the bridge. Figure 11.1 contains a photograph of test truck #2. A summary of the truck weights is given in Table 11.1. The geometry of the test trucks is contained in Table 11.2.

Test truck #2 was used for the majority of the static crawl tests and all dynamic tests. The rear tandem weight of truck #2 was 1.5% heavier than the rear tandem of the Phase 1 truck.

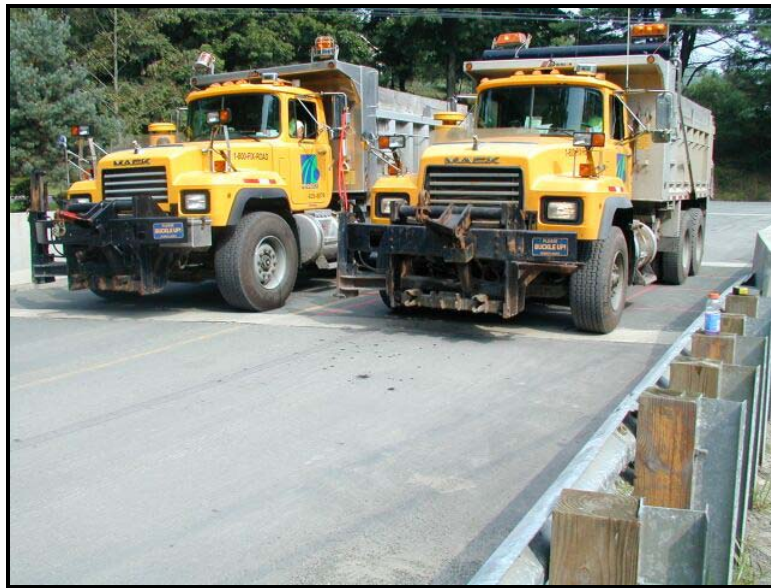
Figure 11.5- Photograph of side-by-side static crawl test
