Evaluation of Mechanical Properties of Welded TMCP Jumbo Sections

AWI 9126
Weldability of QST Jumbo Sections

Final Report

ATLSS Report No. 92 -06

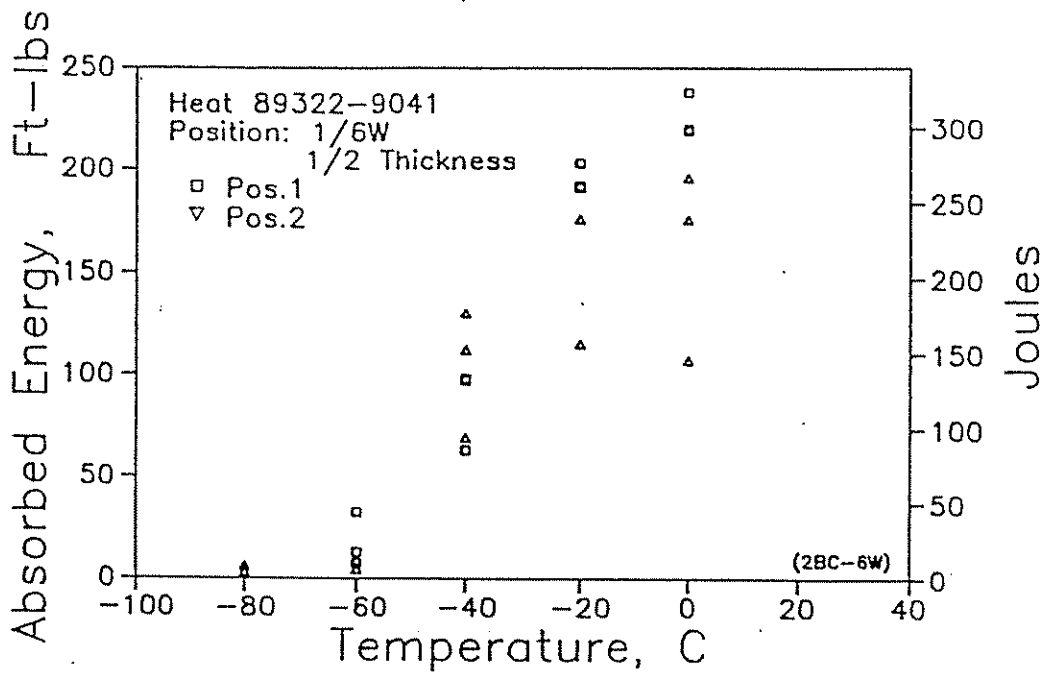
Fig. 23 Base Metal Charpy V-Notch Test Results at Position 1/6 W - 1/2 Thickness

1. The fracture toughness of the base material varies considerably over the flange cross-section. The two heats of material have very similar fracture characteristics at all flange test locations. Both heats of material show upper shelf energies ranging from 100-240 ft-lbs and transition temperatures (15 ft-lb) ranging from below -100°C to -10°C depending upon test location. As might be expected, the lowest transition temperatures occur at surface locations and rise with increasing depth below the surface.

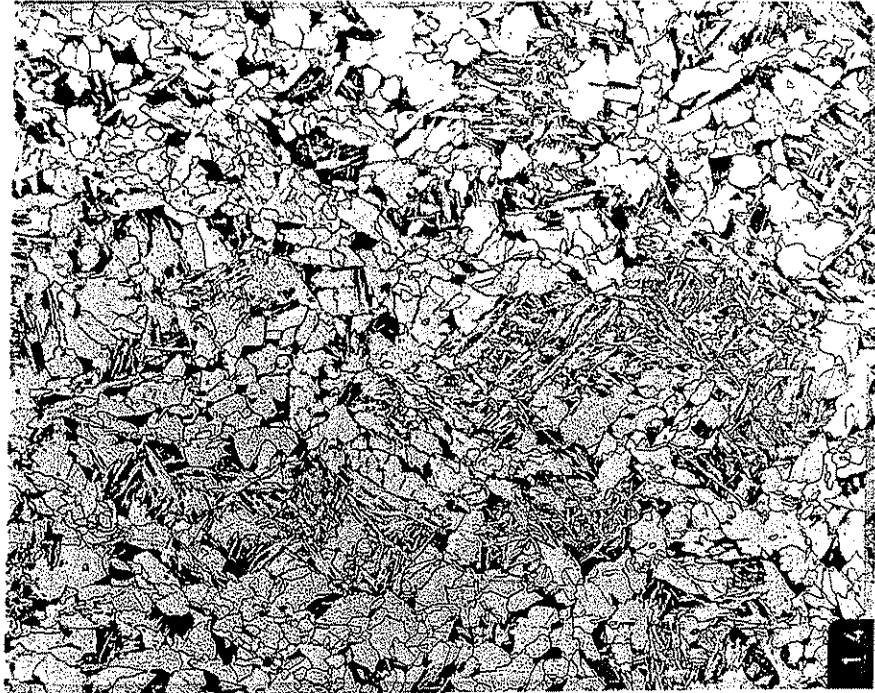
Flange Microstructure at 1/4W-1/2T, Pos.1
Heat No. 89322-9009(100X), [Photo 9/91/47]

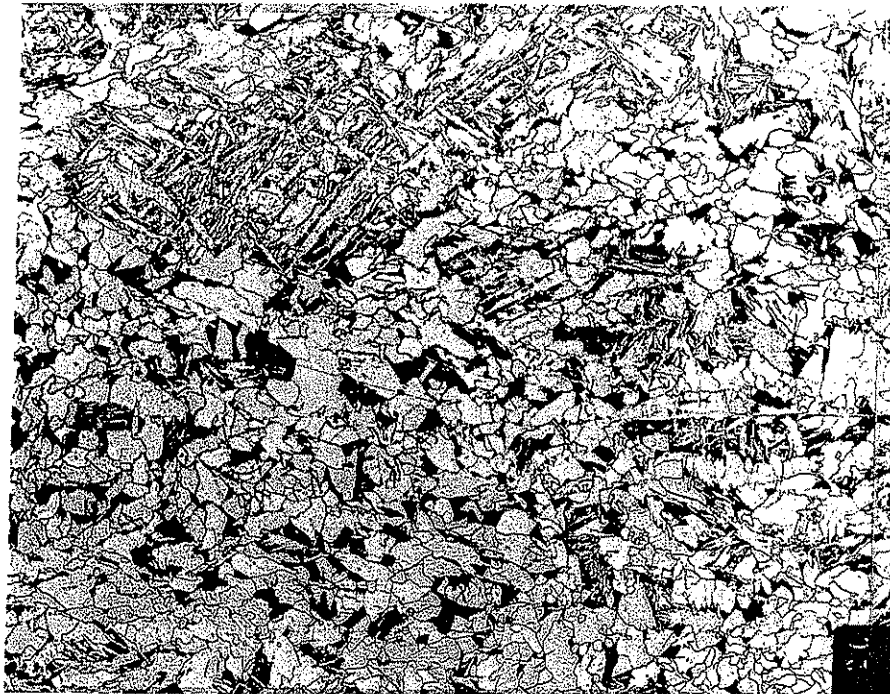
Flange Microstructure at 1/4W-3/4T, Pos.1
Heat No. 89322-9009(100X), [Photo 9/91/48]
