Experimental and Analytical Study of a Retrofitted Pin and Hanger Bridge

EXPERIMENTAL AND ANALYTICAL STUDY OF A RETROFITTED PIN AND HANGER BRIDGE

ATLSS Report No. 04-02

January 2004

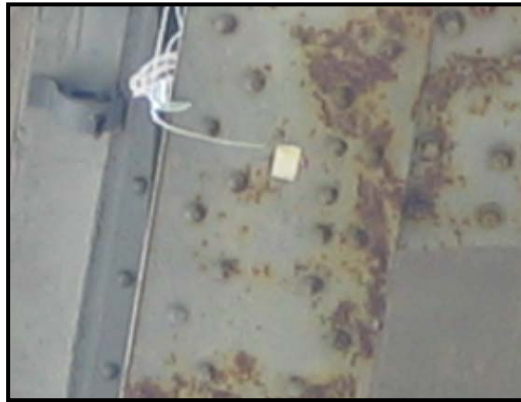
Figure 8 – Typical strain gage installed on bottom flange of a girder

All strain gages were uniaxial weldable gages produced by Measurements Group Inc. and were 0.25 in. gage length type LWK-06-W250B-350 (See Figure 8). A total of 18 gages were installed. Weldable type strain gages were selected due to ease of installation in a variety of weather conditions. The “welds” are a point or spot resistance weld about the size of a pinprick. The probe is powered by a battery and only touches the foil that the strain gage is mounted on by the manufacturer. This fuses a small pin size area to the steel surface. It takes ten or more of these dots to attach the gage to the steel surface. There are no arc strikes or heat affected zones that are discernible. There is no preheat or any other preparation involved other than the preparation of the local metal surface by grinding and then cleaning before the gage is attached to the component with the welding unit. There has never been an instance of adverse behavior associated with the use of weldable strain gages including their installation on extremely brittle material such as A615 Gr75 steel reinforcing bars.

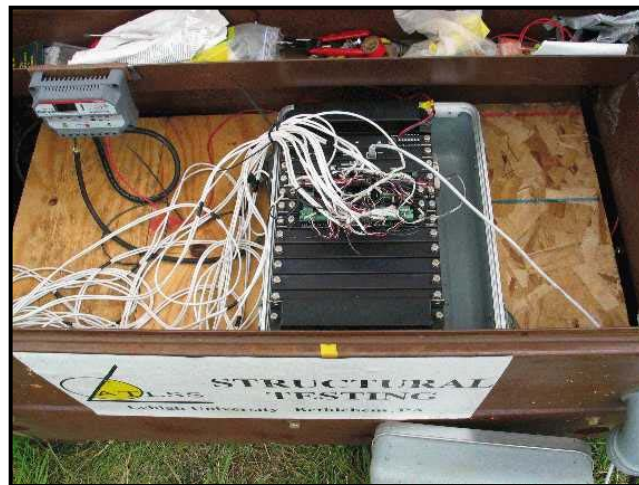
Figure 9 – Photographs of CR9000 data logger installed in weather-tight box

Data were recorded using a CR9000 data logger manufactured by Campbell Scientific as shown in Figure 9. The CR9000 is a modular, multi-channel digital data acquisition system that provides precision measurement capabilities in a rugged, battery-operated package. The logger used was powered with two solar panel units and batteries, as shown in Figure 10. Signal wires were run from each of the gages to the top of pier three. The wire was then dropped down pier three to the data logger located at the base of the pier.

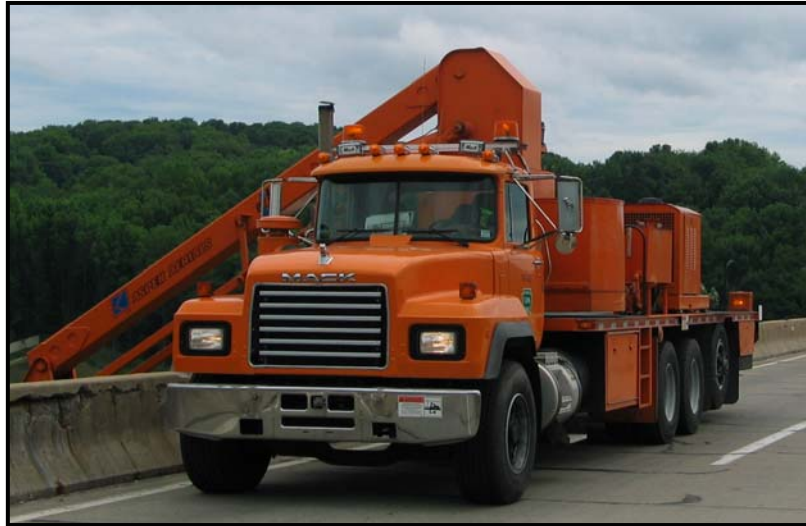
Figure 12 – Photograph of test truck and “snooper”

The test truck was a four axle Mack Aerial UB 50 snooper with the third rear axle riding up. A photograph of the test truck parked on top of the bridge with the snooper arm extended can be seen in Figure 12. The dimensions of the truck are provided in Figure 13. The steering axle weight was 18,320 pounds; drive axles, 17,580 pounds; trailer axle, 26,540 pounds. The gross vehicle weight of the truck was 62,440 pounds. The truck was provided by the Pennsylvania Turnpike Commission and was labeled as Truck #14-002.

A series of controlled load tests were conducted using a test truck of known load and geometry (See Figure 12). The truck possessed a “floating” third rear axle, which is identified in Figure 13 as the “trailer axle”. This rear axle can be lowered using air pressure in order to distribute the rear load to three axles. The third rear axle was in the “up” position for all controlled load tests.

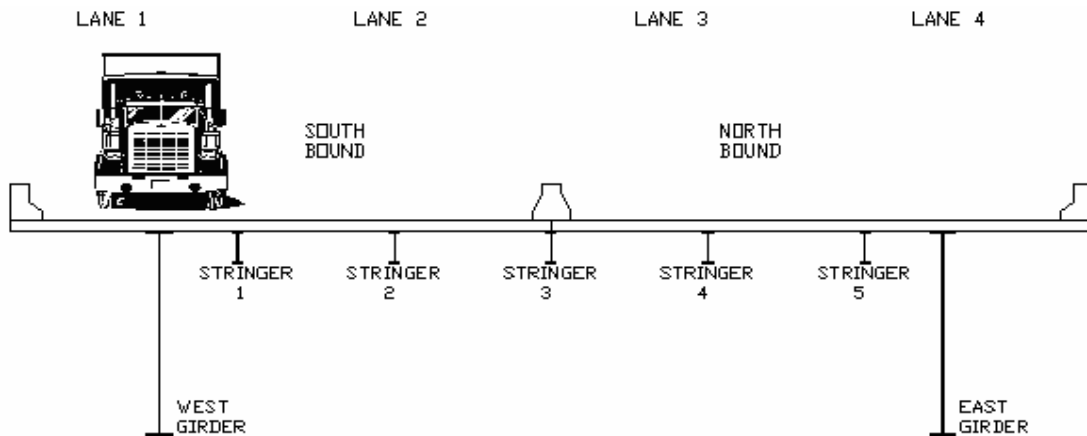
Figure 14 – Location of lane numbers as identified during controlled load testing
(View looking northbound)

The lane designations used during the controlled load testing can be seen in Figure 14. The tests included crawl, park, and dynamic (speed) tests. During all tests, no other traffic was permitted on the bridge. The crawl tests were performed in each lane twice to establish the variability of the data and determine if the measurements were consistent. Crawl tests were conducted with the truck positioned in each lane and driven slowly (< 5 mph) across the entire bridge. Dynamic forces may be developed due to the moving traffic. However, these effects can only be accurately determined by first establishing the response of the structure to static loads. Therefore the series of crawl tests were conducted prior to conducting the dynamic speed tests. This data is also very useful for comparison to analytical models if developed. The first set of tests in lanes 1 and 4 were recorded separately. For ease of traffic control, the remaining tests were performed as loops, with the southbound test performed first.

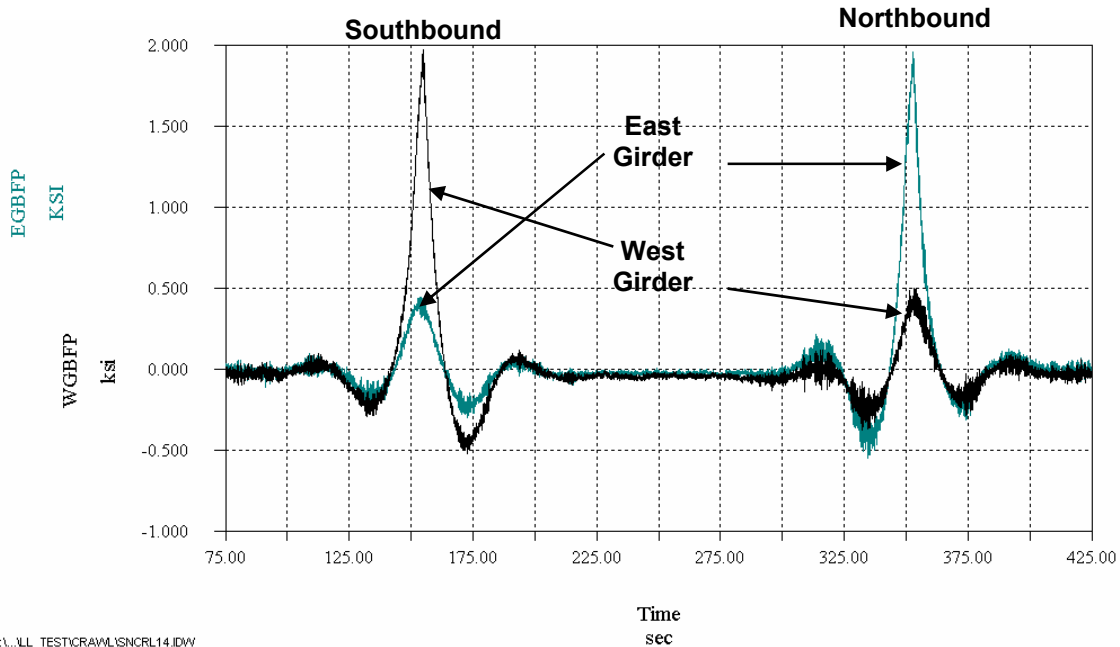
Figure 16 – Girder bottom flange response positive moment region (truck southbound in lane 1, northbound in lane 4)

As can be seen in Figure 16, the effect of transverse position is essentially identical in mirrored lanes. Similar results were observed for all gages installed on the main girders for all test positions. Table 4 summarizes the measured stress range for all gages installed on the main girders as the test truck crossed in each lane. It is clear from Table 4 that symmetric response was observed for all gages and all lane positions. This also confirms that superposition can be used to estimate the influence of multiple trucks on the bridge at the same time.

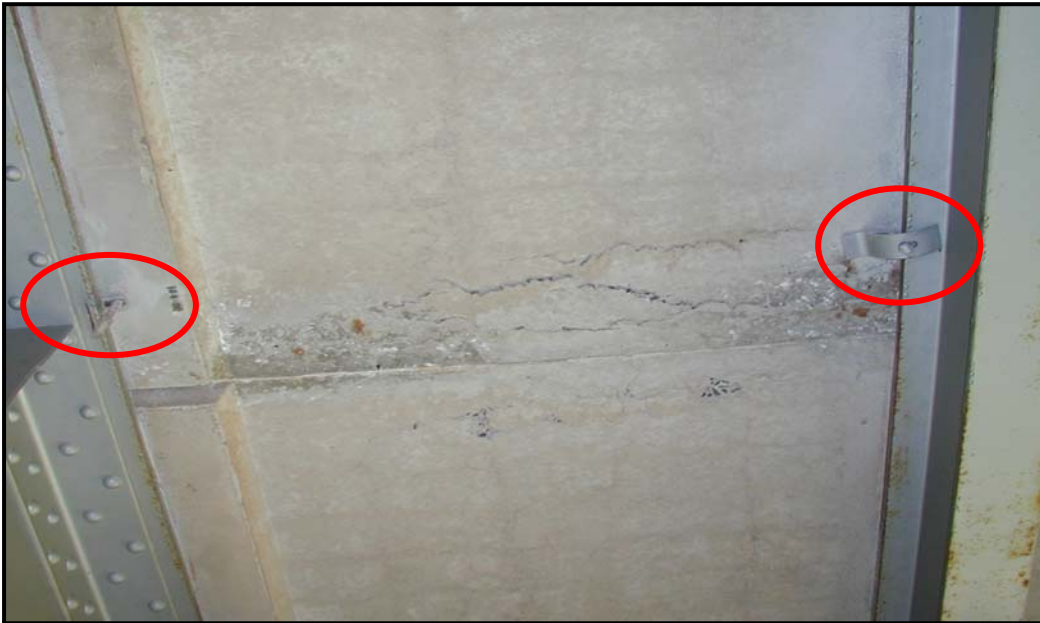
Figure 17 – Portion of bottom of deck.
Notice missing spring clamp on left

Initial review of the bridge showed the pre-cast deck panels attached to the girder with multiple spring clamps as shown in Figure 17. Many spring clamps were observed to be broken in the last bay near the southern abutment. The lack of connection between the deck and girder suggests that there should be little to no composite action between the deck and girders.

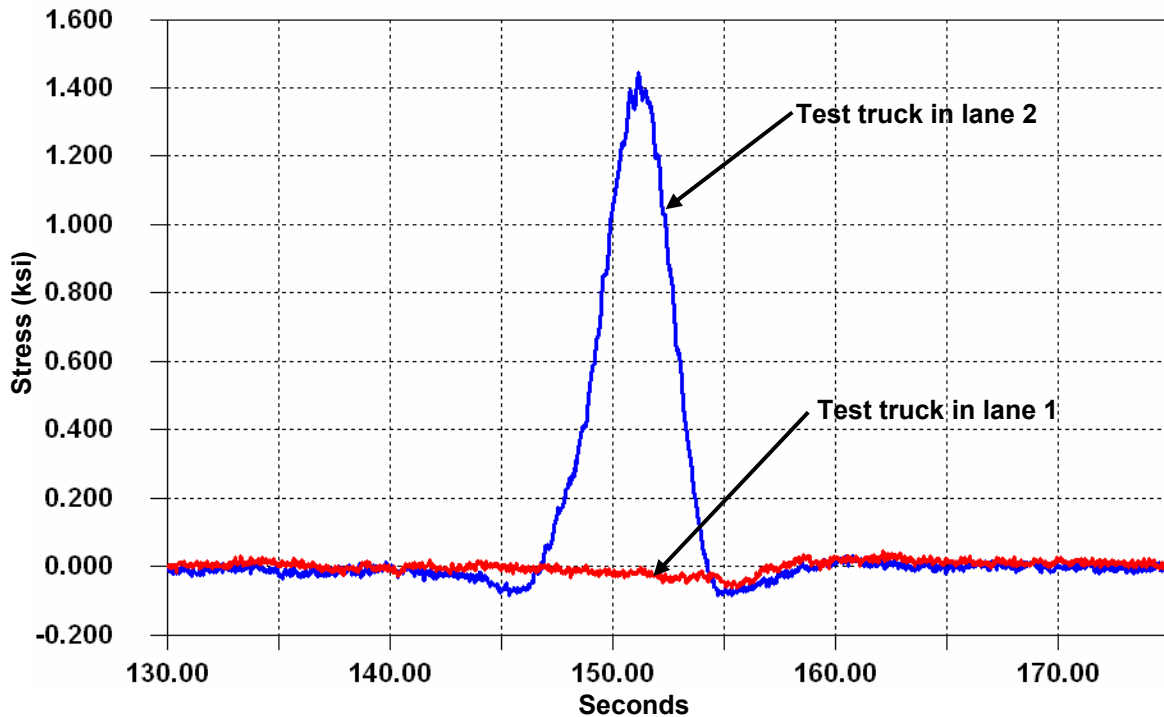
Figure 20 – Comparison of floorbeam bottom flange response at midspan as test truck passed in lane one and lane two

It is clear from Figure 20 that the test truck produced no effect when passing in lane 1. However, as expected, the bottom flange was subjected to measurable tensile stress as the truck passed in lane 2. As stated, similar results were obtained as the truck passed in lanes 3 and 4.

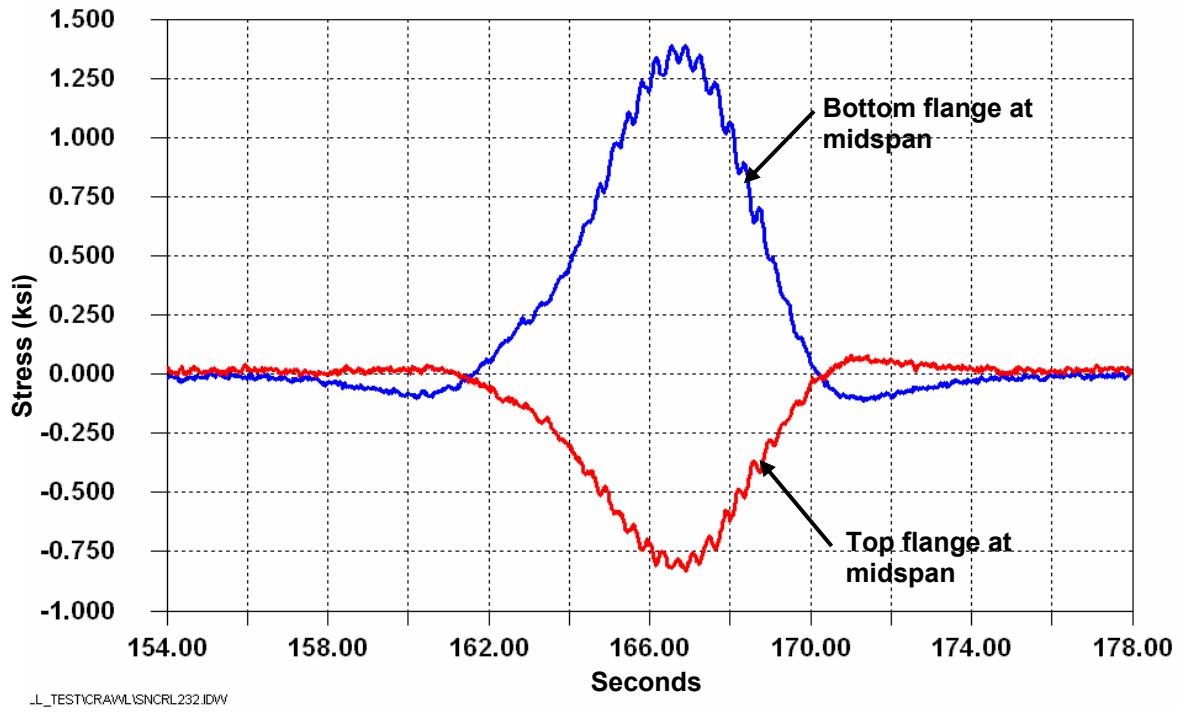
Figure 21 – Response of top and bottom flange of floorbeam at midspan as test truck passed in lane 2

Figure 21 compares the response of the top and bottom flange of the floorbeam as the test truck passed in lane two. As expected, the top and bottom flanges are in compression and tension respectively. The top flange of the floorbeam is not embedded in the deck slab, hence the stresses would be expected to be equal and opposite. However, there are local effects which are the result of the point loads applied by the stringers which are near the top flange gage. In addition, the top flange gages were located on the bottom of the top flange and would be subjected to lower stresses than on the top of the top flange.

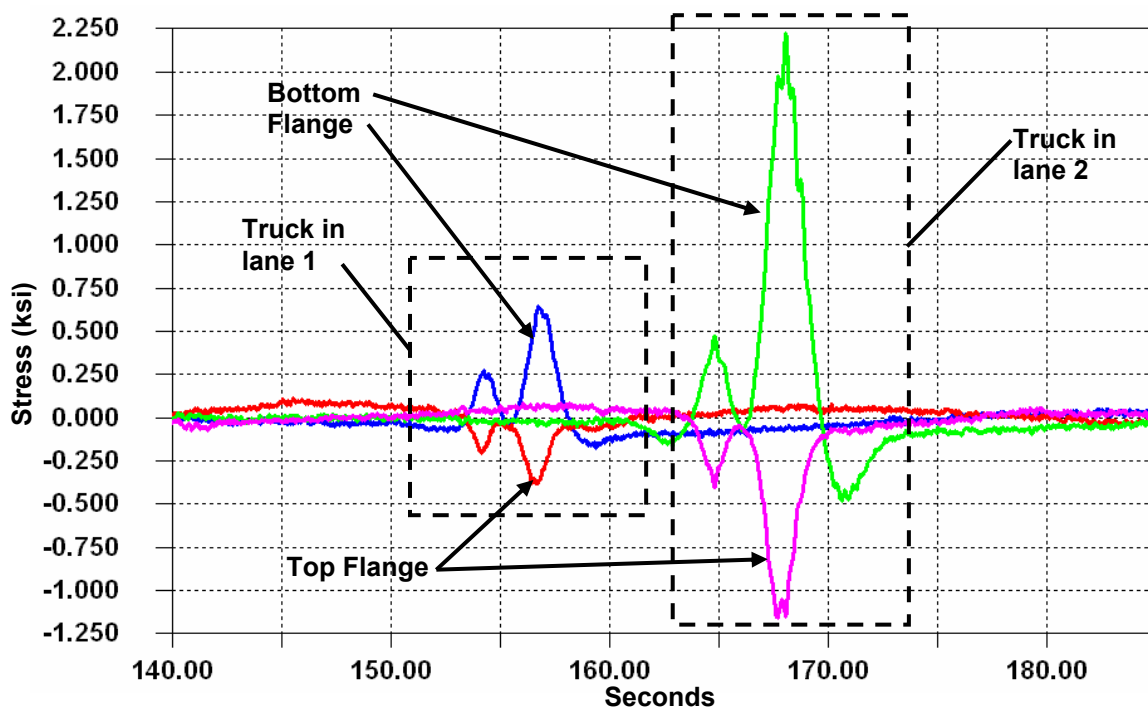
Figure 22 – Stringer response as test truck passed in lanes 1 and 2

Strain gages were installed at midspan of the first interior stringer near the west girder. Gages were located on the bottom of the bottom flange and on the bottom of the top flange. Measurable stresses were only observed as the test truck passed in lane 1 or 2. Very little stress was produced as the truck passed in lanes 3 or 4, as expected. Stringers are very sensitive to the transverse position of wheel loads. When the truck is in lane two, the right wheels are nearly directly over the stringer. Hence, the greatest stresses are produced (*in this stringer*) with the trucks in this lane.

The response of the stringer to the front axle and rear axles is also clearly distinguished in Figure 22. In fact, the response of the rear axles (i.e., tandem) is discernable in the top flange response as the truck passed in lane 2. In addition, the response of the top flange is less than measured in the bottom flange. However, it must be noted that the top flange gages were installed on the bottom of the top flange which is not the location of maximum compressive stress. However, the magnitude of the difference suggests that a certain level of composite action exists between this stringer and the deck.

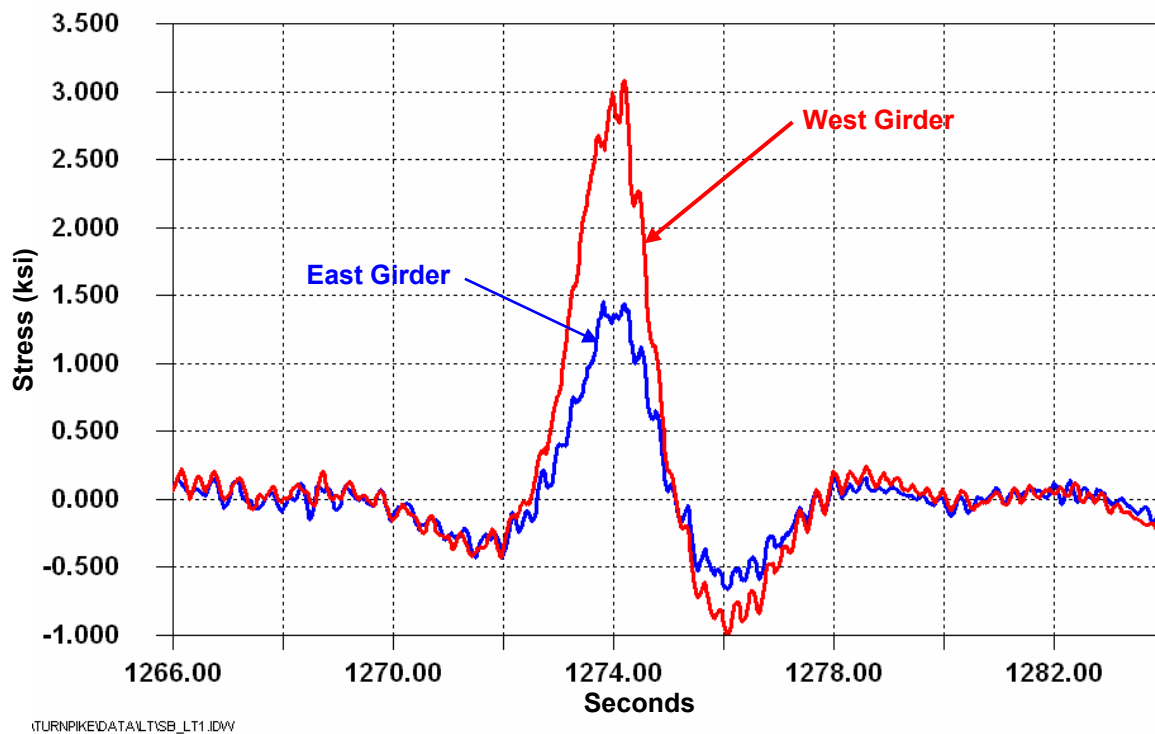
Figure 24 – Maximum random stress range observed in bottom flange of west girder at midspan of span four (*East girder response shown for information*)

One of the largest stress ranges measured in the main girders is presented in Figure 24. These data were recorded during a southbound trigger event. It is thought to be produced by a single truck with a heavy trailer or two trucks nearly side-by-side (*i.e.*, in lanes one and two) passing at the same instant. Although this is the largest stress range observed in the time history data, the peak-to-peak stress range is only about 4.1 ksi in the bottom flange of the west main girder.
