Fatigue Resistance of Corrugated Web Girders

**Work Area 3
Pennsylvania Innovative High Performance Steel
Bridge Demonstration Project**

ATLSS Report No. 03-20

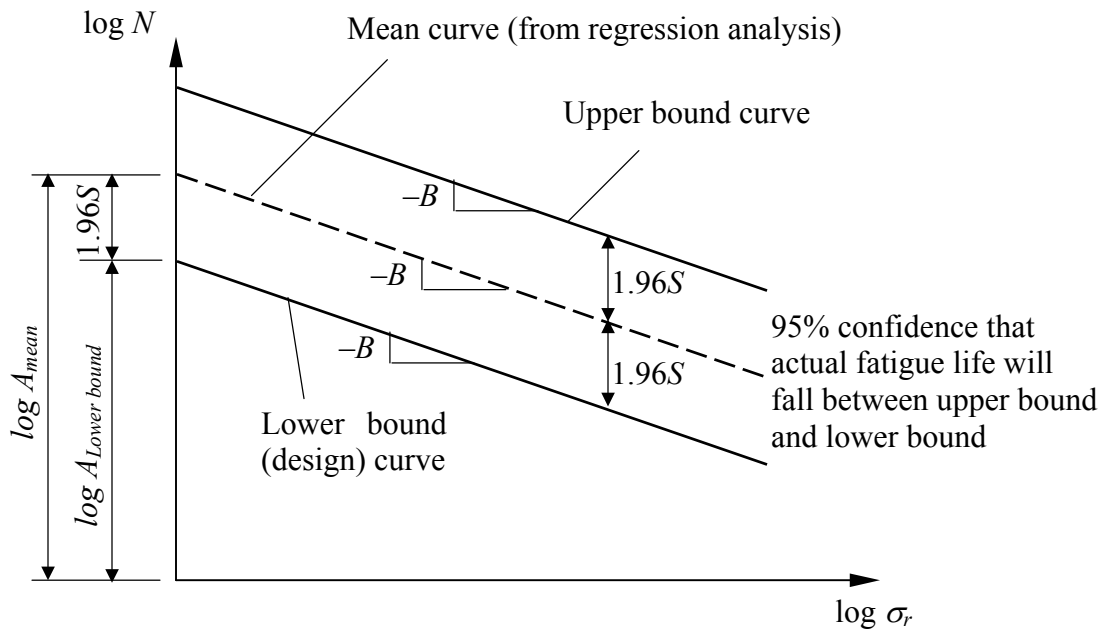
Figure 1. Relationship between mean, lower, and upper bound S-N curves.

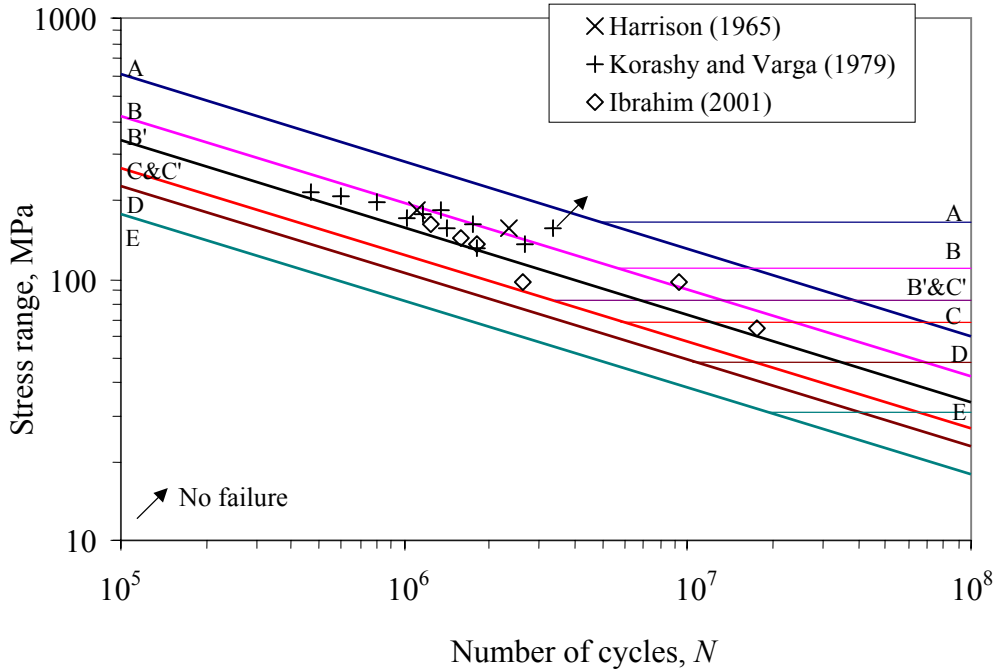
Figure 3. Mean S-N curves for AASHTO LRFD fatigue categories with test data from previous research.

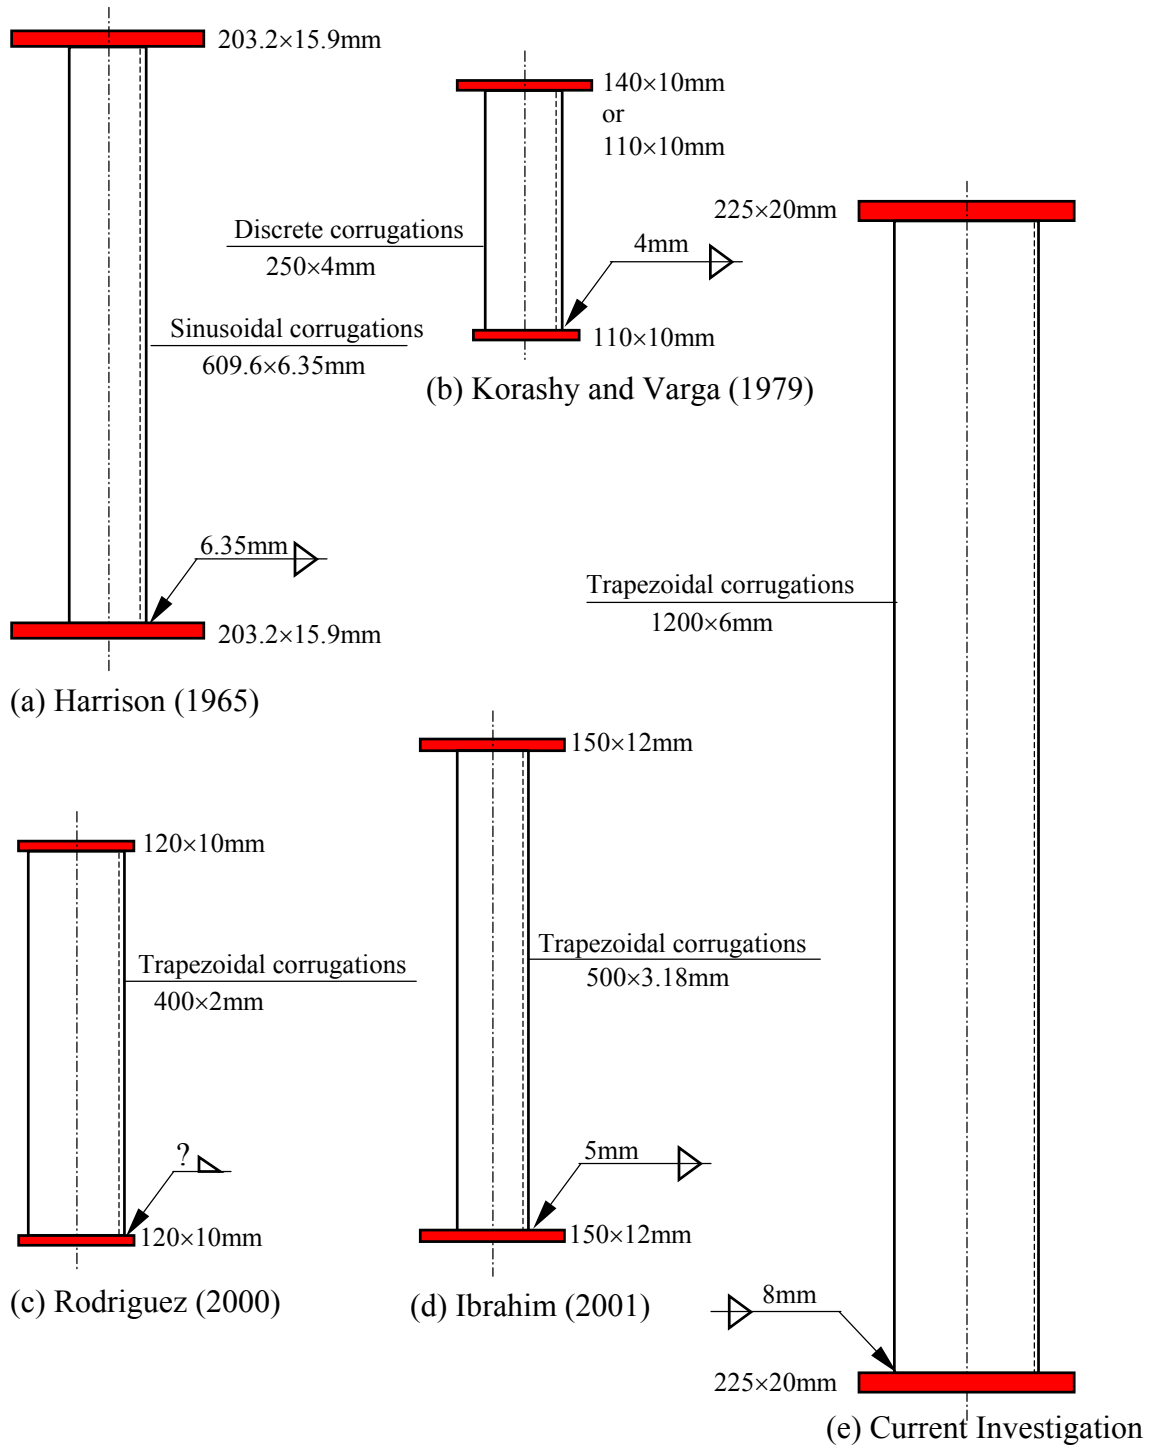
Figure 4. Corrugated web girder cross sections used in previous and the current experimental investigations (drawn to same scale).

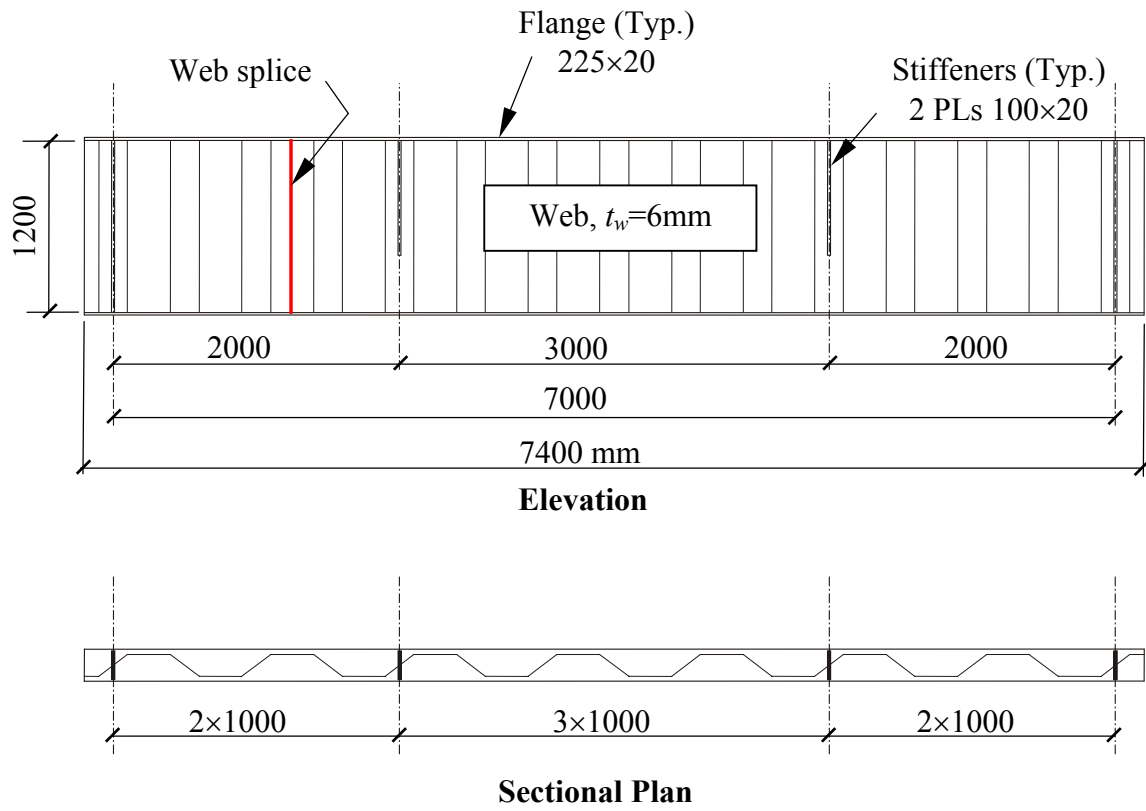
Figure 5. Fatigue test specimens (Girders G1A to G6A).

Bearing stiffeners of the fatigue test girders were located at the center of the inclined folds (Figure 5) based on a recommendation by Elgaaly *et al.* (2000) and Rodriguez (2000). Partial depth stiffeners at the loading points were included for testing purposes. A bridge girder with corrugated webs requires bearing stiffeners only at the reaction points. No other stiffeners are needed, however cross frame connection plates are needed.

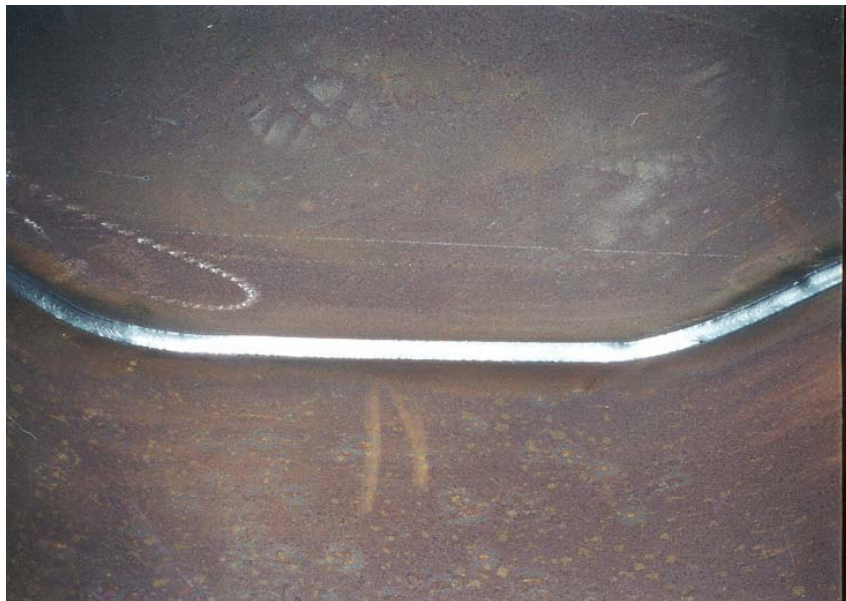
Figure 9. Robotically made fillet weld.

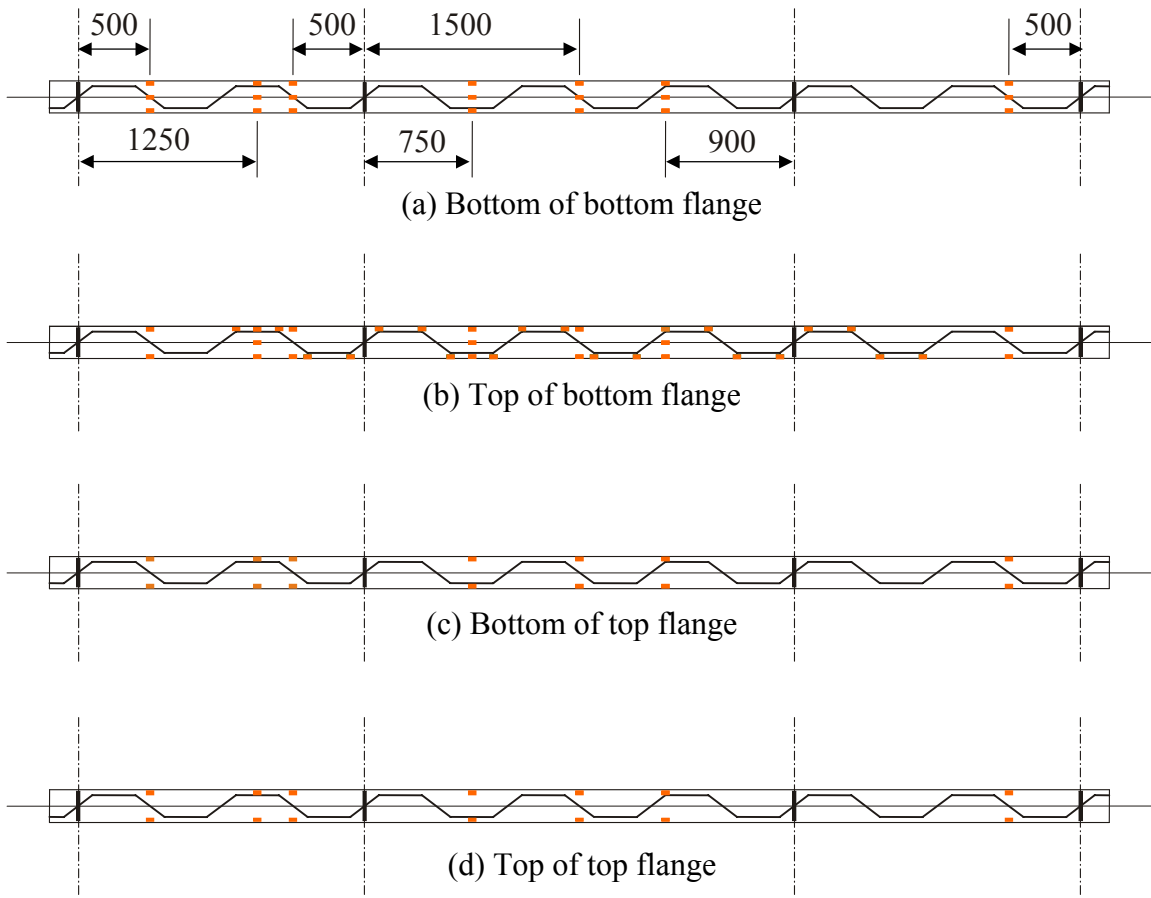
All dimensions are in mm
 Strain gages near flange edges are 13mm from the edge

Figure 14. Strain gage plan for Girder G2A.

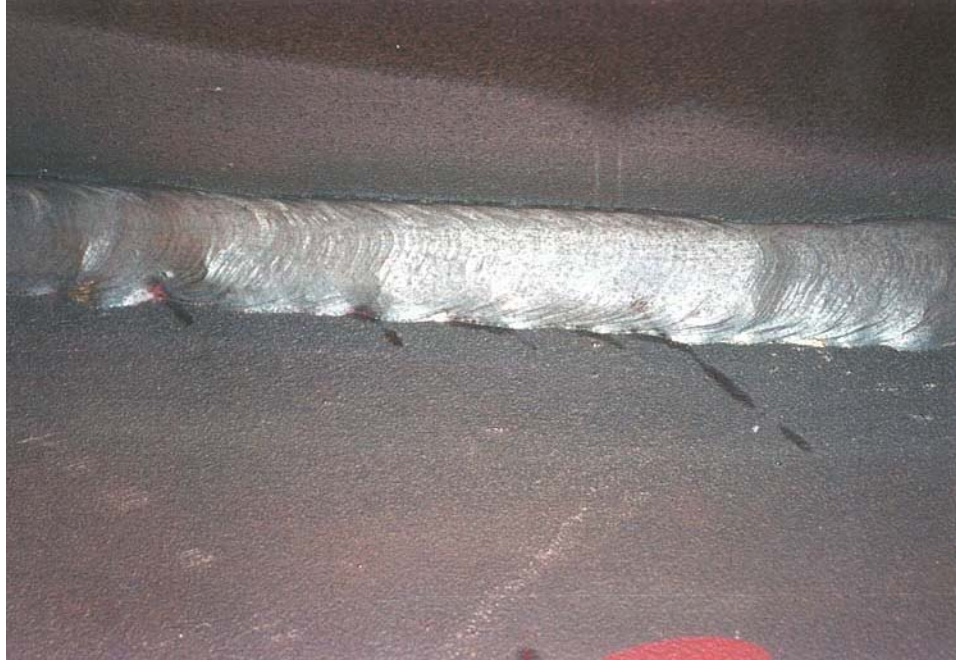
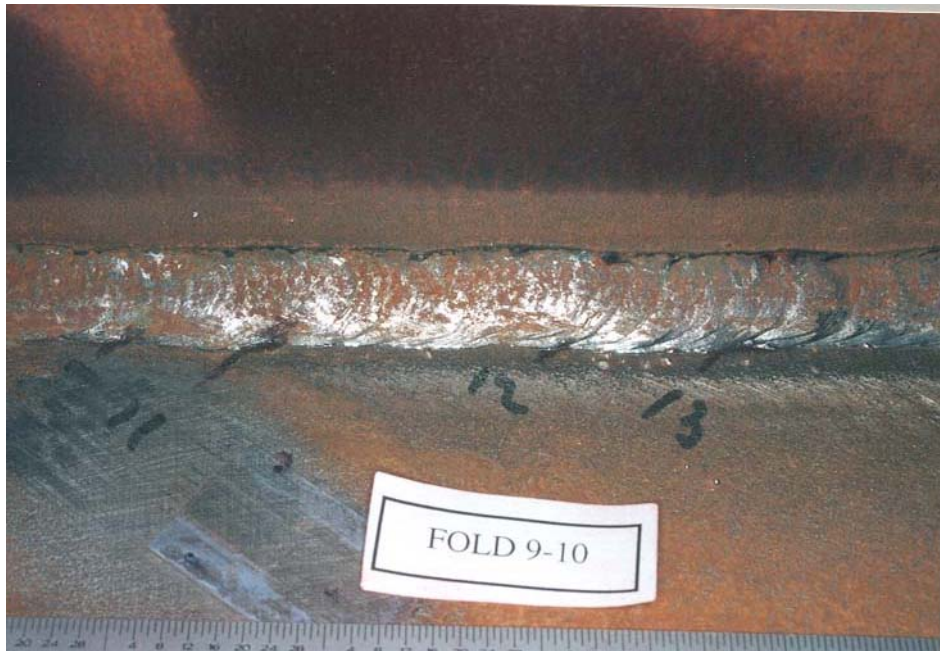
Figure 16. Examples of multiple fatigue cracks at fillet weld toe.

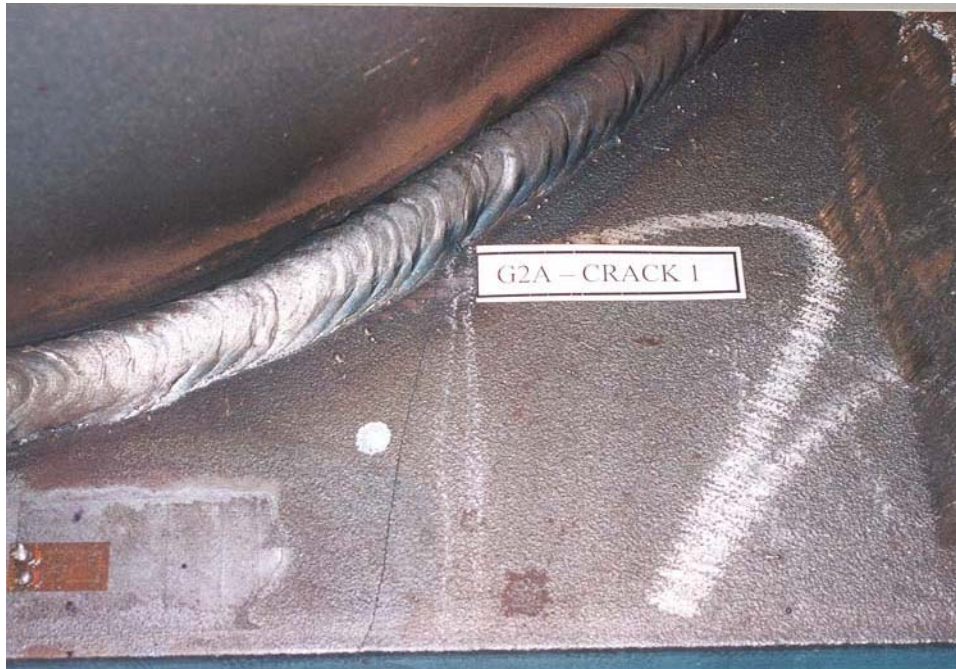
Figure 17. Main fatigue crack of Girder G2A.

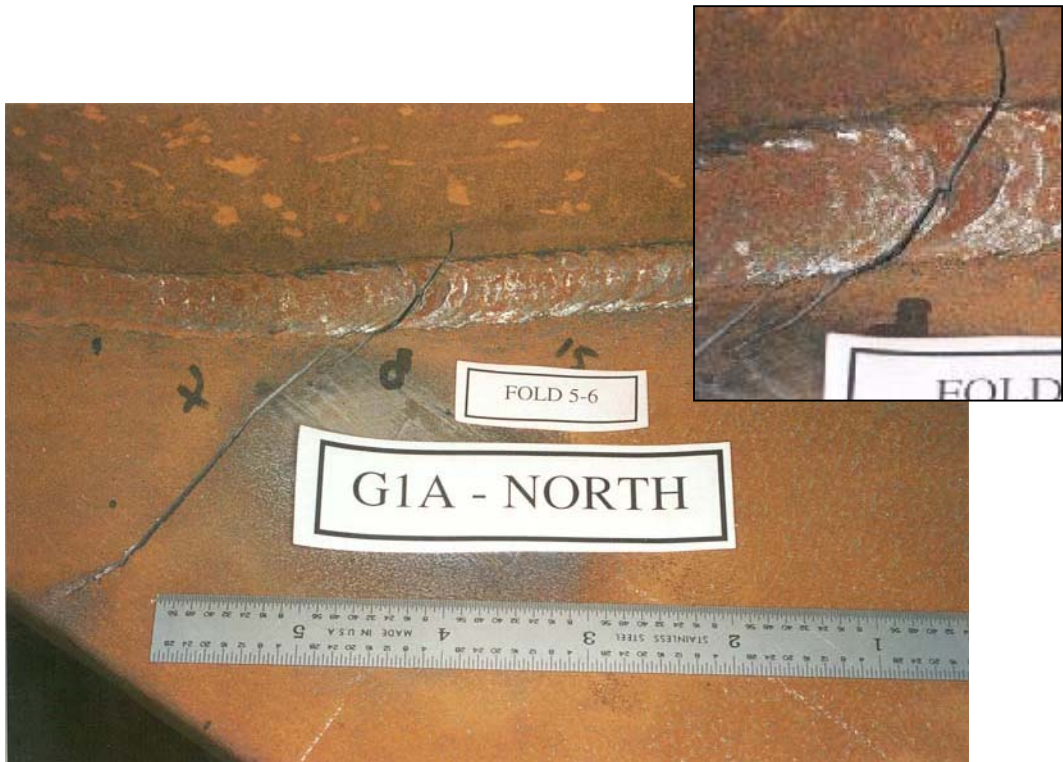
Figure 18. Main fatigue crack of Girder G1A.

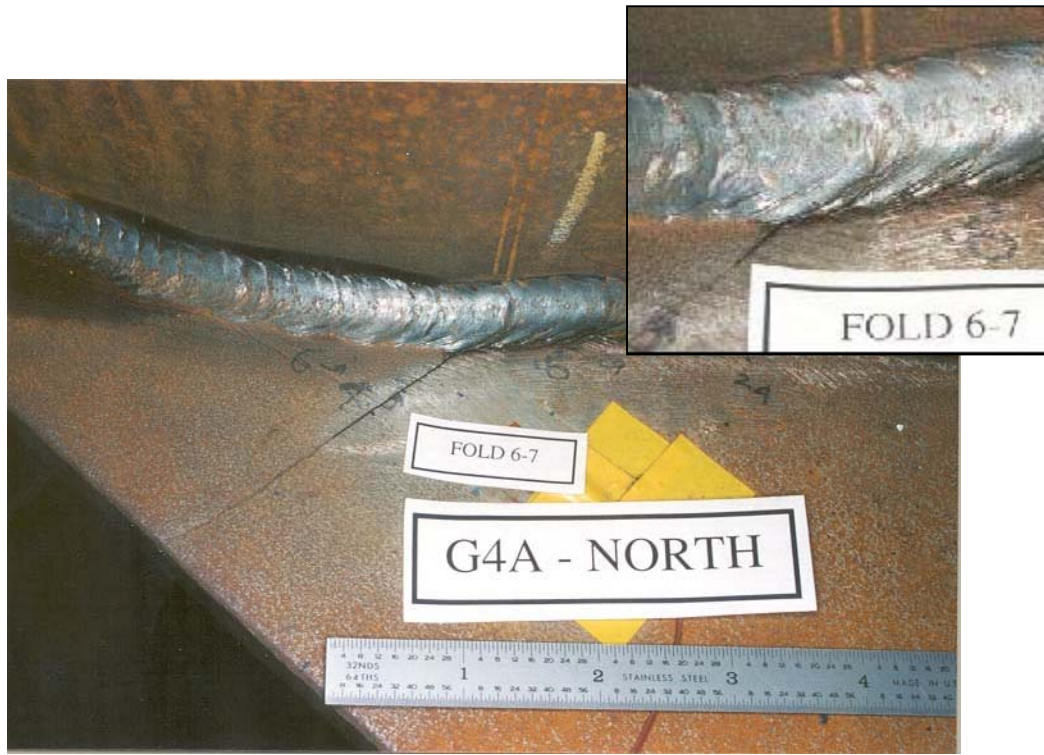
Figure 19. Main fatigue crack of Girder G4A.

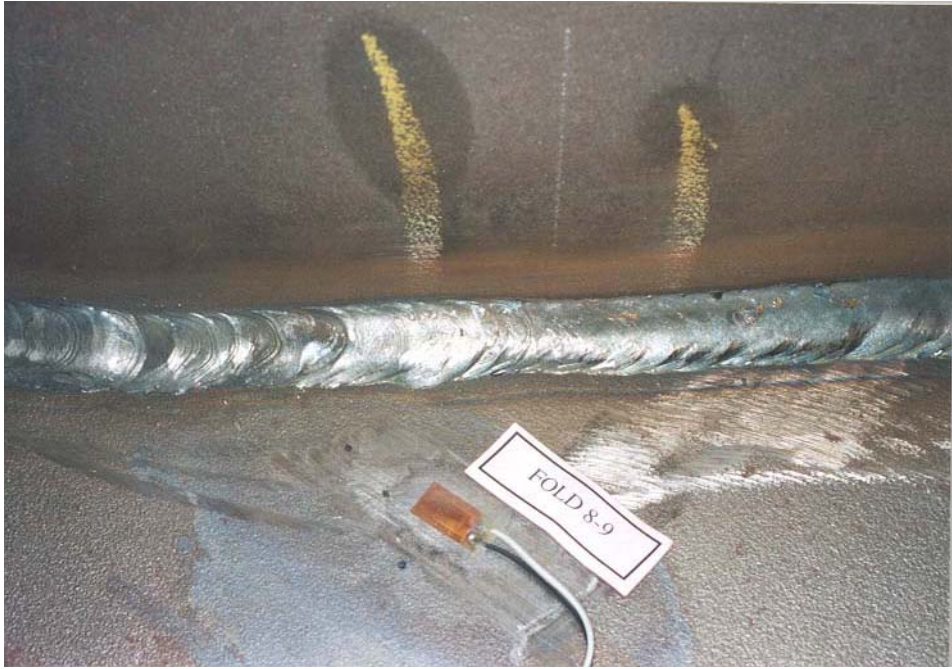
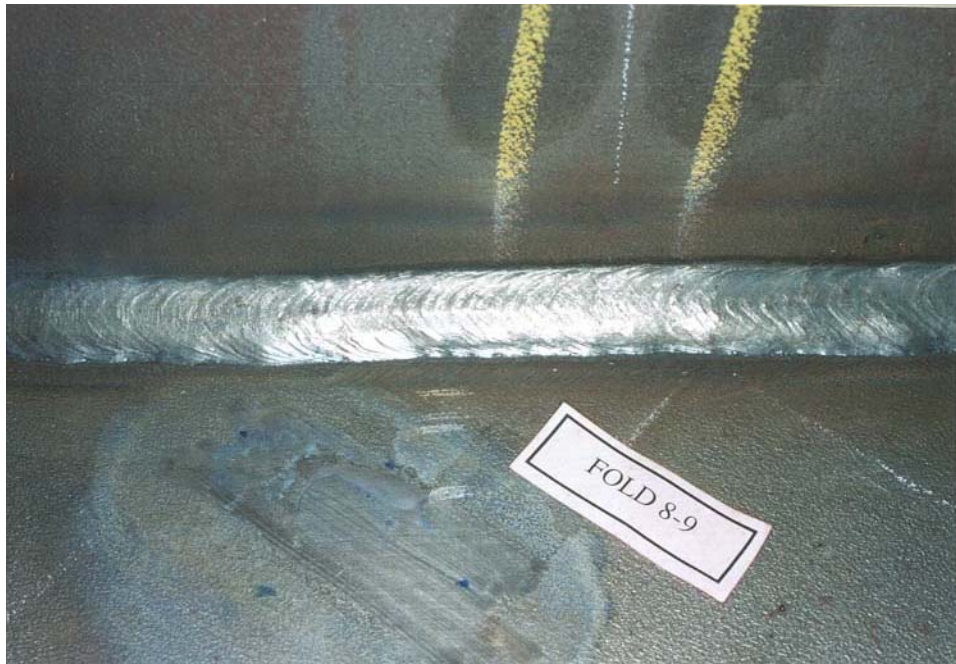
(a) North side

(b) South side

Figure 22. Variable quality of welds of Girder G6A.

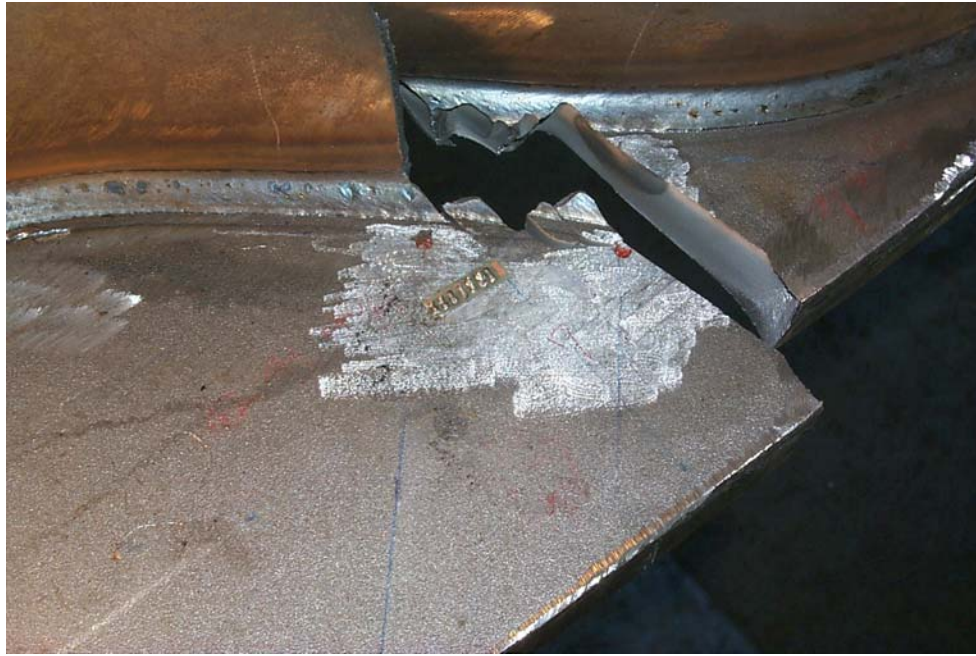
Figure 23. Failure of Girder G4B.

Girder G4B was tested at a nominal stress range of 138MPa (20.0ksi) to evaluate the effect of robotic welding on the fatigue performance. Girder G4B survived 1,980,000 cycles before it failed from fatigue cracking of the bottom flange as shown in Figure 23. As shown in the figure, several fatigue cracks in the flange coalesced just prior to failure. The fatigue cracks initiated from the fillet weld toe along the inclined fold. The use of a robotic GMAW process resulted in an increase of approximately 42% in fatigue life compared to girders welded using semiautomatic GMAW. It is believed that increased uniformity in the weld toe geometry of the robotically-made welds is responsible for the observed longer fatigue life.

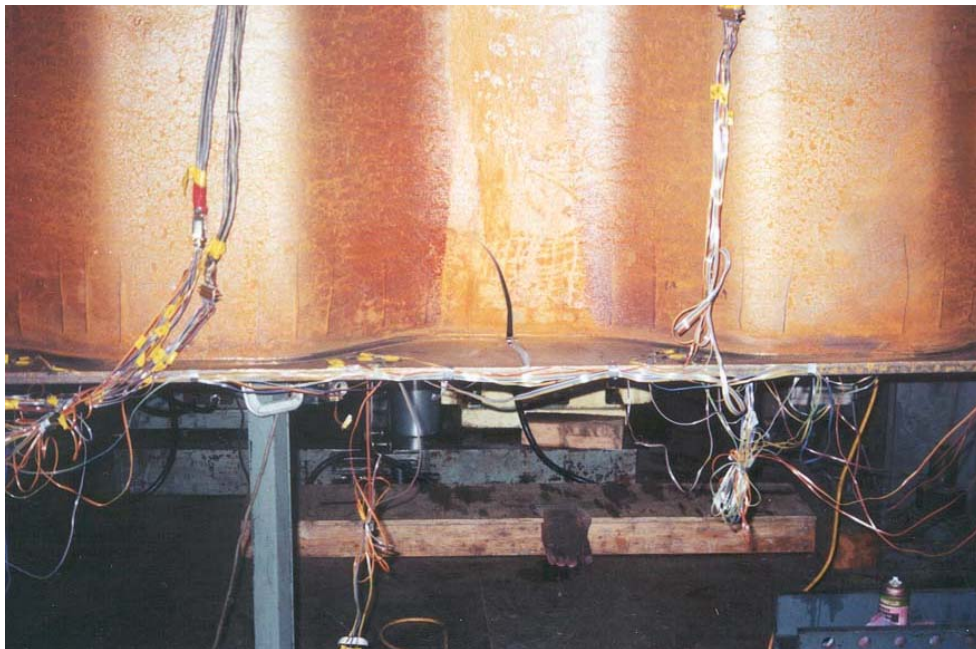
Figure 24. Failure of Girder G1B.

Girder G1B was tested at a nominal stress range of 110.MPa (16.0ksi). This girder was tested at a slightly higher stress range than Girders G5A, G6A, and G3A to determine if Category B of the AASHTO LRFD specifications, with a CAFL of 110.MPa (16.0ksi), could be attained. Multiple cracks were found at 2,800,000 cycles along Fold 7-8 where the stress range was approximately 125MPa (18.2ksi), 14% greater than the nominal stress range of 110.MPa (16.0ksi). These cracks were repaired by grinding and peening, and the test was resumed. Girder G1B failed finally after 3,500,000 cycles from a weld stop-start at the middle of a longitudinal web fold. A photograph of the failure is shown in Figure 24.

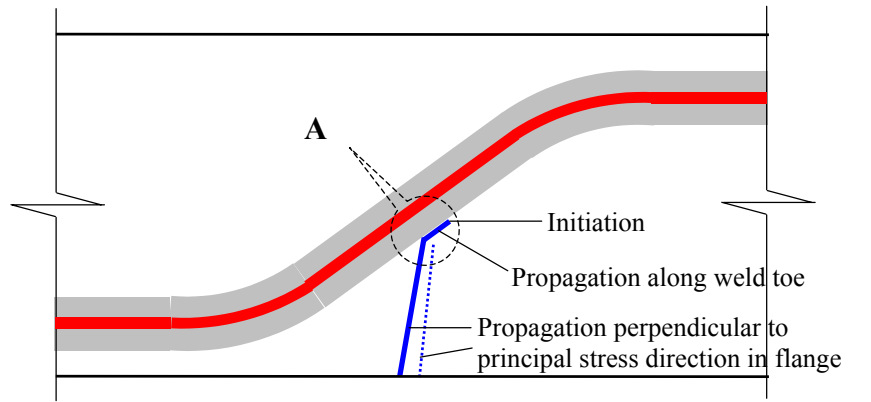
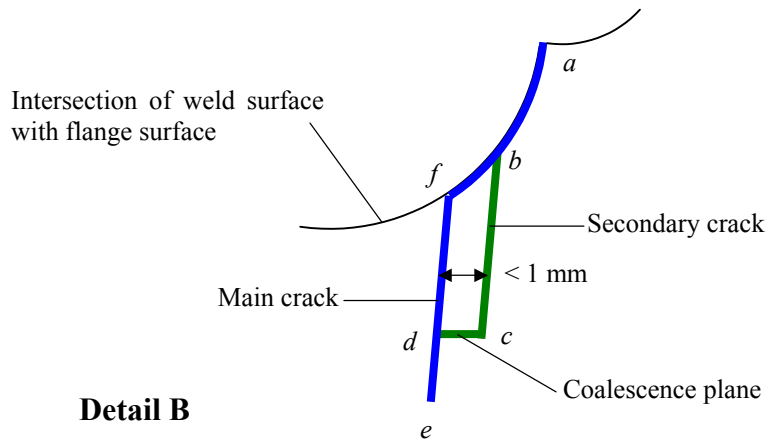
Figure 25. Observed crack patterns for semiautomatic GMAW process welds.

The fracture surface examination suggested three main stages of crack life: (1) crack initiation at the weld toe, (2) crack propagation into the flange along the weld toe, and (3) crack propagation into the flange away from the weld toe. The three stages are schematically represented in Figure 25.

As seen in the figure, fatigue crack initiation (stage 1) generally occurred at the toe of the web-to-flange fillet weld where the surfaces of two weld ripples intersect with the flange surface. The angle between the flange longitudinal axis and the tangent to the intersection of the weld surface with the flange surface at the weld toe, α_{int} , tends to be largest at this location. From measurements made on the fracture surface for Girders G2A and G4A, it was found that α_{int} at the crack initiation point was approximately 70° as shown in Figure 25. Previous fatigue studies suggest that the stress concentration at a fillet weld toe will be largest when the weld toe is perpendicular to the applied stress direction. It follows that fatigue crack initiation is likely to occur where the intersection of the weld surface with the flange surface is closest to perpendicular to the principal stress direction at the flange surface.

Stage 2 is characterized by crack propagation along the weld toe. The propagation along the weld toe was usually several millimeters in length (5mm (0.20in) for G2A and 7mm (0.28in) for G4A) as shown in Figure 25. The fatigue crack surface associated with stage 2 was non-uniform and it was not possible to determine from the fracture surface a clear pattern of fatigue crack propagation during stage 2. However, the short crack propagation length during stage 2 suggests that the extent of propagation through the flange thickness is small during this stage. In the final stage of propagation (stage 3), the fatigue crack turns into the flange and propagates perpendicular to the principal stress direction. From measurements made on the fracture surface for Girders G2A and G4A, it was found that α_{int} at the beginning of stage 3 was approximately 50° as shown in Figure 25.

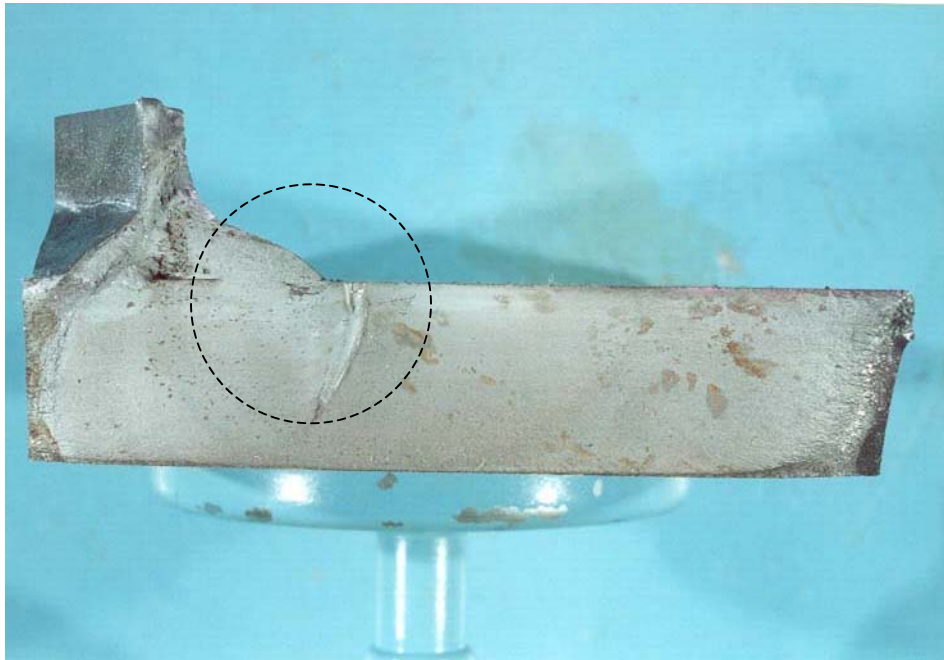
(a) Overall

(b) Close-up

Figure 26. Fracture surface from Girder G2A.

The different stages of crack growth for the main crack of Girder G2A are illustrated in the close-up photograph of Figure 26. Examination of the fracture surface reveals the presence of a secondary crack, such as the one shown in Detail B of Figure 25. This secondary crack started at the weld toe at point 'b' (Figure 25). At point 'c', however, the secondary crack ceased to propagate, perhaps because it was shielded by the faster growing neighboring main crack. Eventually, the two cracks joined along the coalescence plane from point 'c' to point 'd' and propagated toward 'e' as shown in Detail B of Figure 25. Thus, Figure 26 shows the fracture surface along 'abcde' and not 'afde' as shown in Detail B of Figure 25.

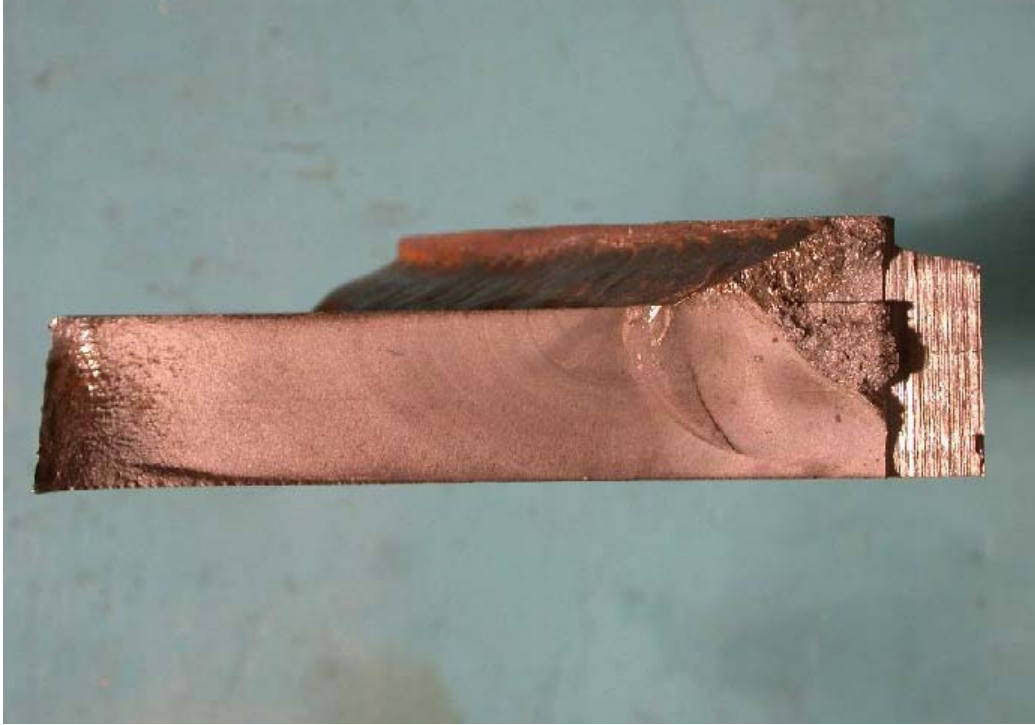
Figure 27. Fracture surface from Girder G4A.

The fracture surface of the main crack of Girder G4A was similarly examined as shown in Figure 27. Crack propagation "beach" marks are readily visible on the fracture surface and are semi-elliptical in shape, suggesting that the crack propagation pattern can be idealized as shown in Figure 28. The ratio of the minor axis of the ellipse to the major axis of the ellipse was found to be rather constant and approximately equal to 0.75.

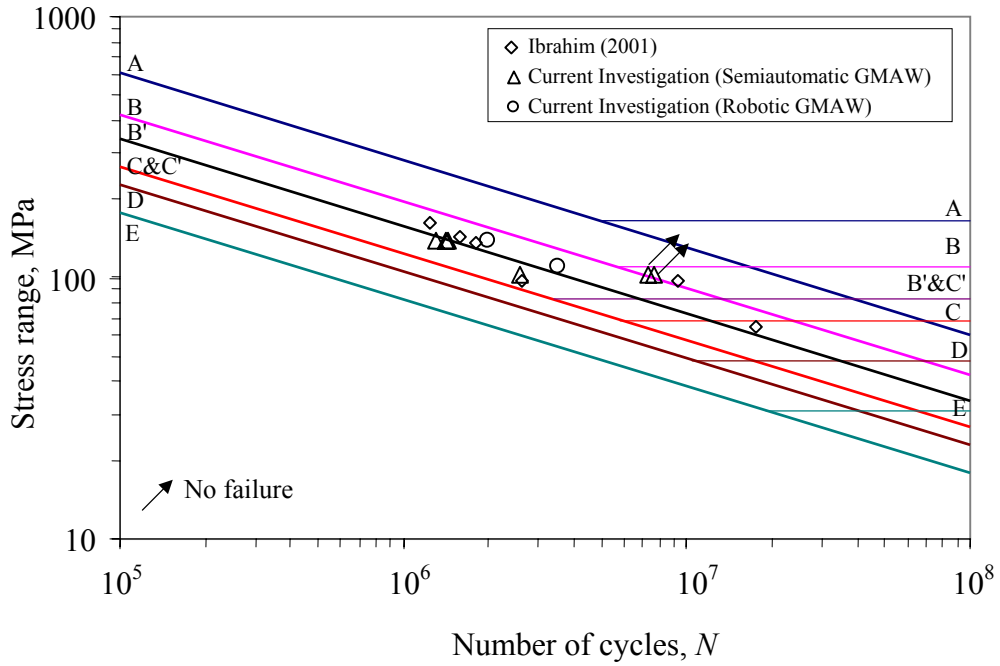
Figure 29. Fatigue test data for corrugated web girders (with trapezoidal corrugations) with mean S-N curves for AASHTO LRFD fatigue categories.

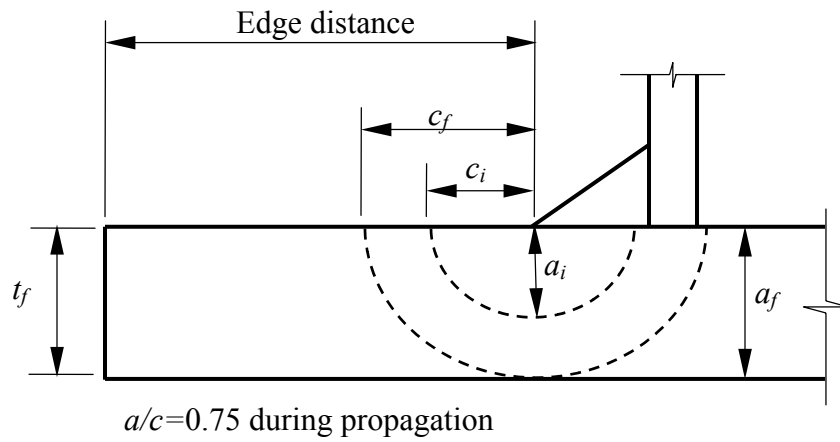
Figure 31. Remaining life analysis assumptions.

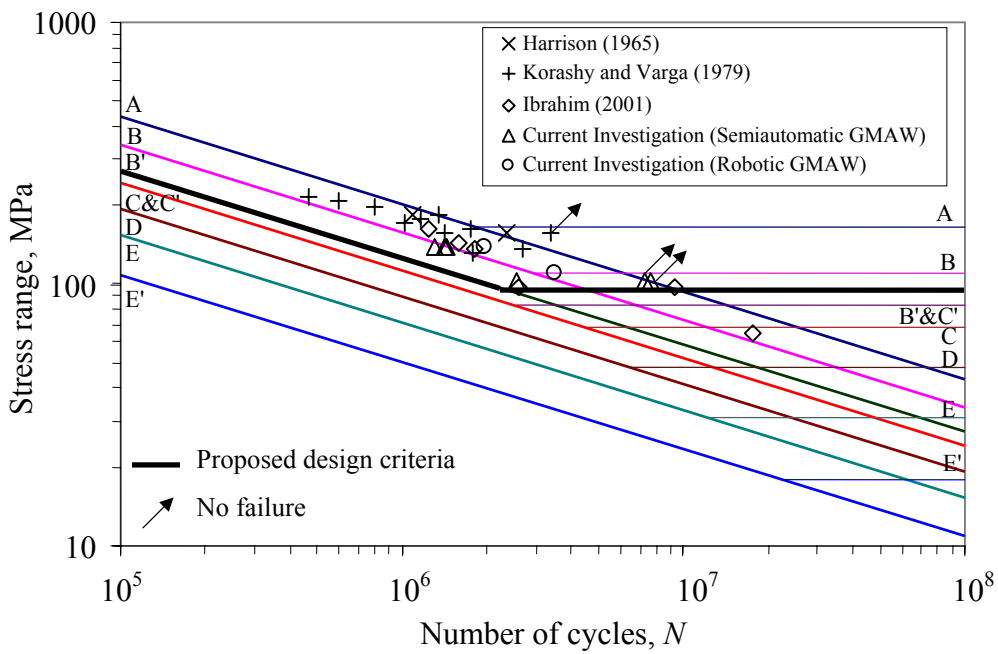
Figure 33. Design recommendations for corrugated web I-girders.
