Measurements and Assessment of Structural Members in Selected Spans of Amtrak's Susquehanna River Bridge

Measurements and Assessment of Structural Members in Selected Spans of AMTRAK's Susquehanna River Bridge

Final Report for
AMTRAK Contract No. PMMM 7174-0001
ATLSS File No. At 86.3

ATLSS Report No. 99-03

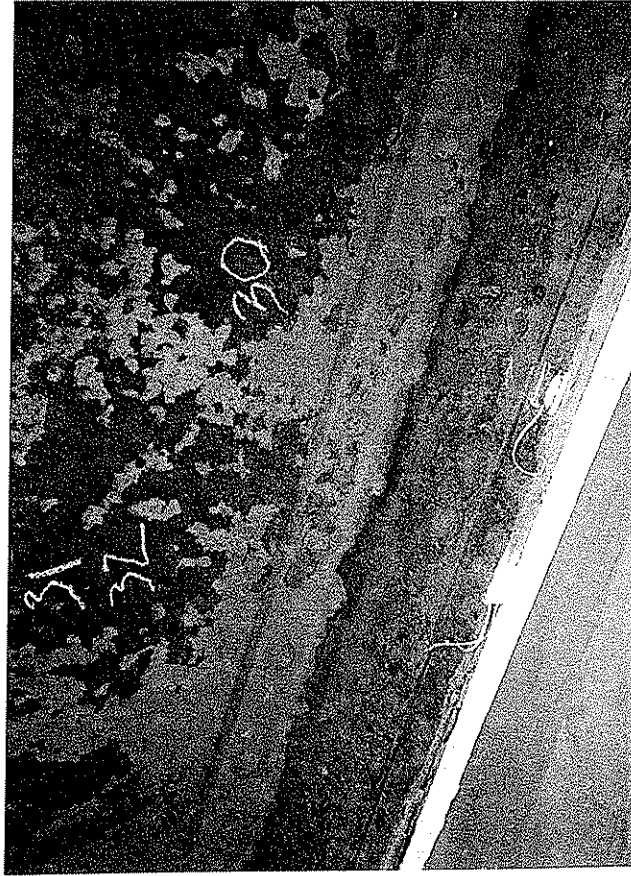
a) Gages 30 to 32 (10/97/13-17)

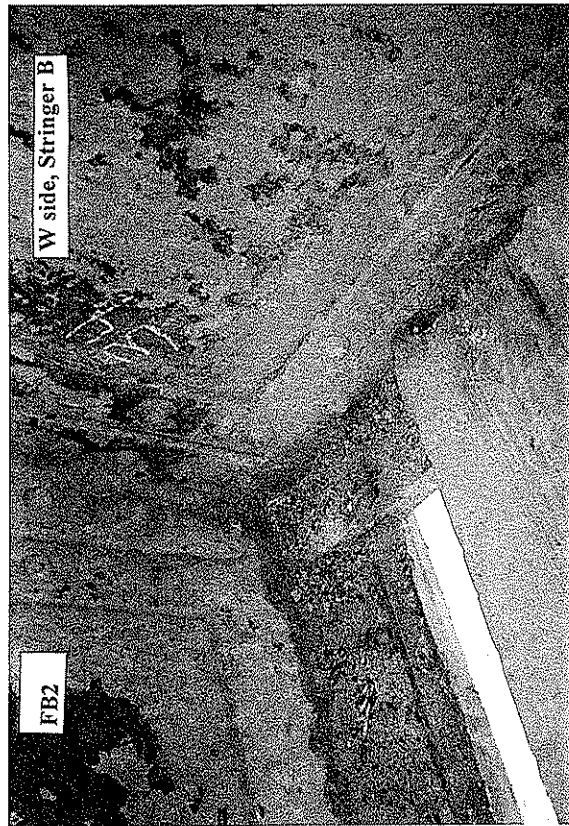
b) Location for gage 34, Stringer B at FB 2 (10/97/13-19)

Figure 6: Span 10, Gage Installations 33 to 37 for Stringer A & B, between Floorbeams 1 & 2

Effect of Stringer Coverplates. The coverplates on the stringers were welded to the outstanding legs of the bottom flange angles after severely corroded flange areas had been trimmed away. In some cases, a considerable part of an outstanding angle leg was involved (Figure 6c). In other locations, a smaller part of the outstanding leg was cut away, usually with a transition. The 16" x 1/2" coverplates were welded to the stringers with continuous fillet welds along the edge of the remaining outstanding legs. This provided a continuous longitudinal weld that deviates at the trim areas but does not terminate. The compatibility condition is satisfied for flexural conformance so that the flange angles and attached coverplate are equally stressed. This condition is analogous to the use of intermittent fillet welds between the web and flanges of built-up beams, which has been well studied. When varying weld-segment lengths of 2 or 4 inches with gaps of 4 or 5 inches were tested in flexure, the test data all exceeded the category C fatigue resistance S-N curve [12]. We believe that the conditions that exist at the welded coverplated stringers along the length of the coverplate similarly provide a fatigue resistance that is Category C. At the weld termination, however, where the coverplate ends at the edge of the floorbeam flange, the fatigue resistance is defined by category E; that is, the classical coverplate termination with a large stress concentration effect.

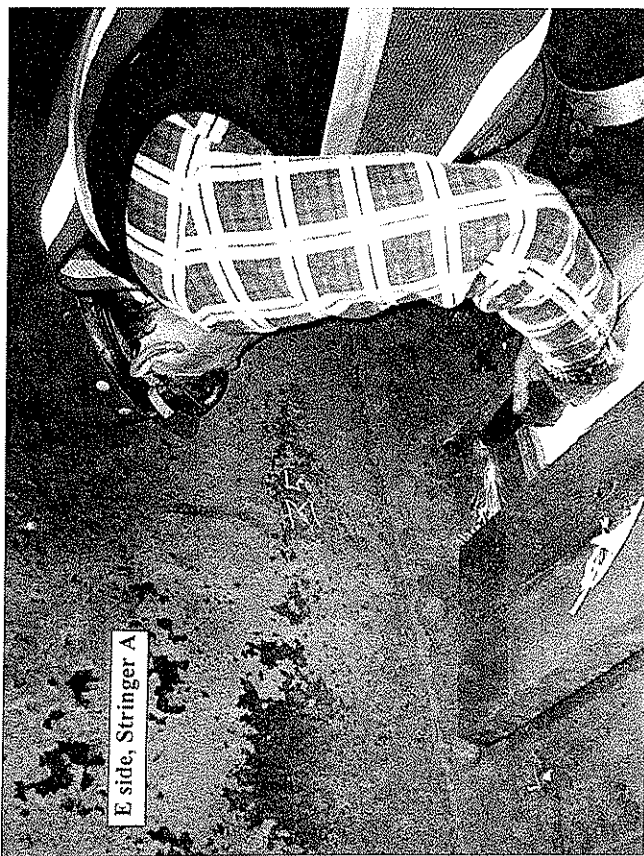
d) Engineer prepares for gage 35 at Stringer A, midway between FBs (10/97/13-20)

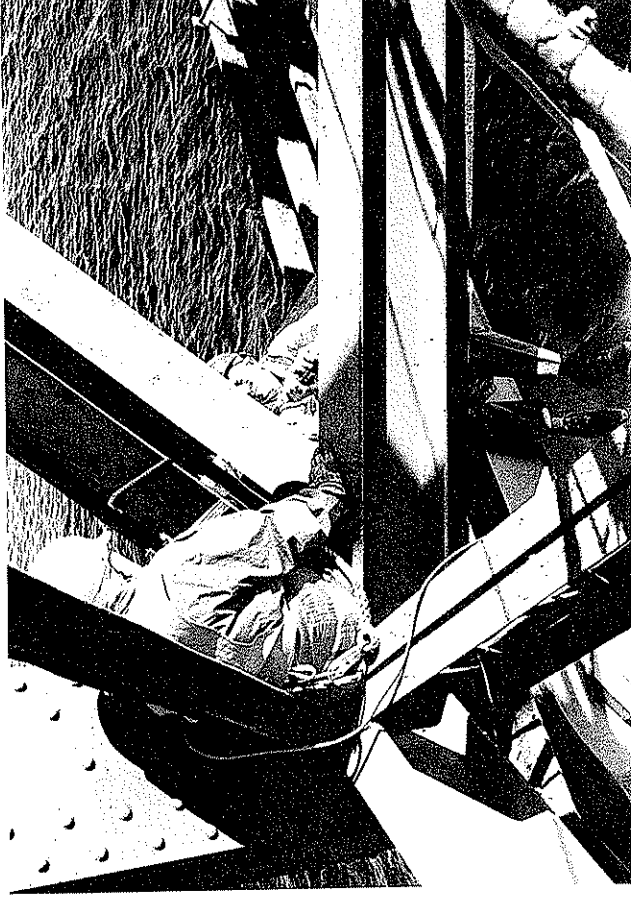
b) Installation of gages 78 - 81 (10/97/14-2)

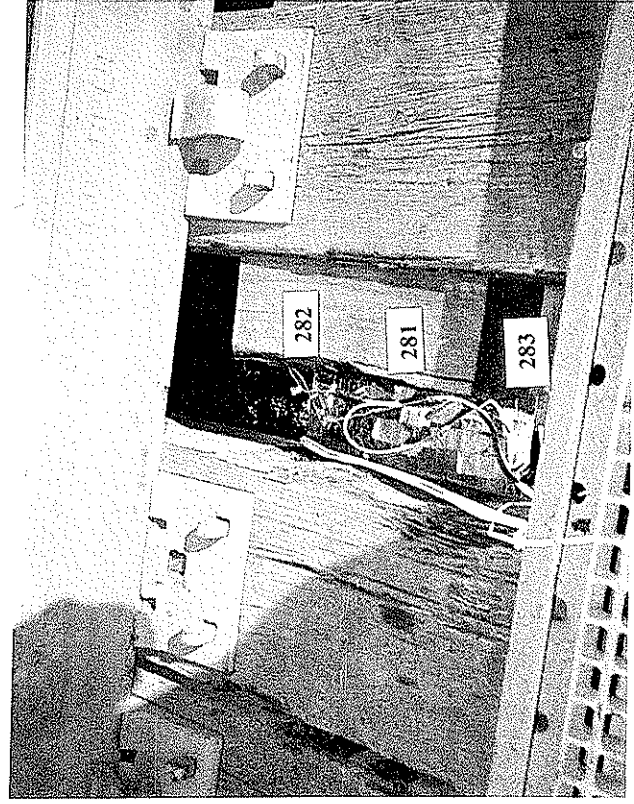
d) Gages 281 - 283 at midspan of Stringer B between U8 & U9 (10/97/17-12)

Figure 13: Span 2, Gages 276 - 283 at West Top Chord and Stringer U8U9

Top chord and interior stringer stresses were measured midway between floorbeams in deck-truss Span 2, at the west-truss or Track 3 side of the bridge. In Span 2, the top chord also serves as the outside stringer (see Figures 13 and 17). Stringer measurements were made between Floorbeams 8 and 9 where the axial stress in the chord is small and the flexural stresses can be assessed. Gages were mounted parallel to the west top chord (Stringer A) and west interior stringer (Stringer B) on the top surface of each and, in January 1998, also on the top surface of the bottom flanges for the top chord and transversely on the top surface of the top chord.

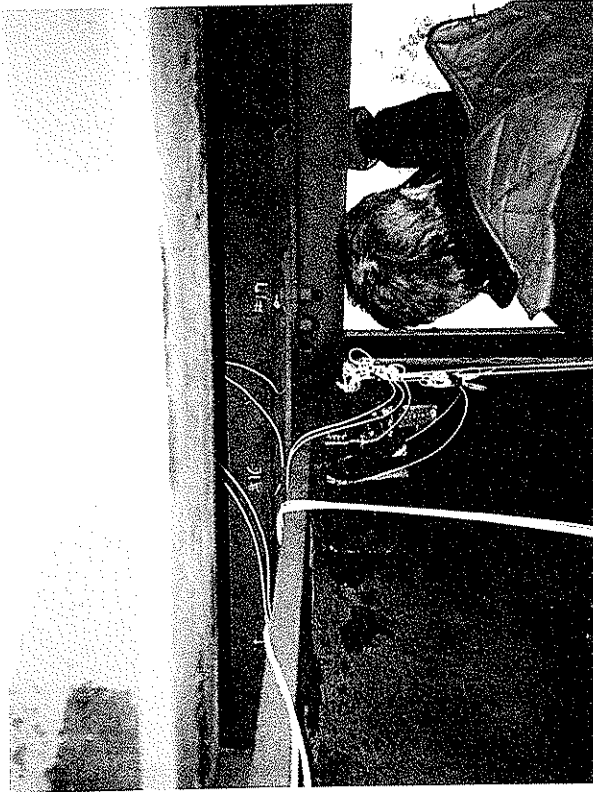
Figure24: Span 2, Floorbeam 5 / West Top Chord, Gage Installations D16 -D17

a) Overall view of D16, D17, and D97 at Floorbeam / top chord junction (1/98/6-7)

b) Gages D16 & D17 on top chord bottom flange (1/98/6-11)

c) Close up of Gage D16 showing local flange condition (1/98/8-14)

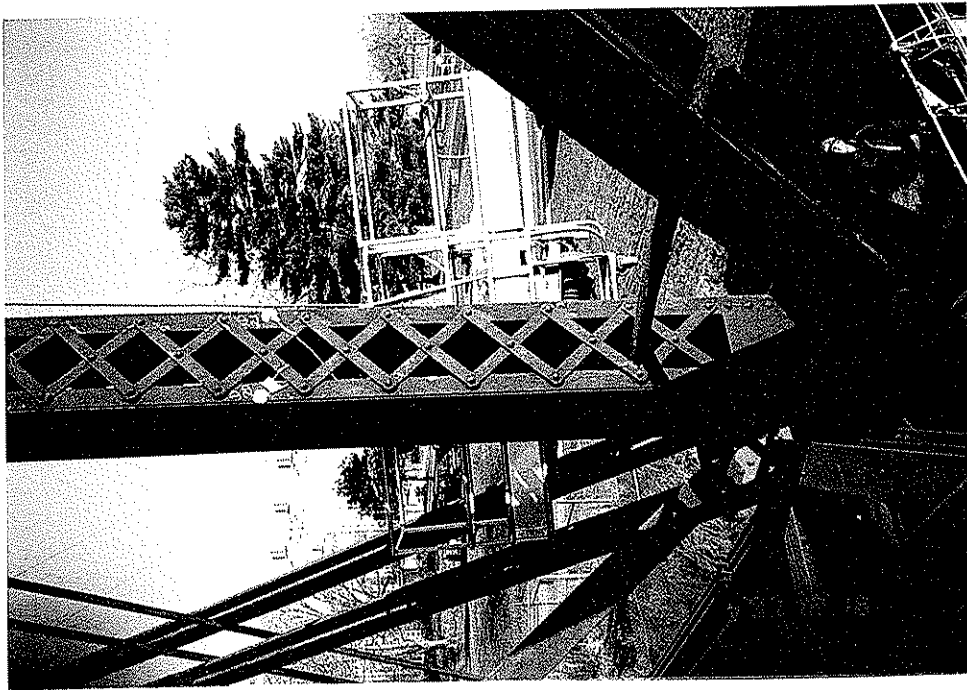
a) East Post L5U5 showing
Gages D20 and D21 (1/98/6-20)

Figure 29: Span 2, Gages on Vertical Posts L5U5

Stresses in the vertical posts L5U5 in Span 2 were measured during January at both the west and east trusses. Four strain gages were mounted vertically on each post, one at each corner angle and midway between lattice bar connections (Figure 29), to measure axial stresses and post bending. The gages were about 10 feet above the lower-chord pins, Figure 28. Each post consists of four 4" x 4" x ½" corner angles. A plate 20" x ½" connects each pair of angles, and these pairs are then connected by laced lattice bars. Discounting the lattice bars, each post has a 35 sq-in cross section.

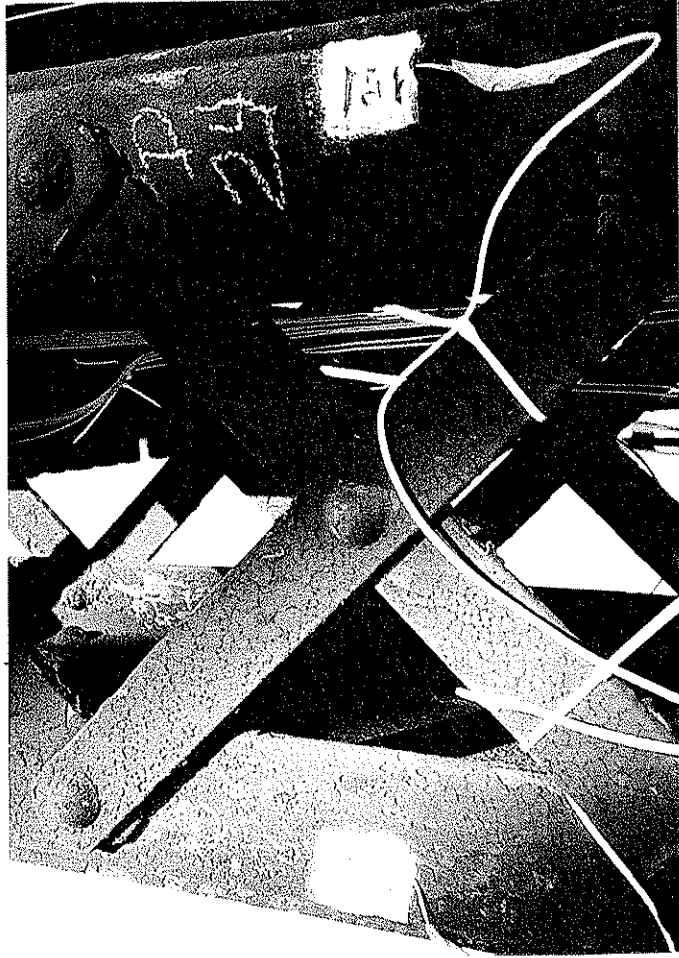
b) West Post L5U5 showing
Gages D24 and D25 (1/98/6-16)

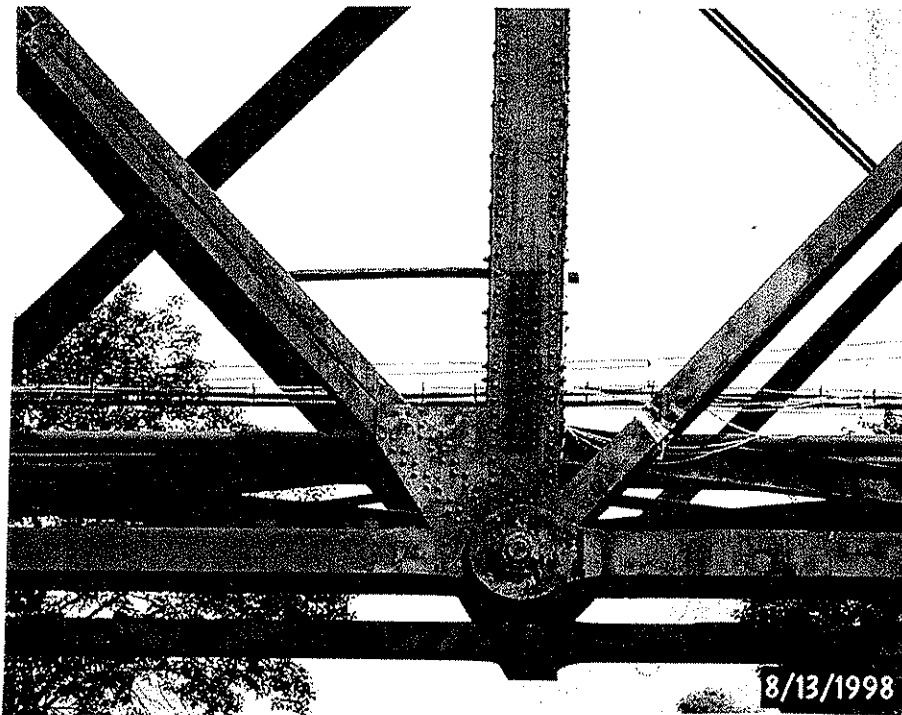
(b) East side of Post L5U5-East after retrofit

Figure 34. Vertical Posts L5U5 in Span 2 After Installation of Retrofit at Lower Panel Points

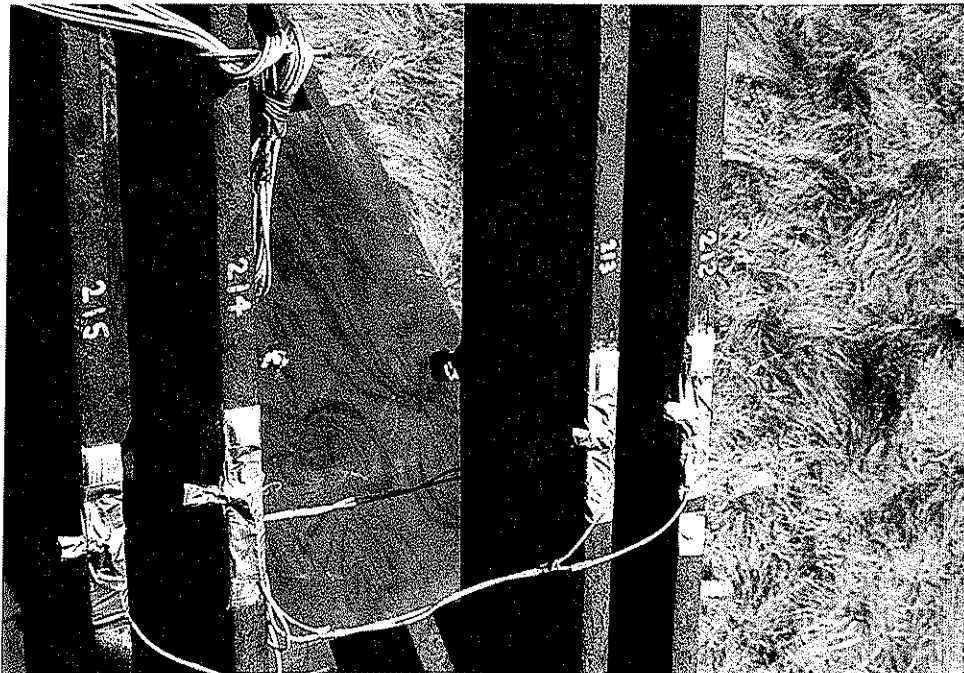
b) Gages 212 to 215 at L5U6-East (8/98/7-14)

**Figure 41. Gage Installations in Span 2 on Eyebar Diagonals L5U6 at L5
(after reinstallation in 08/98)**

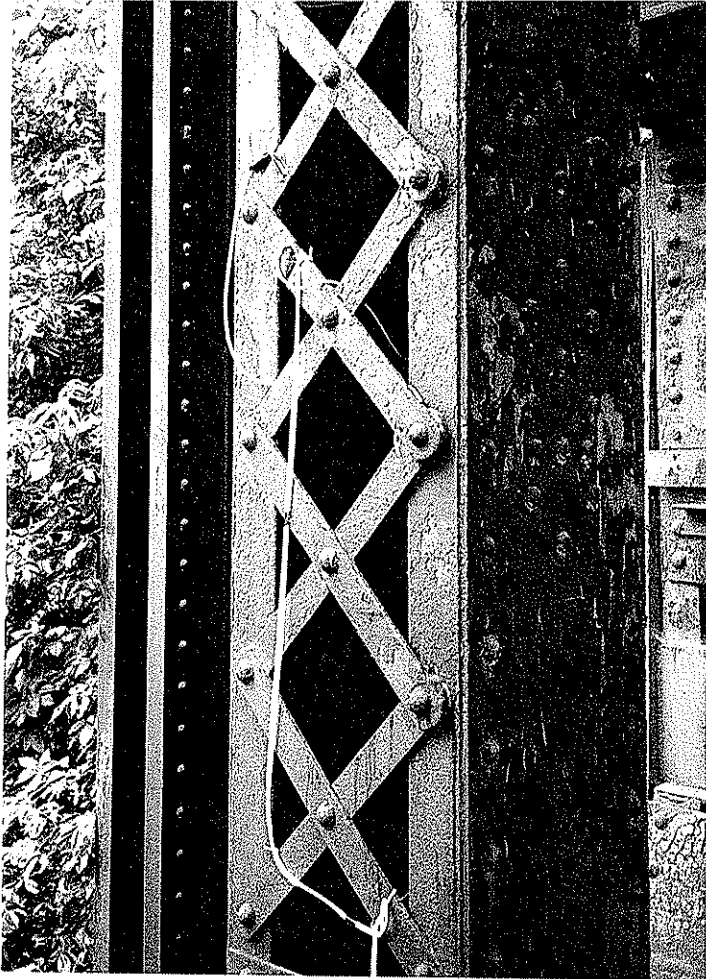
(a) Gage 27.98 at SW corner of post
(8/98/9-3)

Figure 44a. Post-Lubrication Gages on Vertical Post L9U9-West, Span 2

L9U9. Stresses in the vertical end post L9U9-west were measured, because of the pin lubrication done at panel point L9. Two strain gages were mounted vertically, one at each of the NW and SW corner angles, to measure axial stresses and north/south bending in the end post. The gages were each about 9 feet above the lower chord pins; but due to differences in the construction of the north and south faces of the post, the gages on the SW corner angle were between the 4th and 5th lattice-bar rivets and those on the NW corner angle were between the 1st and 2nd lattice-bar rivets. Figures 44 and 44a depict these locations.

Figure 96 illustrates the post behavior with southbound passenger trains in July and August. As the locomotive reached the post, roughly equal compression occurred at both the NW and SW corners of the post. Then, as the locomotive passed, the stress cycle at the SW post remained in compression, but that at the NW post became basically a tension cycle. This suggests that positive bending of the top chord due to the southbound train occurs, inducing positive bending on the north side of the post, and that adequate rotation of the post at pin L9 is occurring so that positive bending of the post is retained at the gage location. This is consistent with the rigid gusset connection between the post and the top chord. Also, as shown in Table 42 and illustrated in Figure 84, lower-chord eyebars bending restraint at L9 was light in Span 2 (less than half of the bending restraint introduced by lower chord eyebars L8L9 in Span 1). The geometry differences of the NW and SW corners of the post (Figure 44a) is not believed to have had a significant effect on the results.

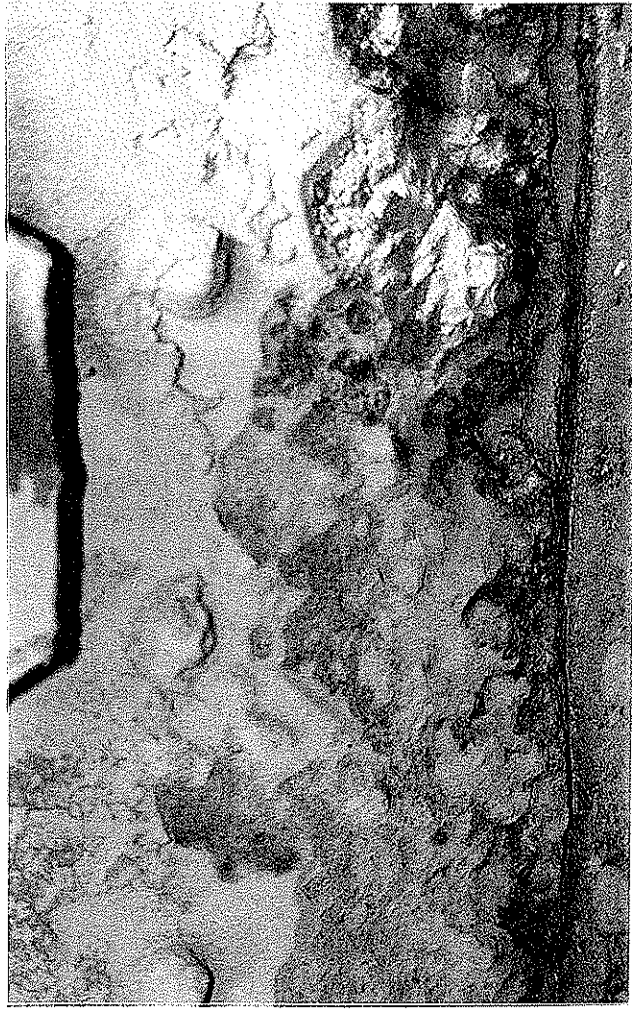
b) Closeup of section loss in region of D26 (1/98/8-21)

Figure 49. Span 1, Panel Point U8-West Gage Installations D26 - D28

Stresses at the floorbeam/top chord junction at FB8-West in Span 1, previously measured in January, were remeasured in August to gain further data for that region and to learn whether any effect of the pin lubrication at Panel Point L9-West would be reflected in new data at U8-West. Moreover, this particular junction was the only pre-retrofit junction design for any span included in the August measurements. Table 49 summarizes the August results; the gage locations are given in Figure 47.

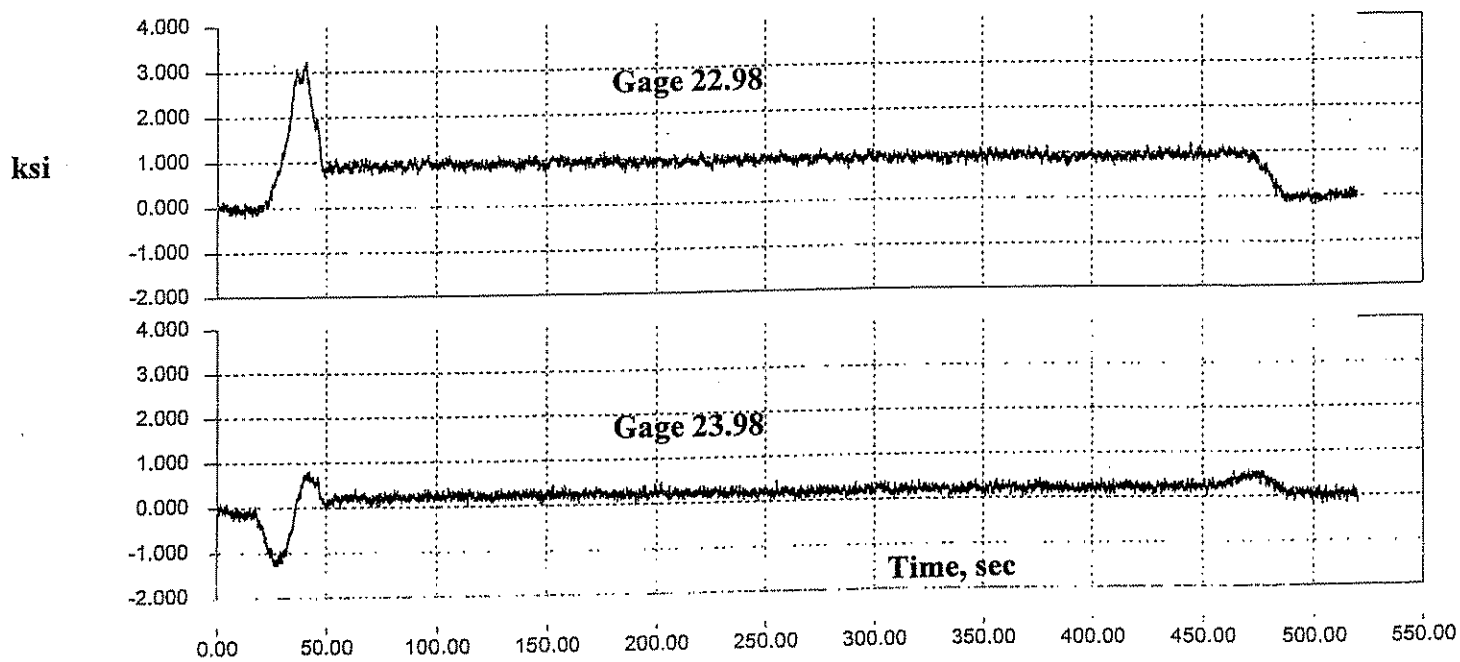
Figure 84 : August Stress Records for Lower-Chord Eyebars L8L9-West in Span 2
(end)

(a) Coal Train UMP 74B Southbound on Track 3

(b) Empty Coal Train XSM 43E Northbound on Track 3

(c) 263K Coal-Car Train ULK 66C Southbound on Track 2

(d) Amtrak Train #97 Southbound on Track 3

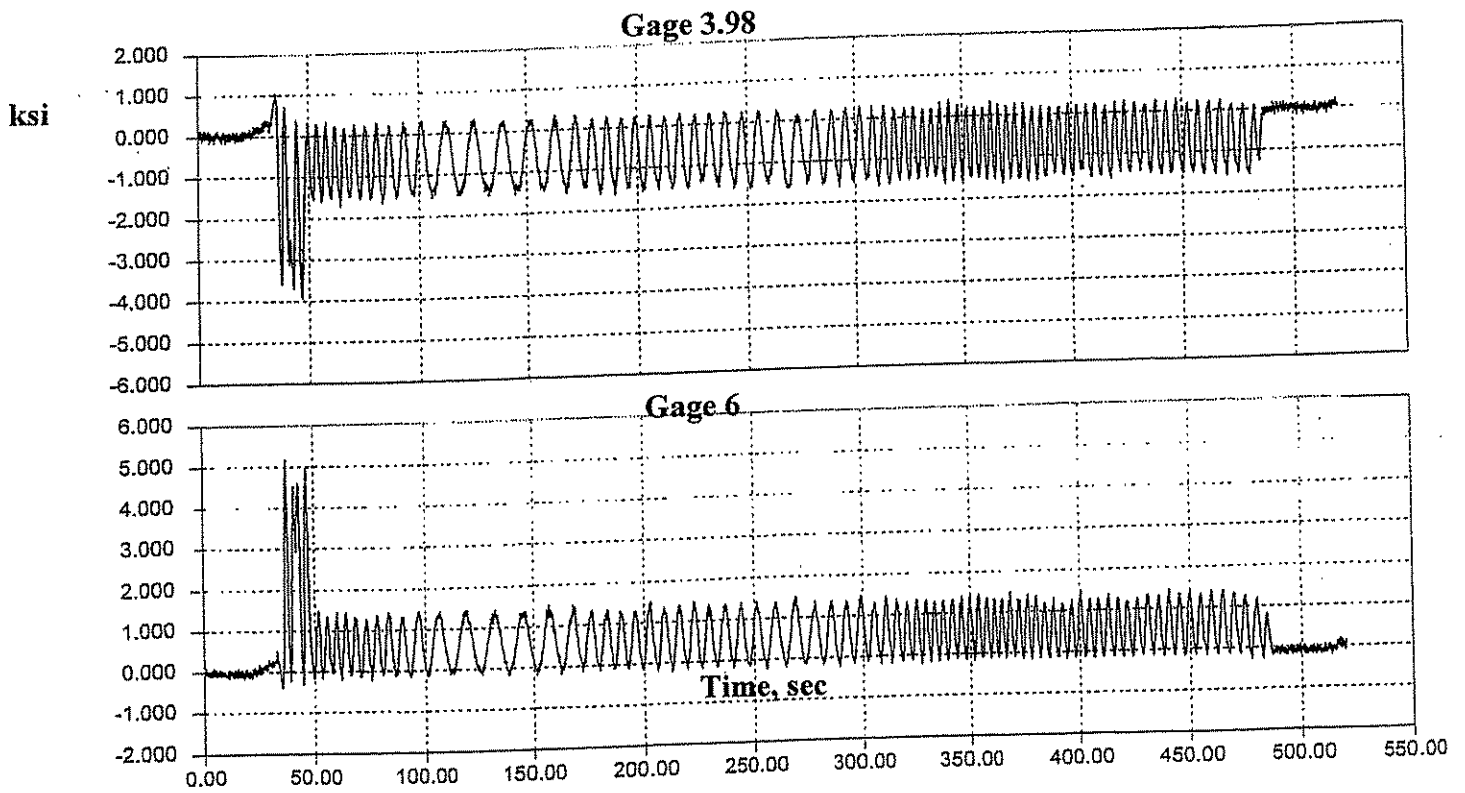
Figure 87: August Stress Records in Span 2 at Top Chord U8U9-West at Midspan
(end)

(a) Coal Train UMP 74B Southbound on Track 3

(b) Empty Coal Train XSM 43E Northbound on Track 3

(c) Passenger Train Amtrak 97 Southbound on Track 3
