Ultimate shear tests of full-sized prestressed concrete beams

Howard E. Brecht
Lehigh University

A THESIS

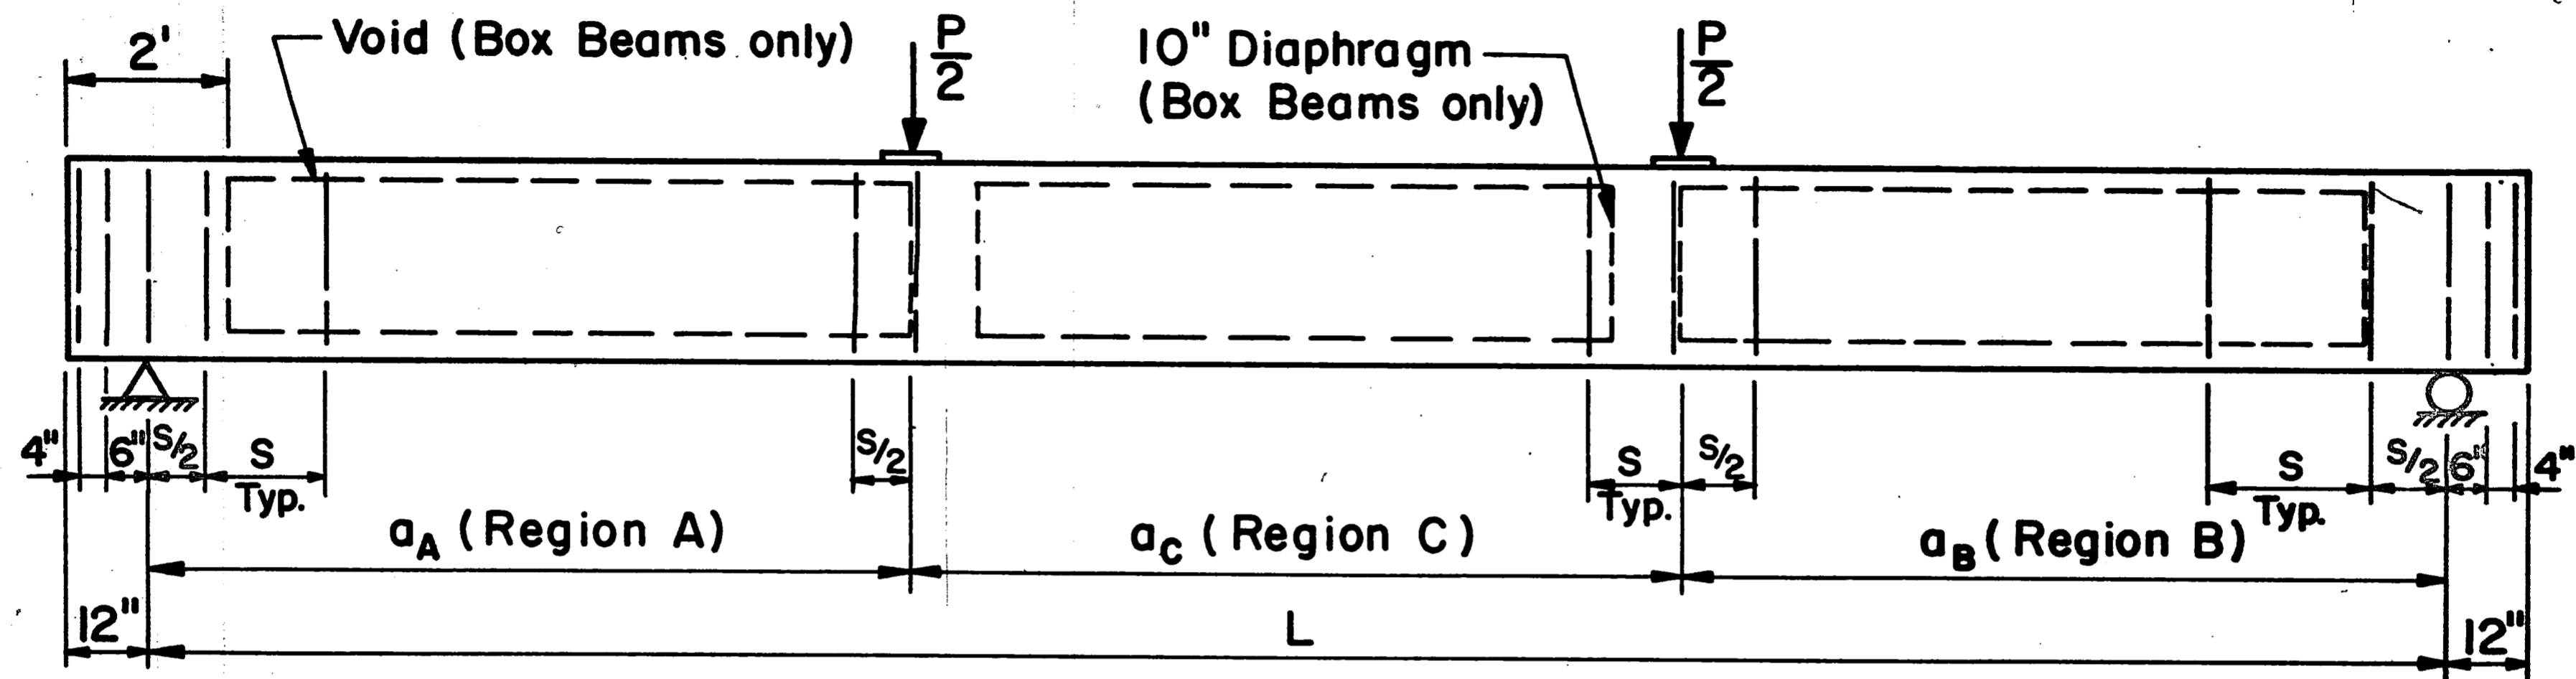
Fig. 1 Details of Full-Sized, G Series Beams

Elevation of Test Beams

Beam	Dimensions			Web Reinforcement								
				Region A			Region C			Region B		
	$a_A = a_B$ (ft)	a_C (ft)	L (ft)	Size (No.)	S (in.)	$r_{fy}/100$ (psi)	Size (No.)	S (in.)	$r_{fy}/100$ (psi)	Size (No.)	S (in.)	$r_{fy}/100$ (psi)
G-1	9	9	27	3	12	105	5	12	247	3	21.6	59
G-2	9	9	27	3	18	114	5	12	412	2	18	55
G-3	15	15	45	3	18	70	5	12	247	3	22.5	56
G-4	15	15	45	3	22.5	91	5	12	412	2	22.5	44

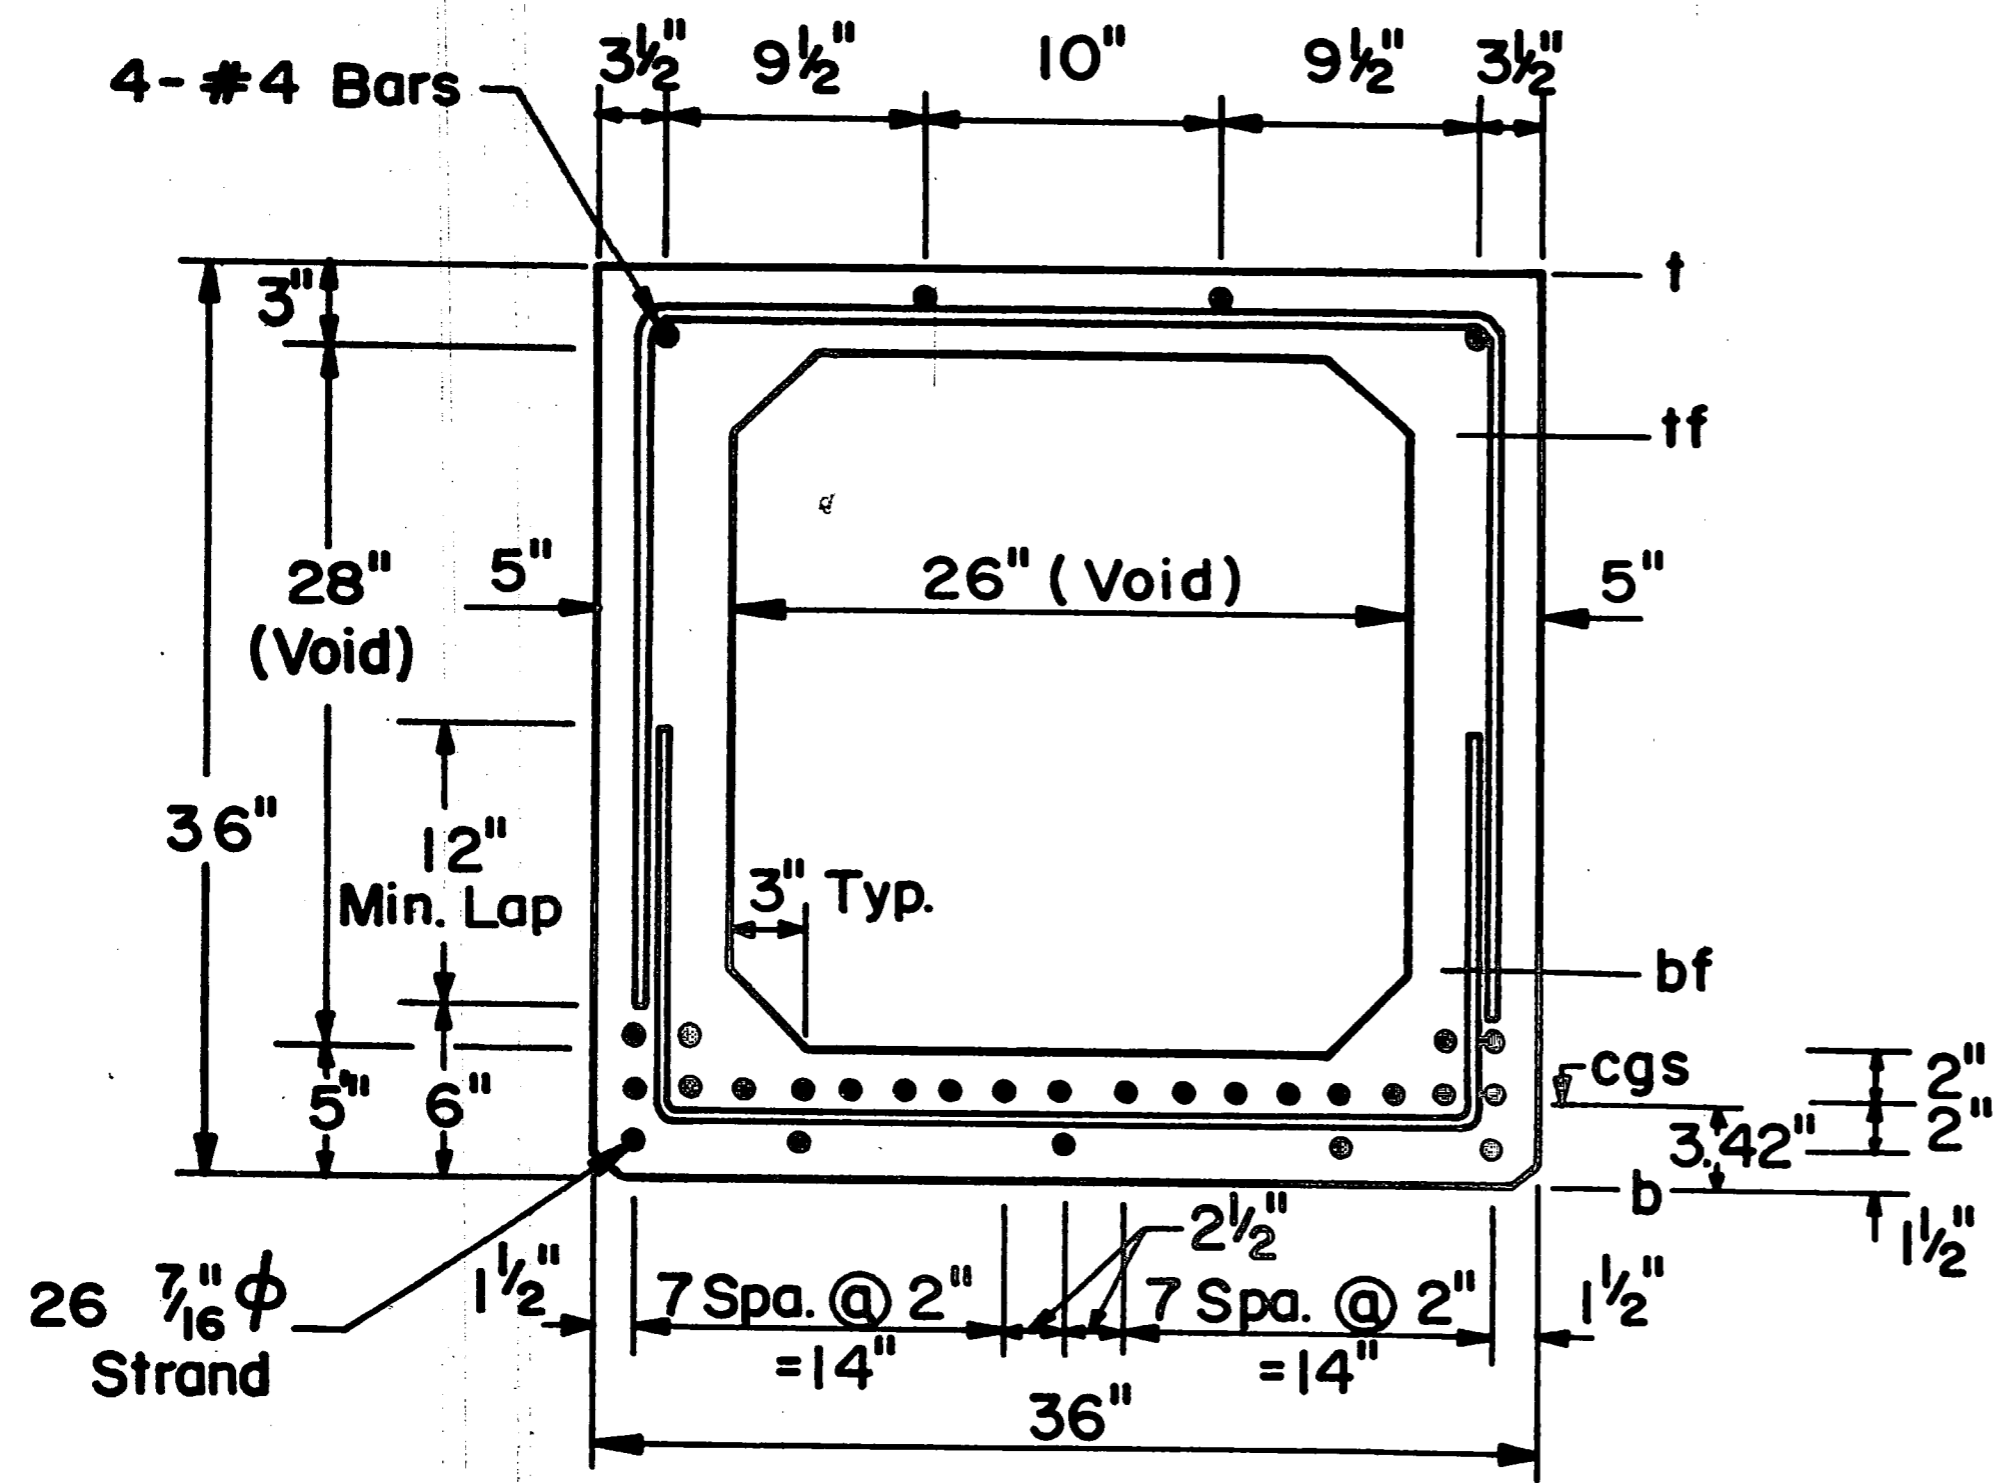
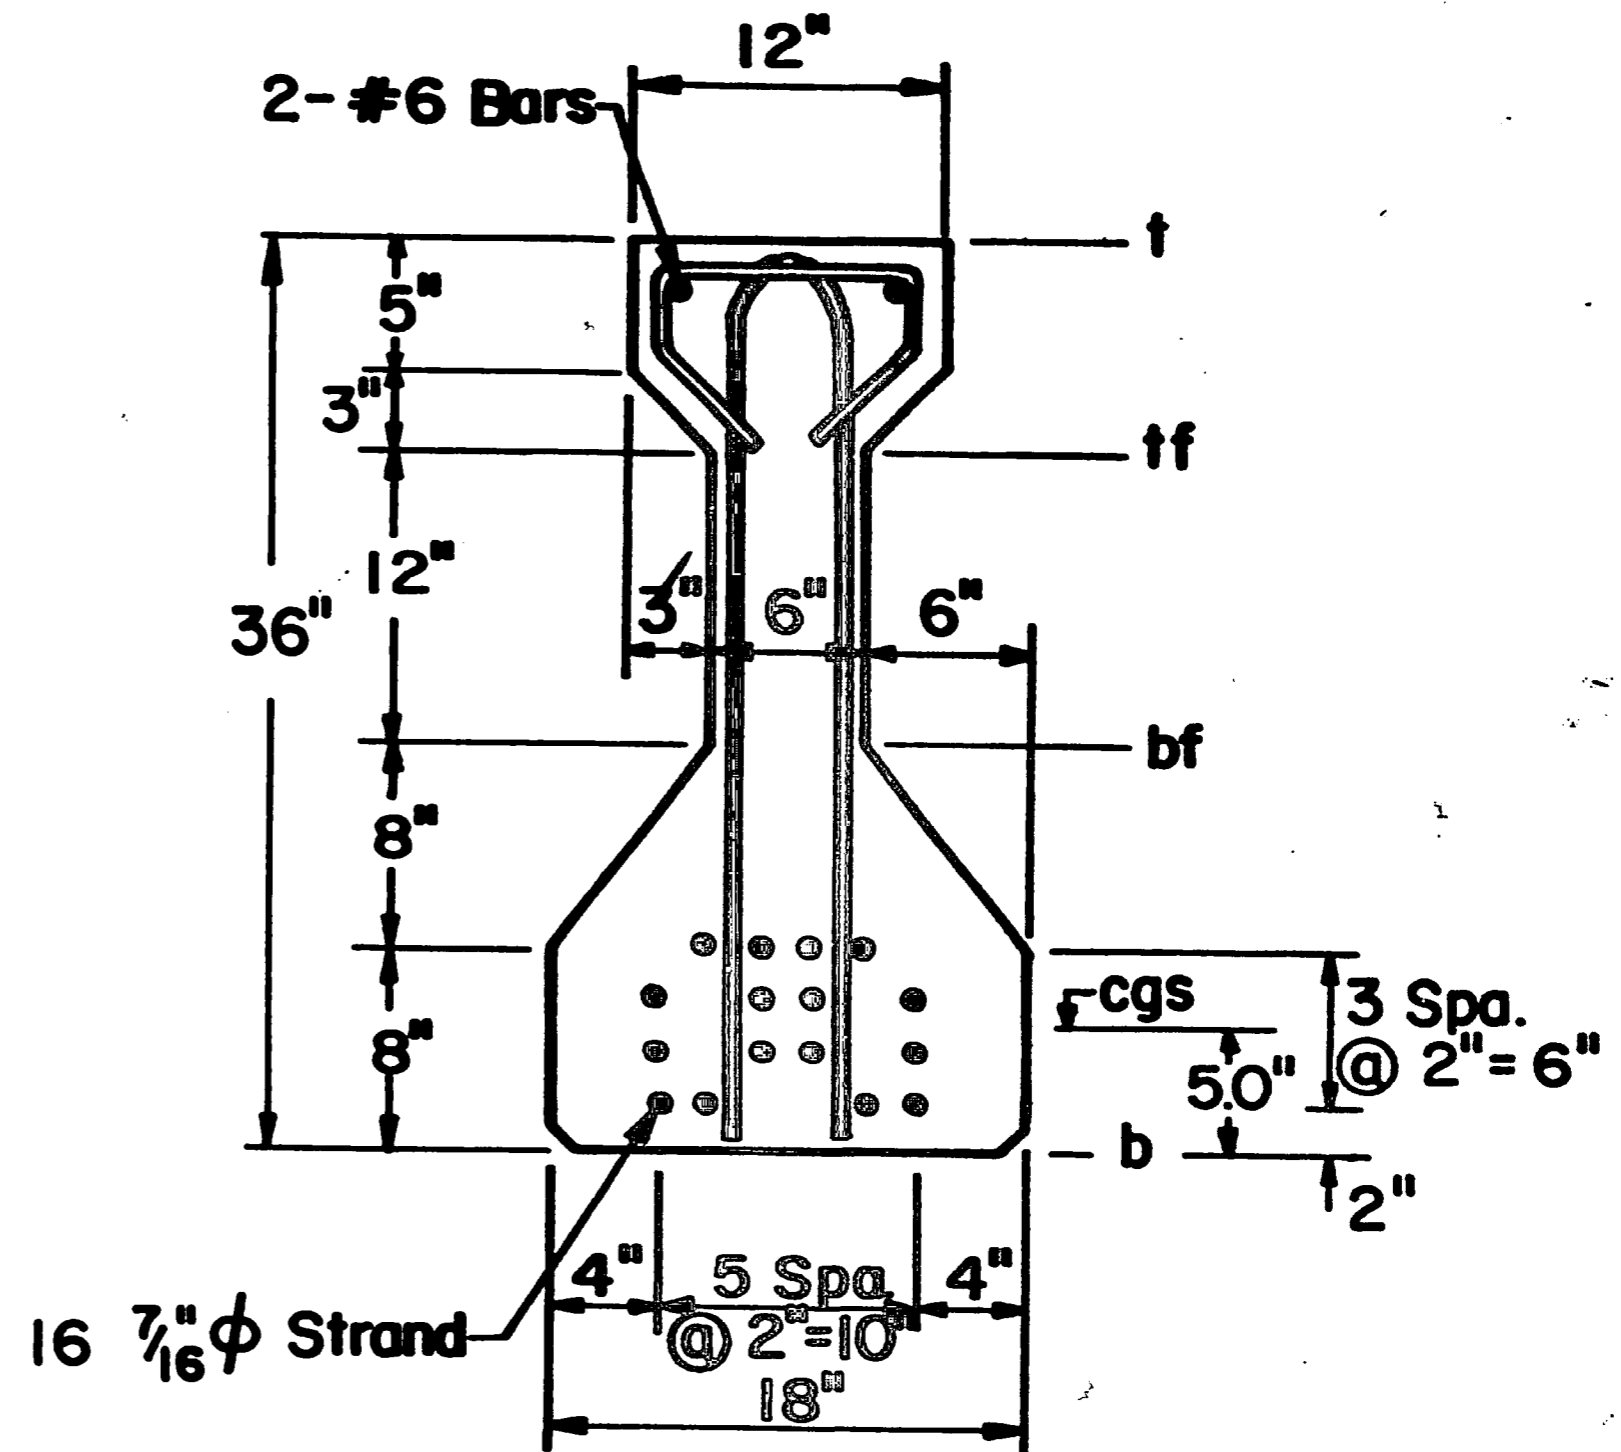
Fig. 2 Sectional Views of Full-Sized, G Series Beams

Box Beams G-1 and G-3

I Beams G-2 and G-4

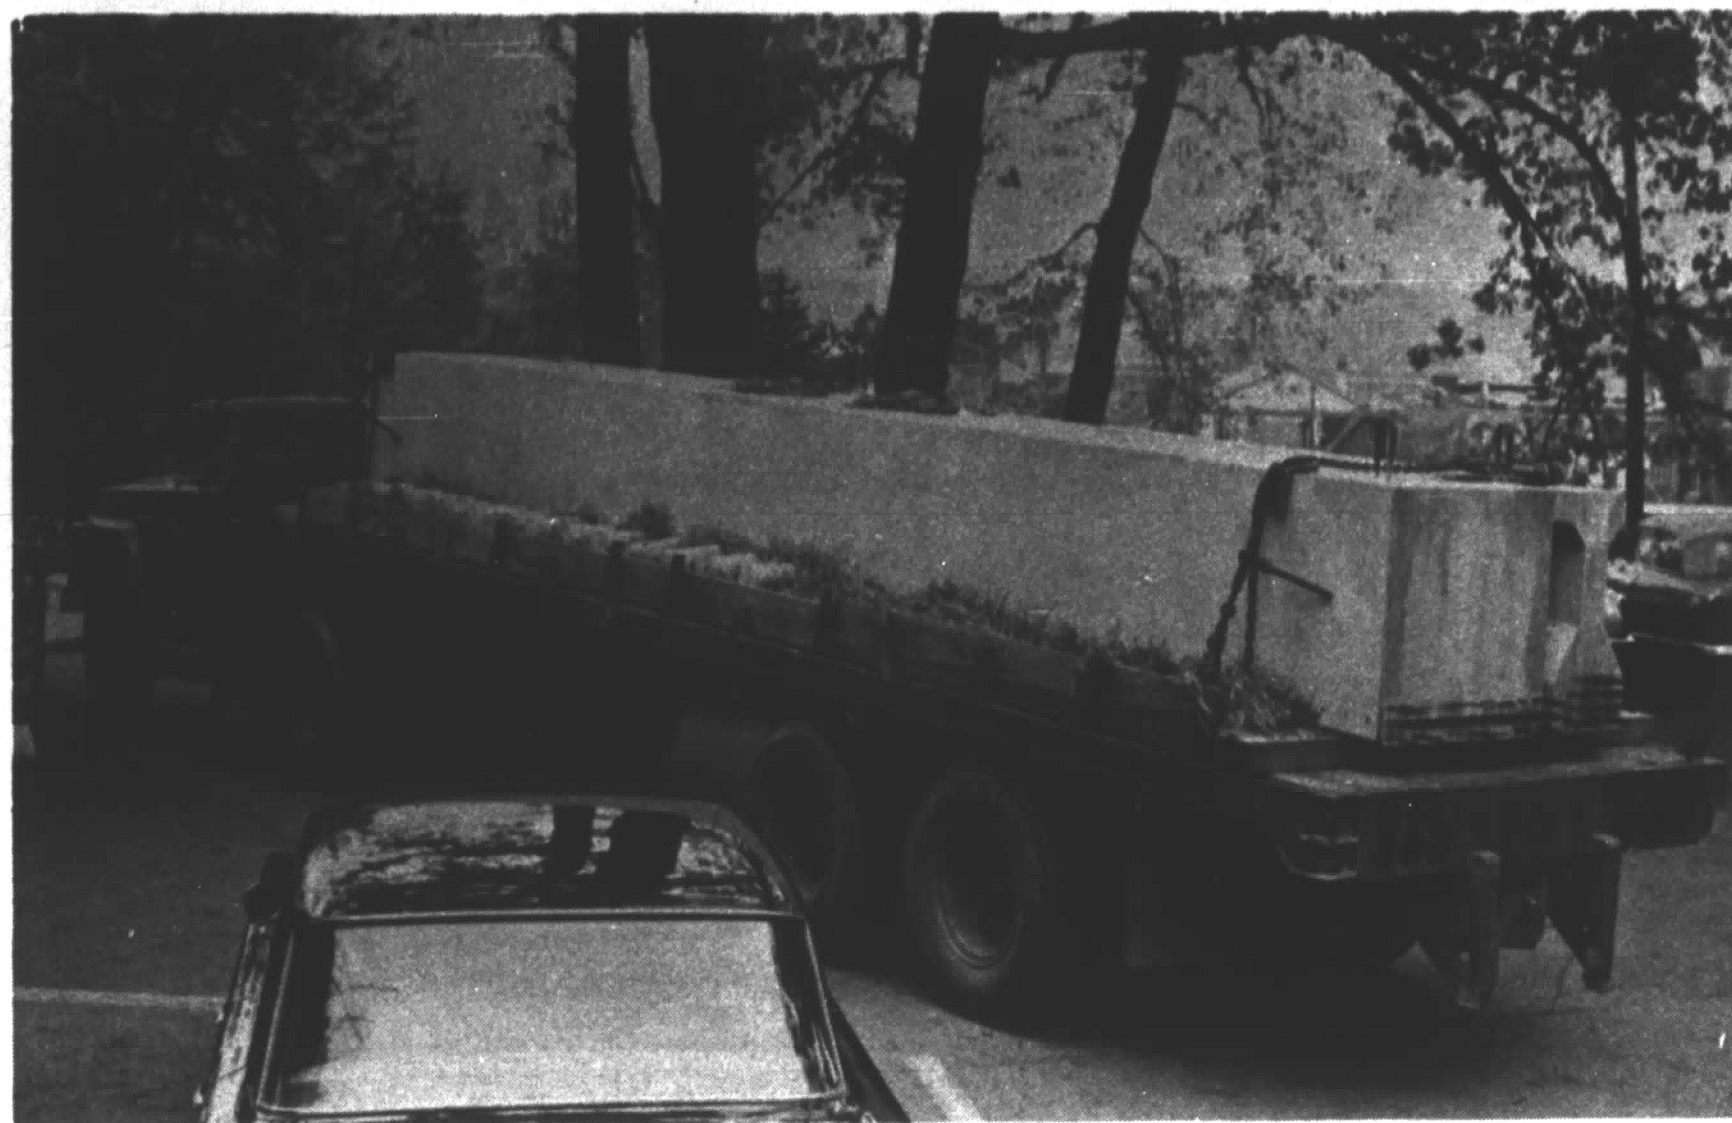
Fig. 13 Beams Arriving at Fritz Engineering Laboratory

a. Beams G-1 and G-2

b. Beam G-4

The beams were stored indoors for approximately 3 weeks after fabrication in order to facilitate the various data readings which had to be taken. They were subsequently stored outdoors where the weather conditions were very similar to the conditions indoors except for the moisture content of the atmosphere. All of the cylinders representative of the concrete in each beam were transported with the beams. Beams G-1 and G-2, the two short beams were shipped by truck to Lehigh together as shown in Fig. 13a. Cylinders were packed in straw alongside

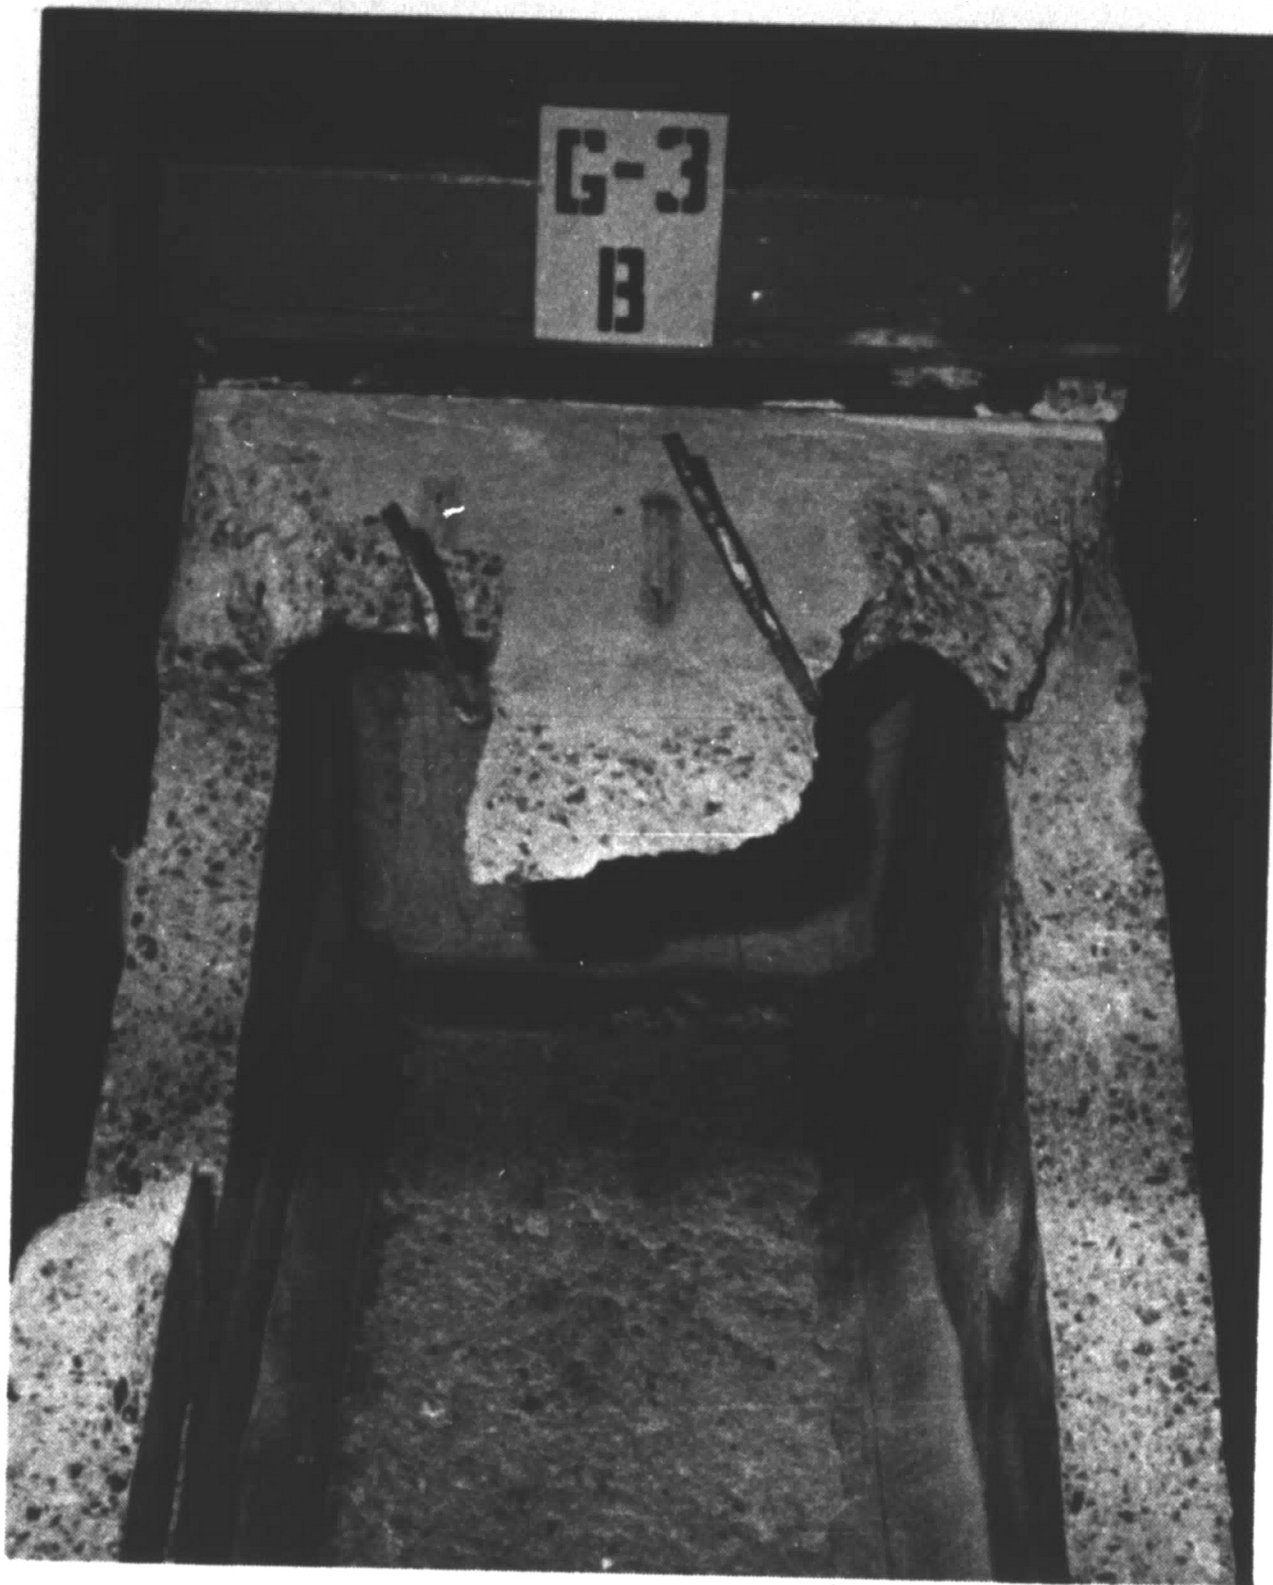
Fig. 14 Cross Section of Box Beam G-3

a. Overhead View

c. Interior Left Side View

was $\pm 3/4$ -in. If one side of the web was found to be smaller than the design dimension, the other side was found to be greater; therefore the total web thickness at any section was approximately 10-in. Figure 14a shows the remainder of beam G-3 after the B shear span was removed at the failure region. The right web is 5 and $3/4$ -in. thick at the top near the compression flange; the left web is only 4 and $1/8$ -in. thick at the top. The interior walls and ceiling of the hollow box were smooth since the concrete was vibrated against the in-place void. Figure 14a also illustrates the extremely rough bottom of the hollow box since the bottom flange was placed and vibrated before the void was placed. The top flange of beam G-1 was as thin as $2\frac{1}{2}$ -in. at some locations; beam G-3 had a minimum top flange thickness of 2 and $11/16$ -in. at the section shown in Fig. 14b. Internal diaphragms and end blocks were found bulged out approximately 2-in. The waxed cardboard voids were saturated and the vents and drains were found to have been clogged. Figure 14c shows the wet discolored interior walls of the beam, and one exposed strap used to hold the cardboard void in place during casting of the beam.

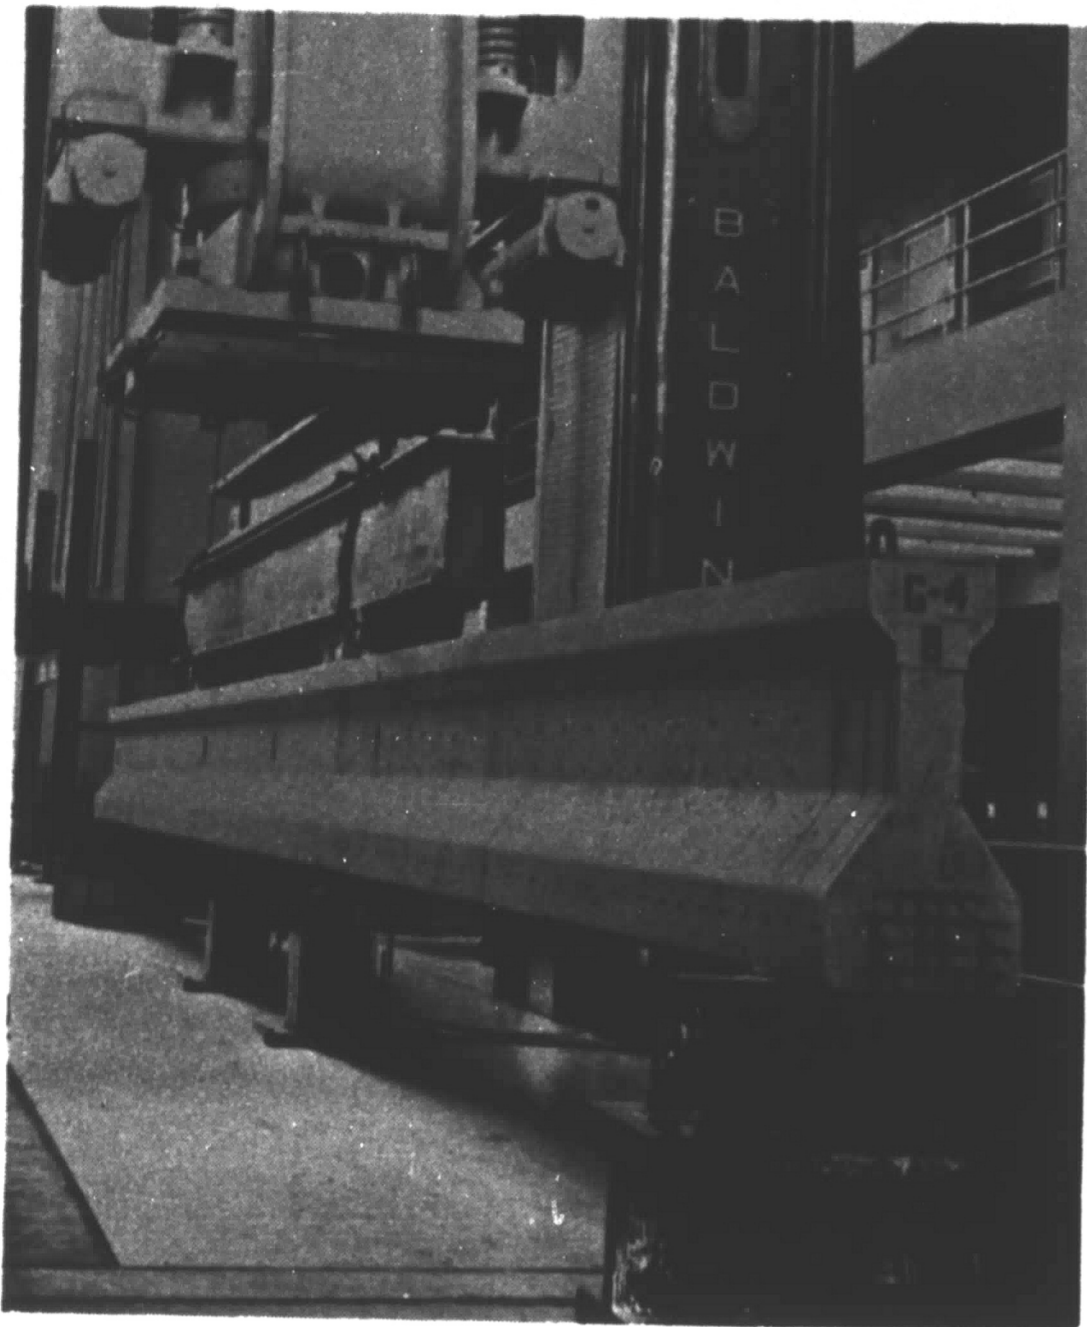
a. First Test on Long I-Beam, G-4

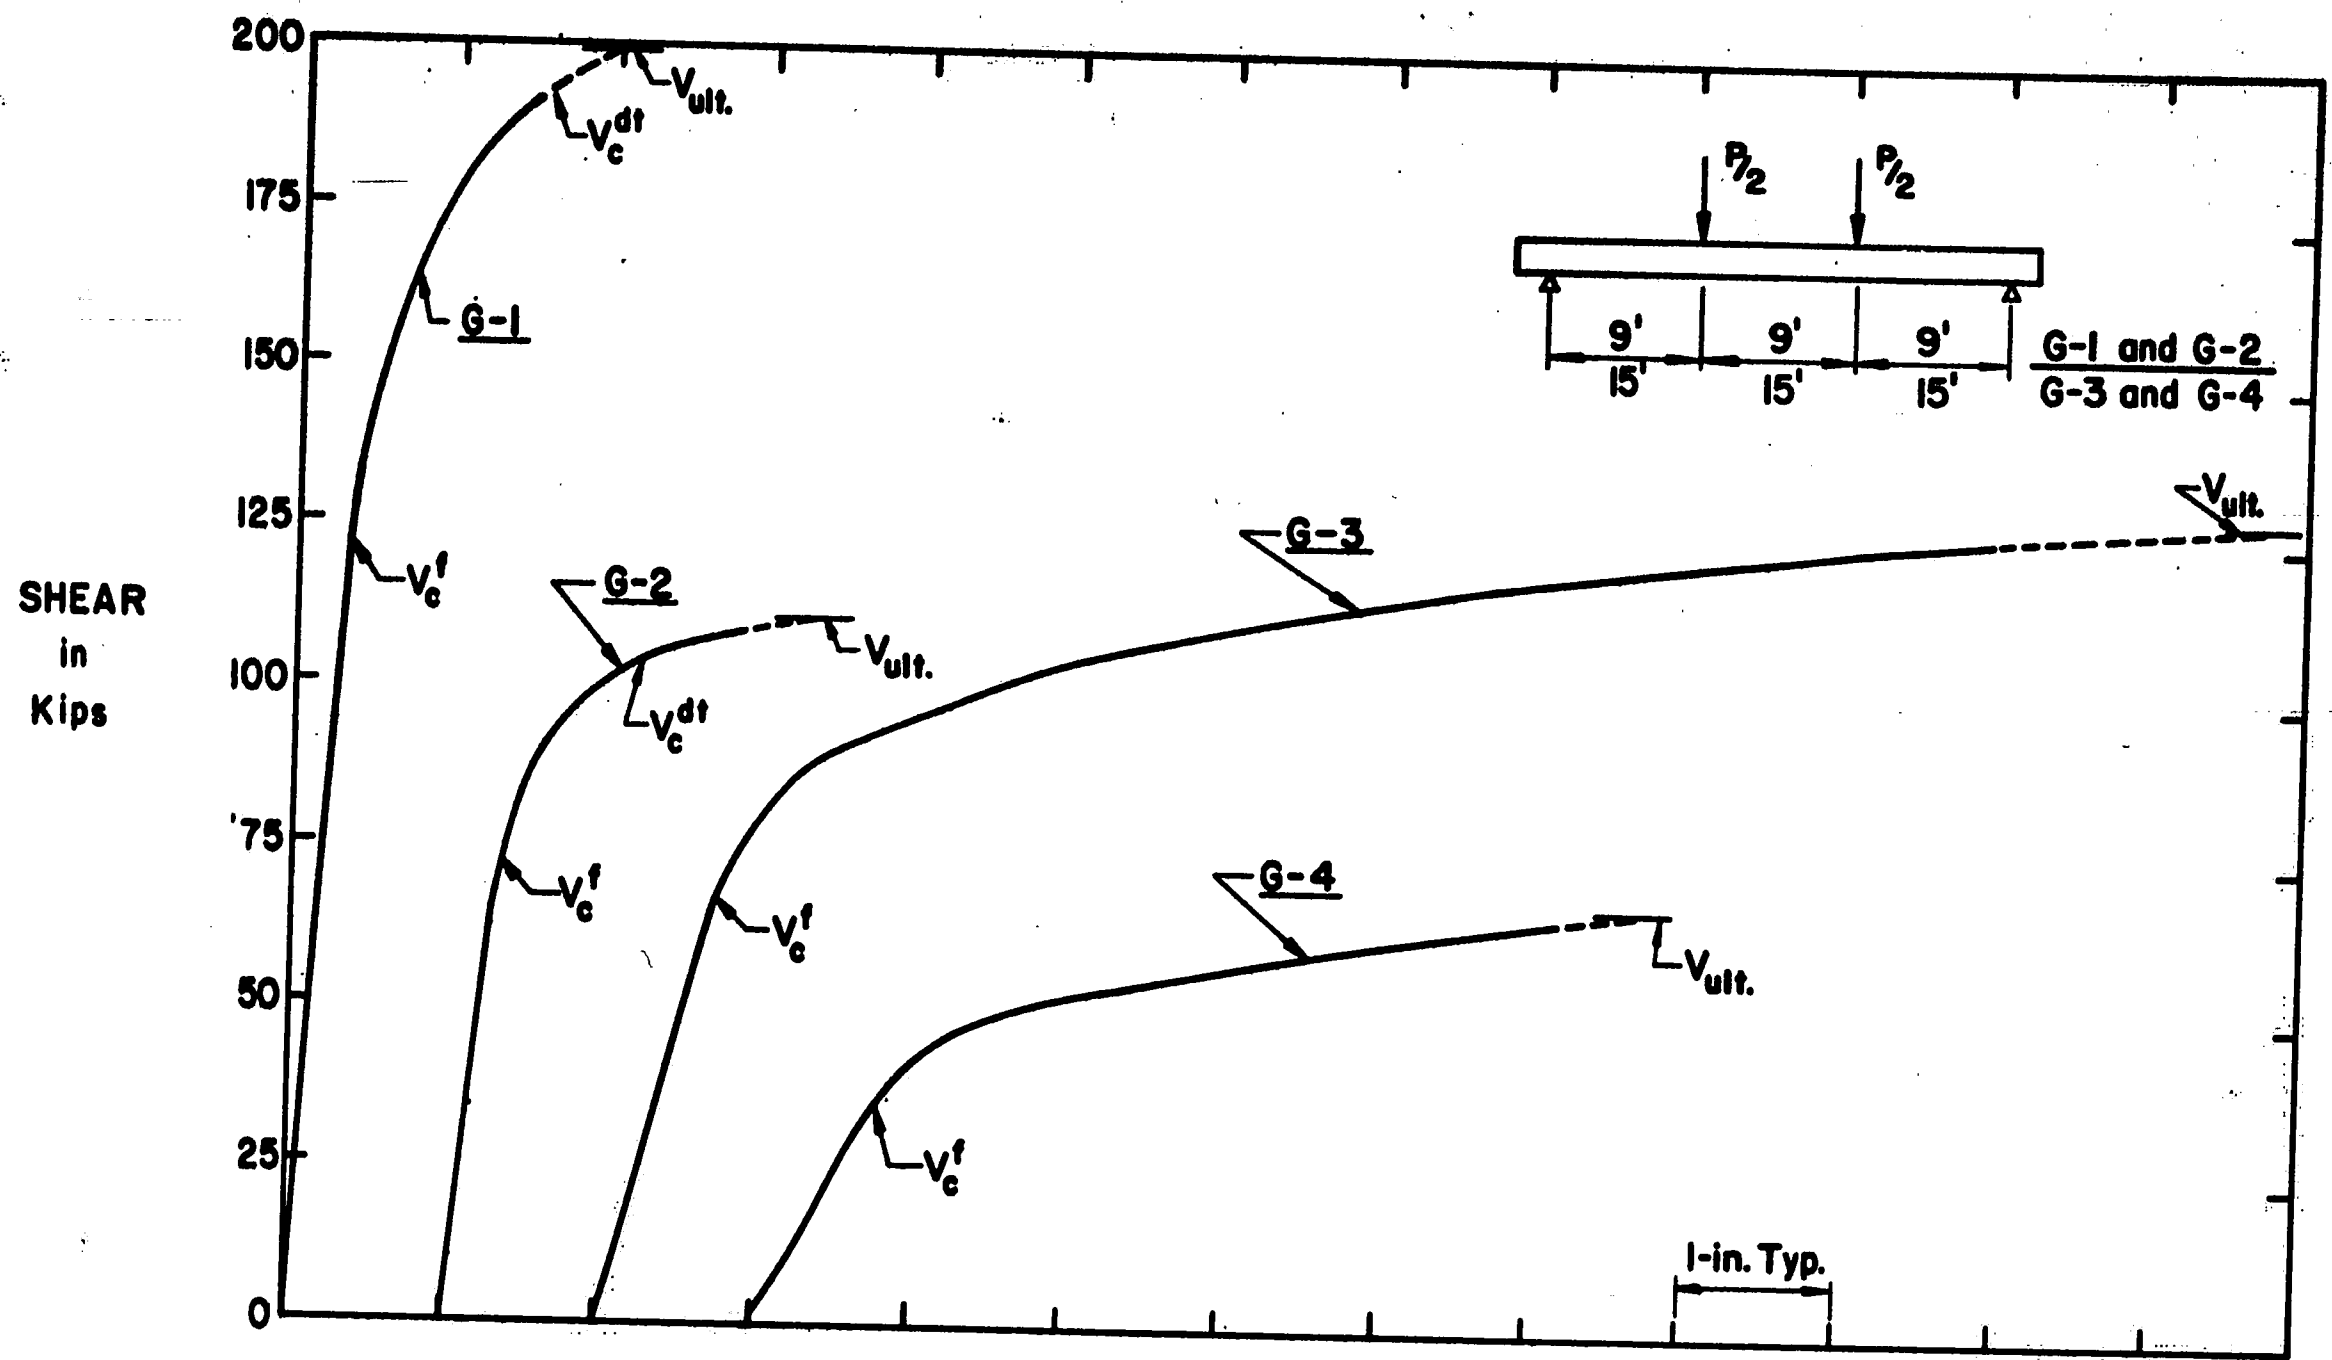
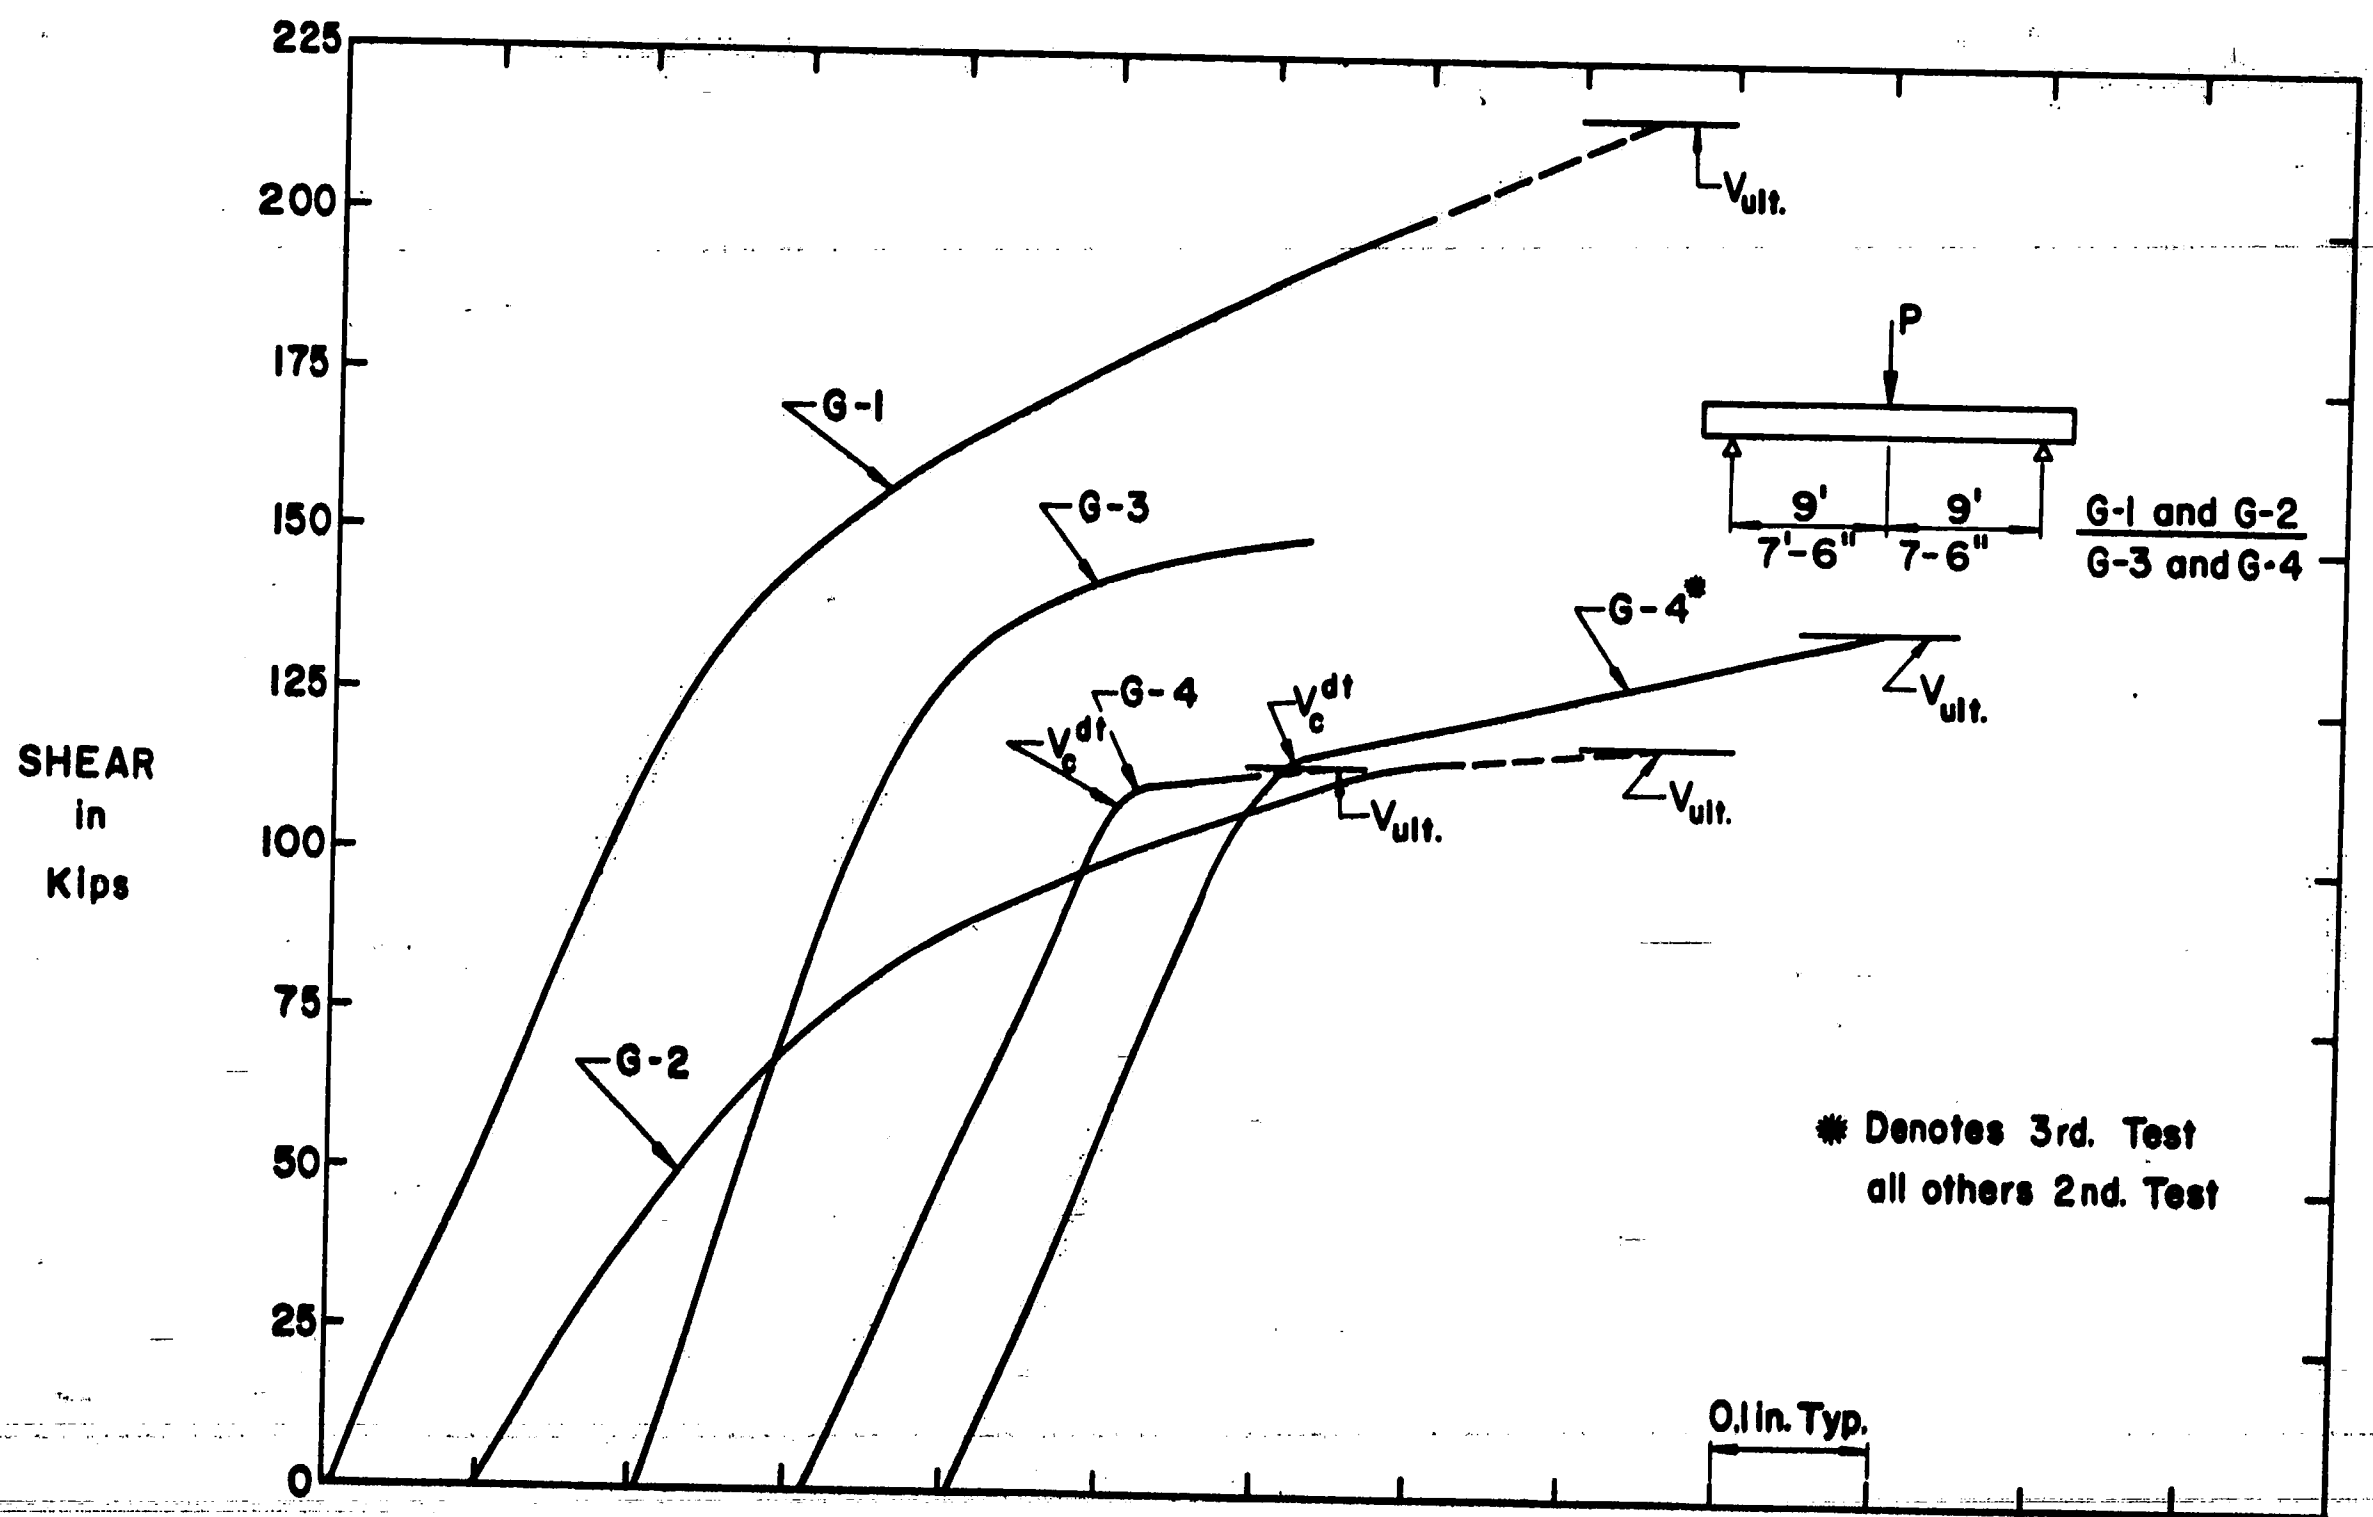
Fig. 17. Load-Deflection Curves

MID-SPAN DEFLECTION, 1st. TEST

a. First Test

MID-SPAN DEFLECTION, 2nd. and 3rd Tests

b. Second and Third Tests
