Ultimate shear tests of full-sized prestressed concrete beams

Howard E. Brecht
Lehigh University

A THESIS

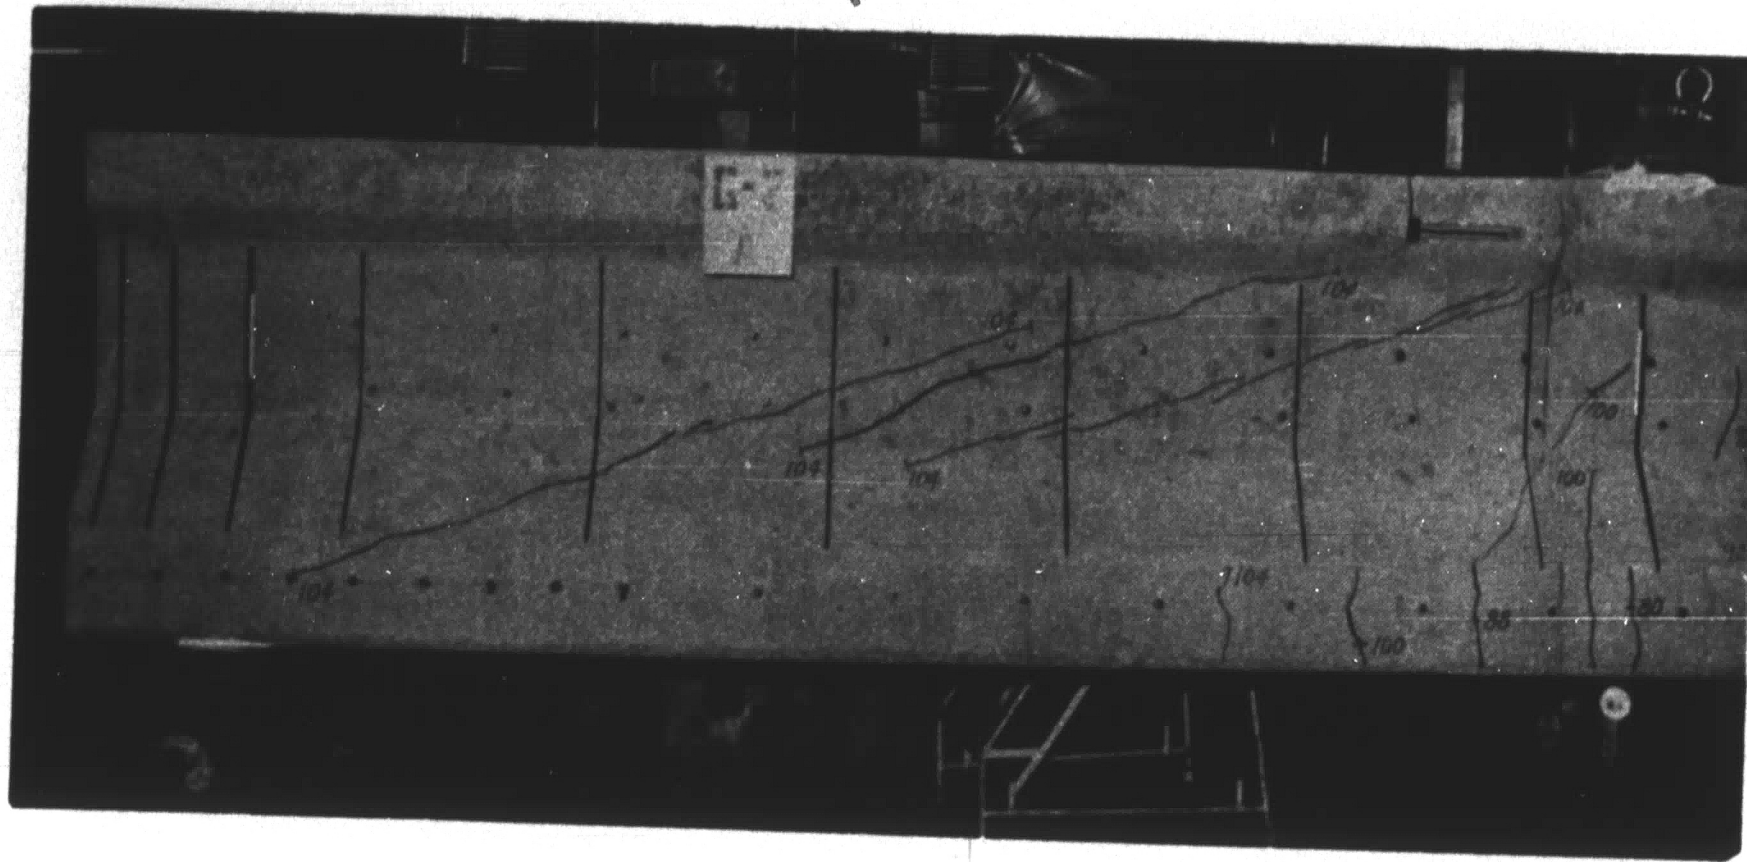
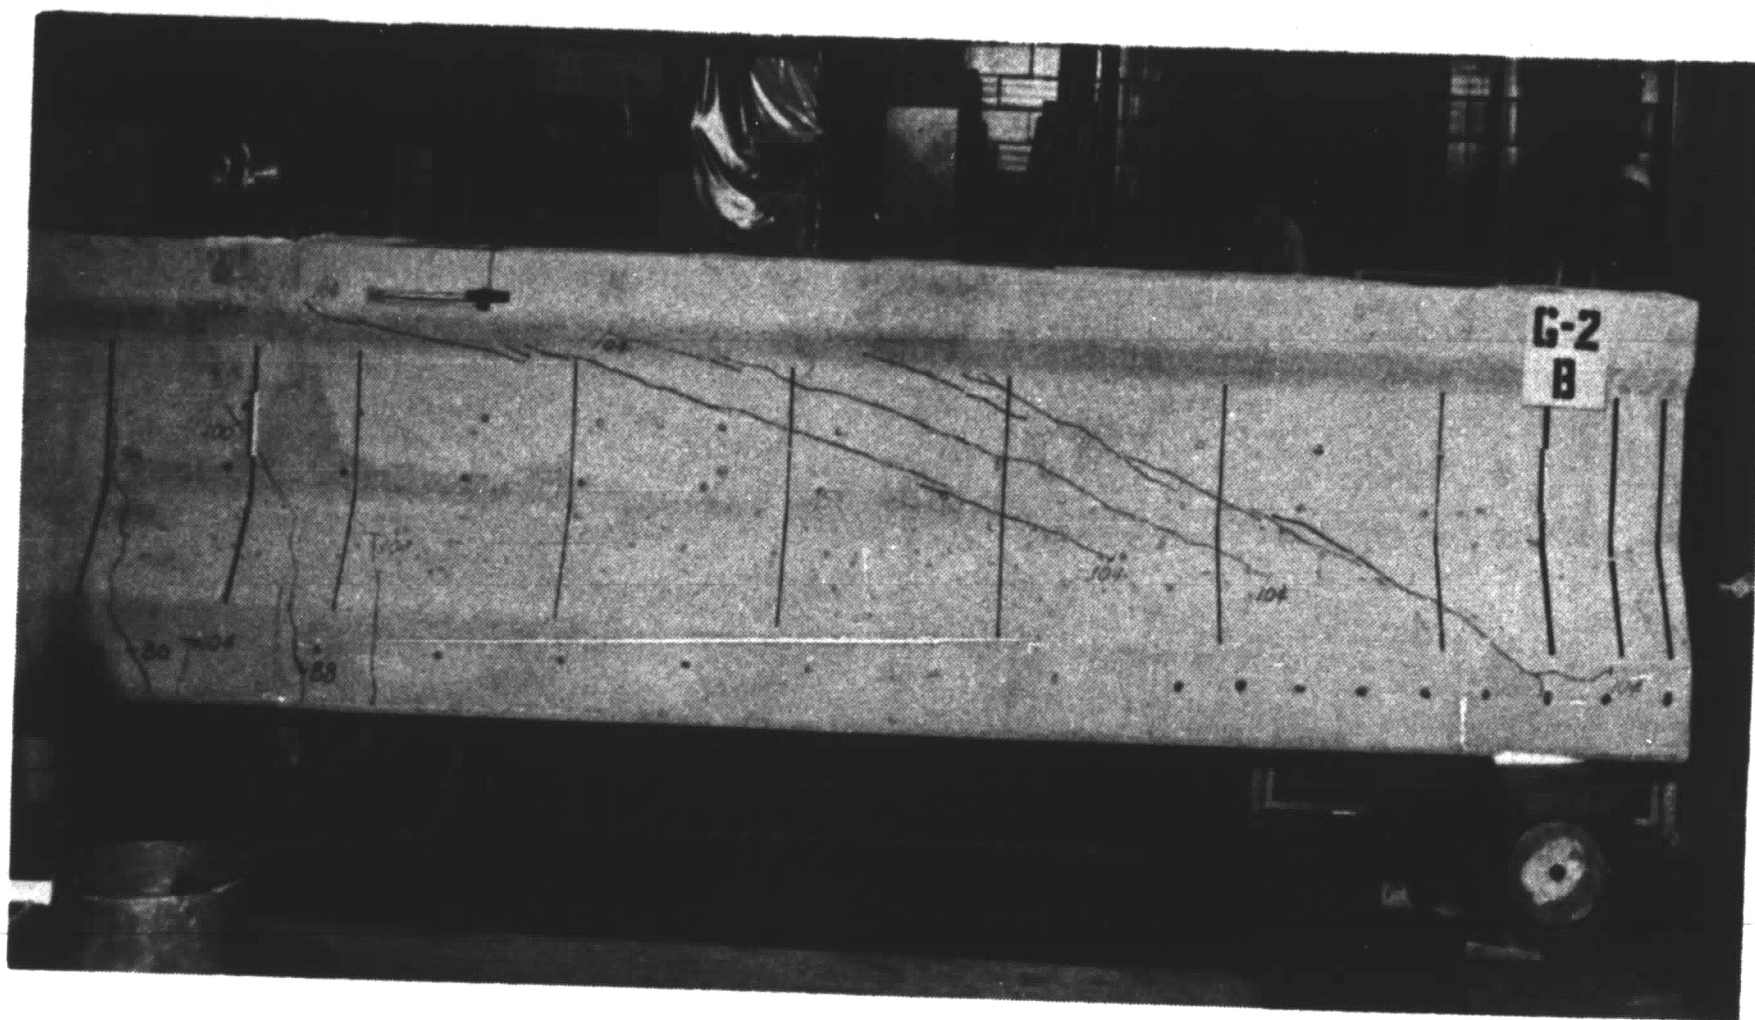
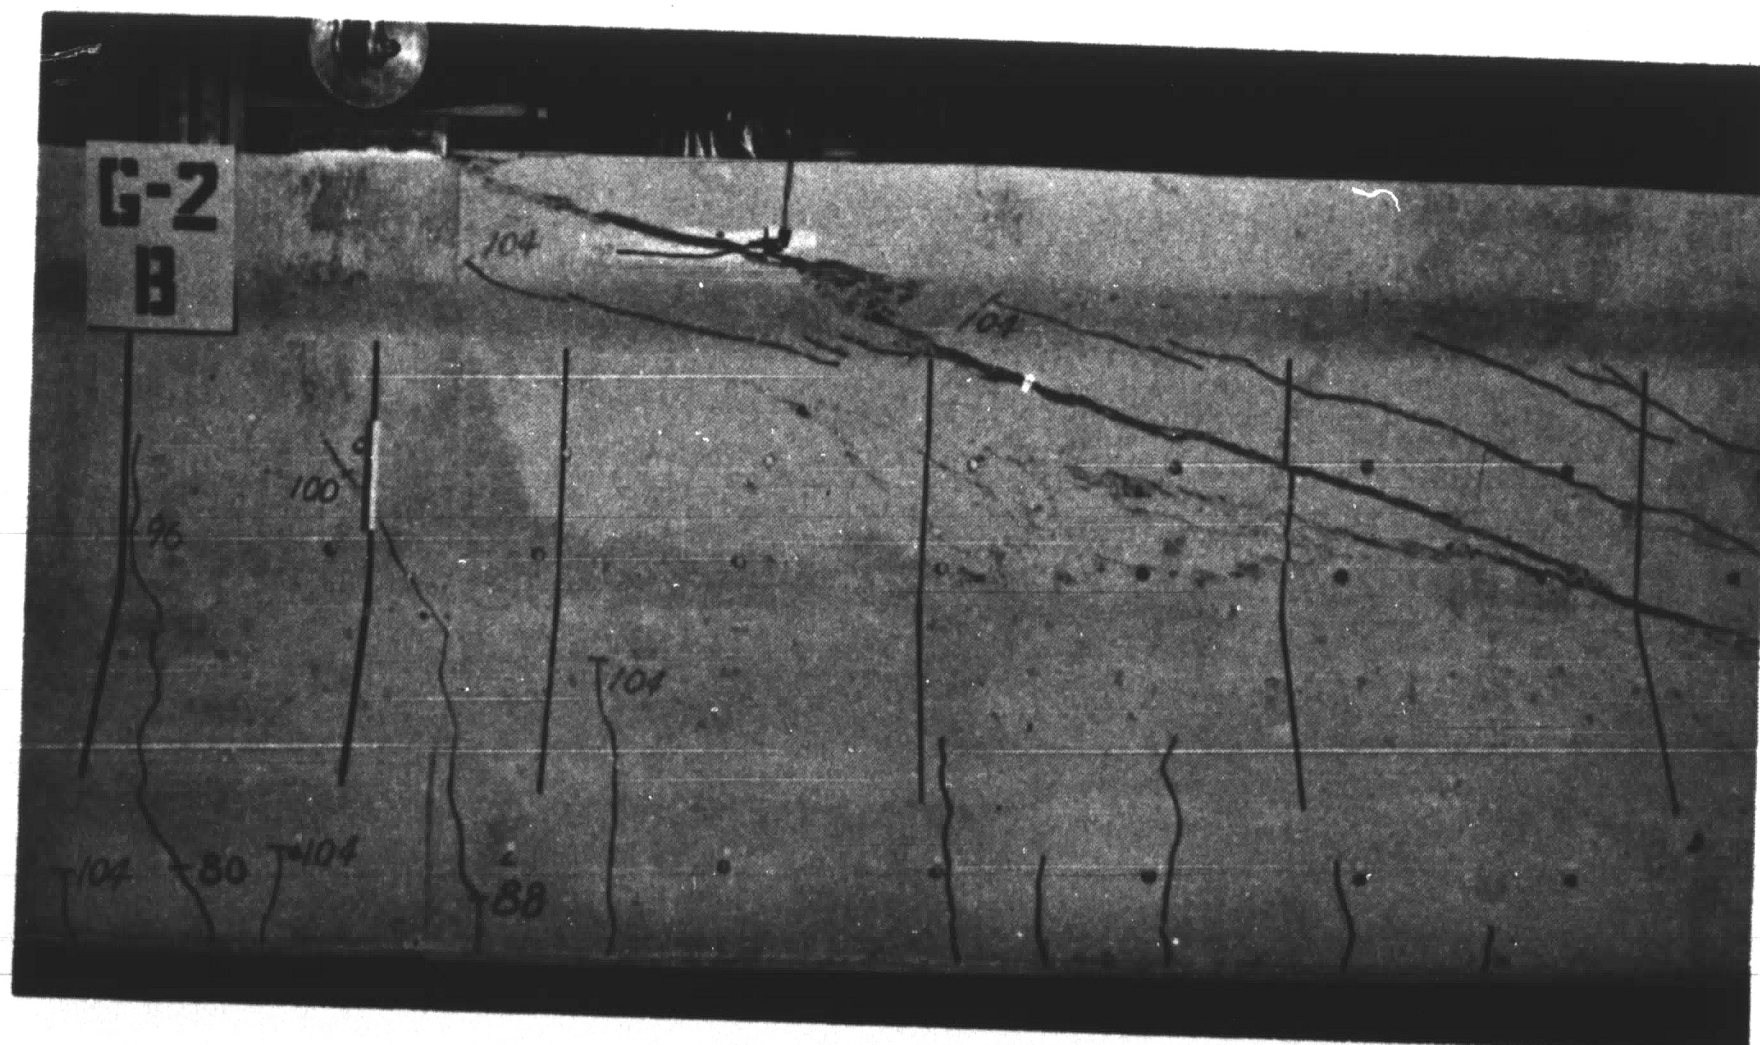
Fig. 18 First Test on Short I-Beam, G-2

a. A Shear Span After Inclined Cracking

b. B Shear Span After Diagonal Tension Inclined Cracking

c. View of Failure Region

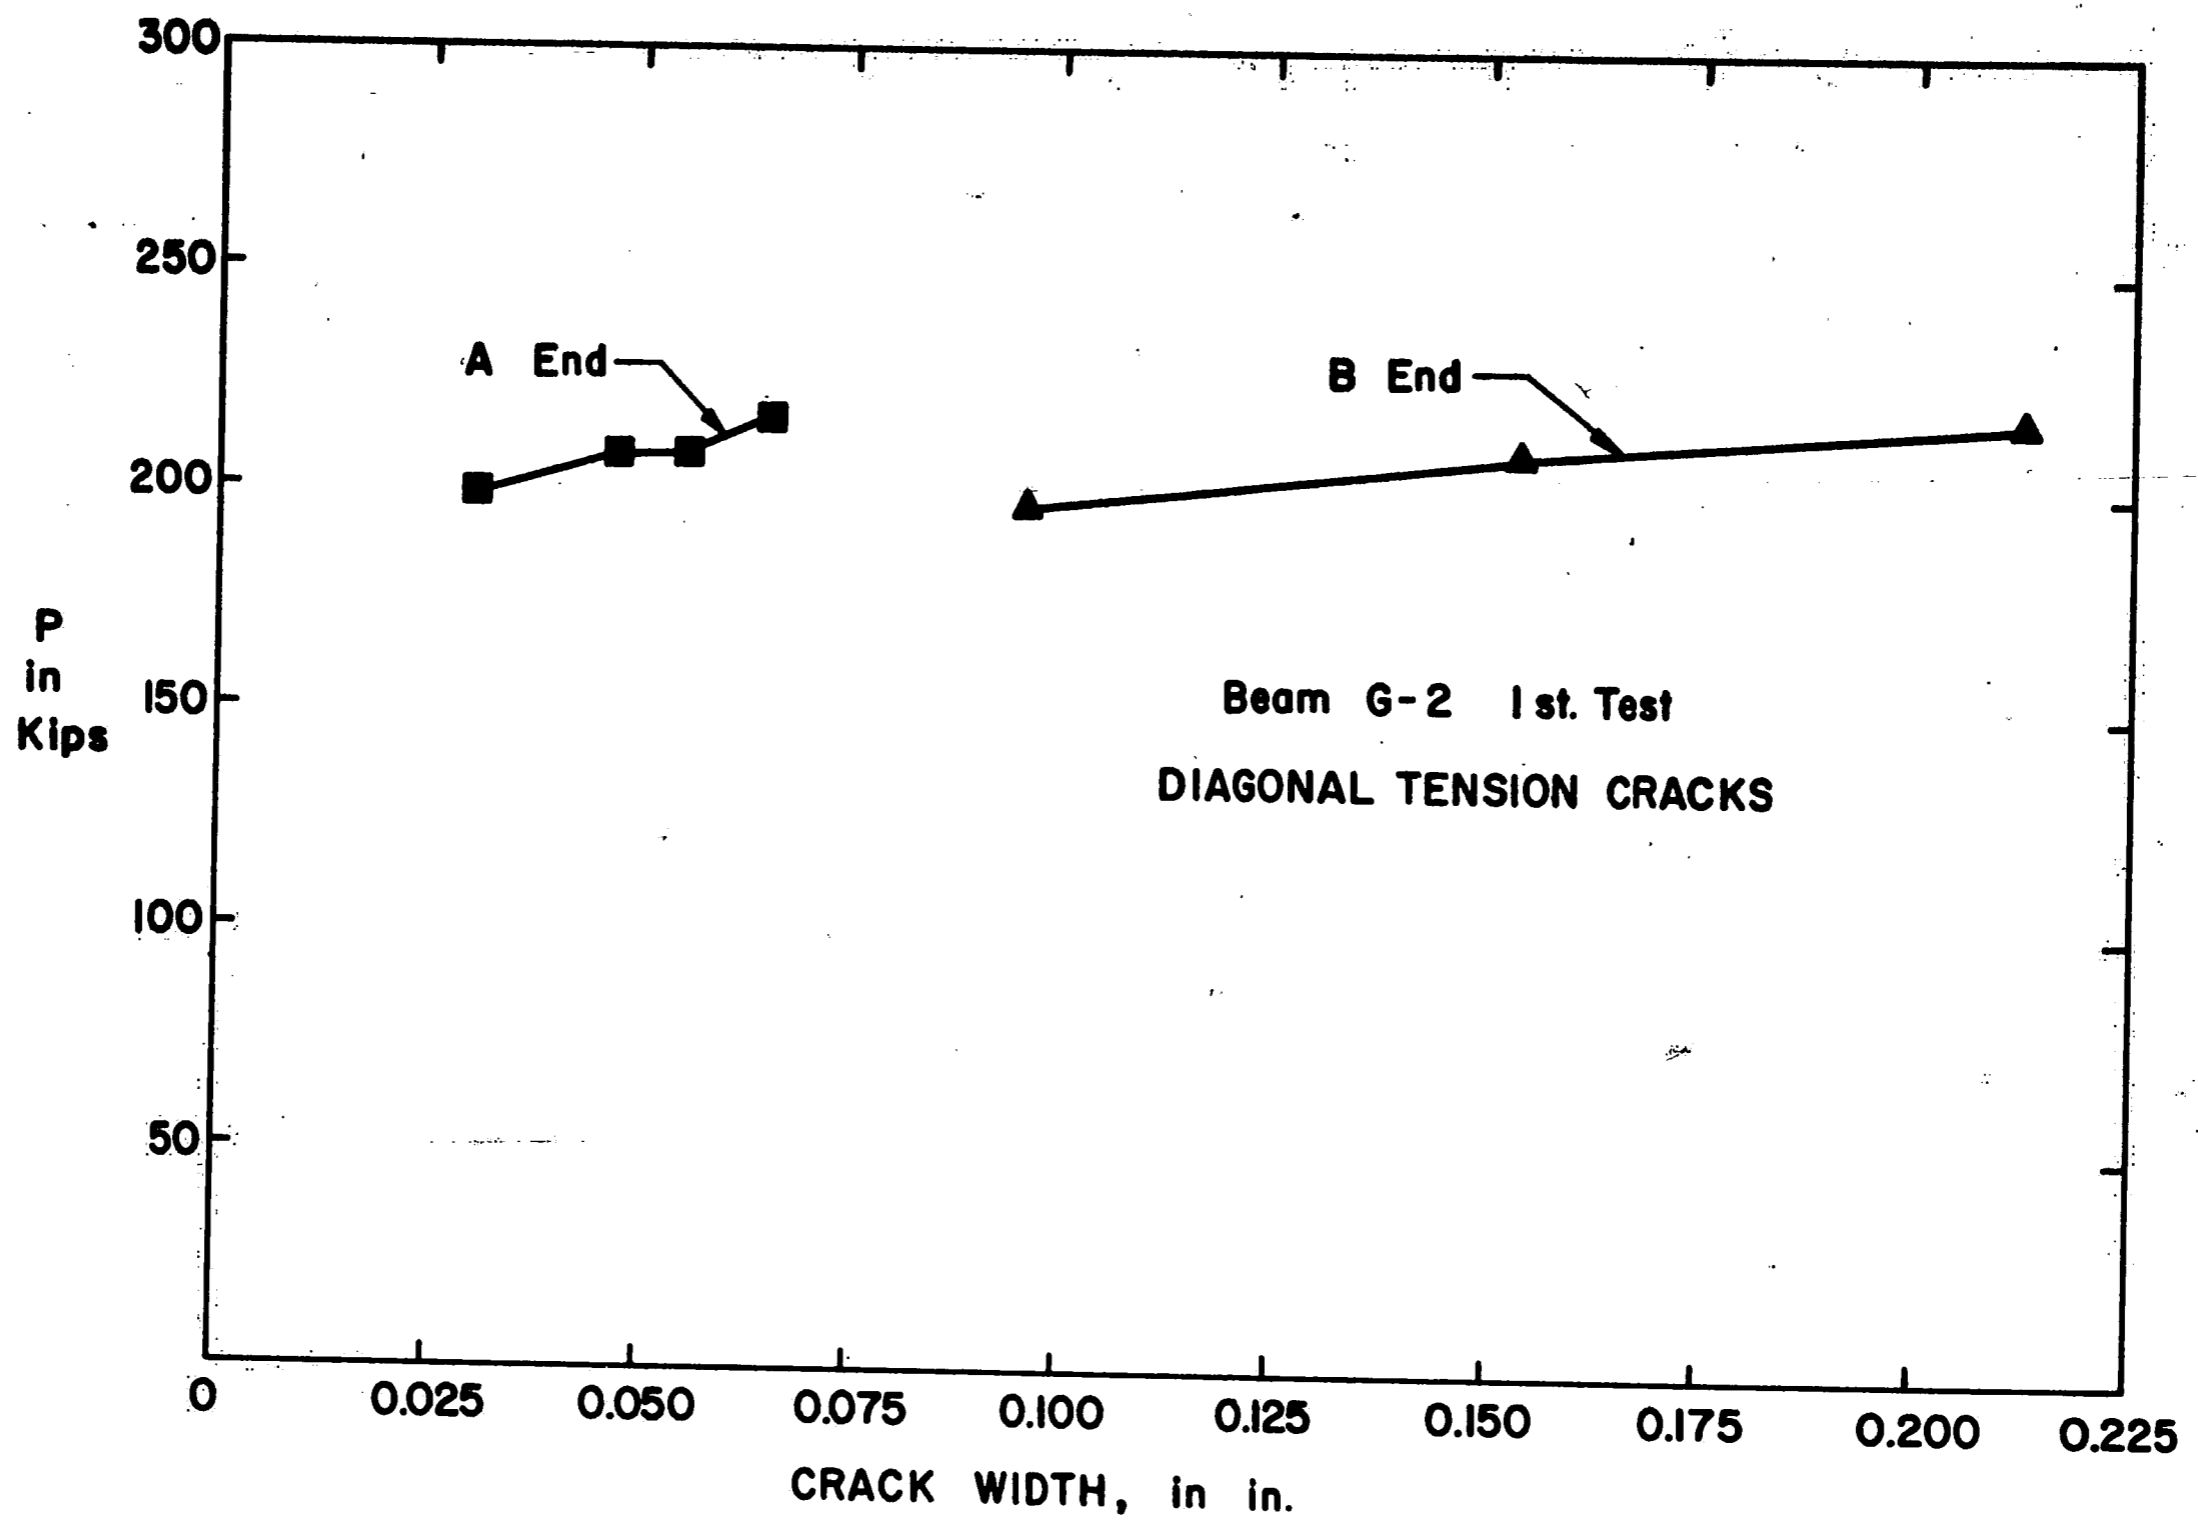
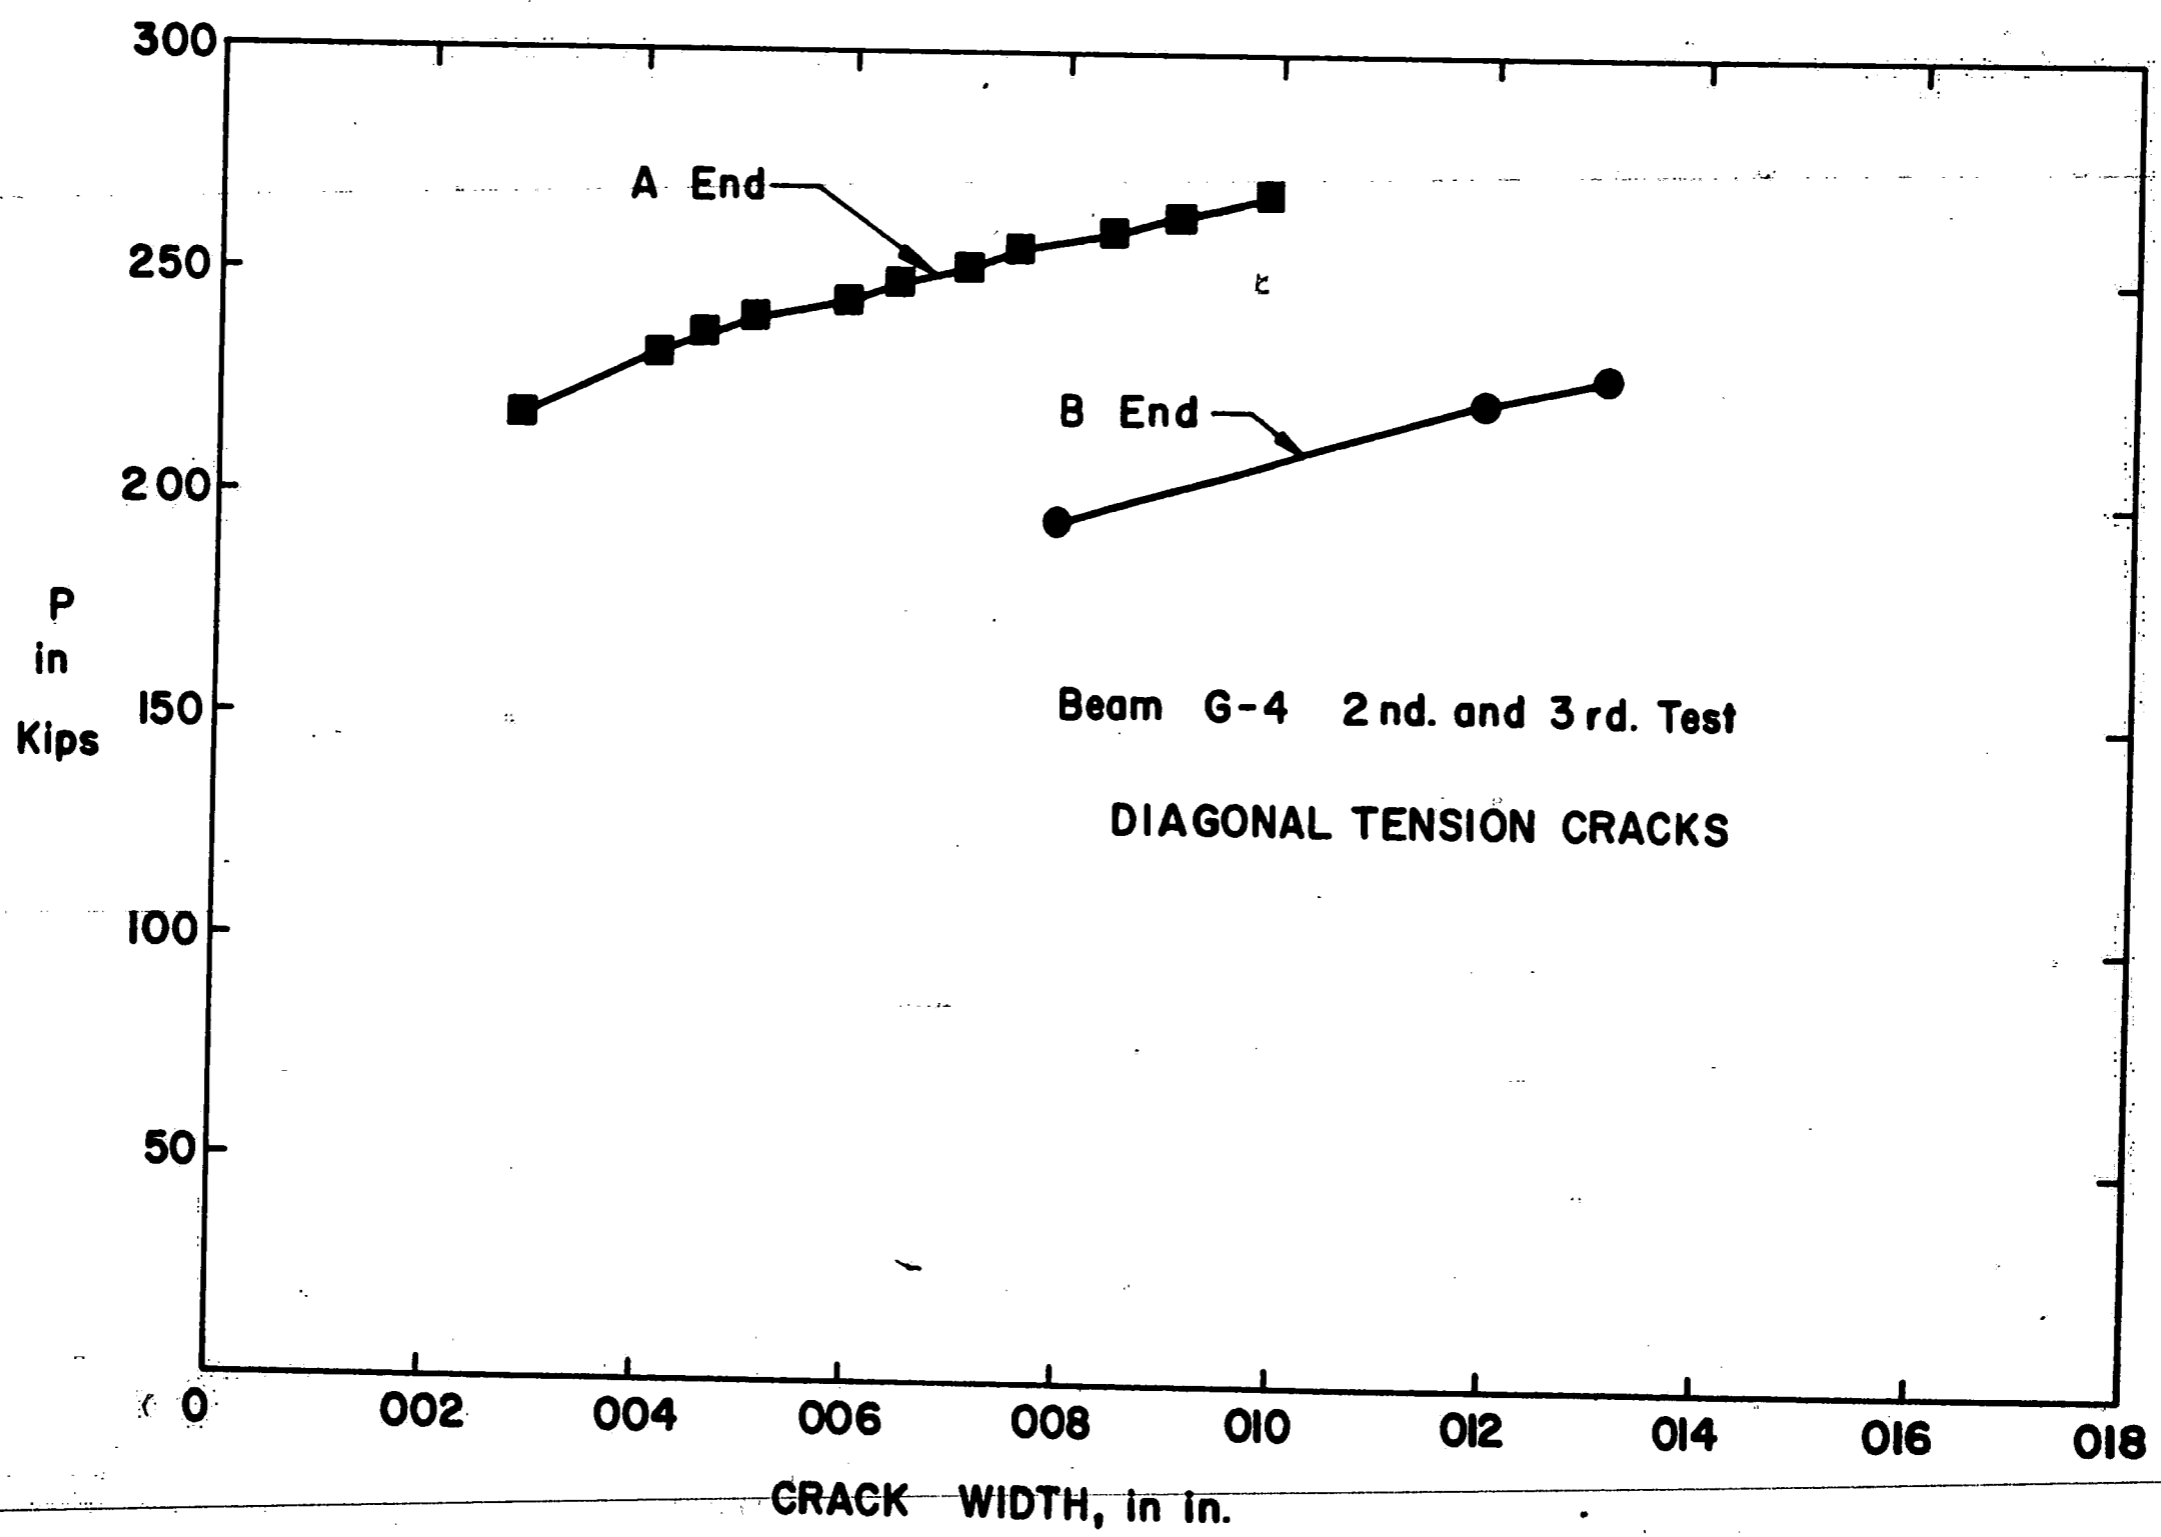
Fig. 19 Diagonal Tension Inclined Crack Width Growth

a. First Test on Short I-Beam, G-2

b. Second and Third Tests on Long I-Beam, G-4

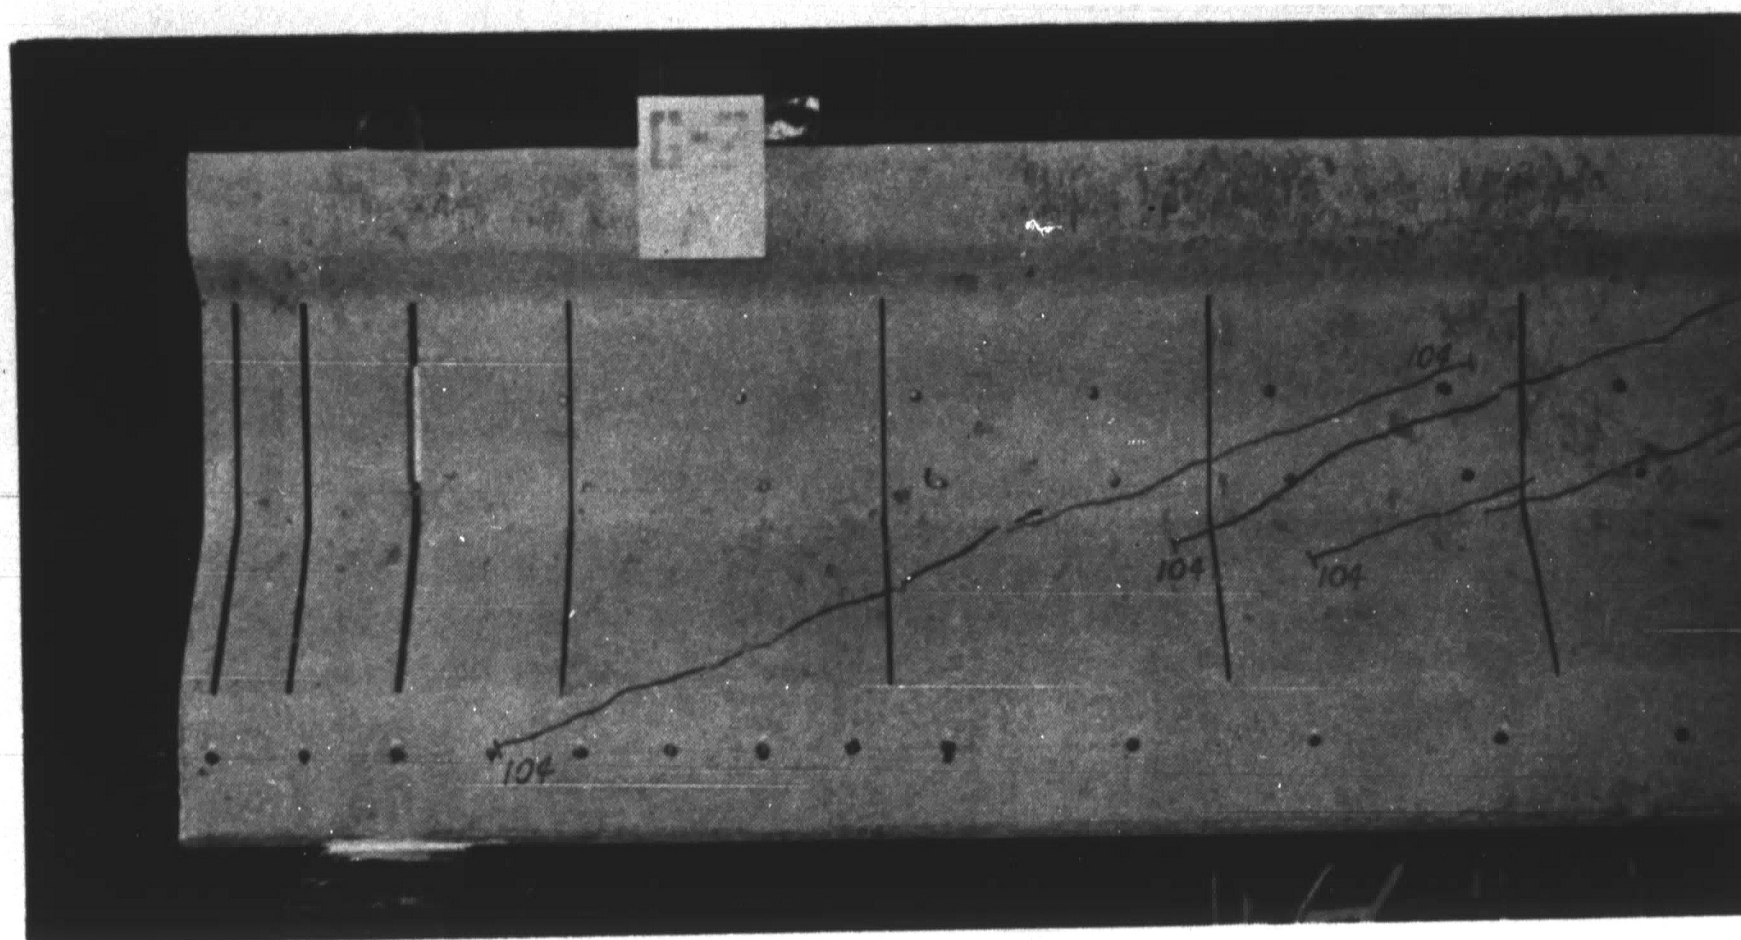
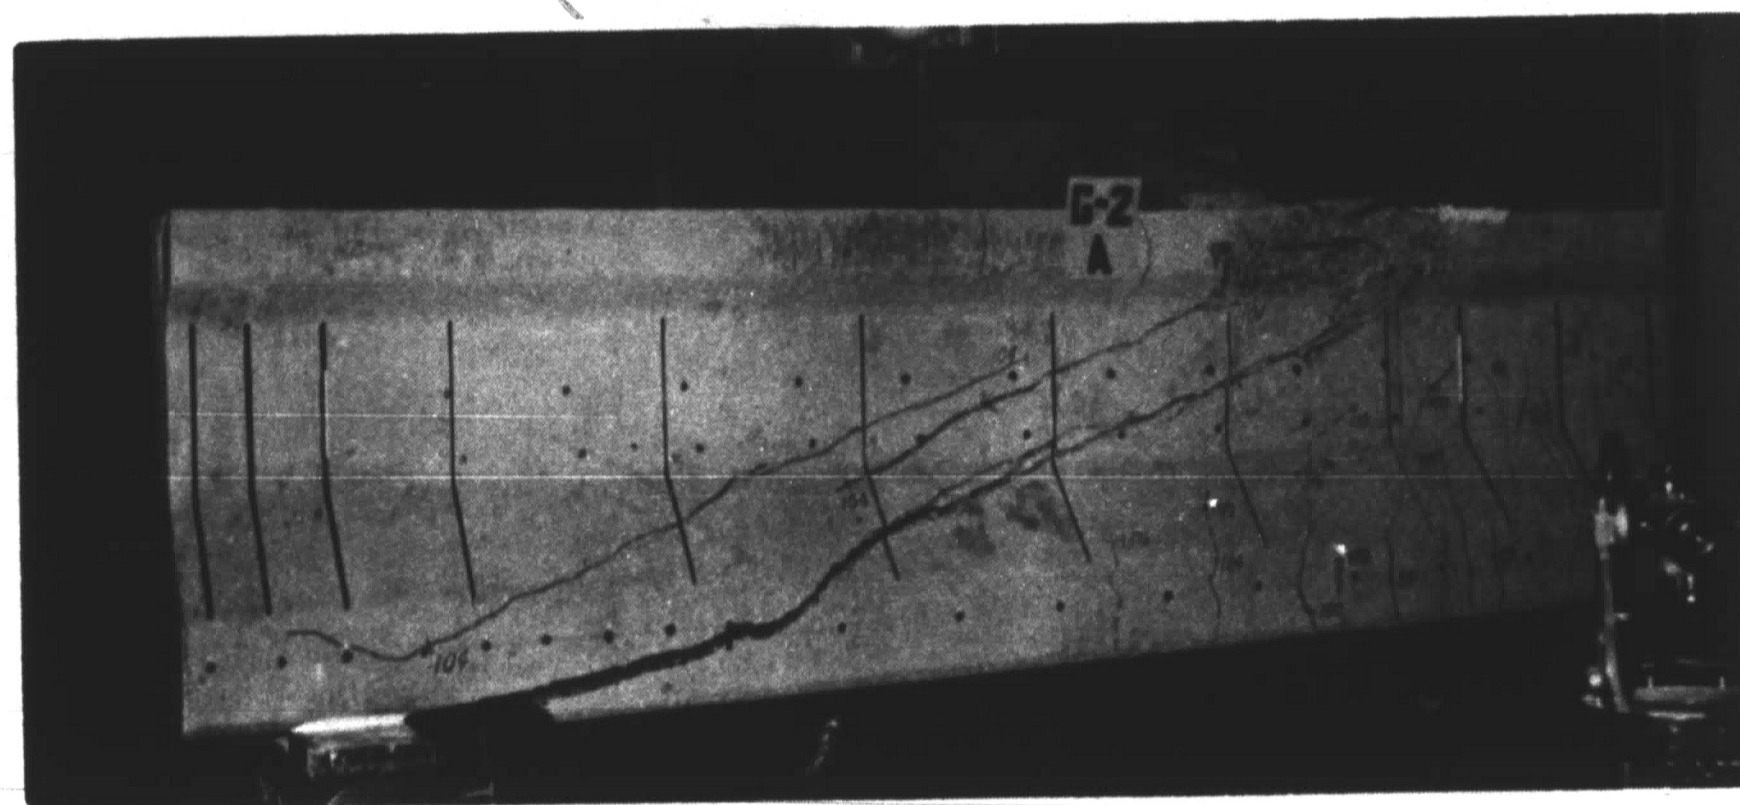
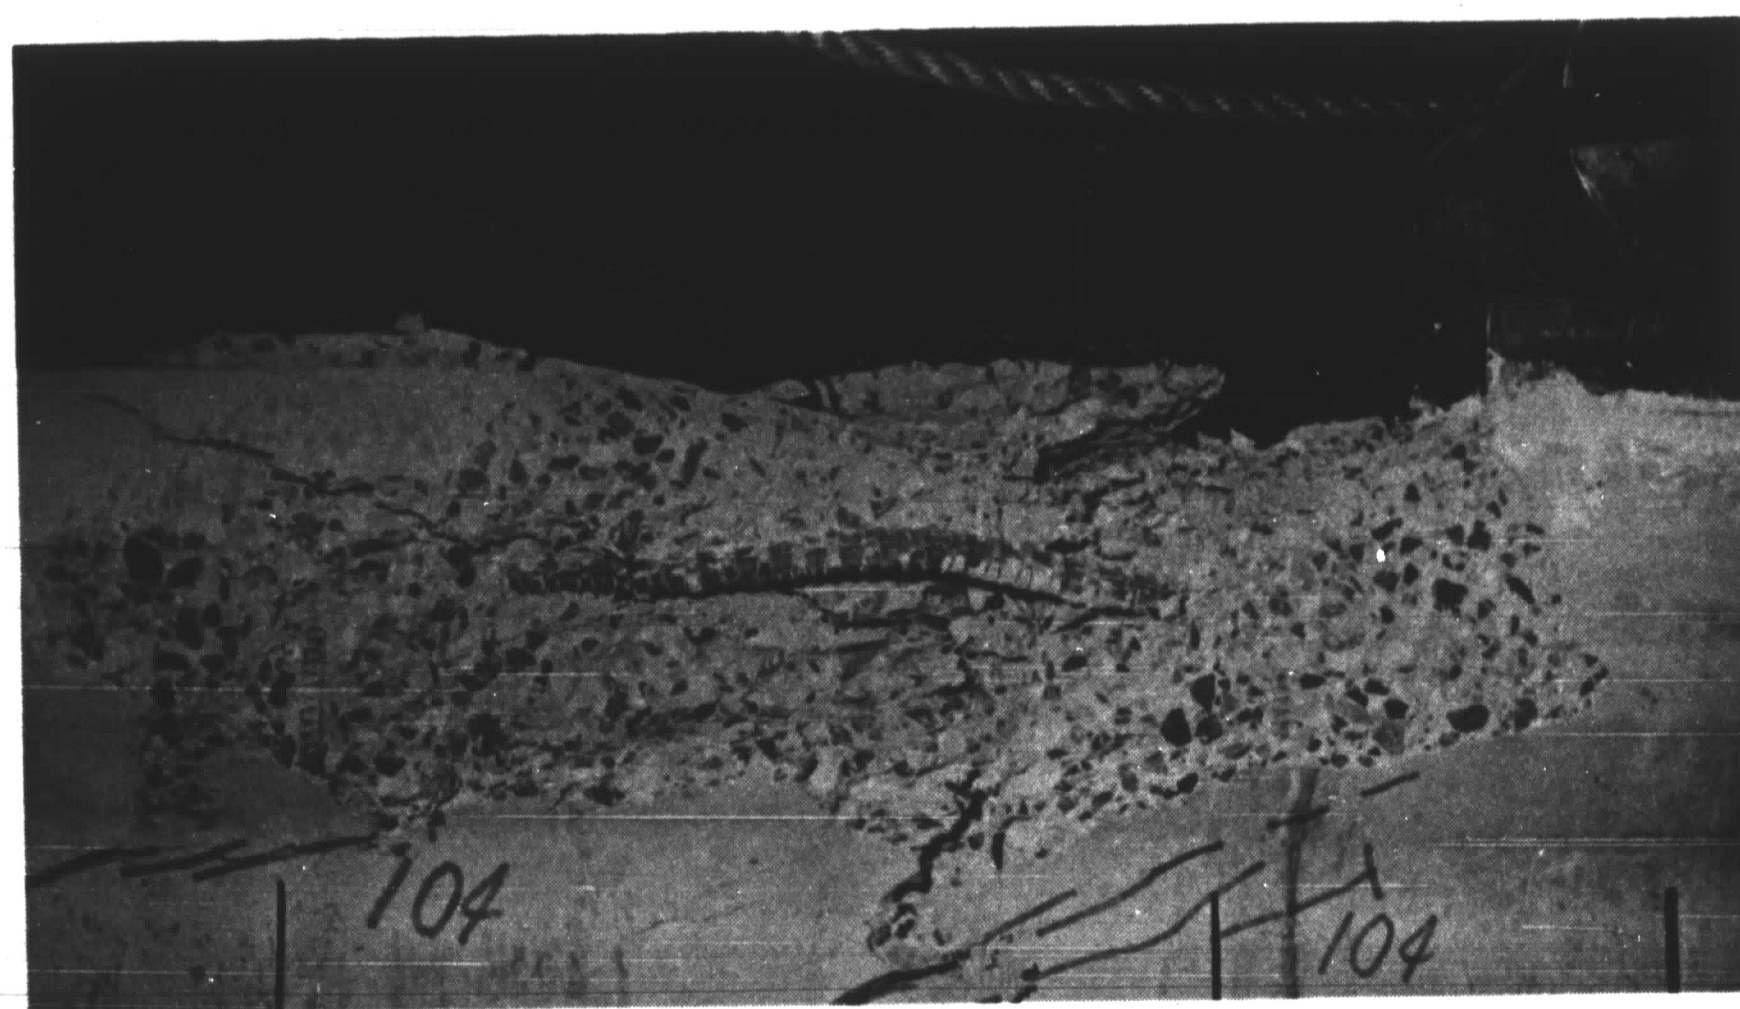
Fig. 20 Second Test on Short I-Beam, G-2

a. Condition of A Shear Span at Start of Test

b. A Shear Span After Failure

c. View of Failure Region

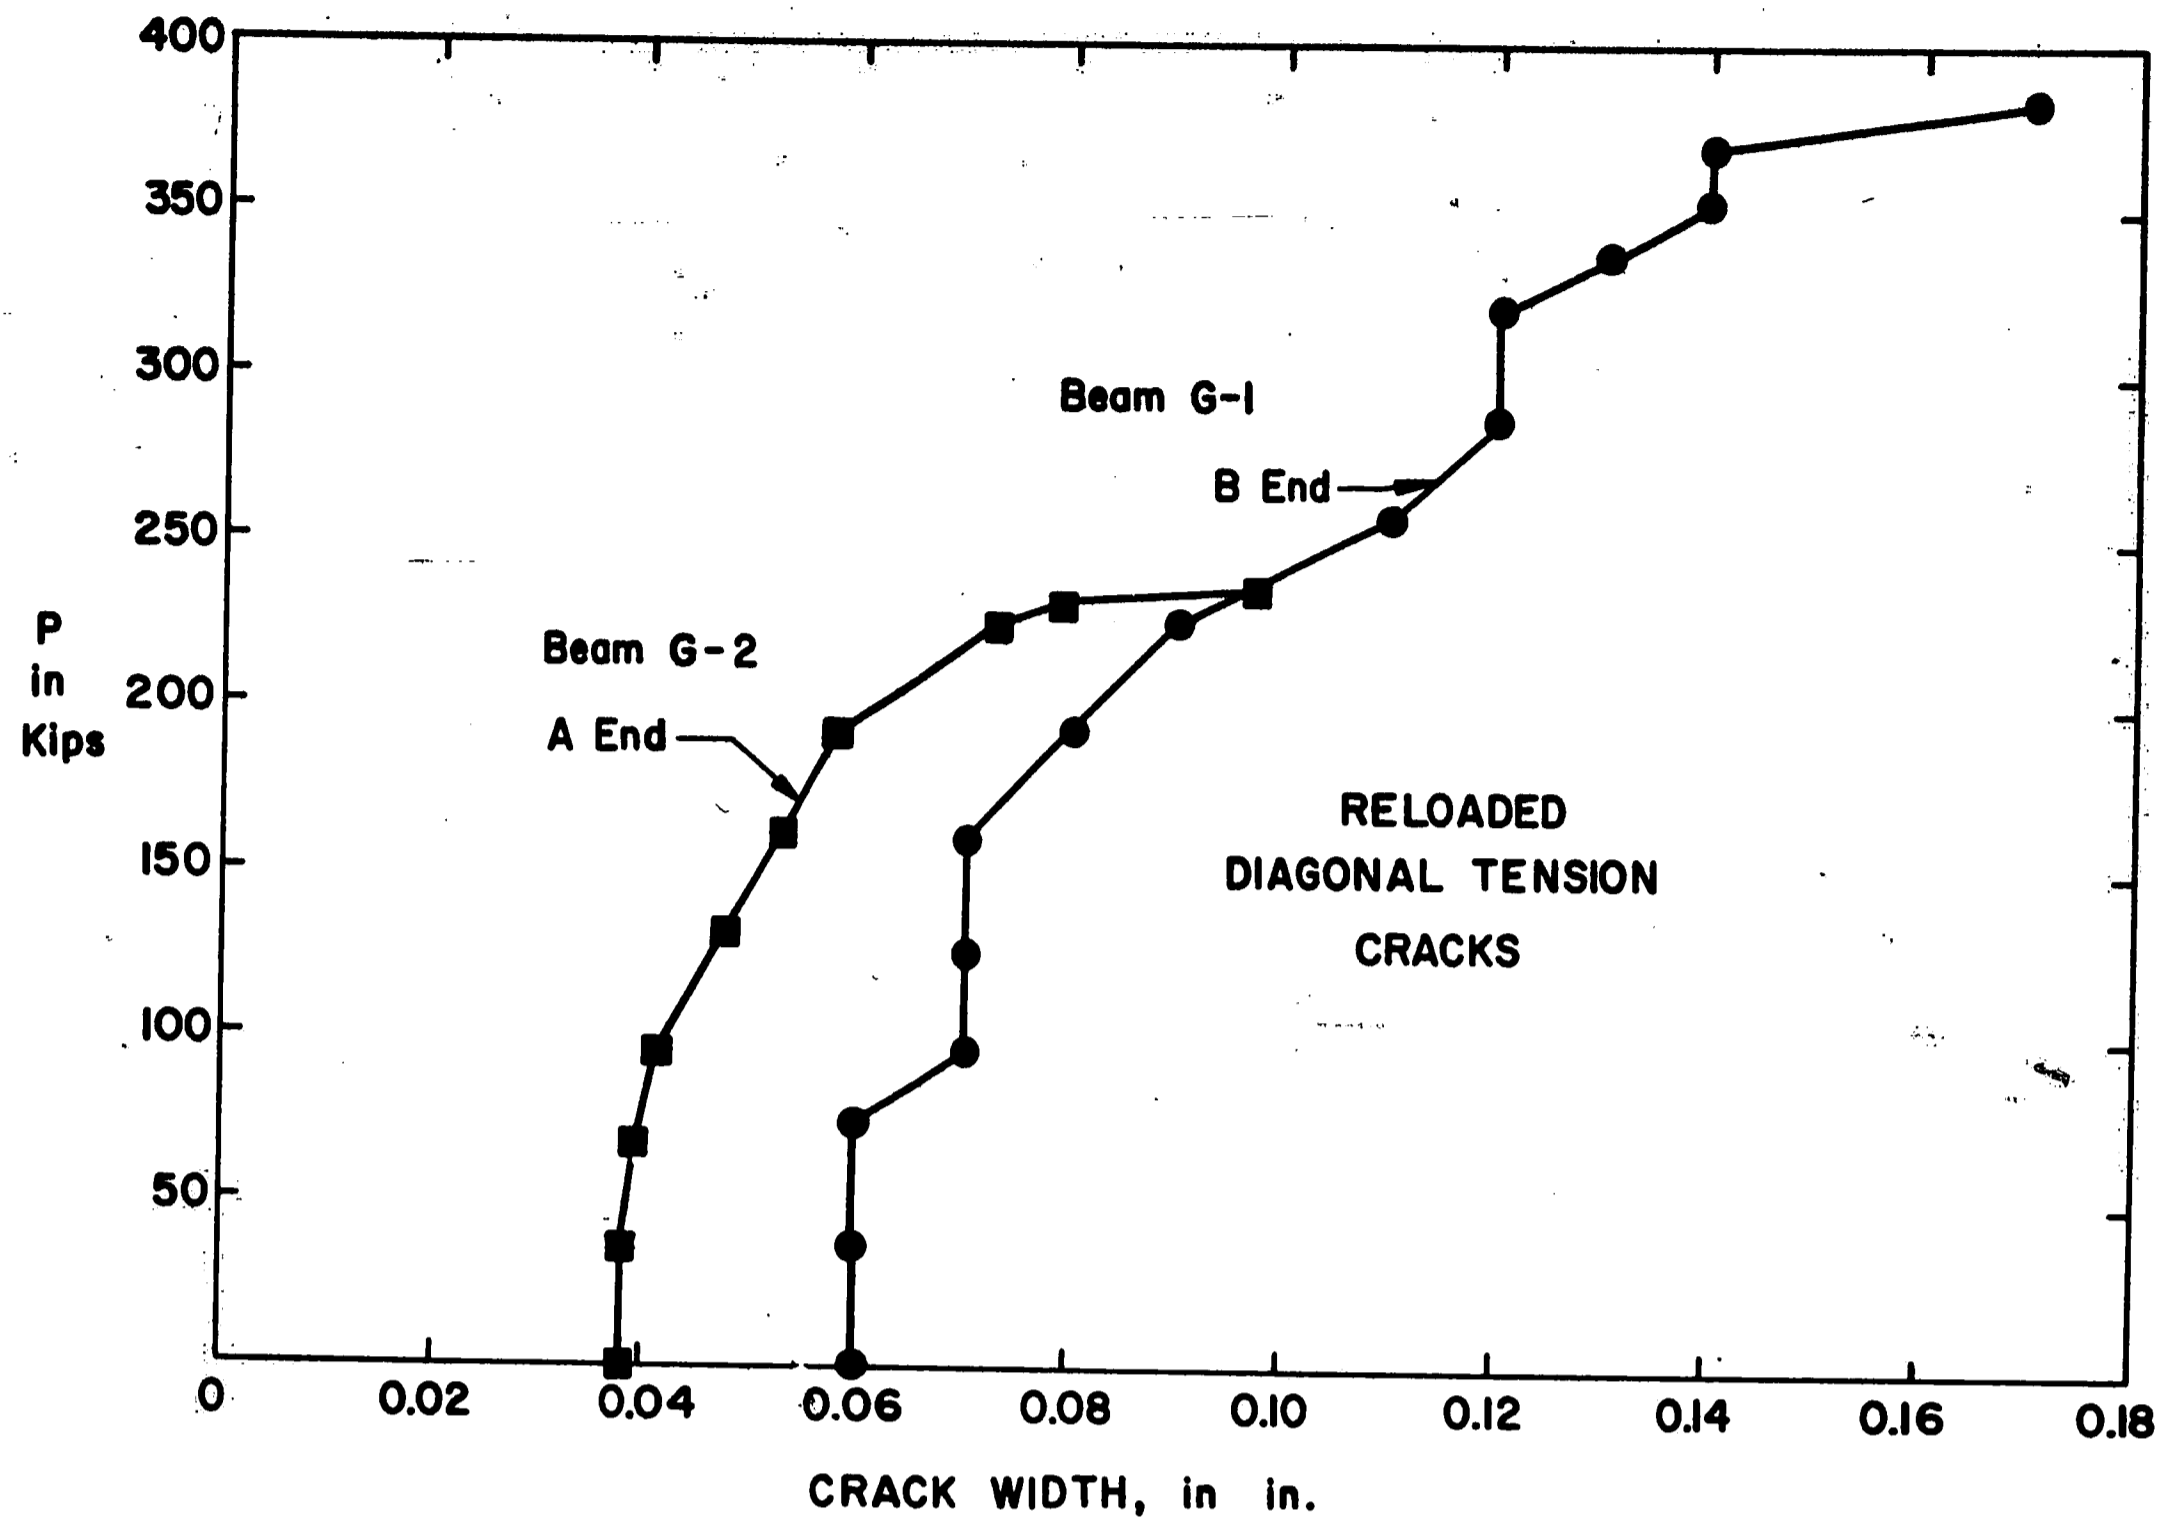
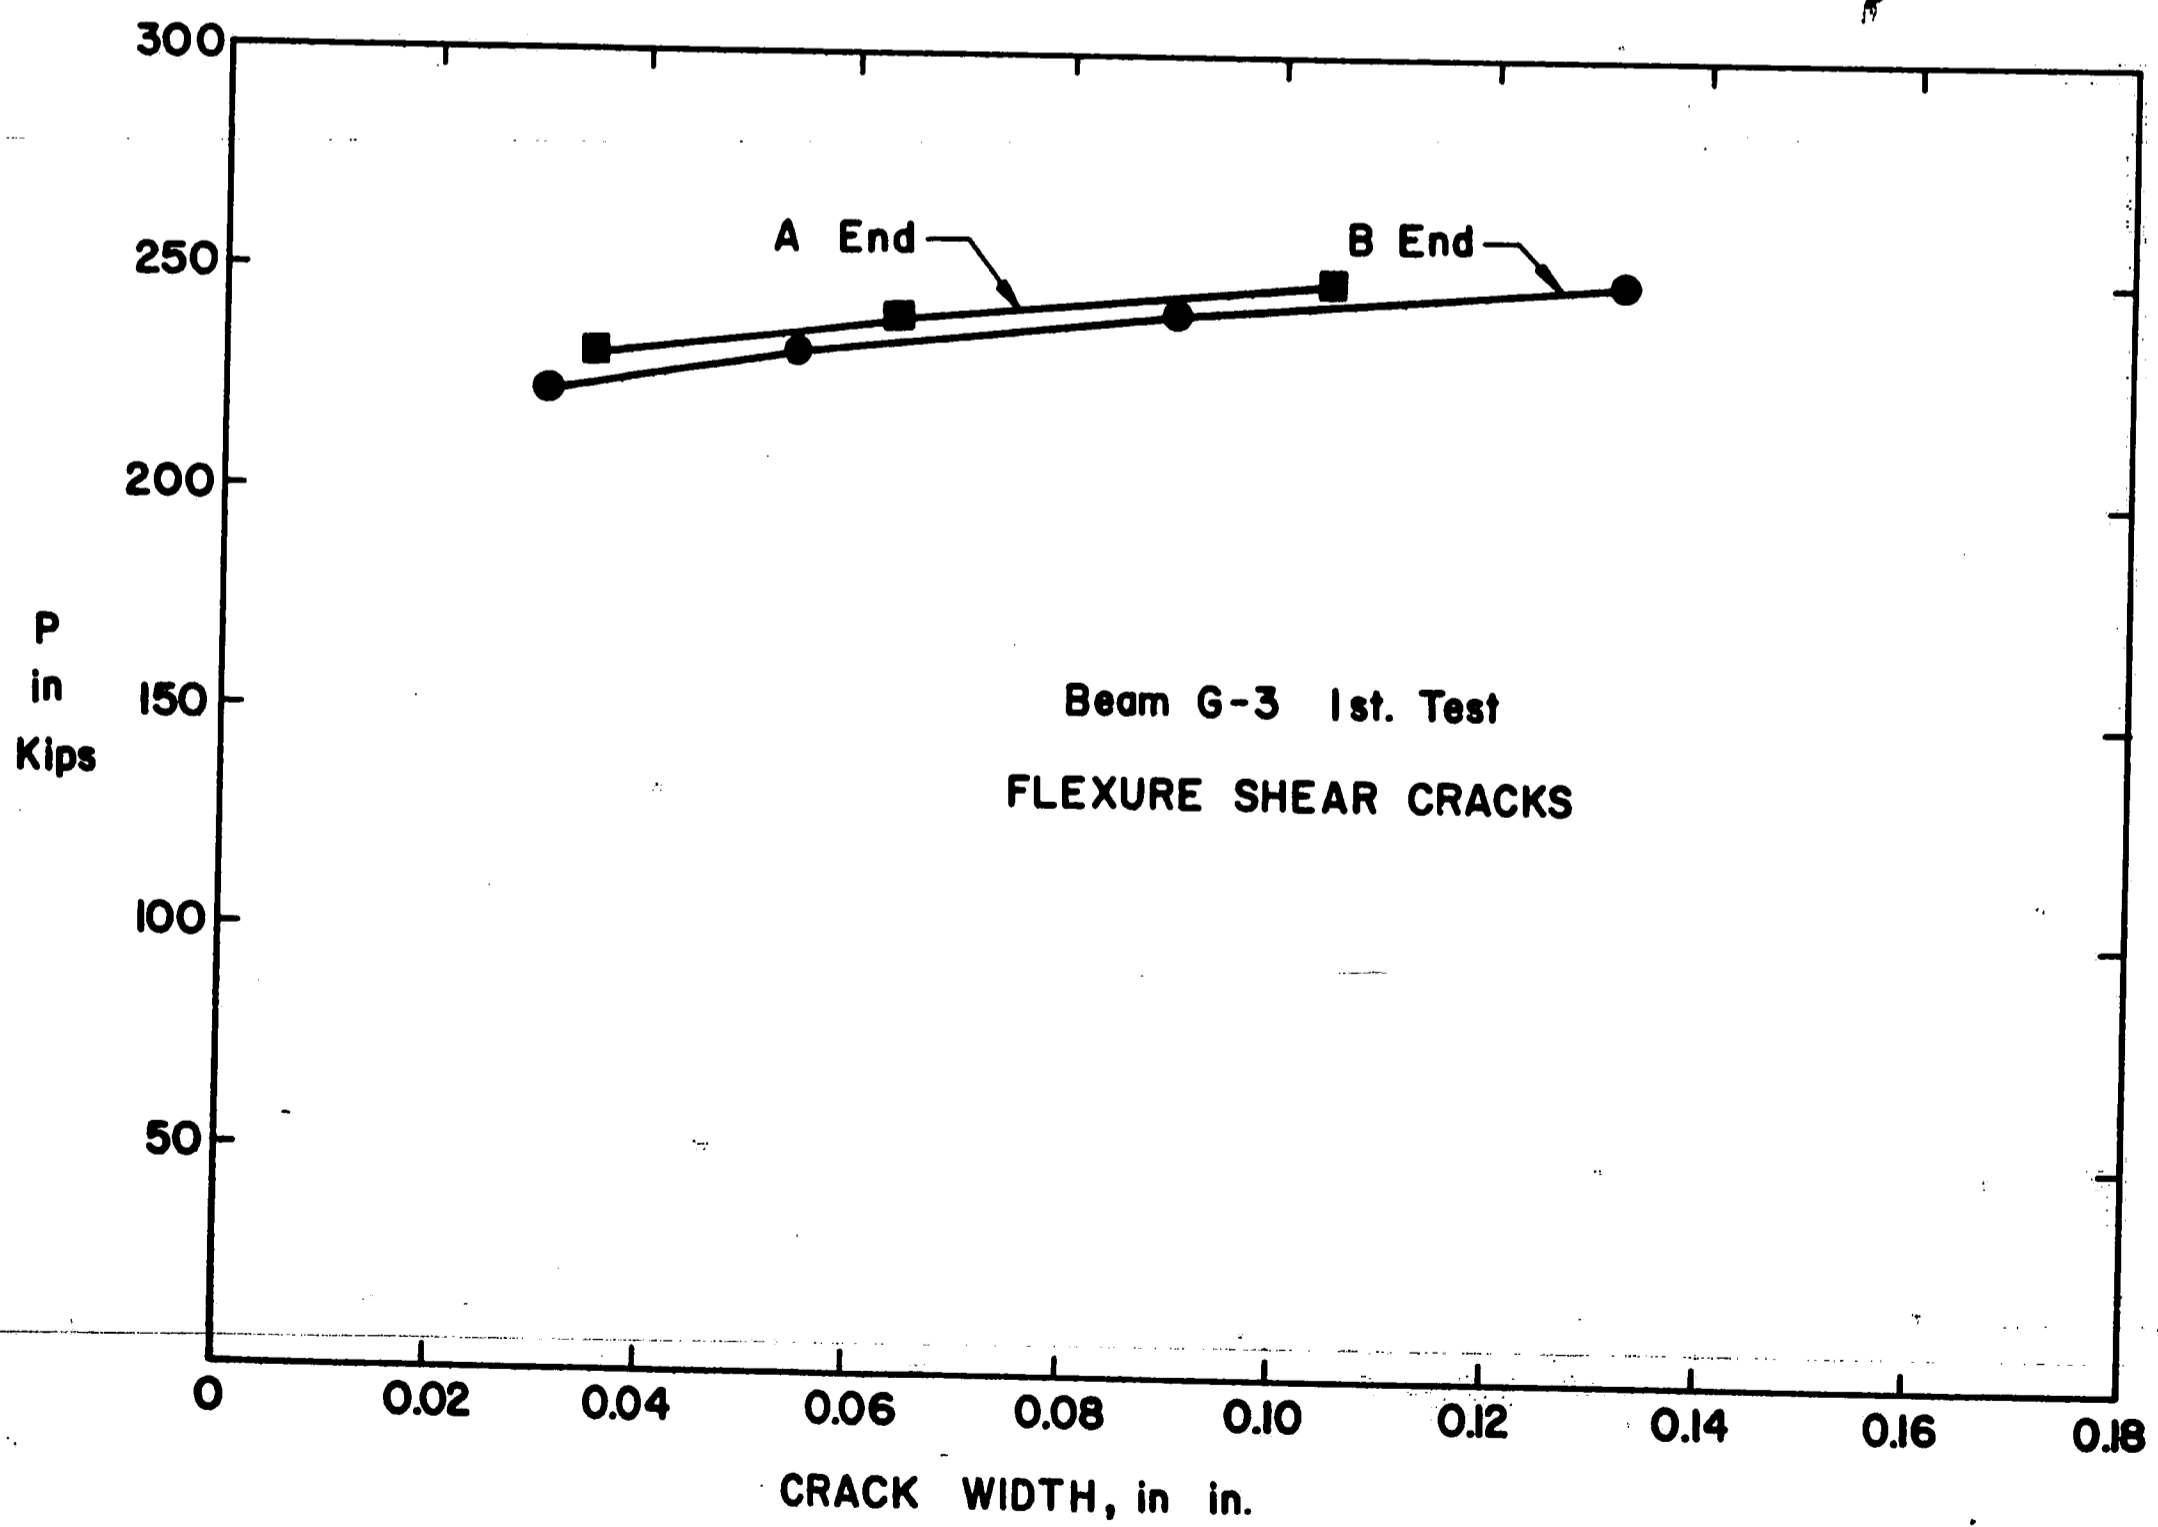
Fig. 21. Inclined Crack Width Growth

a. Reloading of a Cracked Beam to Failure
Second Test on Short I-Beam, G-2, and
Second Test on Short Box Beam, G-1

b. Flexure Shear Crack Width Growth at cg
First Test on Long Box Beam, G-3
