Ultimate shear tests of full-sized prestressed concrete beams

Howard E. Brecht
Lehigh University

A THESIS

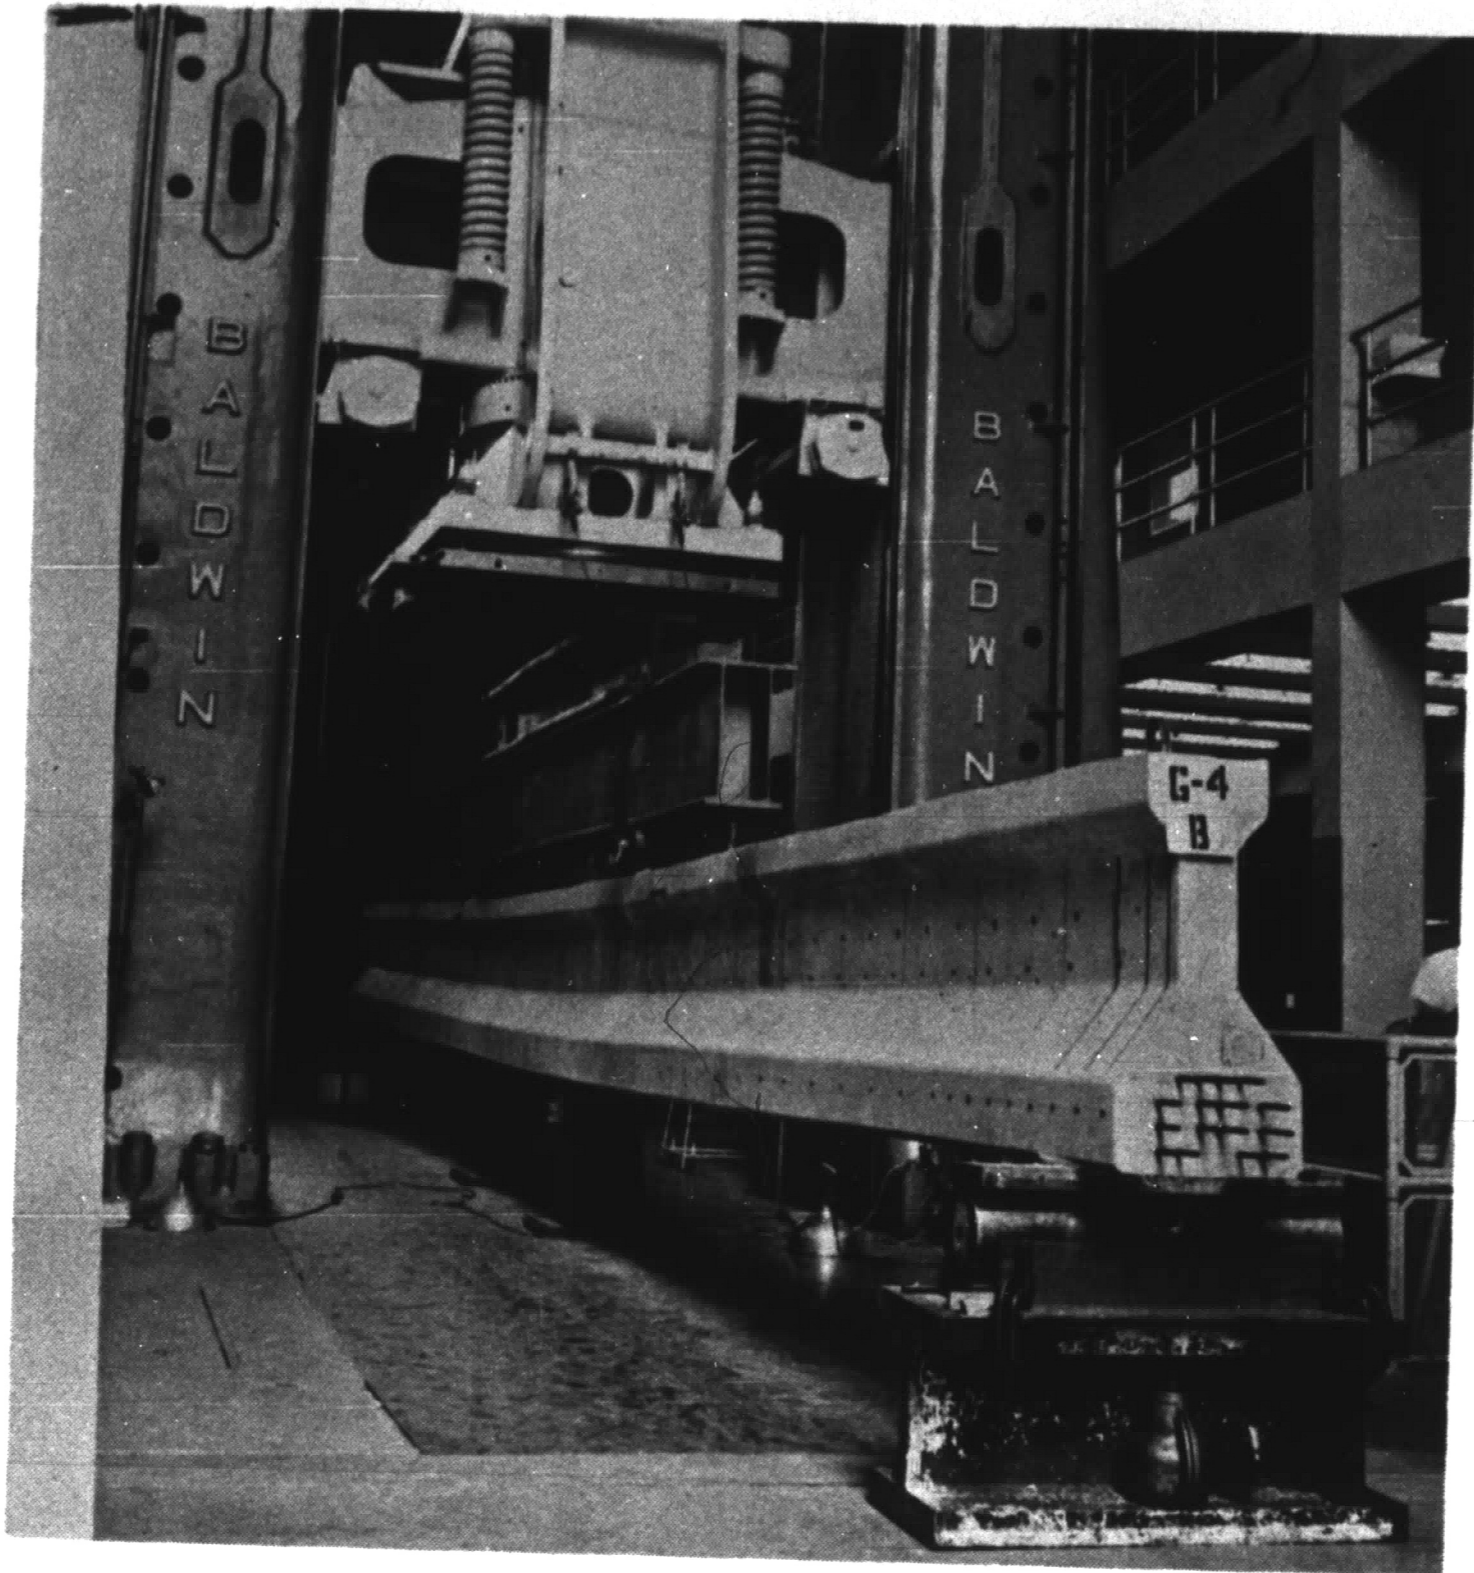
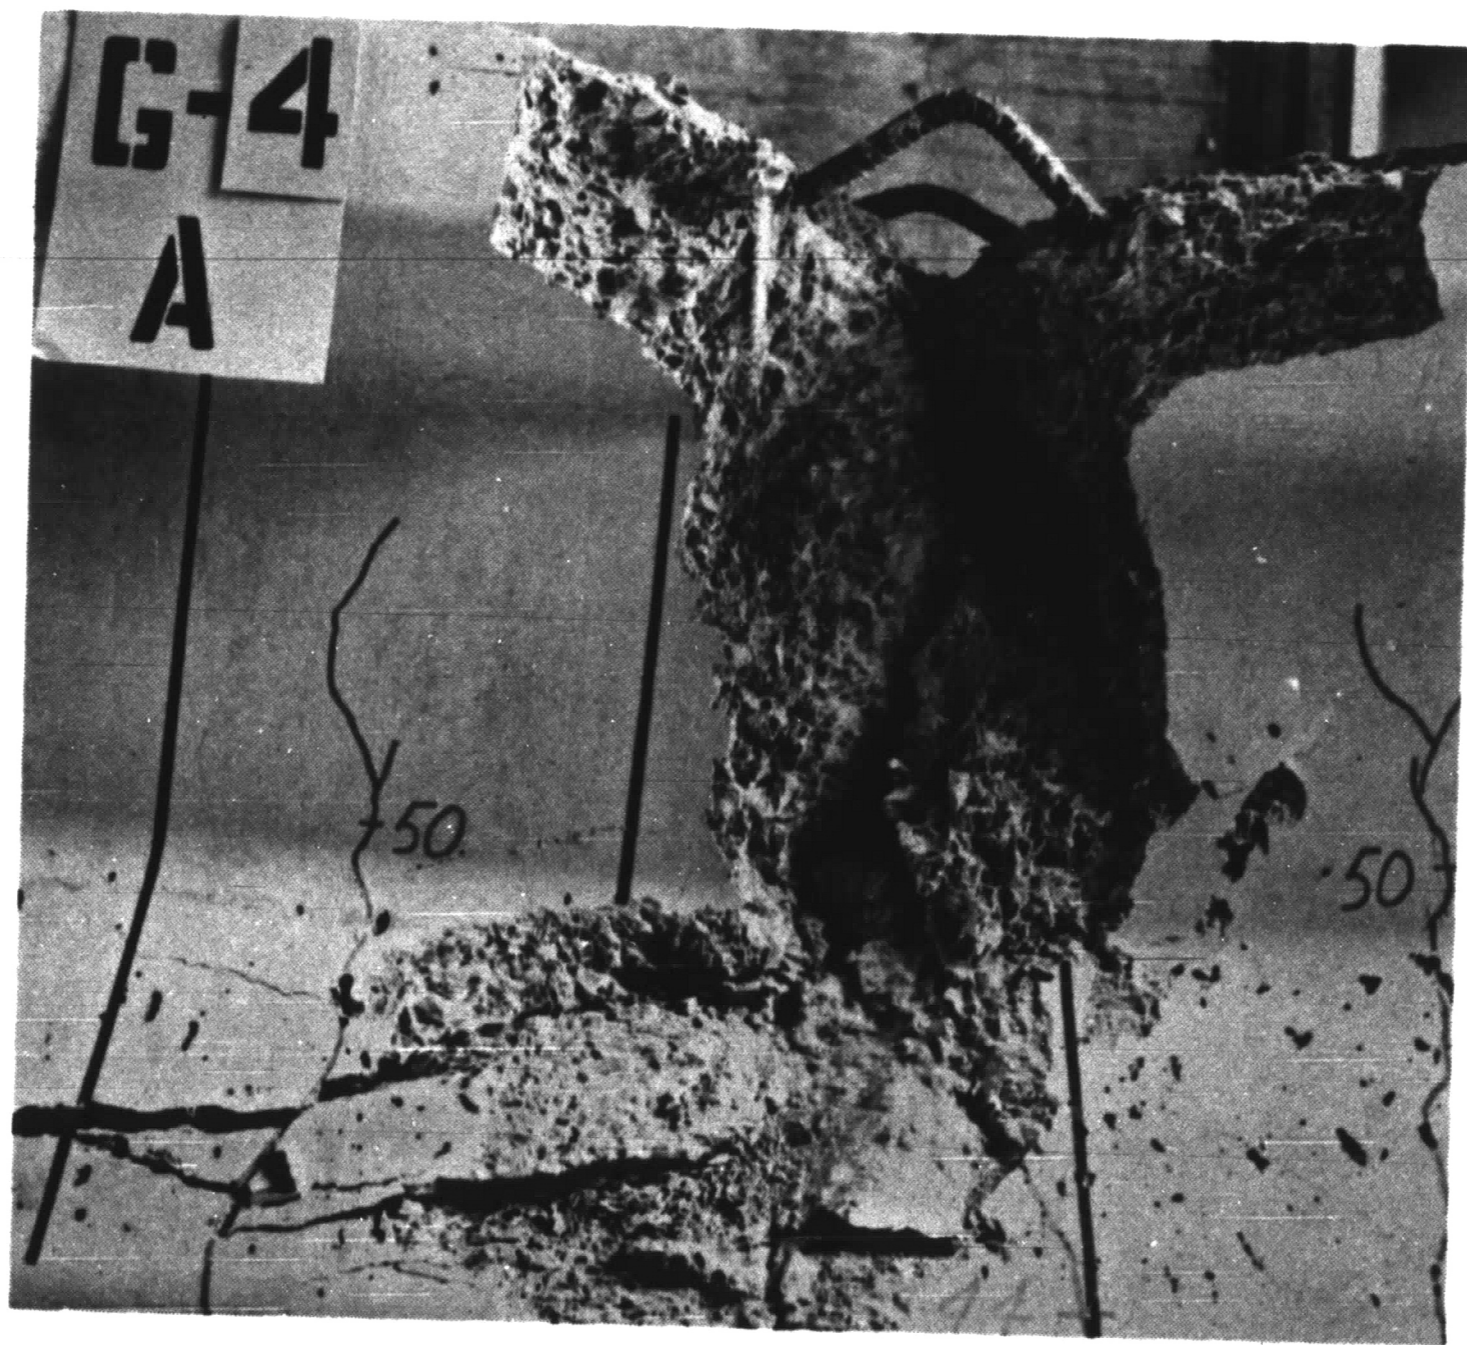
Fig. 22 First Test on Long I-Beam, G-4

a. During Loading Near Ultimate Capacity

b. View of Center Region of Beam After Flexural Failure

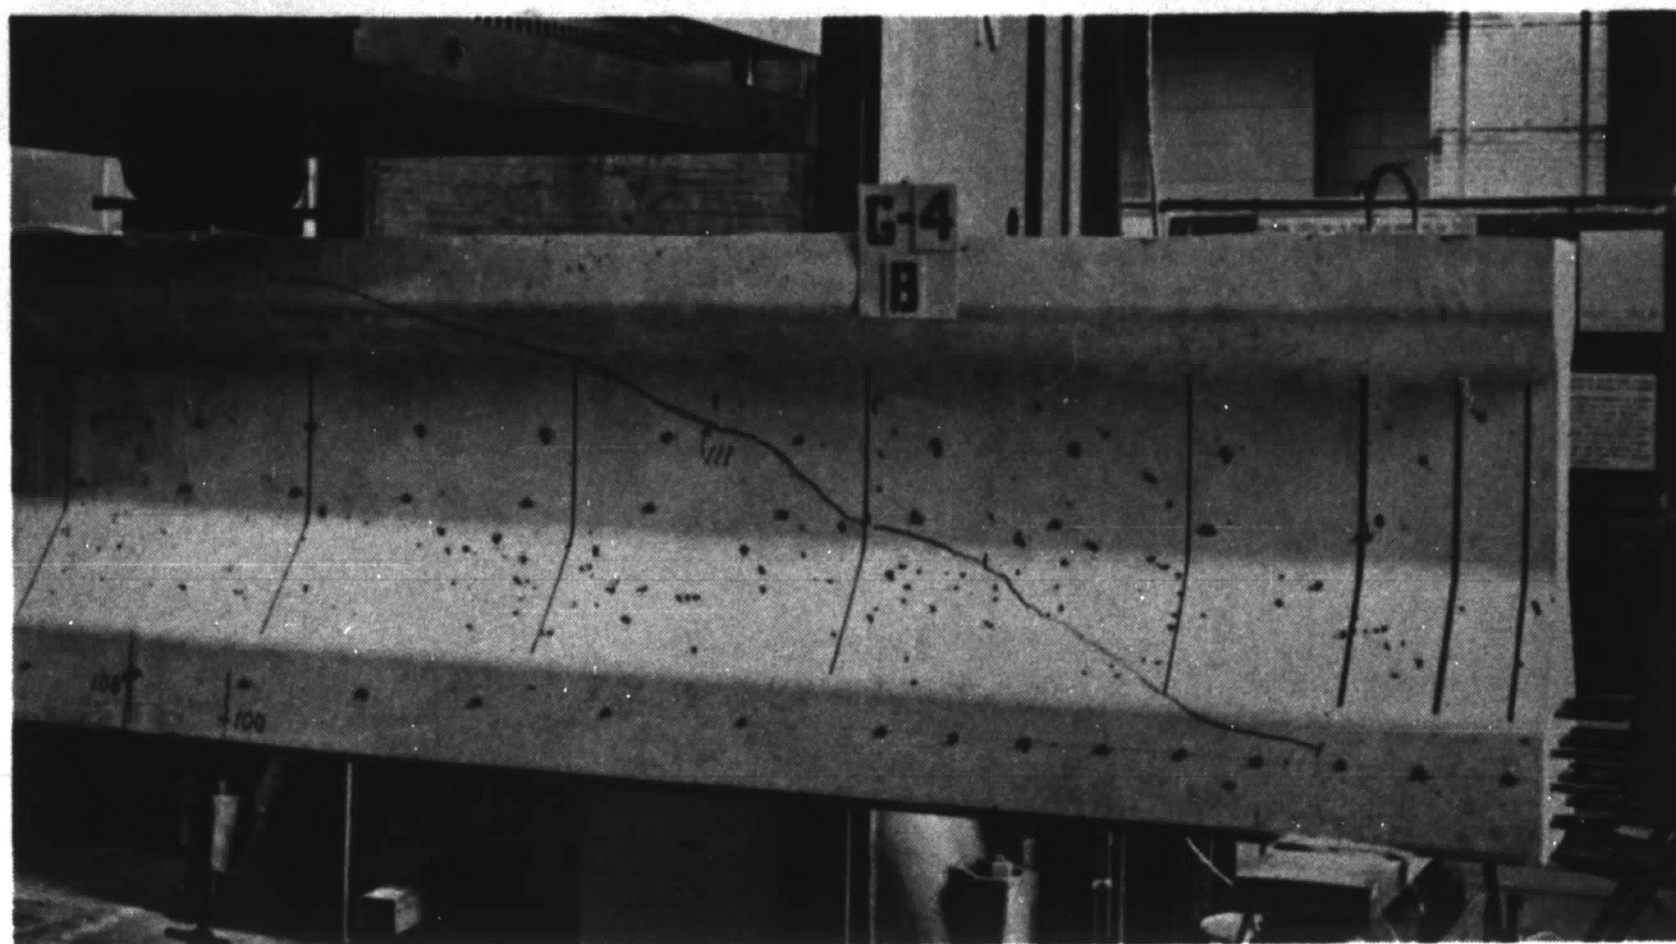
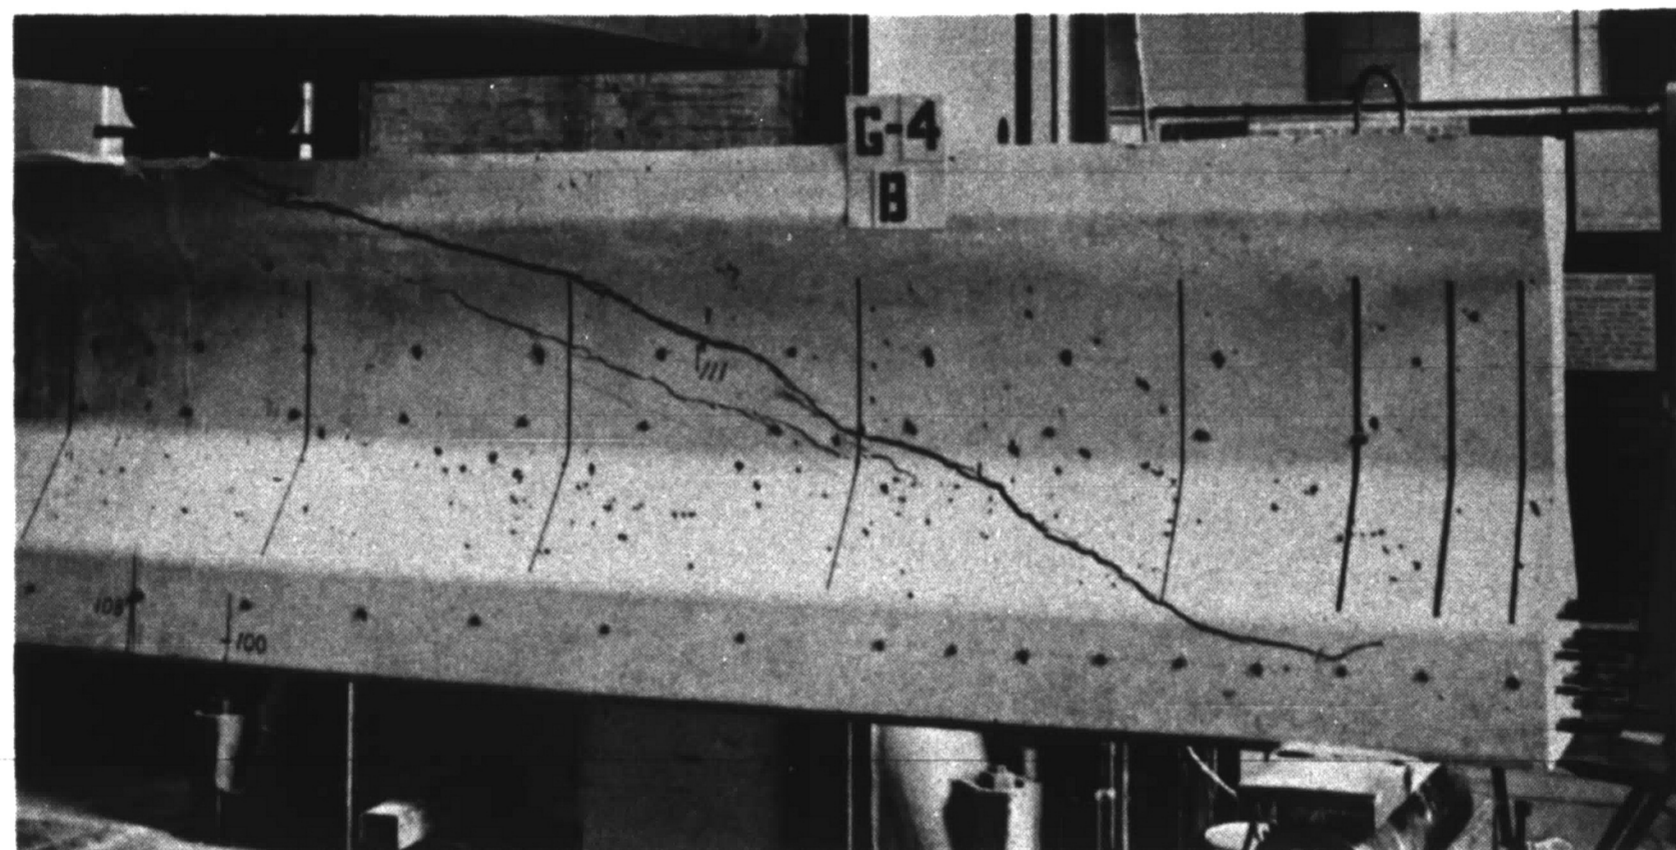
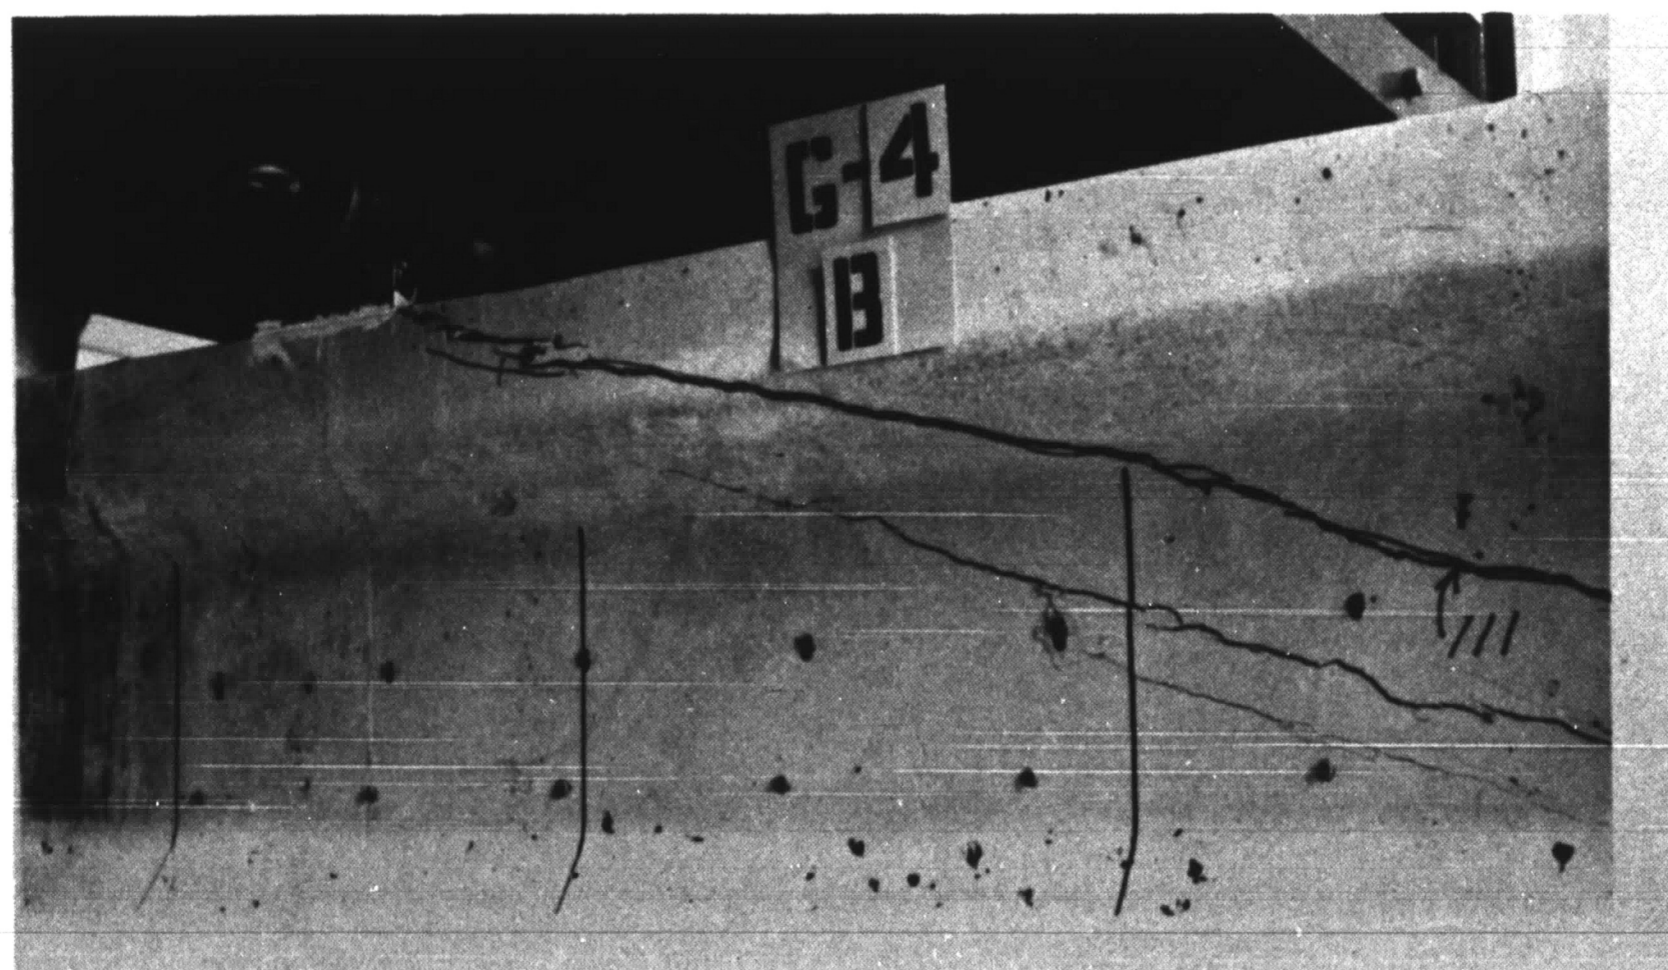
Fig. 24 Second Test on Long I-Beam, G-4

a. B Shear Span After Diagonal Tension Inclined Cracking

b. B Shear Span After Failure

c. View of Failure Region

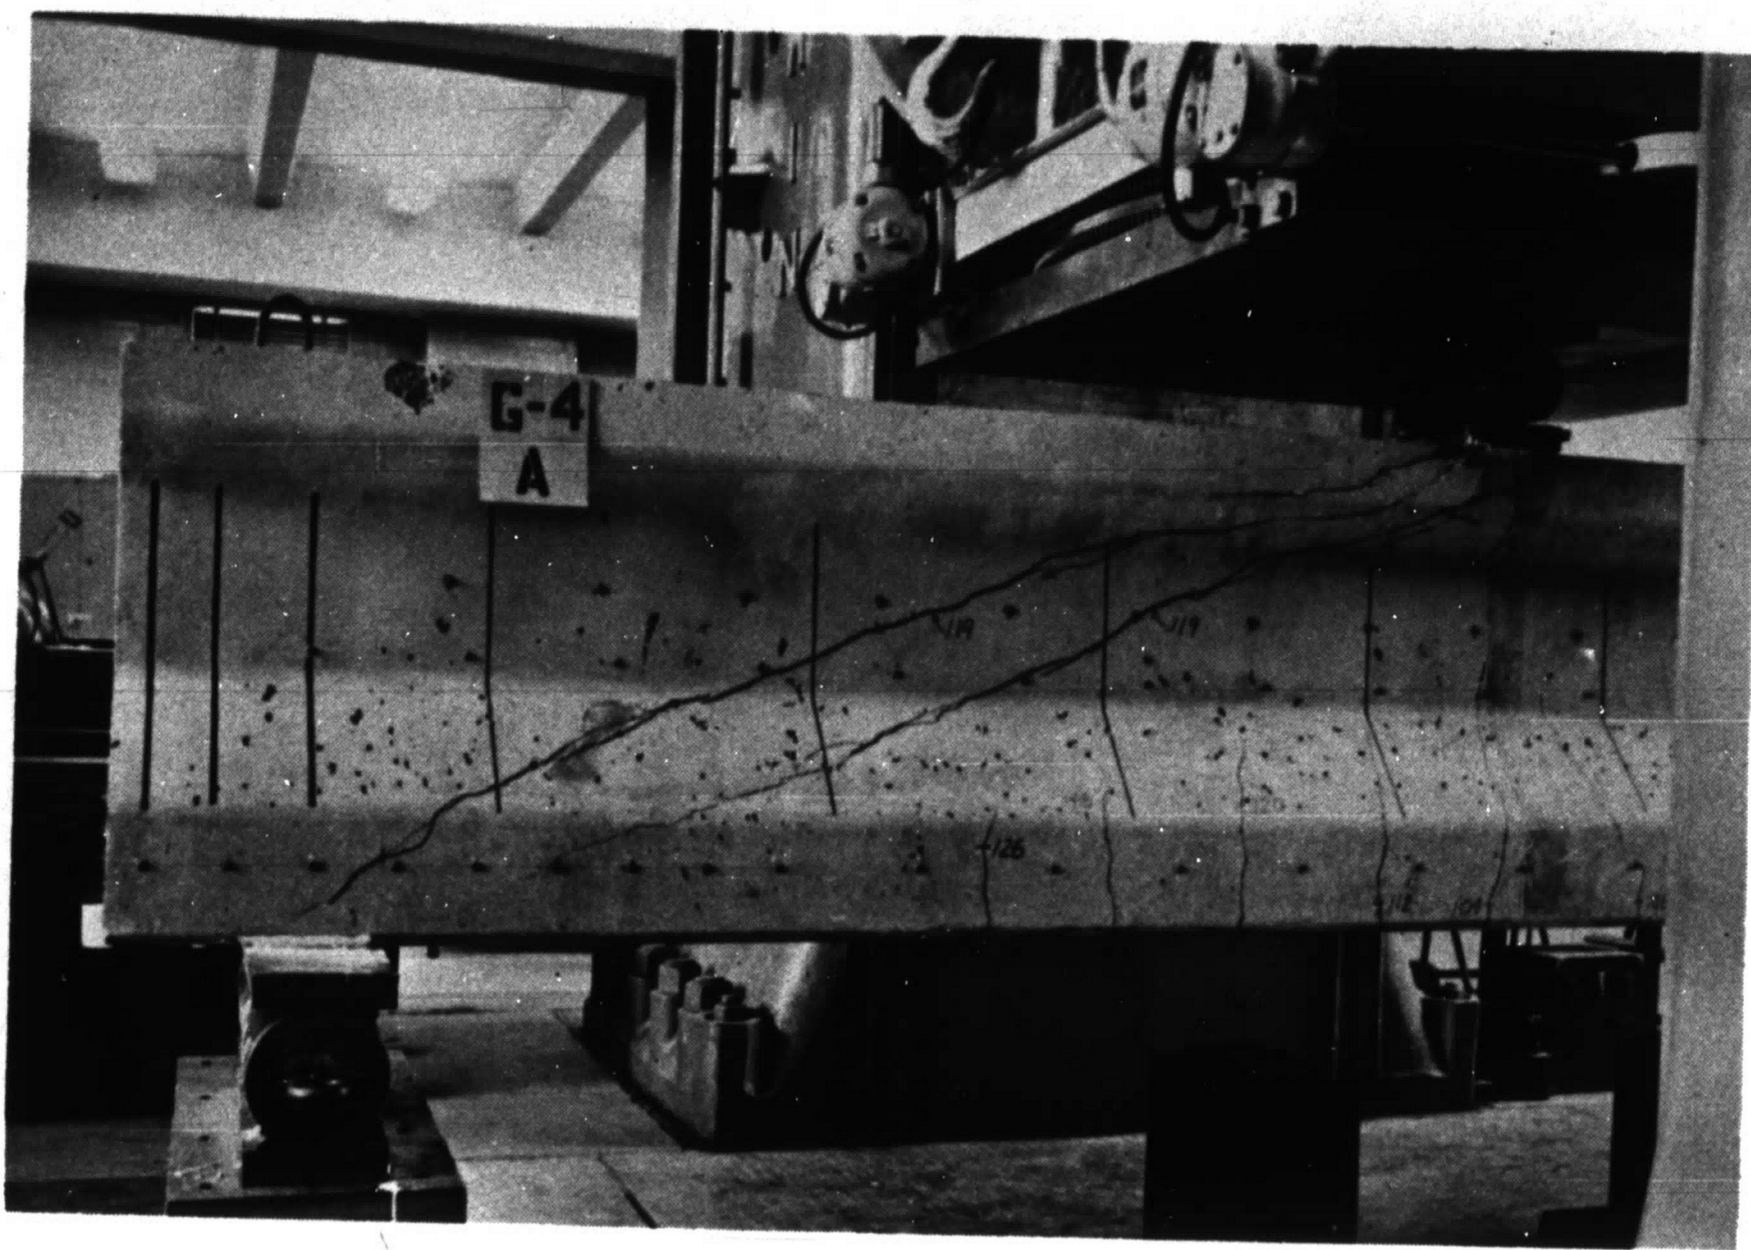
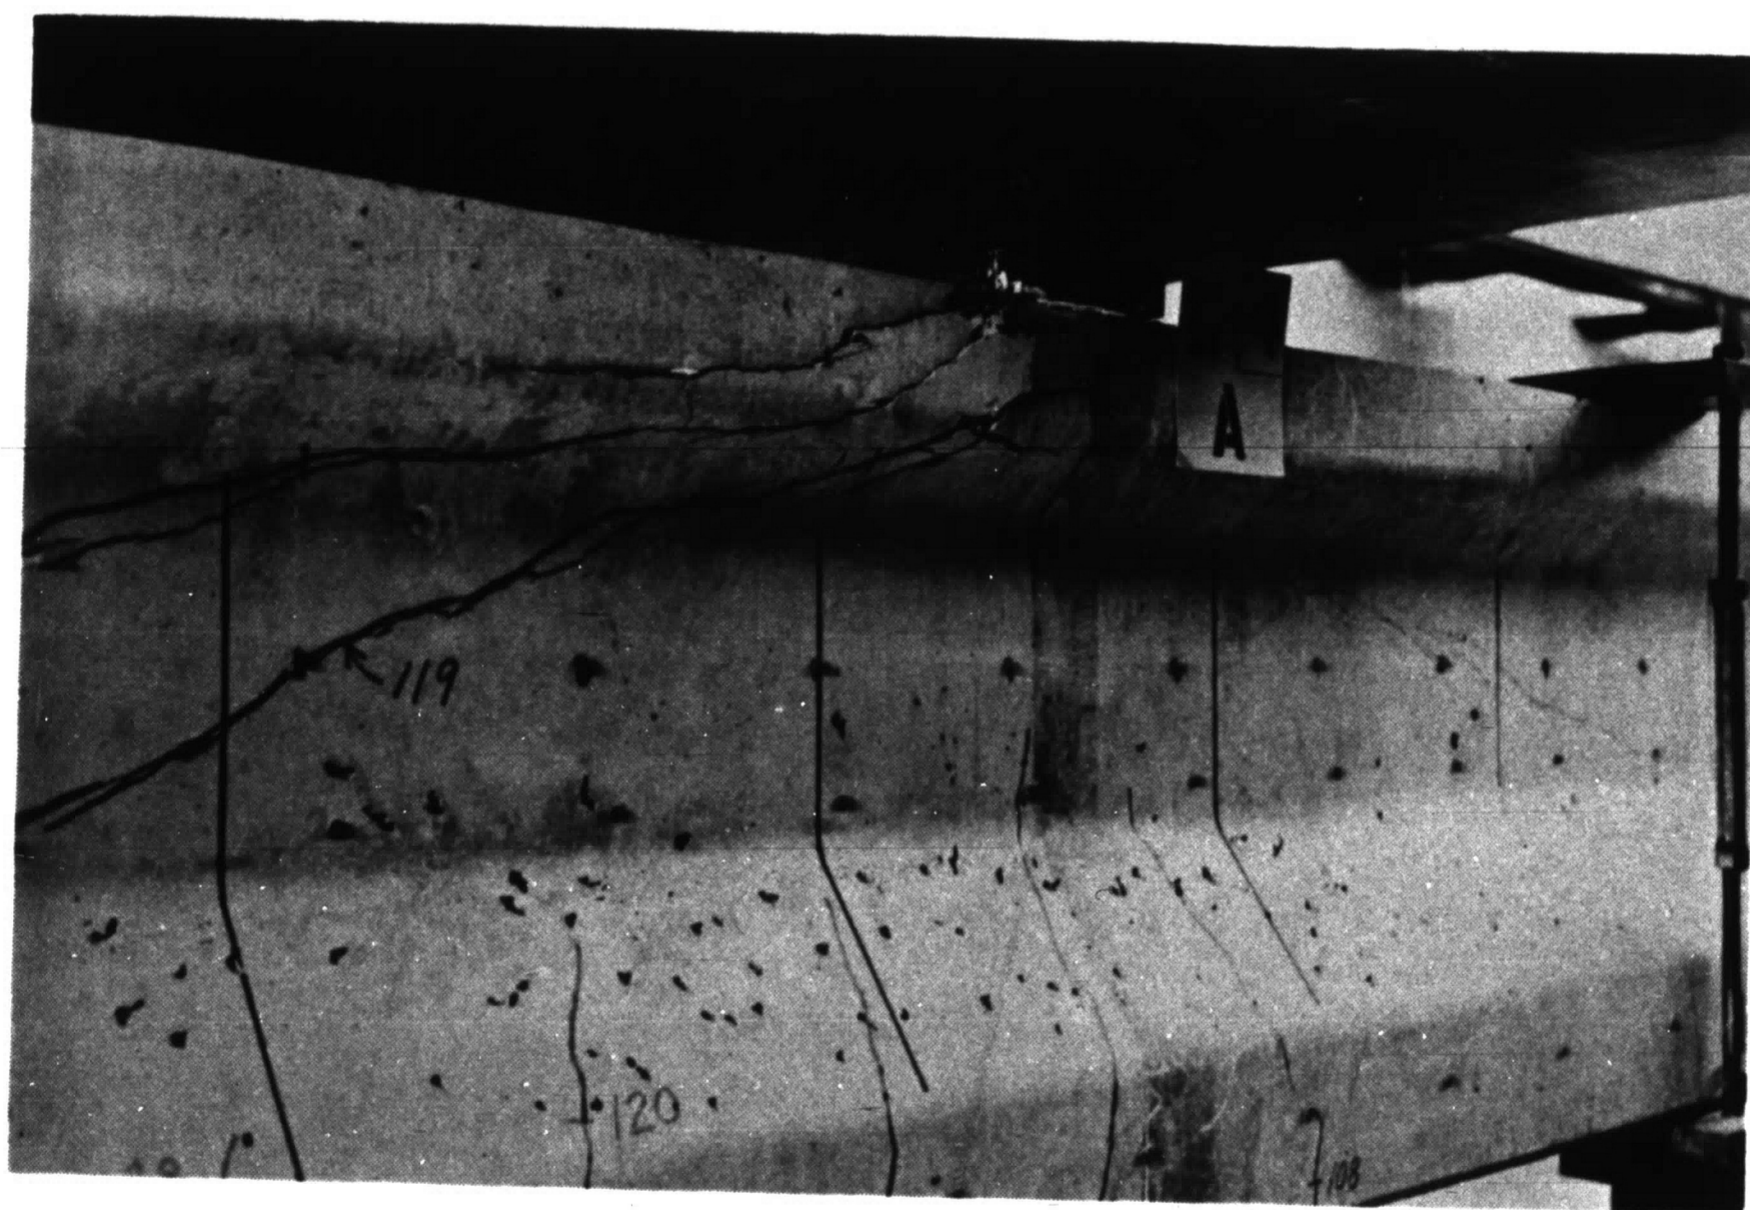
Fig. 25 Third Test on Long I-Beam, G-4

a. A Shear Span After Diagonal Tension Inclined Cracking

b. A Shear Span After Failure

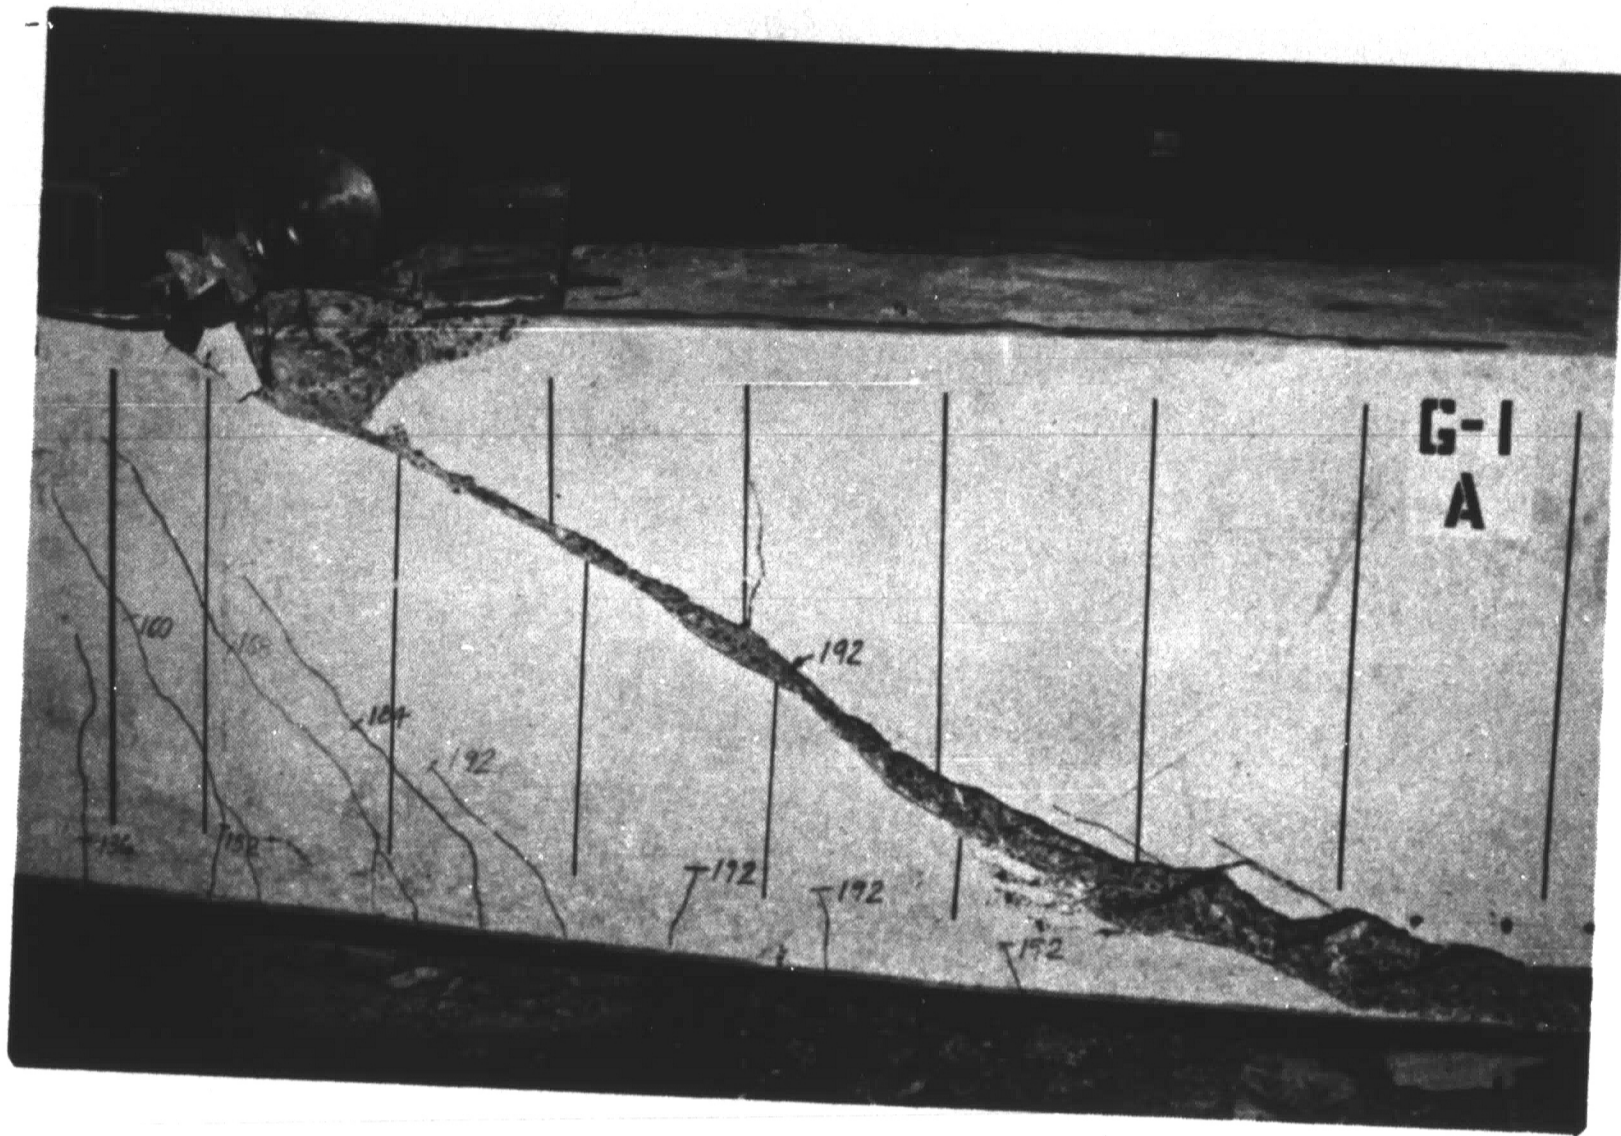
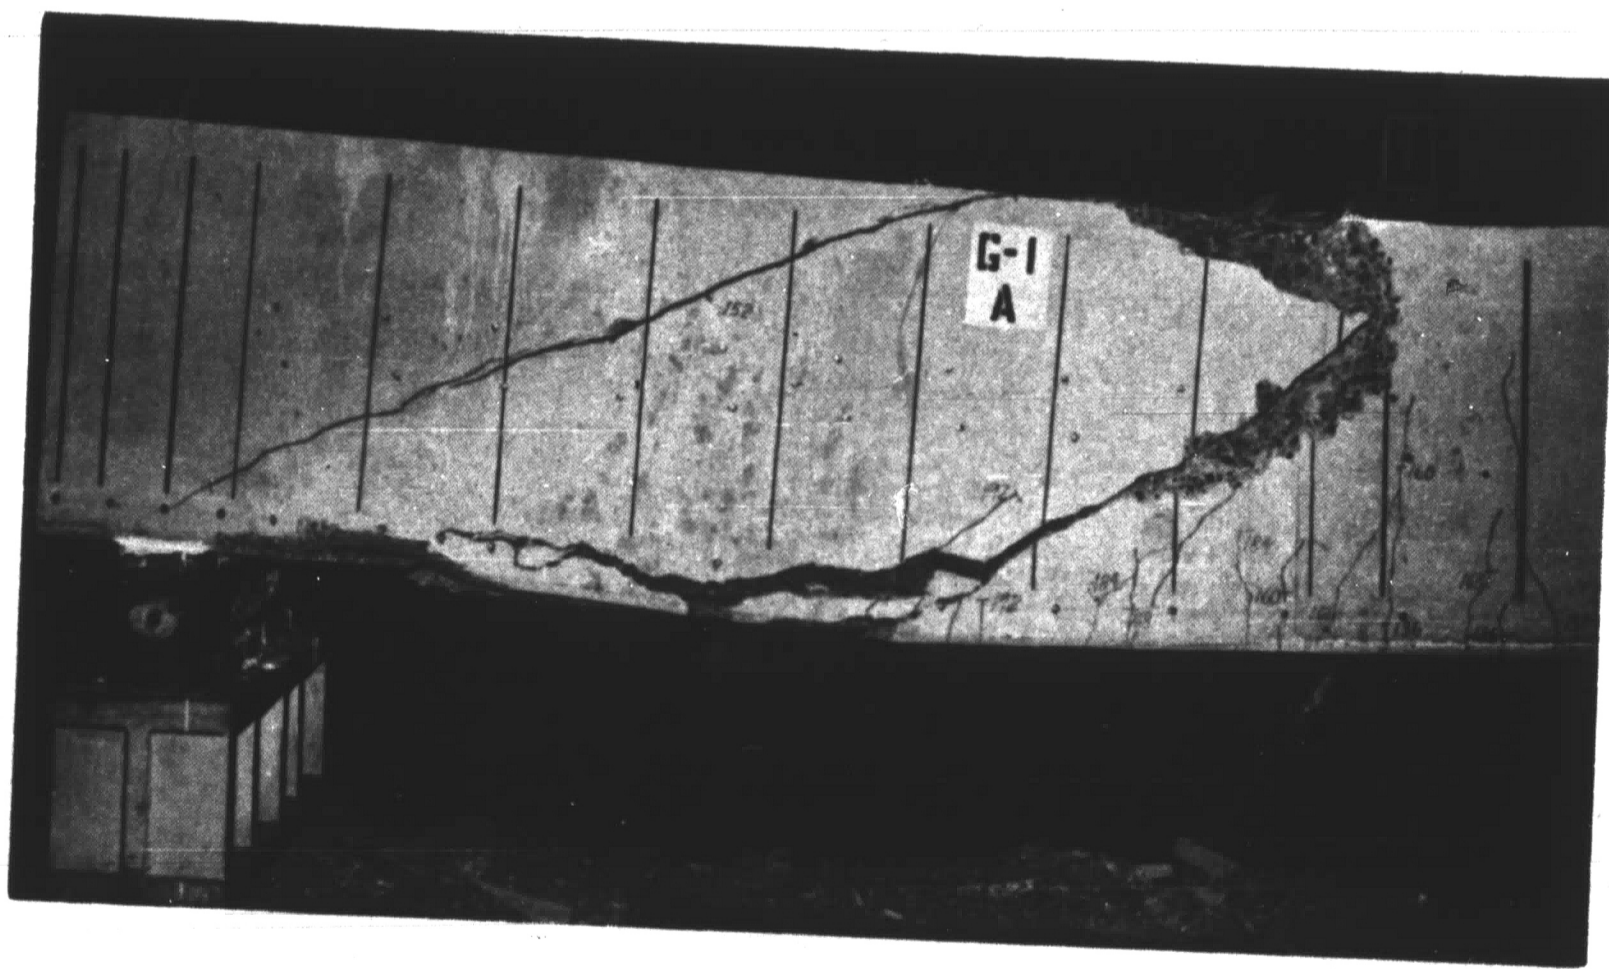
Fig. 26 First Test on Short Box Beam, G-1

a. Right Side of A Shear Span After Diagonal Tension Inclined Cracking and Failure

b. Left Side of A Shear Span After Torsional Inclined Cracking and Failure
