Ultimate shear tests of full-sized prestressed concrete beams

Howard E. Brecht
Lehigh University

A THESIS

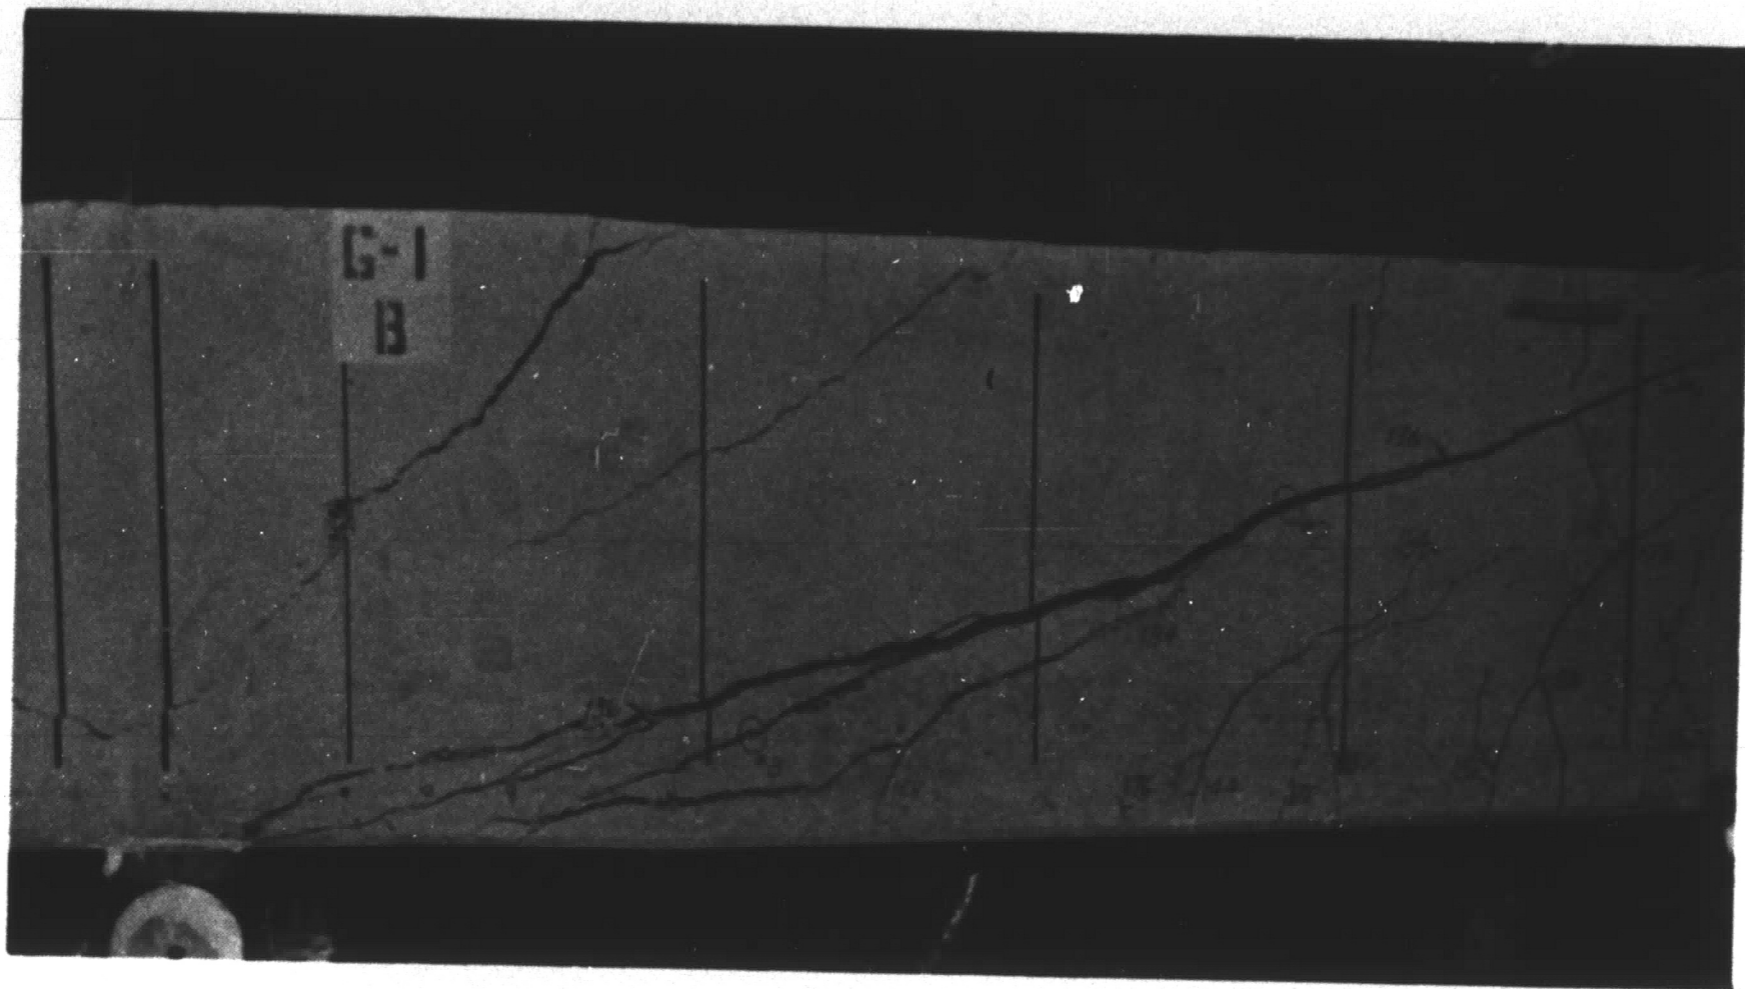
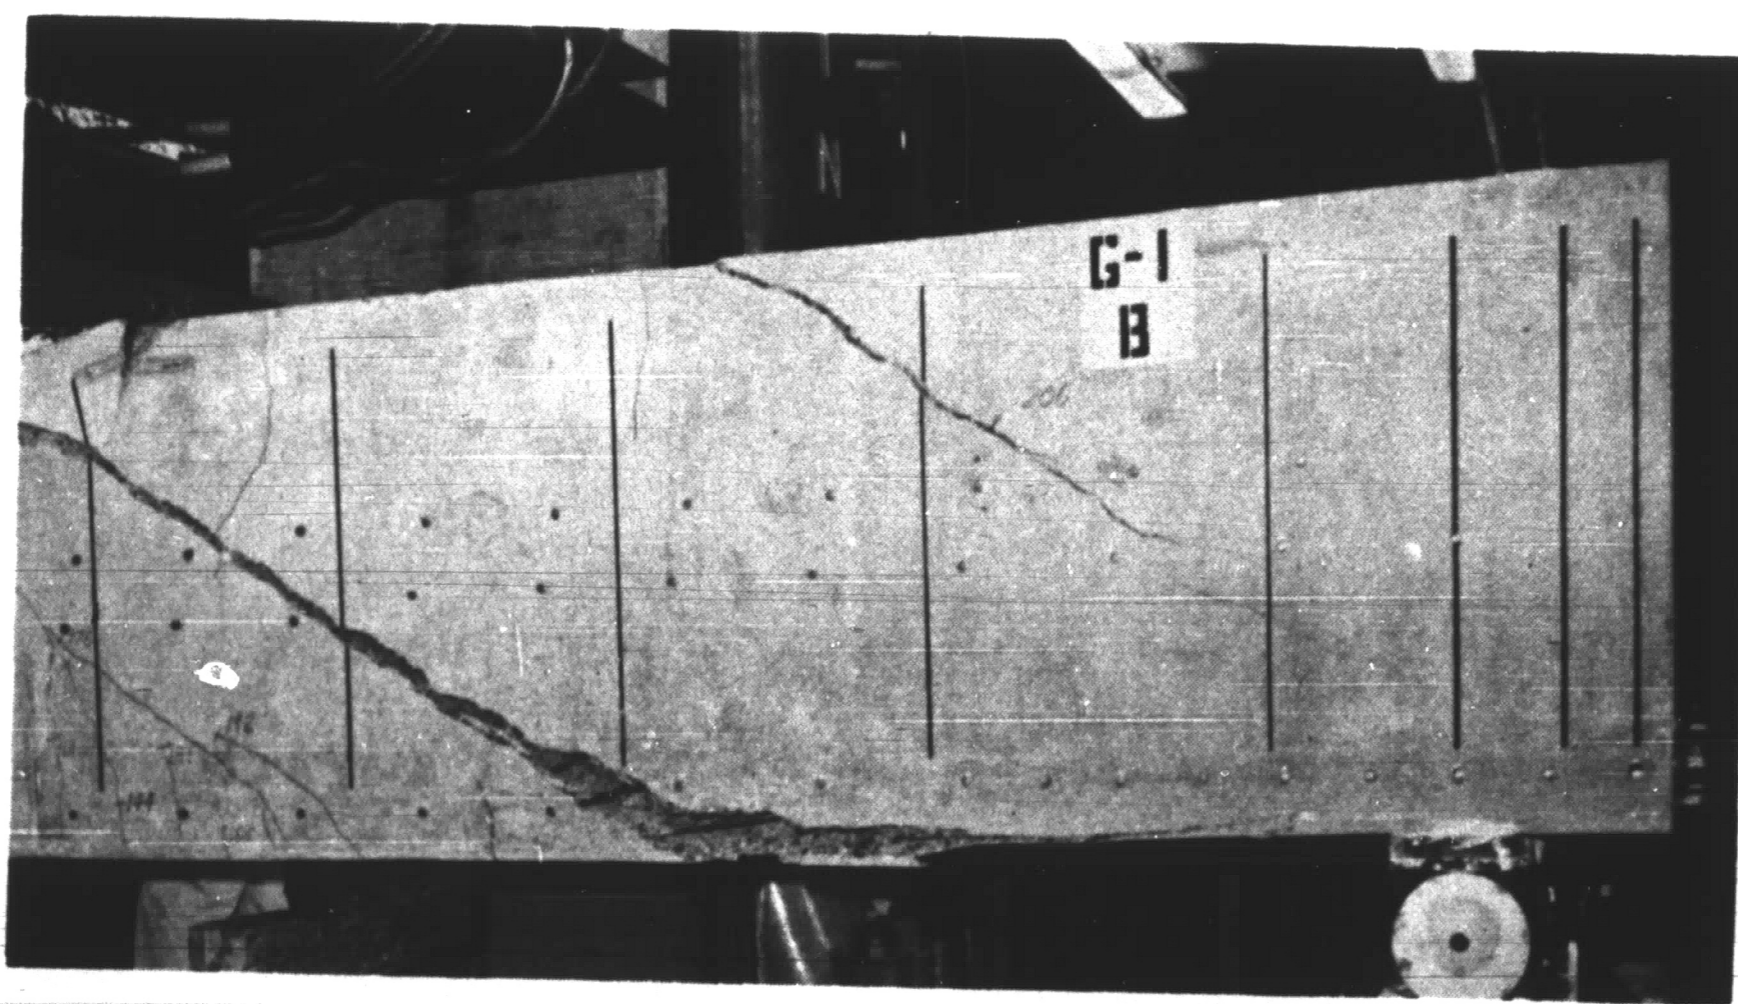
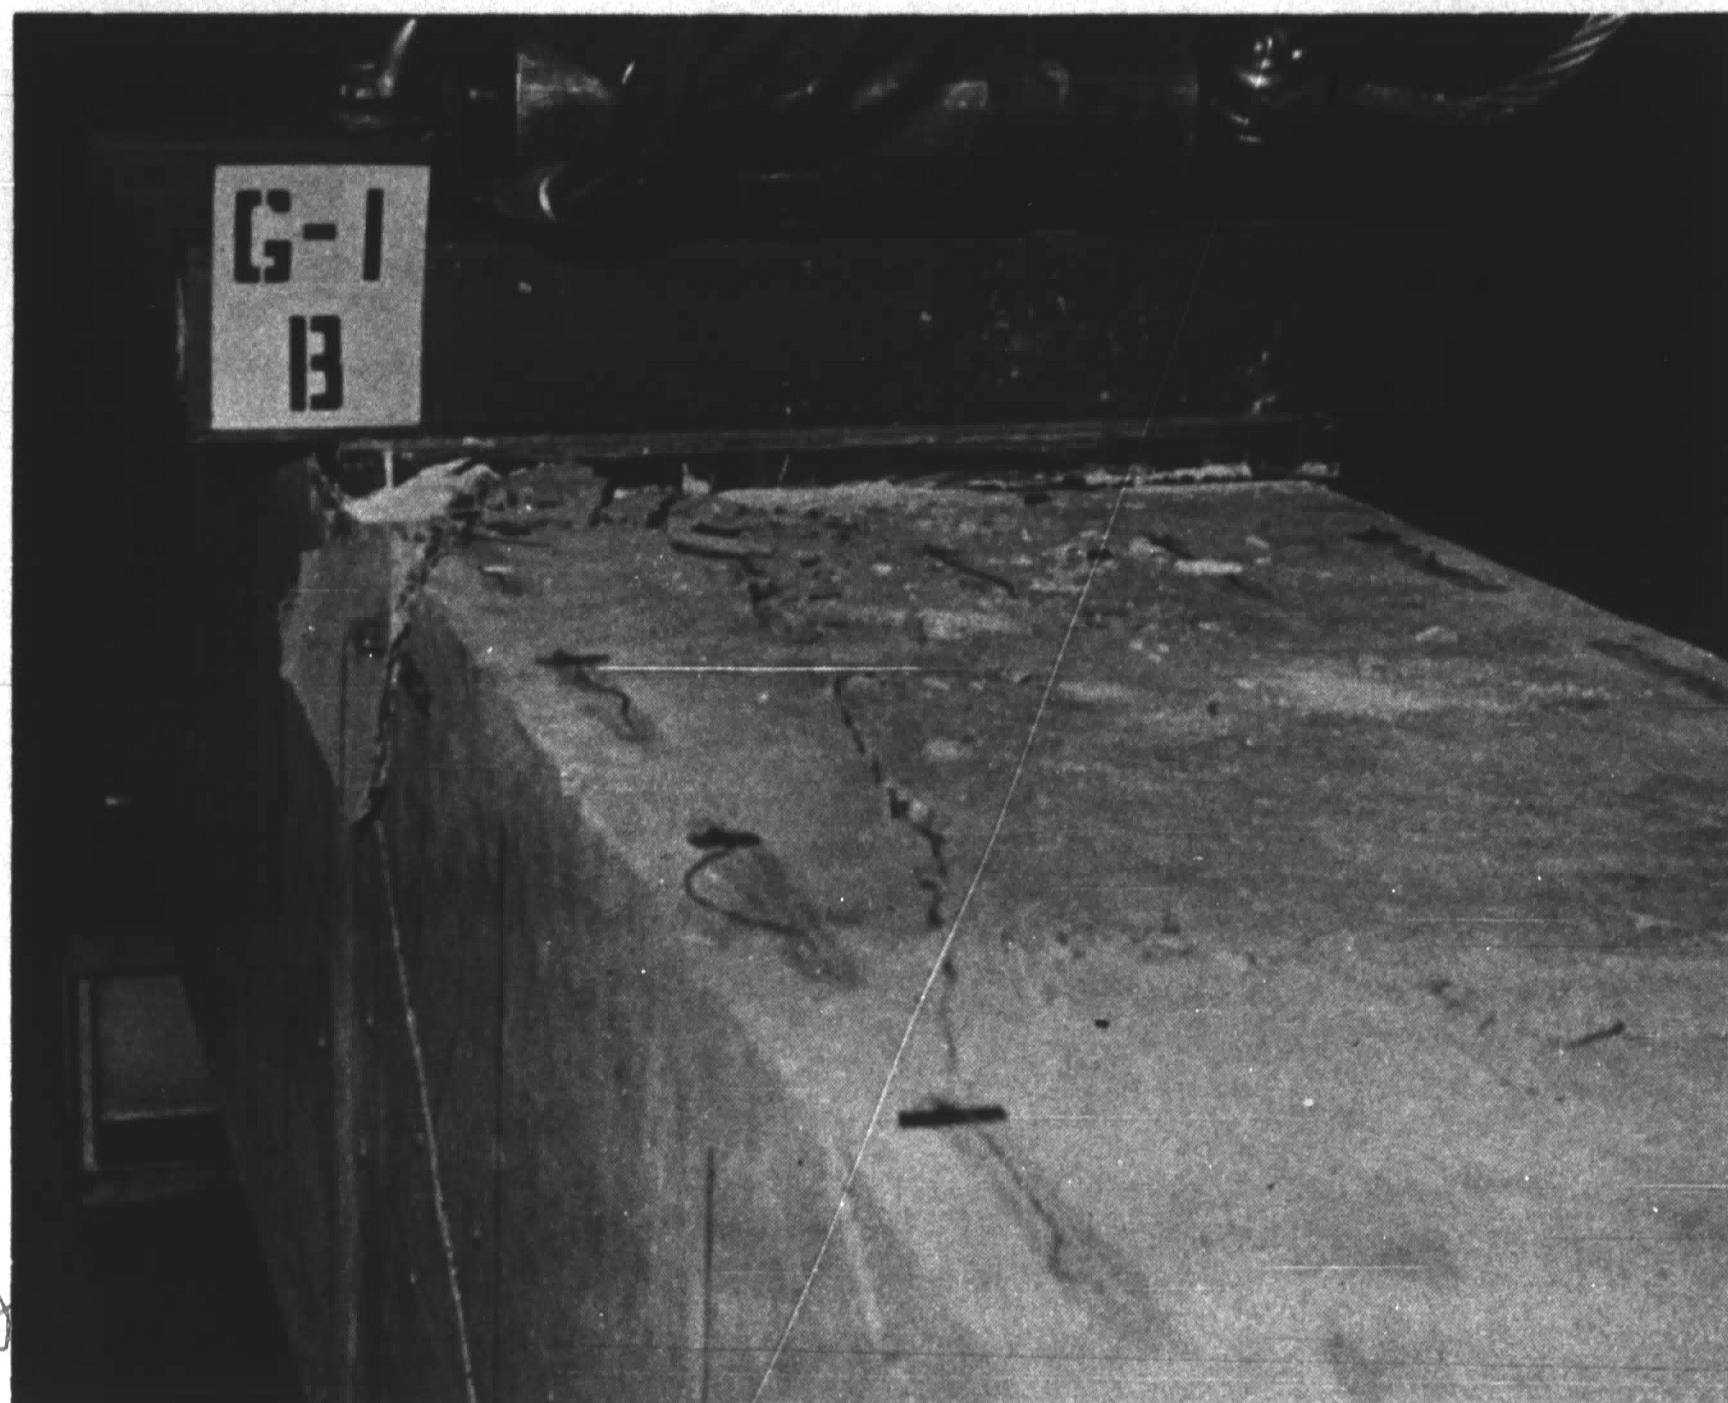
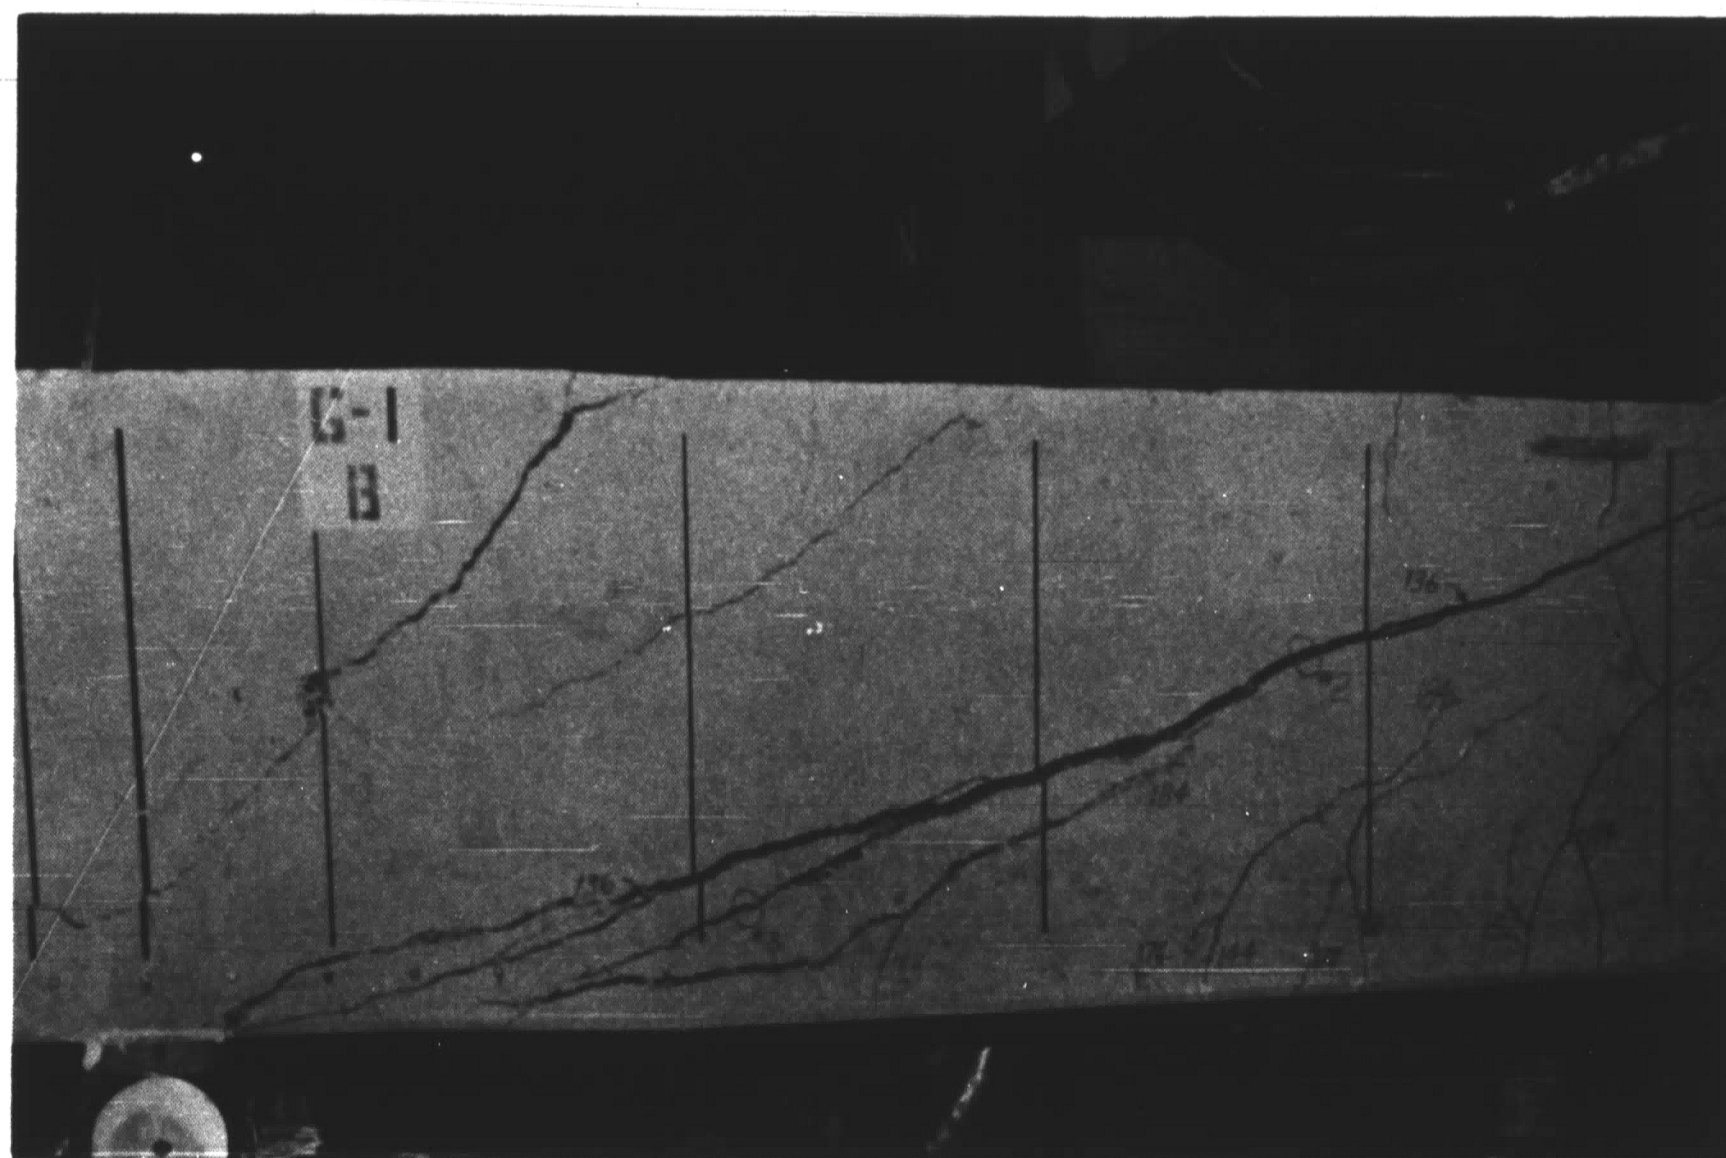
Fig. 27 Second Test on Short Box Beam, G-1

a. Right Side of B Shear Span at Start of Test

b. Left Side of B Shear Span at Start of Test

c. Left Side of B Shear Span After Torsional
Inclined Cracking and Failure

d. Left Side and Top Flange of B
Load Point After Failure

e. Right Side of B Shear Span After Failure

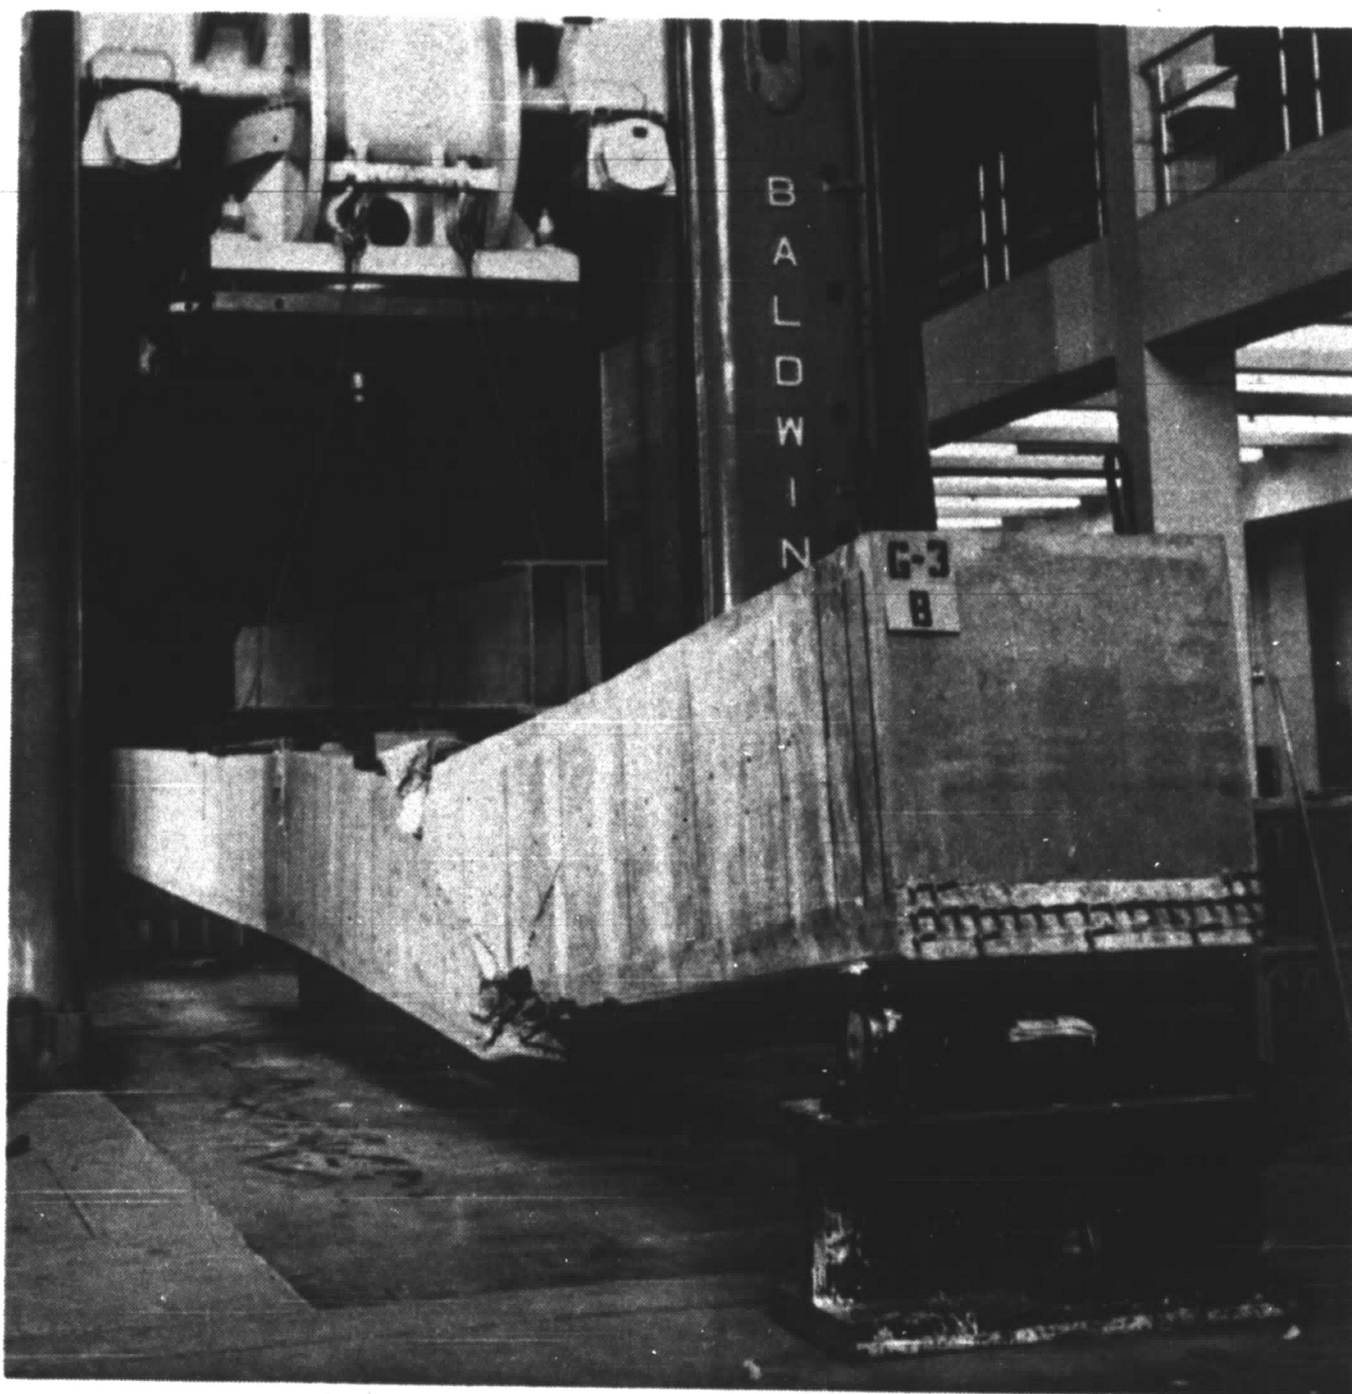
Fig. 28 First Test on Long Box Beam, G-3

a. During Loading Near Ultimate Capacity

b. B Shear Span After Failure

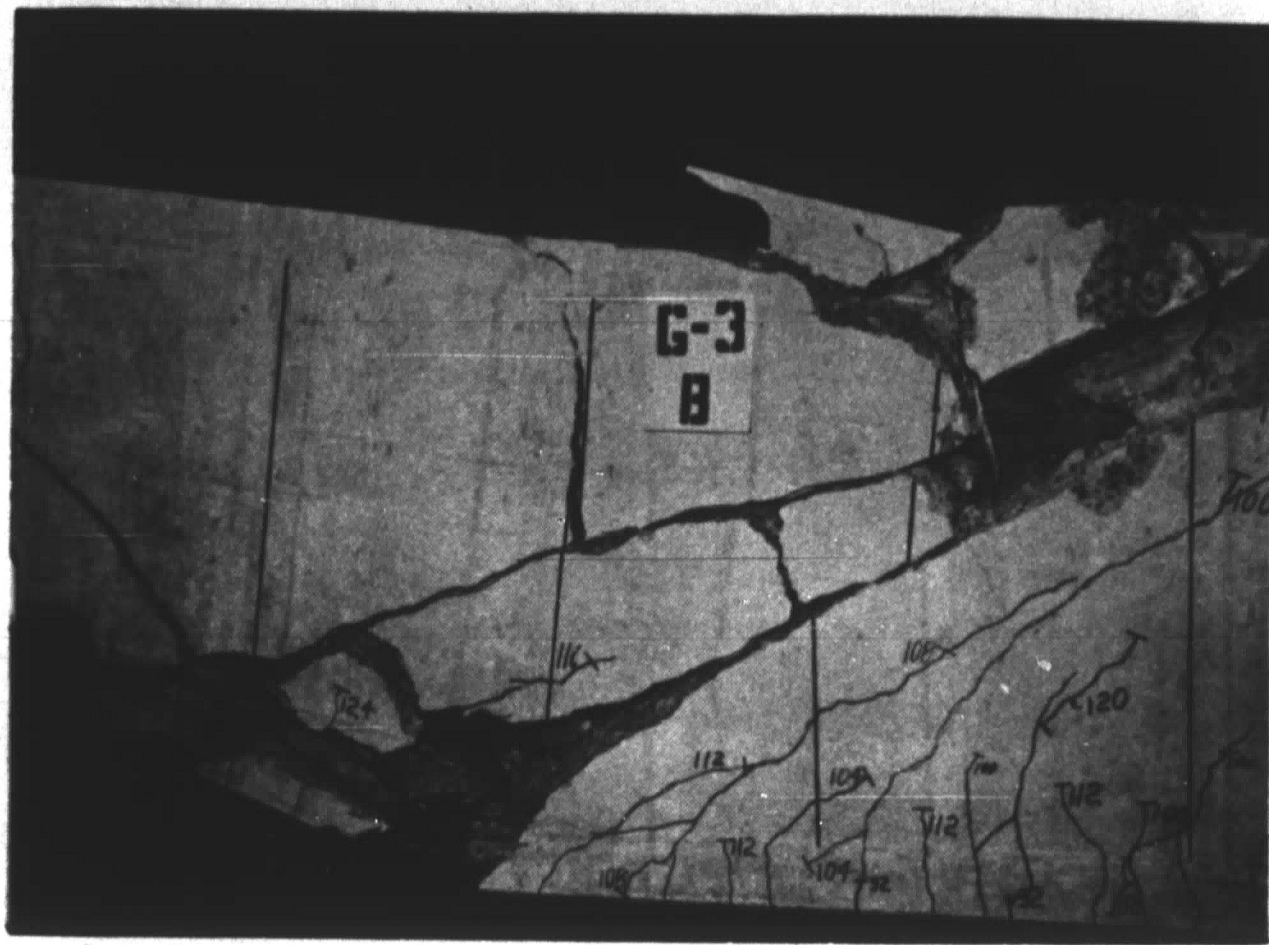
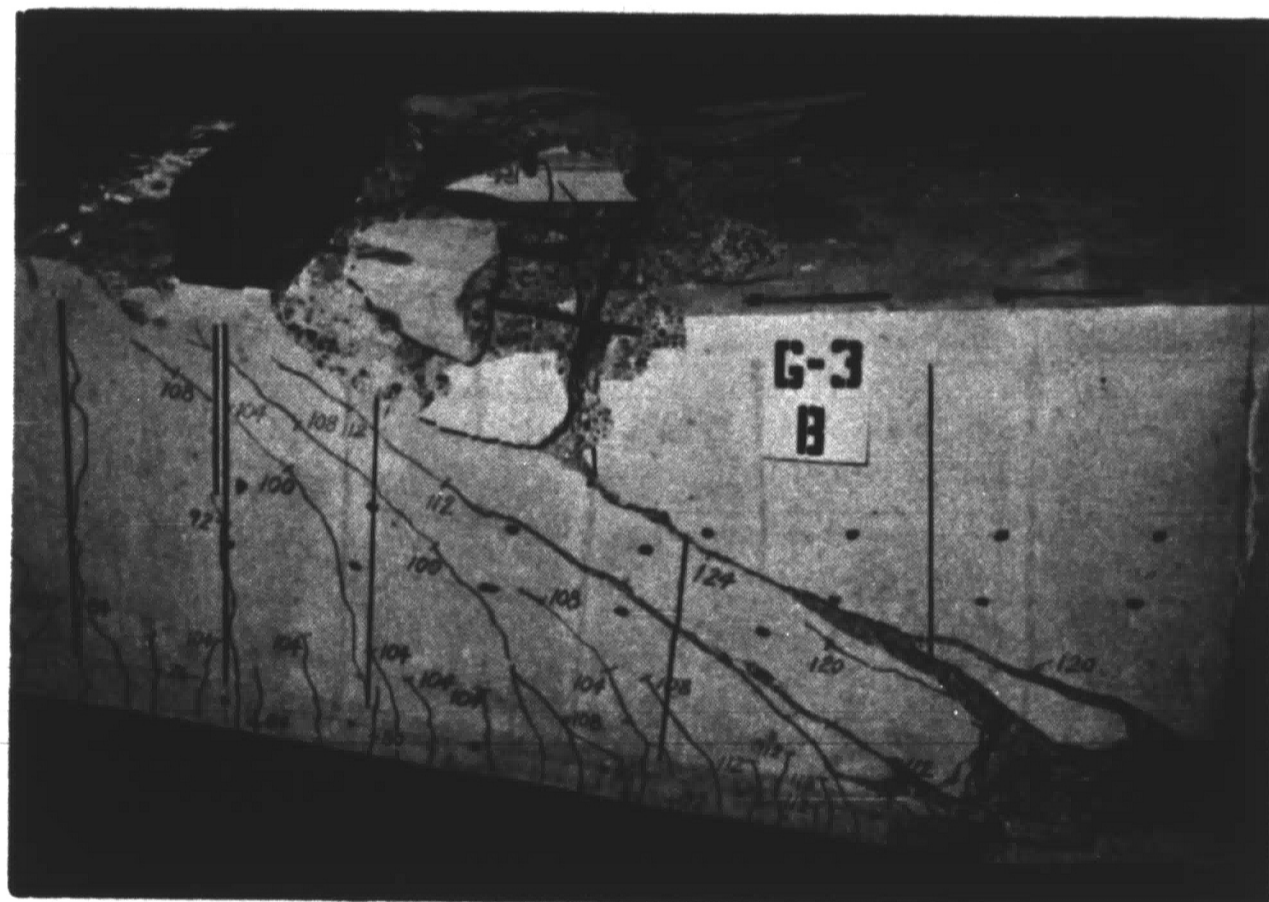
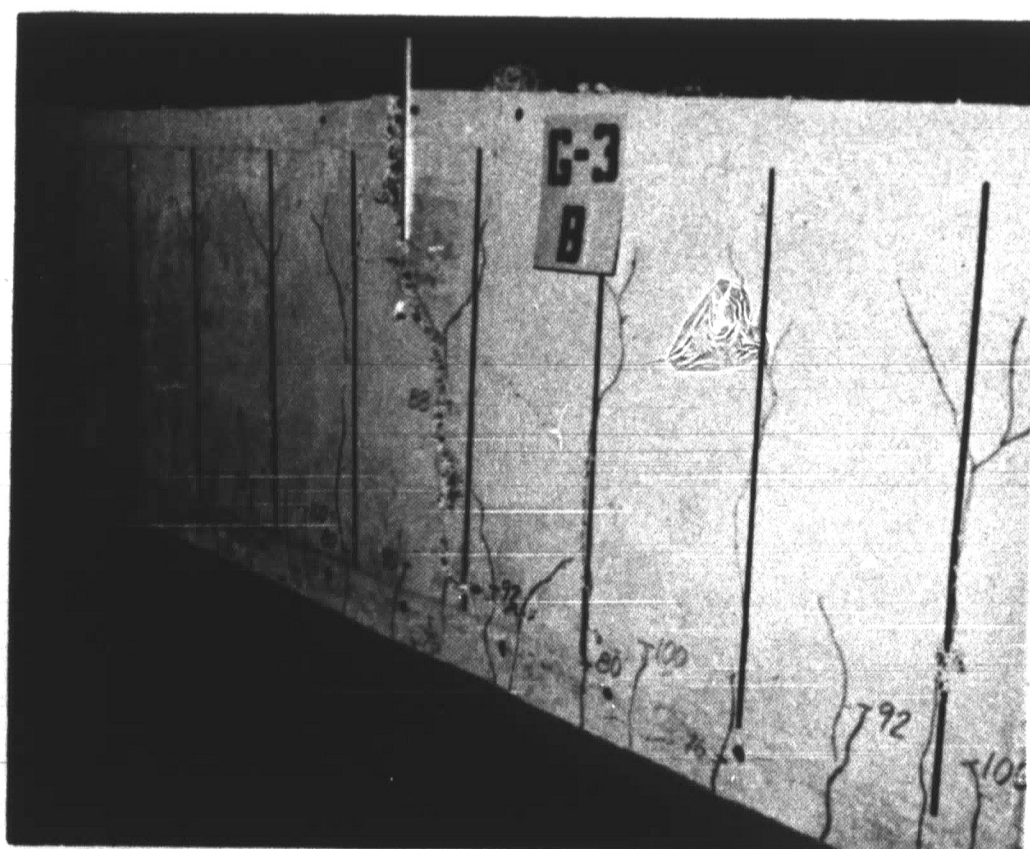
Fig. 29 First Test on Long Box Beam, G-3

a. Right Side of B Shear Span After Failure

b. Left Side and Top of B Shear Span After Failure

c. Left Side of C Region at Mid-Span After Failure

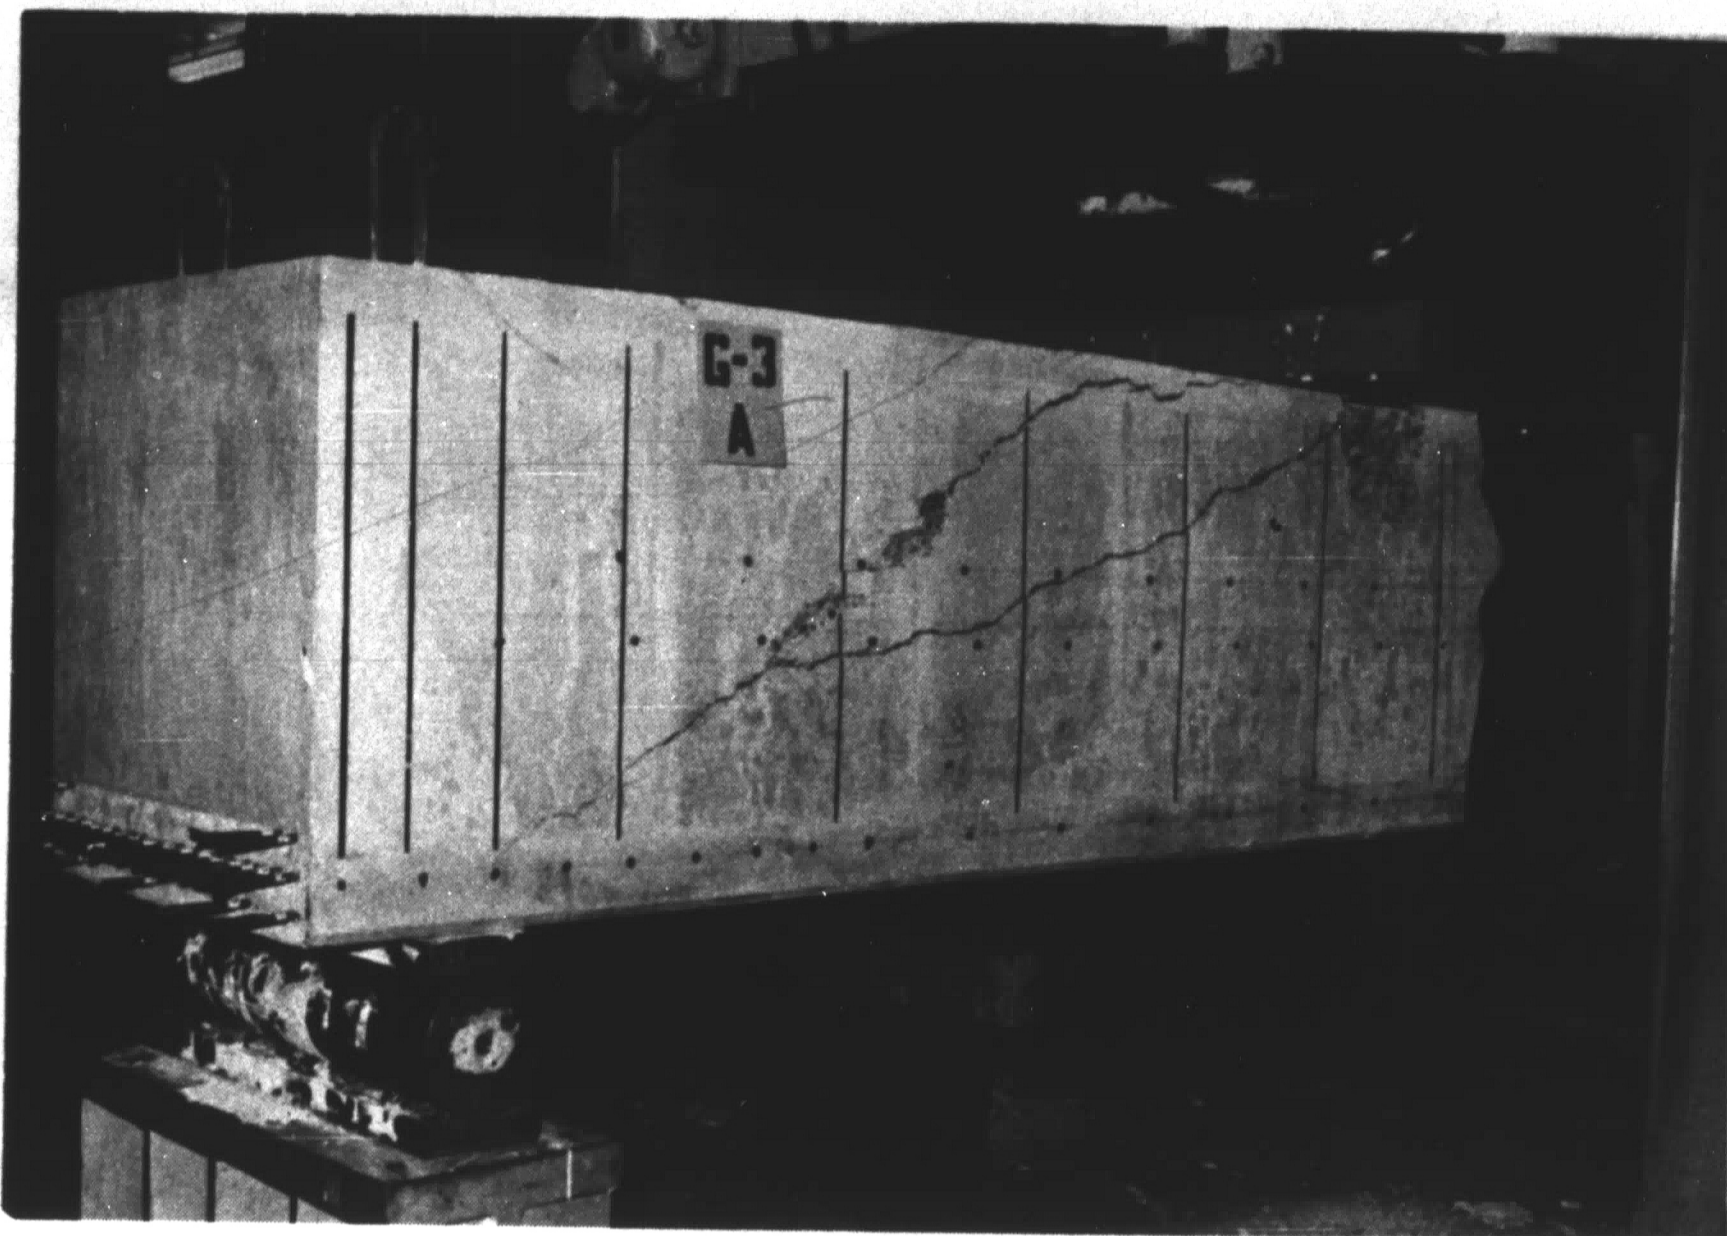
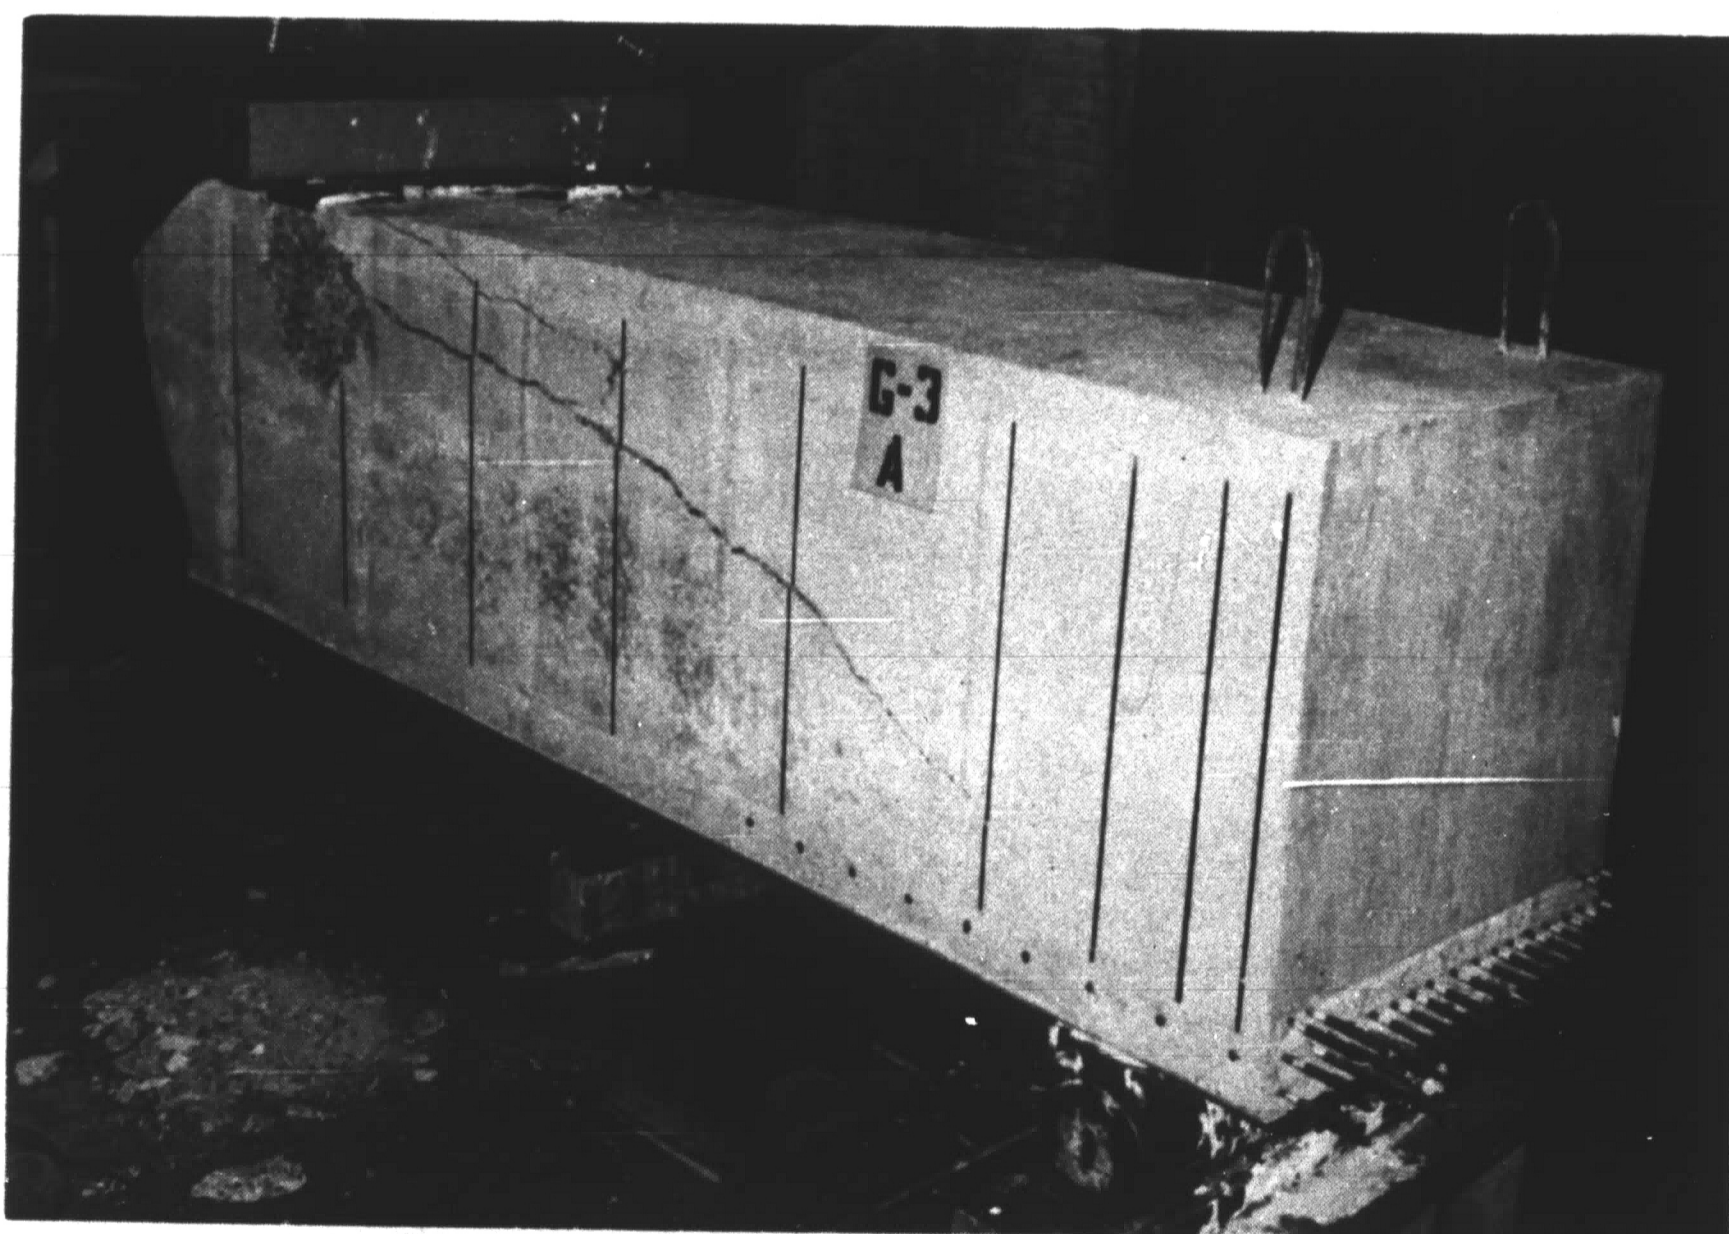
Fig. 30 Second Test on Long Box Beam, G-3

a. Left Side of A Shear Span After Failure

b. Right Side of A Shear Span After Failure

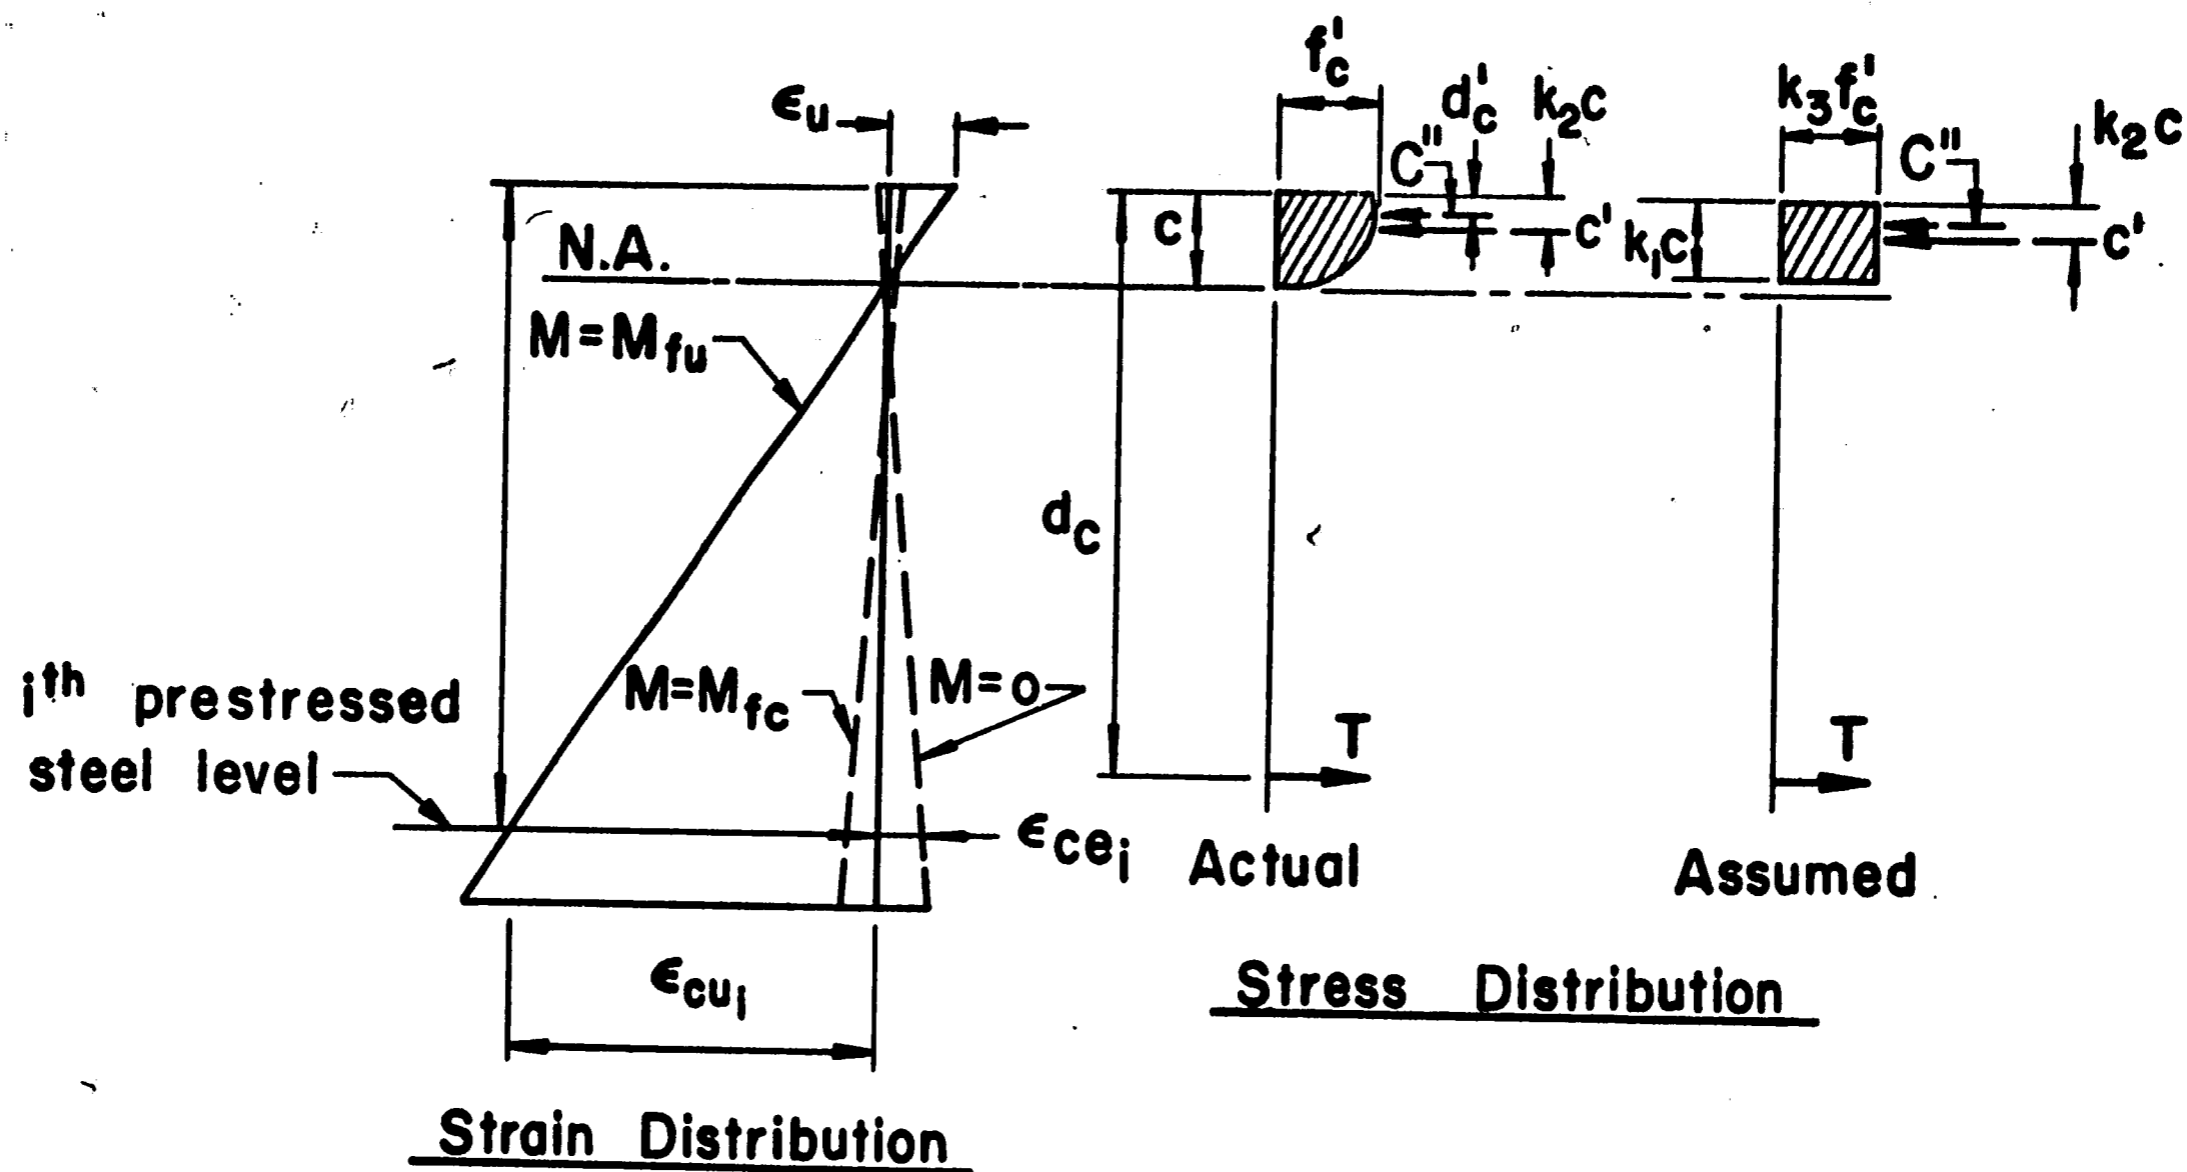
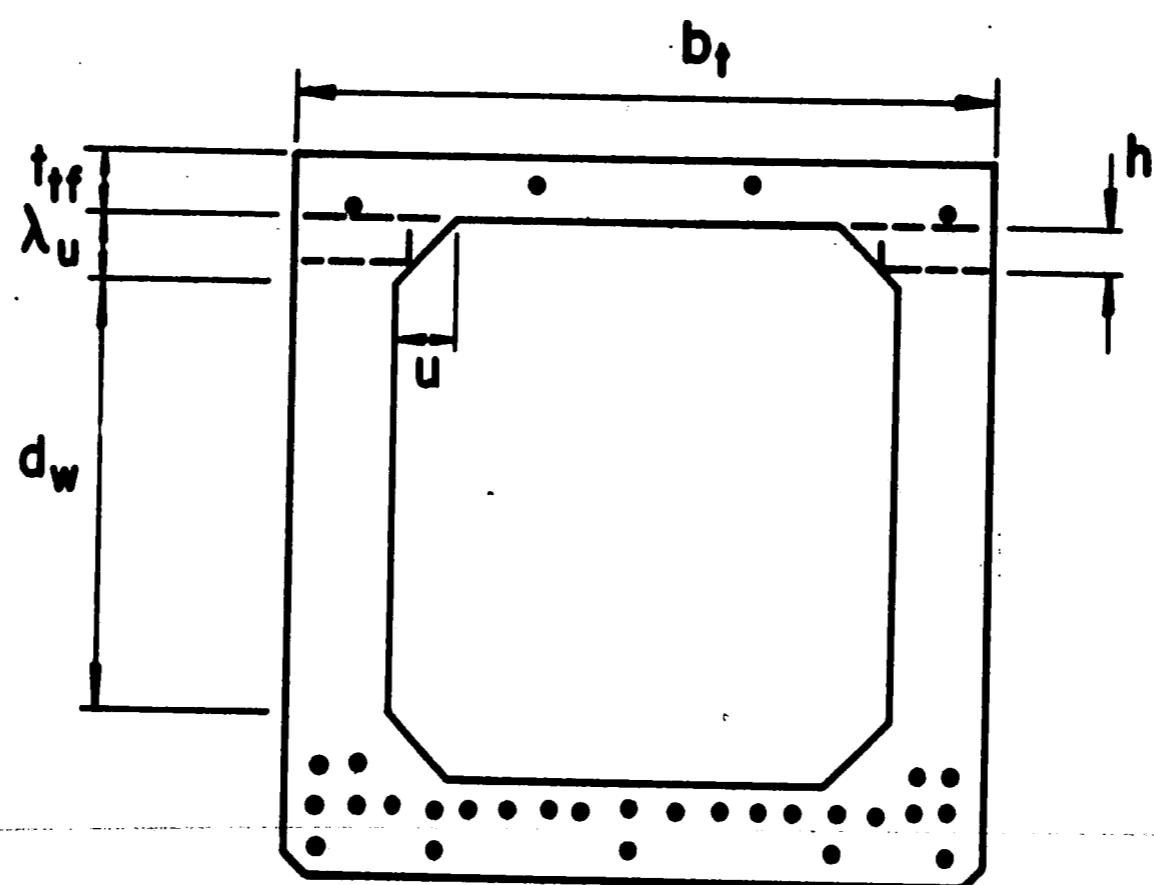
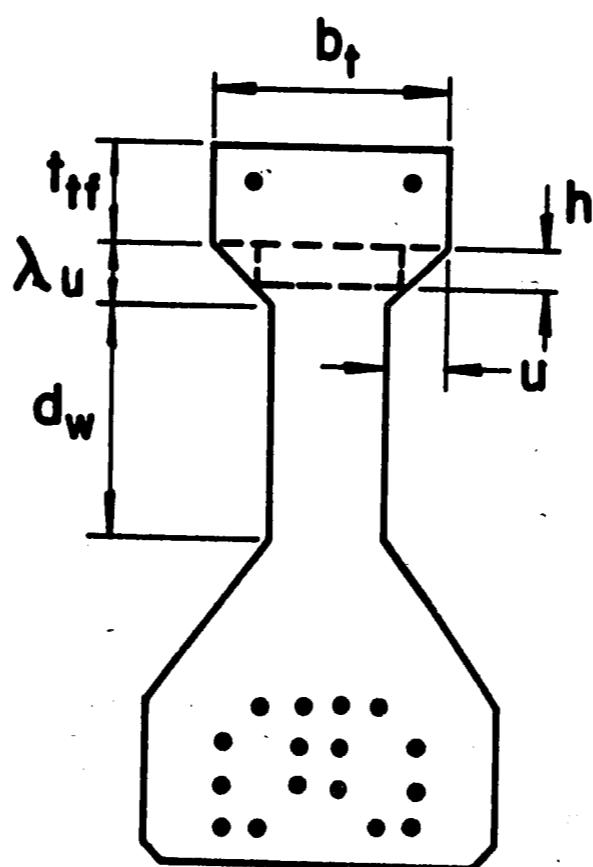
Fig. 33 Assumed Strain and Stress Distribution at Flexural Failure

Box Beam

I Beam
